BUILDING-STRUCTURE INVENTORY FORM

1. BUILDING NAME(S): Beckwith Farmhouse, Component #1
2. COUNTY: Madison TOWN/CITY: Cazenovia VILLAGE: Cazenovia vic.
3. STREET LOCATION: 4652 Syracuse Road
4. OWNERSHIP: a. public b. private
5. PRESENT OWNER: Stephen Cheney ADDRESS: Brick Yard Falls Rd., Box 213
6. USE: Original: residence Present: residence Manlius, NY
7. ACCESSIBILITY TO PUBLIC: Exterior visible from public road: Yes No 13104
Interior accessible: Explain no; private residence

Cazenovia Multiple Resource Area
Cazenovia, Madison County, New York

Beckwith Farmhouse, Component 1
Continuation sheet, page 1

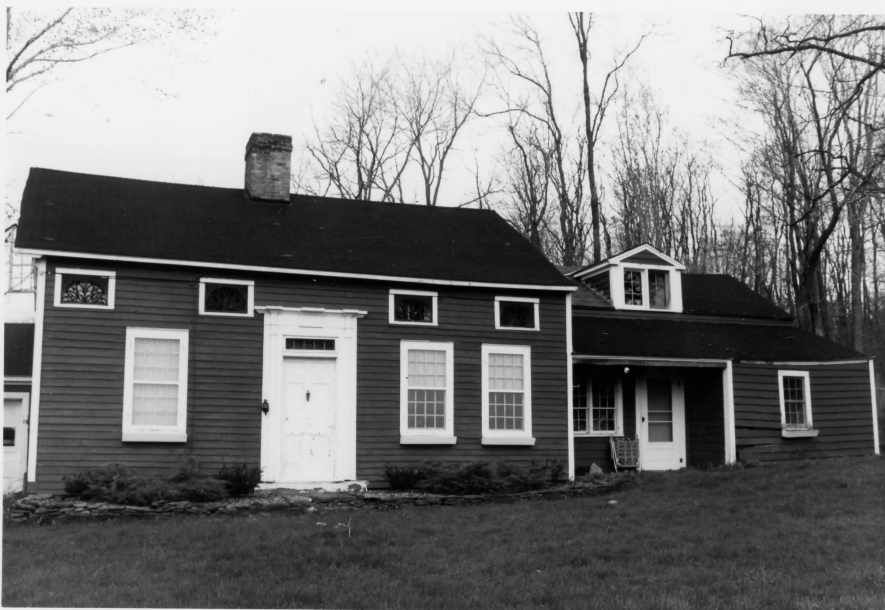
1. South (front) facade

18. The Beckwith Farmhouse is a rectangular, one and one-half story, gable-roofed frame residence built ca. 1810. The building is sheathed in clapboard and covered by a modern, asphalt shingle roof. The structure is organized around a brick center chimney, a house plan unusual in the region. The principal (south) elevation is asymmetrical, dominated by an ornate Federal style, molded entrance. Delicate wood pilasters supporting a molded entablature surround the six-panel door and rectangular transom. The entrance is flanked by double-hung windows containing twelve-over-twelve sash within simple moldings. The half-story windows above contain decorative iron grilles. A one and one-half story frame wing added later in the century to the east gable end of the main block incorporates a recessed secondary entrance on the south side. A non-contributing mid-twentieth century two-stall garage is attached to the west elevation of the main block.

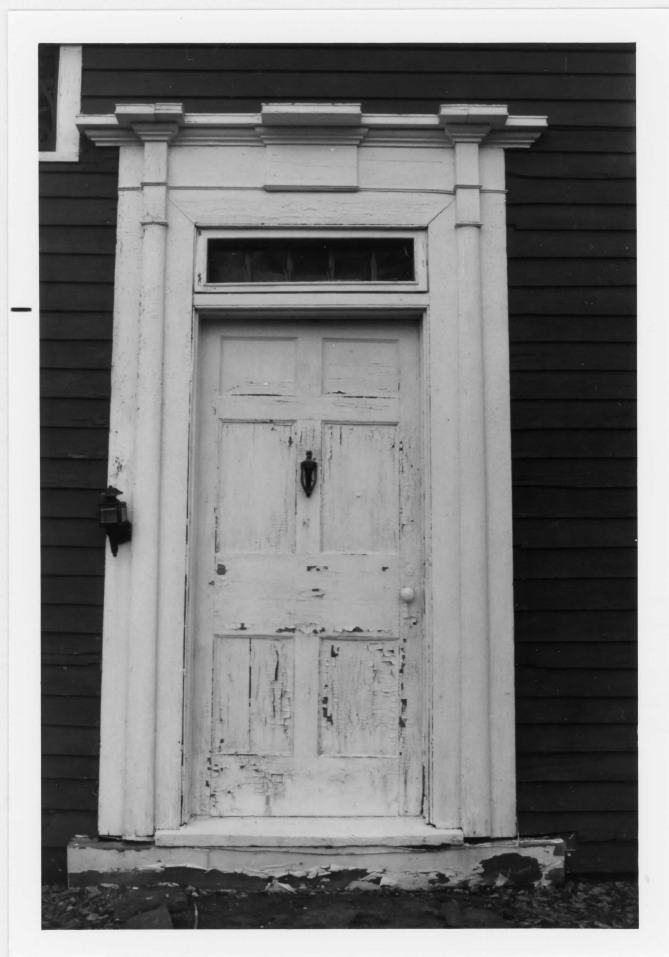
2. Main entrance; door detail

Vernacular interpretations of the style (such as the Beckwith Farmhouse) survive as well, particularly in rural settings and on the fringes of the historic core of the village. Although distinguished by particularly finely crafted entrance details, the Beckwith Farmhouse remains a rather modest, vernacular example of the early Federal style in its small scale and slightly asymmetrical fenestration. Unlike other center-hall-plan buildings of the period, the facade of the Beckwith Farmhouse features an unbalanced composition of irregularly placed windows which enhances the farmhouse's informal appearance. Similar asymmetrical, four-bay-wide buildings of the

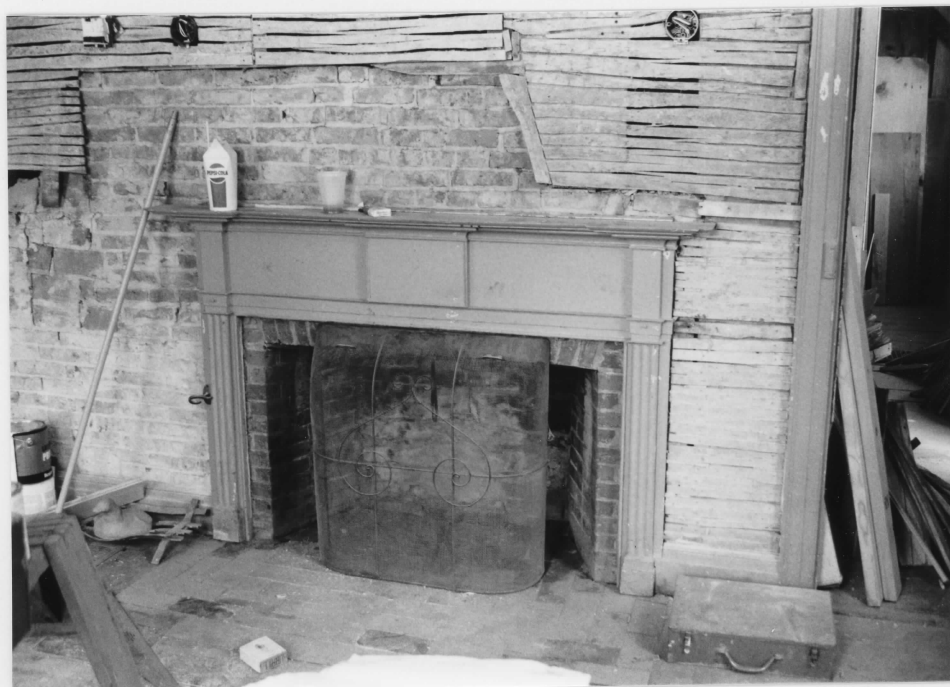
3. Mantelpiece, south parlor

The interior of the Beckwith Farmhouse retains original room configurations, lath walls (covered with modern plaster), wide board floors (believed to be butternut), a large brick kitchen hearth in the east room, a narrow, enclosed staircase in the rear corner of the east room, a finely crafted Federal period mantelpiece around the west parlor fireplace and simply molded wooden trim around original door and window openings.

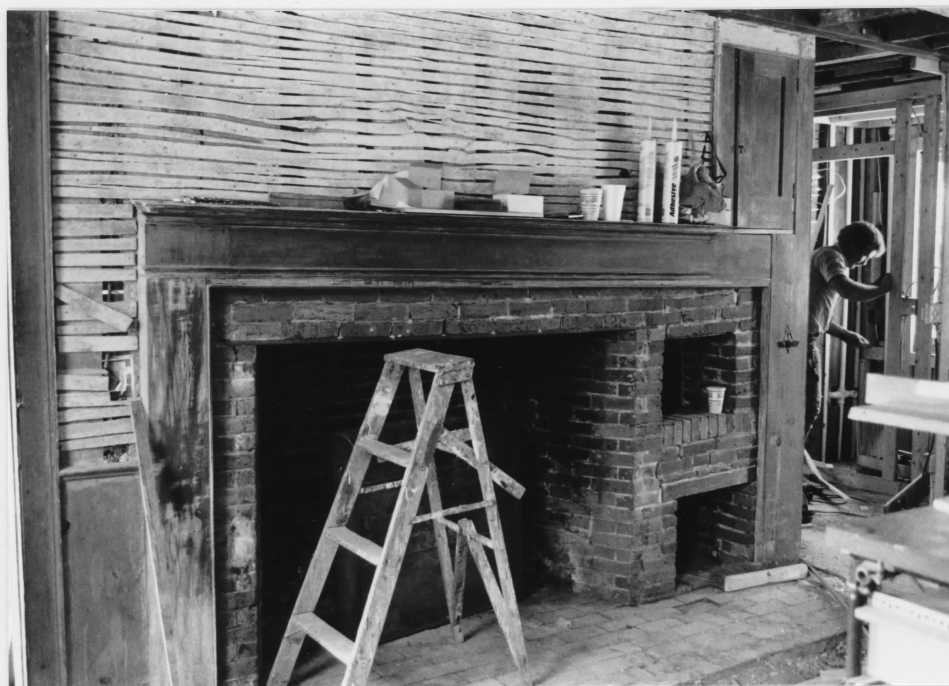
4. Kitchen hearth, north parlor

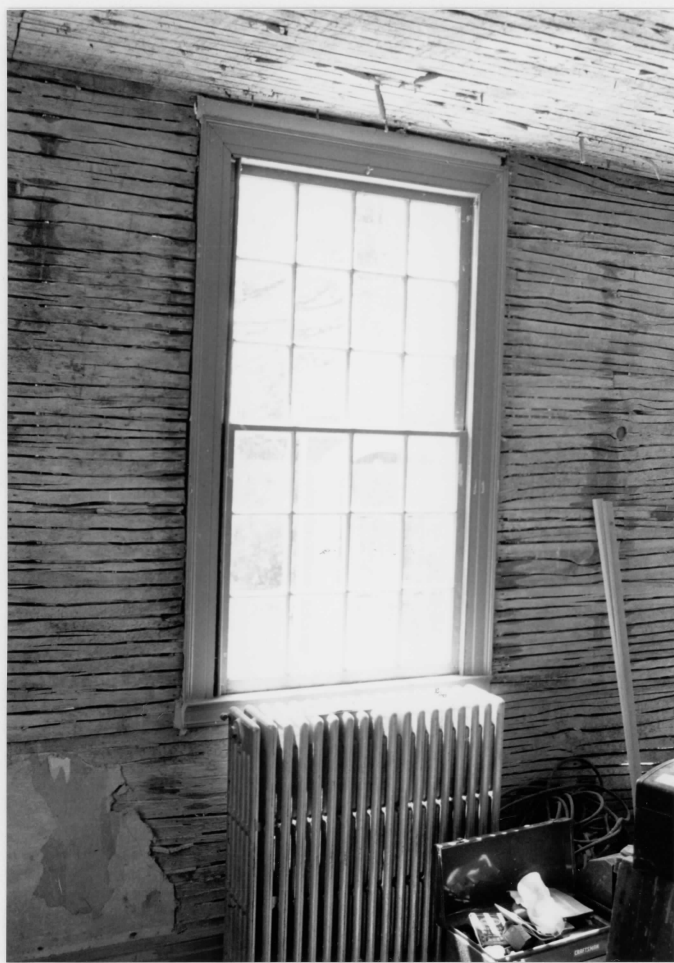
5. Window detail

nineteenth century in the town of Cazenovia. Characteristic features of the period and style include the rectangular, gable-roofed form, the gable roof with slight returns, the narrow frieze and slender corner boards and the eyebrow and twelve-over-twelve, double-hung sash windows with simple wood moldings. The Beckwith Farmhouse is one of the more modest examples of its type; however, it is distinguished by its finely crafted entrance and its center chimney plan, rather unusual in the region. The contributing additions to the farmhouse, including the one and one-half story east wing, reflect the evolution of the farm over an extended period of time to meet the changing needs of the occupants. The significance of the farmhouse is enhanced by the survival of a substantial portion of its rural, farm-like setting.

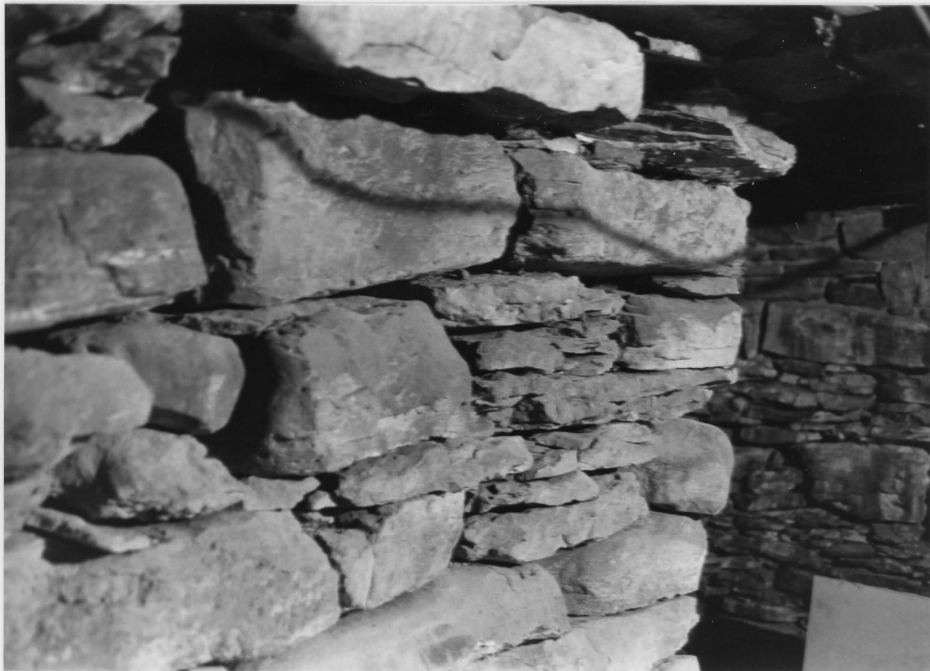
6. Basement, dry-laid stone chimney foundation

The Beckwith Farmhouse is atypical in the region for the central placement of its chimney, a plan commonly associated with New England regional building traditions. The Sweetland Farmhouse (ca. 1825; Component #3), the Niles House (ca. 1807, Component #2) and the J. A. Parker Farmhouse (ca. 1820; Component #17) also display centrally placed chimneys. End chimneys, as displayed on the Zephnia Comstock Farmhouse, Evergreen Acres and numerous village dwellings in the Cazenovia Village Historic District, are found much more frequently on buildings of the period and style in Cazenovia and the central New York region.

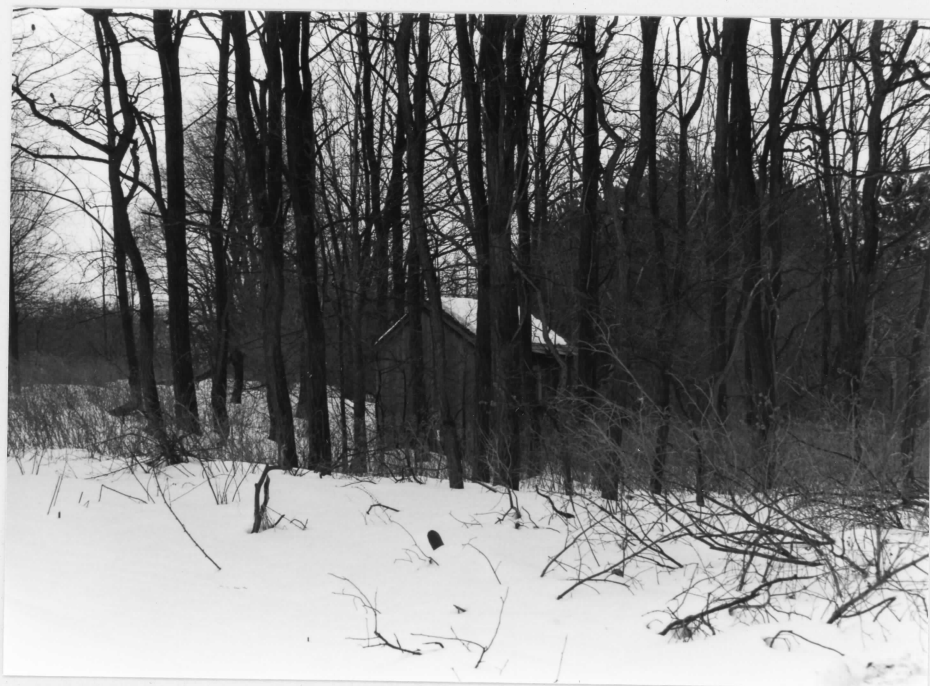
7. Shed #1, viewed from northwest

There are two contributing outbuildings located on the property; situated southeast of the main house are two small, late nineteenth/early twentieth-century frame sheds.

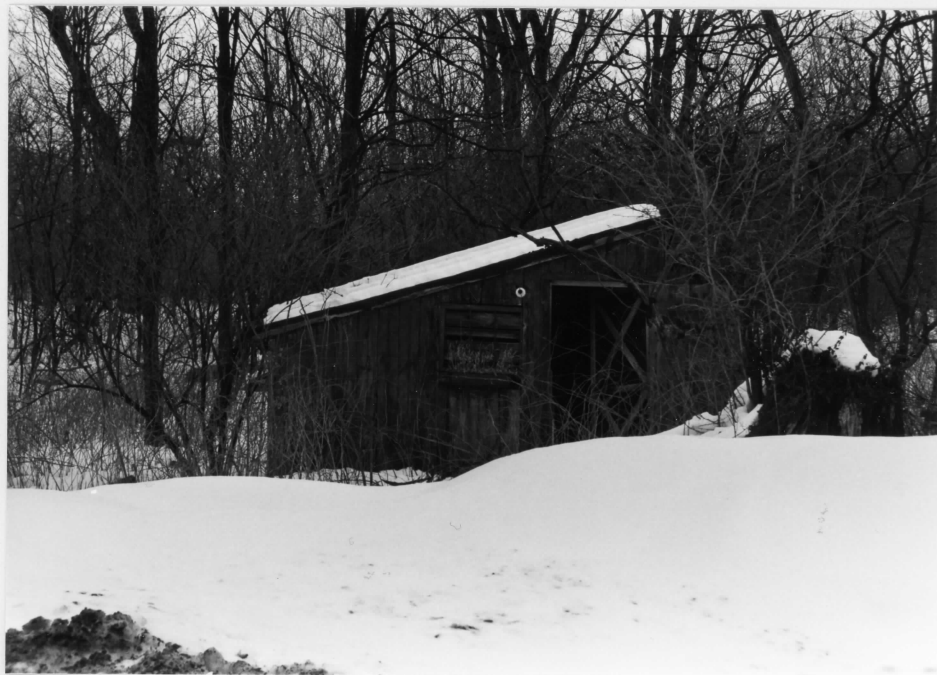
8. Shed #2, viewed from west

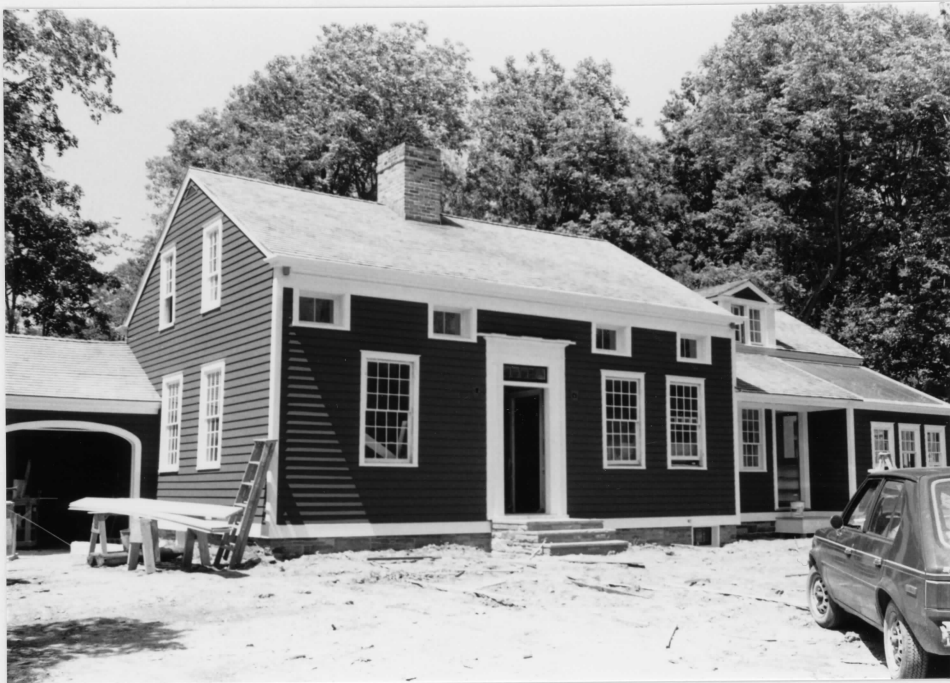
9. Restoration in progress, 1987

The building is currently undergoing restoration employing techniques and treatments consistent with the Secretary of Interior's guidelines and standards for rehabilitation.
