National Register of Historic Places
Registration Form

historic name Joseph Horton House

THE JOSEPH HORTON HOUSE
ROUTE 376
NEW HACKENSACK
DUTCHESS COUNTY, NEW YORK

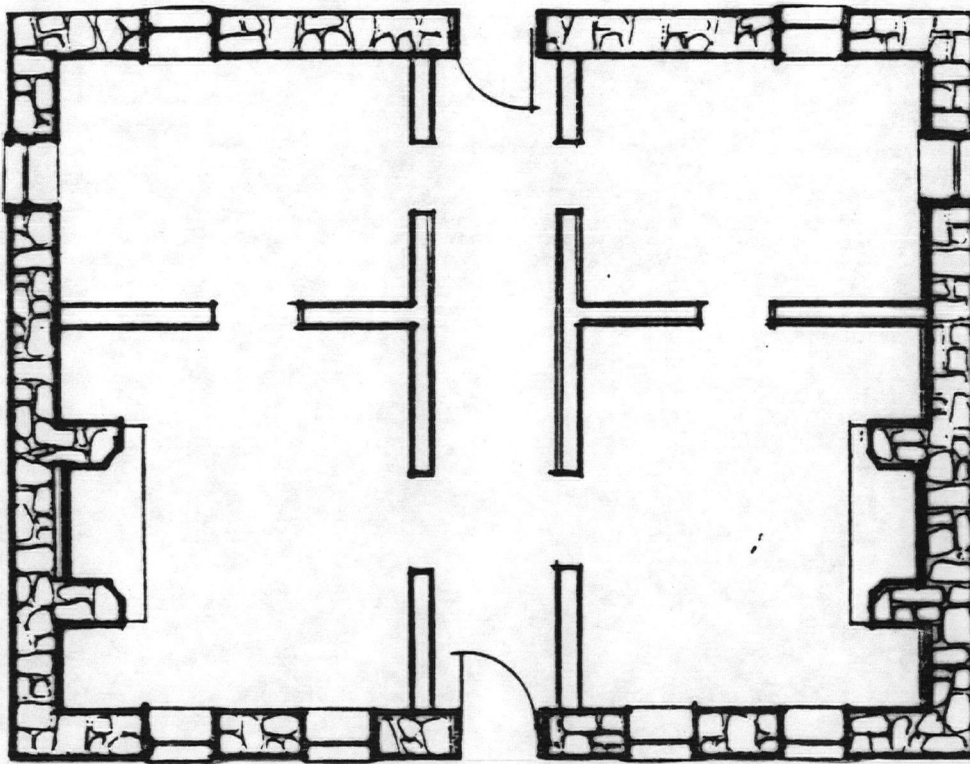
FLOORPLAN A

FIGURE 1 - PLAN A FLOORPLAN, A FOUR ROOM, CENTER HALL PLAN WITH FIREPLACES AT THE GABLE ENDS. ONE OF MOST COMMON FLOOR PLANS IN EIGHTEENTH CENTURY DUTCH HOUSES.

In the Bergen County stone house survey, ten varieties of Dutch floor plans were identified. In general, an evolutionary sequence from single-room, to two-room, to four-room, to center-hall plan was identified over the 1740 to 1840 period. Variants of these forms involved differing interior hearth locations, room sizes, and entrance locations in each of the basic plans. One of the most common floor plans encountered was plan A (figure 1), a four-room, center-hall plan with fireplaces at each gable end. A notable variant of this layout was plan B (figure 2), which can be described as a two-thirds example of the five-bay, center-hall type A plan. This form was a recognizable type in the Bergen County survey, but not common. It has been suggested that the plan A form dates to the 1770 to 1825 period, and that the plan B form, as a variant of plan A, dates 1775 to 1838.¹³

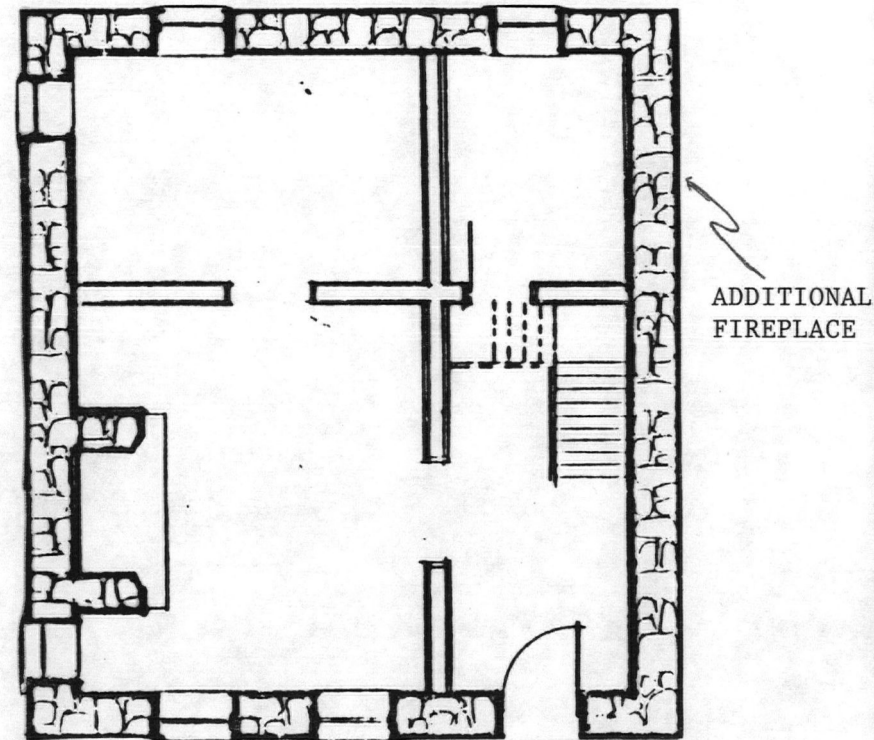
FLOORPLAN B

FIGURE 2 - PLAN B FLOORPLAN, A TWO-THIRDS VARIANT OF PLAN A, WITH SIDE HALL ENTRANCE AND SINGLE FIREPLACE IN OPPOSITE GABLE END. THE JOSEPH HORTON HOUSE HAS AN ADDITIONAL FIREPLACE IN THE REAR ROOM BEHIND THE STAIRS.

The interior layout of the Joseph Horton house consists of a side entrance and hallway with two large rooms (living room and keeping room) on the ground floor. The appended wing has a kitchen in front with a den and bathroom in the back. A stairway in the entrance hall leads up to a wide center hall with four bedrooms and a bath on the second floor.

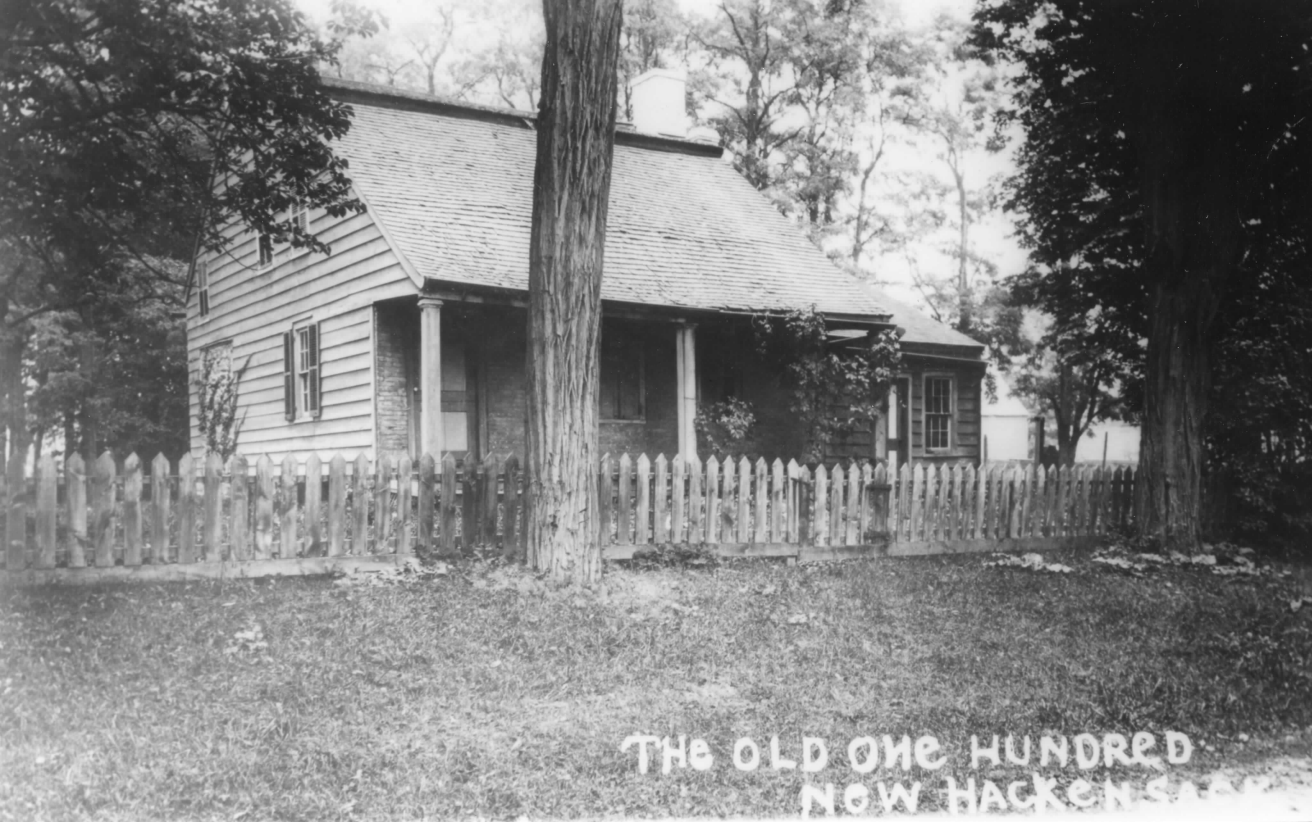
"Old Hundred"
Rte 376, New Hackensack vic-
inity, Wappingers Falls,
Dutchess Co., New York
Photo from old postcard,
date unknown
View #1 front (south side)

The front elevation of the Horton house faces south. The three-bay facade has two original six-over-six double-hung sash windows with paneled shutters to the right (east) and an original two-panel Dutch door with five-pane transom to the left (west). The 42-inch-wide door retains its original HL hinges and some of its latches. Window and door trim are plain. The facade is sheathed with an original brick veneer laid in English bond. Historically the brick surface was left exposed; today the facade is painted white.

The front elevation is visually dominated by the broad, gently sloping gambrel roof which flares out over a front porch. The porch, placed at the level of the exposed fieldstone foundation, is constructed of narrow flush board. A lattice apron encloses the space beneath. Three columns have plain bases and capitals, elongated plain pedestals, and are painted white. Together the simple porch, dominating roof, and impressive brick front of the formal elevation evoke a sense of austere rural dignity and economic security.

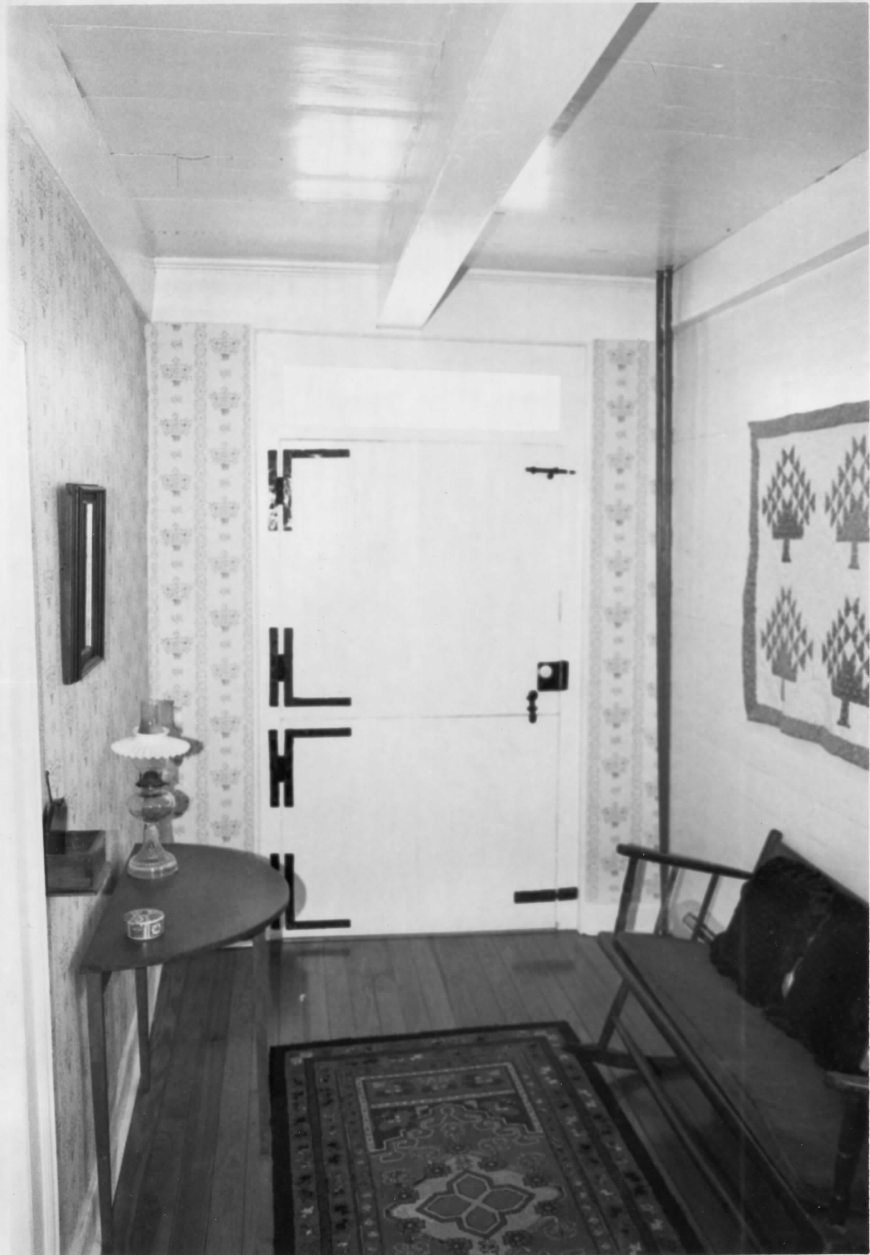
"Old Hundred"
Rte 376 New Hackensack
Wappingers-Falls
Dutchess Co., New York
Photo by G. Hammond 12/23/85
Neg. at Div. for Hist. Pres,
Albany View # 2
front hall facing front door

The wide front hall features a Dutch door with original hardware, exposed beams with visible mortise joints, and 180 degree pine winder stairs to the second floor. The staircase has original balustrades with turned balusters. A closet under the stairs has an original batten door and HL hinges. The original wide pine flooring has been covered with narrow maple hardwood, and the west wall of the hall is covered with later horizontal boards.

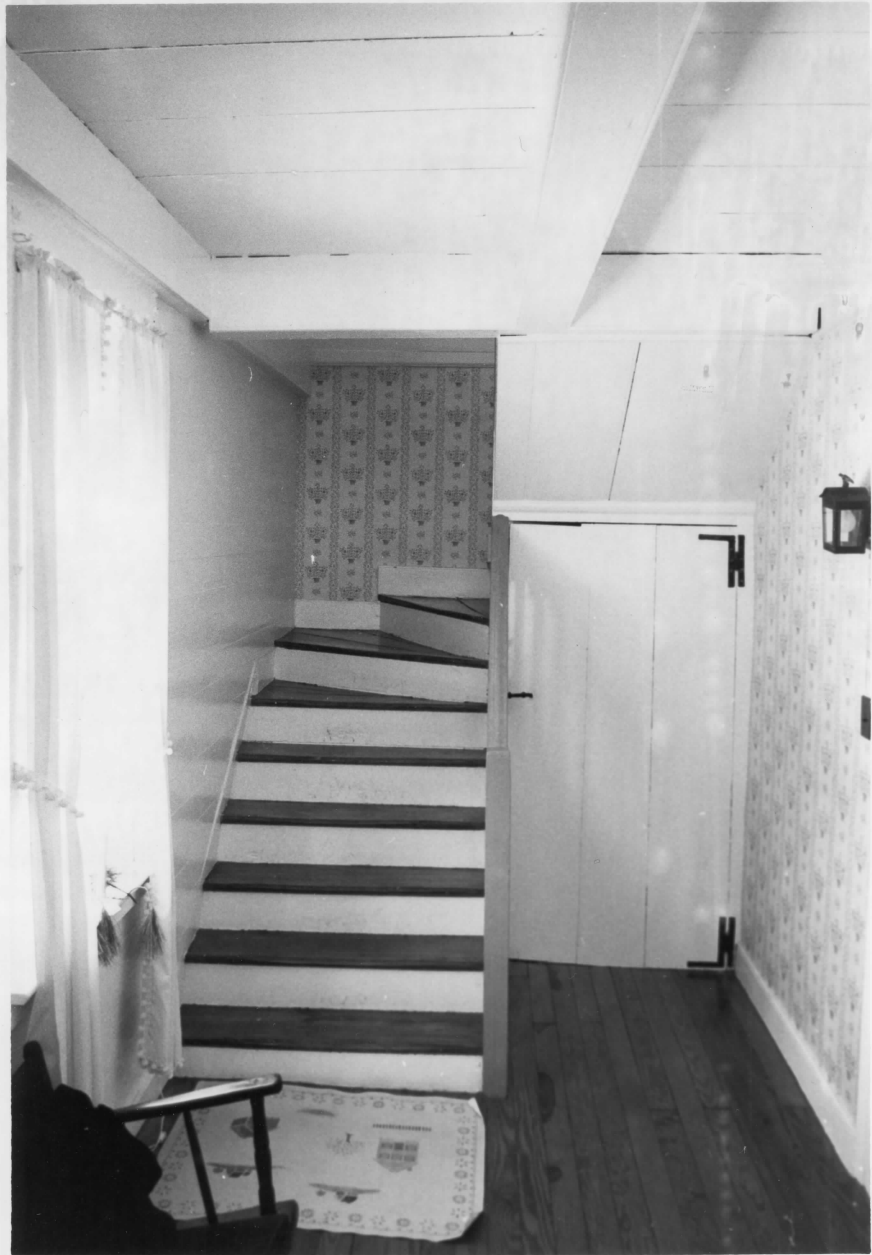
front hallway facing staircase

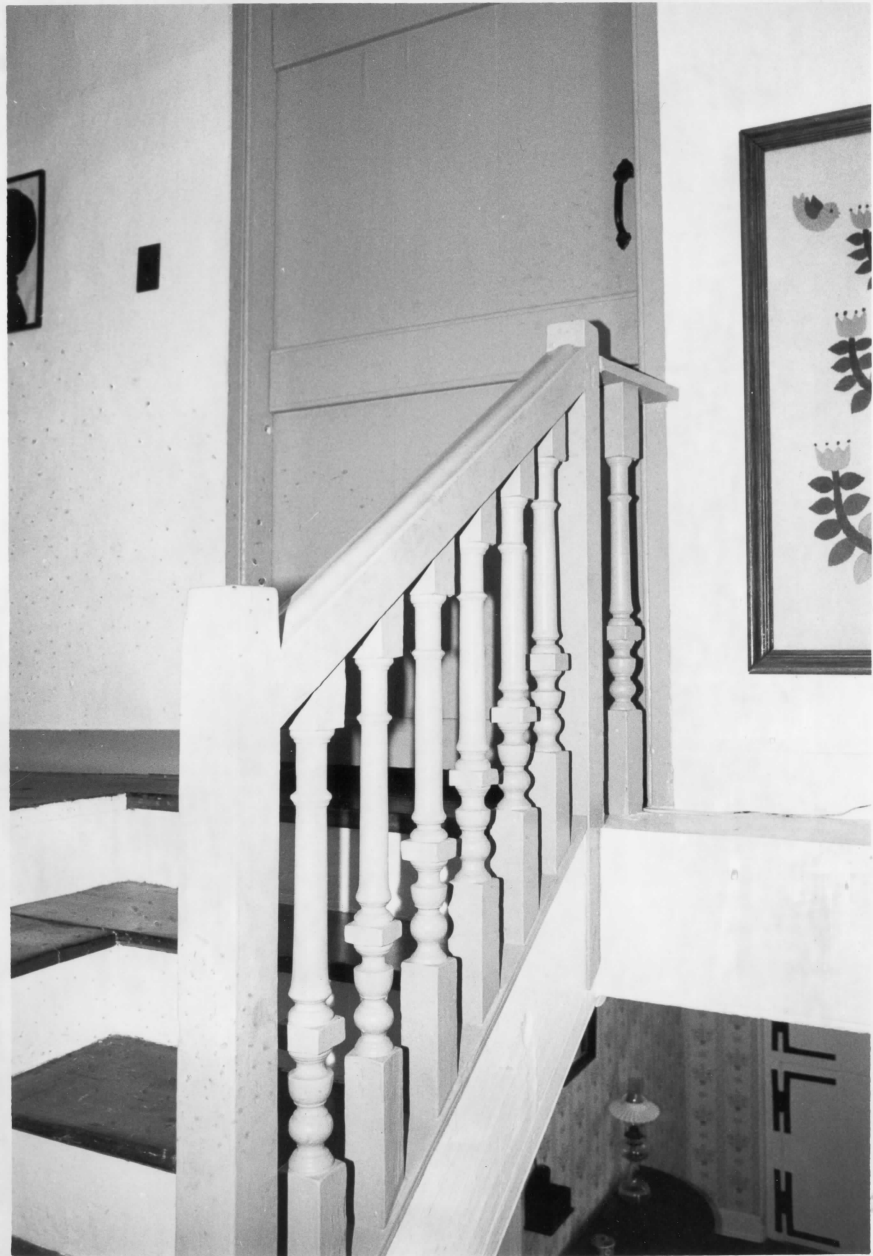
"Old Hundred"
Rte 376, vicinity New Hacken-
sack, Wappingers Falls,
Dutchess Co., New York
Photo by G. Hammond 12/23/85
Neg. at Div. for Hist. Preserv.,
Albany View #4
top of staircase facing
bedroom door

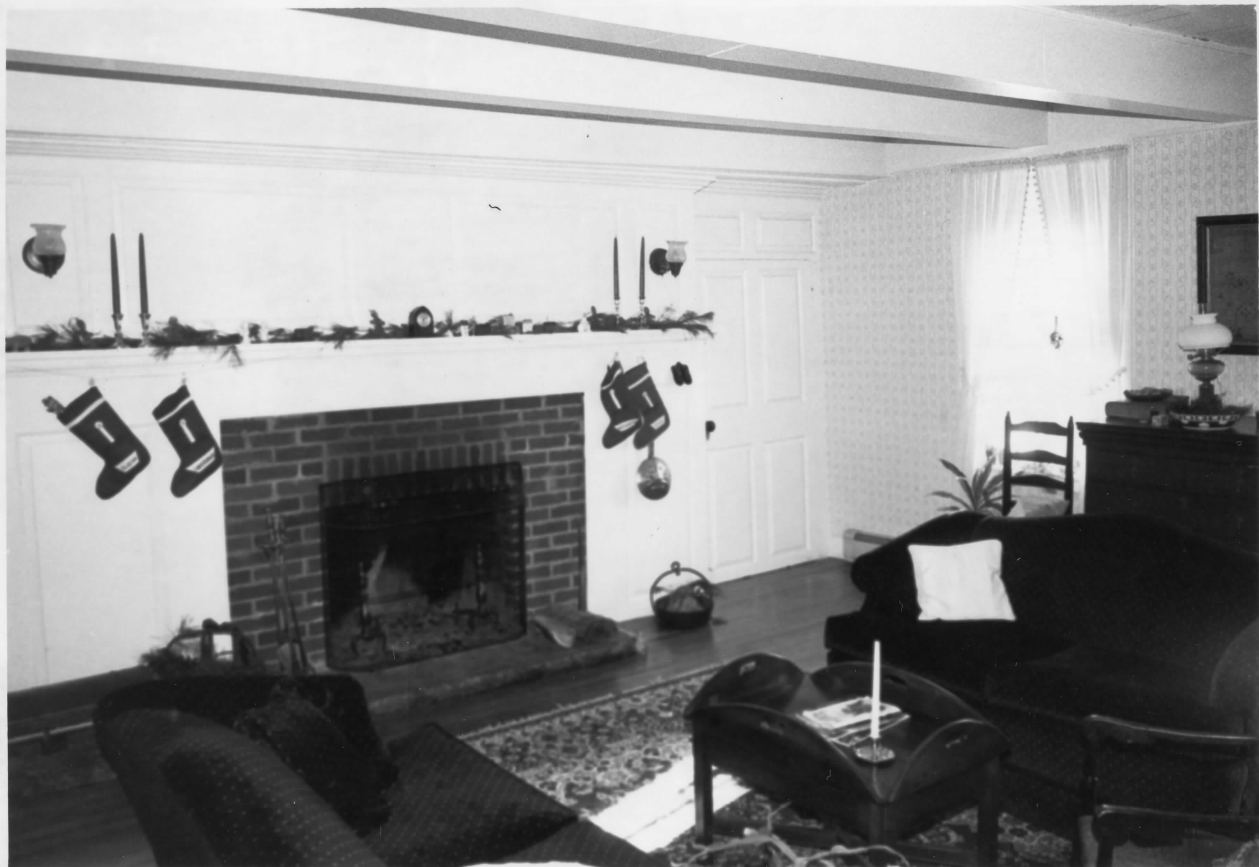
Panelled fireplace wall in
living room

The large rectangular living room has six exposed ceiling beams. Four of these have been boxed with one inch pine. The two exposed beams feature beaded edges and planed surfaces. All of the beams are painted white. The fireplace on the far wall of the room is sheathed in original paneling, and the four-panel doors that lead from the room match it in design. The fireplace opening, originally surrounded by delft tiles, has been rebuilt

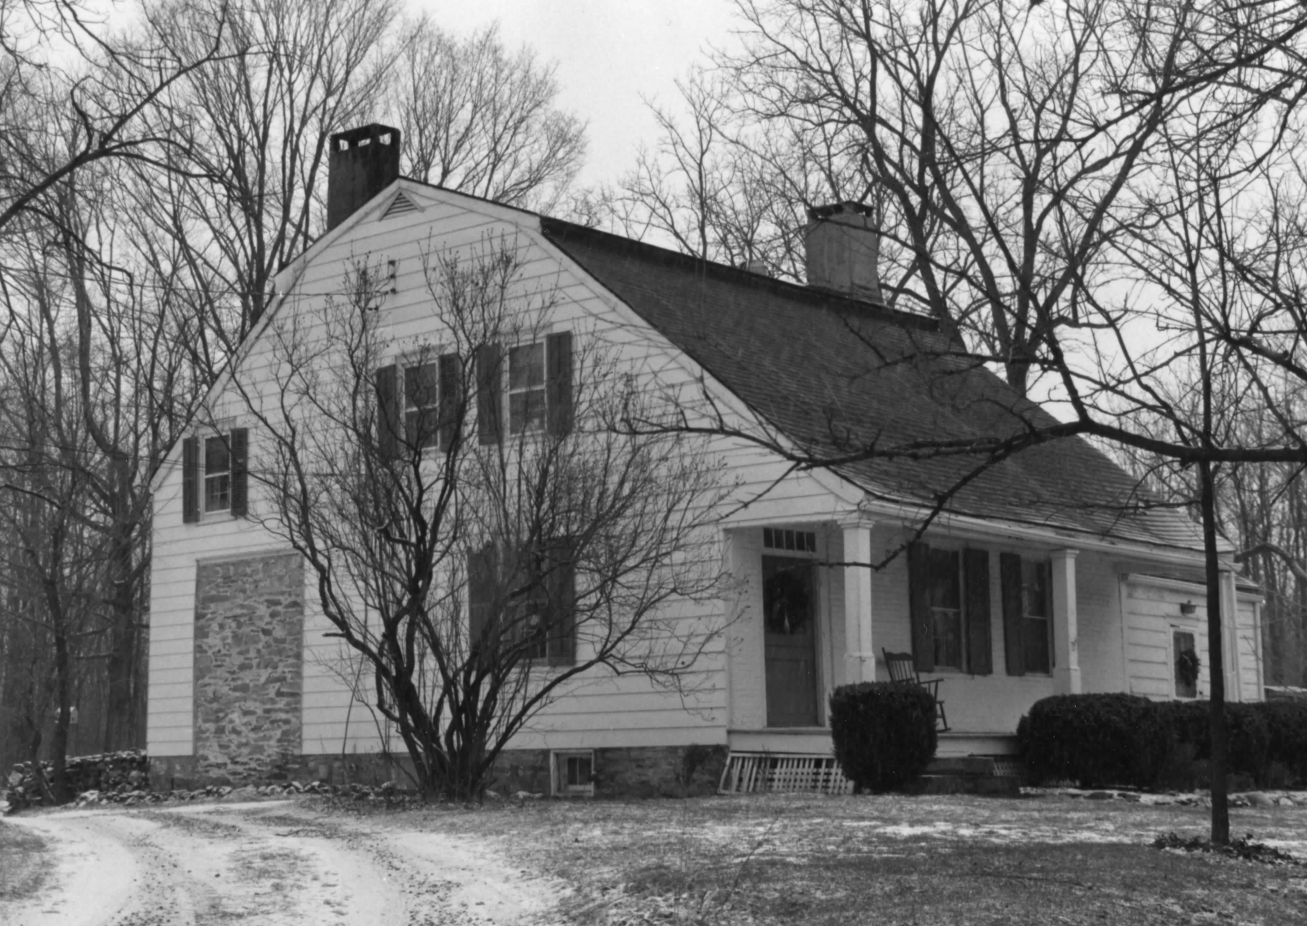
JOSEPH HORTON HOUSE
ROUTE 376, NEW HACKENSACK
DUTCHESS COUNTY, NEW YORK
PHOTO BY: M. PECKHAM, 1985
NEG. AT: OPRHP, ALBANY, NY
PHOTO #7: SOUTH (FRONT) AND
WEST (SIDE) FACADE.

The west (side) elevation of the dwelling has four original six-over-six double-hung sash windows with louvered shutters. Fenestration is irregular with one window on the first floor and three unevenly spaced windows on the second floor. Window trim is plain and unobtrusive. A small, triangular, louvered vent is placed high under the flush fascia in the gable. The mortared fieldstone chimney, set off center to the rear, is left exposed on the first floor level, but is sheathed in clapboard on the second floor. A dry-laid stone wall extends north from the rear corner of the building.

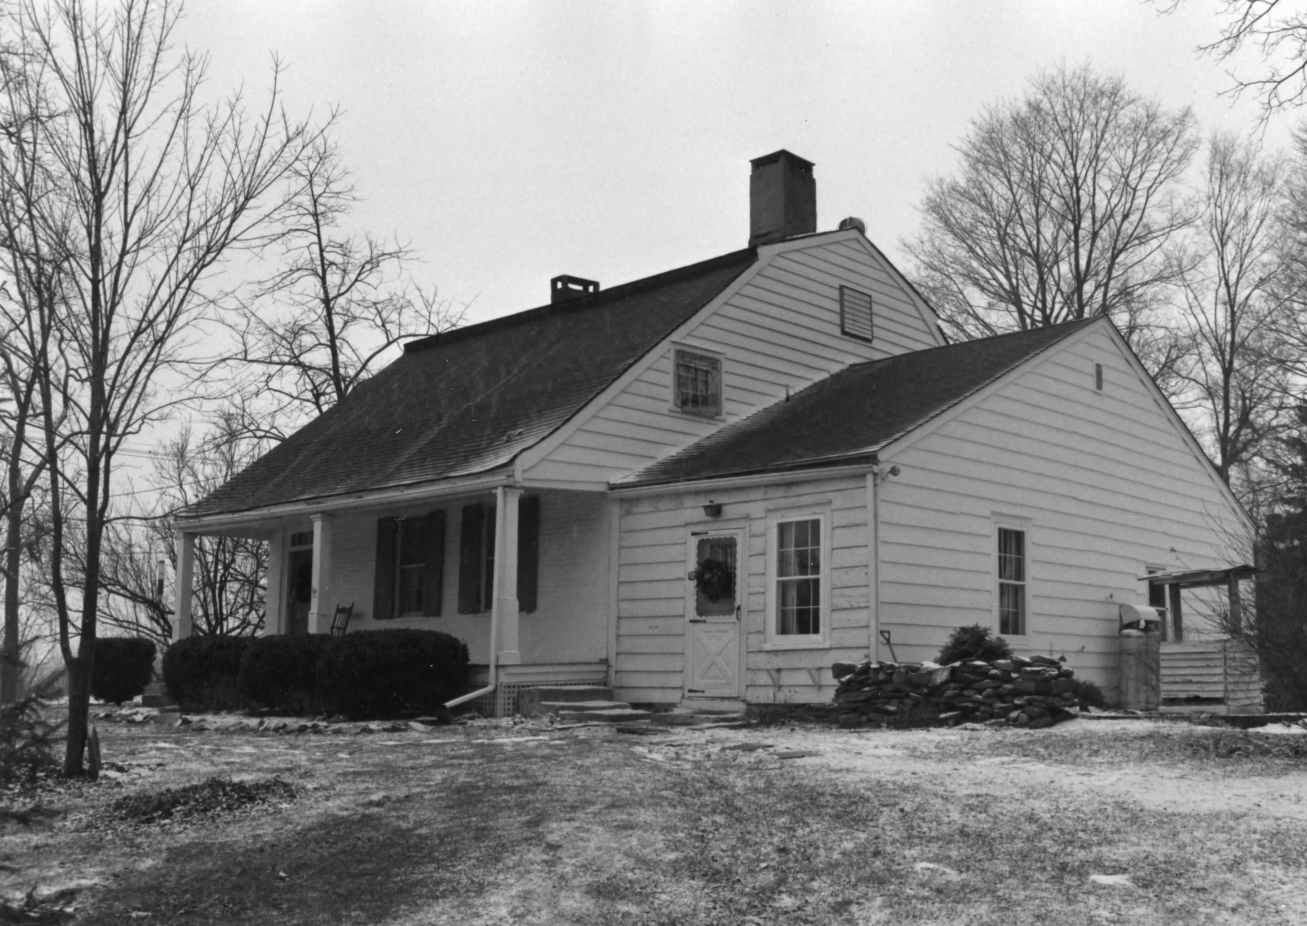
JOSEPH HORTON HOUSE
ROUTE 376, NEW HACKENSACK
DUTCHESS COUNTY, NEW YORK
PHOTO BY: M. PECKHAM, 1985
NEG. AT: OPRHP, ALBANY, NY
PHOTO #8: SOUTH (FRONT) AND
EAST (SIDE) FACADE.

The kitchen wing is located on the east side of the house. Added to the main dwelling by 1795, the one-story, gable-roof, timber frame appendage has no foundation. Clapboarded, with corner boards and flush fascia, the wing has a door and six-over-six double-hung sash window on the front (south) side. The door is not original. The side (east) and rear (north) of the wing each have two evenly spaced six-over-six double-hung sash windows of different sizes. The wing is the same width as the main house and the sides of the two elements are flush in the front and the rear. The east side of the main house above the gable roof of the wing has two twelve-pane casement windows with original glass panes. A dry-laid stone wall extends east from the right front (southeast) corner of the appendage.

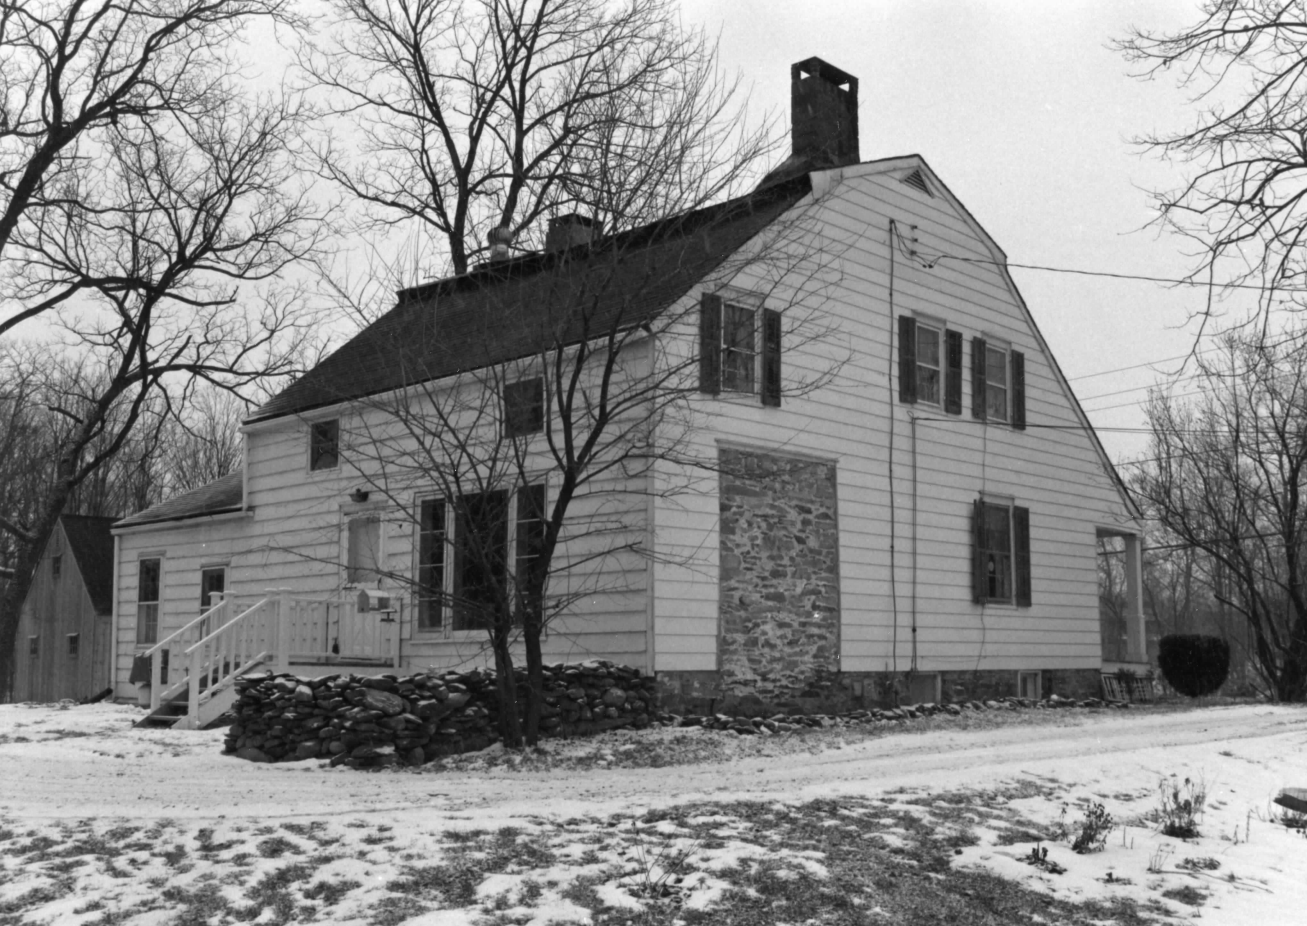
JOSEPH HORTON HOUSE
ROUTE 376, NEW HACKENSACK
DUTCHESS COUNTY, NEW YORK
PHOTO BY: M. PECKHAM, 1985
NEG. AT: OPRHP, ALBANY, NY
PHOTO #9: WEST (SIDE) AND
NORTH (REAR) FACADE.

The north (rear) elevation of the Horton house is clapboarded and has corner boards. Fenestration is irregular. The doorway is situated slightly off center to the left (east). Its Dutch door is not original. To the right is a modern triple-sash picture window that probably replaced two smaller original windows. Abutting the eave are two evenly spaced, small, square windows, with replacement lights. A small open porch leads to the rear door.
