### National Register of Historic Places Registration Form

(Form 10-900a). Type all entries.				
1. Name of Property	sadat be			
historic name The John Jones	Homestead		- 34 1 1 - 1	
other names/site number		Education of the second		
				18

The John Jones Homestead Oregon Road and Durrin Avenue Hamlet of Van Cortlandtville Westchester County, New York

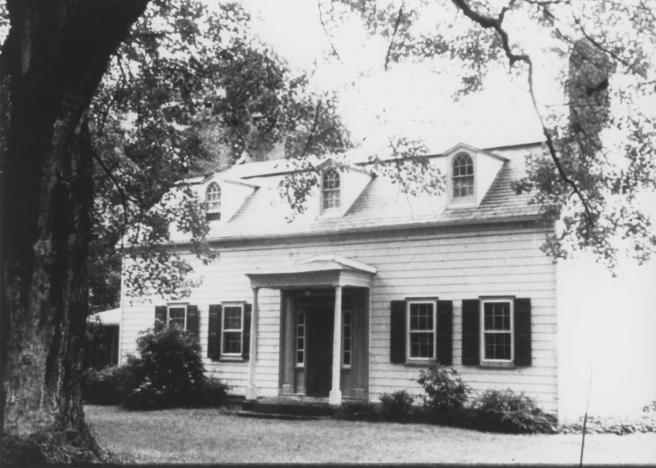
The John Jones Homestead Oregon Road, Van Cortlandtville Westchester County, New York Photo by: R. Kuhn, 1989. Neg. at: OPRHP, Albany Photo No. 1: Front (South) Facade.

The front elevation of the John Jones homestead faces south. The one-and-one-half story, five-bay facade has four six-over-six double-hung sash windows with original paneled shutters on either side of a center entrance. The facade is sheathed in wood shingles, exposed seven inches to the weather. The oversized front door is an eight-paneled Georgian variety with ogee molding and box lock. The elaborate entrance includes four-pane sidelights and a leaded transom surmounting the door, with a highly detailed paneled and molded wood veneer entrance surround. A square stone, measuring nine feet, five inches by four feet, two inches, forms the base of a small porch which protects the entrance. Two delicate unfluted columns with simple capitals support a full entablature of unorthodox proportions. The hipped roof of the porch, covered in modern asbestos shingles, may be the result of a later alteration.

The gambrel roof of the front facade is pierced by three evenly spaced dormers. The identical dormers are narrow, gable-roofed, and shingled on the sides. Each has a single double-hung sash window in the face. The top sash in each of these windows is arched and has decorative tracery. While the square panes of the sash have been replaced, some of the small panes in the tracery have original crown glass.

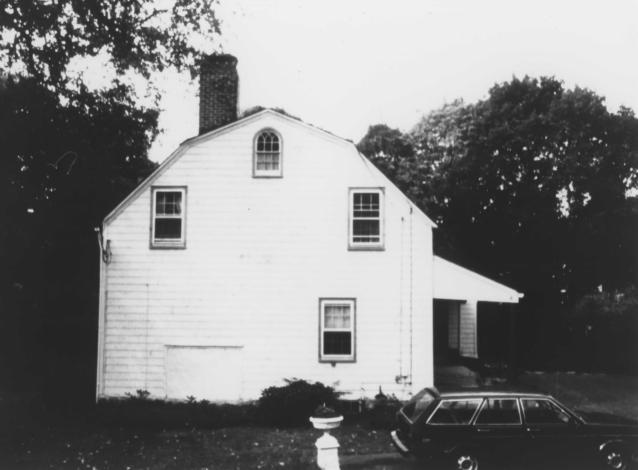
The John Jones Homestead Oregon Road, Van Cortlandtville Westchester County, New York Photo by: R. Kuhn, 1989 Neg. at: OPRHP, Albany Photo No. 2: Side (East) Facade.

The east side of the John Jones residence is shingled and has four asymmetrically placed windows. Centered on the ridge line and tucked under the gable is a single attic window. This double-hung window is arched and has a traceried upper sash. It is identical to the dormer windows on the front of the house. The other three windows, two on the second story and one on the first, are all six-over-six double-hung sash. Also on this elevation, the brick end-wall chimney is left exposed on the first floor level. The exposed portion of the chimney, laid in an English bond pattern with alternating courses of headers and stretchers, has an original beaded-board surround.

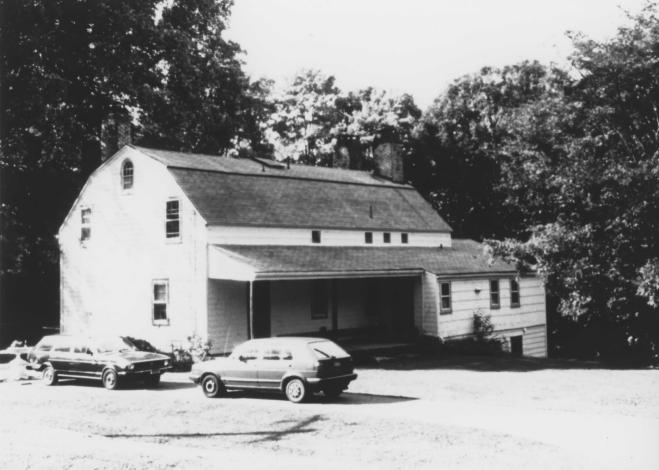
The John Jones Homestead Oregon Road, Van Cortlandtville Westchester County, New York Photo by: R. Kuhn, 1989 Neg. at: OPRHP, Albany Photo No. 3: Rear (North) Facade.

The rear or north side of the homestead includes the rear of the wing to the west and the set-back rear of the main block to the east. The exposed basement level of the wing is sheathed in clapboard. It has an old door with beaded edge wood surround. The first floor level of the wing is sheathed in wood shingle exposed fourteen inches to the weather, and has three asymmetrically placed windows. The short east wall of the wing, created by the setback of the main block, contains a six-panel door with ogee moldings. The rear wall of the main block has asymmetrical fenestration. On the first floor level there are two six-over-six double-hung sash windows. To the east of these

windows a new doorway with a reproduction Dutch door has been cut into the rear of the house. On the second floor level, above the roofline of the overlapping wing, are four small, square, asymmetrically placed casement windows.

A porch extends along the rear of the main block. The support posts and roof of this porch do not appear to be original; however, the long stoop probably dates to the period of house construction. The stoop consists of massive mortared stones, not unlike the foundation of the house. Many of these stones are quite large, measuring as much as eleven by six-and-one-half feet.

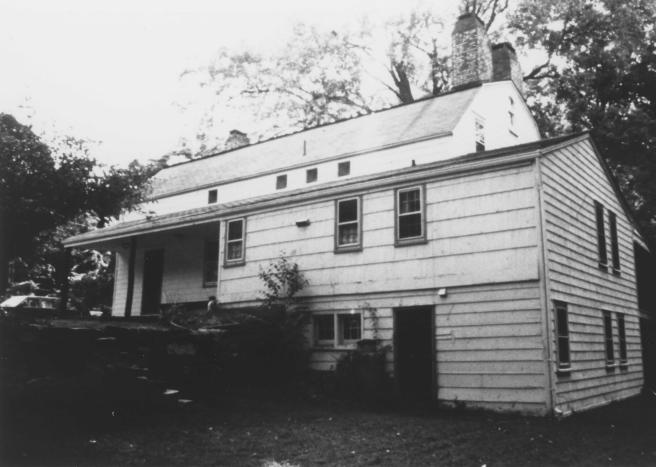
The John Jones Homestead Oregon Road, Van Cortlandtville Westchester County, New York Photo by: R. Kuhn, 1989 Neg. at: OPRHP, Albany Photo No. 4: Rear (North) and Side (West) Facade.

The west side of the John Jones homestead includes the side of the main block as well as the side of the one-story western wing. Both are sheathed in wood shingles identical to the front facade. The fenestration on both side walls is unbalanced. All of the windows are six-over-six double-hung sash with original paneled shutters. A single double-hung arched window is tucked under the gable of the main block. This window undoubtedly matched the traceried window on the east side of the house; however, the muntins of the upper sash have been removed and replaced by a single pane of glass.

The slope of the hill exposes the massive stone foundation of the main block on the western side. A batten door with strap hinges leading into the basement is located near the front corner of the foundation wall. There are no other entrances into the building from this side. The stone foundation wall continues on the south side of the wing, but the west wall of the wing is constructed, at ground level, of heavy timber framing and brick nogging, sheathed over with wood shingles. A stone wall built of massive dry-laid boulders extends south from the southwest corner of the residence.

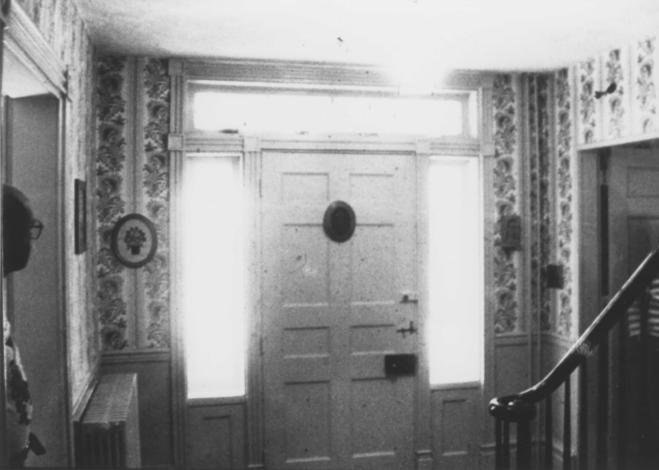
The John Jones Homestead Oregon Road, Van Cortlandtville Westchester County, New York Photo by: R. Kuhn, 1989 Neg. at: OPRHP, Albany Photo No. 5: Interior, Front Hall

The rectangular front hall retains original wide board flooring. An elaborate front entrance surround, with detailed molding, highlights the door, sidelights, and transom. A similar molding surrounds the doorway into the formal parlor. The hall has wide, molded baseboard and a chair rail. The three doors leading off the hallway into interior rooms are original sixpanel doors. The stairs to the rear of the hall have a cherry banister with plain, slim balusters and a scroll end volute. Detailed scroll brackets adorn the open stringer under the end nosing of each stair. The staircase returns upon itself, and the return is supported by a round, delicately fluted post with detailed capital. A stairwell into the cellar is located under the landing.

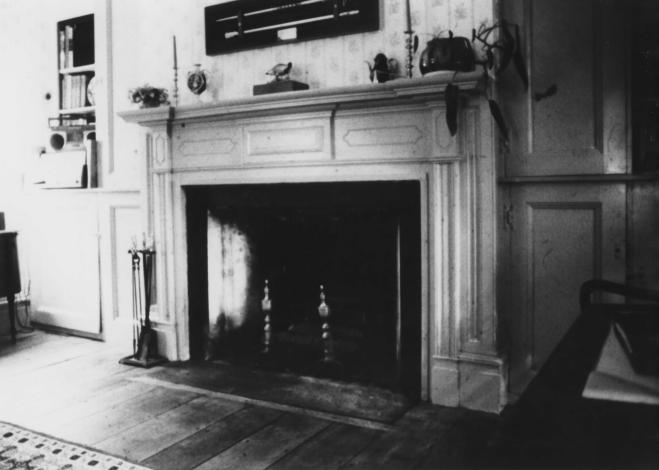
The John Jones Homestead Oregon Road, Van Cortlandtville Westchester County, New York Photo by: R. Kuhn, 1989 Neg. at: OPRHP, Albany Photo No. 6: Interior, Parlor Mantelpiece.

The east front room of the house was the formal parlor. It has the most highly detailed mantelpiece in the house with a five field entablature and deeply molded sides that give the appearance of colonnettes. A single large rectangular stone forms the hearth. The fireplace wall may have been entirely paneled. Portions of the original paneling and cabinetry are preserved on either side of the fireplace; however, modern built-in bookcases have been installed at the corners of the wall. The formal parlor also retains original wide-board flooring, wide 10 1/2 inch baseboard, paneling under the windows, and door and window surrounds that match those of the front hall.

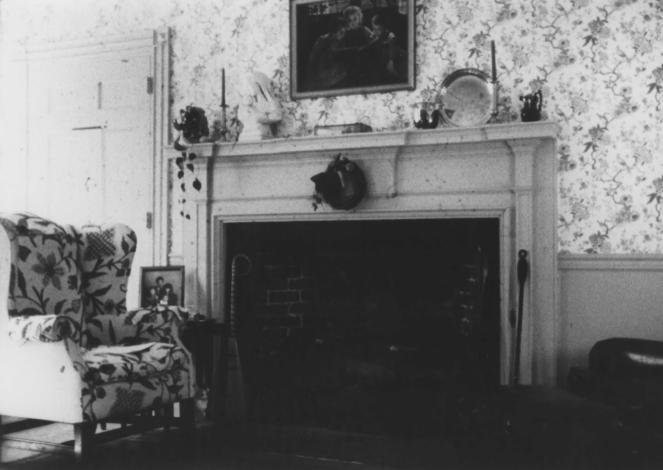
The John Jones Homestead Oregon Road, Van Cortlandtville Westchester County, New York Photo by: R. Kuhn, 1989 Neg: at: OPRHP, Albany Photo No. 7: Interior, Second Parlor Mantelpiece.

The west front room of the house was originally a second parlor. It has door and window surrounds, baseboard, wide board flooring, panels under the windows, and six-panel doors like the formal parlor. The wood mantelpiece is similar to the one in the first parlor, but less highly detailed.

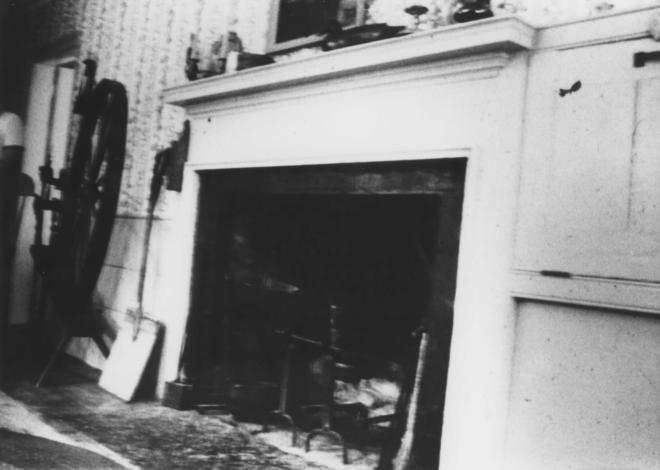
The John Jones Homestead Oregon Road, Van Cortlandtville Westchester County, New York Photo by: R. Kuhn, 1989 Neg. at: OPRHP, Albany Photo No. 8: Interior, Kitchen Mantelpiece.

dining area. The kitchen has been completely modernized. The dining room is the most intact of the rear rooms. Originally a kitchen, it retains a fireplace and brick bake oven. The fireplace wall retains original wide board, beaded edge, horizontal wainscoting. The fireplace has a plain mantelpiece, and a nine and three-quarter foot hearth stone. A small closet, which may have been a smoke closet, exists above the beehive oven. The room has intact beaded-edge door surrounds on the doorway leading into the front parlor.

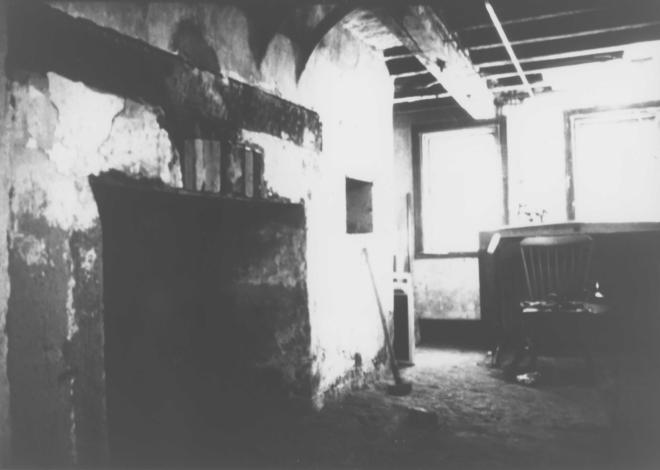
The John Jones Homestead Oregon Road, Van Cortlandtville Westchester County, New York Photo by: R. Kuhn, 1989 Neg. at: OPRHP, Albany Photo No. 9: Interior, basement fireplace with bake oven.

The interior of the John Jones homestead retains a remarkable degree of physical integrity. The basement level of the northwest wing, which apparently dates earlier than the main block, appears to have been a kitchen at one time. It has a brick and stone fireplace with heavy-hewn lintel beam, a brick bake oven, and a stone floor constructed of flat, dry-laid, rough-cut stone blocks. Most of the floor stones are approximately three-foot square. The walls of this room are constructed of heavy hewn posts with brick nogging that has been plastered over. Since it is built into a hill, this "basement" room is accessible from ground level through a rear door.

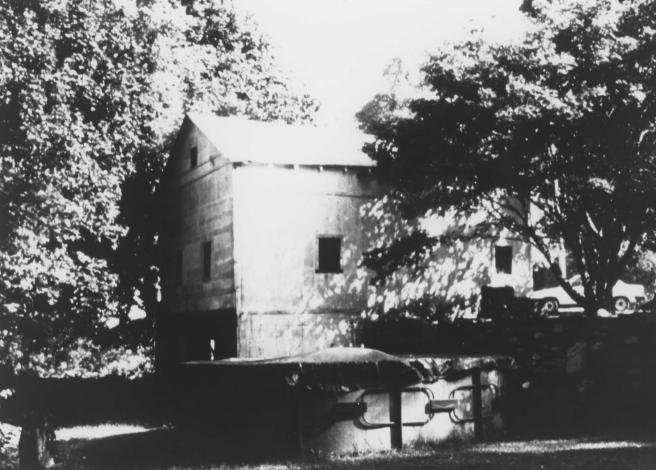
The John Jones Homestead Oregon Road, Van Cortlandtville Westchester County, New York Photo by: R. Kuhn, 1989 Neg. at: OPRHP, Albany Photo No. 10: Contributing Barn.

The barn (one contributing building) is located behind the residence to the north. It is a small, one-story, one-bay building with a gable roof. The barn has a boulder stone foundation that is similar, in many respects, to the foundation

of the house. Original elements of the barn's heavy timber framing are intact in the foundation level of the barn. The upper level of the barn has been largely rebuilt and resheathed. The barn appears to have been built contemporaneously with the house.
