UNITED STATES DEPARTMENT OF THE INTERIOR
NATIONAL PARK SERVICE
NATIONAL REGISTER OF HISTORIC PLACES
REGISTRATION FORM

historic name John Settle Farm
other names/site number _____

street & number 1054 Settle Road [] not for publication
city, town Newark Valley [] vicinity
state New York code 036 county Tioga County code 107 zip code 13811

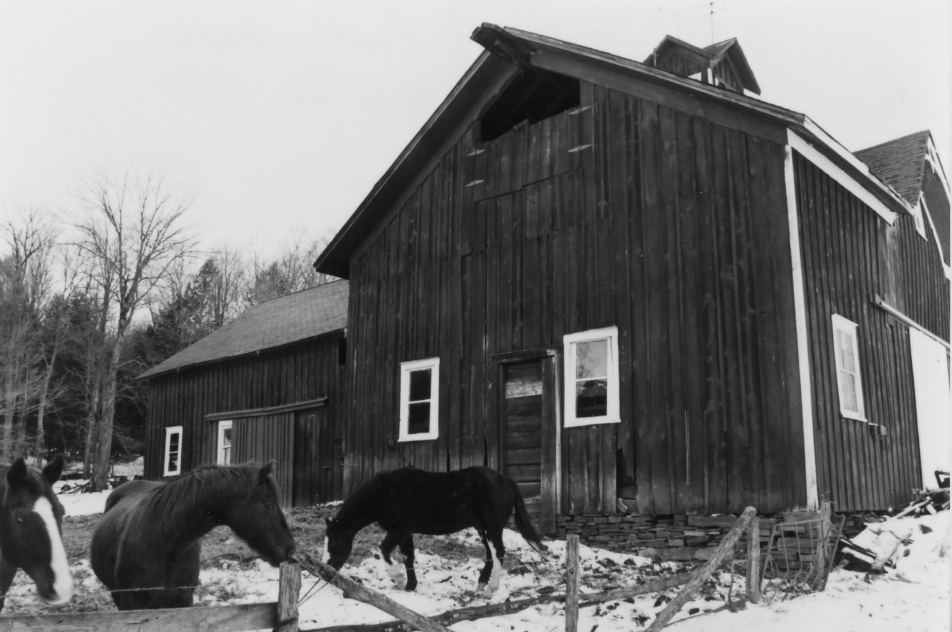
Horse barn facing SE

Horse barn. Like the dairy barn, the horse barn was constructed in two stages. The front section was probably constructed as a carriage house at approximately the same time as the dairy barn, ca. 1880. The building's function was expanded to that of a horse barn when a large rear wing was added, probably at the turn of the century or shortly thereafter. The rear wing is approximately the same size as the original carriage house.

This barn shares many design elements with the dairy barn, suggesting a similar date of construction for the two barns. Both have board and batten siding, a center gable in the principal facade that features decorative trusswork, and an ornamental cupola featuring a square plan, cross-gabled roof, and paired slatted ventilation openings on each facade. The building rests on a field stone foundation and is covered by a composition shingle roof.

The front facade of the barn, which faces east, has a double-leaf sliding track door and a single six-over-six-light window. The north facade features an oval window in the gable, two other windows on the first story, and a loft door. The south facade has a pair of windows on the first story and a hinged, double-leaf loft door centered directly beneath a small hay hood in the gable. The rear section has sliding doors and several windows on the north and south facades. Currently the rear section houses carriage and horse stalls.

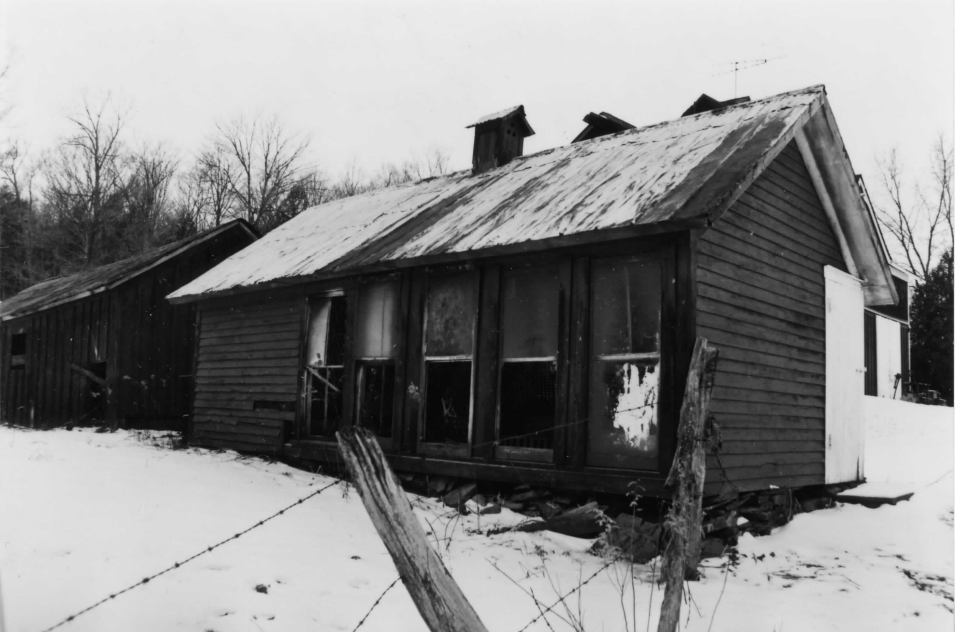
Chicken House facing NW

Chicken house. This gable-roofed building was built prior to 1937, probably in the early twentieth century. It is clad in clapboard siding and rests on a stone foundation. Its roof is covered in standing seam metal. Fenestration consists of a row of five large windows on the south facade, and an entry door on the east facade. The building also features a small gable-roofed ventilator.

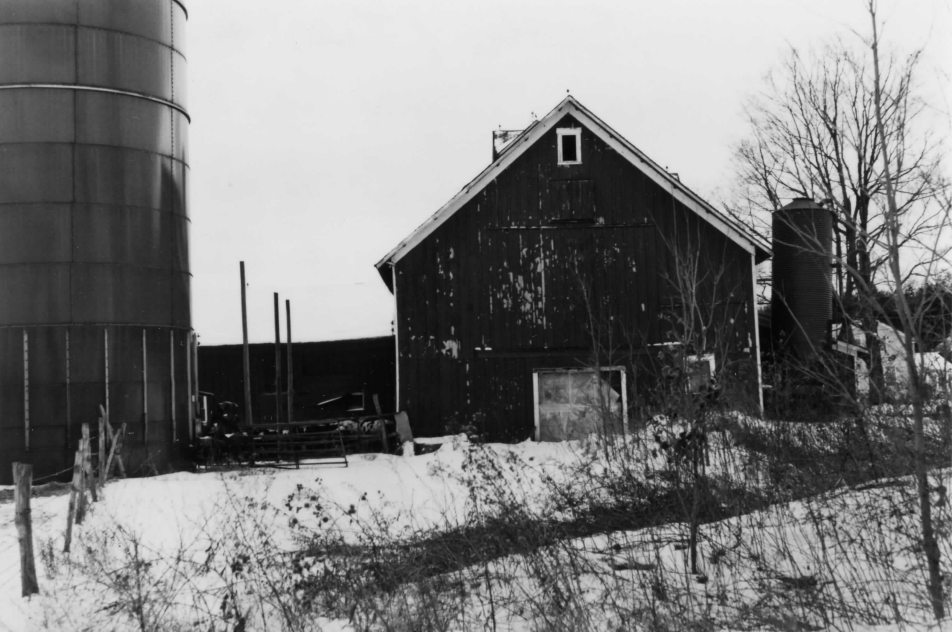
Cow barn and silos
facing SSE

Dairy barn. This large dairy barn is the largest building on the farm, and the only building located on the east side of Settle Road. It appears to have been built in two stages. Stylistic details on the front section, whose gable ridge parallels the road, suggest that it was constructed ca. 1880. The cross-gabled rear wing was probably built earlier, as its roof support system employs diagonal bracing rather than the H-frame bents found more typically in later barns. Both sections rest on stone foundations and are covered by standing seam metal roofs. The barn, including the modern milk house addition, is clad in board and batten siding.

The principal front section is most notable for its decorative roof details. These include a center gable on the west facade featuring decorative trusswork, and a distinctive cupola with a square plan, cross-gabled roof, wood shingle siding, and paired slatted ventilation openings. The decorative center gable and the elaborate cupola are also found on the horse barn across the road. The dairy barn's roof also contains gabled dormers on the west facade. These dormers feature the same siding and roofing materials as the rest of the barn.

The windows on the first story of the barn have four lights. Ground-level drive doors are centered in the north and south gable ends of the barn. A larger drive door, formerly located near the center of the west facade, has been sealed and replaced by a small entry door.

Silo. This A. O. Smith Harvestore silo, located on the north side of the dairy barn, was erected by the present owners after 1950. Like other A. O. Smith Harvestore silos, it has a fiberglass interior and blue metal exterior.

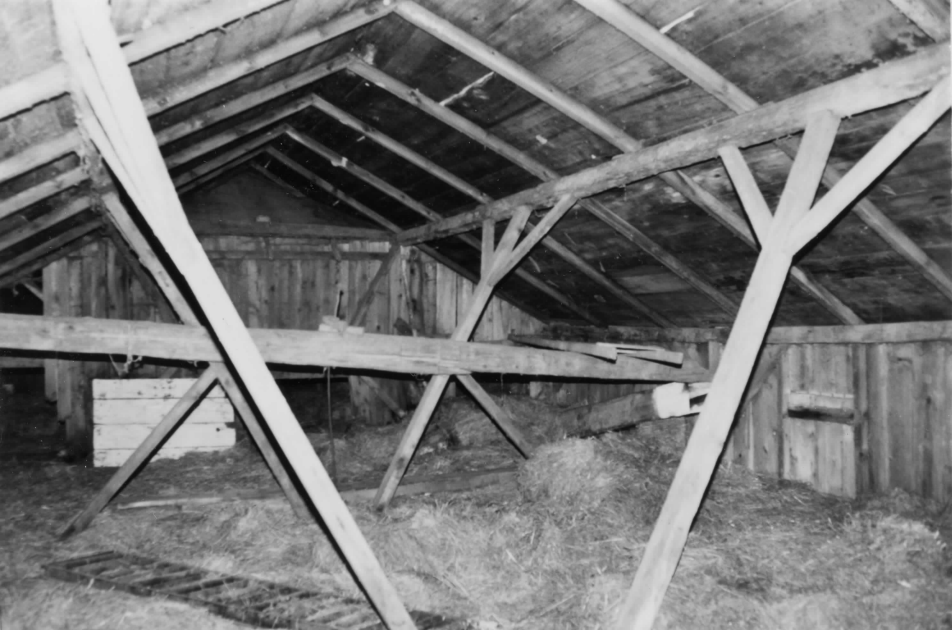
Cow barn interior, rear section
loft area, facing south

The rear wing of the barn appears to be older than the principal section. The diagonal bracing used to support its roof, which permitted the support posts to intersect the purlins at right angles, suggests an earlier date of construction. However, because the timbers appear to be standard dimensional mill-sawn lumber rather than hand-hewn posts and beams, this section could have been constructed any time during the mid-nineteenth century. Therefore, while probably older than the ca. 1880 front section, the rear wing is not necessarily the original barn on the farm.

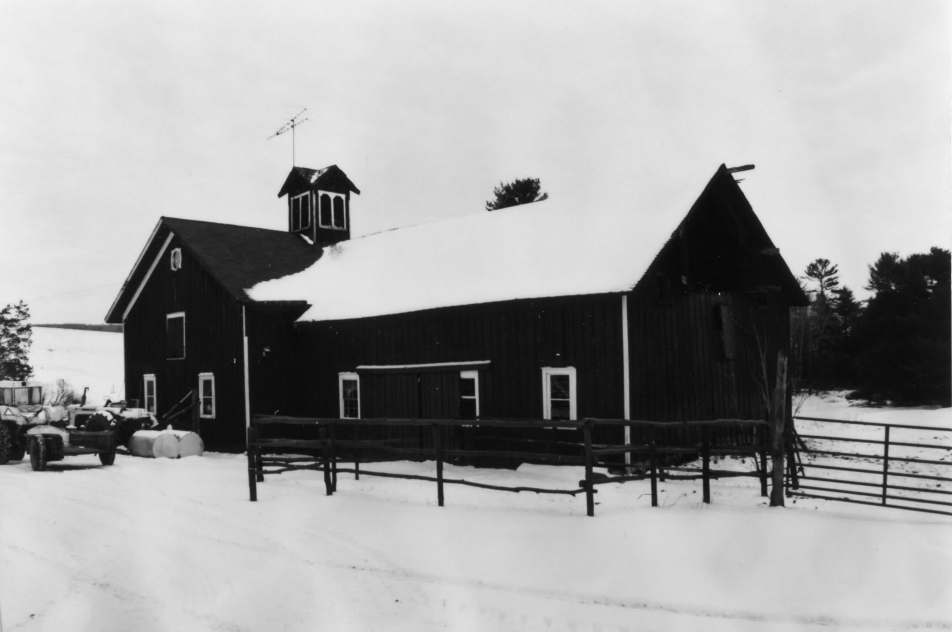
Horsebarn facing SE

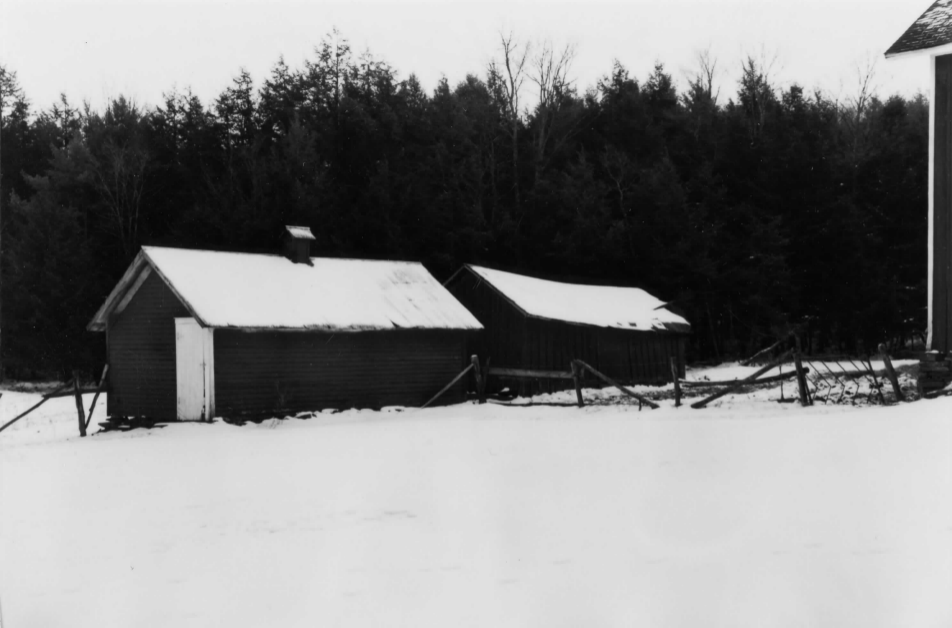
chicken house and pig house
facing SW

Pig house. This gable-roofed building, located immediately west of the chicken house, was built prior to 1937, probably in the early twentieth century. It is clad in board and batten siding and rests on a stone foundation. Its roof is covered in standing seam metal. Fenestration consists of a door and a window on the south facade, a large entry door on the north facade, and a small opening on the east facade.

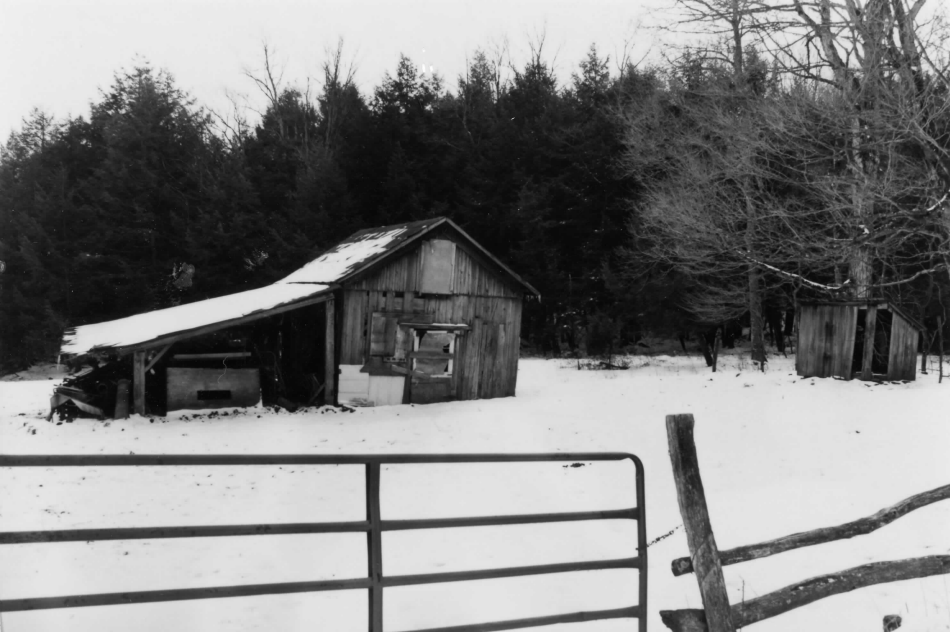
Granary and shed SW

Granary. This granary was built between 1937 and 1955. It has vertical board siding and what appears to be a tarpaper roof. It has a lean-to shed addition attached to the east side. The structure probably lacks a foundation, but this could not be determined from a distance.

Shed. According to the present owner, this small shed formerly housed a gas tank. The building, which probably dates to the mid-twentieth century, is clad in vertical board siding. The materials used to construct the foundation and to cover the shed roof were not visible from the driveway.

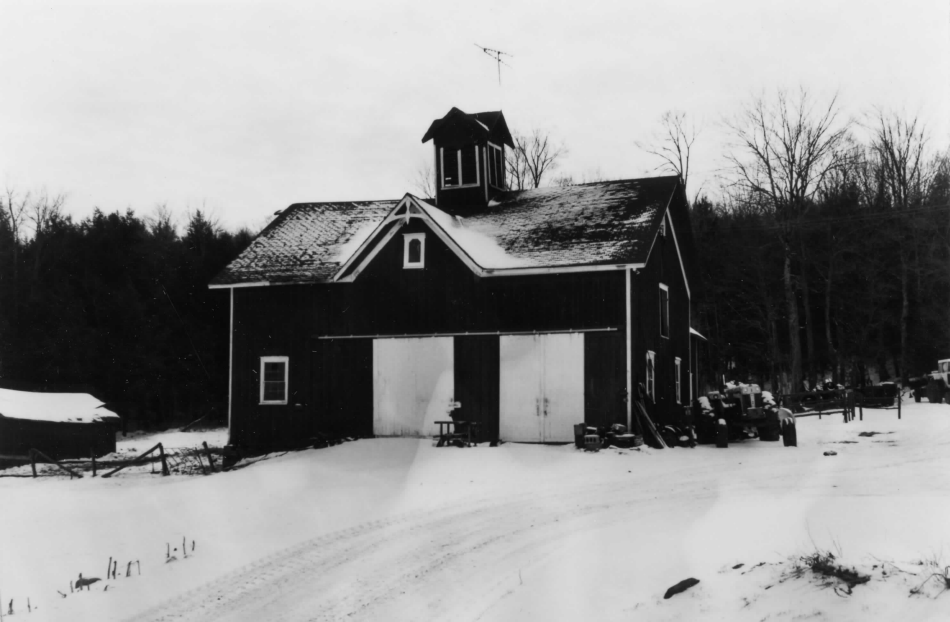
Horse Barn facing SW

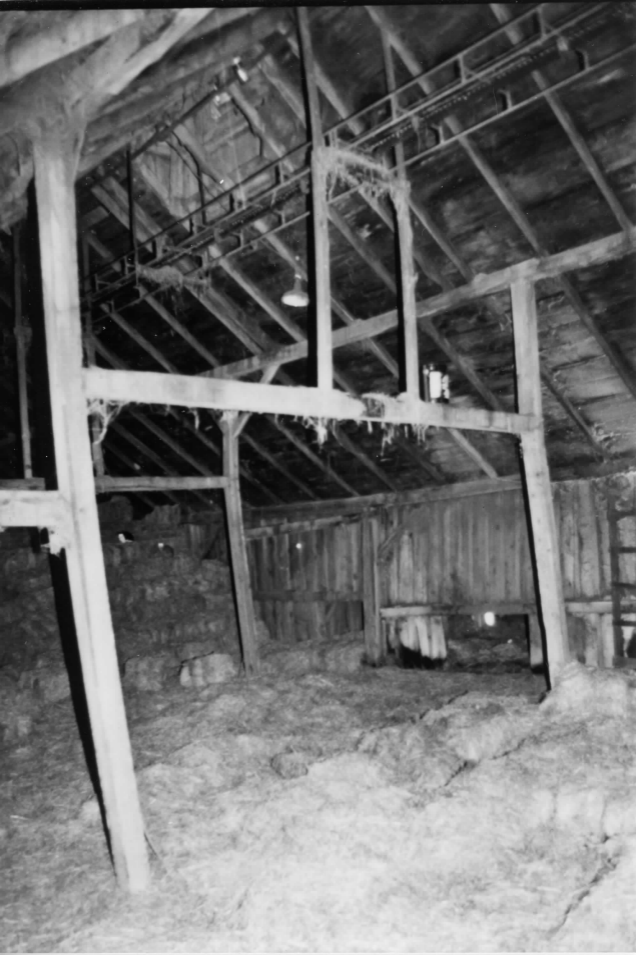
Cow barn upper level
facing S

The framing of the principal section uses the post-and-beam timber frame construction typical of barns erected in the last quarter of the nineteenth century. The posts and beams are constructed of mill-sawn lumber. The gabled roof is supported by an H-frame (queen-post) truss to permit a hay track to extend the length of the barn beneath the gable ridge. The center section of this barn was formerly open up to the loft area, but the present owners extended the loft floor across this opening to gain additional loft space.

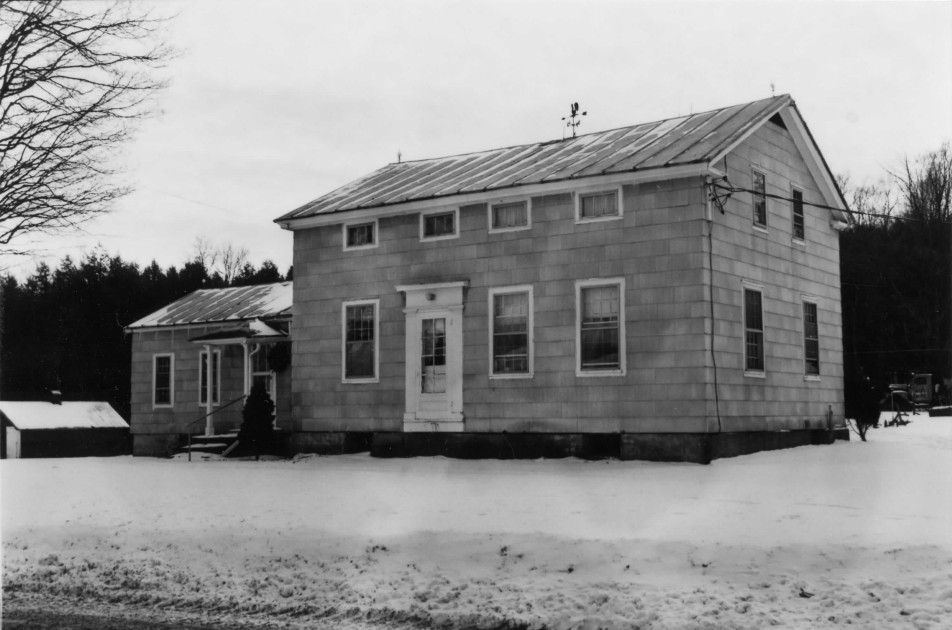
House, facing SW

House. This house was built around ca. 1840 in the Federal style. Although it has been modified extensively since that time, it remains recognizable as an early house in the area. The house is divided into three principal sections: a one-and-one half-story section on the north, and a one-story, L-shaped section on the south. Both sections are clad in asbestos shingles siding and are covered by standing seam metal roofs. The house sits on a stone plastered with concrete foundation, over a cellar that was excavated by the present owners around the 1950's. Prior to that time, the house had a cellar under the main section. The present owners reportedly installed the siding around 1975, and made several alterations to the windows and doors at about the same time.

The taller section at the north end of the house is a side-gabled Federal-style building with a four-bay front facade. Its first-story windows contain original twelve-over-twelve light sash. The second-story windows are six-over-six-light sash in the gable ends, and three-light frieze band windows on the front facade. Although any original frieze band has been covered or removed, the open returns in the gables are still evident. The original front door, located in the second bay from the south on the east facade, features a doorway flanked by pilasters and capped by a simple decorative cornice. Bedrooms occupy most of this section.

The one-story L-shaped wing on the southside of the house consists of a pair of intersecting gabled wings, one facing south and the other facing west. The south-facing wing, which contains the living room, sits on top of a basement garage. The west-facing wing contains the kitchen and a laundry room. A woodshed addition, formerly attached to the south facade of the west-facing wing, was removed by the present owners, the Tulls, and its doorway sealed. The Tulls enclosed an open porch with new concrete floor, and windows to the north side of the west-facing wing in 1956.

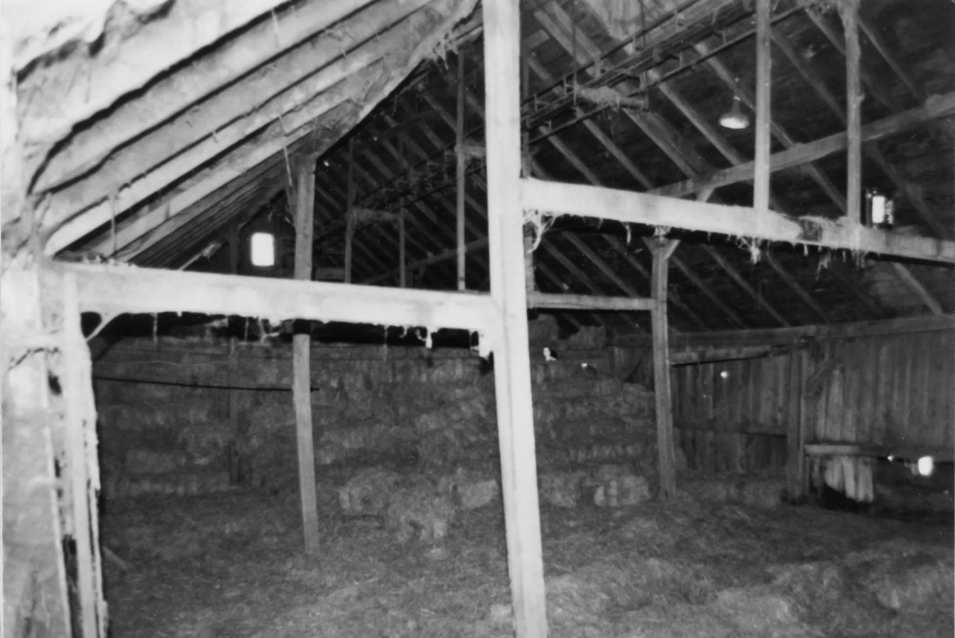
Cow barn interior upper level
facing S

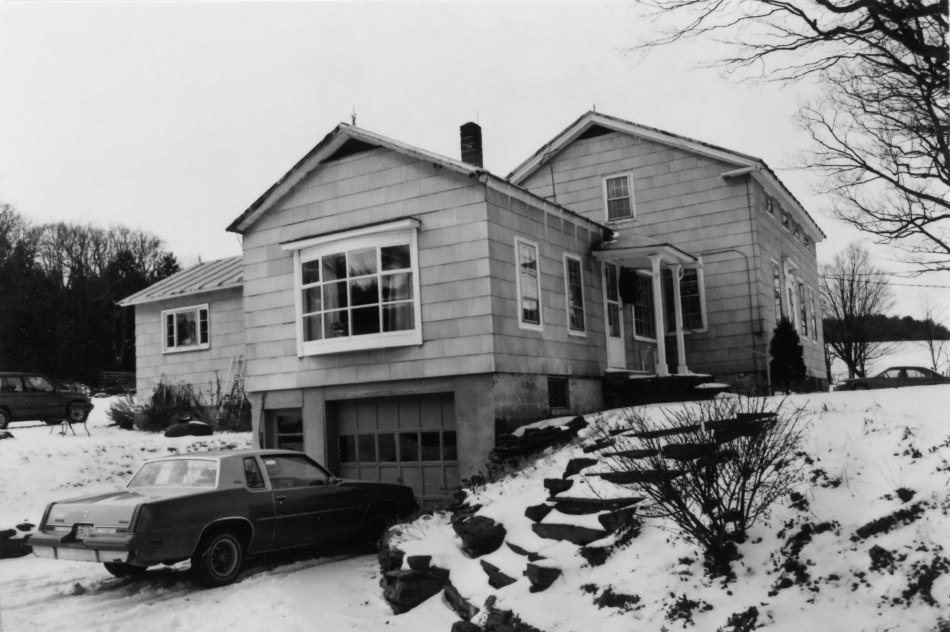
House, facing NW

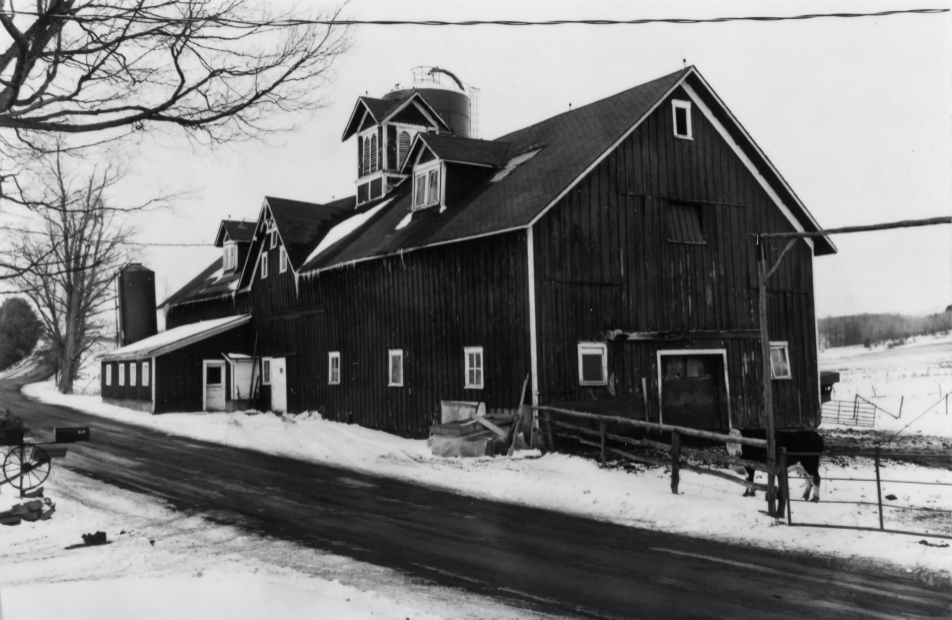
Cow barn, facing NE

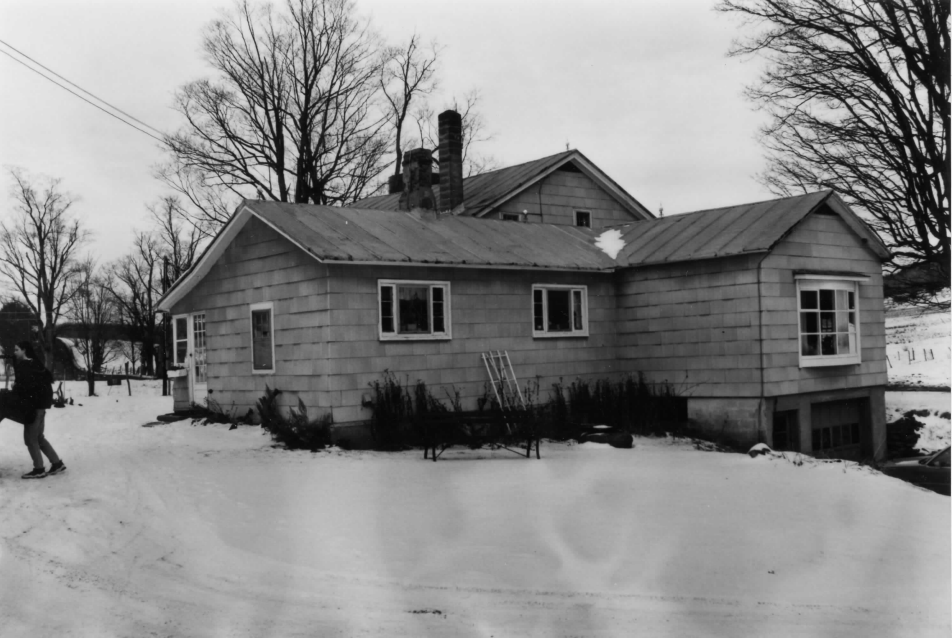
House facing NE
