**NATIONAL REGISTER OF HISTORIC PLACES
REGISTRATION FORM**

historic name Oesterlein Machine Company-Fashion Frocks, Inc. Complex

street & number 3301 Colerain Avenue/ 1326 Monmouth Avenue not for publication N/A
city or town Cincinnati vicinity N/A
state Ohio code OH county Hamilton code 061 Zip 45225

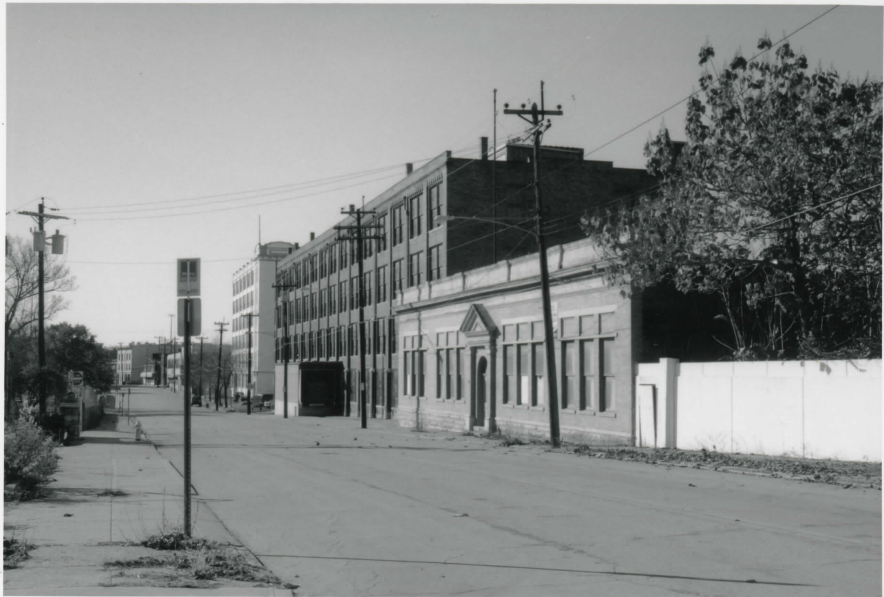
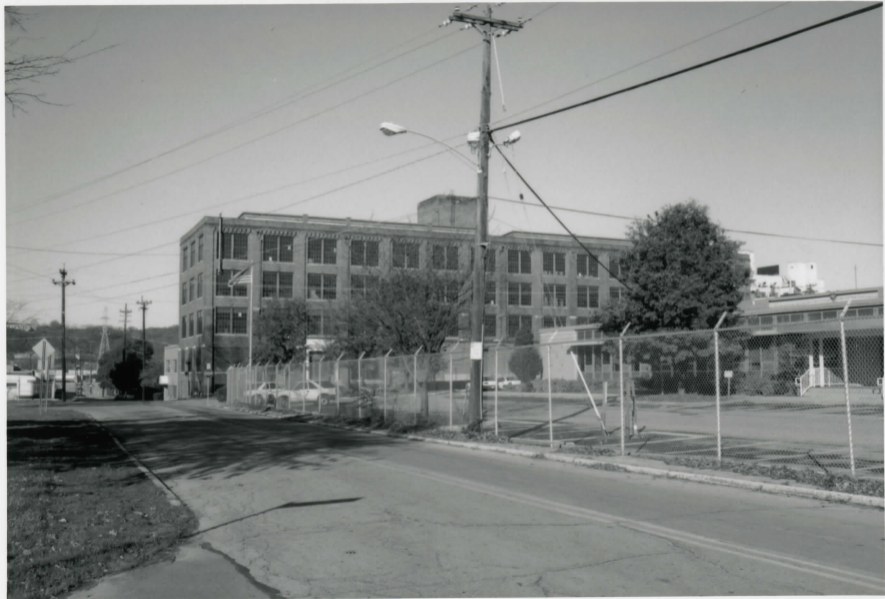
Building 1 was built in 1918 and was the first building constructed in the complex. Oriented on a north-south axis, its façade faces east, along Colerain Avenue (Photos 1 and 3). It is of stretcher bond, load bearing brick construction and sits on a poured concrete foundation. At grade level, the foundation appears to be faced with a higher quality concrete that is scored to resemble stone. Windows to the basement are visible only on the south elevation and the southern end of the east façade, as the building is constructed on slightly sloping land.

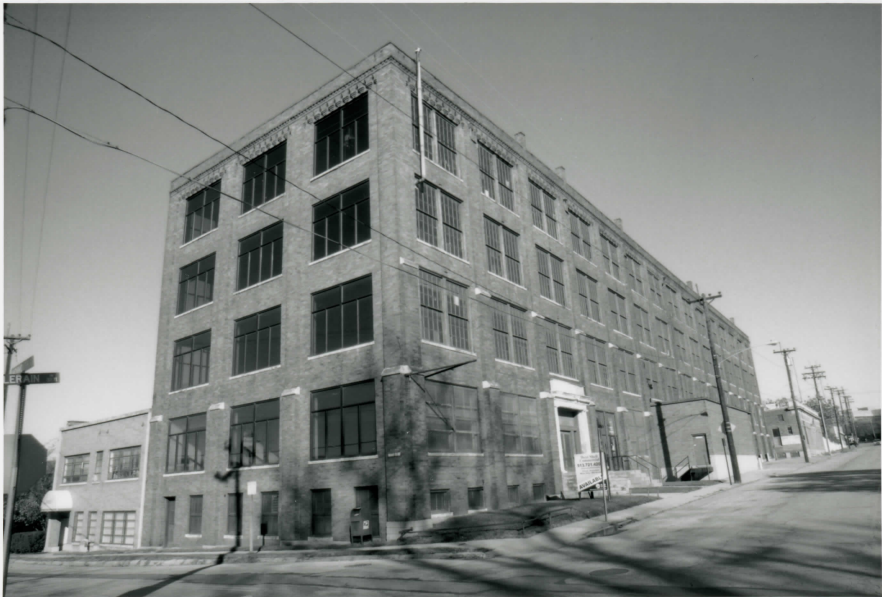
Photo # 4

The south elevation of Building 1 resembles the east façade in proportion but has only 3 bays (Photo 4). More of the basement level is visible on the south side than on the east façade because of the slope on which the building was constructed. The basement level of the south elevation has 5 windows with original 2-over-2 wood sash, all of which are covered with metal mesh. Windows on the first through fourth stories have circa 1985 replacement, metal, 3-light fixed sash that entirely occupy the original window openings. Although the sash have been replaced, the historic fenestration pattern was retained as the new windows fit in the historic window openings. Just as on the east façade, each bay is separated by a section of raised brick, resembling a column. On this façade, the shallow buttresses reach only from the basement level to the top of the first story. The same corbelled brick and dentil cornice that is present on the east façade is found here. An entry at the west corner of the basement story consists of a wood door with two panels in the lower half and four square fixed lights in the upper half.

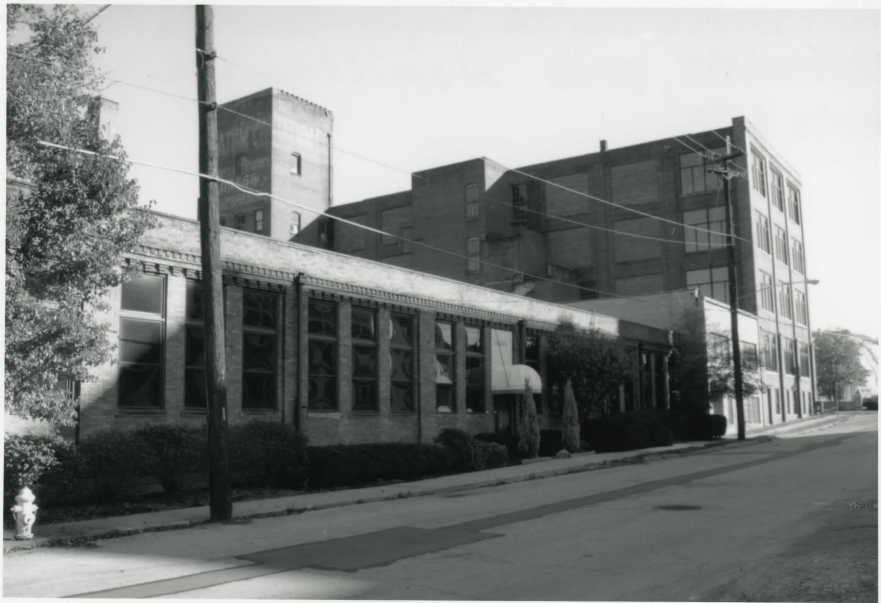
The south façade of Building 2 is composed of brick in a stretcher bond (Photo 28). There are 14 bays, each with 3 windows. As on the east and south facades of Building 1, each bay is separated by a section of raised brick, giving the appearance of a column. Circa 1985 metal storm sash with opaque glass cover the original window sash, which are 6-over-6 double-hung sash topped with a 6-light transom. The original sash are visible from the interior and appear to be in good condition. The cornice on this building is very similar to that on Building 1. Separated corbelled bricks line the area immediately above the windows, with a row of dentils just above the corbelled bricks.

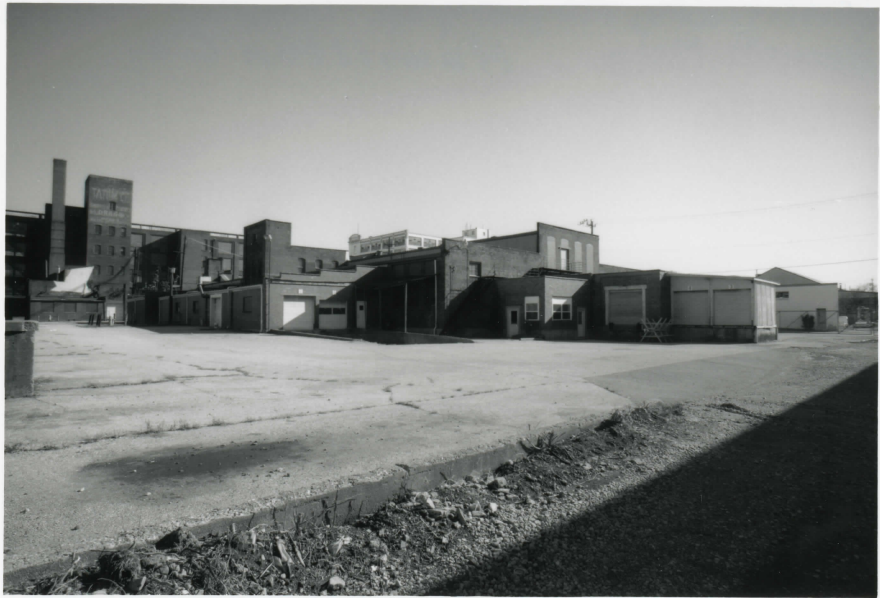
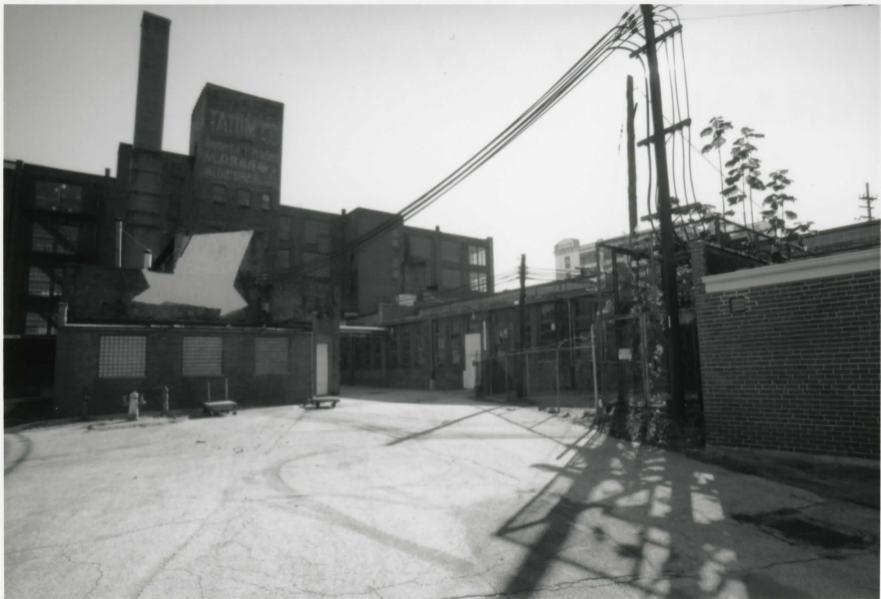
The north elevation of Building 2 appears quite different from the south façade (Photos 30 and 31). The foundation is not visible on this façade. The windows have 6-over-6 double-hung wood sash topped with 6-light transoms. These windows line the length of the building and are not covered with storm sash as on the south façade. The symmetrically ordered bays are still visible, each containing 3 windows and separated by a section of raised brick, resembling a column (Photo 32). There is no decorative cornice on this façade. A circa 1935 addition spans much of the western half of the north elevation. Rising from a concrete slab foundation, the 1-story structure is built of concrete block faced with brick. An overhead door and three regularly spaced rectangular window openings punctuate the north wall. The flat roof is augmented by a stepped parapet. Directly east of this is another smaller circa 1935 addition of similar construction. Windows on both these additions have 5-over-5 hopper sash, and large overhead doors provide access for loading and unloading materials. Between the two additions, the projecting stair tower rises two stories above the flat roof. It has 3 windows on each story of its east, north, and west walls. Centered beneath the roofline on the north wall is a smaller, 6-light sash.

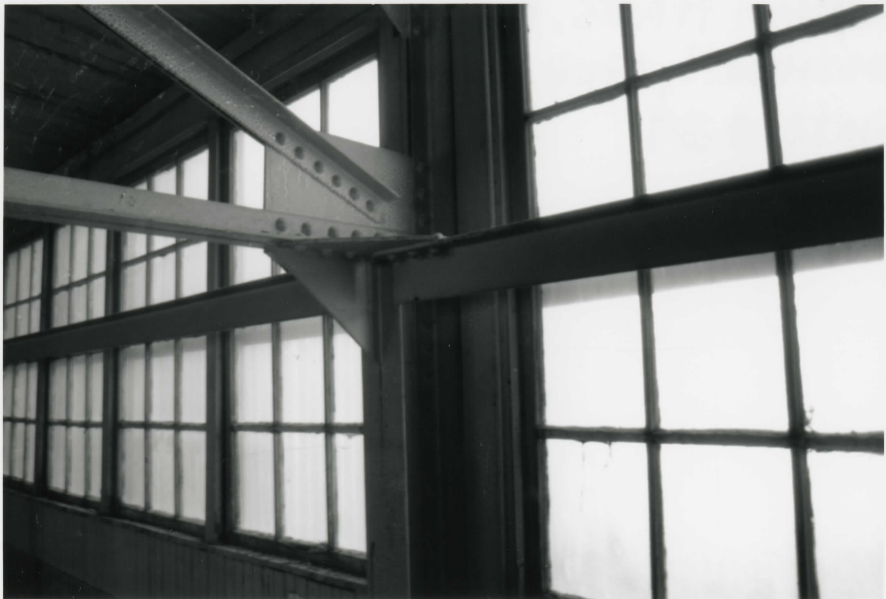
Fashion Frocks, Inc., Complex-Oesterlein Mach.
Cincinnati, Ohio Hamilton Co.
Photo #38

The clerestory is accessed by a stairwell located in between the two additions on the north wall of Building 2. It consists of a vast open space which projects up above the roofline of the building (Photo 38). It has a wooden ceiling supported by metal beams and a Pratt roof truss system, eliminating the need for columns (Photo 39). A conveyer belt runs the length of this story leading down into the circa 1935 addition on the north wall of Building 2. Six-over-six tilt windows line both sides of the clerestory, once allowing light to stream in. Although now

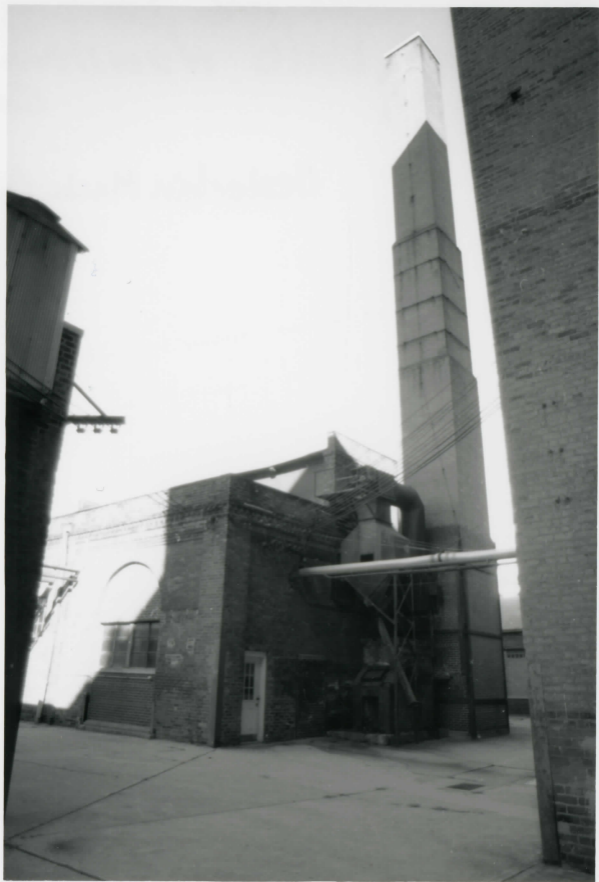
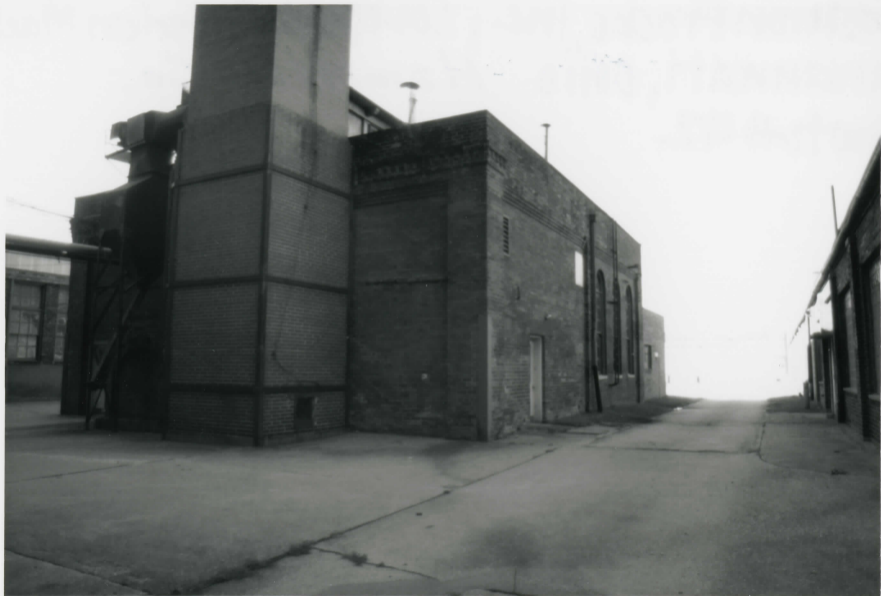
The brick smokestack spans almost a third of the east façade (Photo 40 and 42). An infilled window opening occupies the façade's northernmost bay, while an entry with a replacement door is in the southernmost bay. Brick piers punctuate each corner of the façade, and the cornice is decorated with the same style of corbelled brick and dentil designs found on Buildings 1 and 2. The smokestack appears to have been a later addition, installed sometime between 1930 and 1941.

The north wall of Building 3 is composed of common bond brick. It has one small entrance on the eastern portion of the façade, with three windows on the western portion (Photo 42). These windows have their original 9-over-9 double-hung sash topped with a fan light. This façade exhibits the same cornice found elsewhere, although it does not have the dentil course, only the corbelled brick course.

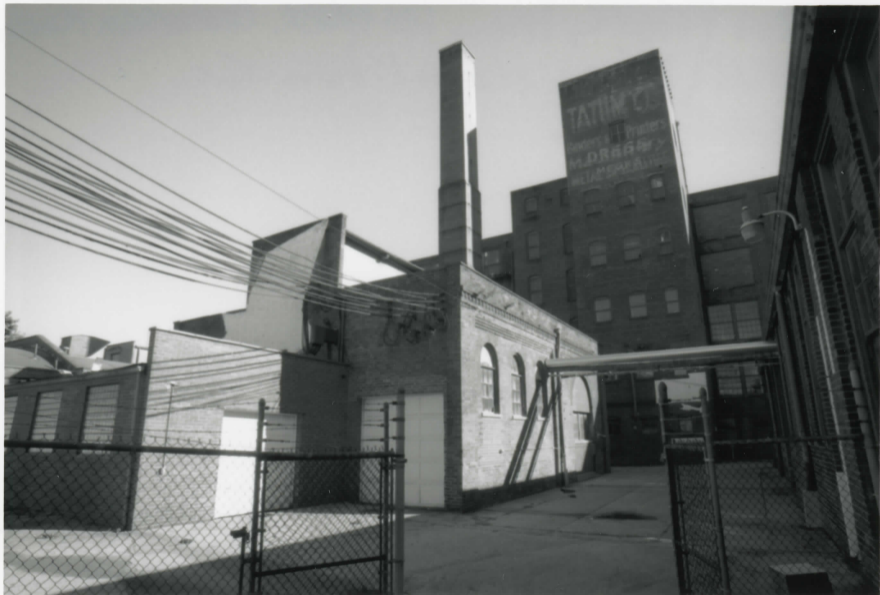
Fashion Frocks, Inc., Complex
Cincinnati, Ohio Hamilton
Photo # 40 Co.

On the south elevation, a large round-arched door opening at the east corner has been infilled with brick and a series of fixed pane sash has been installed (Photos 40 and 41). Based on the appearance of the sash, this alteration appears to have occurred circa 1950-1956. The remainder of the south wall features three round-arched window openings, with brick infill occupying the lower third of the original openings. The plywood boards cover two of the three fanlights. Based on the windows on the north façade of this building, the remaining sash on this elevation appear to be only the upper portion of the 9-over-9 double-hung sash that were once there. This wall exhibits the same decorative cornice found on the east façade.

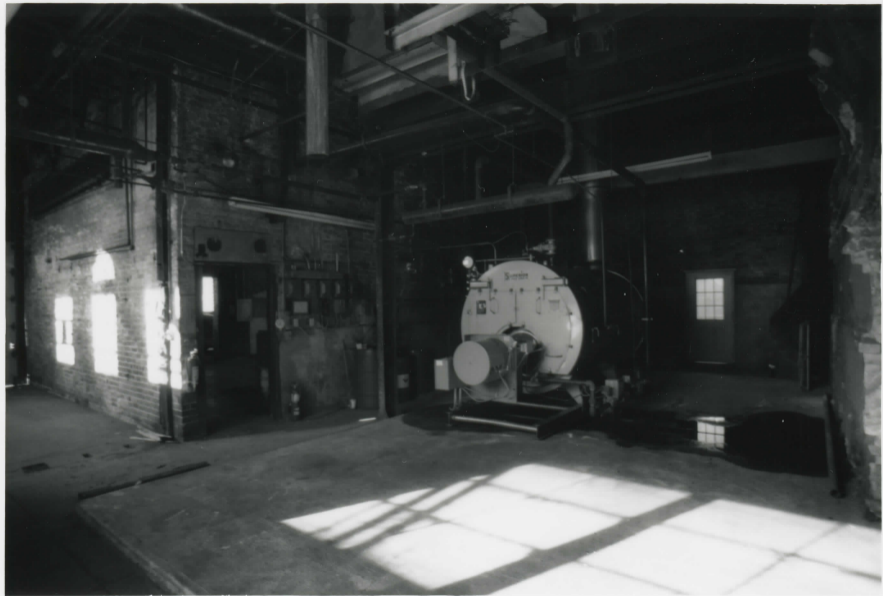
Photo#43

The interior of Building 3 has exposed brick walls and a concrete floor. It has a wooden ceiling with steel supports. A large boiler (no longer operable) in the main room is set on a raised concrete platform (Photo 43). It, along with multiple electrical boxes and the remnants of other former machinery, confirm this building's function as a power house (Photo 44). The clerestory of Building 3 has 6-over-6 tilt windows and a large sliding fire door. Although corrugated metal covers most of the windows, the sash appear to be intact and in good condition (Photo 45). The circa 1935 west addition is currently used for vehicular storage.
