The Anderson Schoolhouse is an unusually ornate building for a single room schoolhouse. The structure has remained in continuous use as a school or community club since its completion. It is presently the preservation project of the Anderson Community Club.

Property Anderson Schoolhouse

Anderson Schoolhouse Ashland Co., Ohio  
Photo & Negative: Anderson Community Club  
1976  
Southeast corner

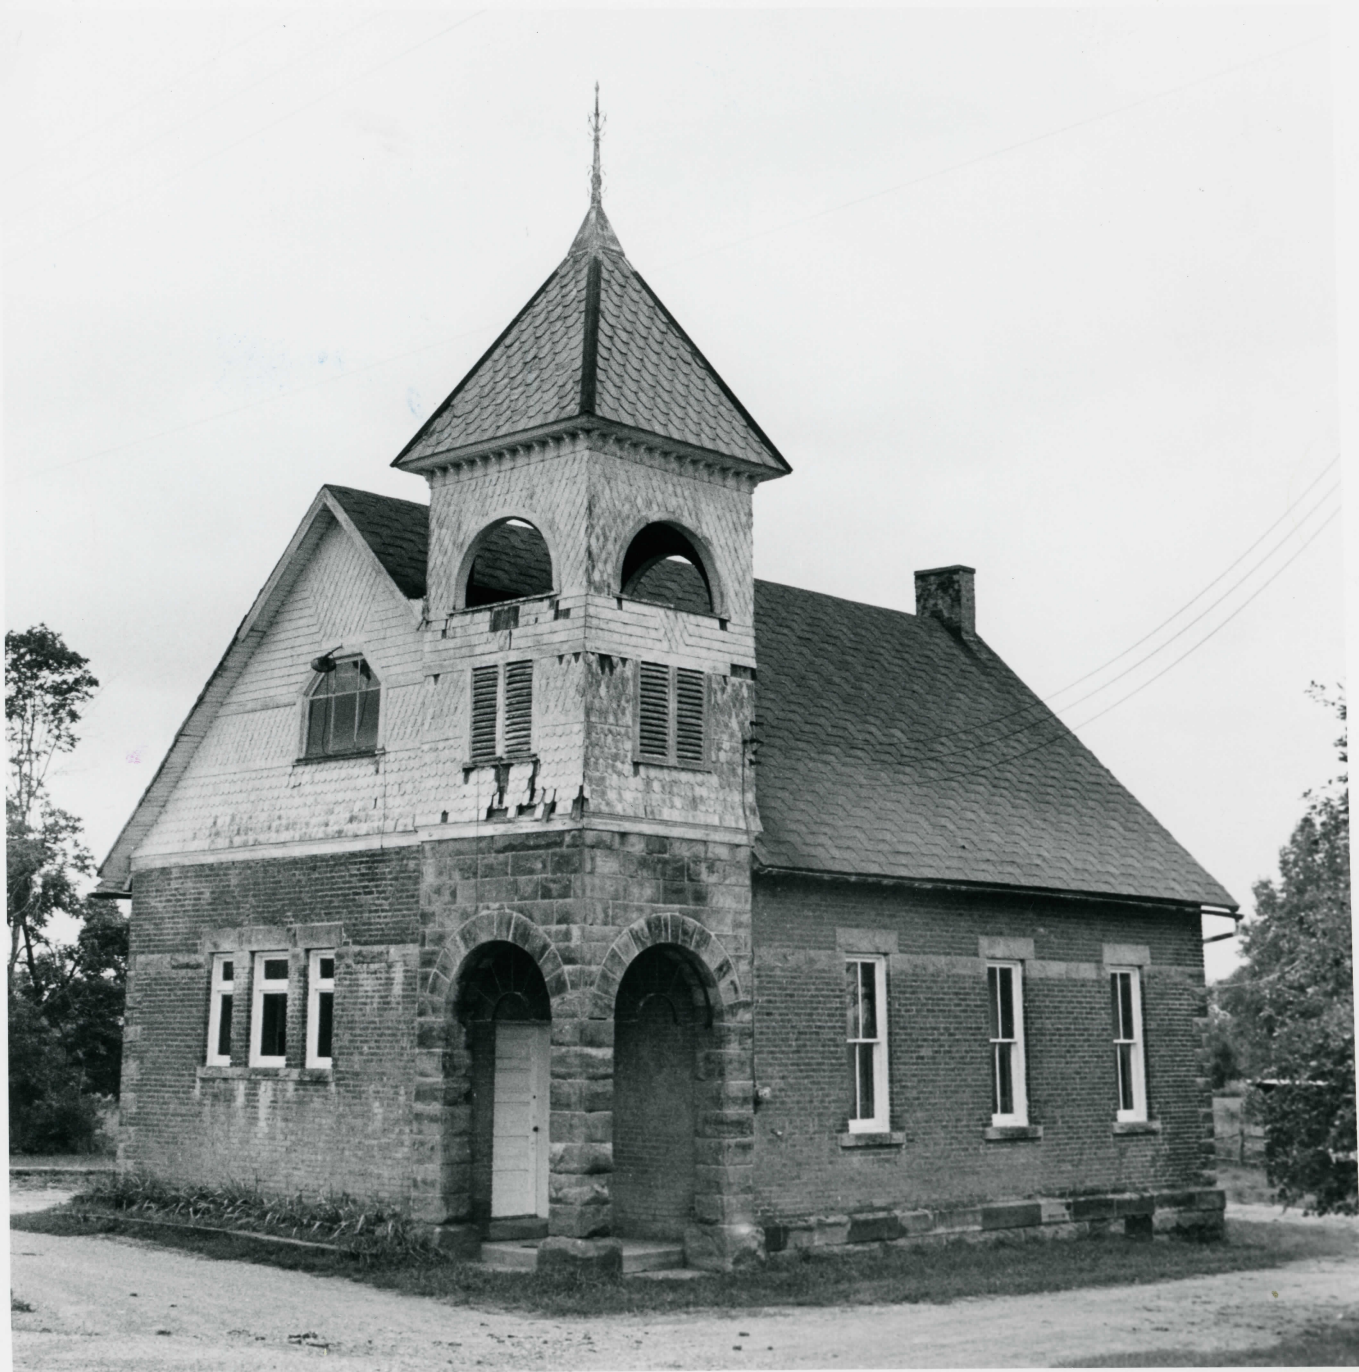
The Anderson schoolhouse is a nearly square, 1-1/2 story brick building. The foundation is rough cut sandstone block. It measures approximately 30' x 40'. The southeast corner of the schoolhouse has a three-stage belltower built of sandstone and wood. The first stage is built of smooth and rough cut sandstone block. There are full-width arched openings on the south and east sides. Within the tower there is a single paneled door on the east face of the building. An identical opening in the south side has been bricked in. Above the doorways are round arches framed with brick voussoirs. The second portion of the tower has double louvered panels. It is sided with decorative wood siding in a scallop pattern. The last stage of the tower has half-round openings on each face. Diamond patterned and scalloped siding covers this portion. The pyramidal roof has a slight overhang supported by a row of small wood brackets around the tower. The shingled roof has a metal cap and finial. The original bell remains in the tower.

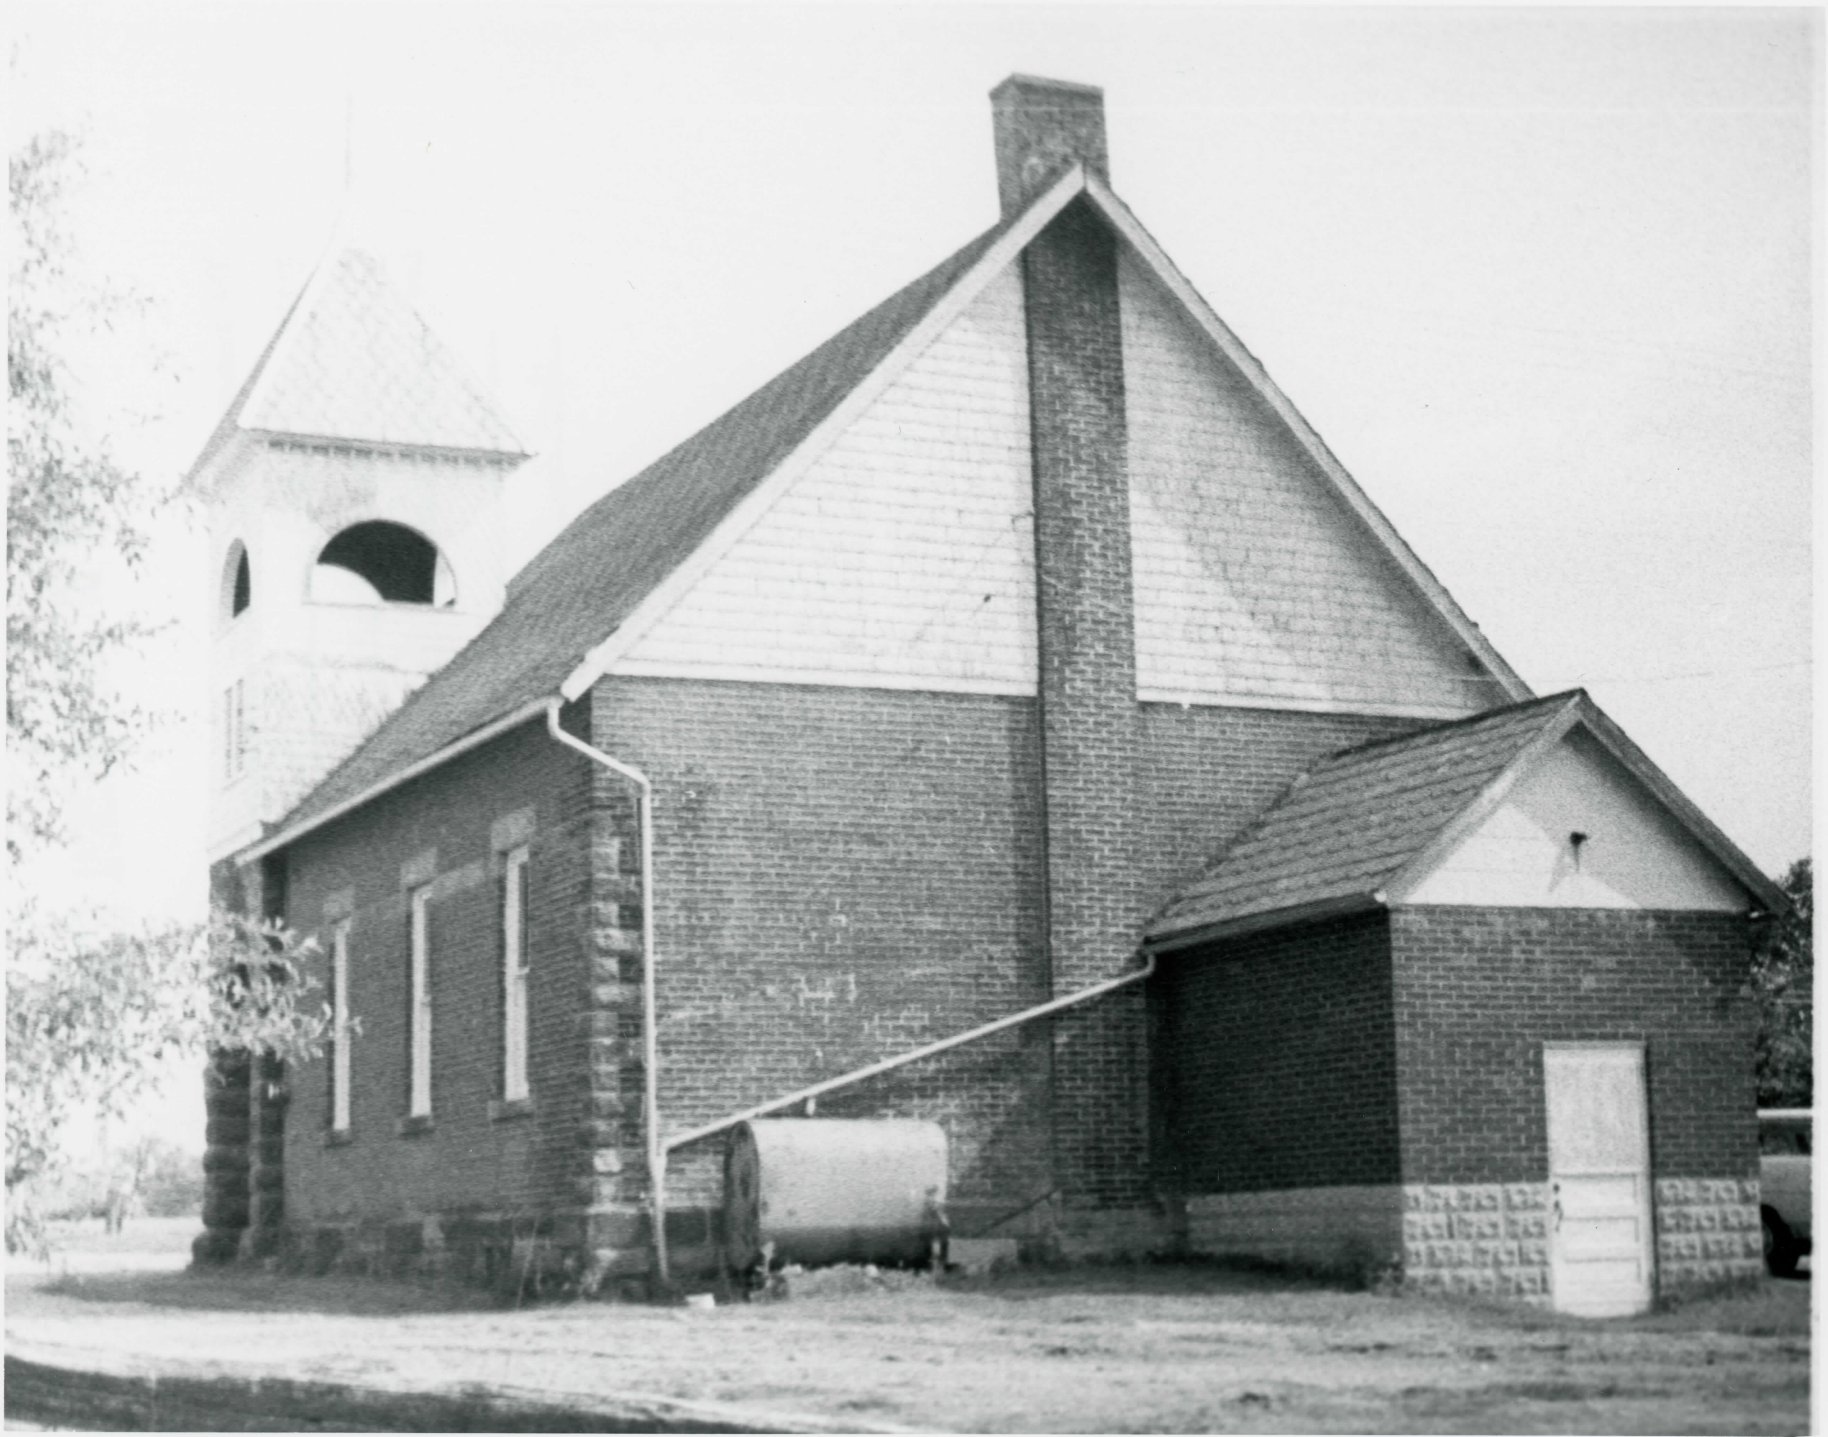
2 of 2

The south face has a small three-part window centered in it. The window has a stone sill and stone lintels. A sandstone belt course, placed just below the lintel, extends around the building. Rows of scalloped and diamond patterned shingles cover the area within the gable. There is a decorative shaped window centered in this area.

The east face has three 2/2 light windows. Stone lug sills, lintels, water table, and quoins are the only detailing. The north face is blank. There is a center chimney rising above the ridgeline and visible down the face of the building. The roof is asbestos shingles laid in a herringbone pattern. At the northwest corner is a more recent gable-roofed one-story, one-bay addition which measures 12' x 12'. This section is on a concrete block foundation and has a door centered on the north side. The roof of this addition is slate.

near view
