NATIONAL REGISTER OF HISTORIC PLACES  
INVENTORY -- NOMINATION FORMSEE INSTRUCTIONS IN *HOW TO COMPLETE NATIONAL REGISTER FORMS*  
TYPE ALL ENTRIES -- COMPLETE APPLICABLE SECTIONS**1 NAME**\*  
HISTORIC Baumgardner, William, House and Farm Buildings

Hopper House and Farm Buildings

Baumgardner, William, House and Farm Buildings  
Miami County, Ohio

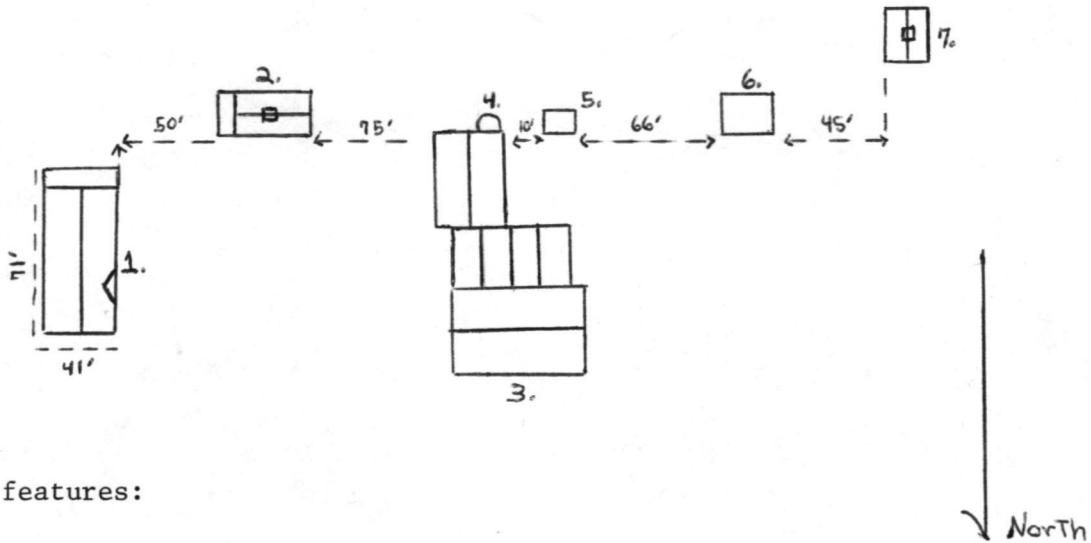
sketch map

1. barn
2. carriage house
3. house
4. exterior oven
5. spring house
6. seed barn
7. granary

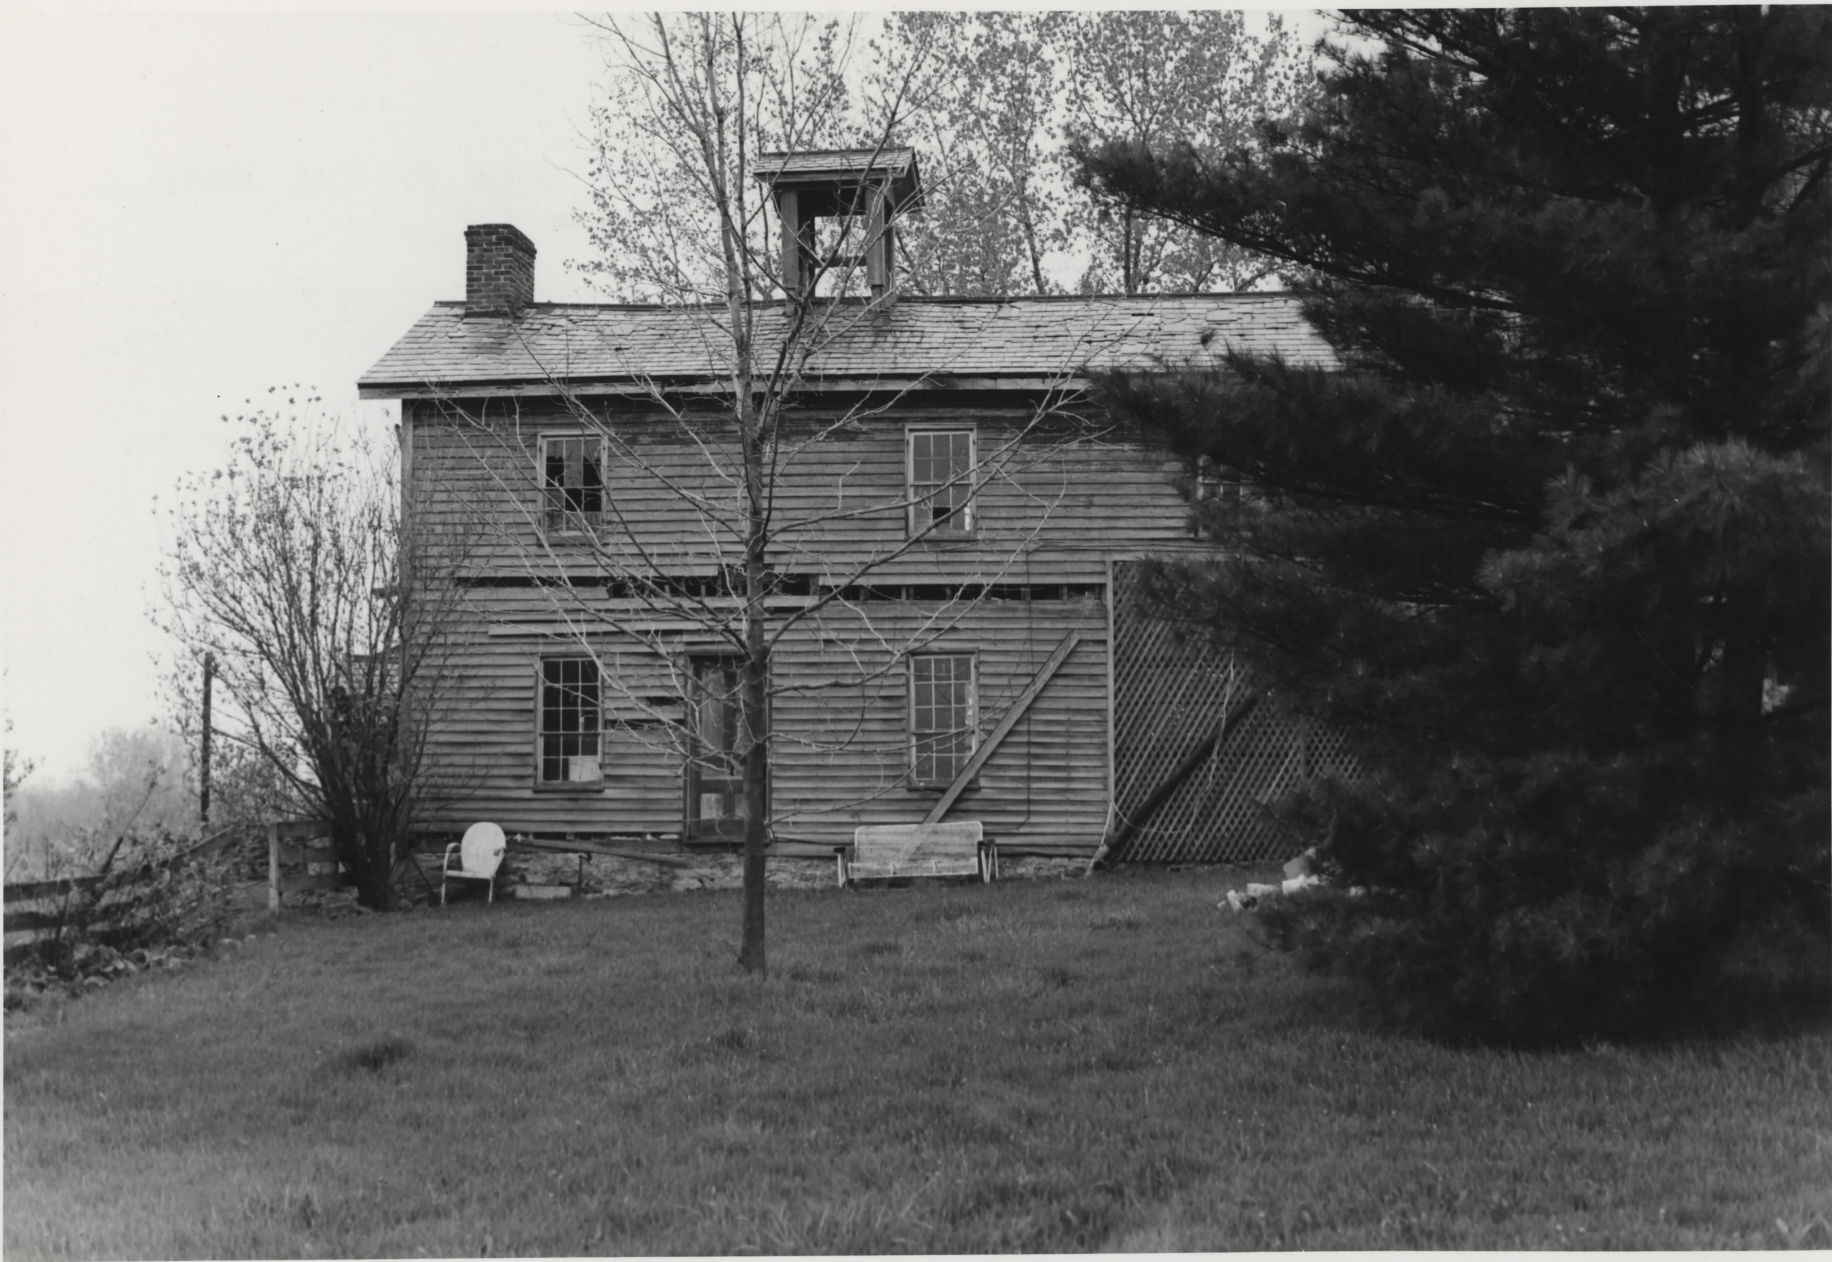
EAST SIDE OF FRAME ADDITION ATTACHED TO THE SOUTH SIDE OF THE HOUSE.

Summer kitchen, looking west  
Shows original structure before recent  
alterations.

The two story farmhouses is T-shaped in plan, built of brick on a coursed stone foundation. There is a smooth stone water table. The entrance is centered in the 3-bay facade (north). The doorway has sidelights and a rectangular transom. There is a one-bay entrance porch. Square pillars support the bracketed frieze and flat roof. The second floor has a doorway which opens onto the roof of the entrance porch. It is likely that at one time there was a more elaborate, two-story porch across the front onto which this door opened. Windows are 6/6 light with plain stone sills and lintels. All windows have louvered wood shutters. The frieze and gable are plain. The roof is gabled and there are two inside end chimneys. There are three windows per floor across the west gable end and two per floor across the east end. To the rear is a centrally placed two-story section flanked by one-story shed roofed brick additions. The two story section has two 6/6 light windows per side which match those of the front section. The ridgelines of the gable roofs intersect and there is an inside end chimney on the south end. The one-story addition on the west is early but had recently undergone an unsympathetic alteration. A full size window was replaced with a smaller one and the brick was not very expertly replaced. The east side addition is an enclosed porch of recent date. Attached to the 2-story section is a 2-story frame summer kitchen with an exterior bake oven at the rear. The rectangular kitchen structure has unfortunately been sided over and windows have been altered. The structure was in a very deteriorated condition and the rehabilitation was not sensitively done. A 1973 photo shows the building in its original configuration. The kitchen has a gable roof with open belfry; the ridge-line runs north-south. Originally the kitchen had a door placed toward the south end flanked by 9/6 light windows. Above these lower windows were 6/6 light windows. The north end of the 2nd floor was cantilevered over an open space below, supported on the north end by square posts. The open area acted as a breezeway-porch. The windows and porch have all be altered when the building was sided in 1975.

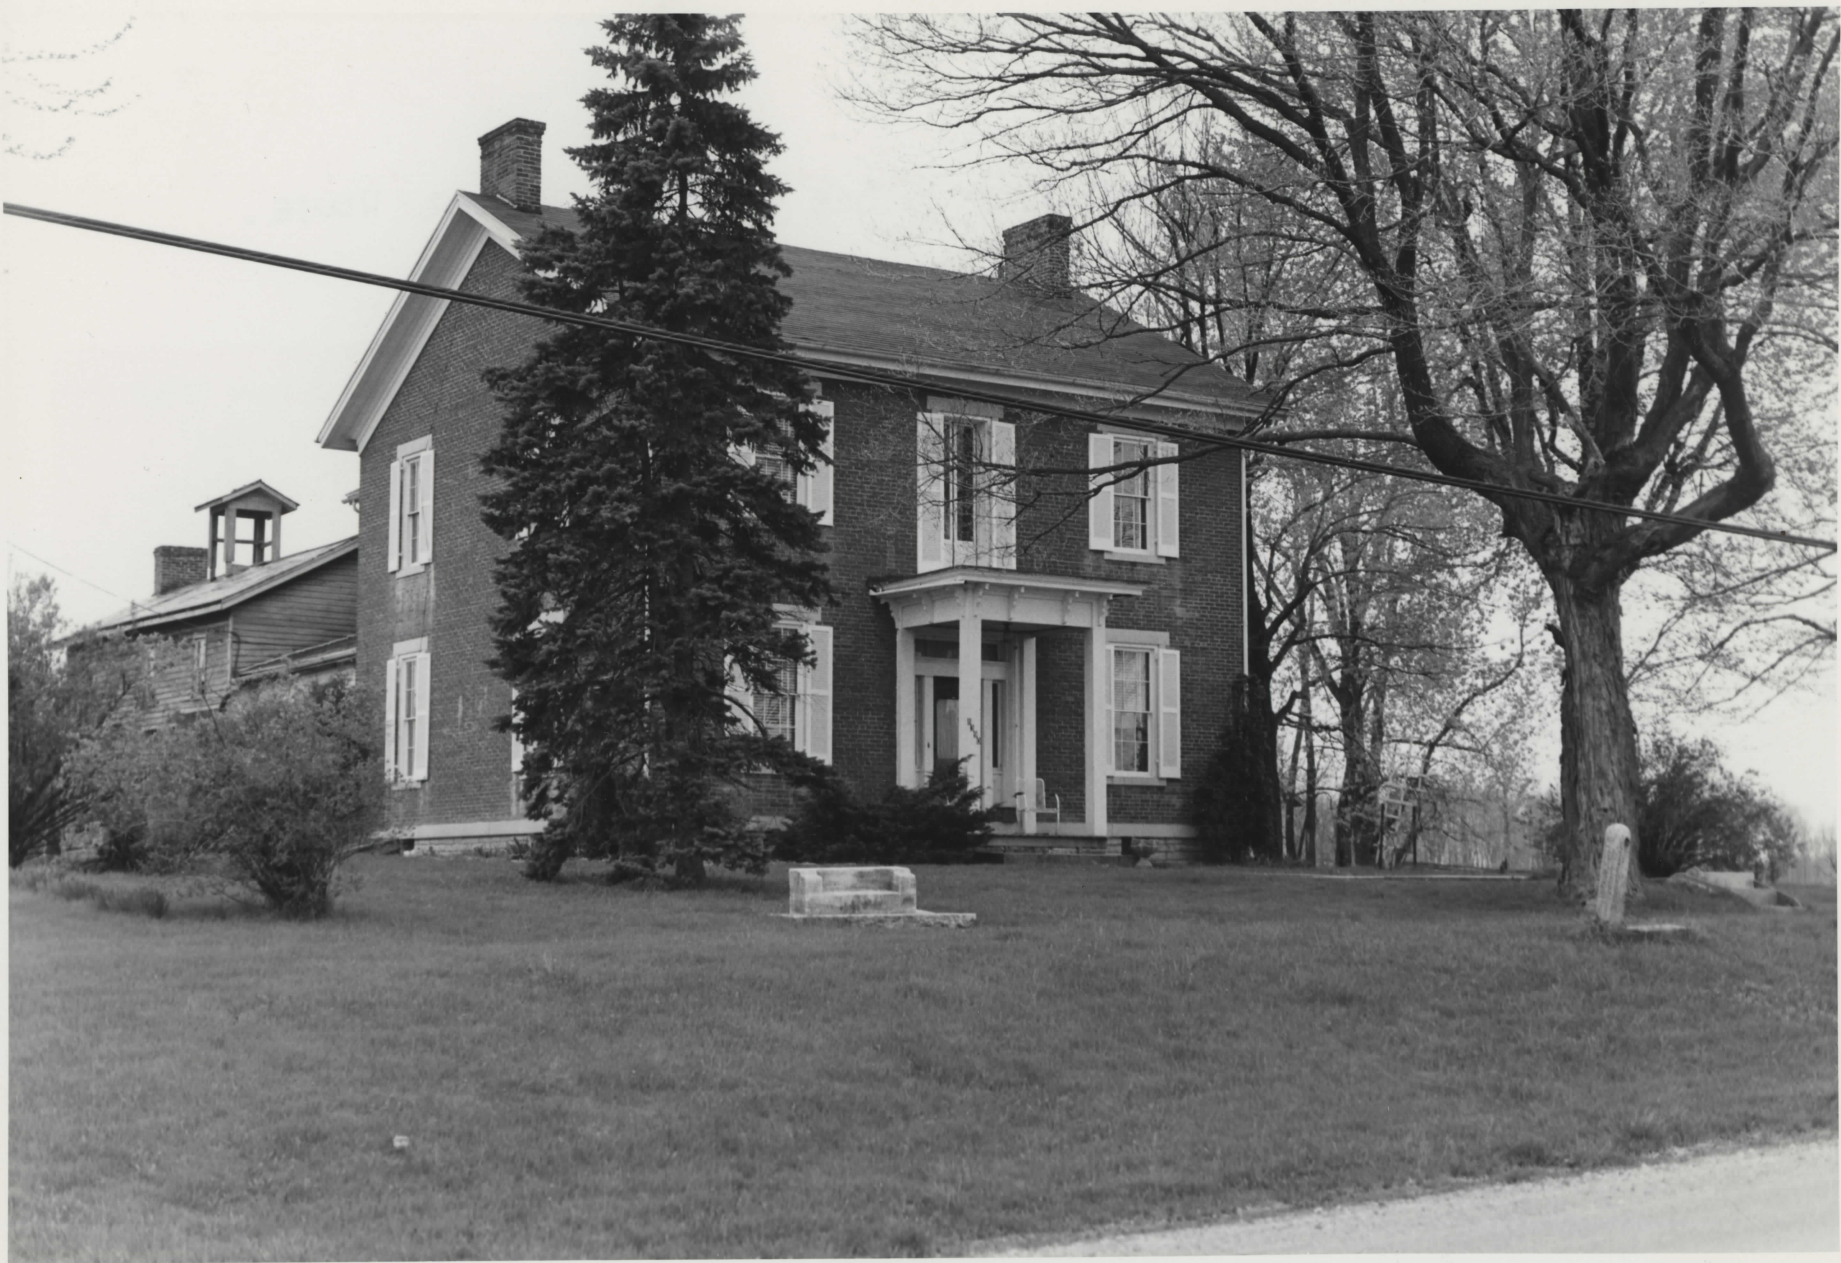
VIEW OF THE NORTH (FRONT) AND EAST SIDES OF THE HOPPER HOUSE.

House looking SW

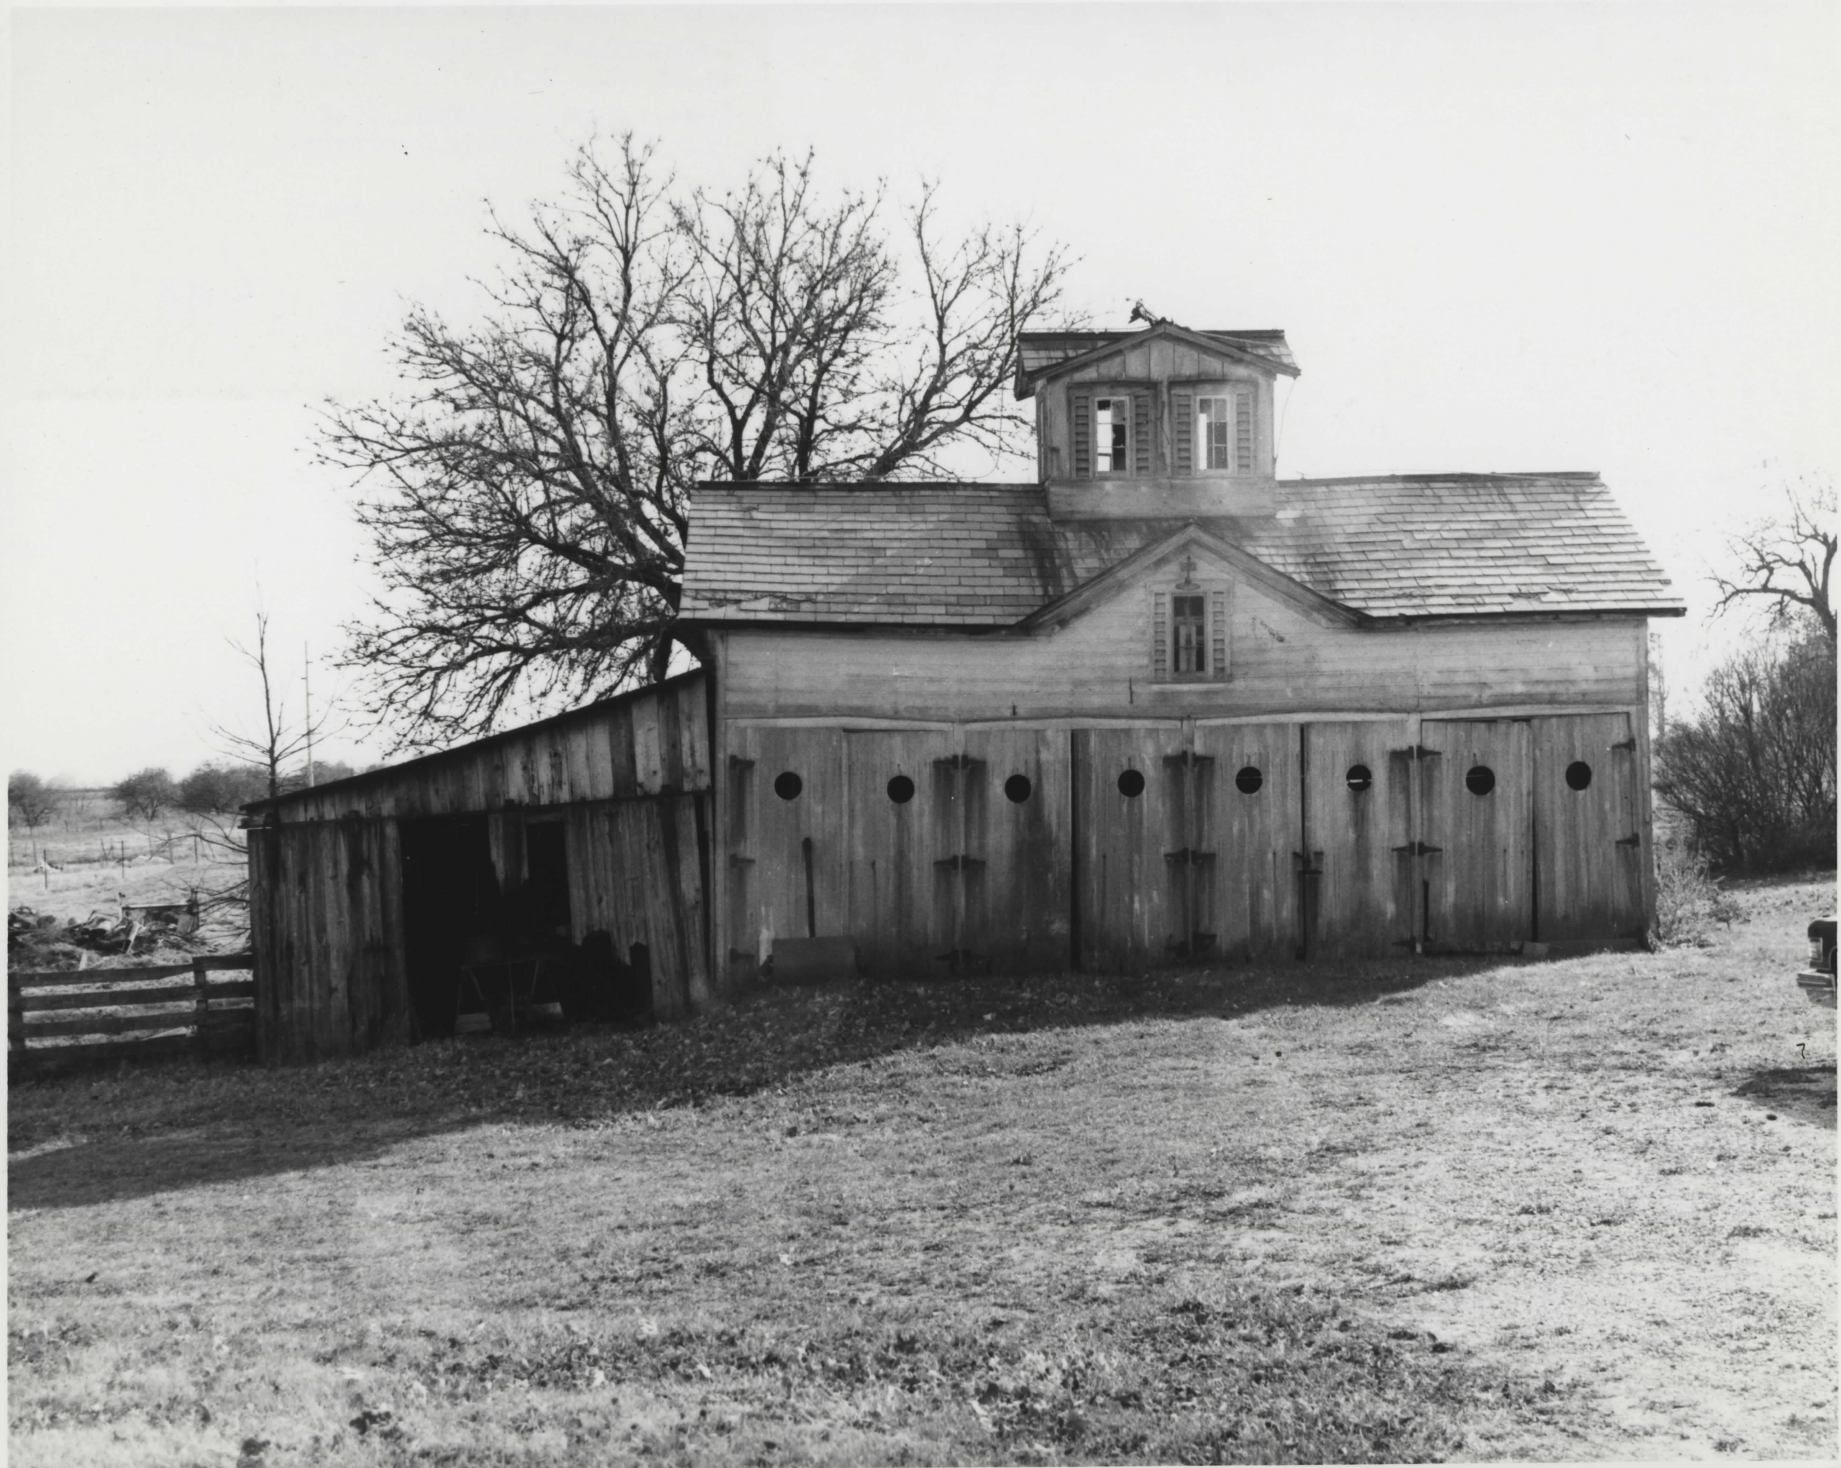
Carriage House looking south

The 1-1/2 story carriage house is also frame, measuring 33' x 14'. The north side has four sets of double doors across the lower level. Each door has a small round window. There is a gable centered on this side. The large square cupola is centered on the gable roof. Each side of the cupola has two windows. Intersecting gable roofs top the cupola. The east end has a shed-roofed addition.

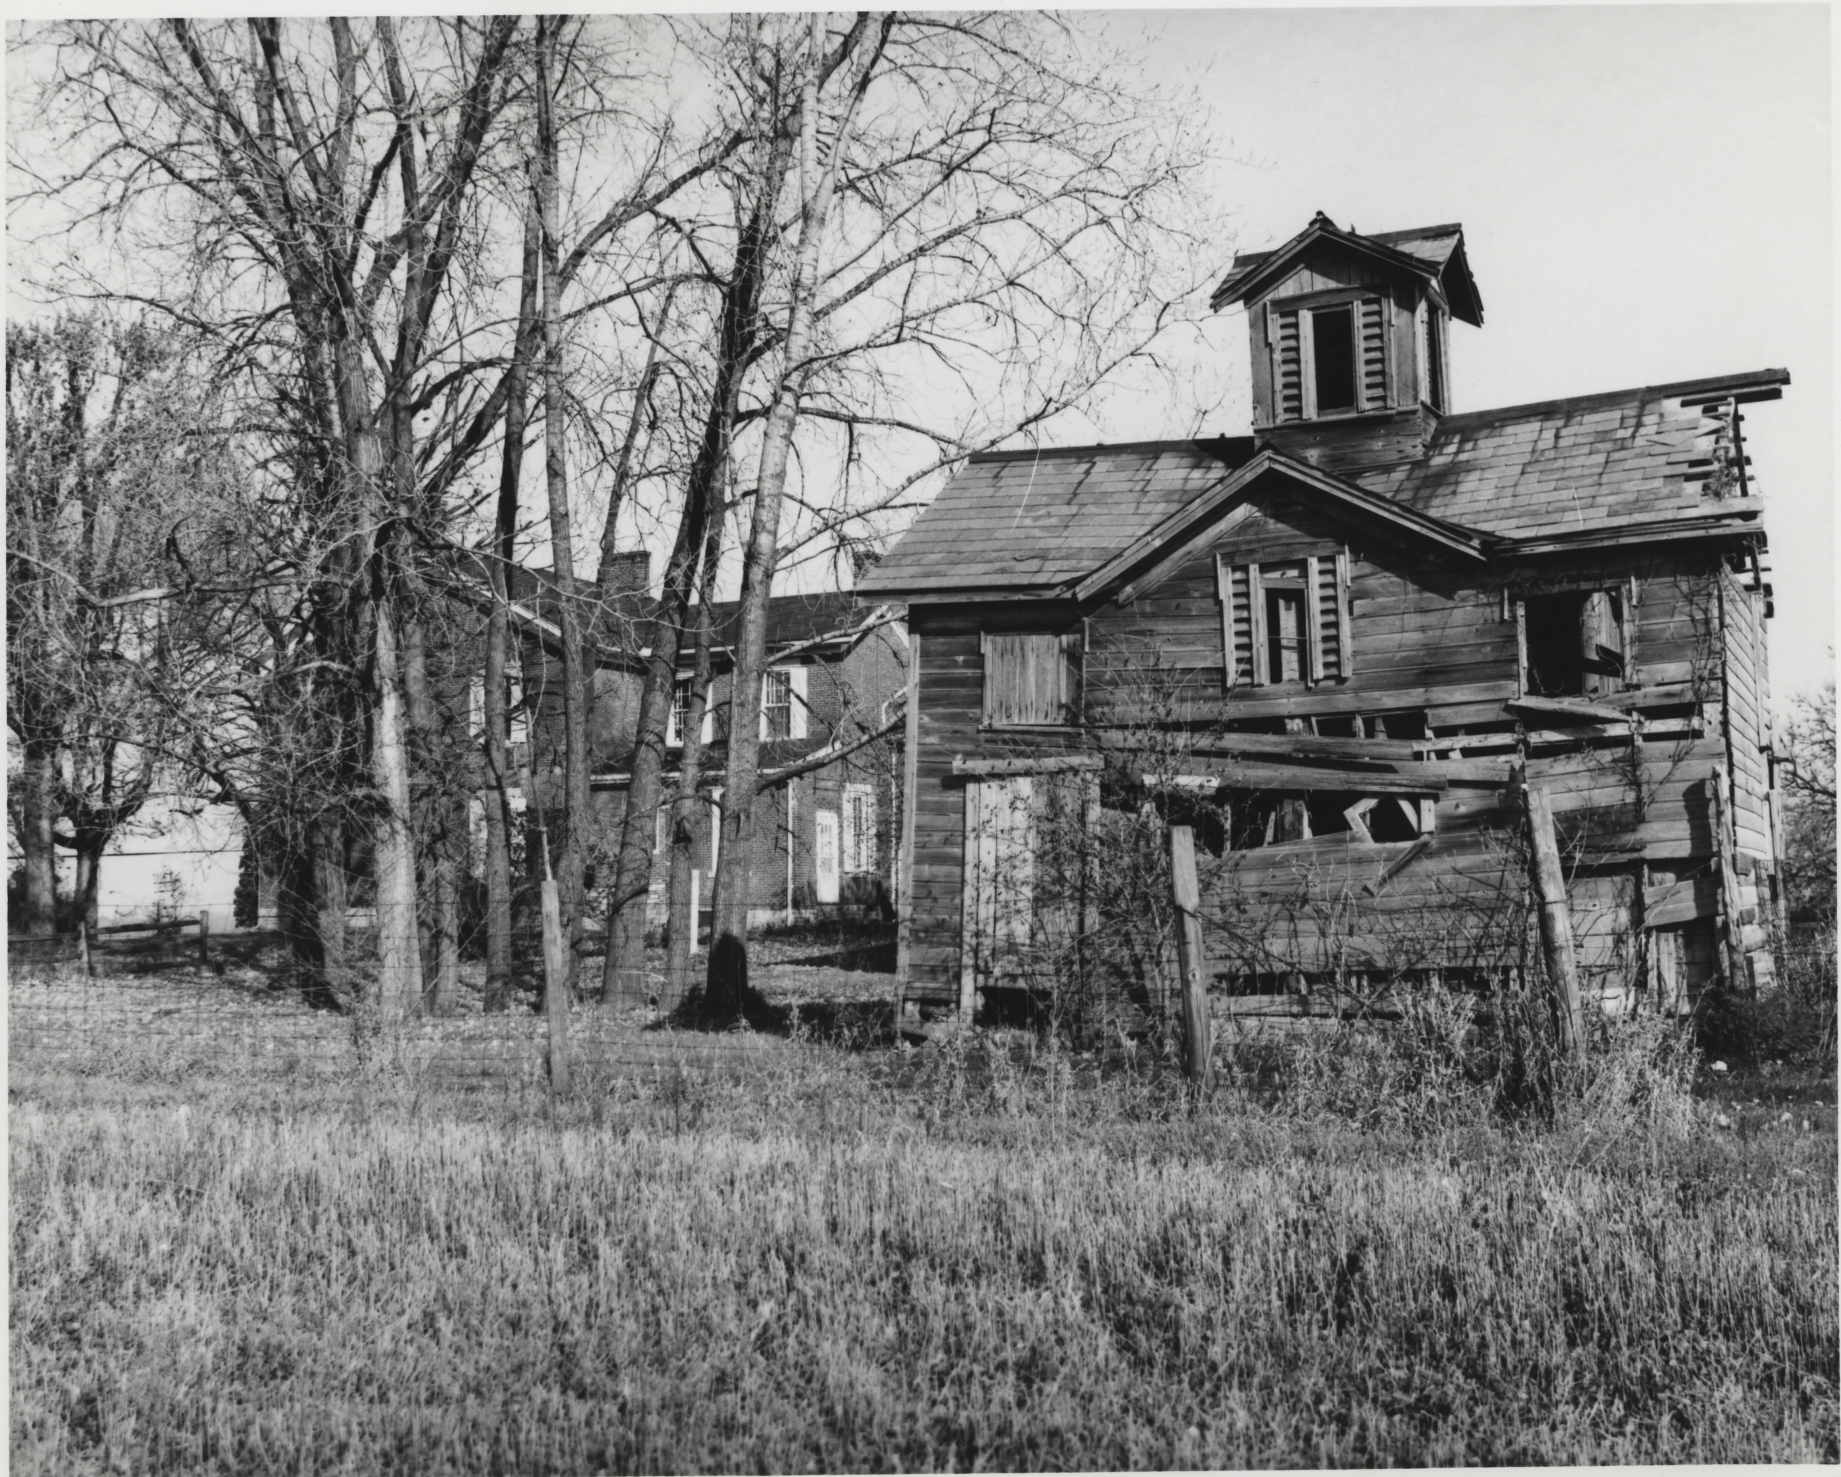
Granary and House looking east

The granary is very dilapidated. The 2-story building was once one of the finest of the farm's outbuildings. It measures 14' x 20'. The gable roof runs north-south. The east and west sides have a centered gable. Within the gable is a narrow window flanked by louvered sidelights. There is a door on the lower level of the east side and two small second story windows. There is a square cupola with intersecting gable roofs. Each side has a window which has louvered sidelights.

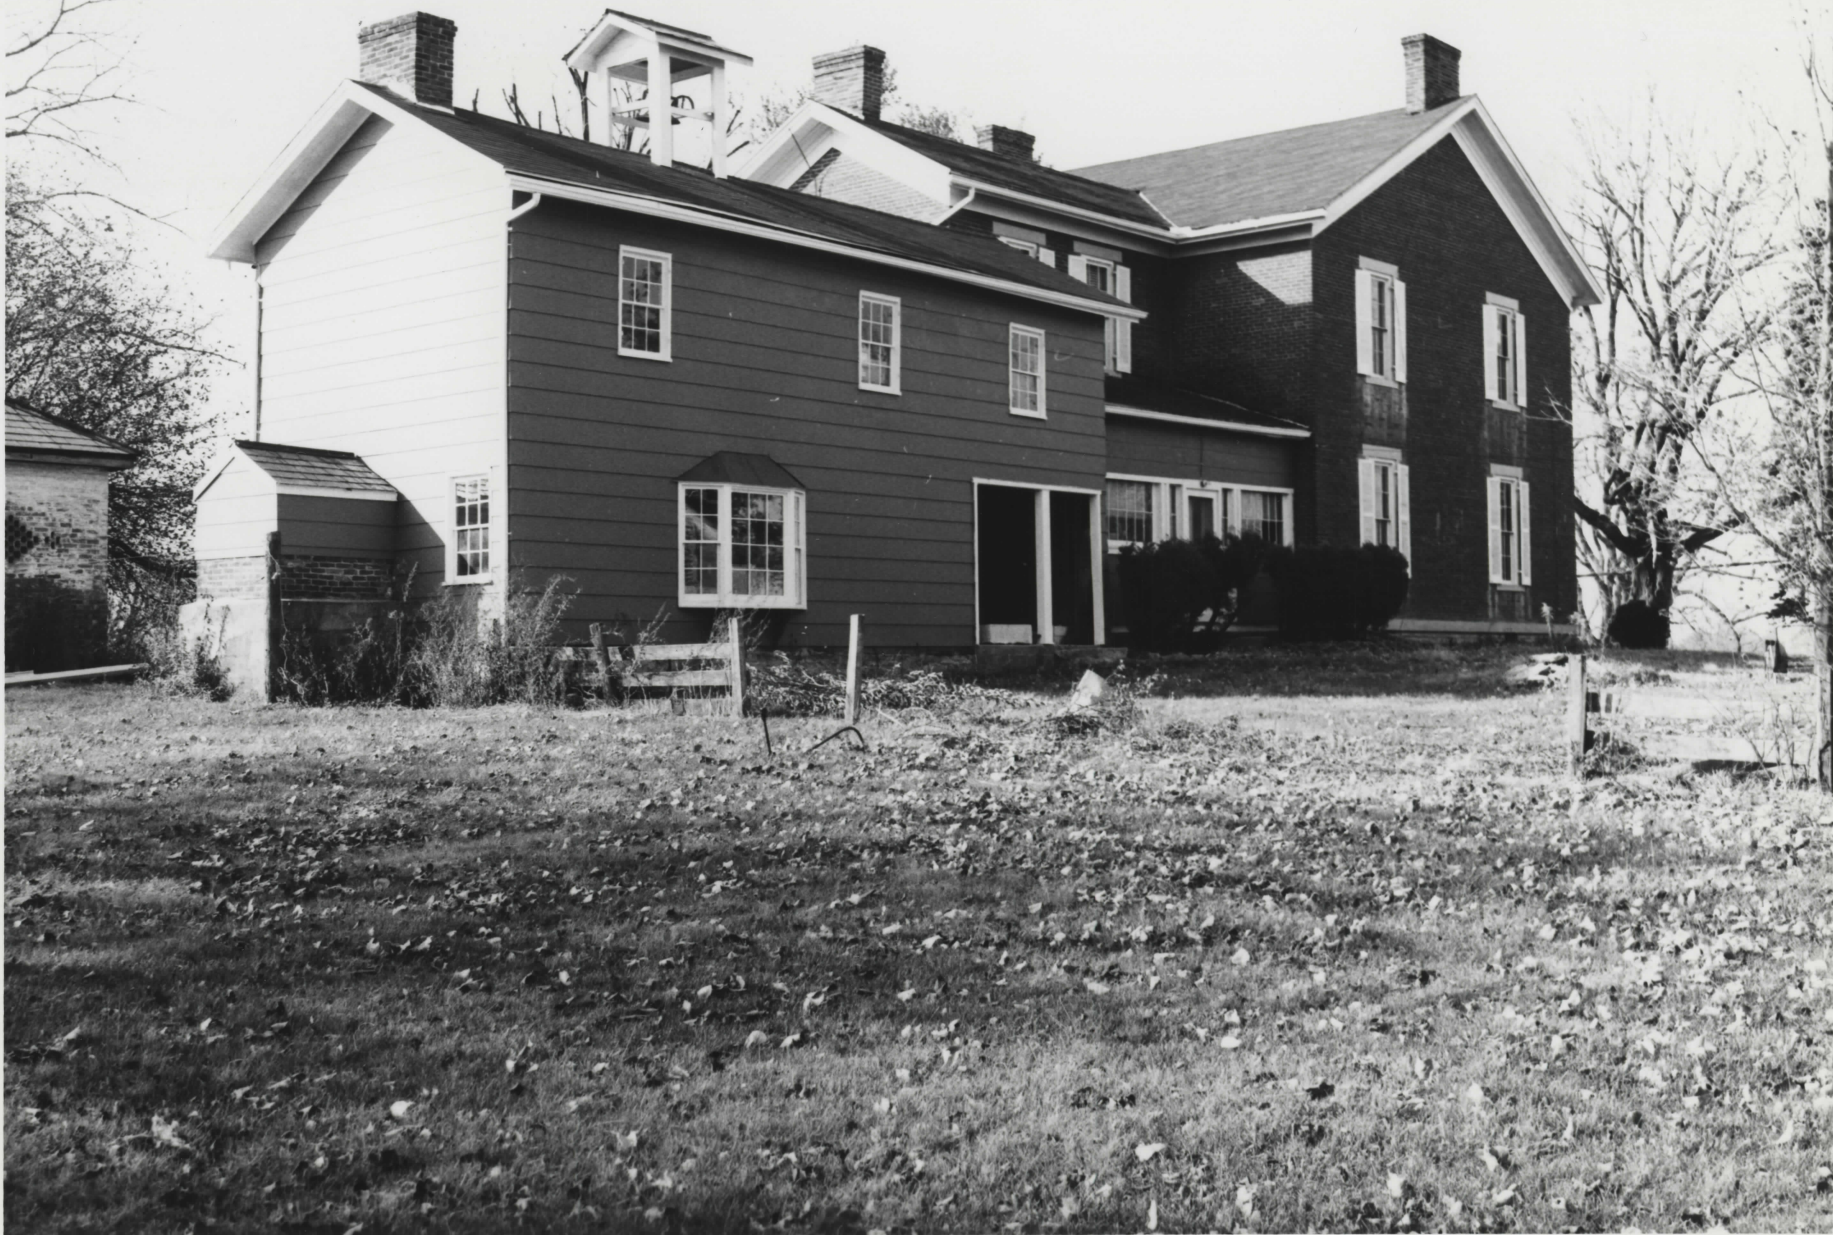
Rear of house showing altered summer  
kitchen and exterior oven, looking NW

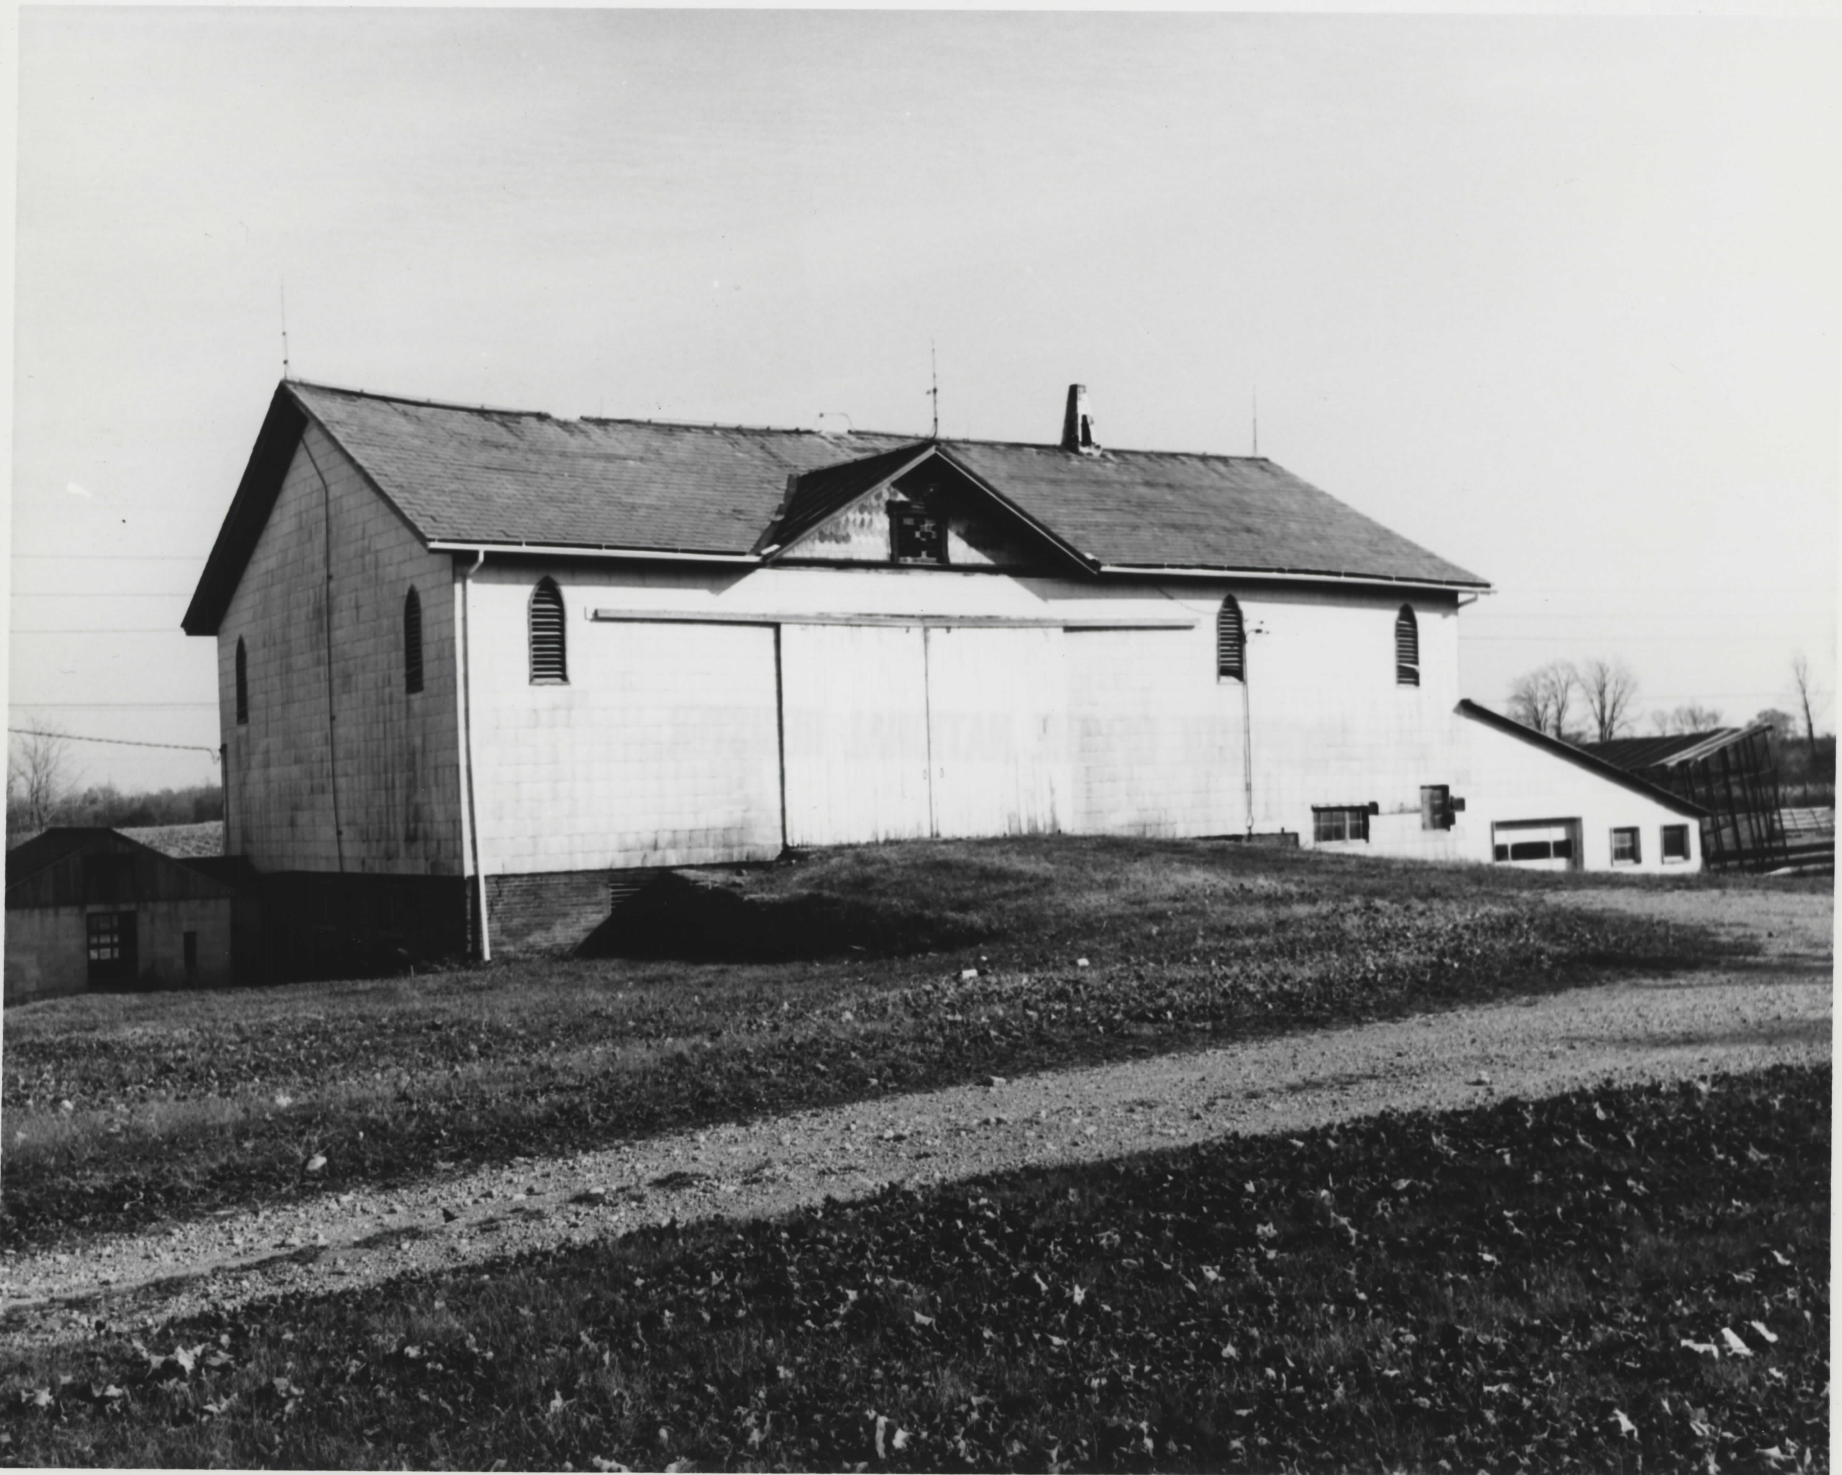
Barn Looking SE

The large two-story barn is 41' x 71'. The ridgeline of the gable roof runs N-S. The west side has a double sliding door above which there is a gable. Within the gable is a square, mulit-paned light. The gable is covered with scalloped shingles; the barn is covered with asbestos shingles. There are pointed arch, louvered openings placed high in the building. The gable roof once had two cupolas. There is a shed-roofed, one-story addition on the south end.

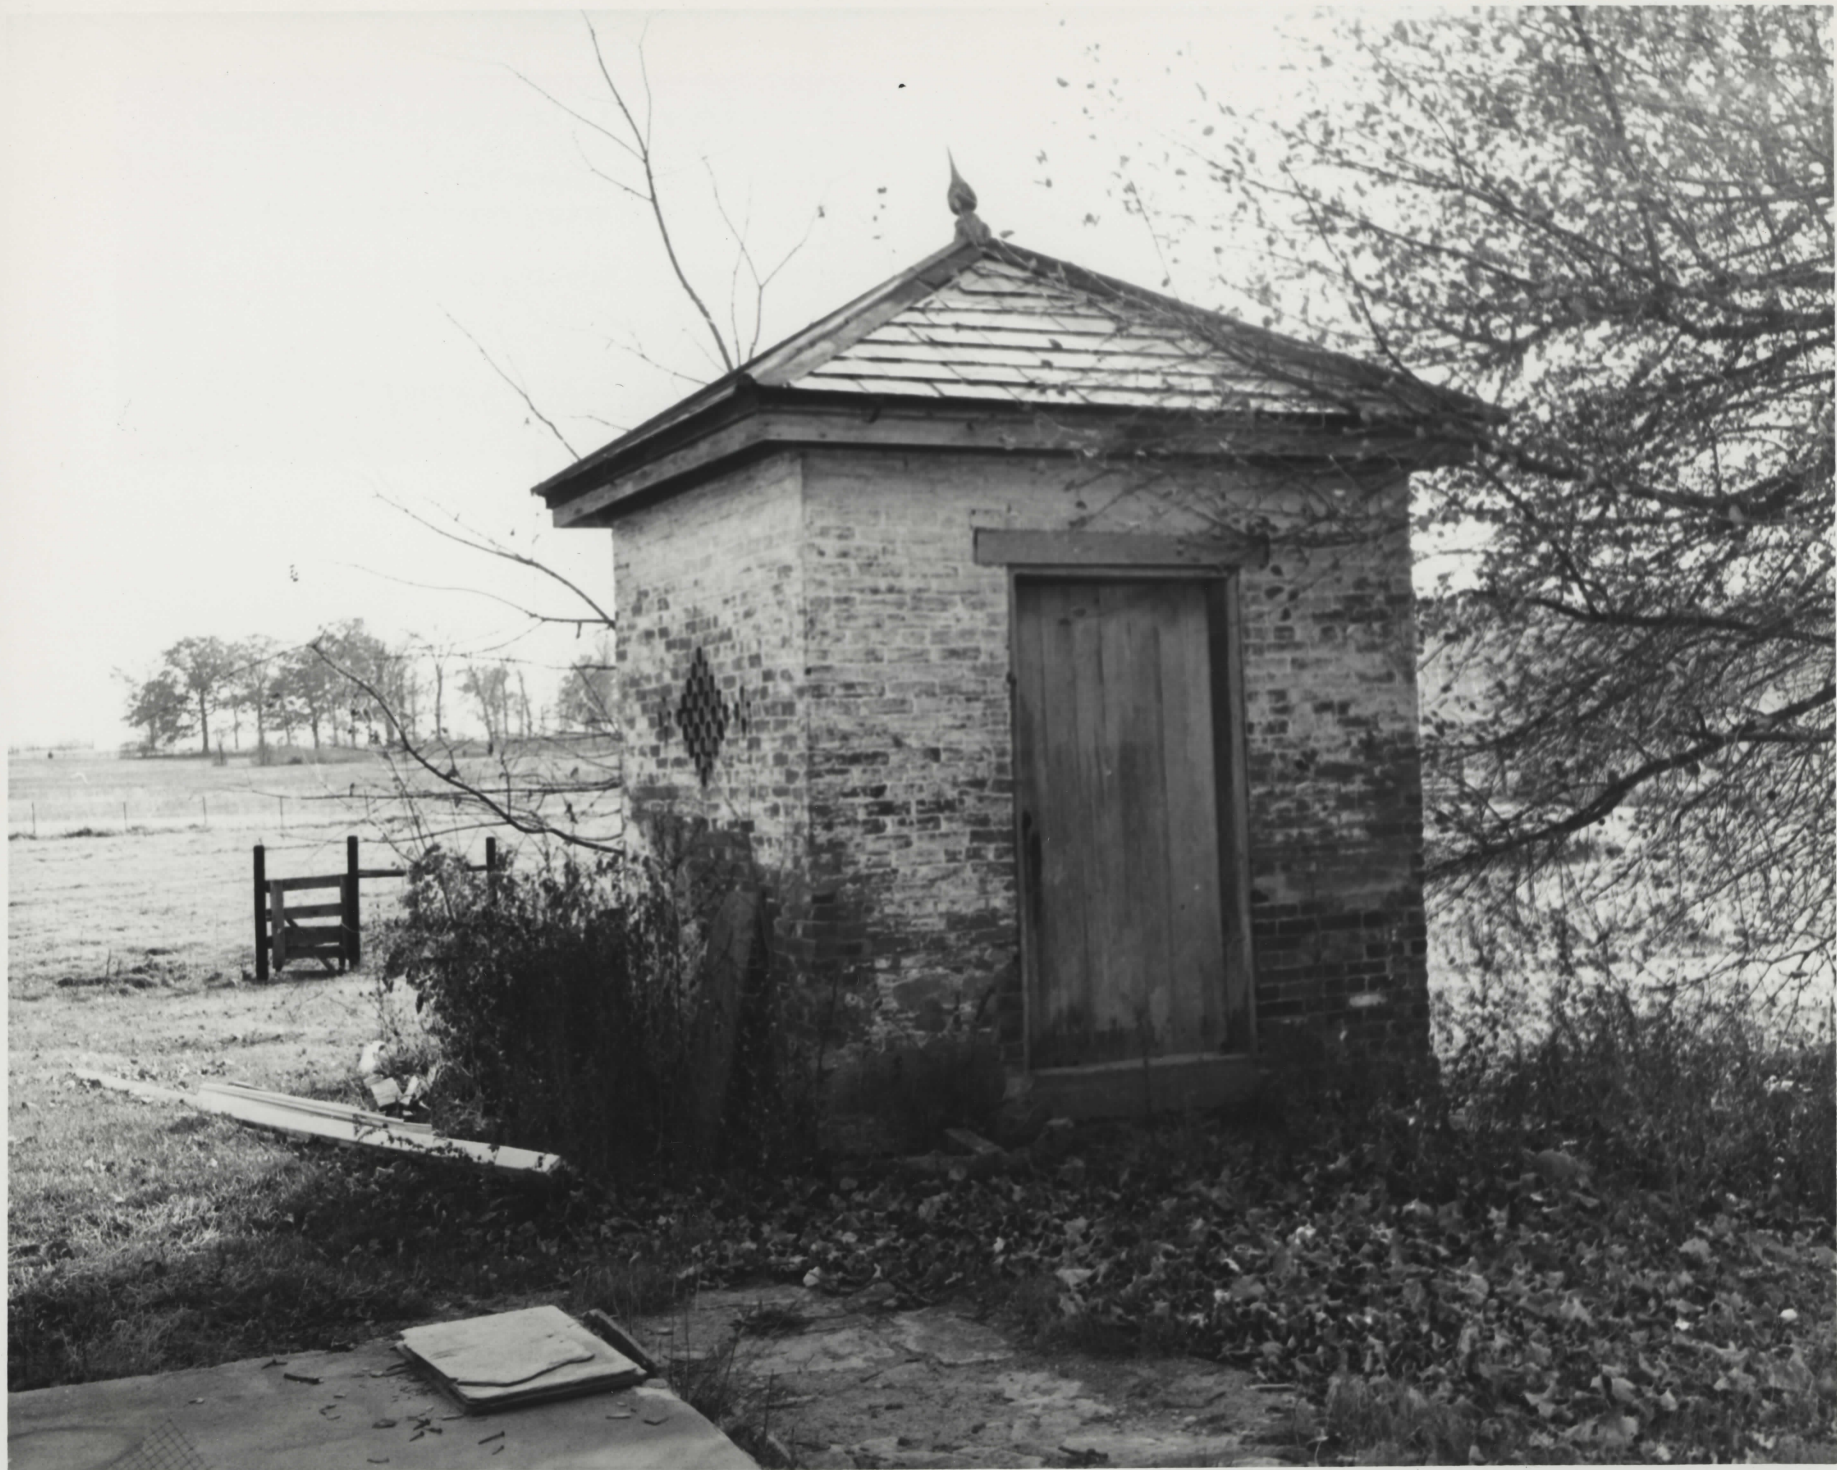
Spring House, Looking south

The springhouse is a 5' square structure built of brick. Diamond pattern brick work forms air vents on three sides. The north side has a simple door. The roof is hipped and terminates with a small finial at the peak.
