NATIONAL REGISTER OF HISTORIC PLACES
INVENTORY -- NOMINATION FORMSEE INSTRUCTIONS IN *HOW TO COMPLETE NATIONAL REGISTER FORMS*
TYPE ALL ENTRIES -- COMPLETE APPLICABLE SECTIONS

HISTORIC Old Ohio Union

Student Services Building

Building 085
Student Services
Building

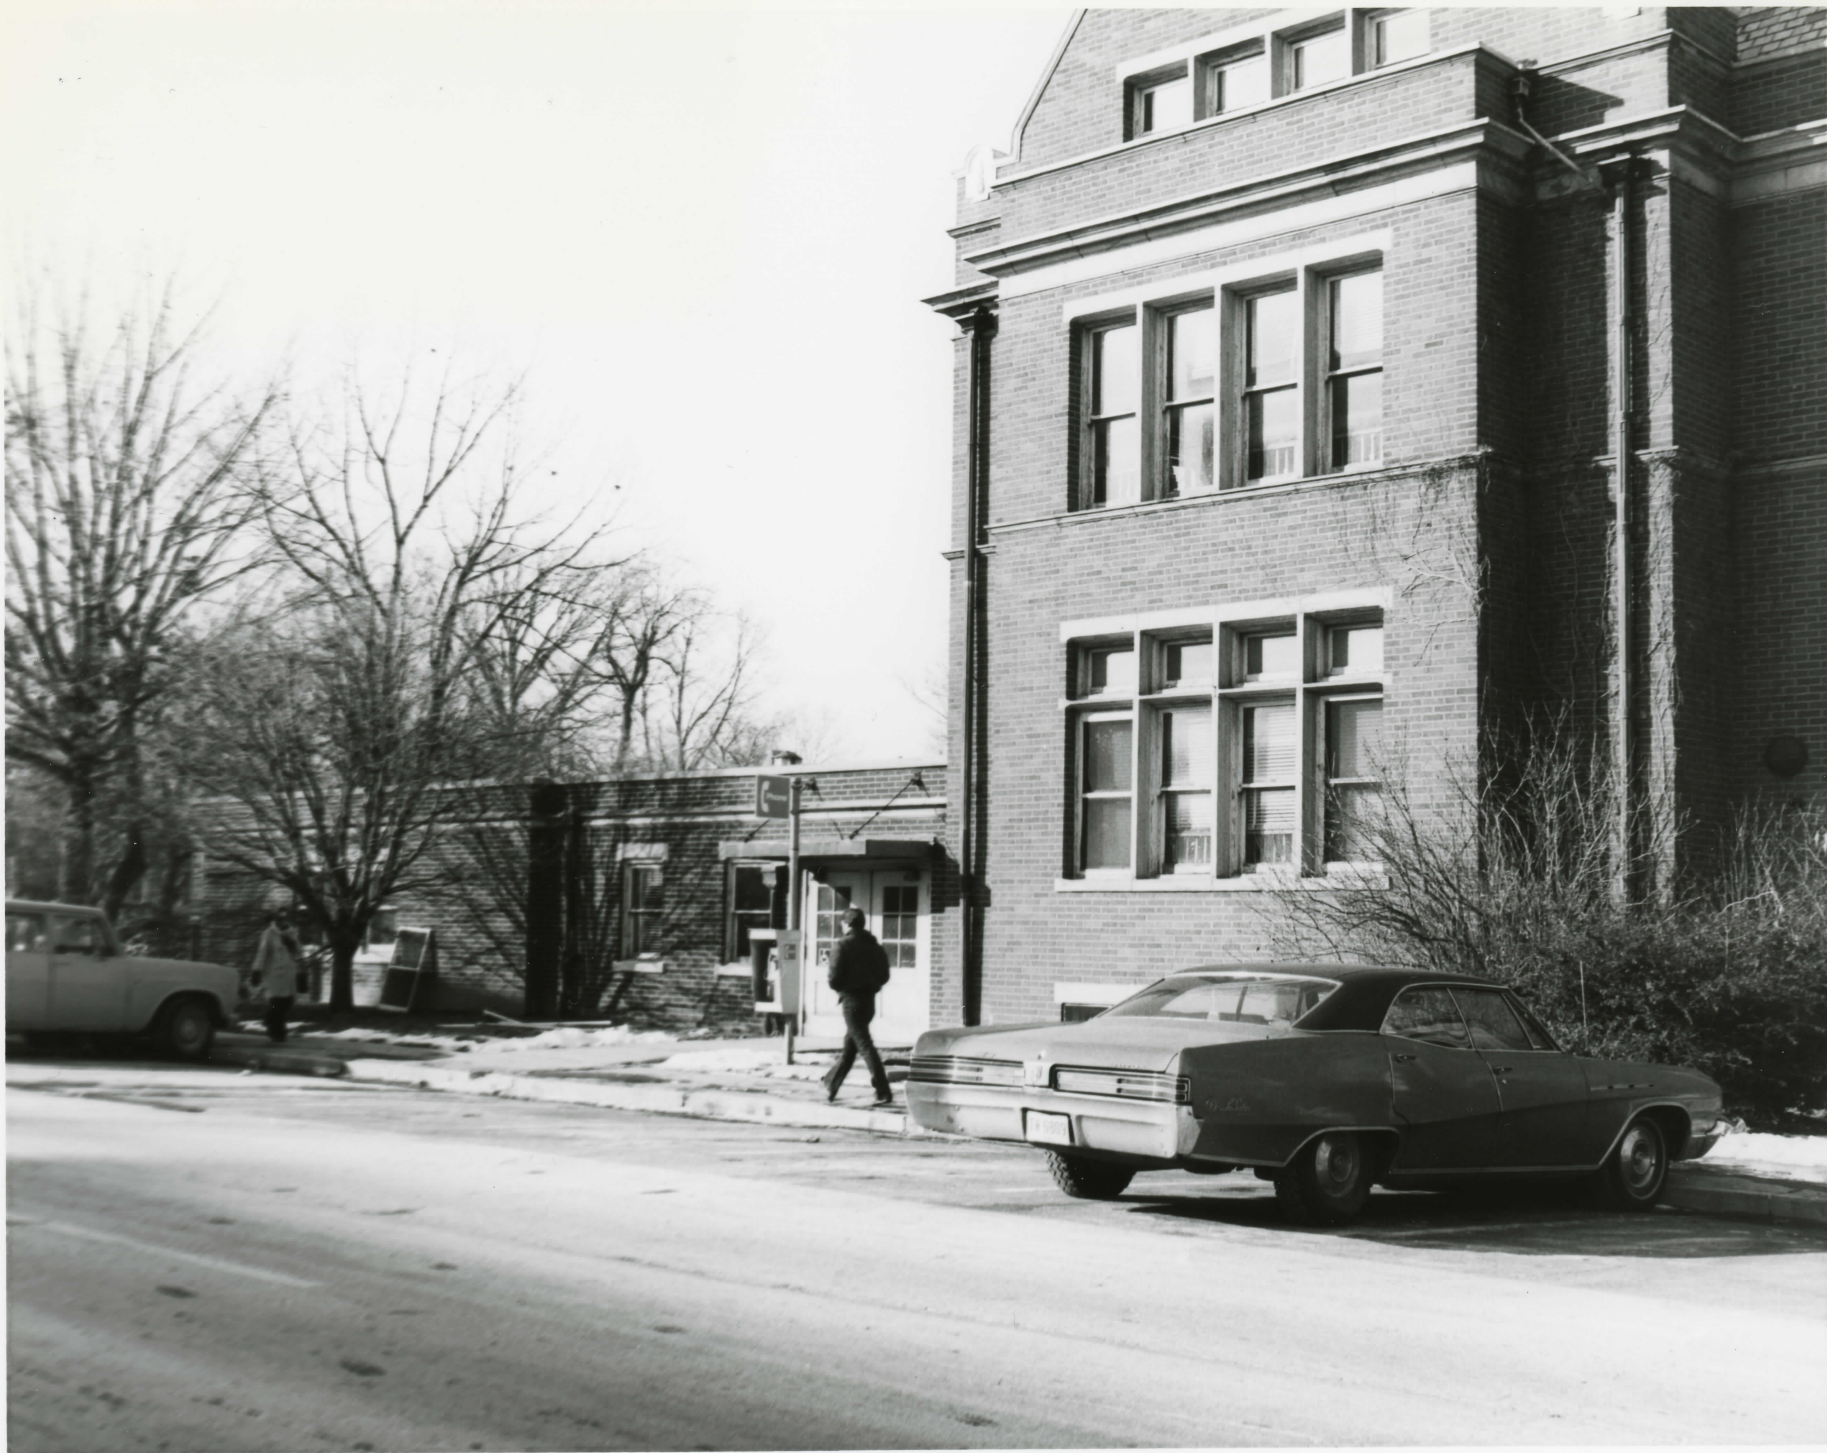
#1 Old Ohio Union, Franklin Co.
Photographer: Gretchen Klimoski, 1979
Negatives: Ohio Historic Preservation
Office

West end south facade looking NW showing
brick additions built on the west side
between 1917-1940

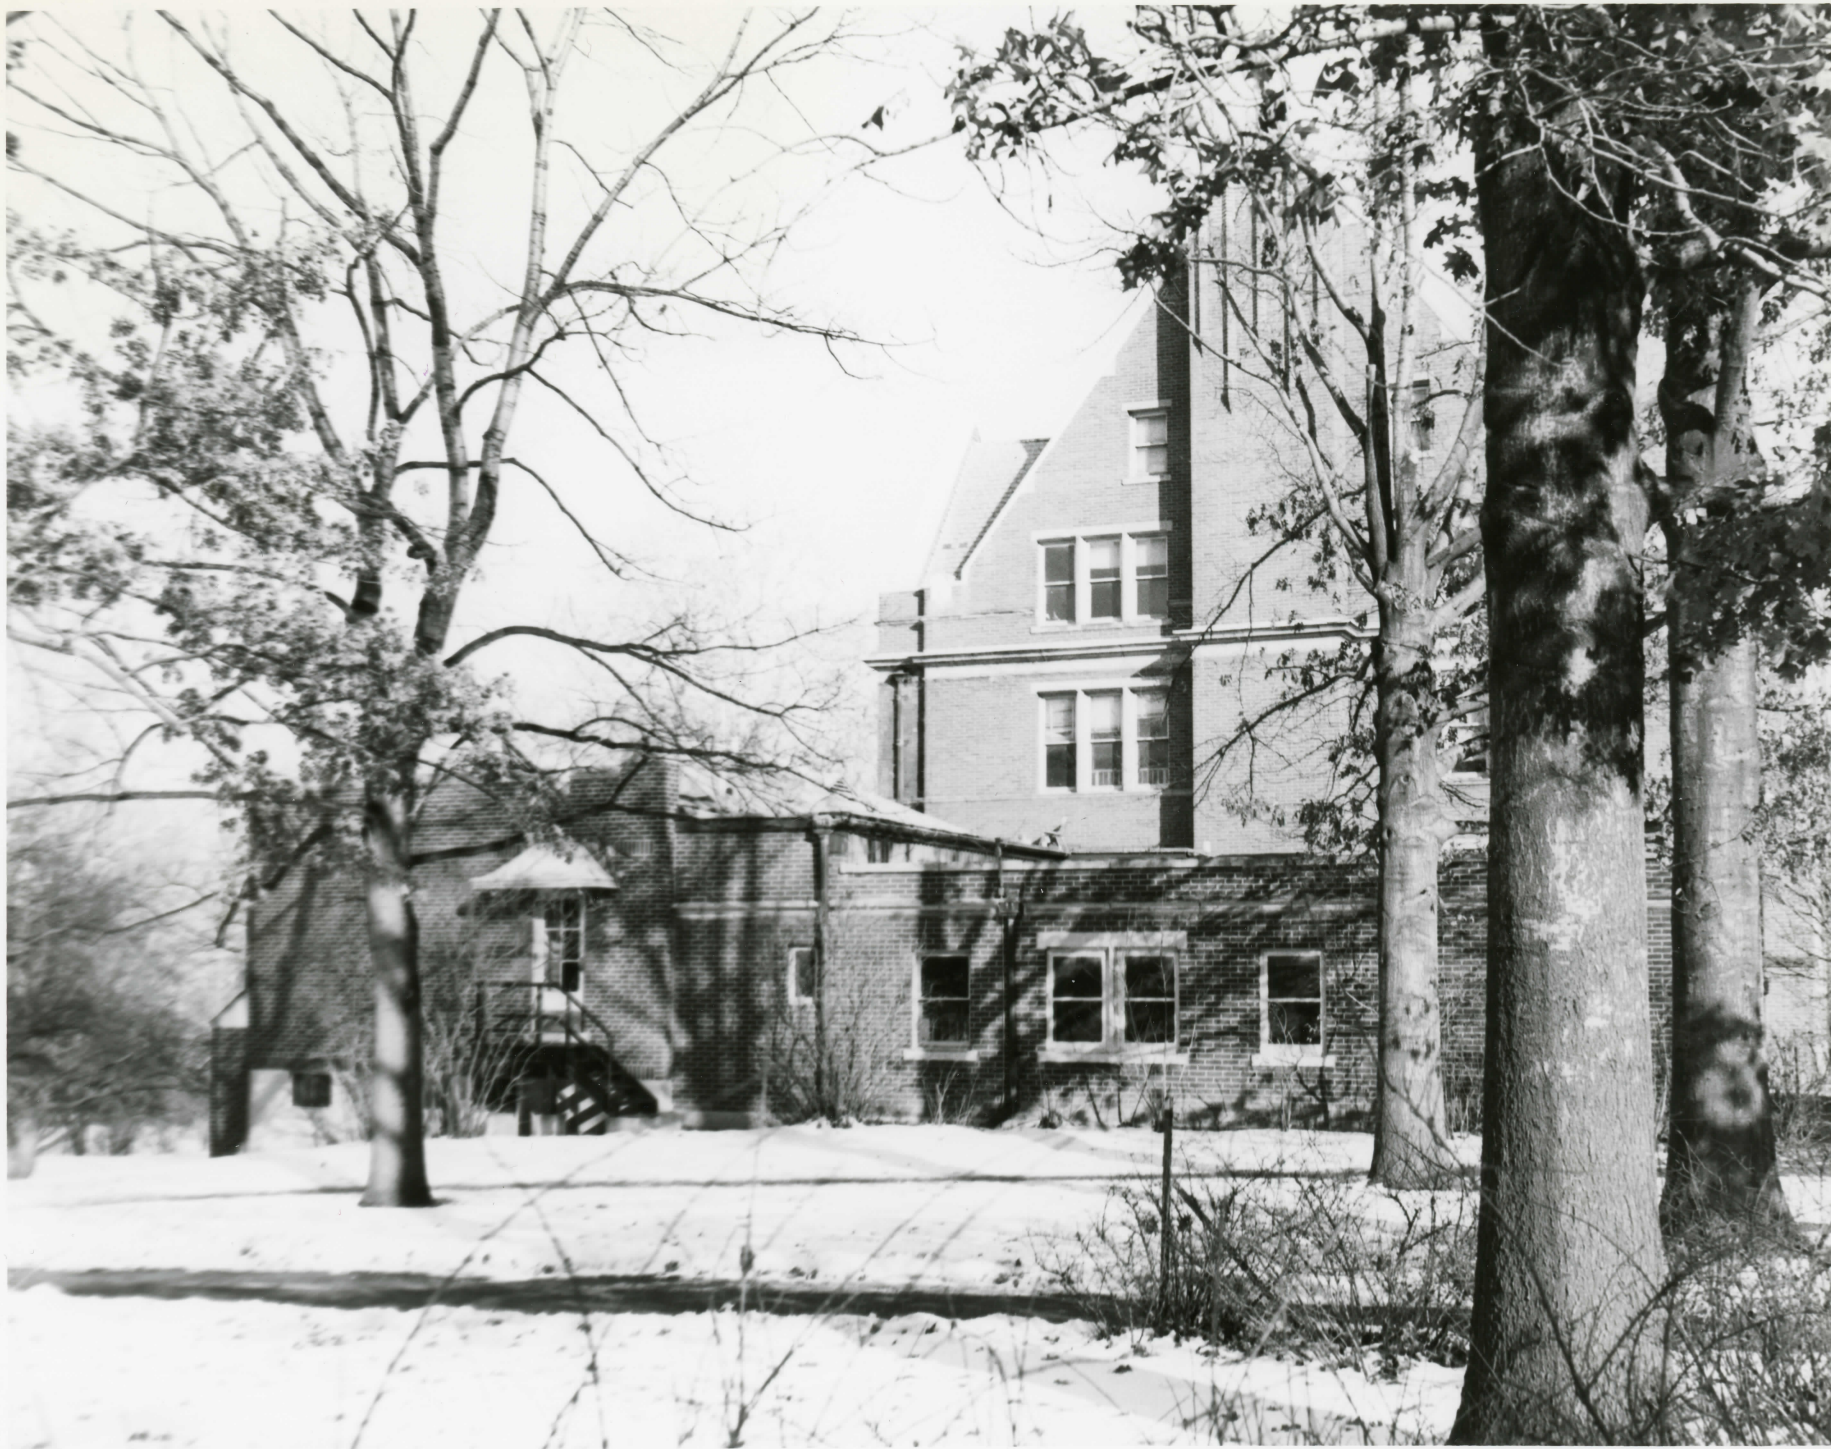
#2 Old Ohio Union, Franklin Co.
Photographer: Gretchen Klimoski, 1979
Negatives: Ohio Historic Preservation
Office

West end looking east showing west
end additions

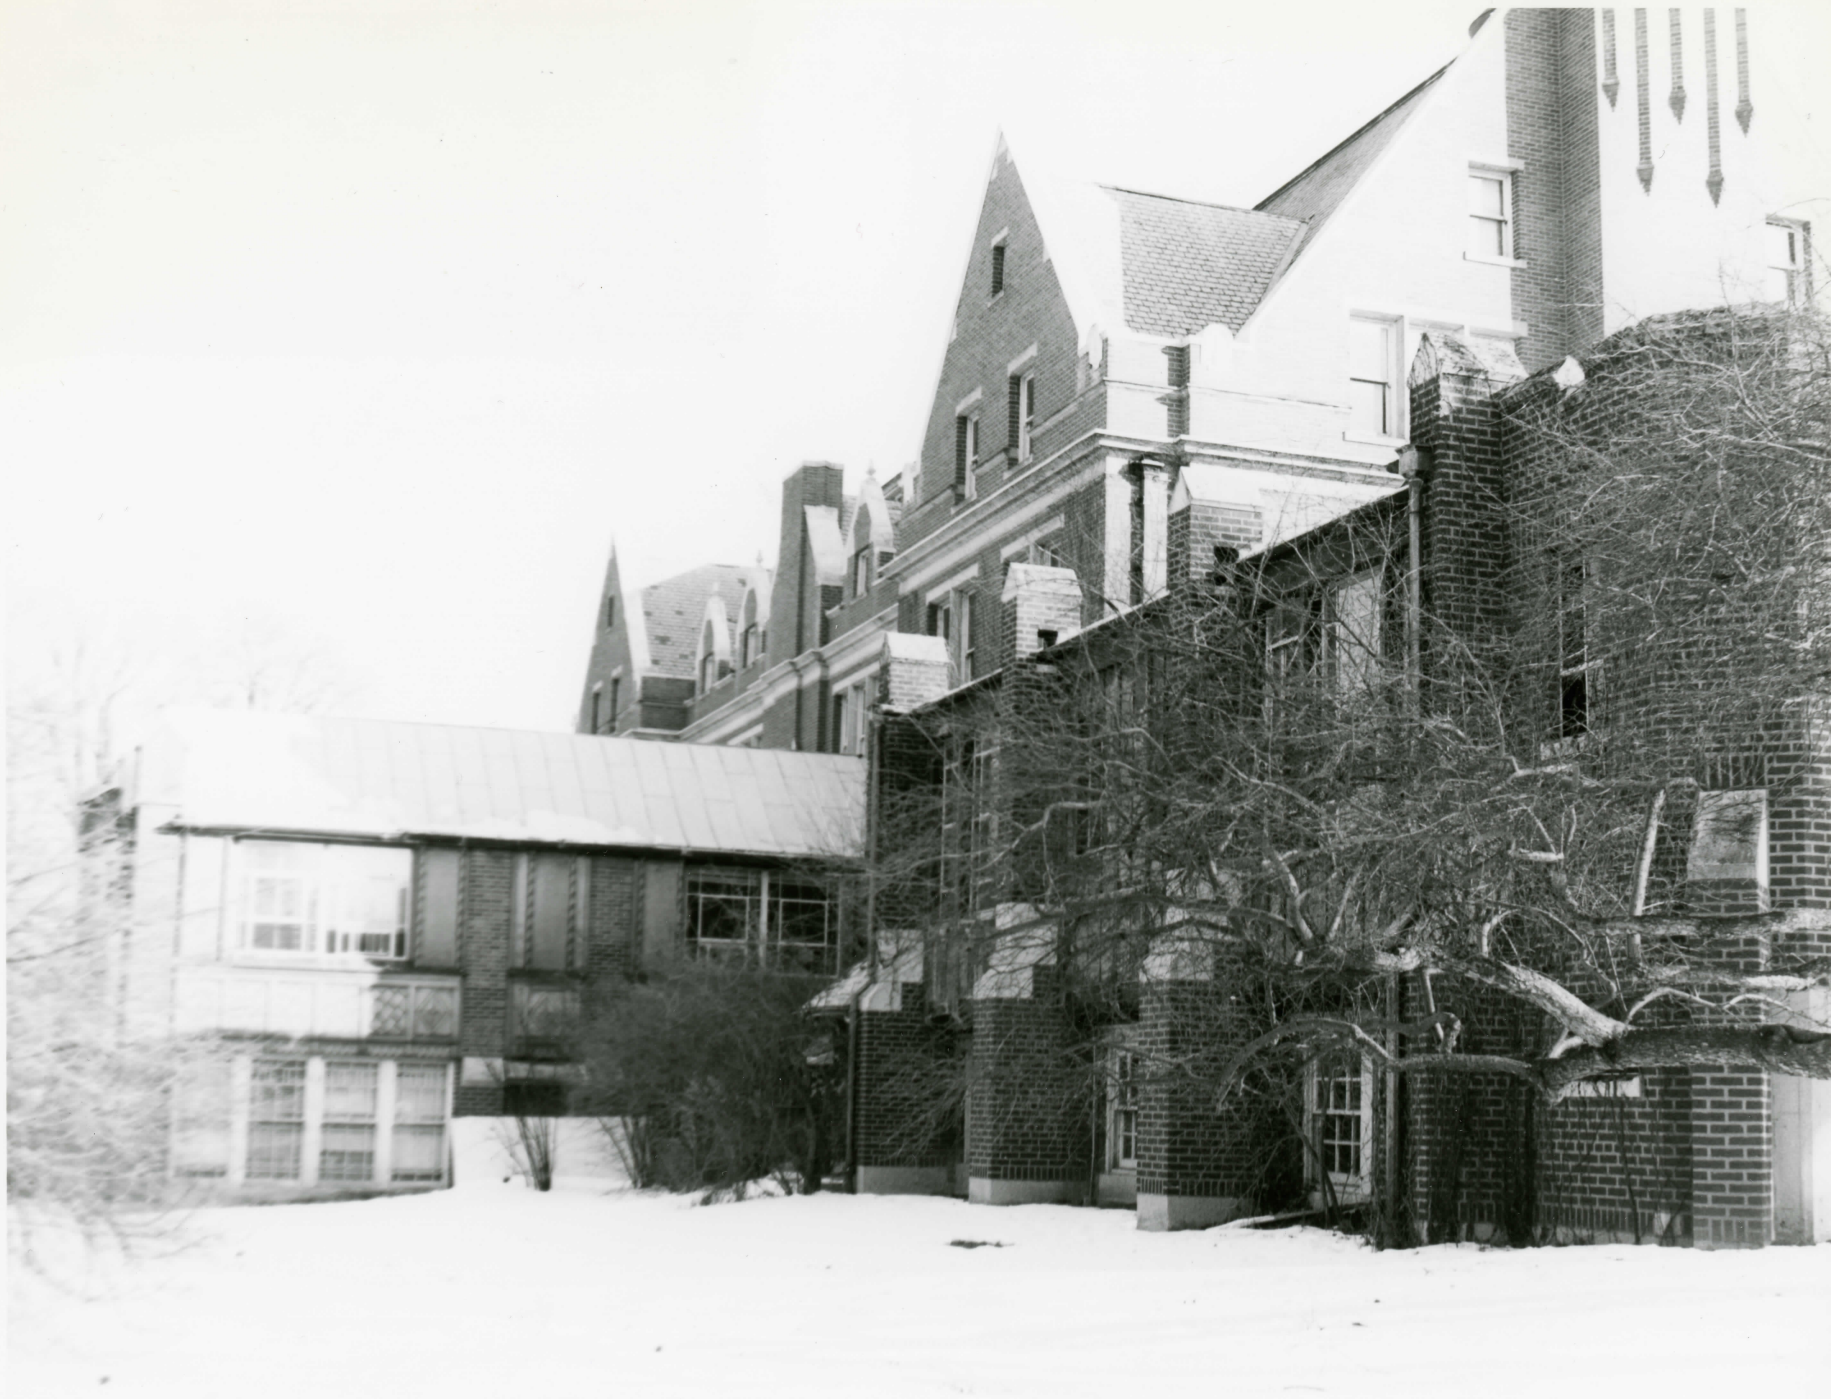
#3 Old Ohio Union, Franklin Co.
Photographer: Gretchen Klimoski
Negatives: Ohio Historic Preservation
Office

Looking SE showing west end addition
and north addition (1921)

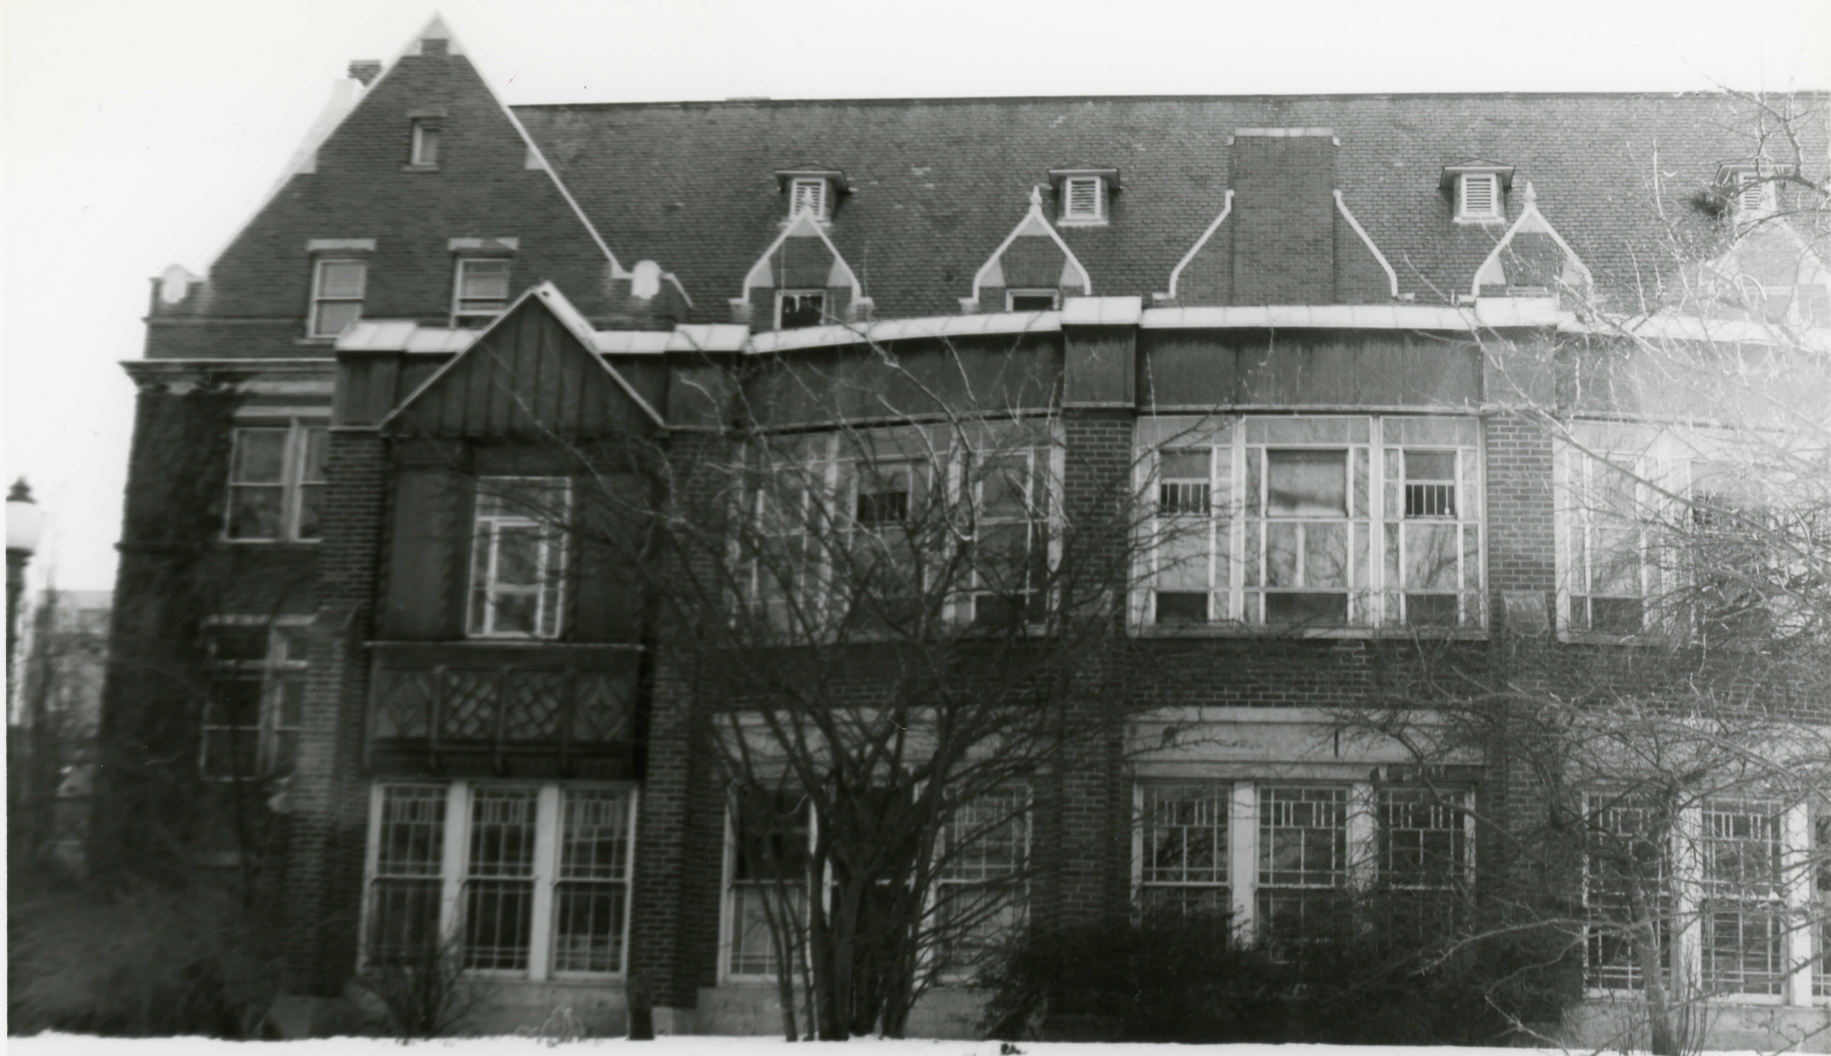
#4 Old Ohio Union, Franklin County
Photographer: Gretchen Klimoski
Negatives: Ohio Historic Preservation
Office

Looking south at 1921 addition. Lower
story existing since 1917; remodeled and
upper story added 1921

In 1921 the most important addition was made by adding the 2nd story over the original dining room and its addition. Also of brick and stone this addition compliments the original structure with rectangular, grouped windows, stone trim, mullioned panes and some strapwork continuing the elements of the Jacobethan revival. Here, however, the effect is more of the scale found on the 1909 Albert Kahn Cranbrook structures (also in Whiffen) and is indicative of the later Cranbrook architecture of Saarinen.

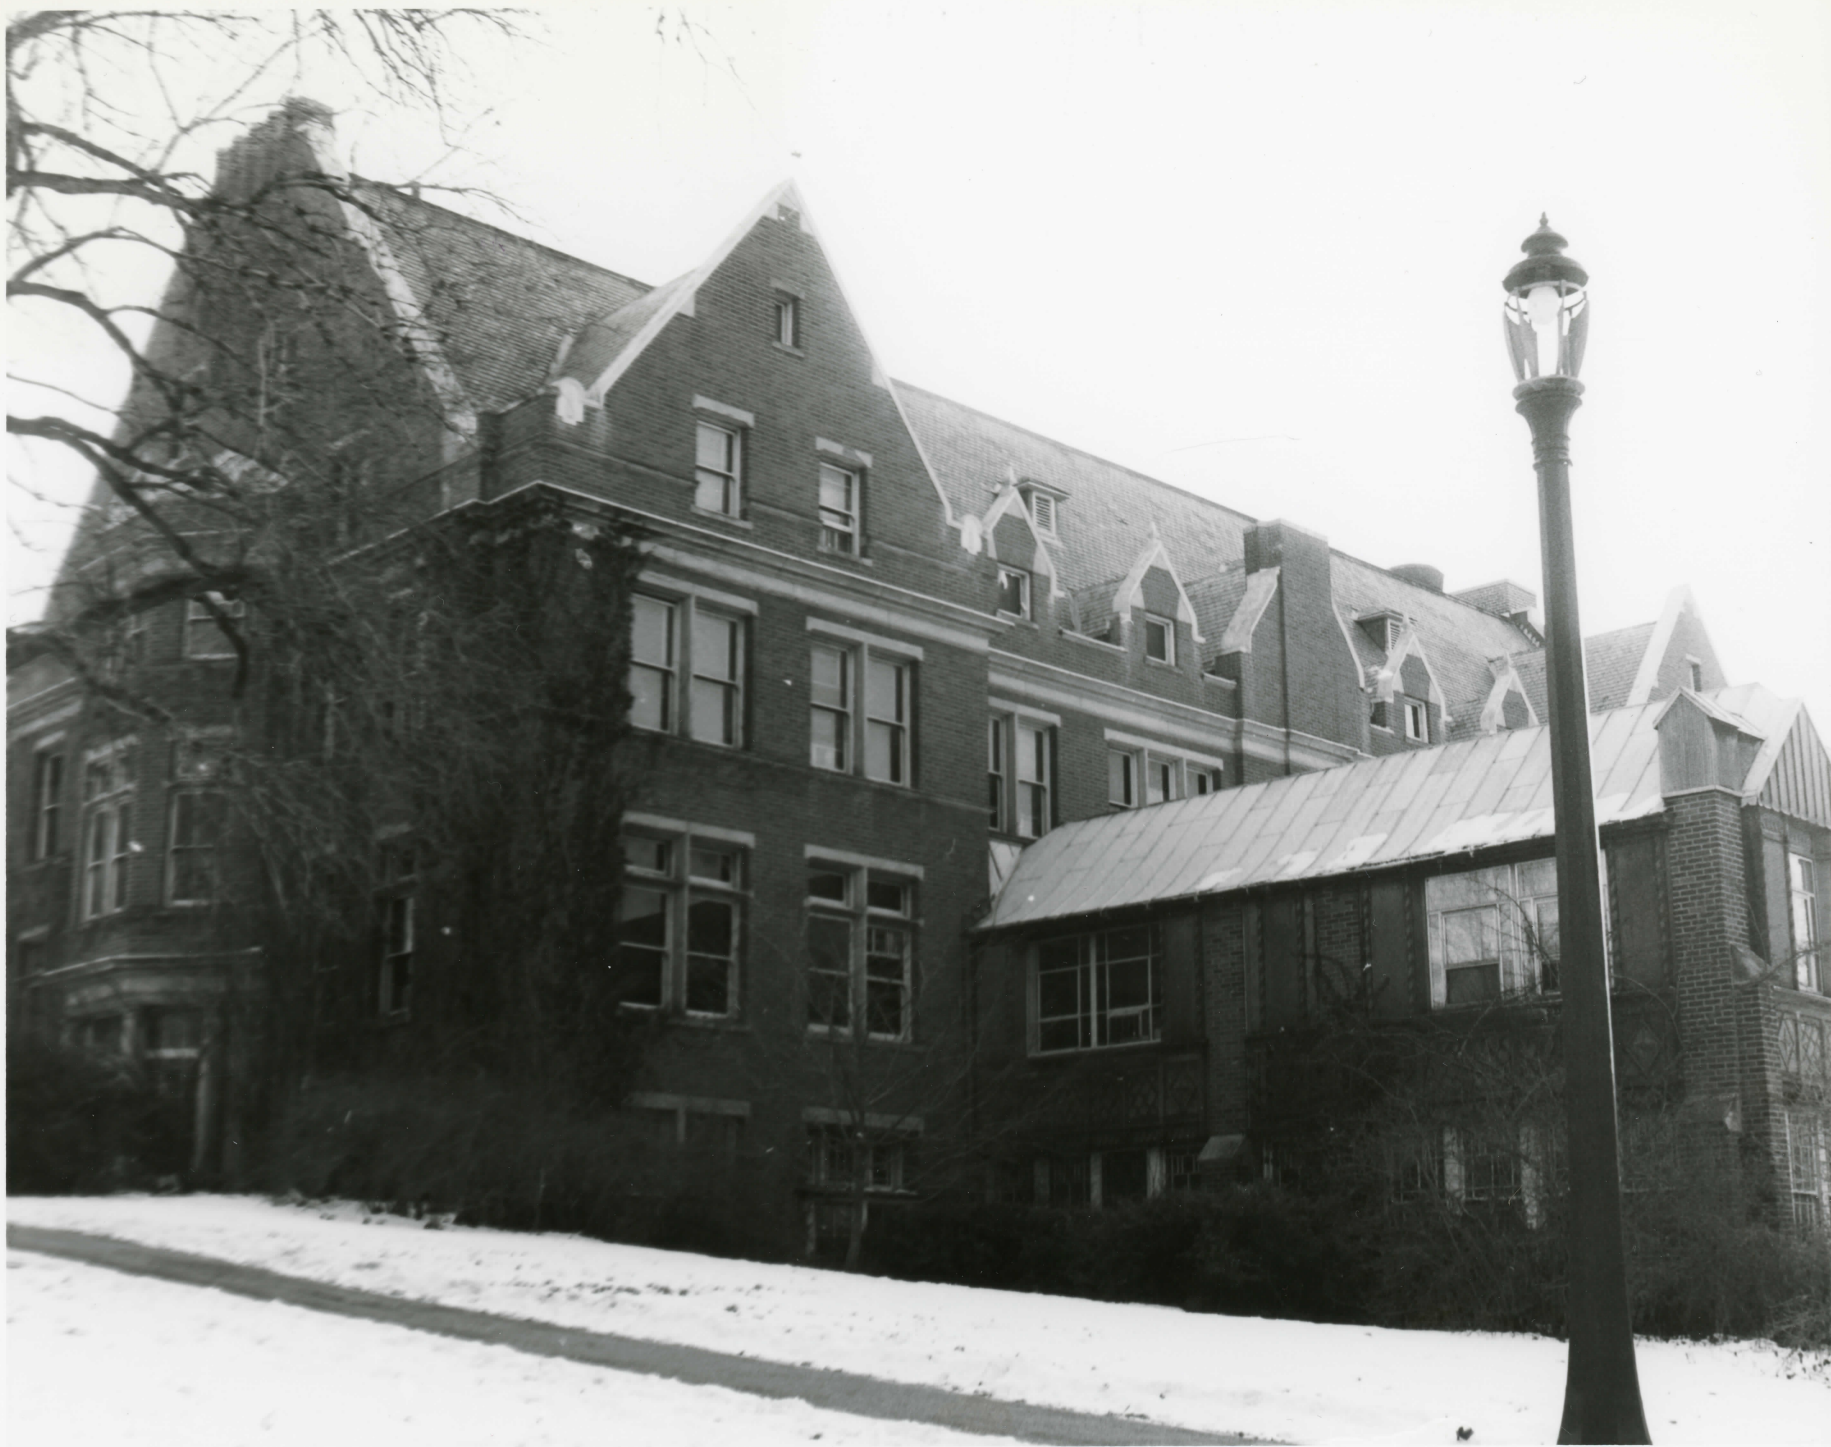
#5 Old Ohio Union, Franklin County
Photographer: Gretchen Klimoski
Negatives: Ohio Historic Preservation
Office

Looking SW at original building and 1921
addition

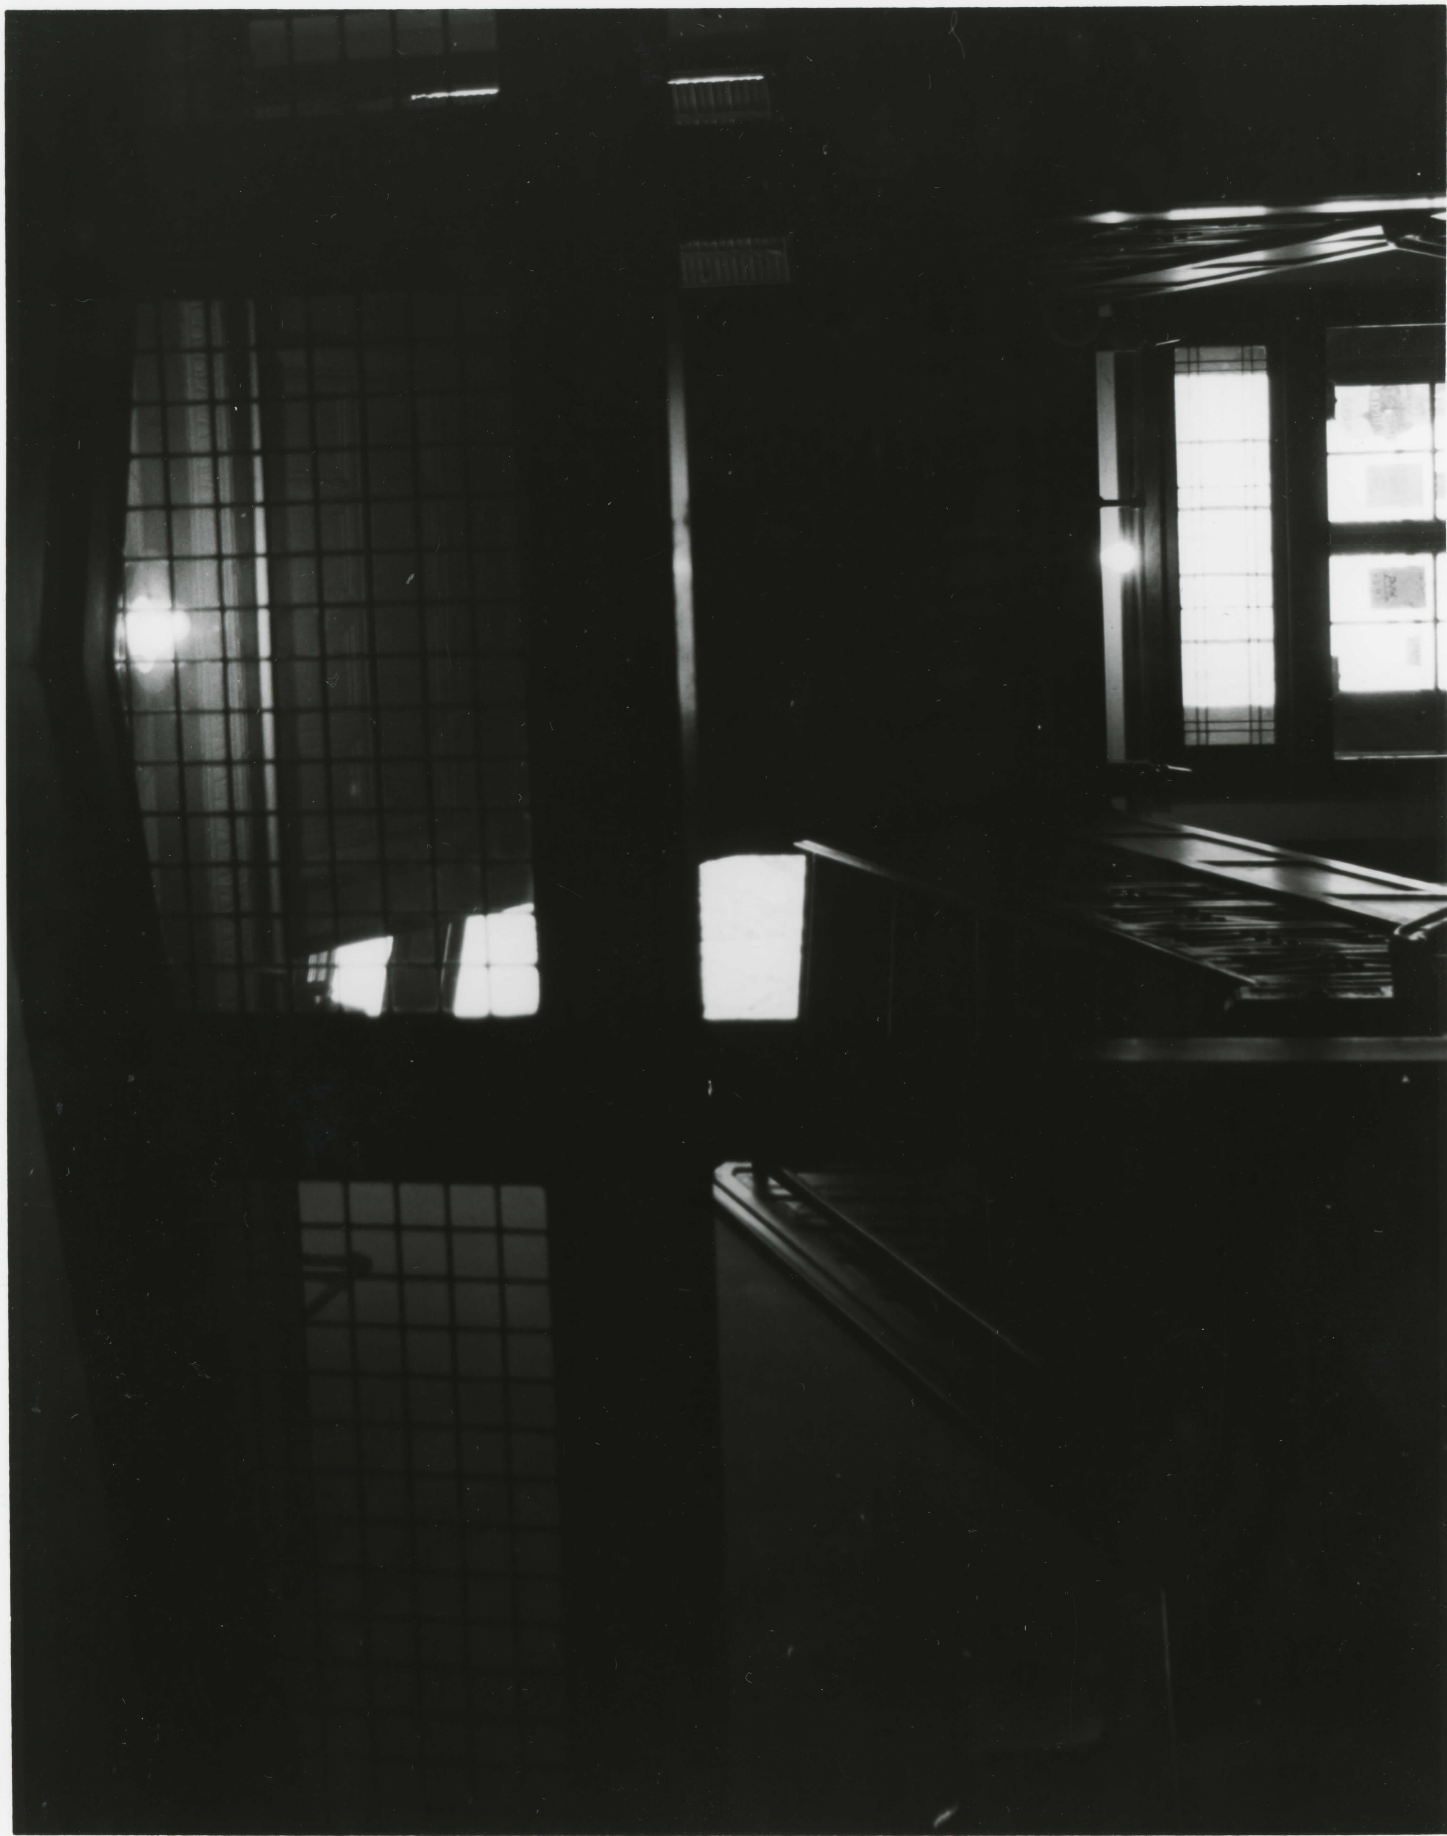
#6 Old Ohio Union, Franklin County
Photographer: Gretchen Klimoski
Negatives: Ohio Historic Preservation
Office

Interior, east stairway in projecting
bay showing original stairway

The main feature of the east side of the building is a hexagonal bay which encloses the main stairway. Since the building is located on a steeply sloped site, the basement opens out at ground level on the rear facade. Originally a one storey ell was located on the rear of the building, but it has been expanded so that it extends out twice as far and is now two storeys tall. The rear wall of the ell is bowed with buttresses separating the bays of windows. The ell is trimmed with pressed copper sheeting. On the west side two story brick additions have been made. The front sections are very plain; the rear section is detailed keeping with the style of the main building.

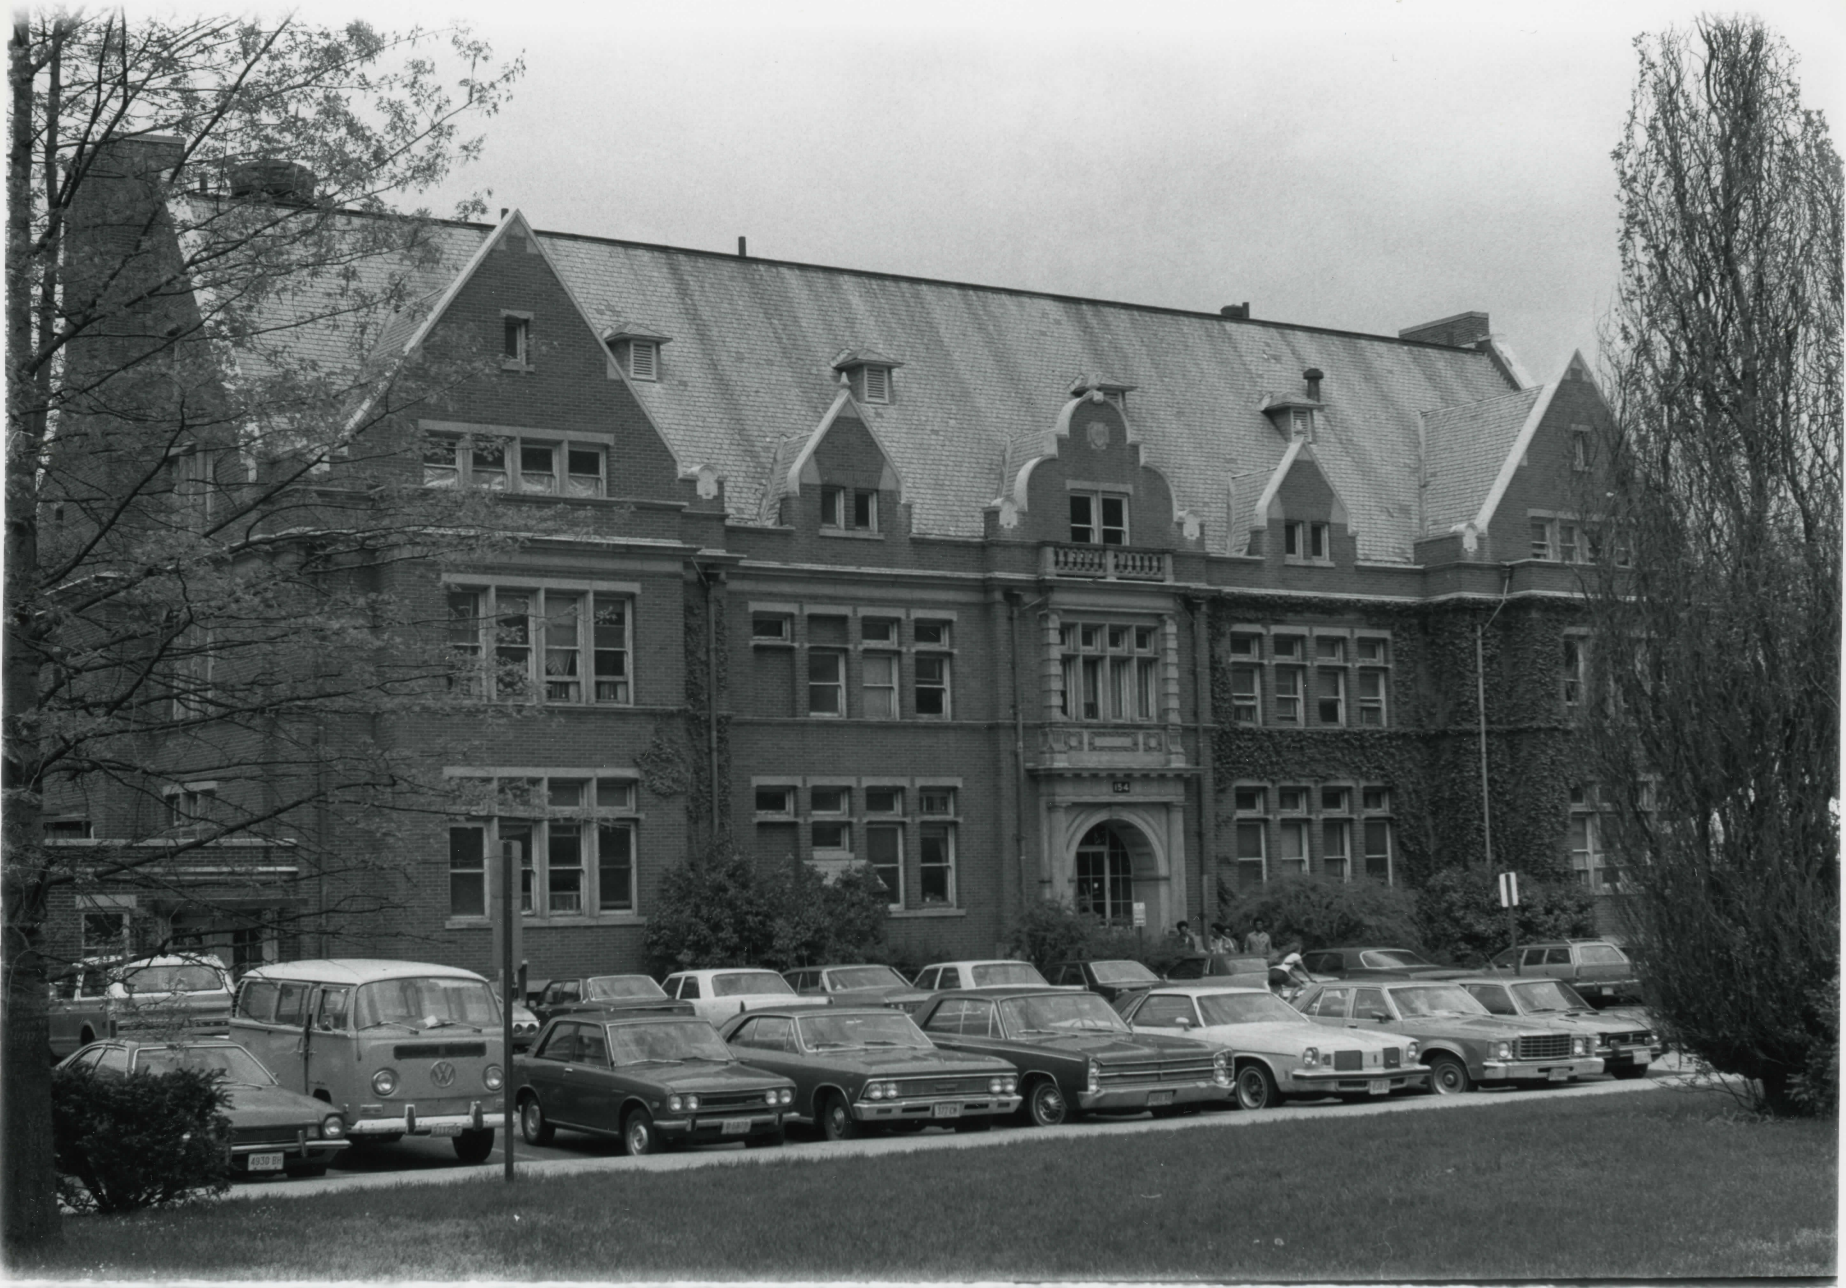
#9089

South Facade, Old Ohio Union
Columbus, Franklin County,
Ohio. Photo by George Kane
May 13, 1978. Negative at
the Ohio Historic Preserva-
tion Office.

The front facade has a five part composition with projecting sections at the center and the ends. The center bay is dominated by a two-story tabernacle frame with a round arched doorway. The projecting end sections have square two-story bays. The front facade faces south.
