OHIO HISTORIC INVENTORY

4. Present Name(s)
Norwell Residence
5. Other Name(s)

Specific Location
6 Tusculum Avenue

Norwell Residence

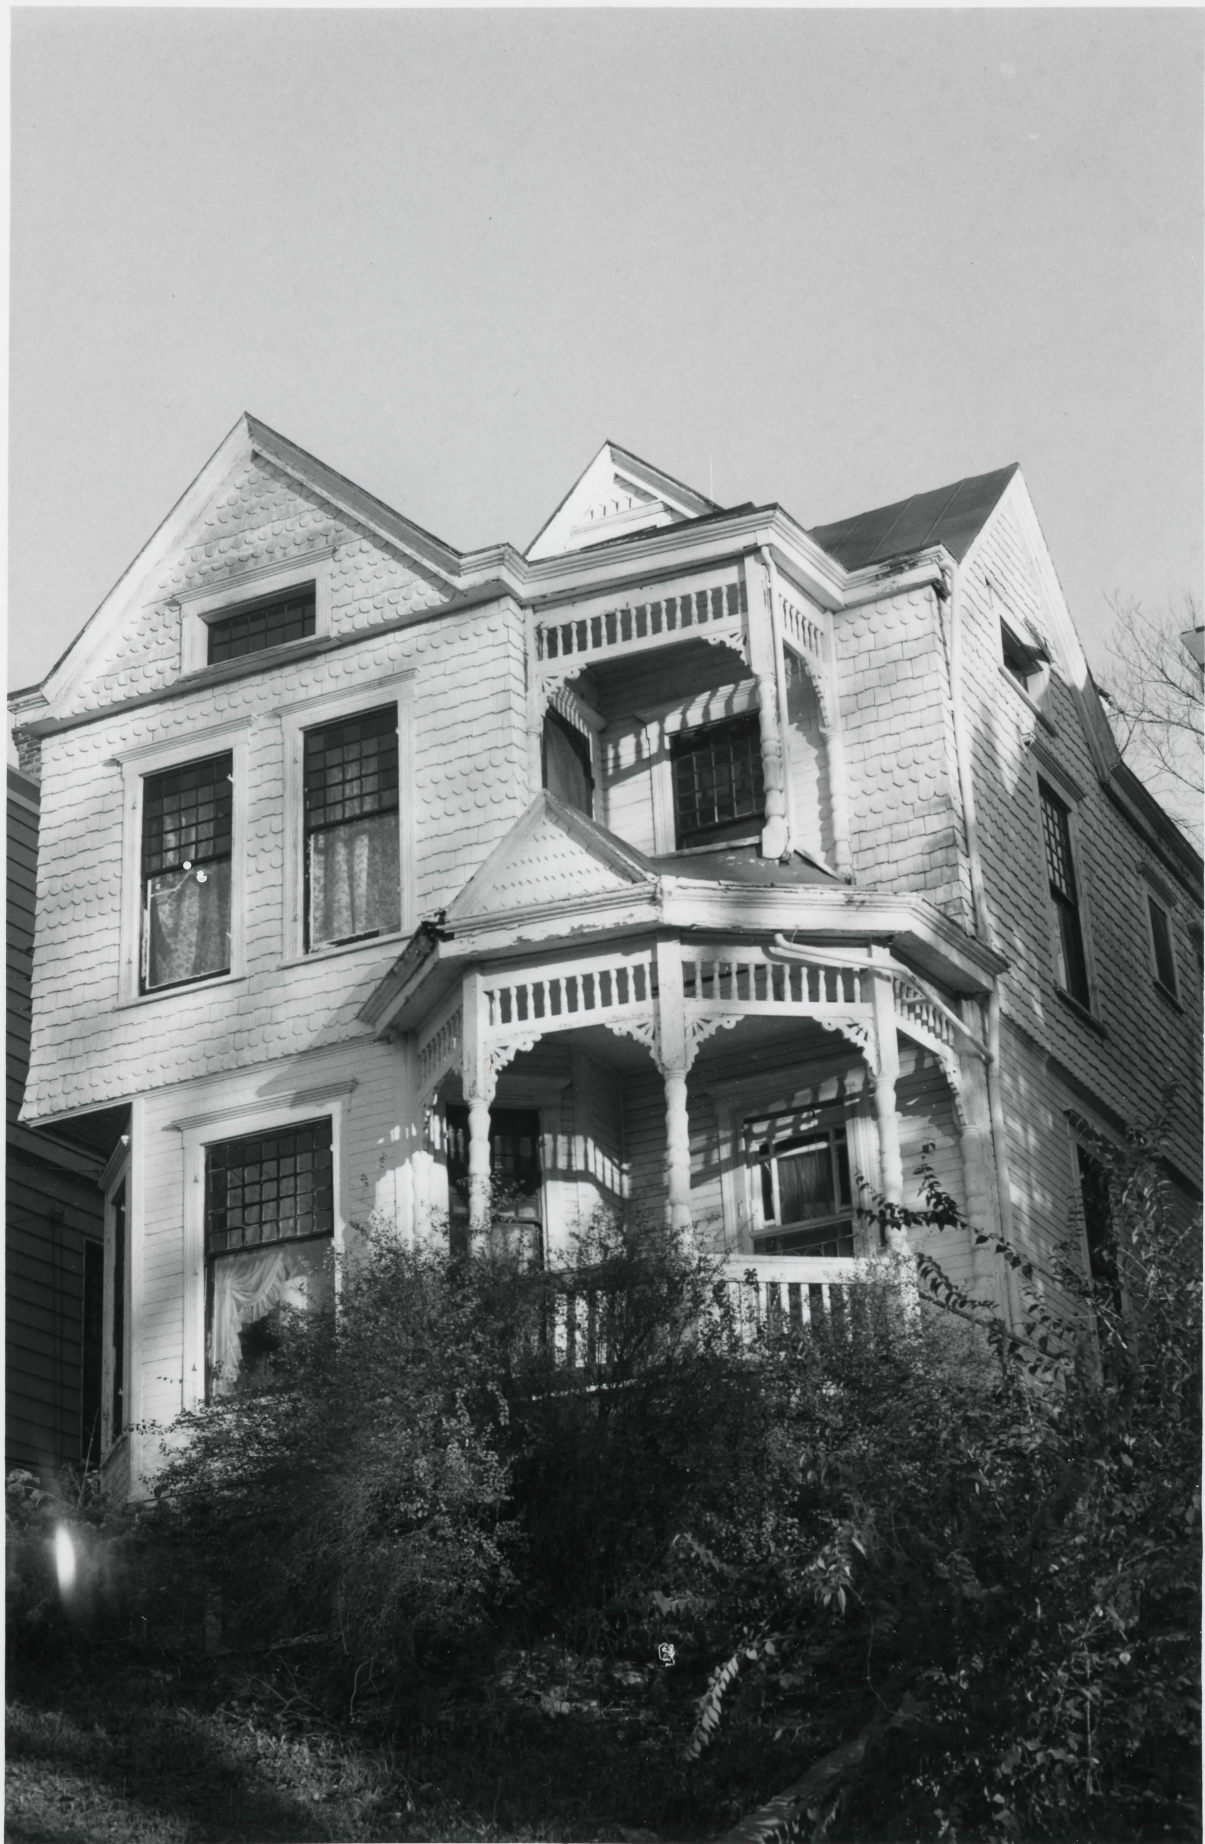
1. Building **2**, Residence (506 Tusculum)
Columbia Tusculum
2. Cincinnati, Hamilton County, Ohio
3. Ben Ross
4. October 20, 1977
5. Zorn Engineering
6. Front elevation, looking northeast
7. Photograph number **8** 24/33

42. Further Description of Important Features This irregular residential building of medium scale is distinguished by its mixed wall treatment and decorative porch construction. The second story and gable end exhibit various shingle patterns while the first story and beveled bay are clapboard. Within the crotch of the "L" are two porches; an entrance porch of four angles exhib-

44. Description of Environment and Outbuildings
The house is located on a steep hillside and above a deteriorating ashlar retaining wall. The foundation is quite wide on the facade.

iting conical cap, frieze spindles, and delicate bracing. The smaller second story porch has two perpendicular sides and identical spindlework and bracing. Most of the windows are ³⁵/₁, the upper panes being leaded.
