National Register of Historic Places  
Inventory—Nomination Form

historic  (A) Frasier, Thomas T. and  (B) Wesley B. Houses

street & number  (A) 898 National Road and  (B) 920 National Road not for publication

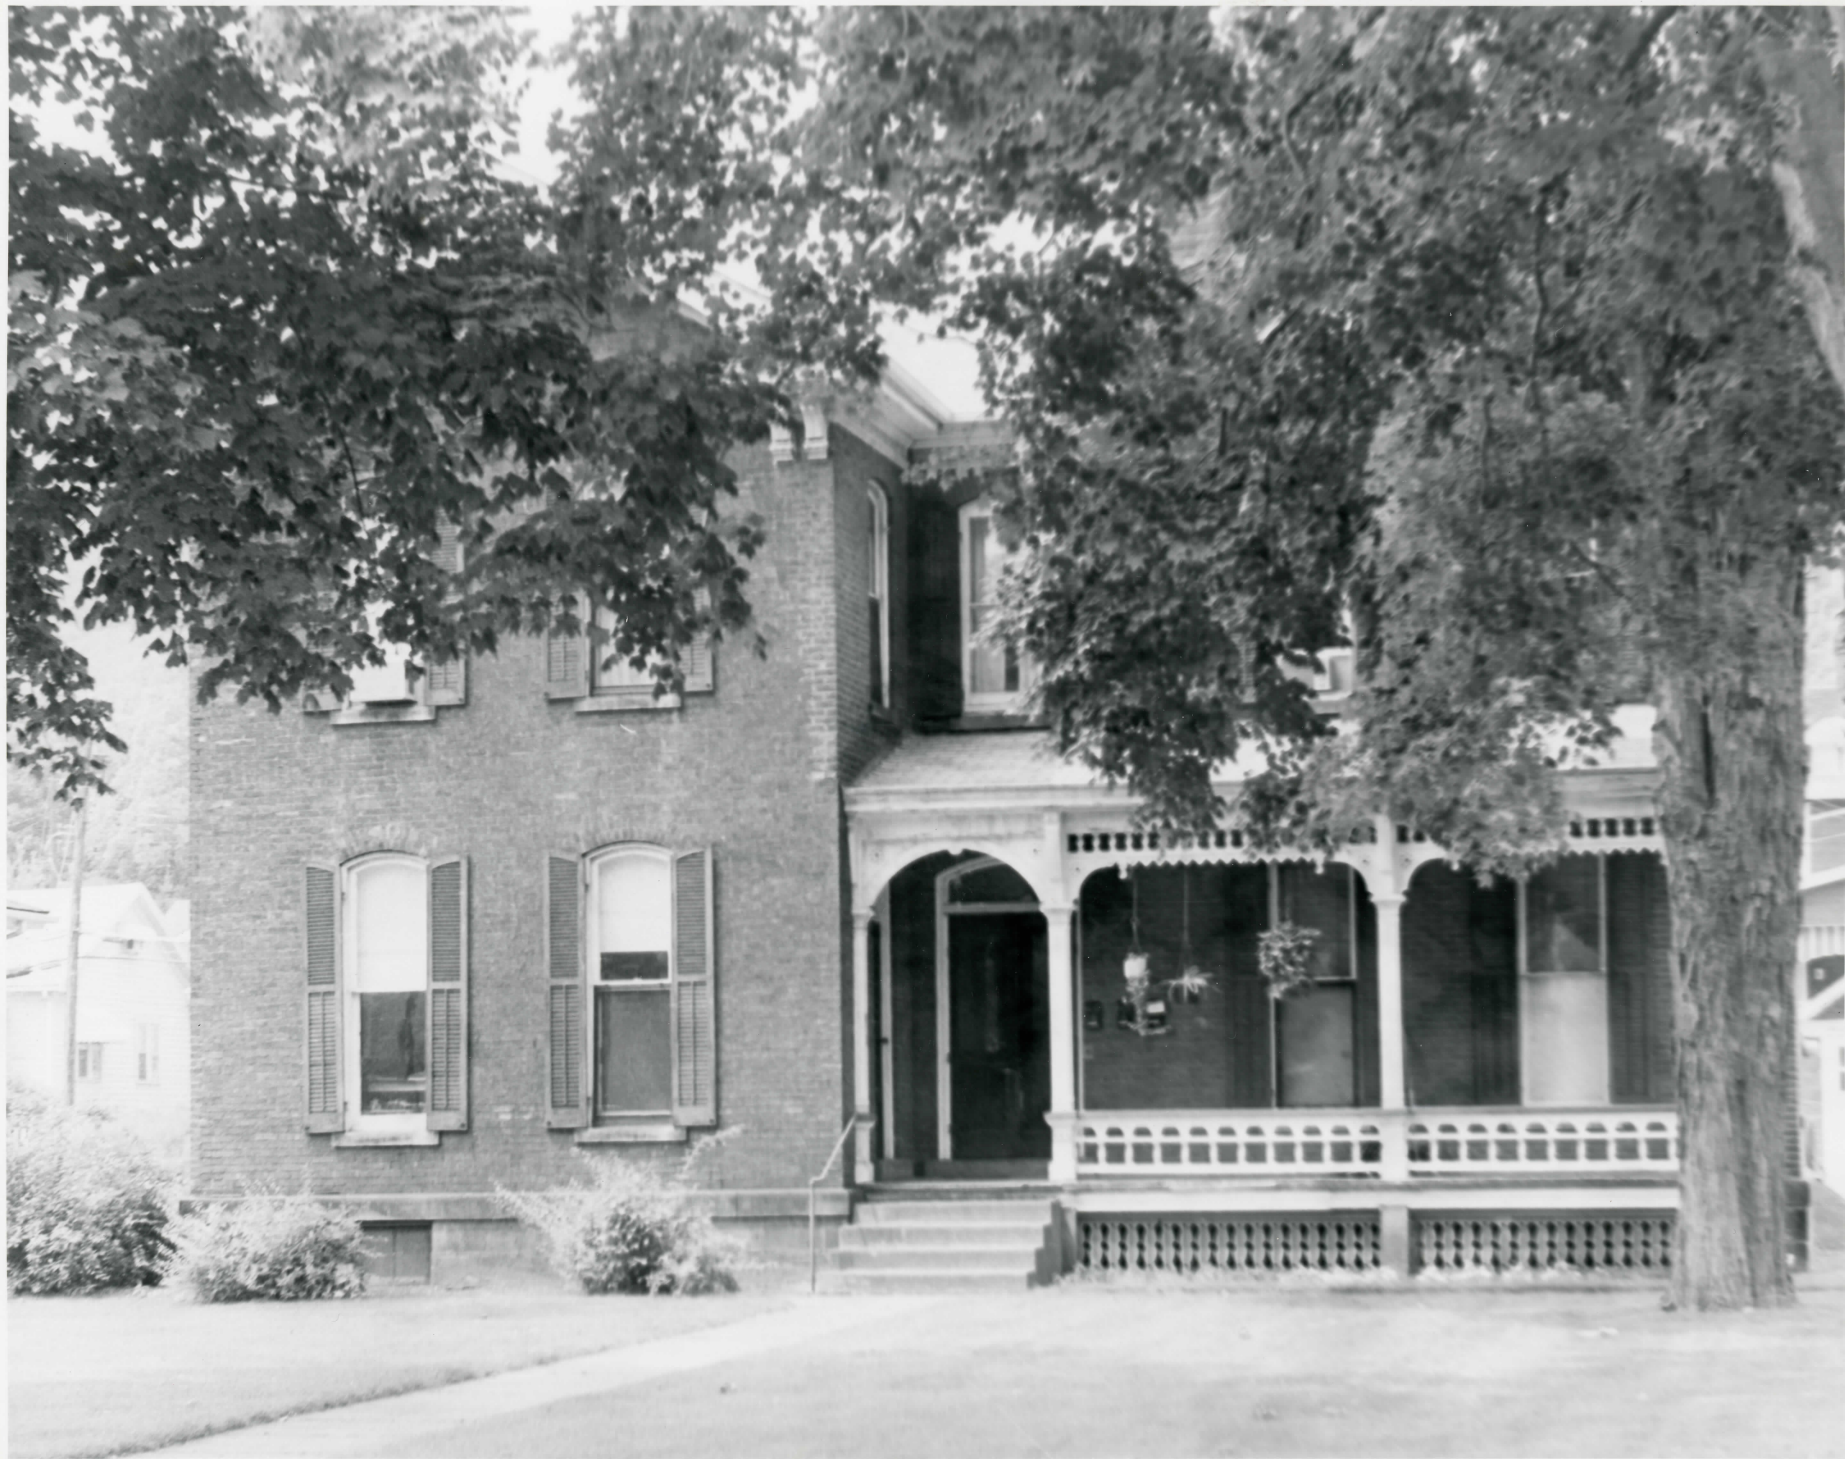
FRASIER, T.T., HOUSE  
Brookside, Ohio (Belmont Co.)  
Photo by David Taylor, 1981  
Neg. BEL-24-6-3, filed at Ohio  
University, Zanesville, Ohio  
Facade, from National Road, showing  
porch, windows, cornice, etc.

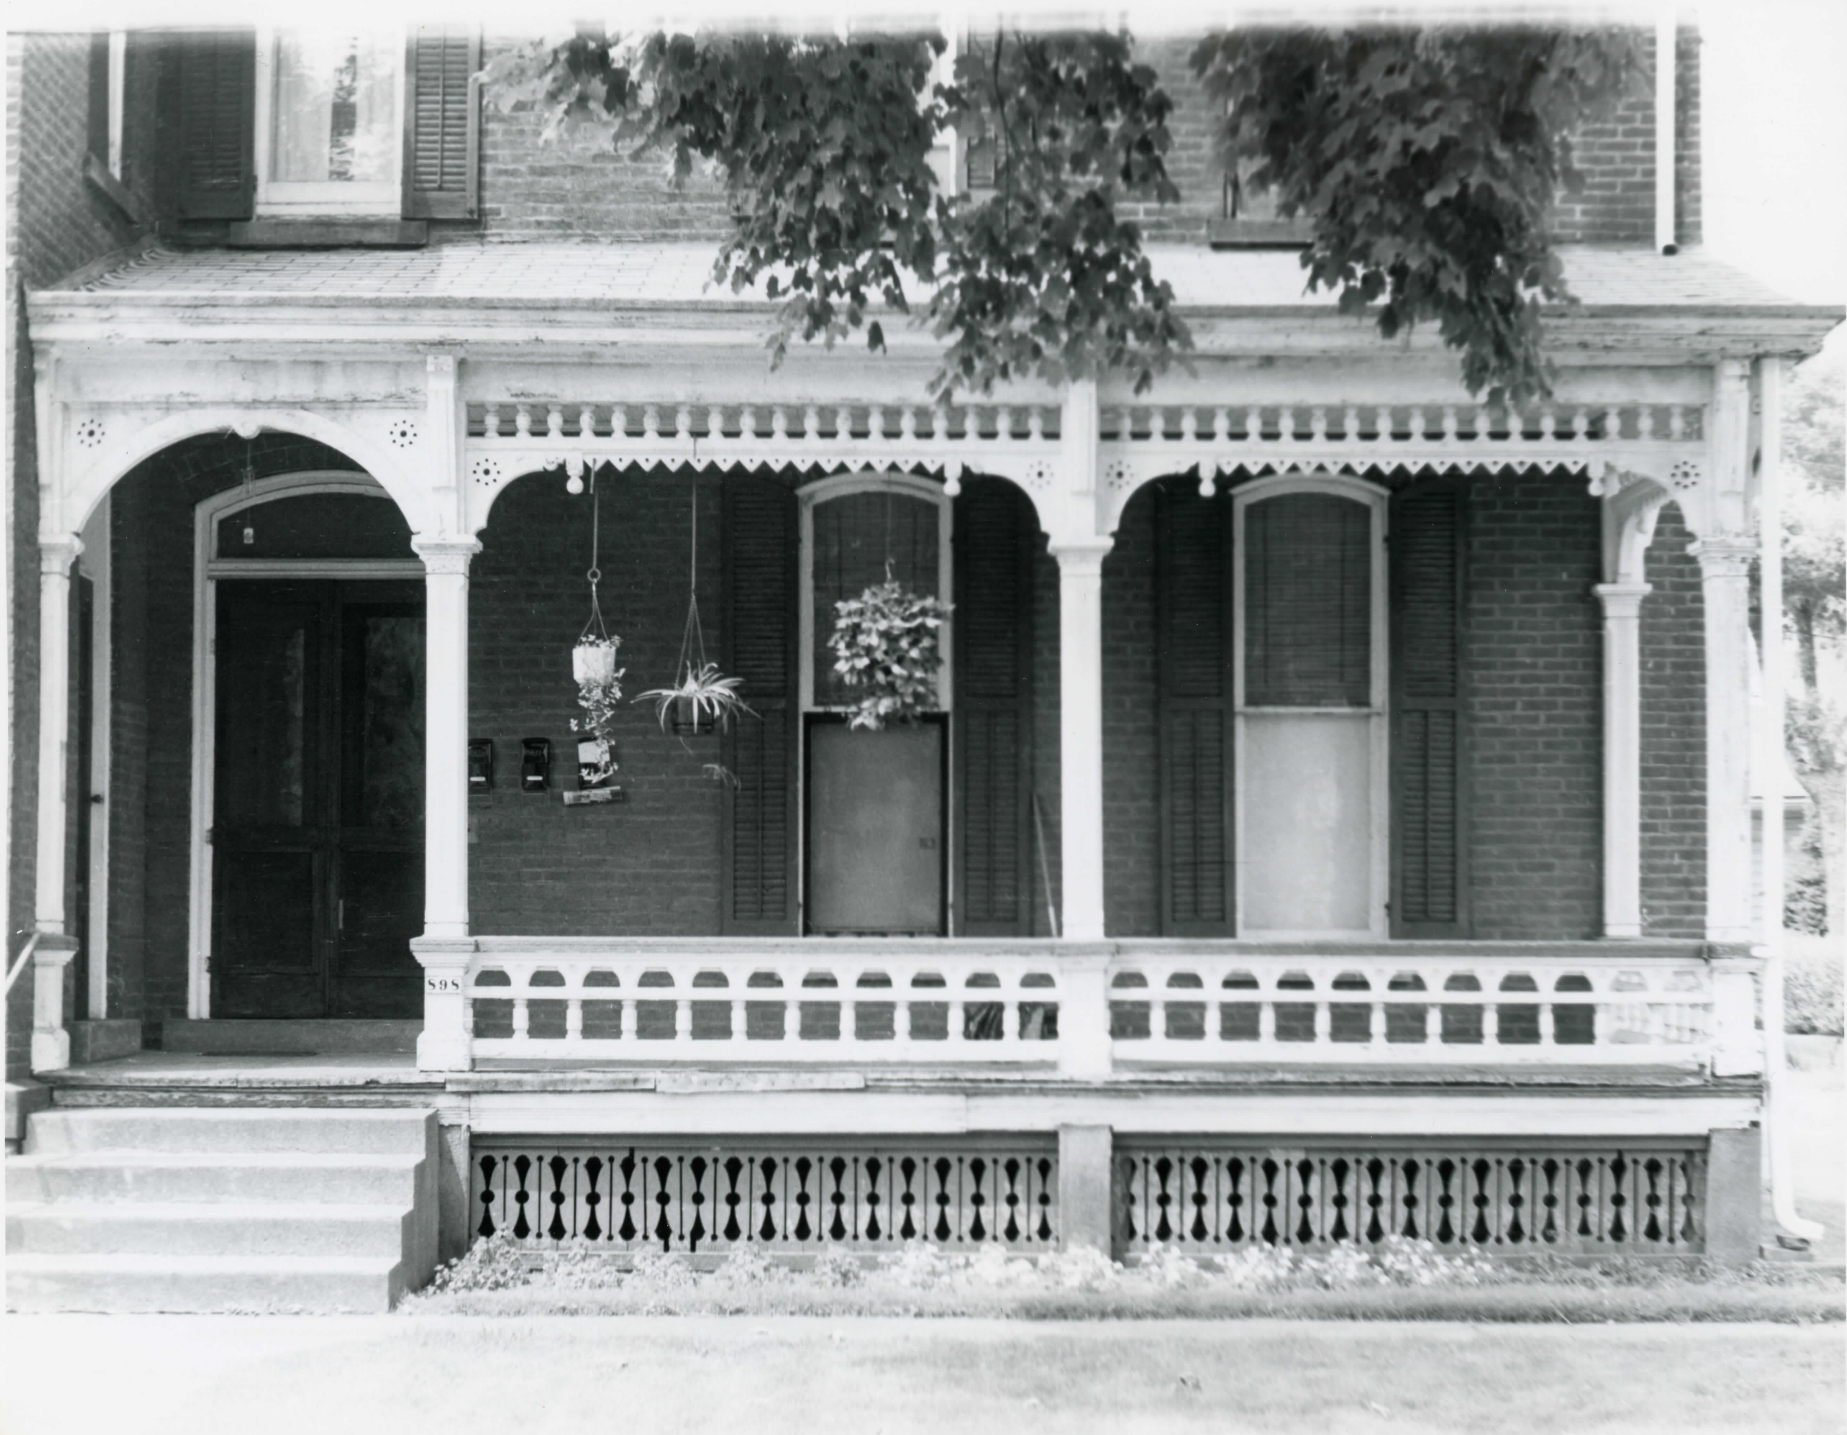
FRASIER, T.T., HOUSE  
Brookside, Belmont Co., Ohio  
Photo by David Taylor, 1981  
Neg. BEL-24-6-2, filed at Ohio  
University, Zanesville, Ohio  
View of porch on facade, unaltered  
from the original

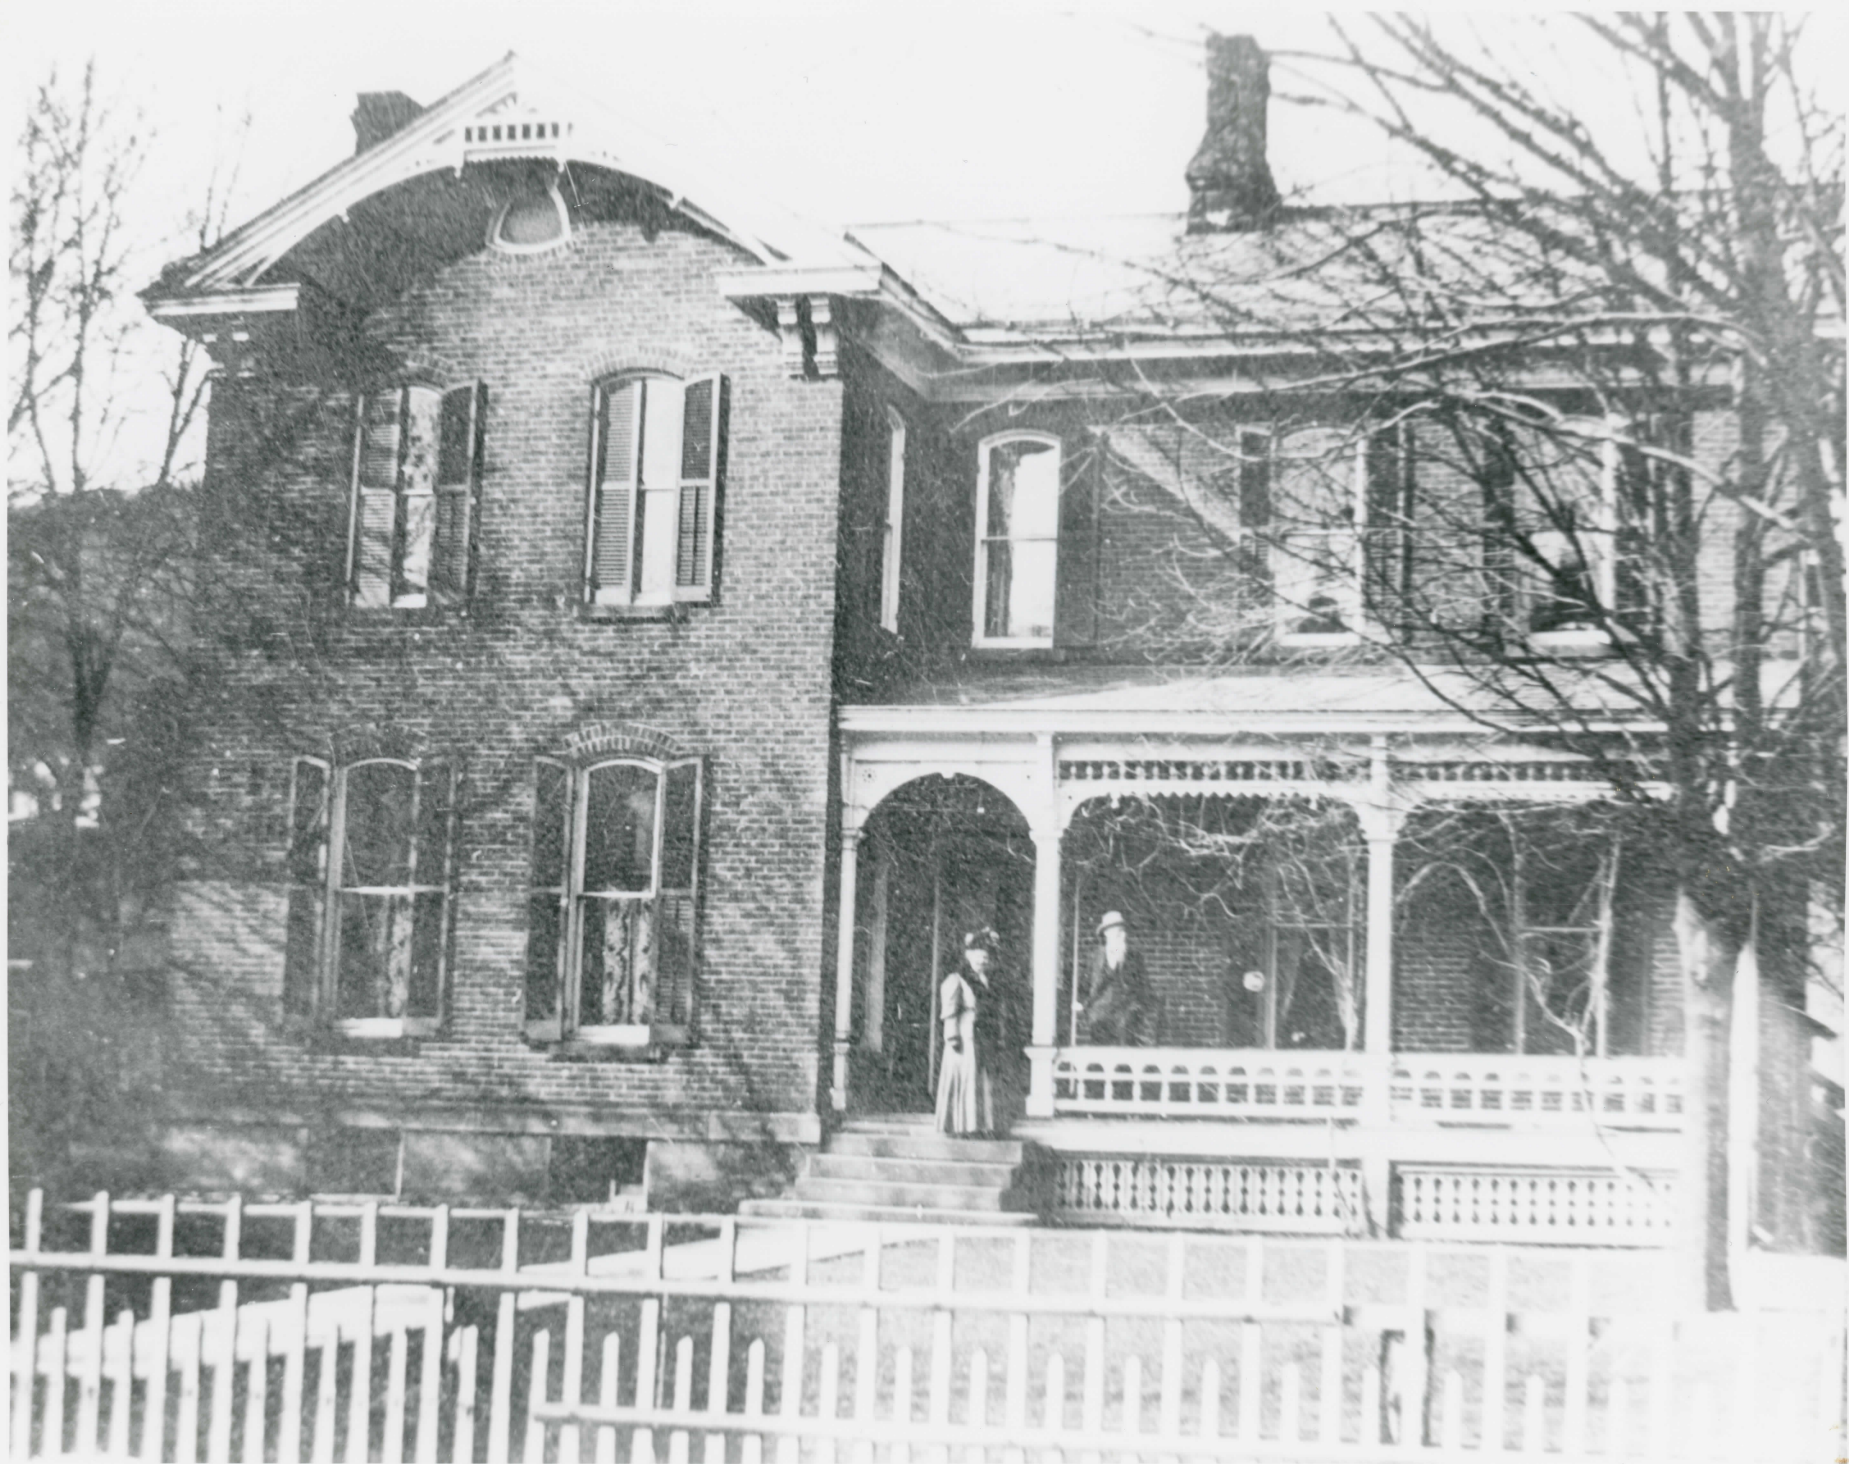
FRASIER, THOMAS TOWNSEND, HOUSE  
Brookside, Belmont County, Ohio  
Historic photo copied by David  
DL. Taylor, 1981

Negative BEL-24-7-1, filed at Ohio  
University, Zanesville, Ohio  
View of house, from National Road  
The property is unaltered from  
this photo, except for the re-  
moval of the fence

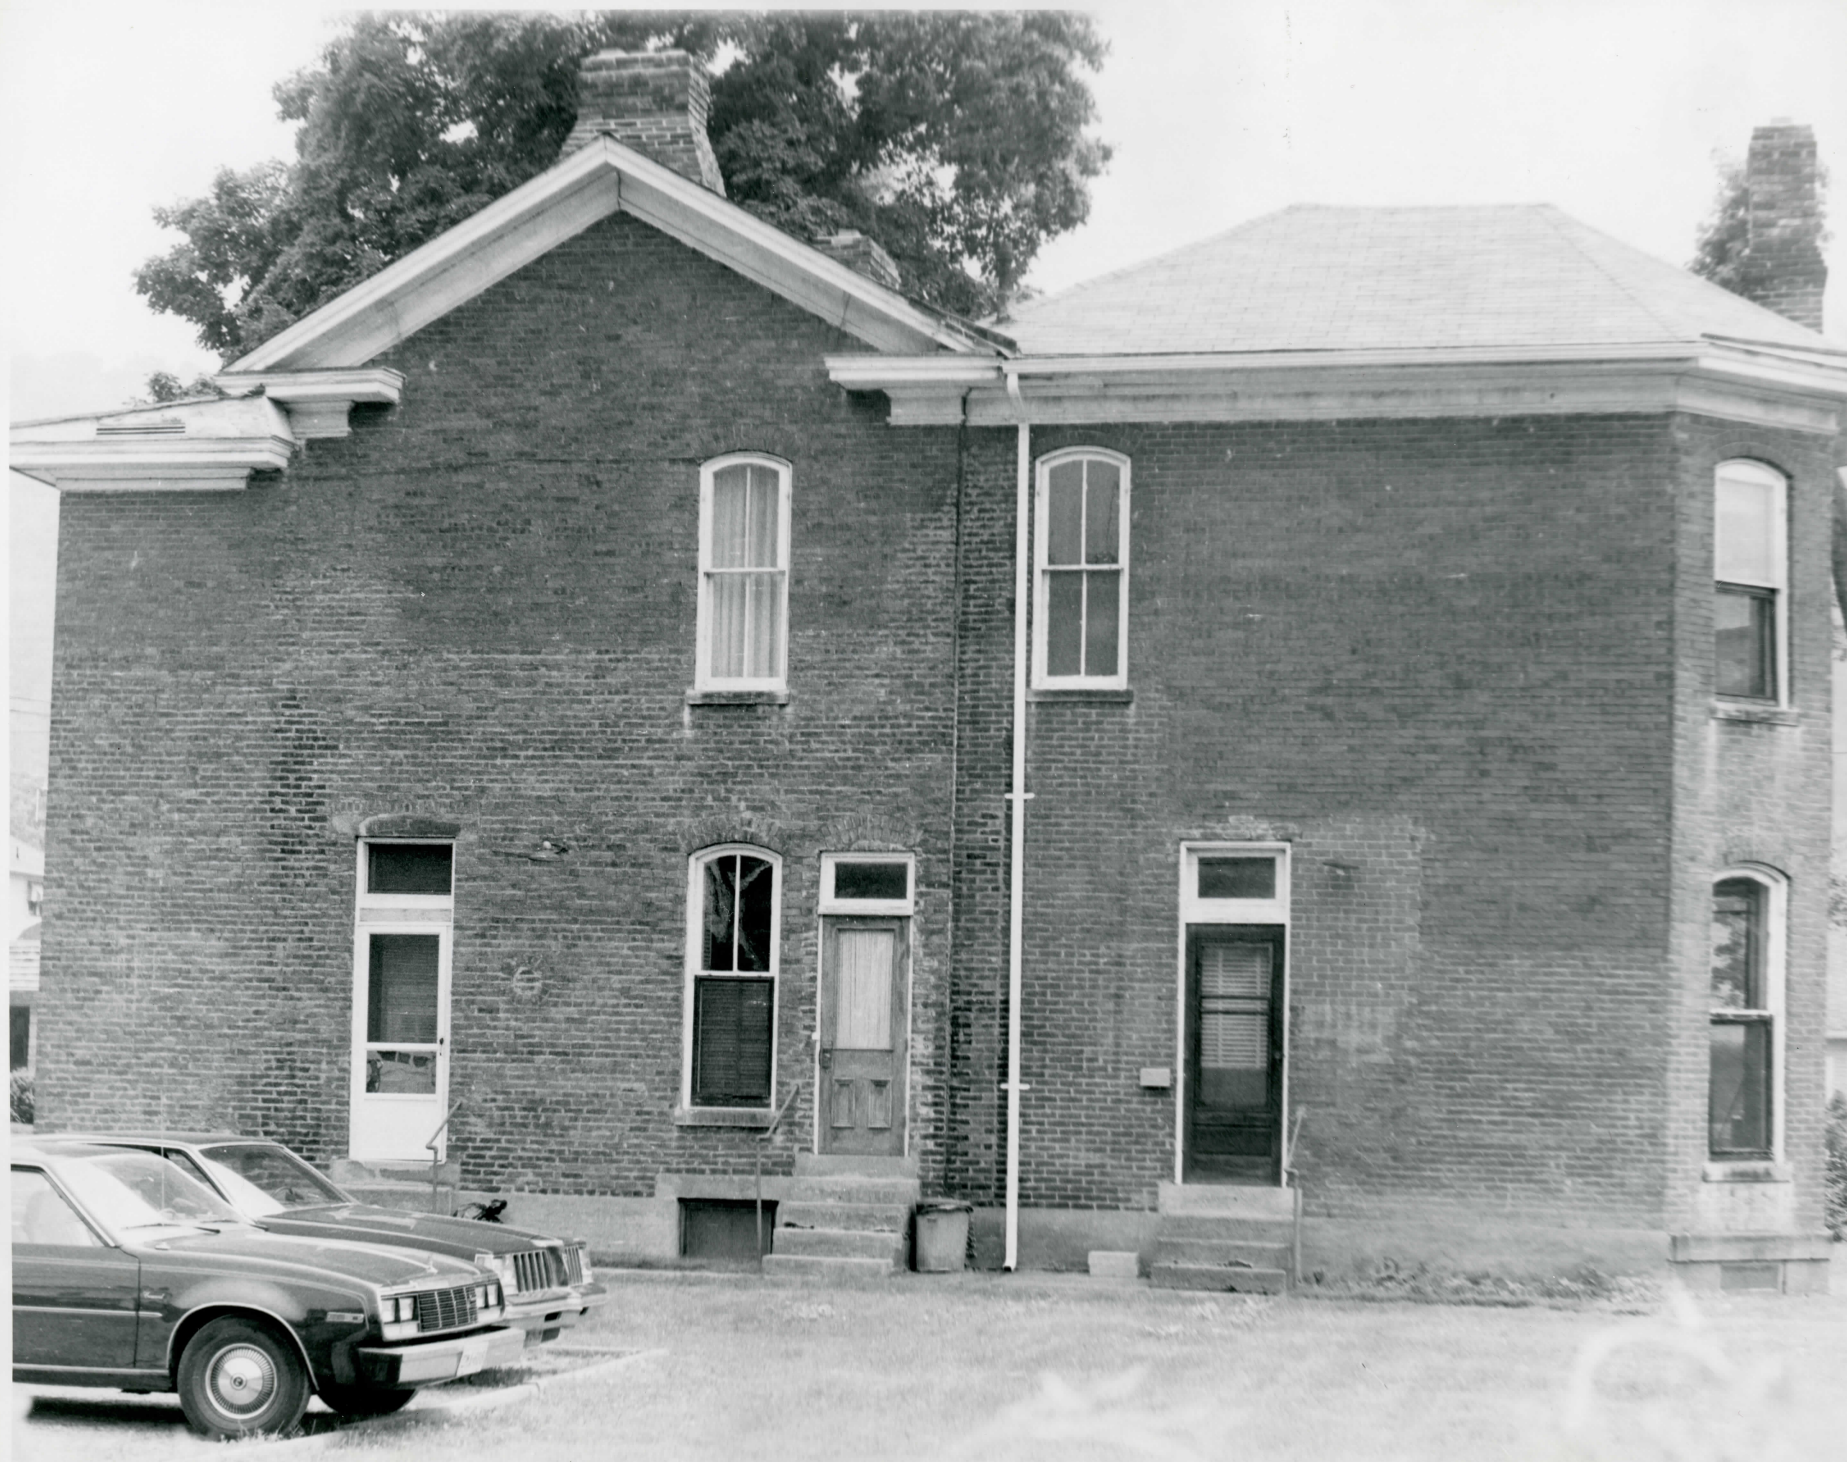
FRASIER, T.T., HOUSE  
Brookside, Belmont Co., Ohio  
Photo by David Taylor, 1981  
Neg. BEL-24-6-1, filed at Ohio  
University, Zanesville, Ohio  
Rear elevation (N) showing early addi-  
tion at right

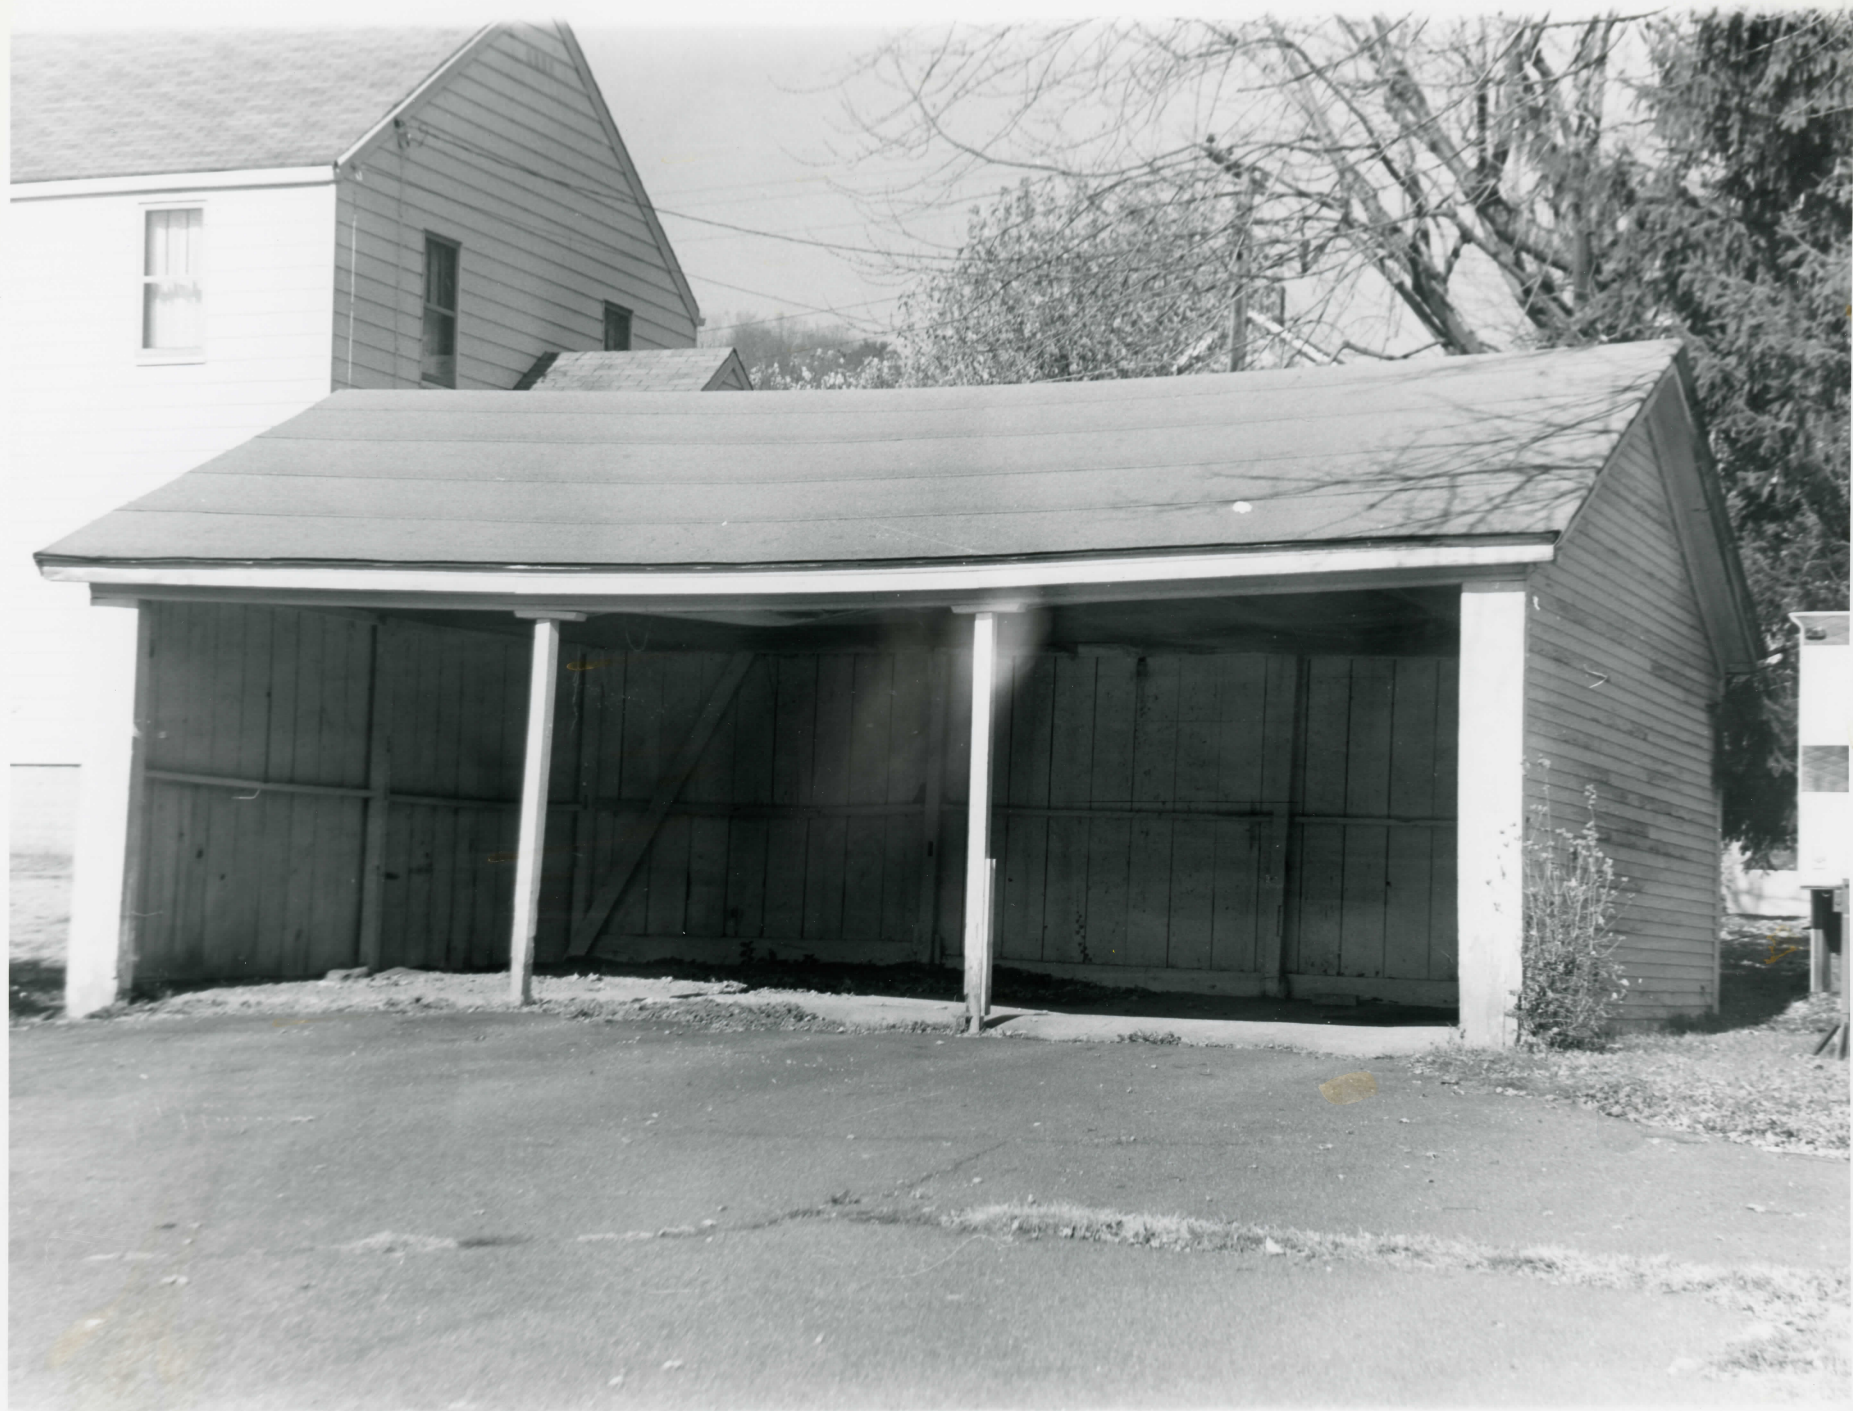
FRASIER, WESLEY B., HOUSE  
Brookside, Belmont County, Ohio  
Photo by David Taylor, 1981  
Garage, located NW of residence.

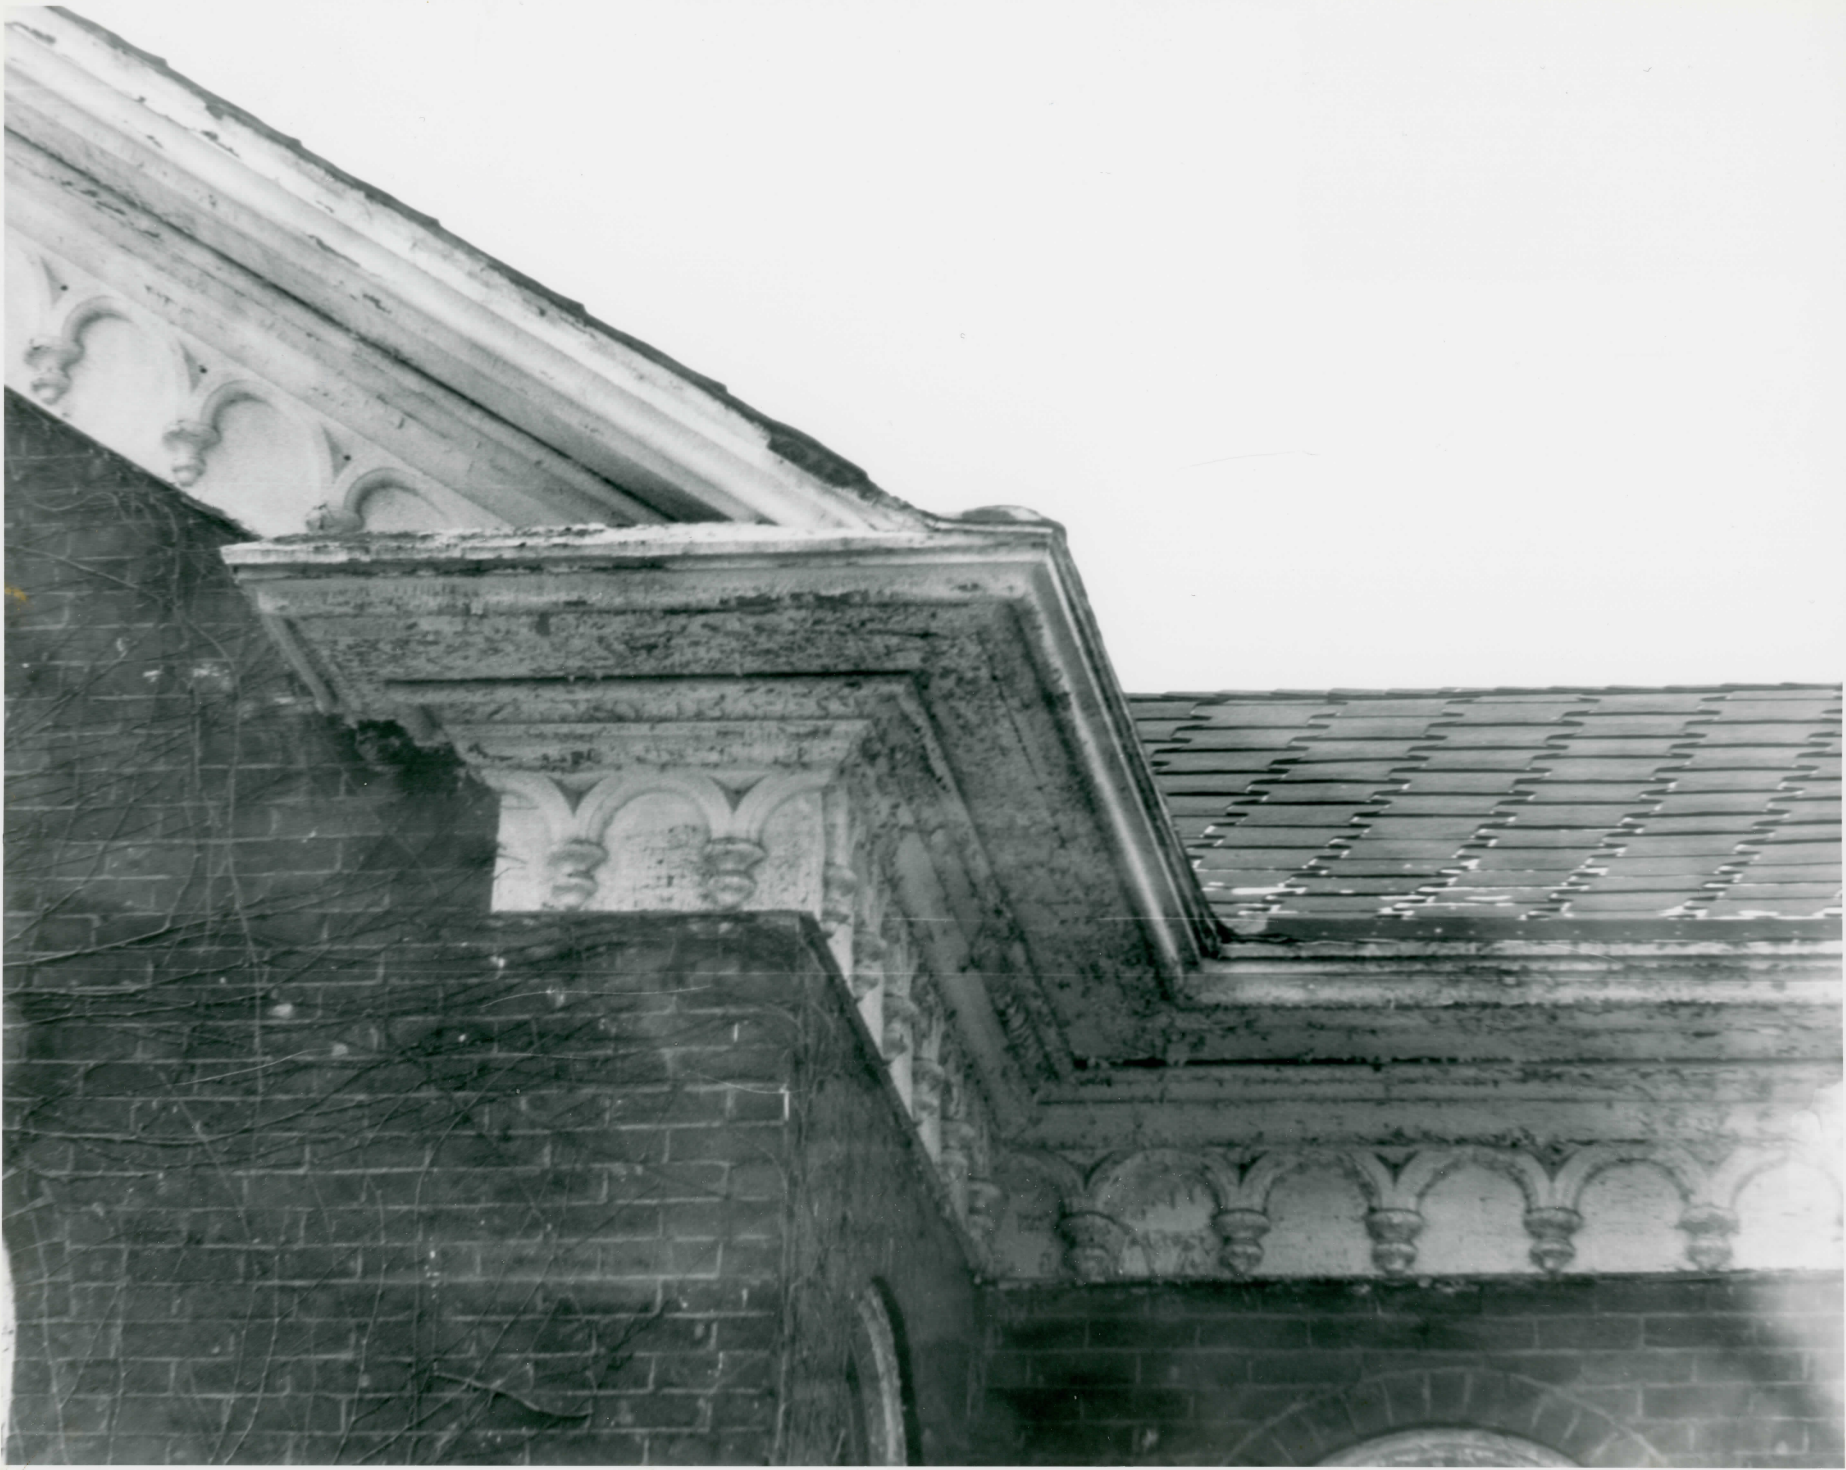
FRASIER, WESLEY B., HOUSE  
Brookside, Belmont County, Ohio  
Photo by David L. Taylor, 1981  
Detail of cornice on facade.

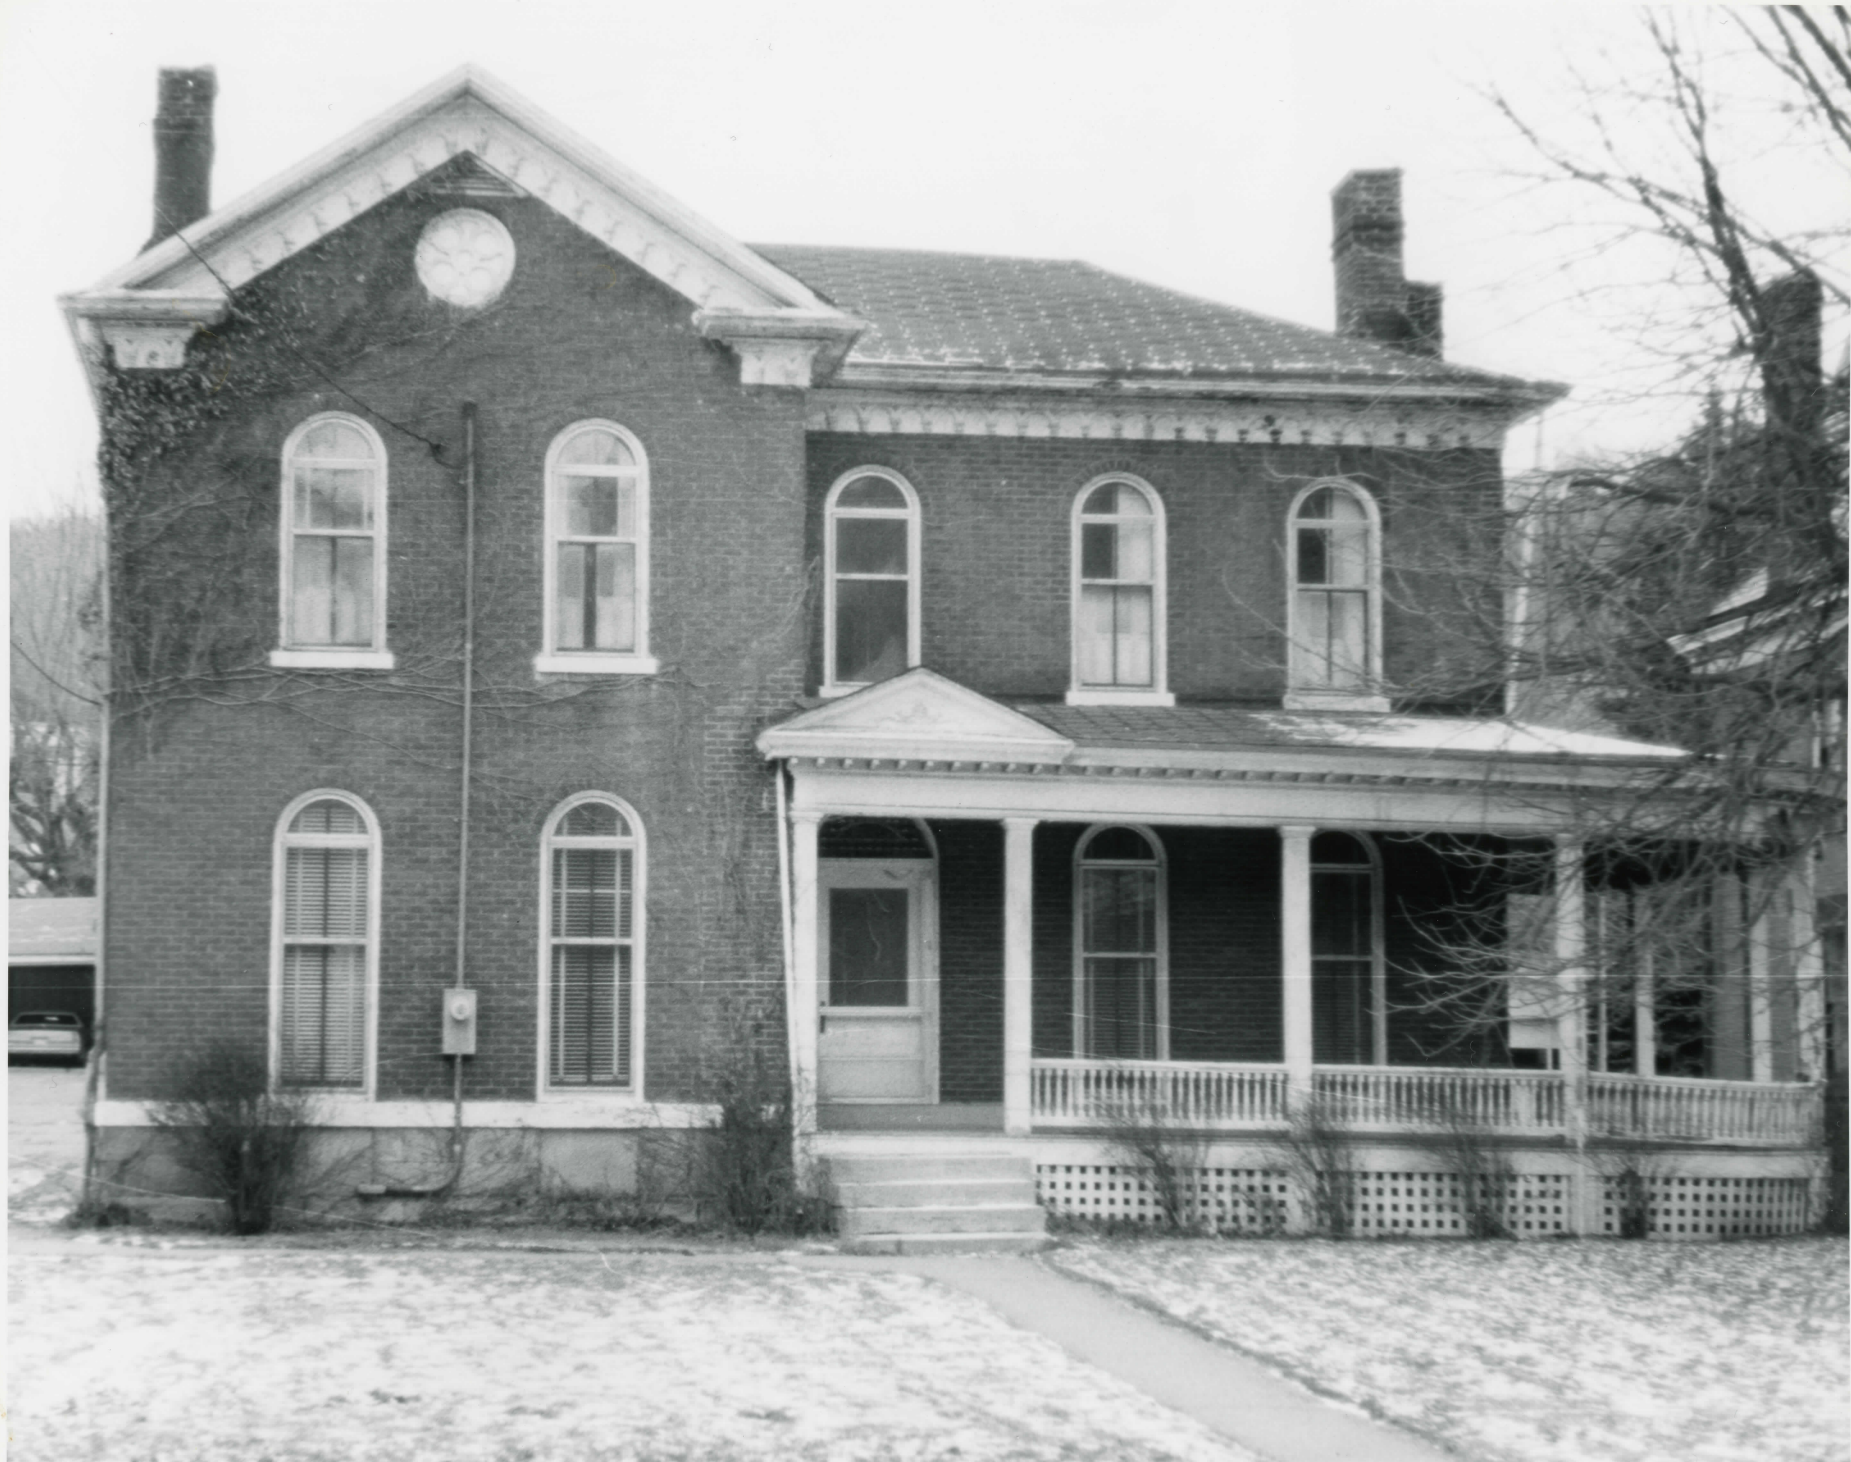
FRASIER, WESLEY B., HOUSE  
Brookside, Belmont Co., OH  
Photo by David Taylor, 1981  
View of facade (S elevation),  
from National Road
