National Register of Historic Places  
Inventory—Nomination Form

historic Alexander, Dr. William S., House

Alexander, Dr. William S., House, Oxford, Butler County, Ohio

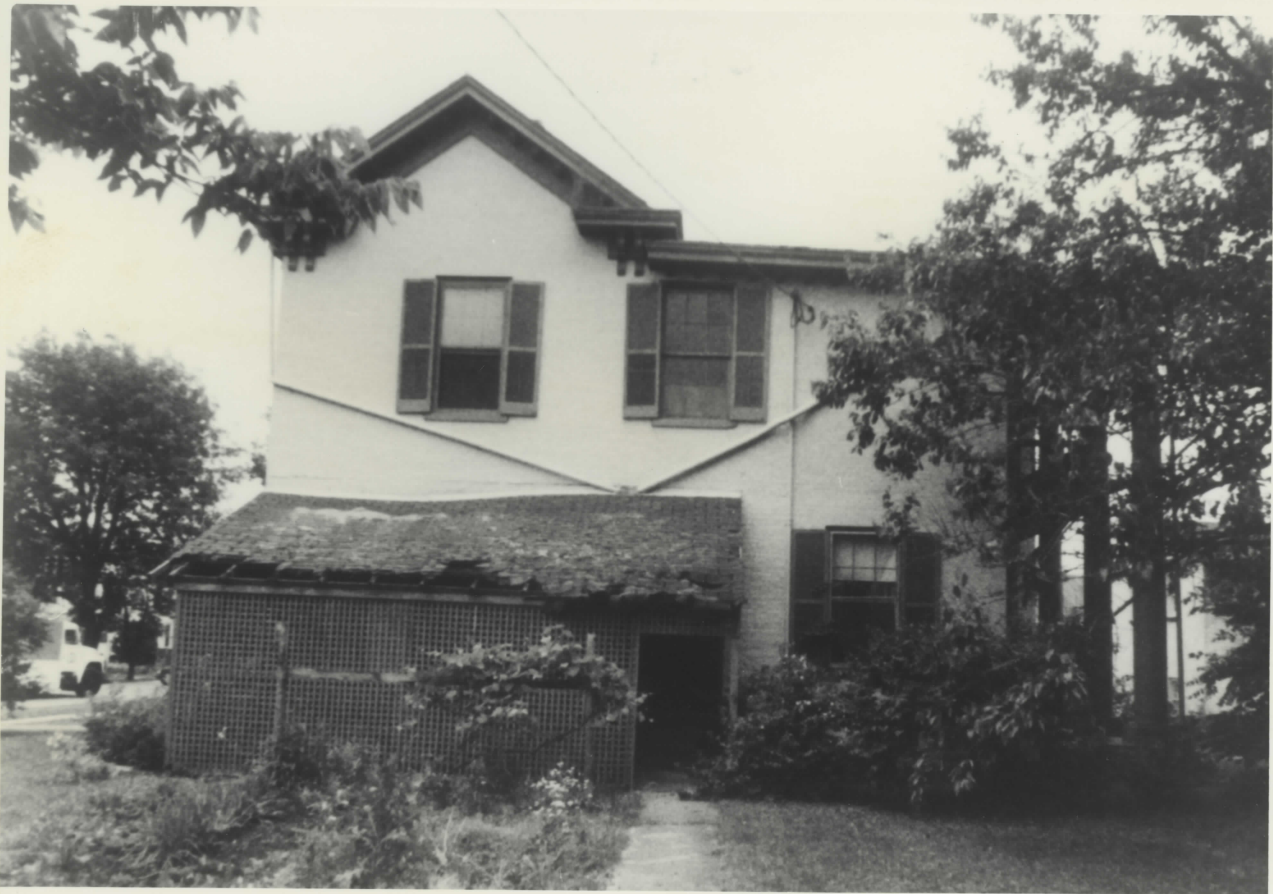
The Alexander House  
22 N. College Avenue, Oxford  
Butler County, Ohio  
Photographer: Stuart Meck  
April 1985  
Negative with City Planning Dept.,  
City Hall, Oxford  
Front (east) and north elevations  
looking southwest. Note carriage house  
visible,

This stately old house and accompanying carriage house are situated on a rectangular-shaped lot facing east, along a major artery of access to the City of Oxford and located within the "Mile Square" district of the city. These two buildings were erected on that site 117 years ago in 1869 by John M. Shera, local resident. The house extends two stories with stone foundations, including a basement, and solid brick exterior walls and interior bearing walls. The style was essentially a traditional Greek Revival/Italianate and ell-shaped. In approximately 1880 an addition was made to the south elevation filling in the ell and adding a two story porch with classical columns and a second floor balcony, thus giving the house its present rectangular shape. About 1900 the front and side porches were added in the Classical Revival style. The carriage house to the rear of the property remained unaltered. In 1954 a second alteration occurred when the owners converted this 12 room single family dwelling into 4 three-room apartments. The only changes to the exterior that occurred were the removal of a small second floor balcony centered over the front porch and the addition of a small, open lattice-work shed at the rear. The interior features remained essentially unchanged; primarily the room functions changed with the addition of kitchens, baths and partition walls. The condition of the house is good and it appears very much as it has for more than 100 years. The carriage house, however, is in poor condition due to neglect and the ravages of time.

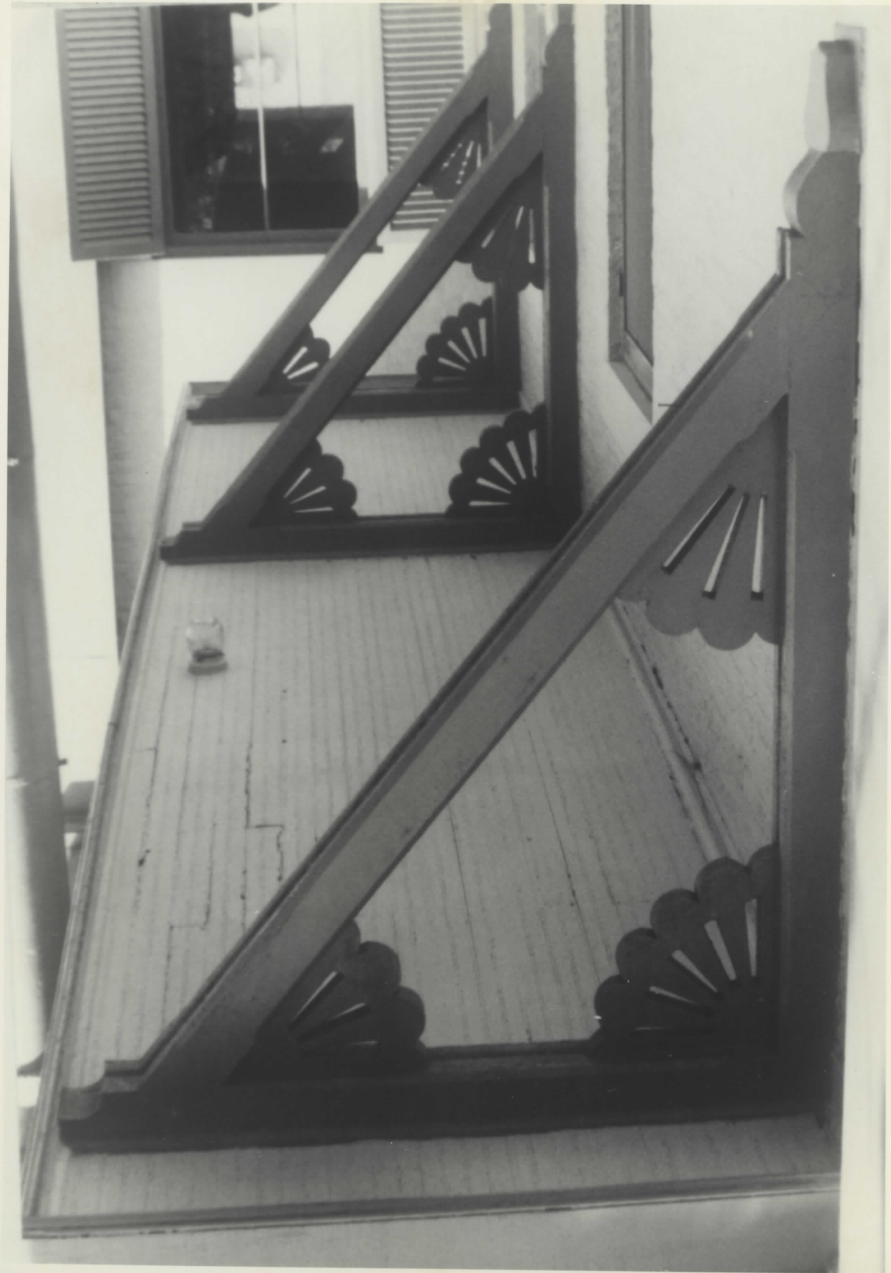
The Alexander House  
22 N. College Avenue, Oxford  
Butler County, Ohio  
Photographer: Alan Chapman  
July 1985

Negative with Barcus & Swift, Oxford  
Detail of south elevation showing  
columns, shuttered window and par-  
tial view of balcony supports.  
View faces east.

As stated earlier, the original house was traditional Greek Revival/Italianate in style. An 1880s addition, which was the in-fill of the ell and on the south elevation of the house away from the street, has 3 impressive Doric Columns dominating a two-story porch with a second floor balcony that repeats the motif found at the front of the house. It has a balustrade with handsome corner posts with finials like the front balcony that was removed in 1954. There is a continuity of decoration and motifs despite the two different styles. This side porch has an entry situated between the second and third columns.

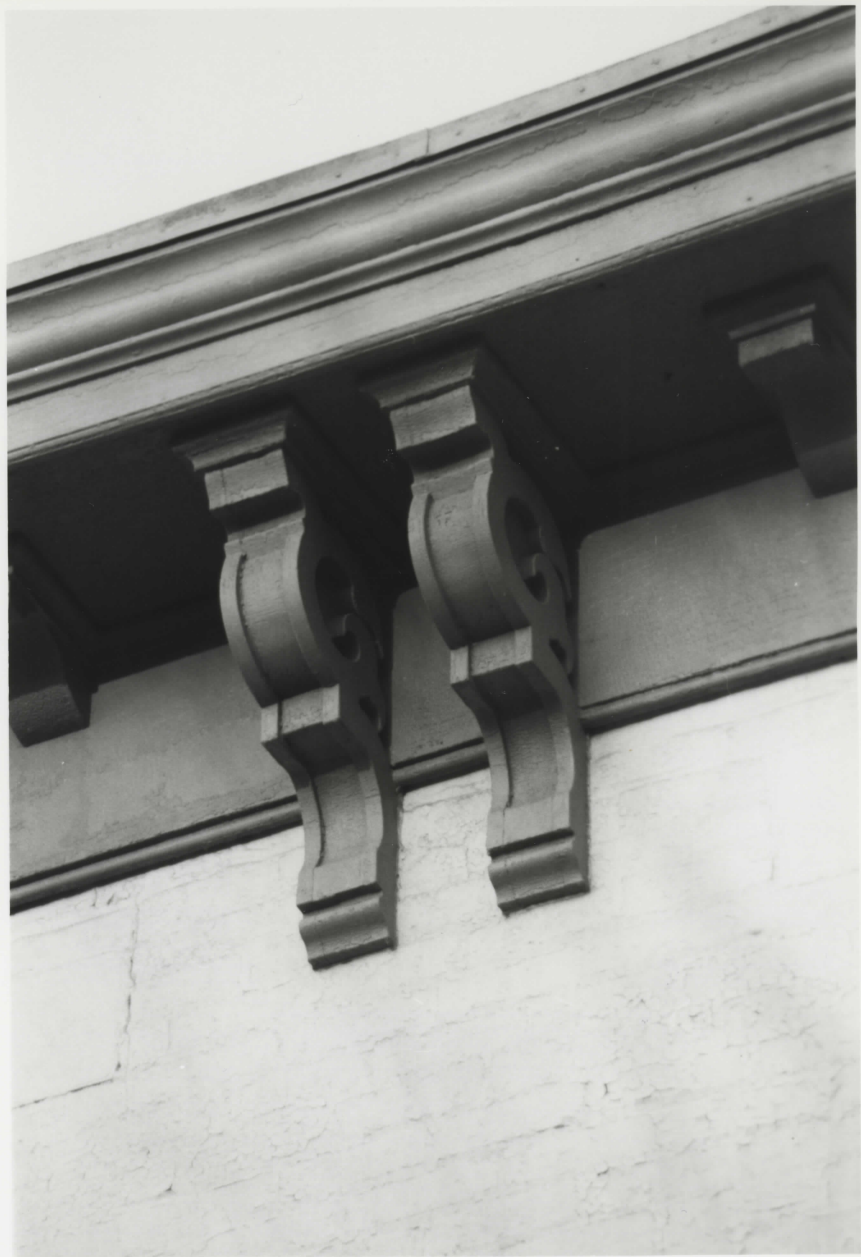
The Alexander House  
22 N. College Avenue, Oxford  
Butler County, Ohio

Negative with owner, G. del Greco  
Detail of upper roof line decoration  
with cornices and brackets.  
South elevation

The lumber and bricks used in the construction of the house came from the farm of the builder, John M. Shera. Well preserved wooden cornices and brackets adorn the house below the roof line. A wooden frieze with a different motif continues below the roof line of the front porch. Louvered wooden shutters graced each side of the double-hung 2/2 sash windows on the exterior throughout. Two remain in a permanently closed position on the first and second floor interior rooms on the north side of the house, since the windows behind them were removed and the spaces bricked in at some previously unknown date.

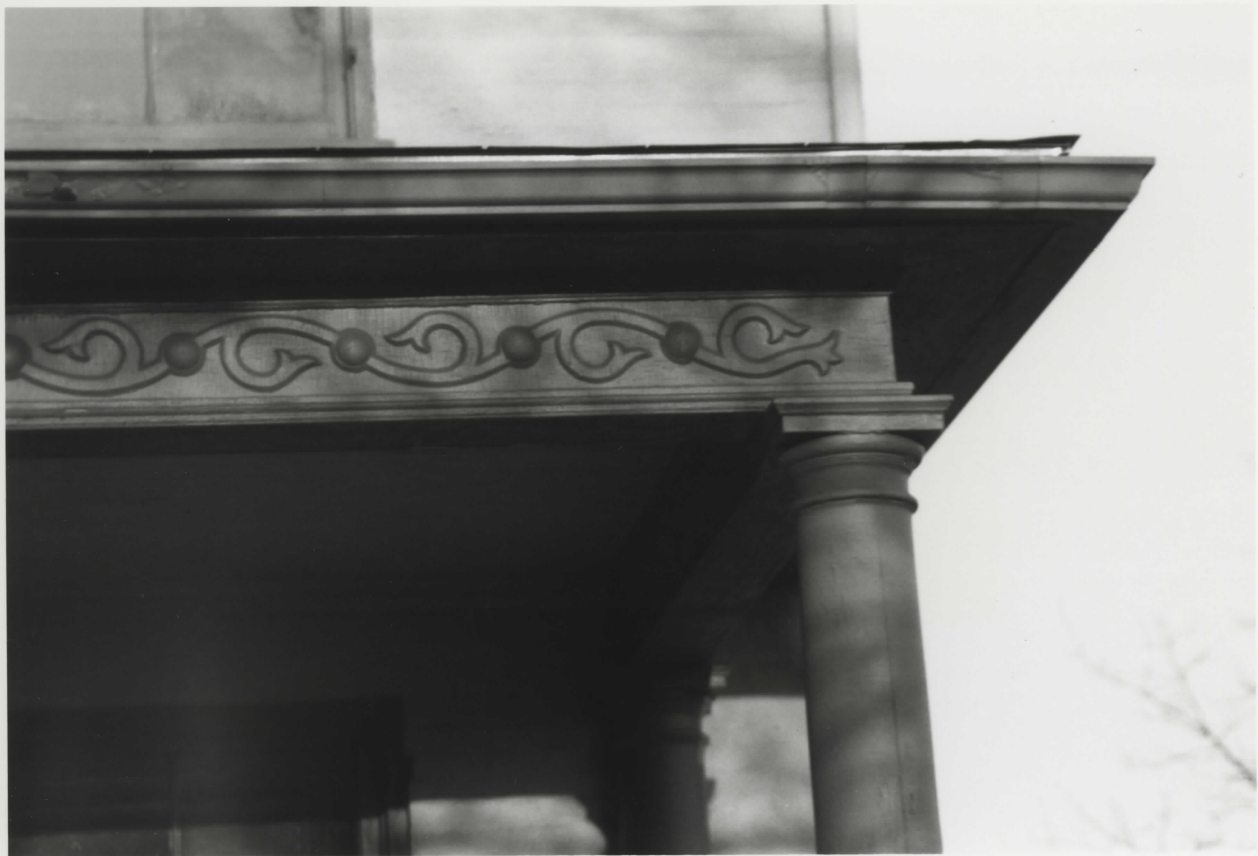
The Alexander House  
22 N. College Avenue. Oxford  
Butler County, Ohio  
Photographer: J. Newman  
Negative with owner, G.del Greco  
Detail of upper roof brackets.

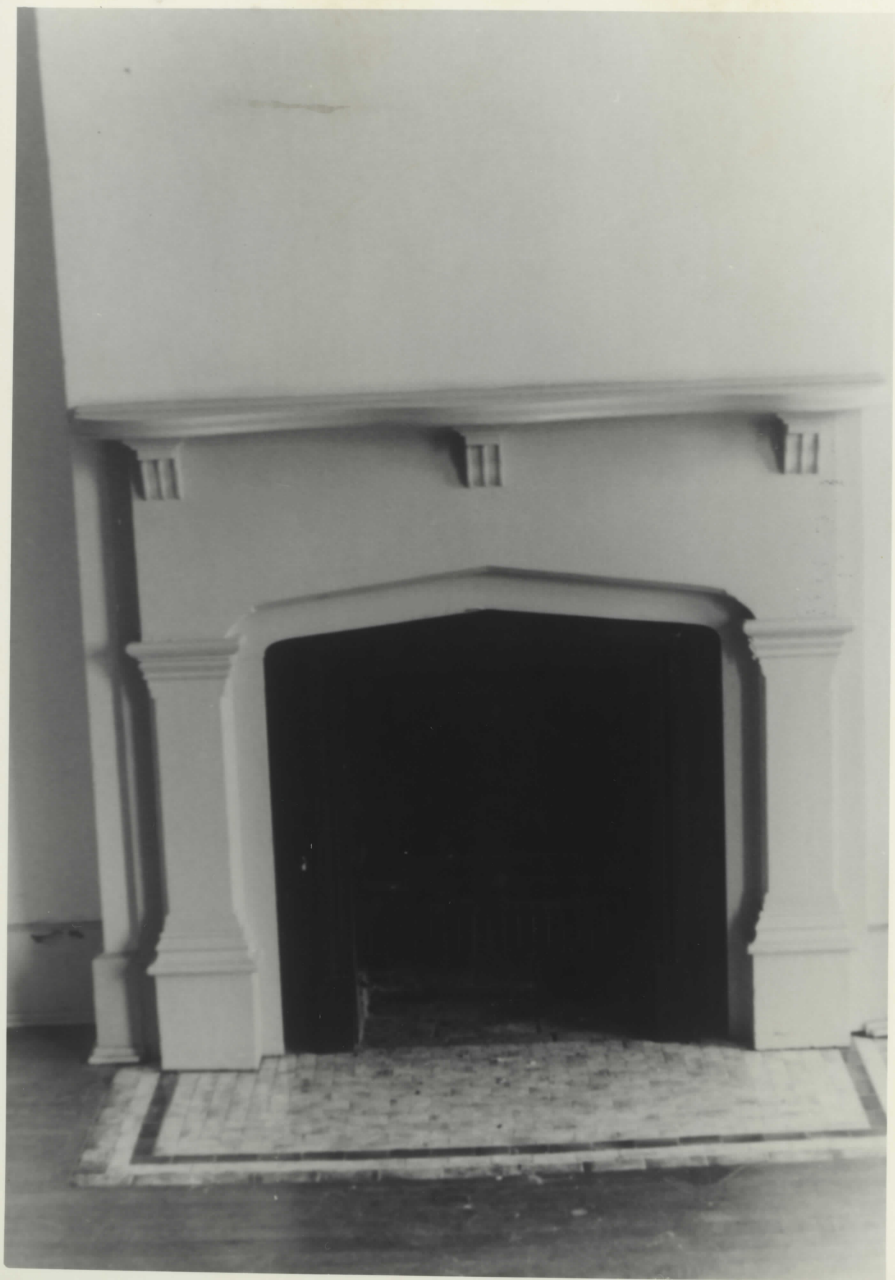
The Alexander House  
22 N. College Avenue, Oxford  
Butler County, Ohio

Negative with Barcus & Swift, Oxford  
Detail of 2nd floor anterior room  
(N.E.) w/fireplace, door treatment,  
view of adjoining rooms.  
Facing northwest.

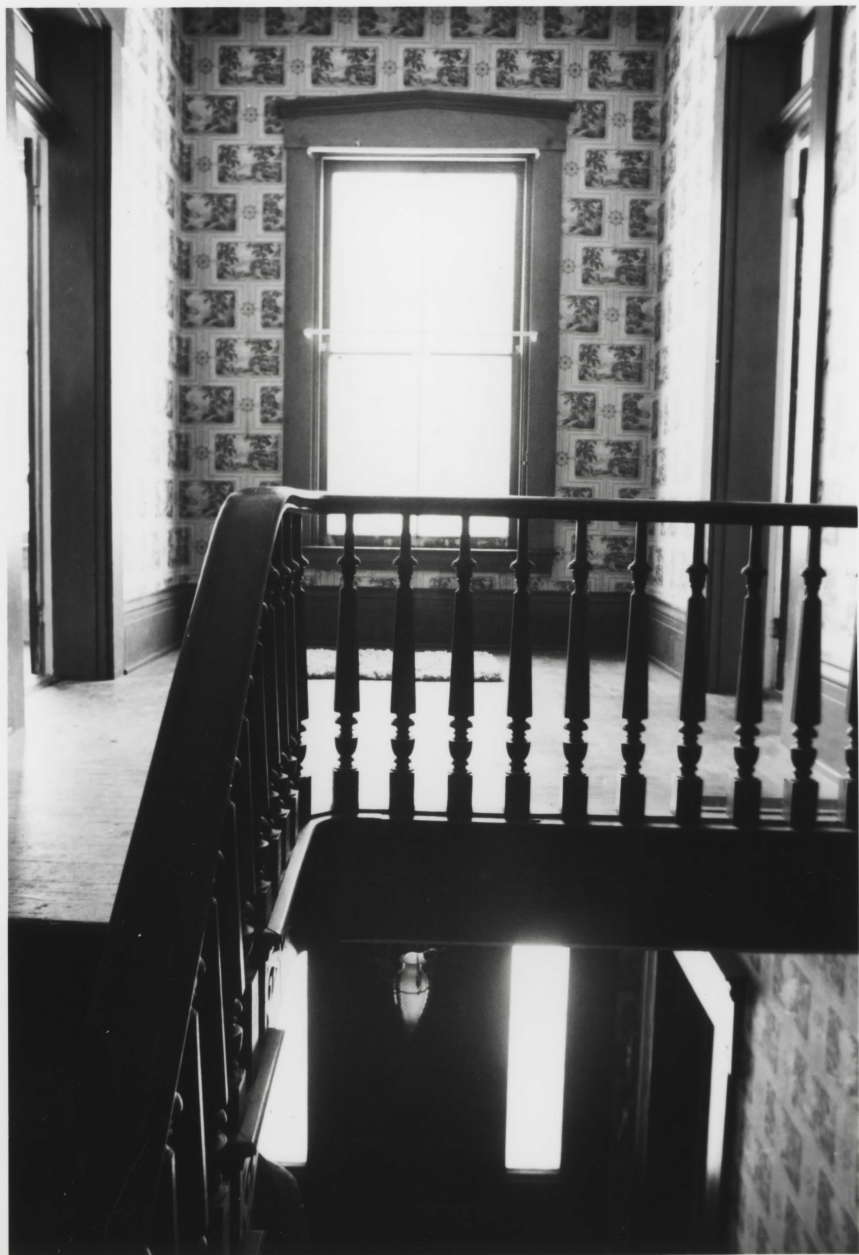
The Alexander House  
22 N. College Avenue, Oxford  
Butler County, Ohio  
Photographer: Alan Chapman  
July 1985  
Negative with Barcus & Swift, Oxford  
Detail of Stairway w/ fluted newel  
post and decorative detail.

Upon entering the front door, one is immediately confronted with a dominant open stairway of wood with an imposing fluted newel post. About two-thirds of the way up, there is a landing where the stairway sweeps broadly and continues in the opposite direction where it terminates in a large upper hallway. A feeling of expansiveness prevails with eleven foot ceilings. Each of the four front rooms, both up and down, have fireplaces with painted wooden decorative mantels. Other wood trim includes casings, headers, baseboards and some interior partial window shutters, all of simple design and painted. There are numerous paneled wooden doors, some with transoms. Some are painted, others are stained. On the first floor there is one set of pocket doors. The floors are of wood of various quality, type and condition. Some can be restored to their original beauty.

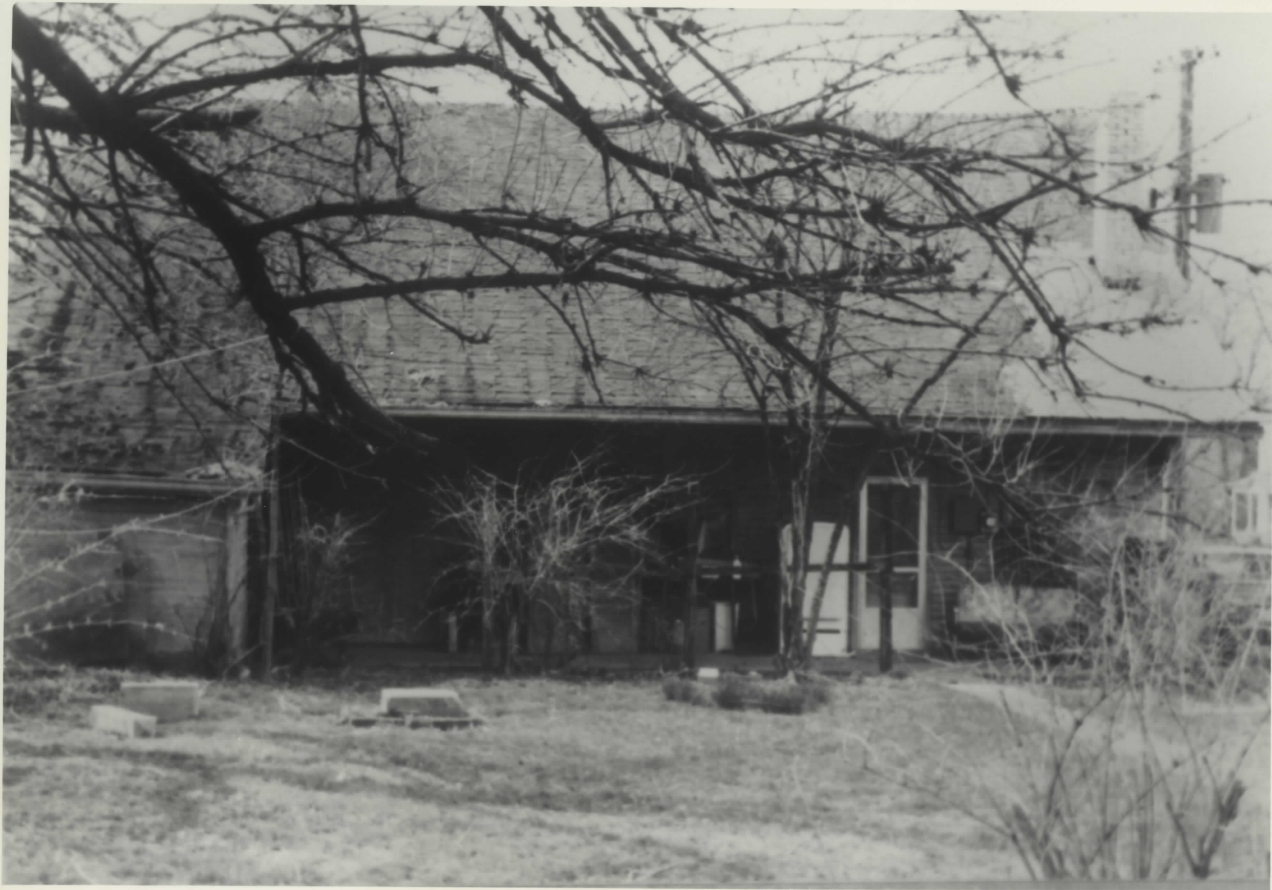
The Alexander House  
22 N. College Avenue, Oxford  
Butler County, Ohio  
Photographer: Alan Chapman  
July 1985

Negative with Barcus & Swift, Oxford  
Carriage house, rear and side view.  
Facing north east.

Street exposure of the house are north and east. Behind the house and to the rear of the property stands the carriage house. Once used to stable horses and at least one carriage, it is only used for storage at present. It is of frame construction with stone foundation (no basement) a side-gabled salt-box roof of shingles. The condition is very poor.

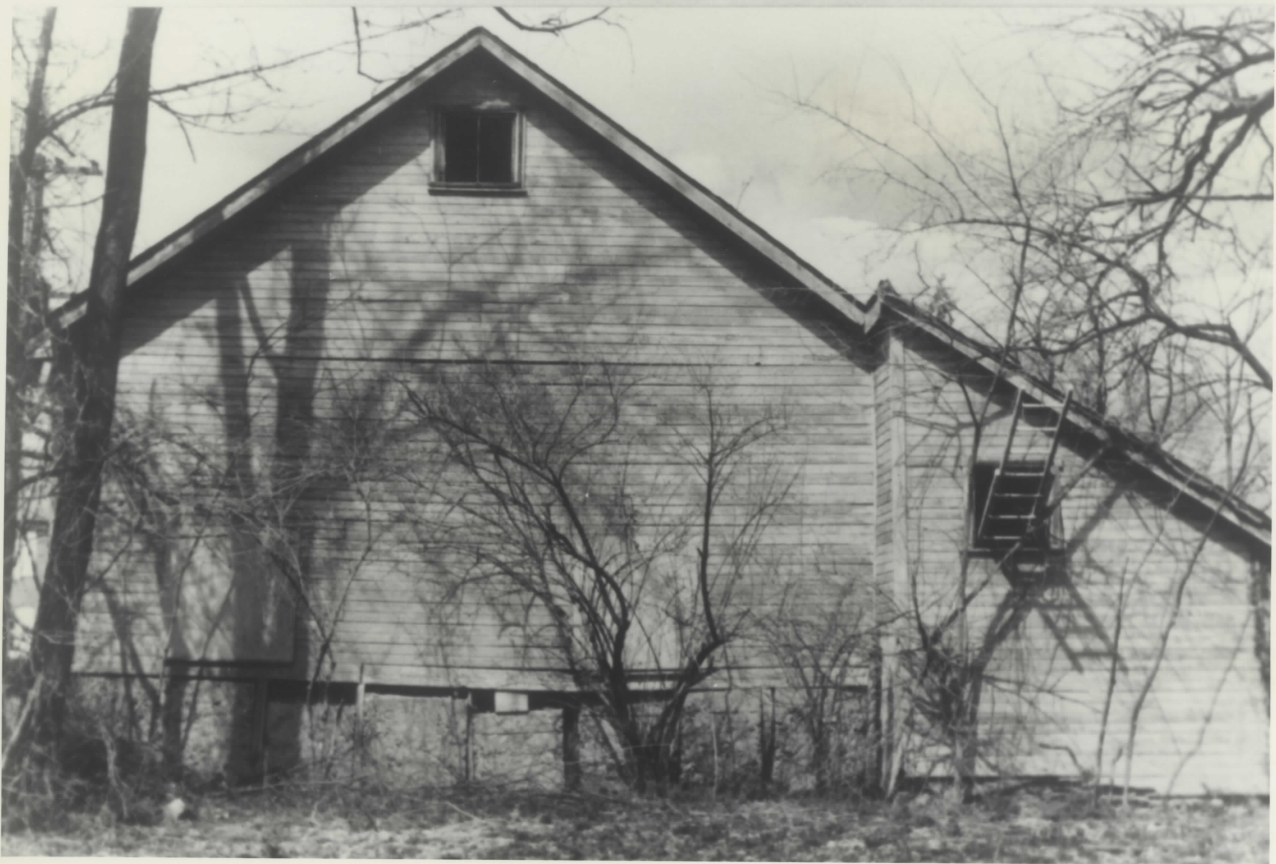
The Alexander House  
22 N. College Avenue, Oxford  
Butler County, Ohio  
Photographer: Alan Chapman  
July 1985  
Negative with Barcus & Swift, Oxford  
Carriage house, front view.  
Facing west.
