National Register of Historic Places
Registration Form

historic name 123-137 East Fourth Street Historic District
other names/site number N/A

123-137 East Fourth Street Historic District, Hamilton County, Cincinnati, Ohio
Section number 7 Page 2

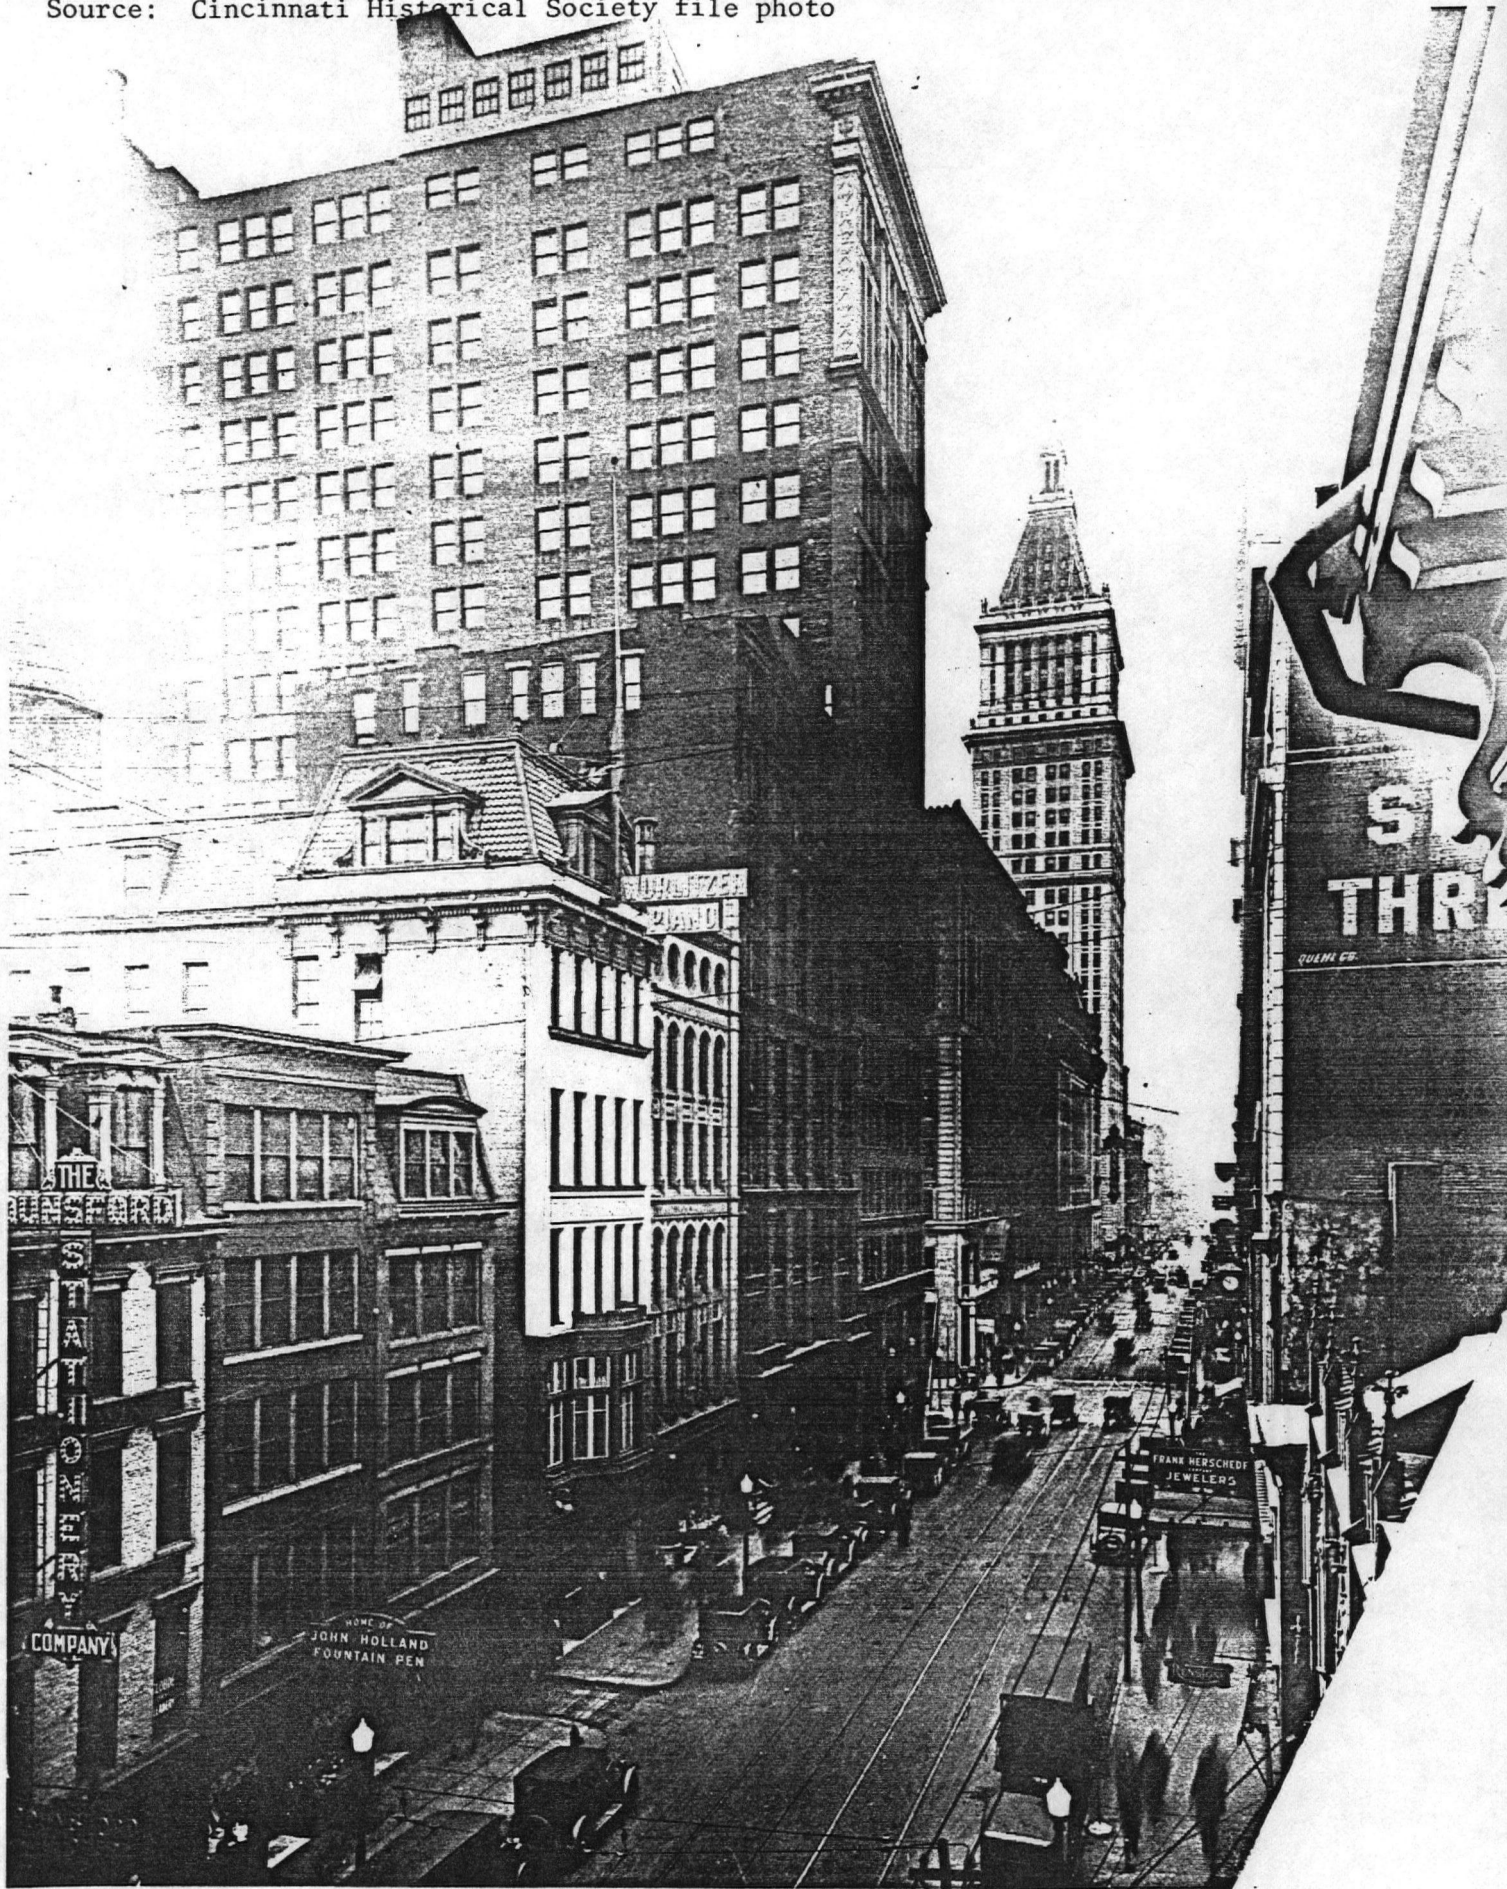
123 - 137 East Fourth St. Historic District, Cincinnati, Hamilton Co., OH
Source: Cincinnati Historical Society file photo

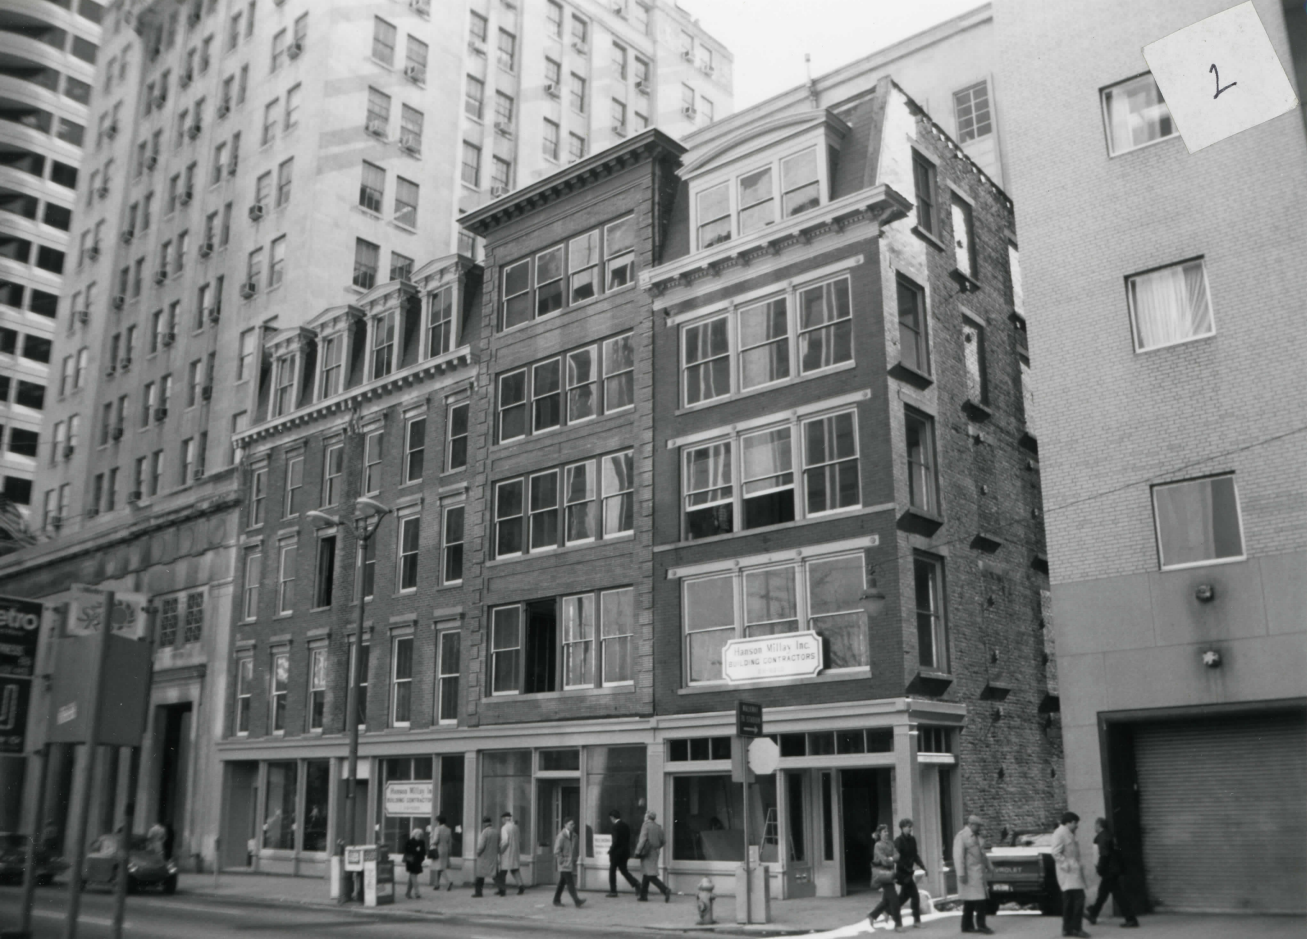
Photographer: Juanita Stork
Direction: Facing south west
Date of photo: 11/10/86
Photo # 1

Photo shows: 4th St. elevation in
relation to adjacent buildings

The 123-137 East Fourth Street historic district is comprised of three continuous five story commercial buildings, located on the south side of East Fourth Street in the midst of downtown Cincinnati's business/financial/retail district. The three building historic district extends east from Berning Place, a mid-block alley between Walnut and Main Streets, and is bounded on the east and south by the Cincinnati Gas and Electric Company Building and its annex. The First National Bank Clipay Building annex is located across Berning Place, while the Formica Building and the Federal Reserve Bank Building are directly across Fourth Street.

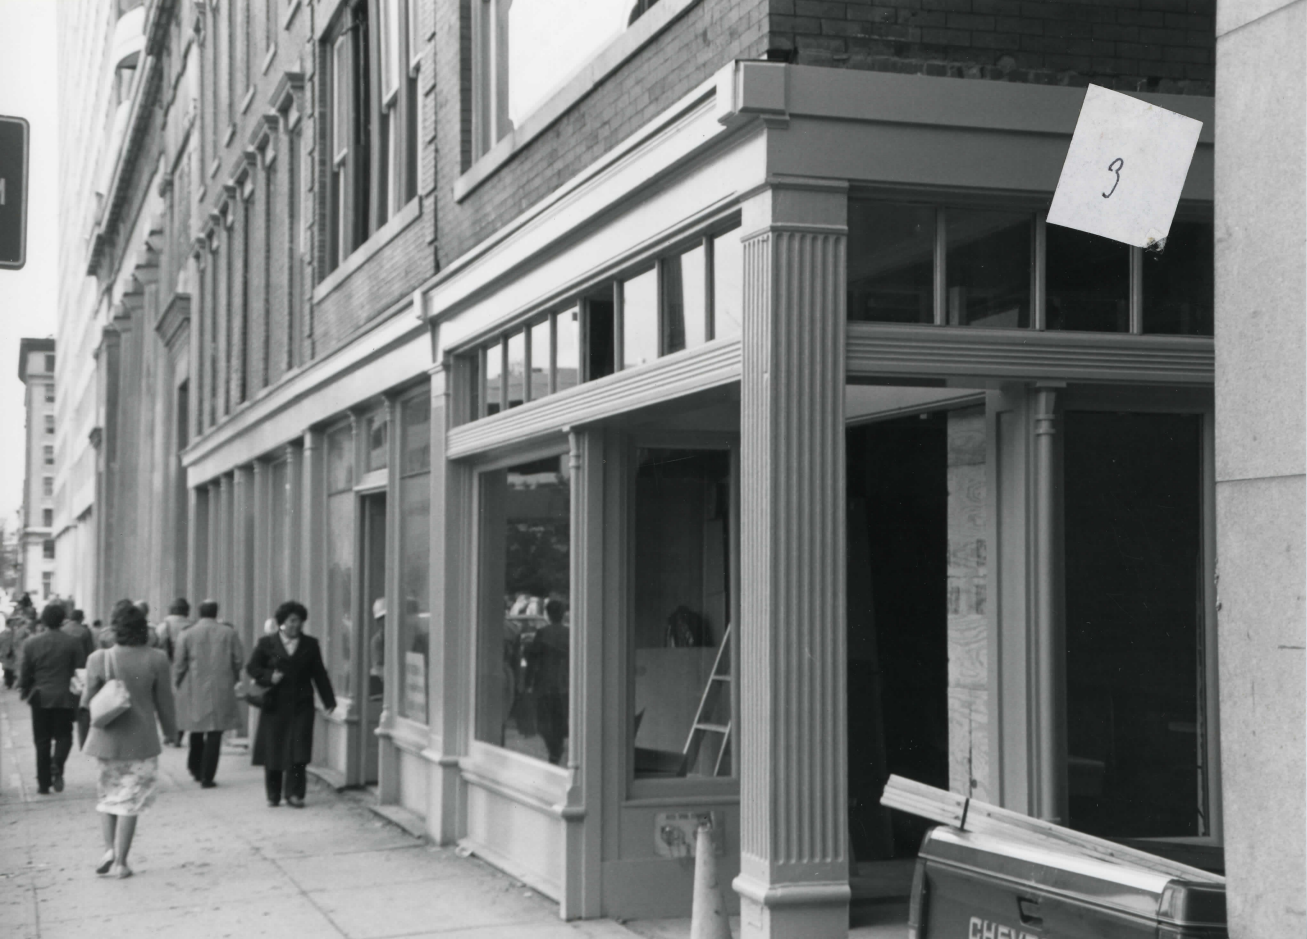
Photographer: Juanita Stork
Direction: Facing south east
Photo # 2 Date of photo: 11/10/86

Photo shows: 4th St. elevation &
partial Berning Place elevation

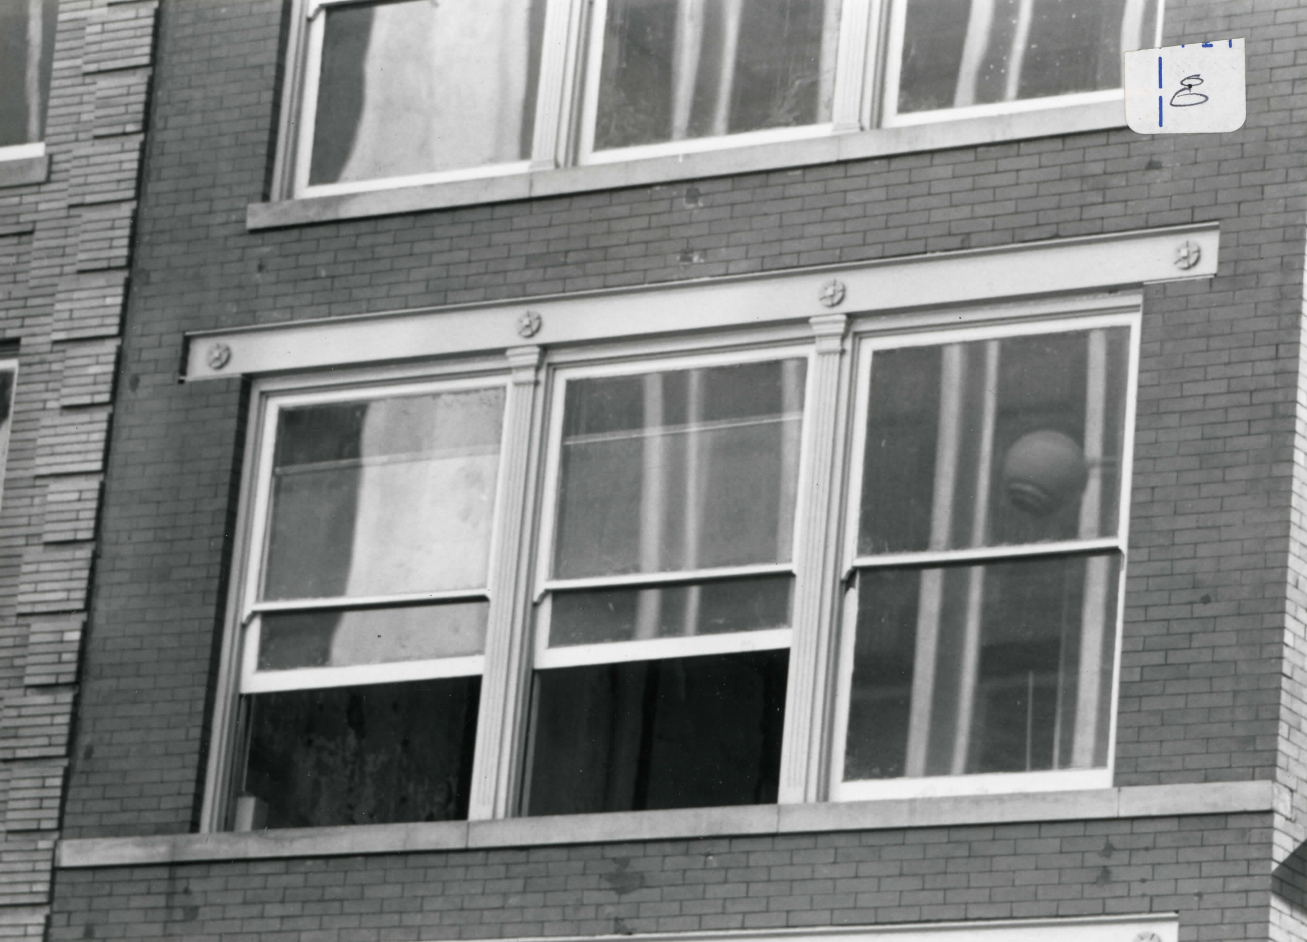
Photographer: Juanita Stork
Direction: Facing south east
Date of photo: 11/10/86
Photo # 7

Photo shows: Restored metal cornice,
Mansard roof and dormer of 123 E. 4th
Street

Added when the building was updated about the turn of the century, the facade features a straight sided Mansard roofed fifth story. The roof is surfaced with Supra Slate to replace the deteriorated original slate, and contains a curved pedimented roof dormer with a bank of triple wood frame 1/1 double hung windows. The original projecting pressed metal bracketed roof cornice has been restored.
