NATIONAL REGISTER OF HISTORIC PLACES
REGISTRATION FORM

historic name: Gleason, Edmund Farm, (boundary increase)

Edmond Gleason Farm
Valley View, Ohio
Cuyahoga County

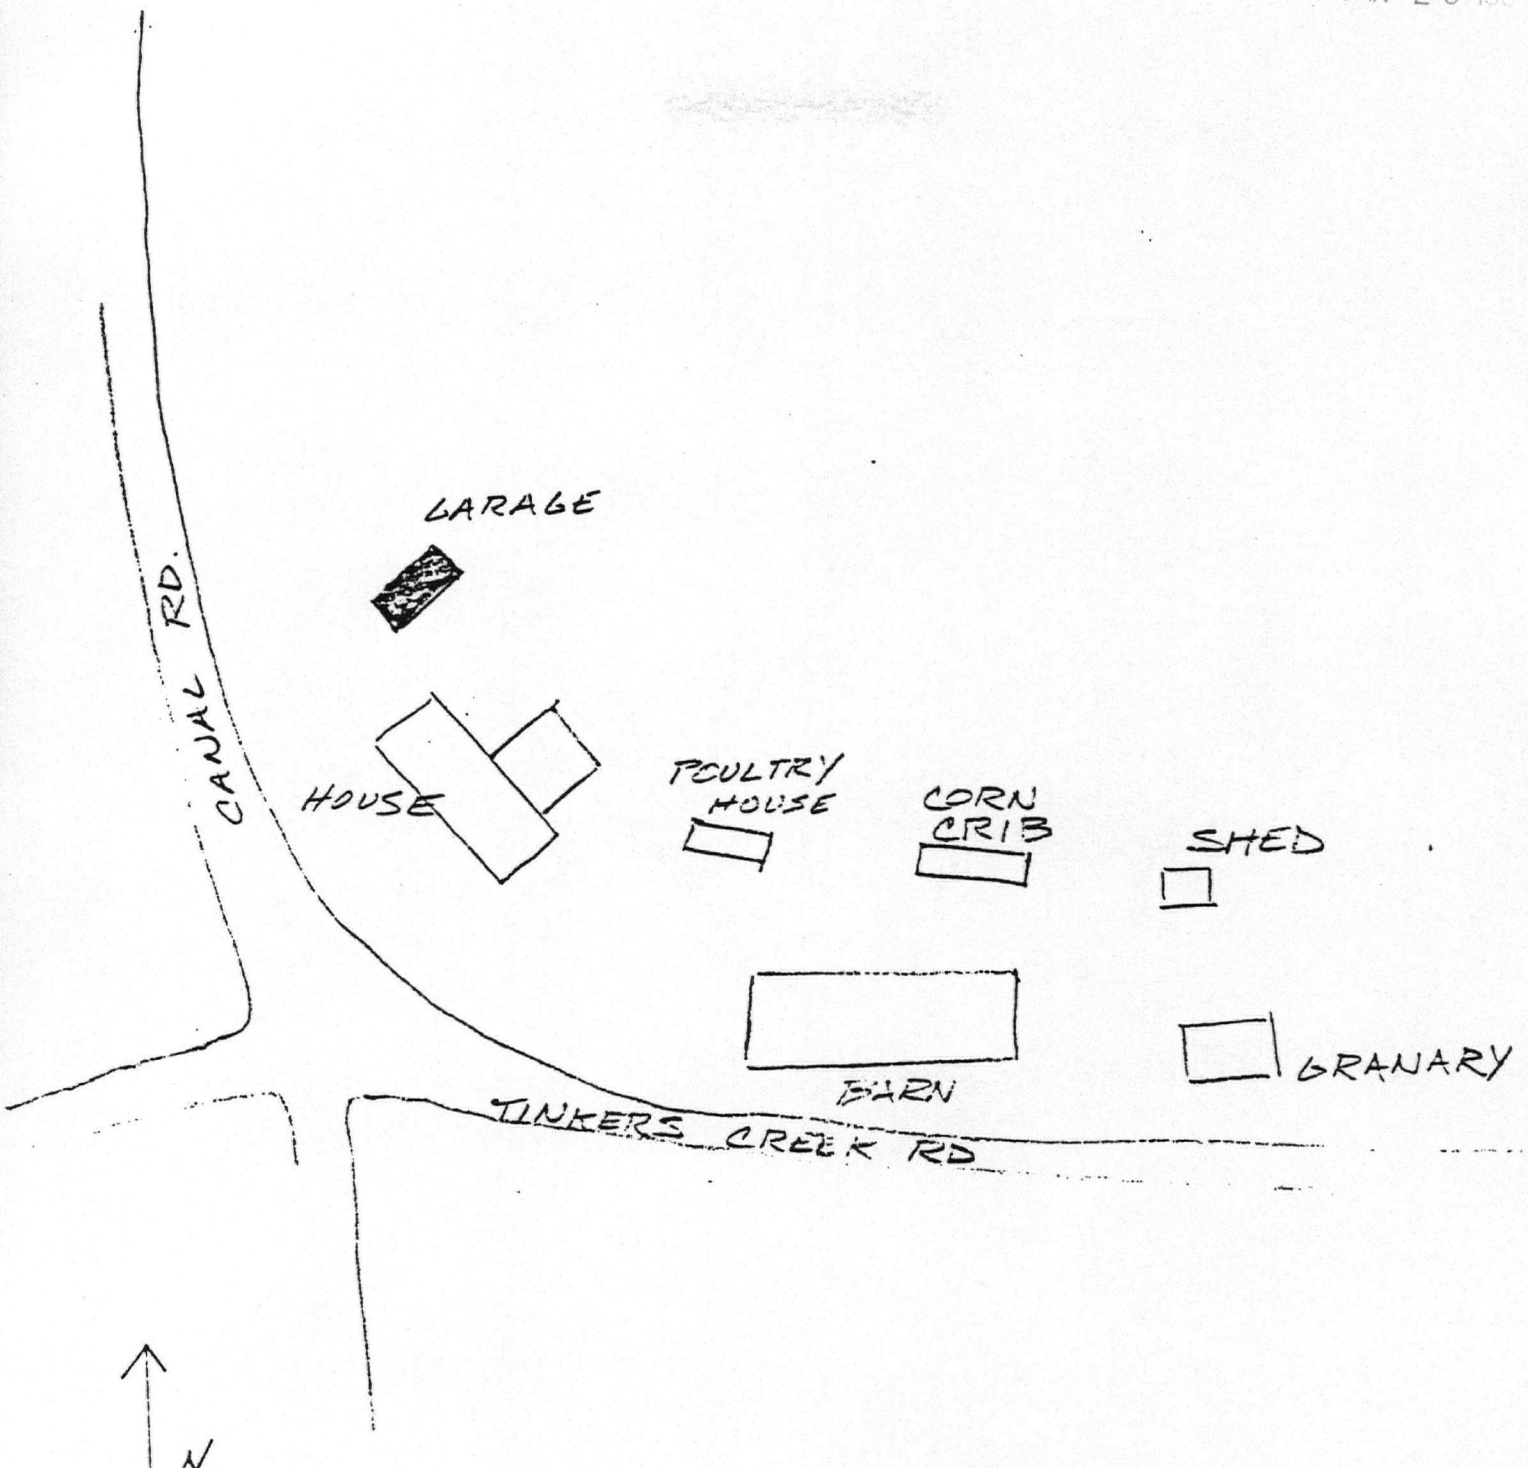
FARMSTEAD SKETCH MAP

EDMUND GLEASON FARM
 VALLEY VIEW, OHIO
 CUYAHOGA COUNTY
 C.V.N. R.A.

There are two outbuildings and one site located east of the barn. the two outbuildings are the granary and a shed, and the site is a barn foundation. Behind the barn is a corncrib and a poultry house. The field, located south of the buildings across Tinker's Creek Road, is historically associated with the property and considered a contributing site.

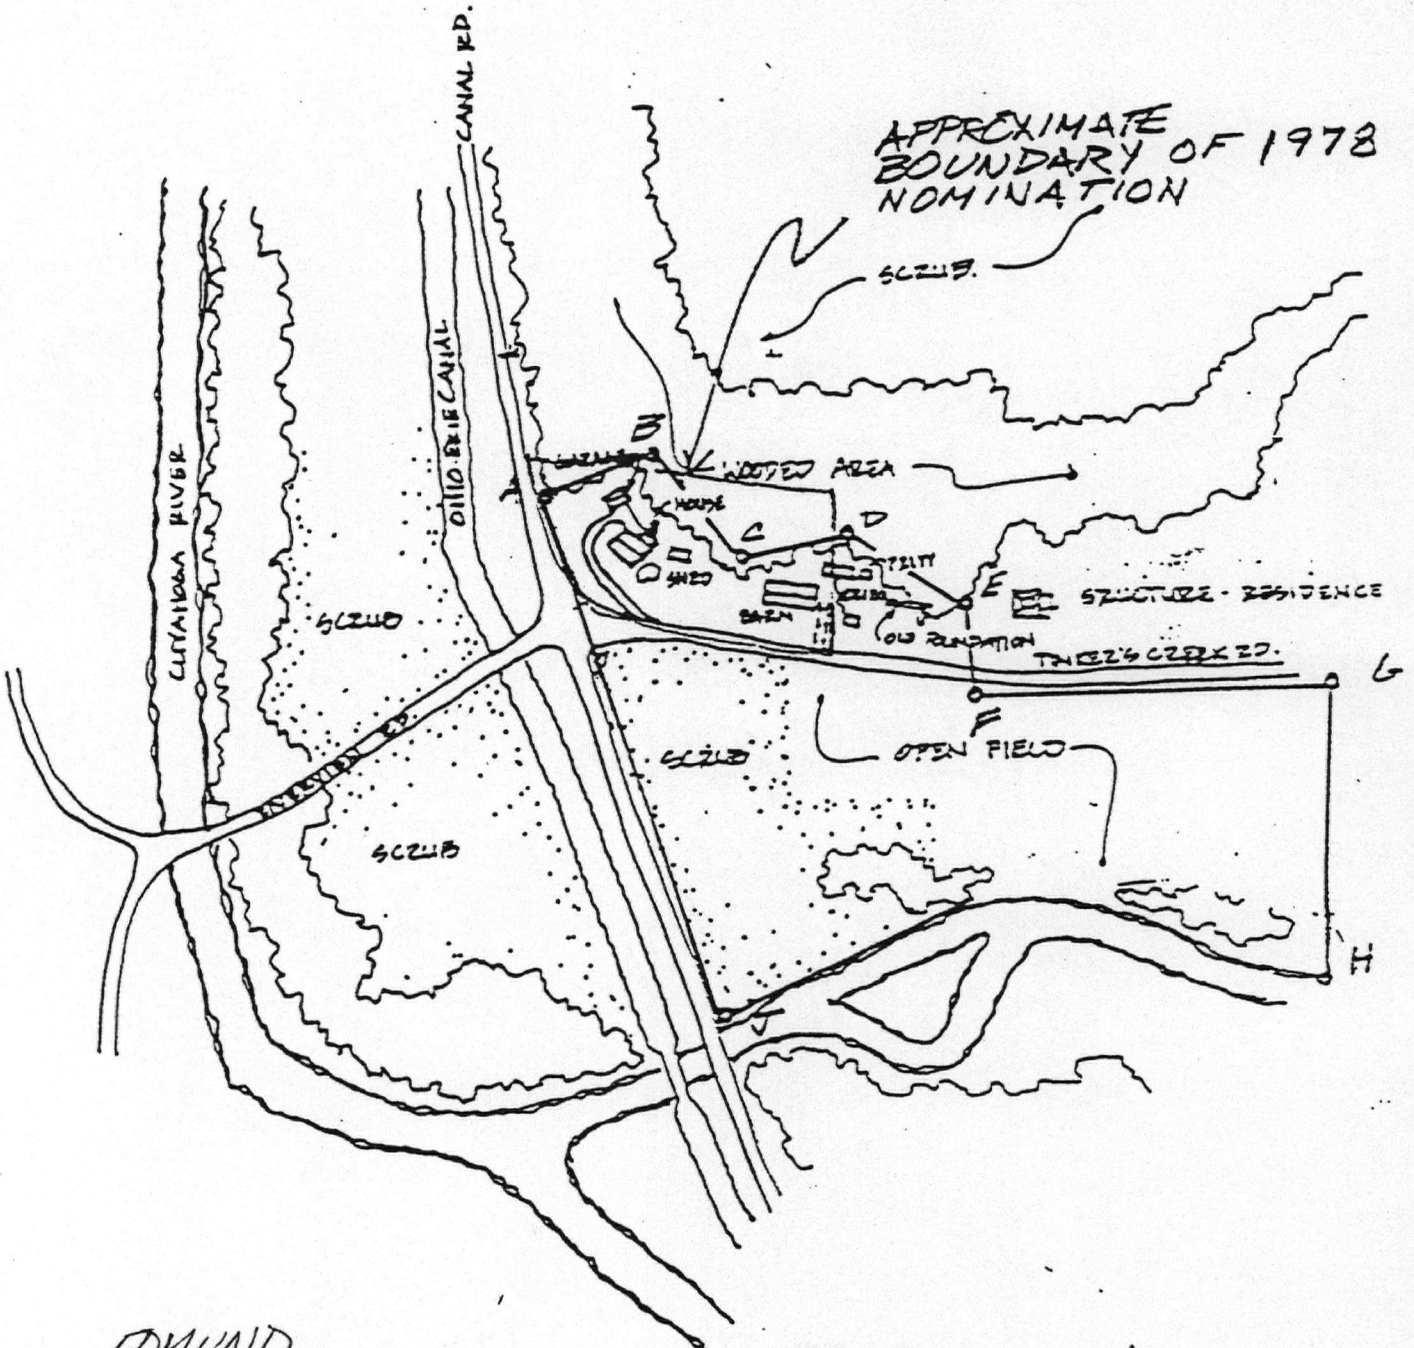
FARM SKETCH PLAN

EDMUND
GLEASON

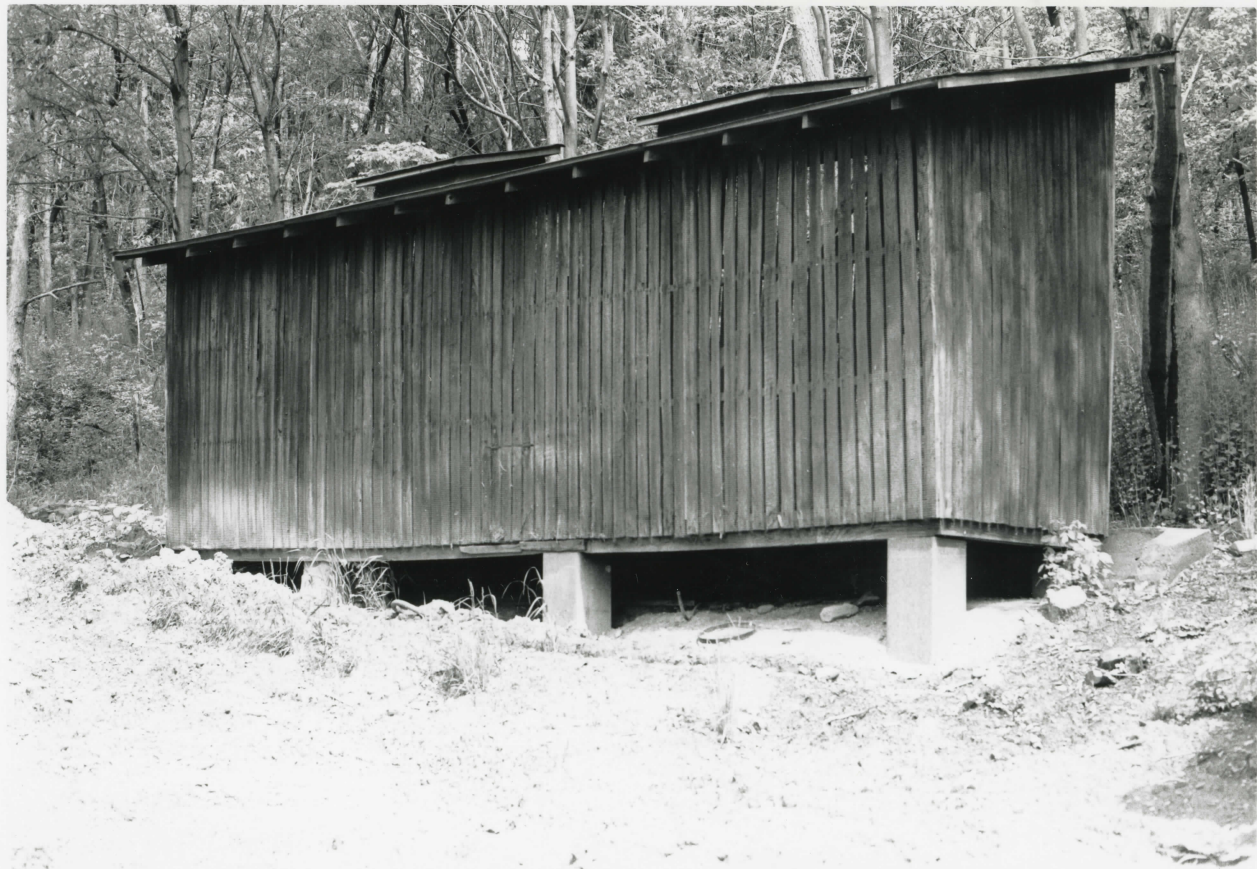
- 1) Edmond GLEASON, CORN CRIB
- 2) VALLEY VIEW, OHIO
- 3) DEAN R. DICKERSON
- 4) MAY 29, 1989
- 5) U. S. DEPARTMENT OF INTERIOR, NATIONAL PARK SERVICE,
MIDWEST REGION, 1209 JACKSON, OMAHA, NE
- 6) CAMERA DIRECTION: NORTH WEST

Similar building features are found on the corncrib-- the concern for ventilation and rodent abatement also being necessary. Unlike the granary, however, the corncrib also has slanted walls, making it more difficult for rodents to get in.

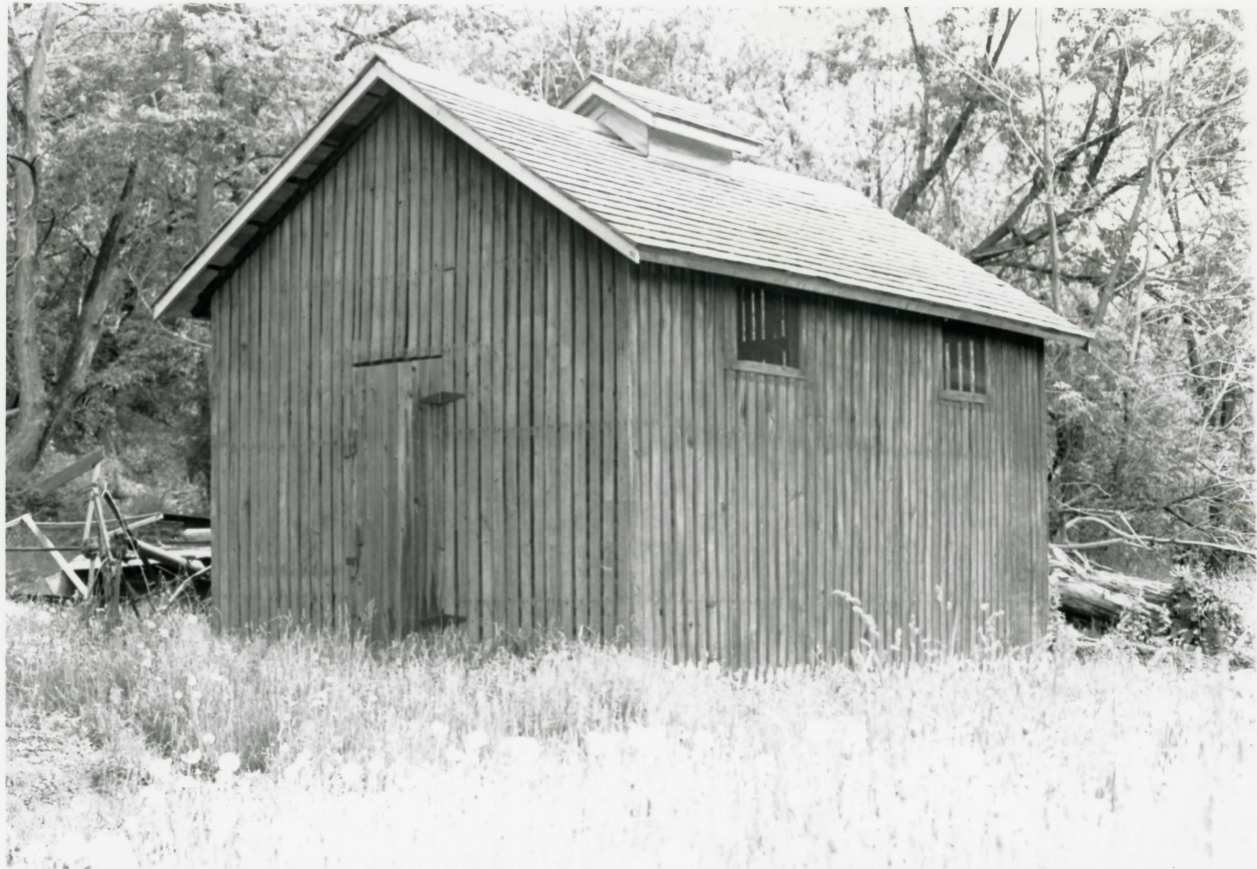
- 1) Edmund Gleason, CORN CRIB
- 2) Valley View, OHIO
- 3) Dean R. Dickerson
- 4) May 29, 1989
- 5) U.S. Department of Interior, National Park Service, Midwest Region,
1709 JACKSON, OMAHA NE
- 6) Camera direction: Northeast

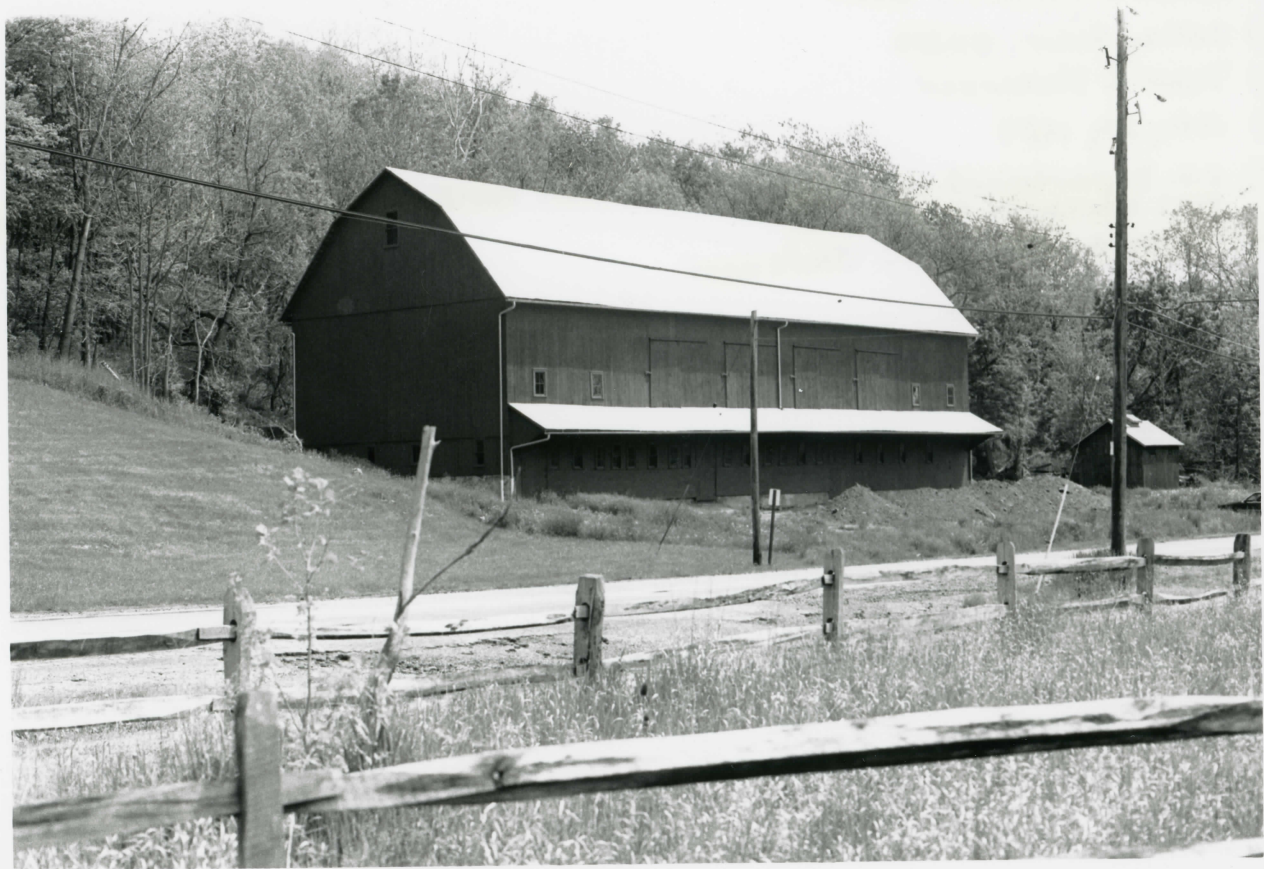
1) Edmund Gleason, Born

6) Camera direction: Southeast

Located approximately one hundred yards southeast of the house at the bottom of the hill is the Gleason barn (NR 1979). Built in 1905, this large 2 1/2-story barn has an gambrel roof covered with corrugated sheet metal. Its exterior walls are vertical wood siding. The south side, facing Tinkers Creek Road, has a sheet metal, pent roof overhang running the full one-hundred and eight-foot length of the barn. The foundation of this structure is concrete. Numerous doors and windows line the facade wall under the pent roof. Four large hay doors are located above the pent roof and are flanked by two symmetrically spaced windows. The other side of the barn is banked into a hillside and contains two large tracked doors.

The Wisconsin Dairy Barn contains architectural features associated with this building type. The rectangular massing, double pitch roof line, light lumber trussing, and rows of hay doors are characteristic features of this barn type developed at the Agricultural Experiment Station at the University of Wisconsin, Madison. The narrow width and rows of small windows are design features that maximize light for the lower livestock area. The gambrel roof profile provided more storage space needed for hay to feed the livestock.

The barn's interior contains rough cut timber beams and pegged mortise and tenon joints. The loft, or second level, retains a functional hay rail and hook; a feature that emphasizes transition from mowing loose hay to contemporary hay bailing techniques. The lower level contains evidence of a dairy operation. On the west end, milking stanchions and a closed-loop watering system remain. On the east end there is evidence of more livestock; mangers are damaged where horses have been "cribbing," or chewing, while they stood in their stalls.

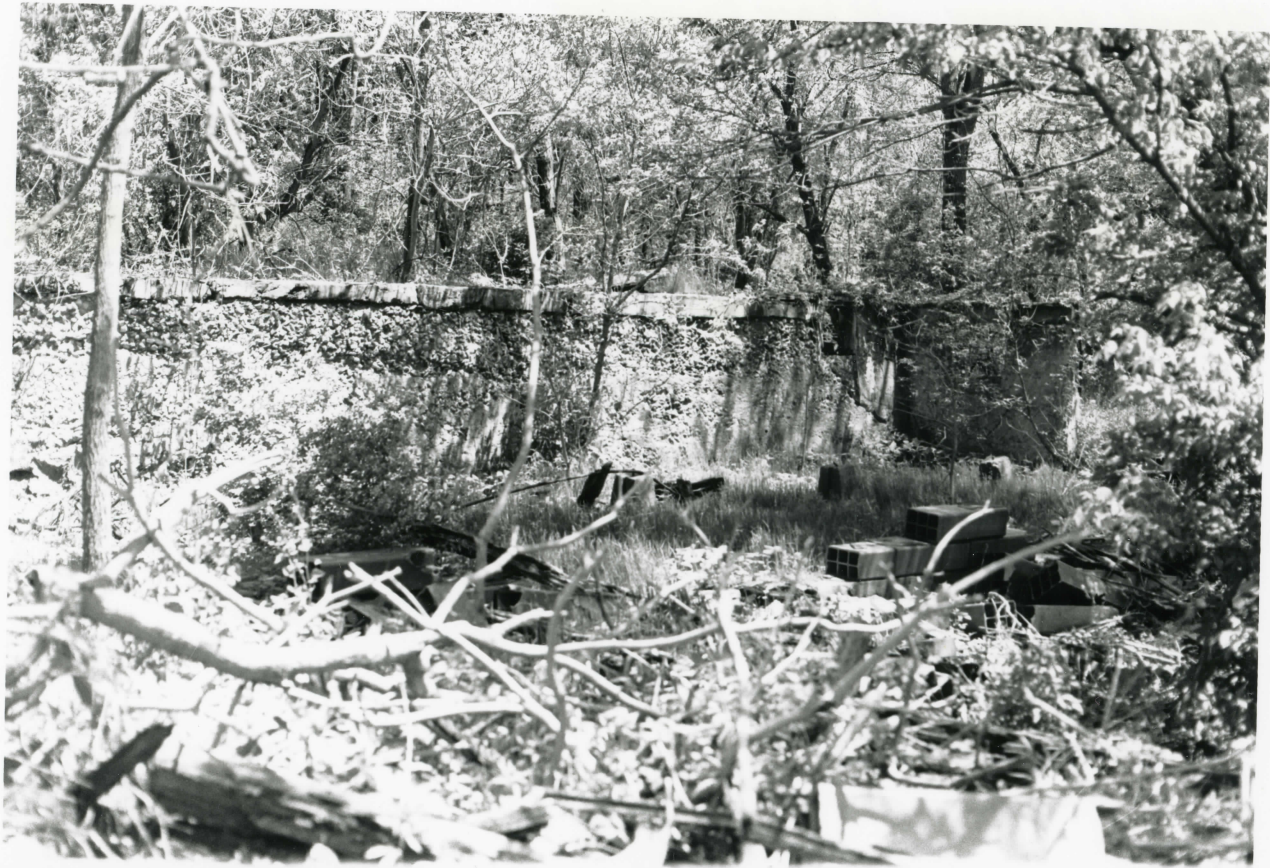
- 1) Edmond Gleason, old barn foundation
- 2) Valley View, OHIO
- 3) Dean Dickerson
- 4) May 29, 1989
- 5) U.S. Department of Interior, National Park Service, Midwest Region,
1709 Jackson, OMAHA, NE
- 6) Camera direction: North east

Located approximately fifty yards east of the barn, and almost entirely hidden by brush and trees, is an old stone foundation approximately 60 by 40 ft. wide. Very little information about this structure is available. However, it appears to be the remnants of an old barn. Possibly this is the location of the first barn built on the Gleason farm. The foundation, and what is left of the basement walls, consists of stone and stone rubble. There is a large opening on the east end of the foundation which appears to be the principal entrance. Inside the foundation are several concrete stubs which, at one time, supported the main floor.
