National Register of Historic Places
Registration Form

historic name Eagles Building, Strand Theater

other names/site number Wallace Building

street & number 243 East Main Street Not for publication

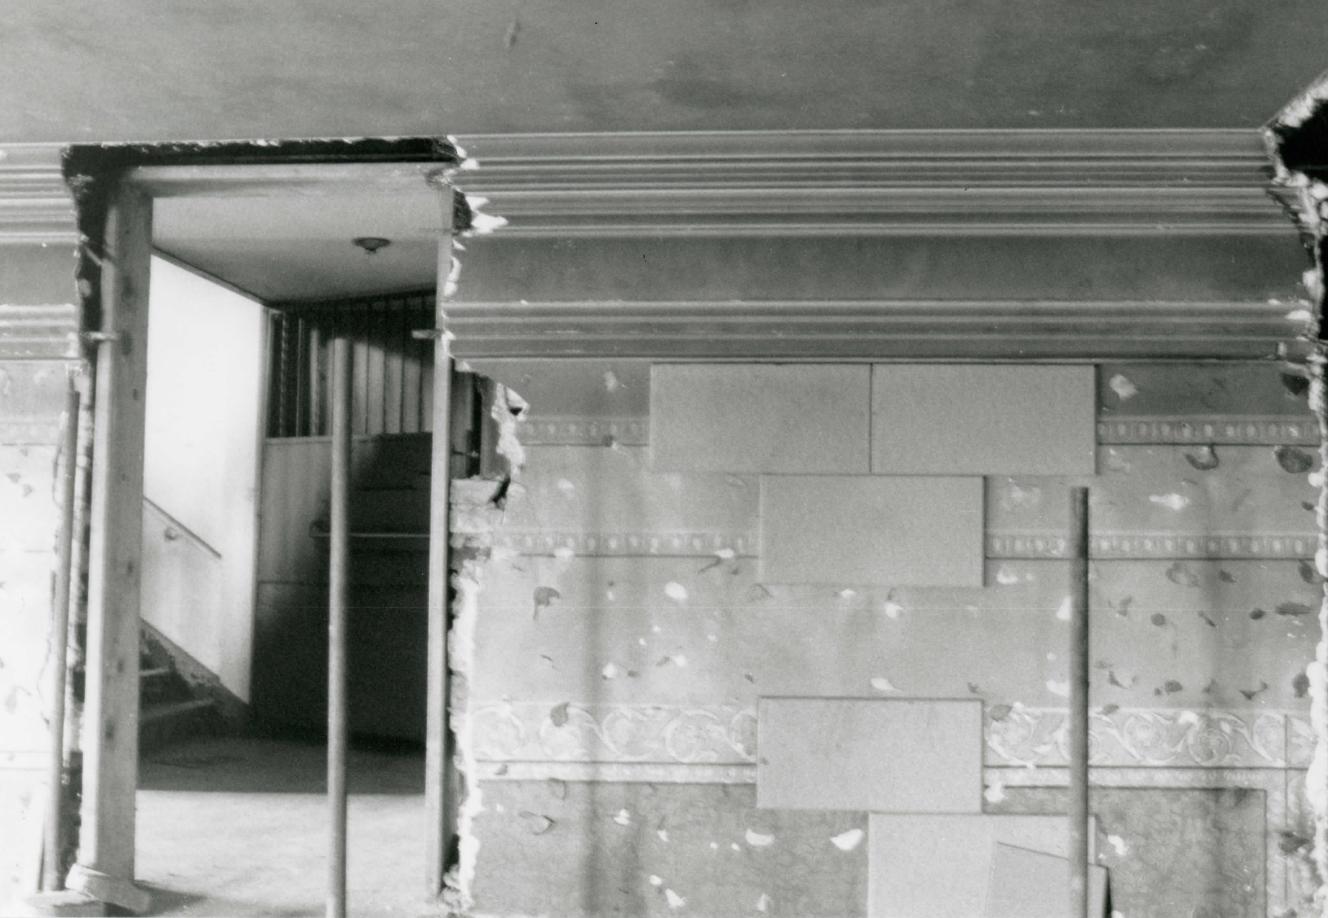
WB-6

In the past, the first three floors were a single large theater space and this may be observed on the upper levels. At the second floor level, a webwork of newer steel framing interlaces the building. It creates a floor level for the third floor, which has actually only been constructed at the north end of this space, perhaps where a theater balcony was once located. When the framework was installed, it was evidently intended to create two complete floors of space here in addition to the new first floor, but this work was abandoned in an incomplete state, but apparently with all steel framing complete. In the process of making this transformation, the original steel beams were opened up for connections, etc. and, as a result, the decorative plasterwork was stripped away. Also, moisture infiltration from years of roof leakage has severely eroded the decorative plasterwork in most areas. Only segments of

interior: old theater north wall

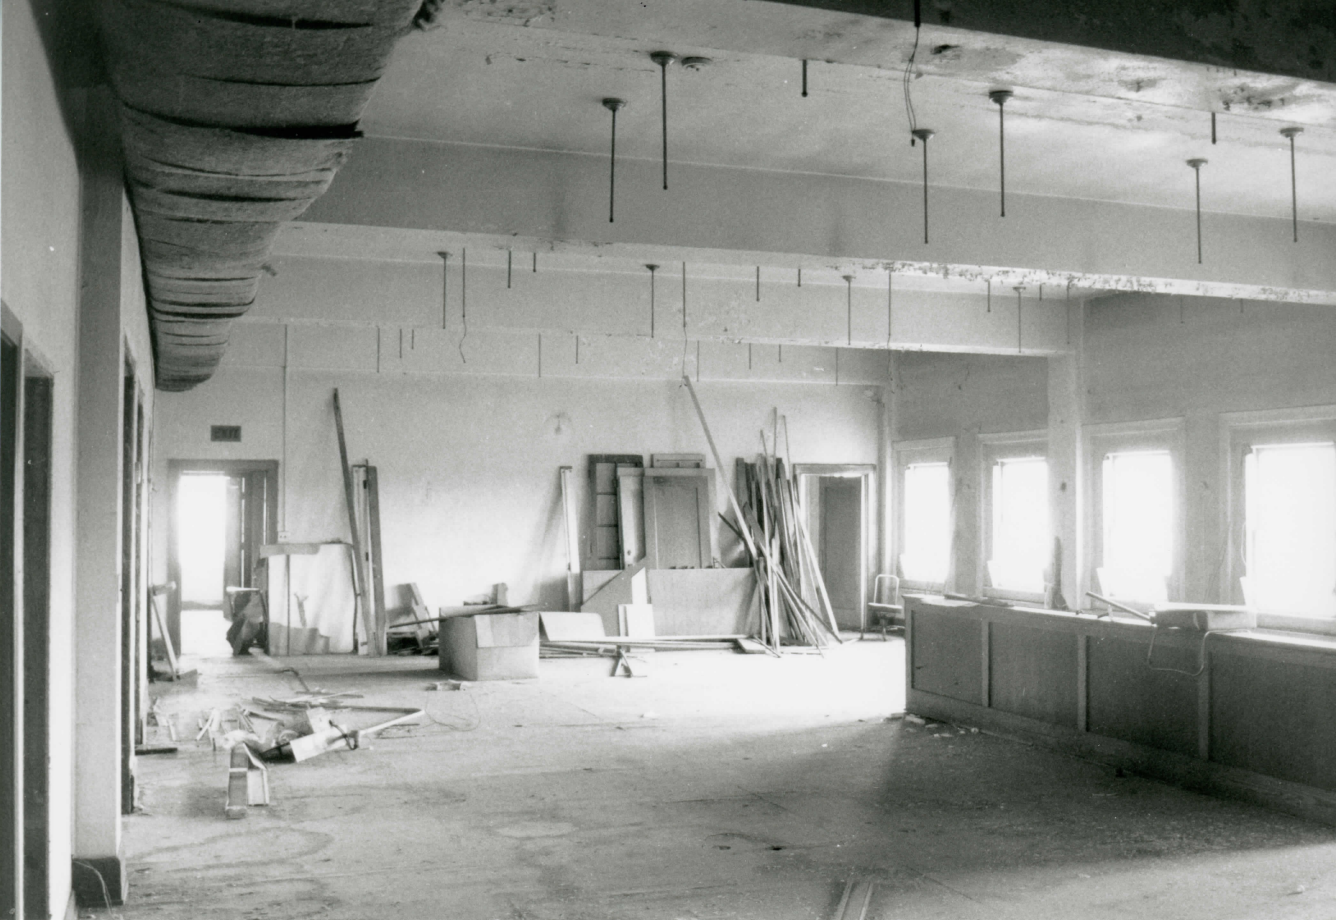
WB-8

The fourth and fifth floors have similar plans. Each has some small offices in front that face onto the recessed portico at these two floor levels. Behind these offices and consuming the bulk of each floor are large halls. Both have fairly tall beamed ceilings. That on the fourth floor is slightly lower, perhaps twelve feet tall, and has very simple plaster trim. A row of offices along the north side of this space makes it smaller than the fifth floor hall, which runs the entire width of the building. The fifth floor is taller, perhaps fourteen feet, and is more elaborate. Its clerestory windows and east side windows make this a brighter space and the structural system here is sheathed in classical plaster decoration. The beams take the form of entablatures and the projecting supports along the walls are pilasters with relatively simple capitals. The original decor on this floor has been compromised, not only by modern fluorescent lighting and acoustical tiles applied to its ceiling, but more seriously by years of moisture infiltration from the leaky roof. The integrity of the plasterwork is largely gone, with only smaller areas still largely intact. Its wood floor has been removed to expose the sleeper joists. The rear of each of these halls is partitioned off to form restrooms and the rear stairway, a simple feature.

interior: 4th floor hall, lkg, S

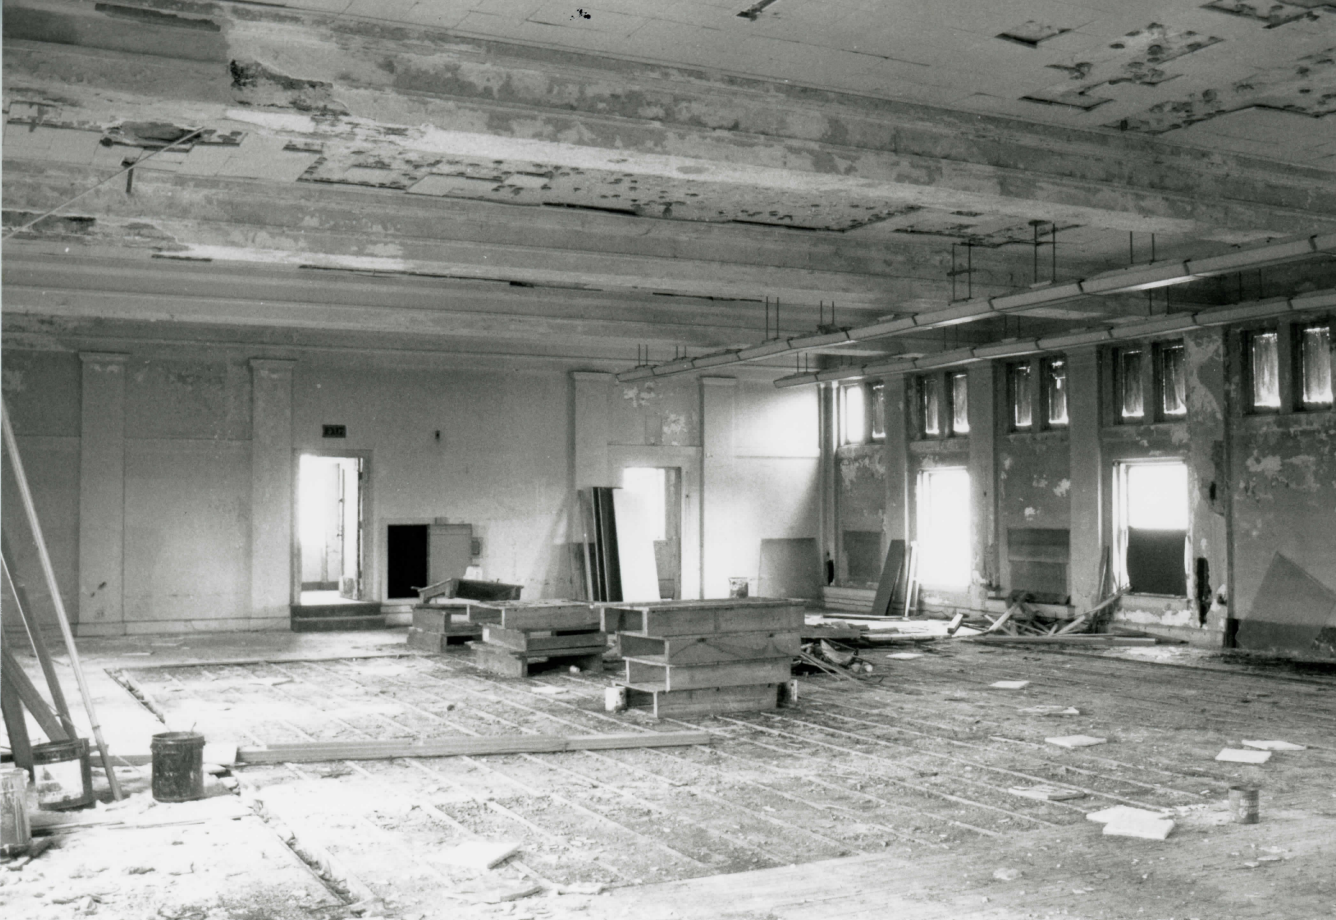
WB-9

interior: 5th floor hall, 1kg, SW

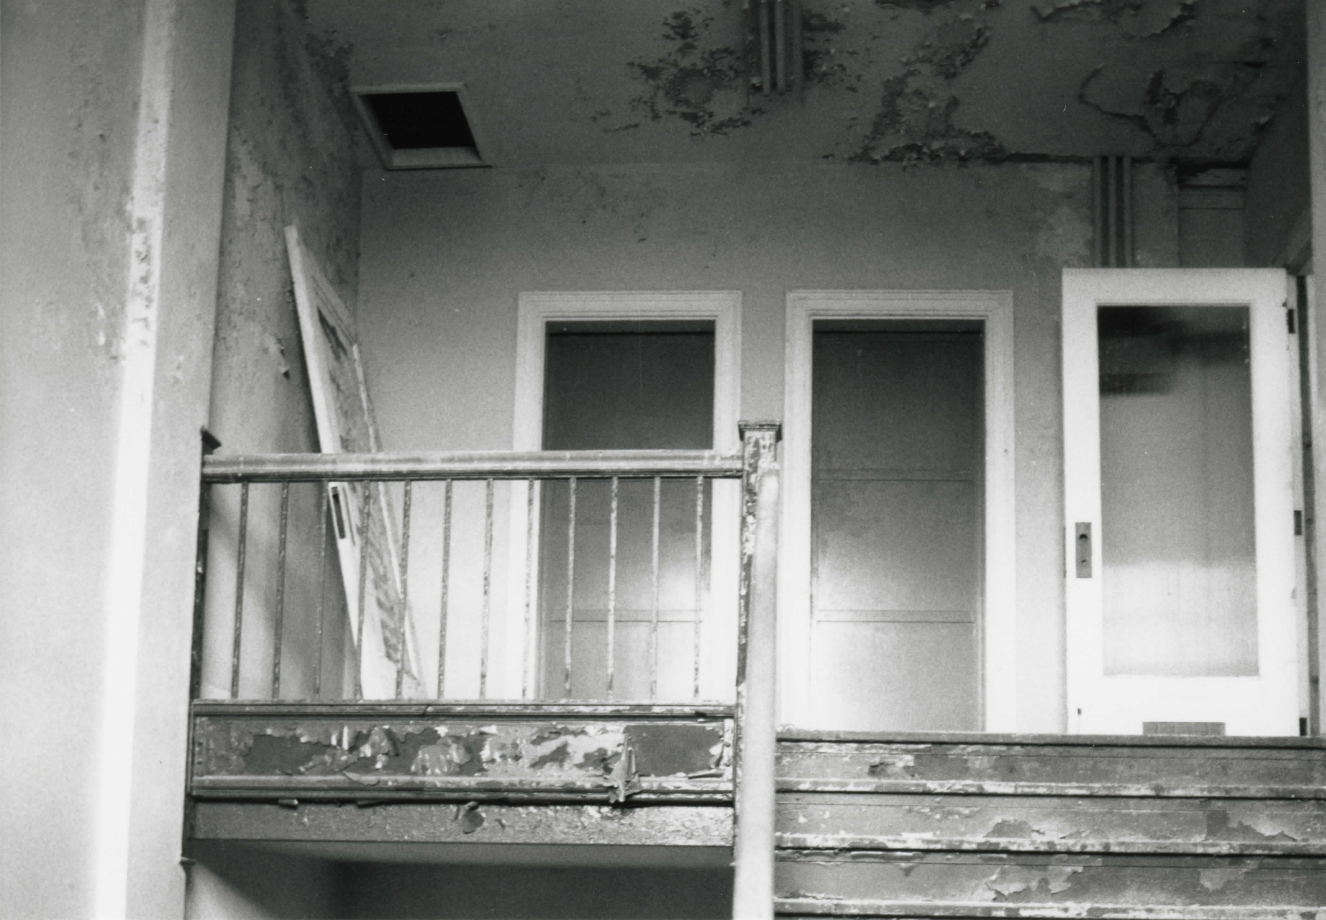
WB-90

interior: 6th floor stair landings,

looking south

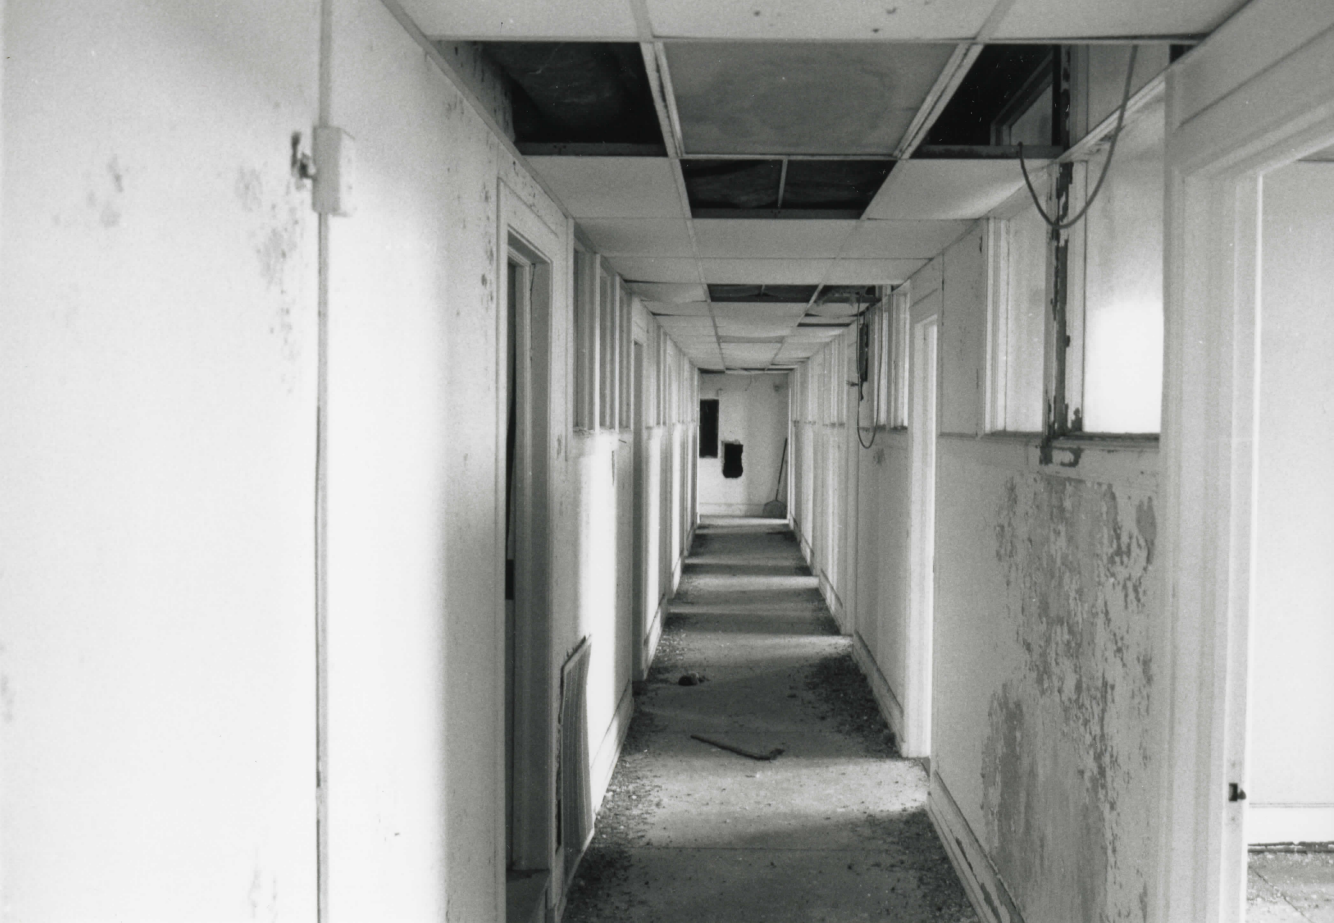
The sixth floor has a different plan. It is entirely devoted to offices and has a C-shaped plan around the small light well that appears only at this level and is on the building's east side. Large windows provide plenty of light and air into these rather small offices. The plan here is simple. A center corridor, with opaque-glazed borrowed light panels, opens onto offices on either side and connects the front and rear stairways. These offices are plainly finished and yet seem to have had little alteration over the years. They are heavily damaged from years of water infiltration.

EAGLES BLDG. Wallace Bldg, Alliance, Ohio
May 1996
Steven M. Quilley, photographer
negs at OHPO
interior: 6th floor corridor, 1 kg, S.
WB-11

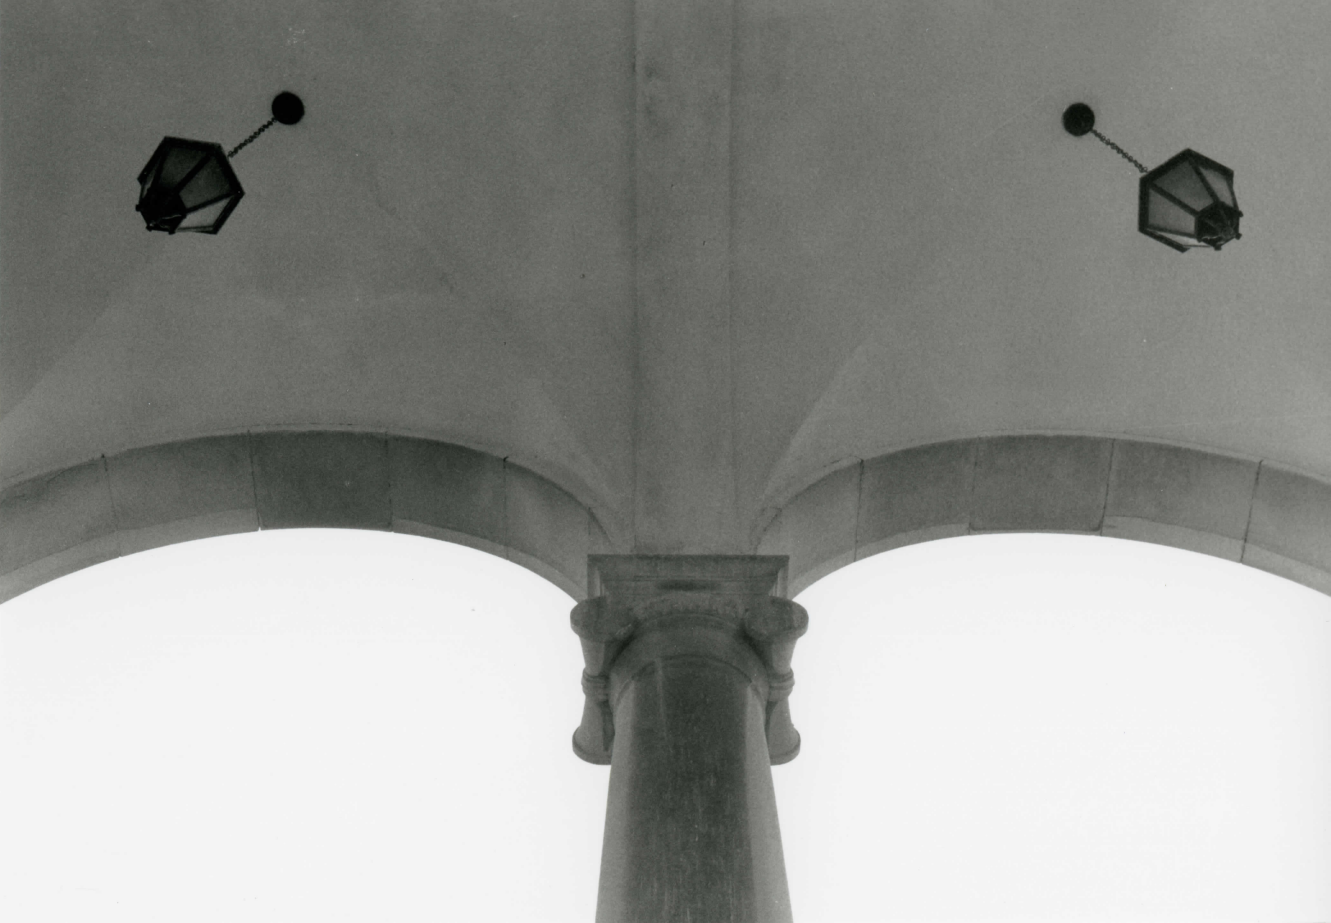
The principal difference here is the presence of the two-story portico in the center of the building's upper levels. Separated by plainer floors above and below, this portico is designed to be the central visual feature of the building. More than simply applied decoration, the portico is deeply recessed and can function as a promenade, having four sets of French doors at its lower level. It was designed to create deep shadow lines and its theatricality is enhanced by the groin-vaulted ceiling and elaborate suspended lanterns. Given the building's height and its hilltop location relative to perspectives from the north, this portico at night could be visible for miles. No other commercial building in Alliance has such a feature. Because of the expense in constructing the portico and the resultant loss of rentable floor area, it is a rare feature in a commercial building but performs the function of proclaiming the building's importance as an institutional or semi-public building in much the same way as a ground-level portico and flight of steps is used to proclaim the importance of a more traditional public building such as a city hall, post office or court house. This feature alone imparts real architectural significance to the building.

EAGLES BLDG. / Wallace Bldg., Alliance, Ohio
May 1996
Steven McQuilln, photographer
negs at OHPO
front balcony detail
WB-12
