NATIONAL REGISTER OF HISTORIC PLACES
REGISTRATION FORM

historic name Sperling Building

other names/site number Sperling Apartments, Mercantile Building

street & number 1007-1013 Penn Avenue not for publication N/A
city or town Wilkinsburg vicinity N/A
state Pennsylvania code PA county Allegheny code 003
zip code 15221

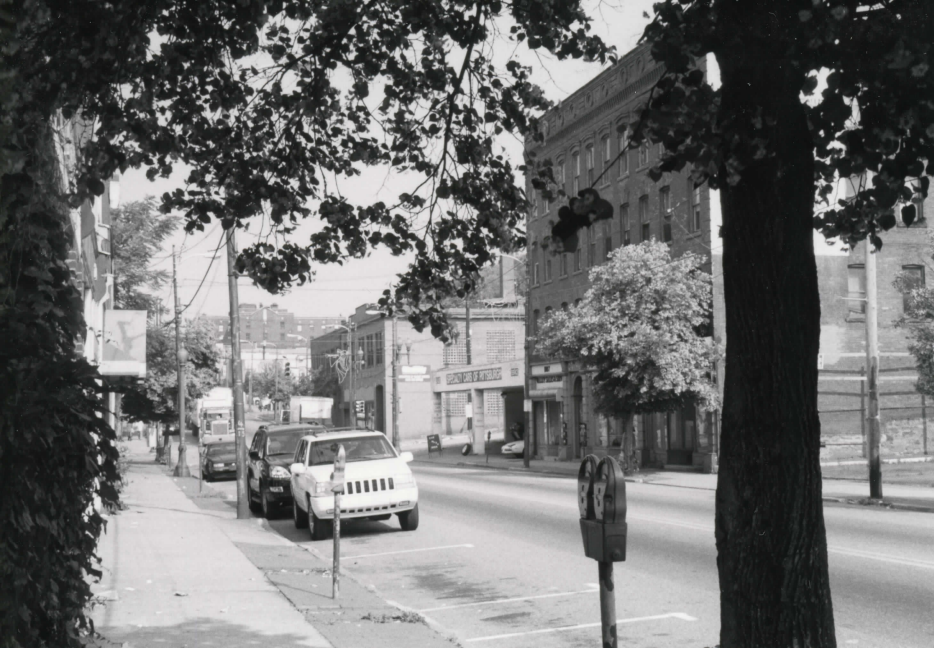
Photo # 5

Photograph 5: Southwest corner of Sperling Building. South and west elevations showing. Camera facing northeast.

The west elevation abuts a single-story building on the adjacent lot (Photo#5.) Centered at this elevation is a rectangular recess (tenement-style) at thesecond, third, and fourth stories. The west facing wall of the recess has two windows, and the north and south facing walls each have one window. The roofline is relatively level at this elevation, with two chimneys south of the recess and one chimney north of the recess. There is a single-story building that occupies the adjacent lot and it butts up against the first floor of the Sperling Building at the west elevation.

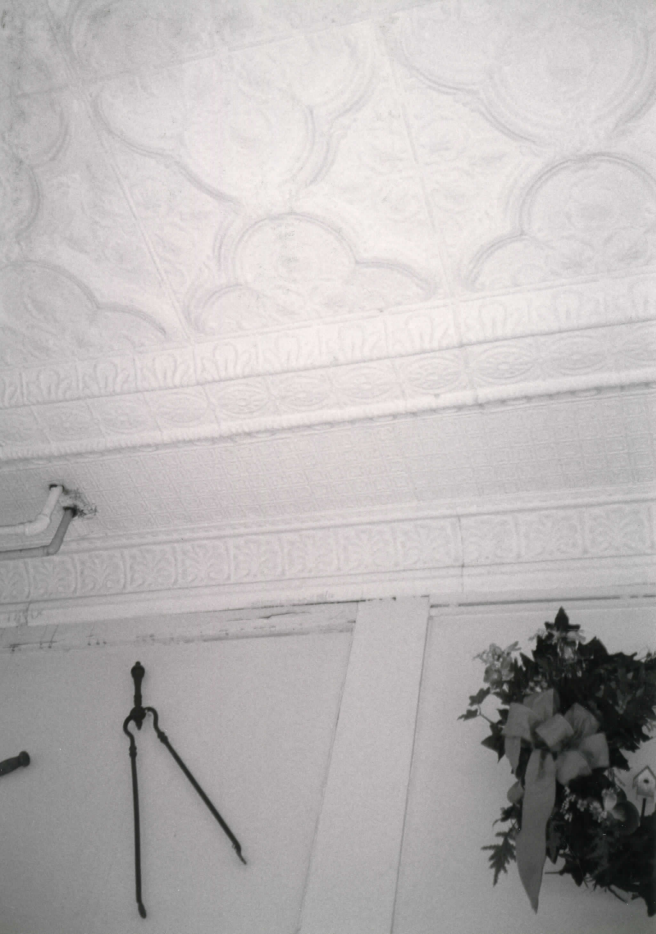
Photo #20

Photograph 20: Ceiling detail in store at 1007 Penn Avenue.

The interior spaces of the building have not been altered since their original construction. All three stores have decorative pressed metal ceilings with a quatrefoil pattern (Photo #20.) Otherwise, the rectangular storefront spaces are nondescript, having wood framed party walls separating them, and a plaster wall finish. Modern interventions such as lights, sprinklers and ductwork hang below the metal ceiling, as there is no room above to hide them; metal panels are mounted onto furring strips and then onto the structural joists. Each store is slightly different. 1007 Penn Avenue (the western-most store) is the longest, narrowest space, extending to the rear of the building (Photo #19.) It has a raised floor at the rear half of the store. The store at 1011 Penn Avenue occupies the central bay of the ground floor footprint, and its space extends behind the store at 1013 Penn Avenue, which is the smallest. (Floor Plan E1.11)

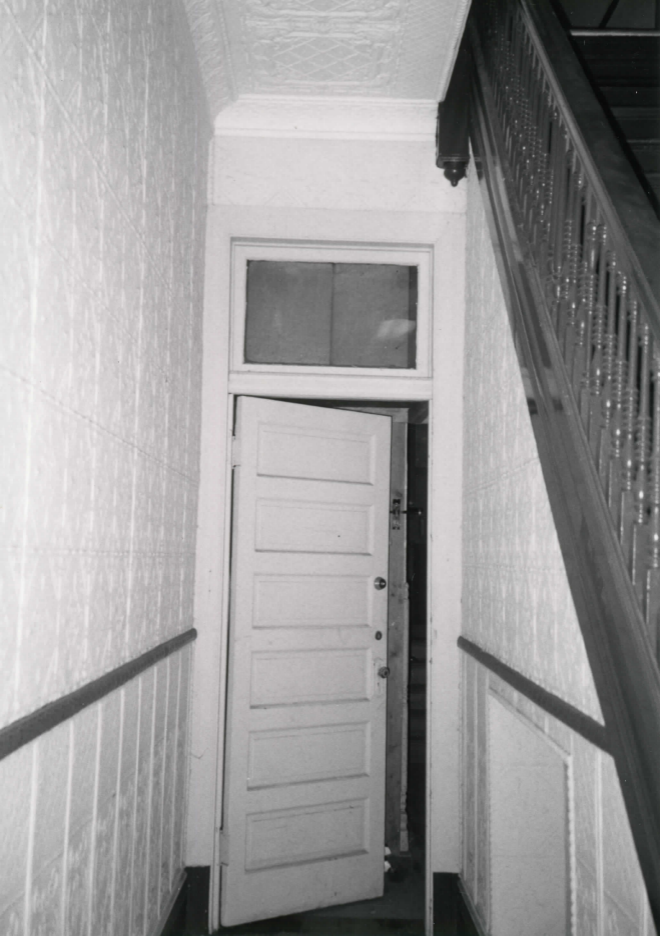
Photo #21

Photograph 21: Interior shot of apartment lobby behind entrance door to 1009 Penn Avenue. Stairwell on right. Camera facing north.

The entrance lobby to the apartments is mainly occupied by a framed stair at its eastern half (Photos #22, 25 & 26.) To the west of the stair is a short hallway leading to a rear door that provides access to the basement, as noted above (Photo #21.) There is a pressed metal ceiling at this short hallway. The metal pattern at this ceiling differs from that at the storefronts; in this case, a series of squares and diamonds on each panel (Photo #24.) The ceiling then has a metal rounded cove at the edge where it meets the sidewalls, also covered with pressed metal (Photo #23.) The pressed

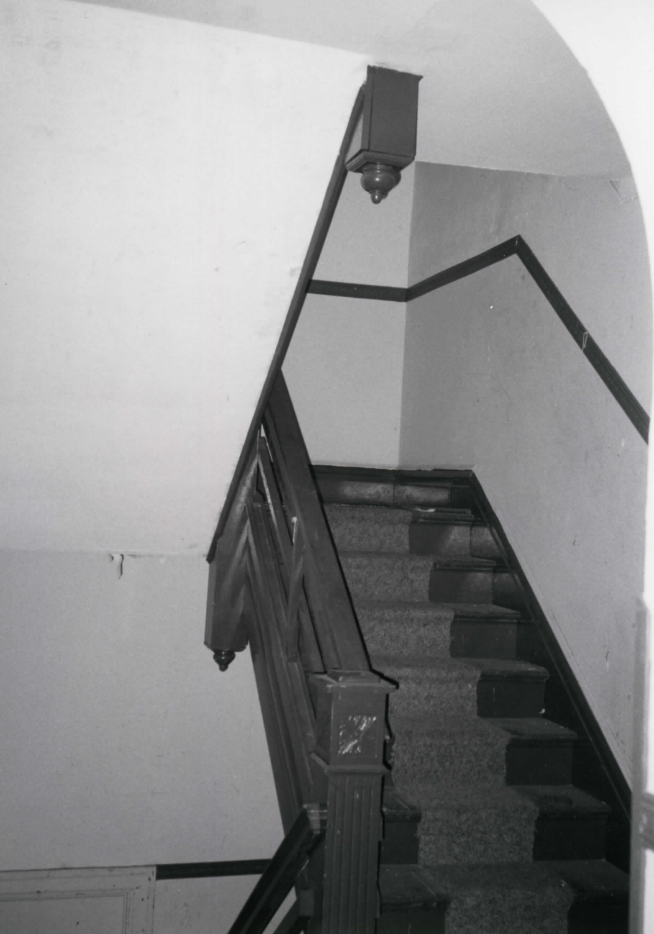
Photo # 27

Photograph 27: Looking up stair from apartment lobby to second floor. Camera facing north.

The floor plan for the second, third, and fourth stories are identical (Floor Plans E1.12, E1.13, E1.14.) The central stair is open to the floors above. Past the lobby, balusters and railings in the upper stories have been replaced with simple wood posts and rails (Photos #27 & 29.) Most newell posts and original treads and risers remain (Photo #28.) The stairwell landings at each floor have decorative egg and dart chair rails and base trim throughout (Photos #28 & 30.) Stairwell landings open into corridors with rounded, rather than cased openings, as found within the individual apartments. The stair that leads from the fourth floor to the roof is enclosed and lacks any detailing whatsoever.

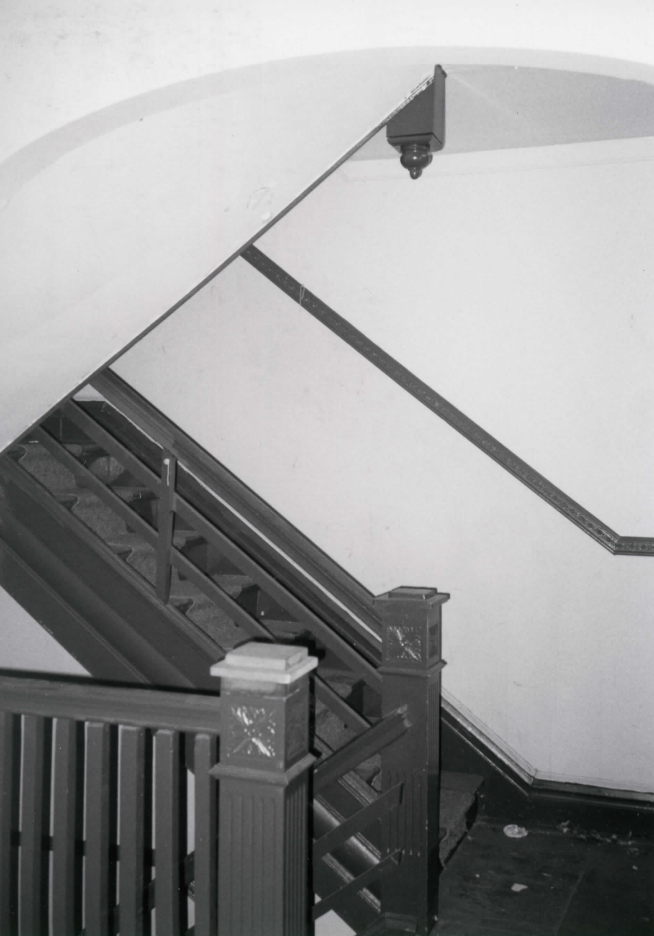
Photo # 30

Photograph 30: Stair rail detail at third floor common circulation space. Camera facing west.

The building plan is primarily a rectangle with a small wing that extends north at the northwest corner. For the purposes of a physical description, it will be described as an "L"-shaped plan. The building has a sub-grade stone foundation and basement, load-bearing masonry exterior walls, a flat asphalt roof with brick chimneys, and a rear framed egress stair. The building stands roughly forty-feet above grade. There are ten bays of one-over-one, wood sash, double-hung windows at the second, third and fourth stories of the entrance facade facing south onto Penn Avenue (Photos #1 & 2.) Penn Avenue, though once an active main street, now is punctuated by open abandoned lots (Photos #6,7, & 12). To the east of the Sperling building is one of these lots, and to the west is a single-story auto repair shop. Exterior decorative features of the Sperling Building include a patterned masonry cornice with projecting brick dentils, arched window openings, window hoods, masonry quoins as the building corners, and original wood-framed storefront entrances separated by pilasters (Photos #17 & 18.) Interior walls are wood framed with a plaster finish for both walls and ceilings throughout the upper story apartments. All floors are hardwood (Photos #32 & 33.) Decorative interior features include a pressed metal ceiling at the ground level commercial spaces and lobby entrance (Photos #23 & 24), as well as decorative newell posts, and egg-and-dart chair rails (Photo #30.)
