National Register of Historic Places Registration Form

historic name John Todd House
other names/site number N/A

John Todd House

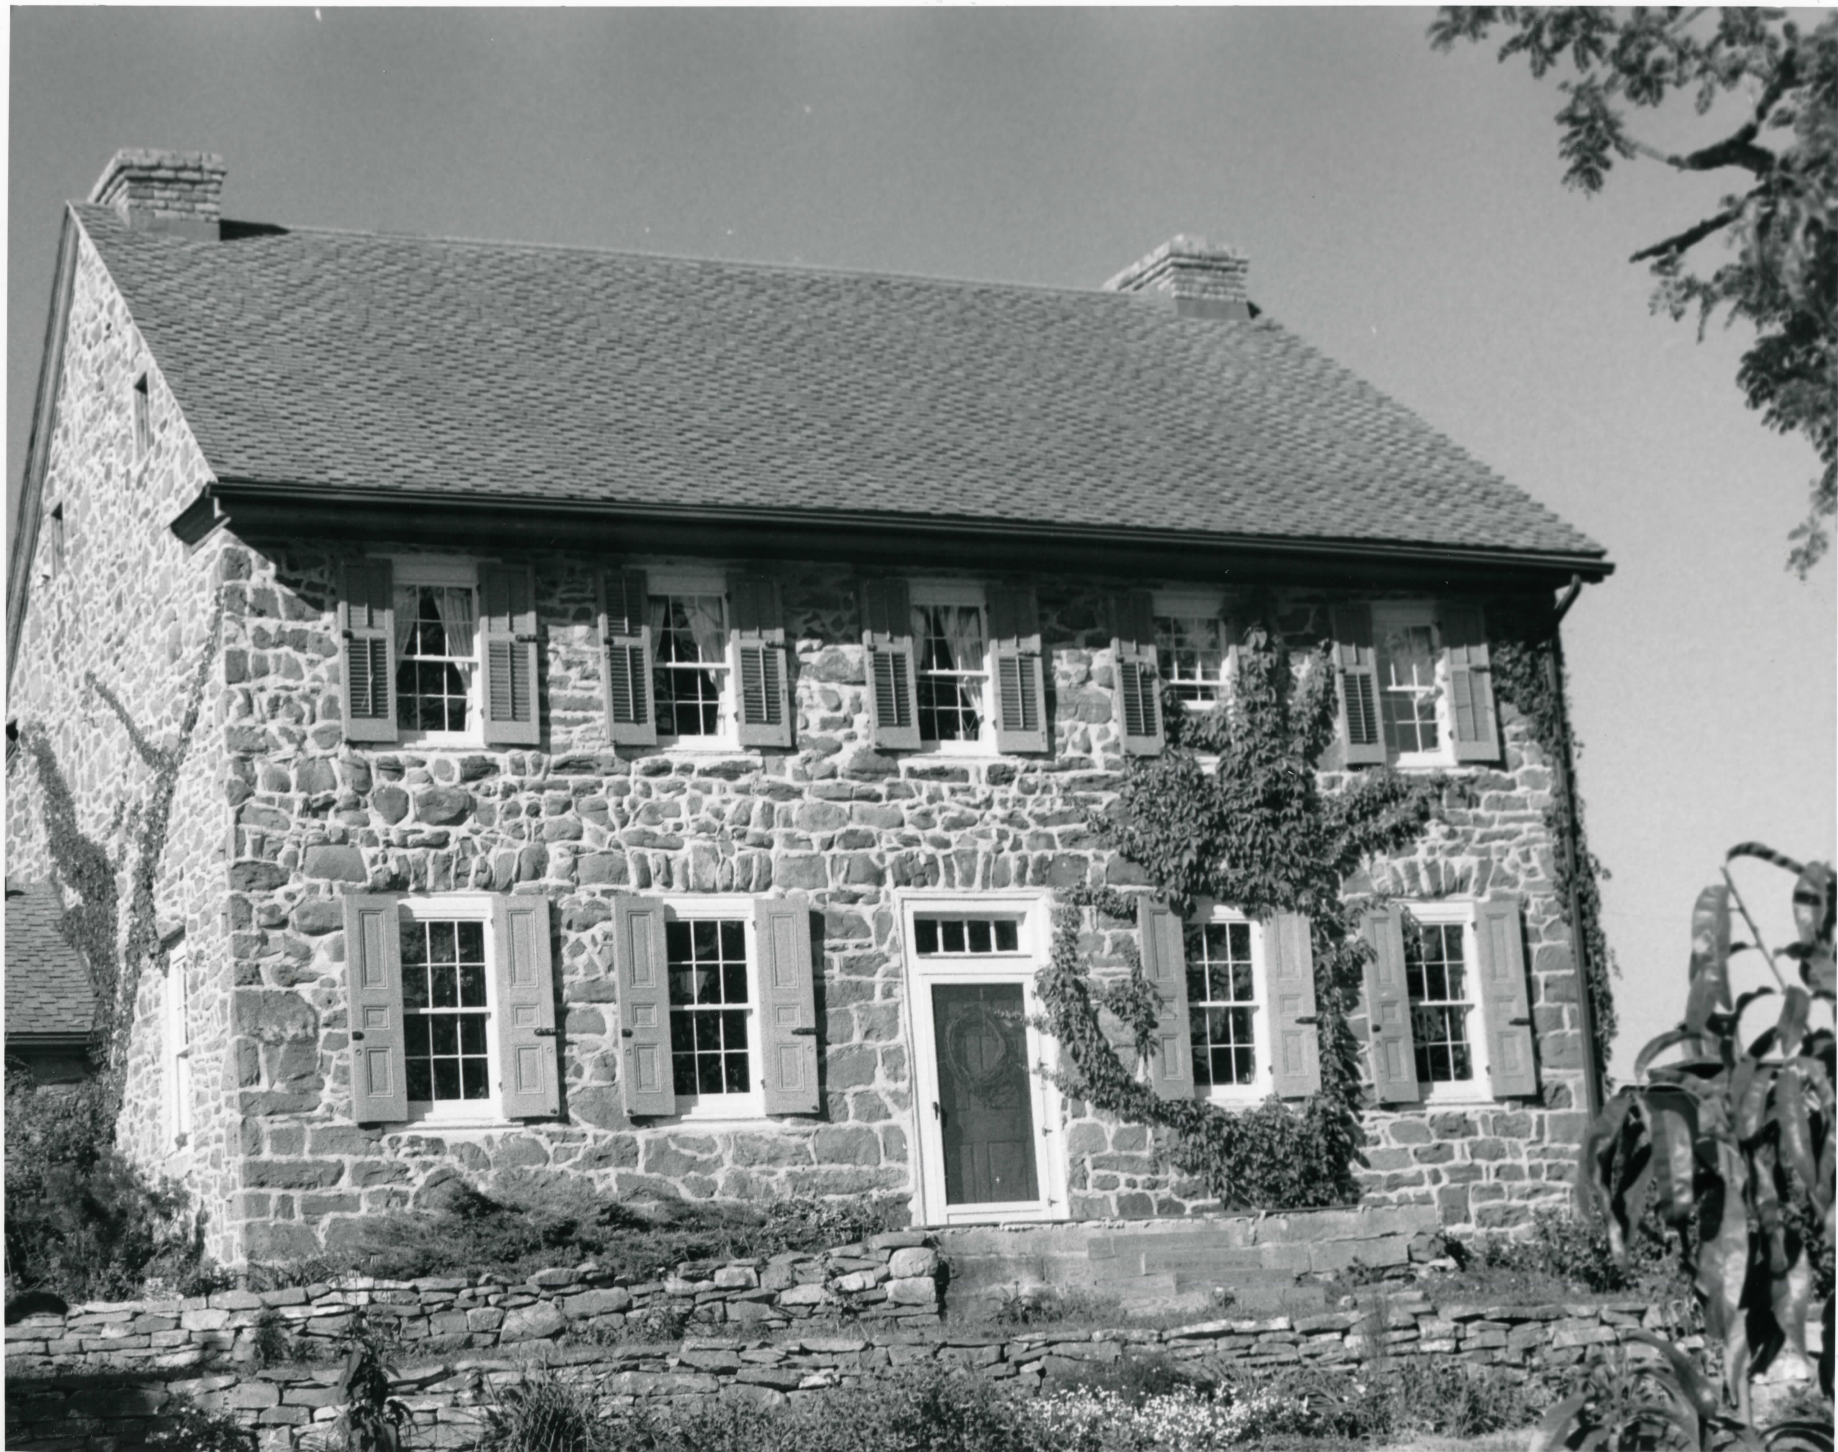
#1

PV Facade and West wall

The front (south) facade, in typical Georgian fashion, contains five windows on the second level and two each flanking the door on the first level. All windows retain their original pegged framing. The lower windows were originally 6/9 or 9/6 as determined by the Direct Tax records of 1798, but have been replaced in more recent years by 6/6 sash. Above each of the lower windows on this facade, as well as above the transom of the door, are rude flat arches of stone, a vernacular expression of the more refined arches of similar urban houses of the period. The windows are shuttered at present and the presence of pintels on a few of the window frames indicates that shutters were in use at one time in the past. It is not known, however, if the house originally had shutters. The ones in current use are replacements installed by the present owners. The lower shutters are solid paneled ones and the upper ones are louvered. The front door contains six raised panels on the outside and a second layer of tongue and groove boards on the inside. It is suspended by two massive iron strap hinges set on pintels. The original four light transom above the door is intact. The door leading to the basement is located at the east corner and is a replacement for the original door which is missing..

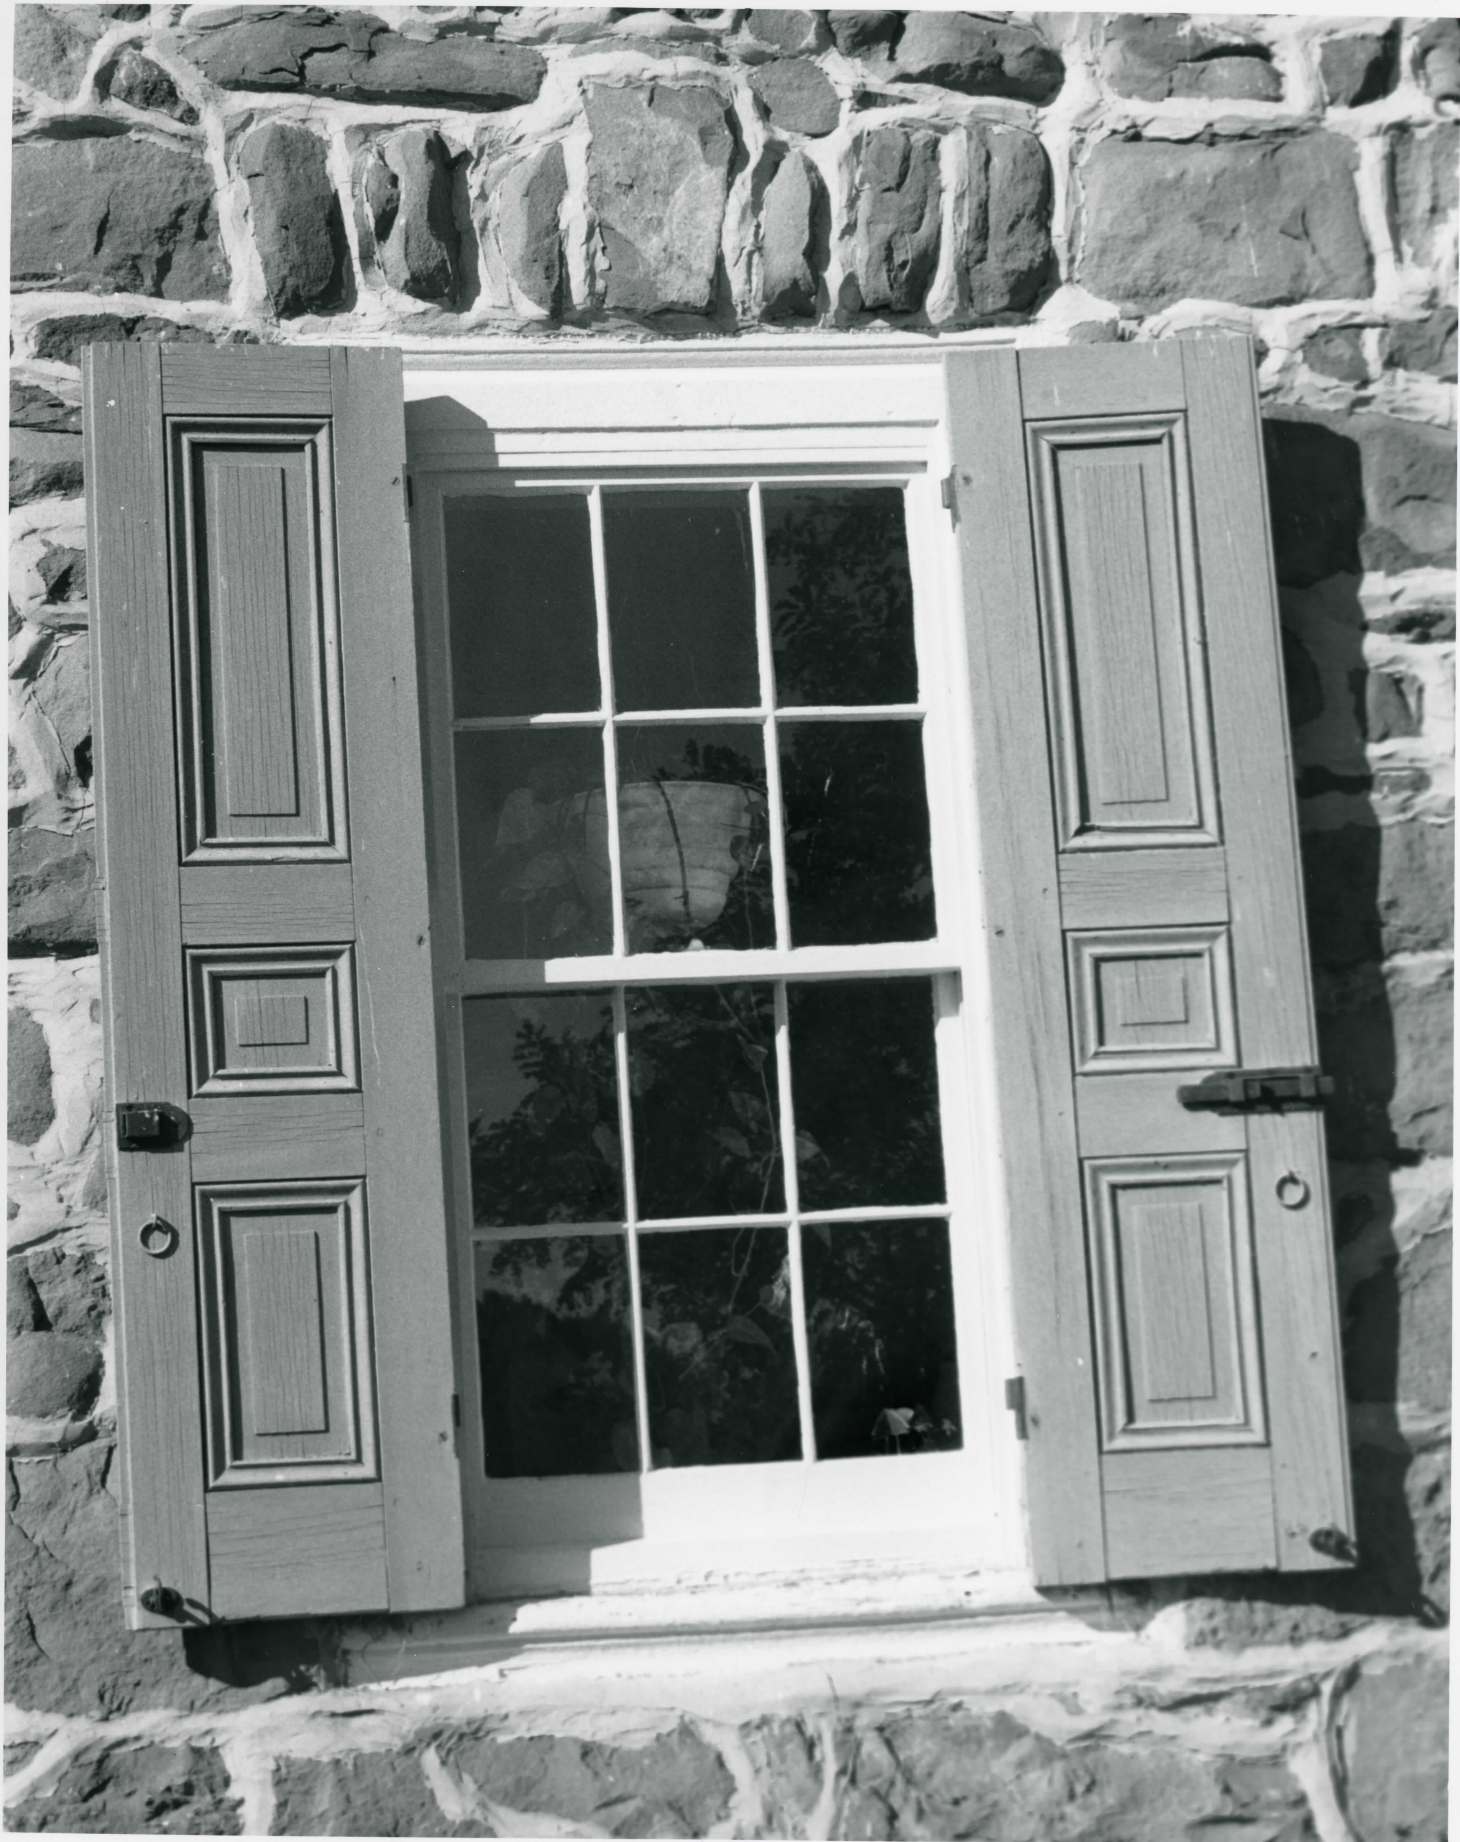
#5 rule flat arch

P.D. 1st floor window showing

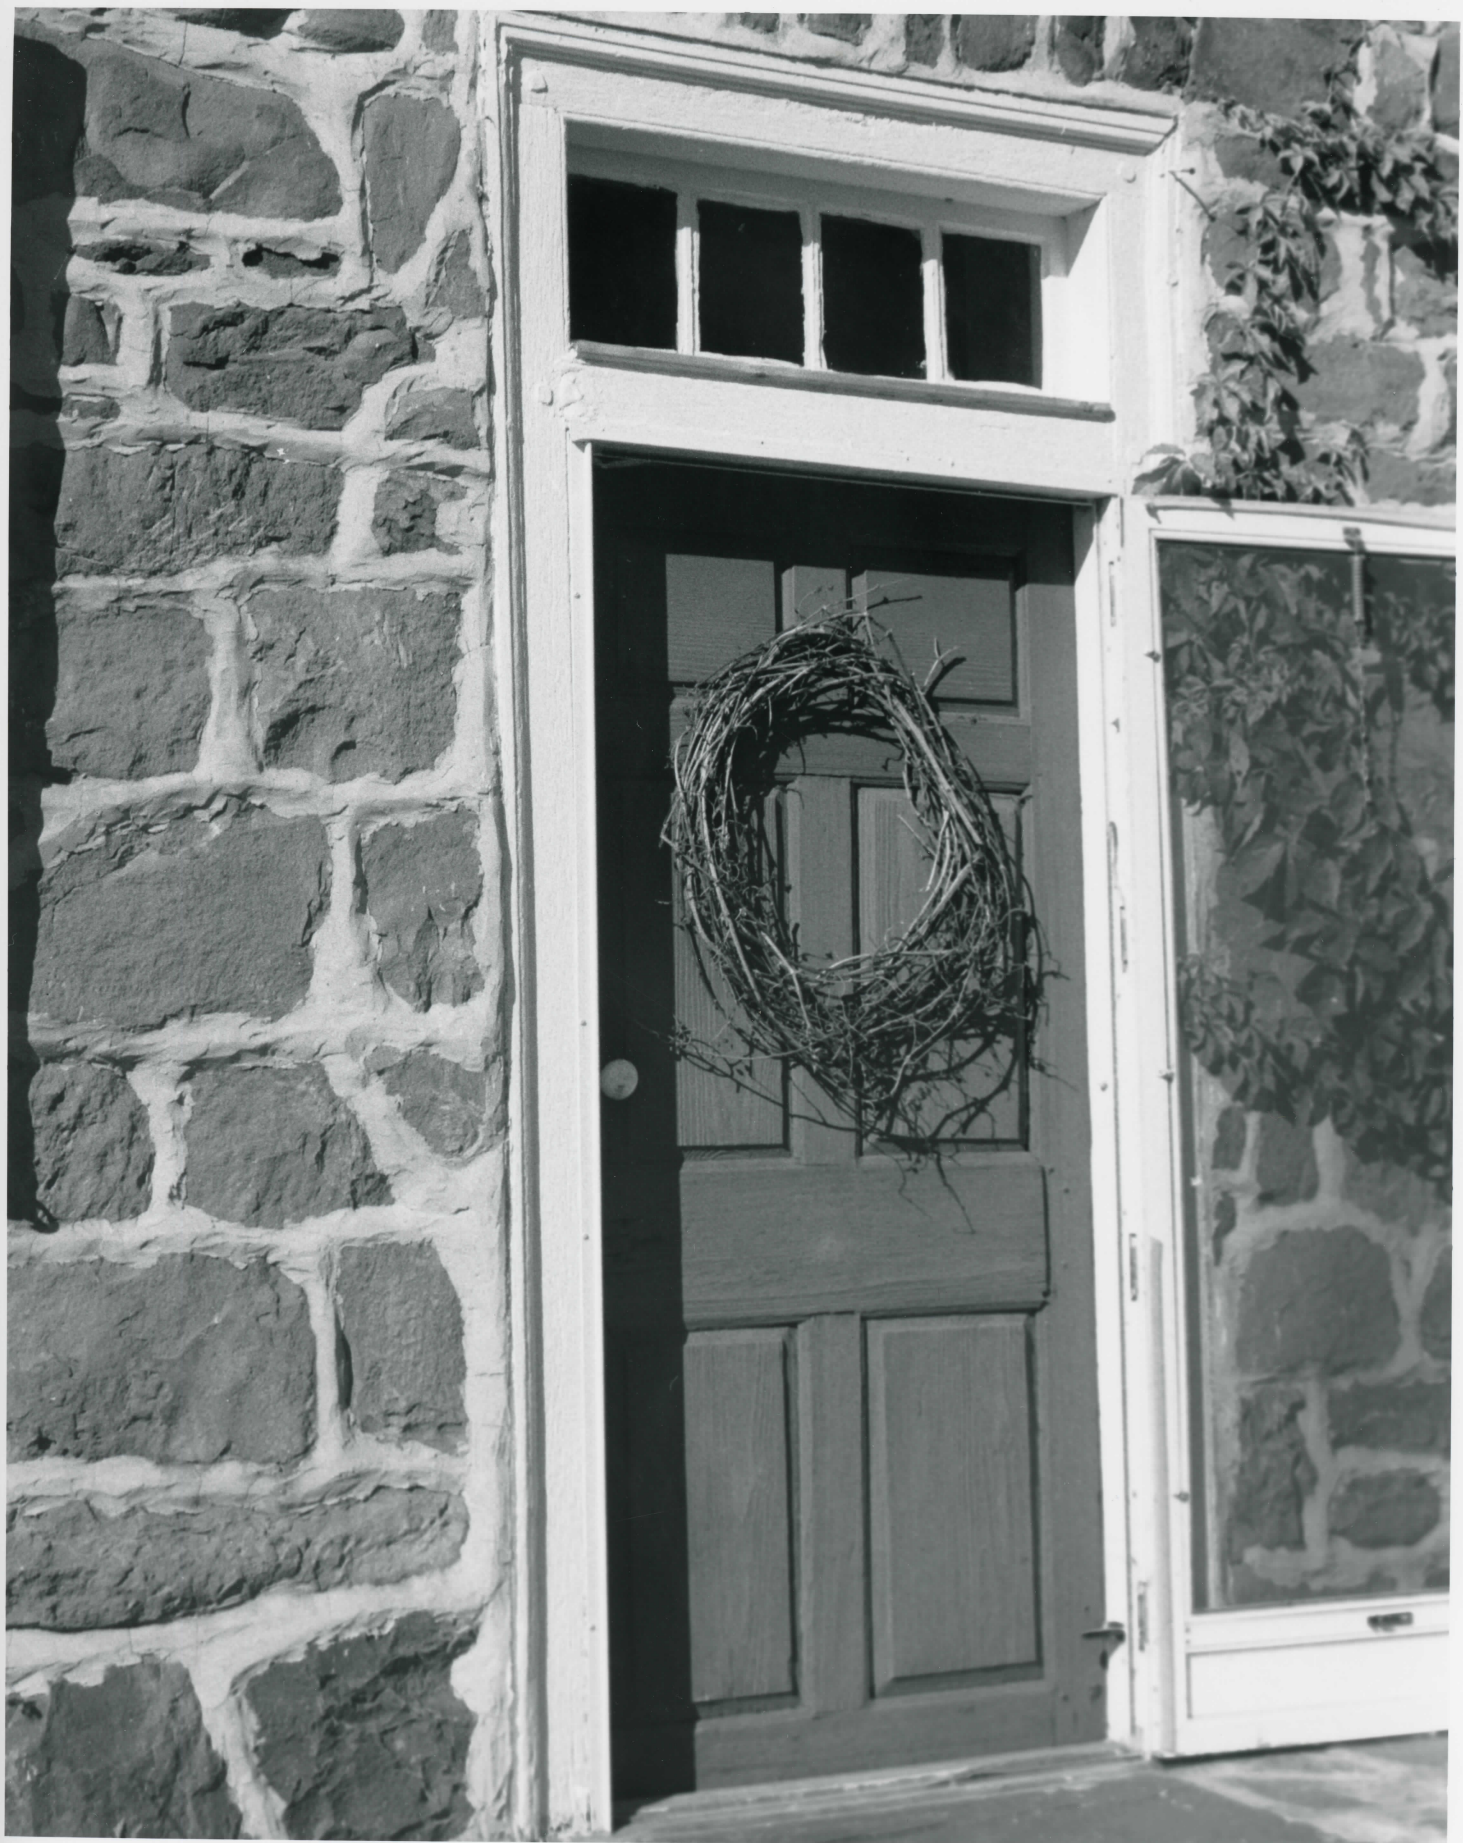
#7 and transom

- P.D. paneled front door

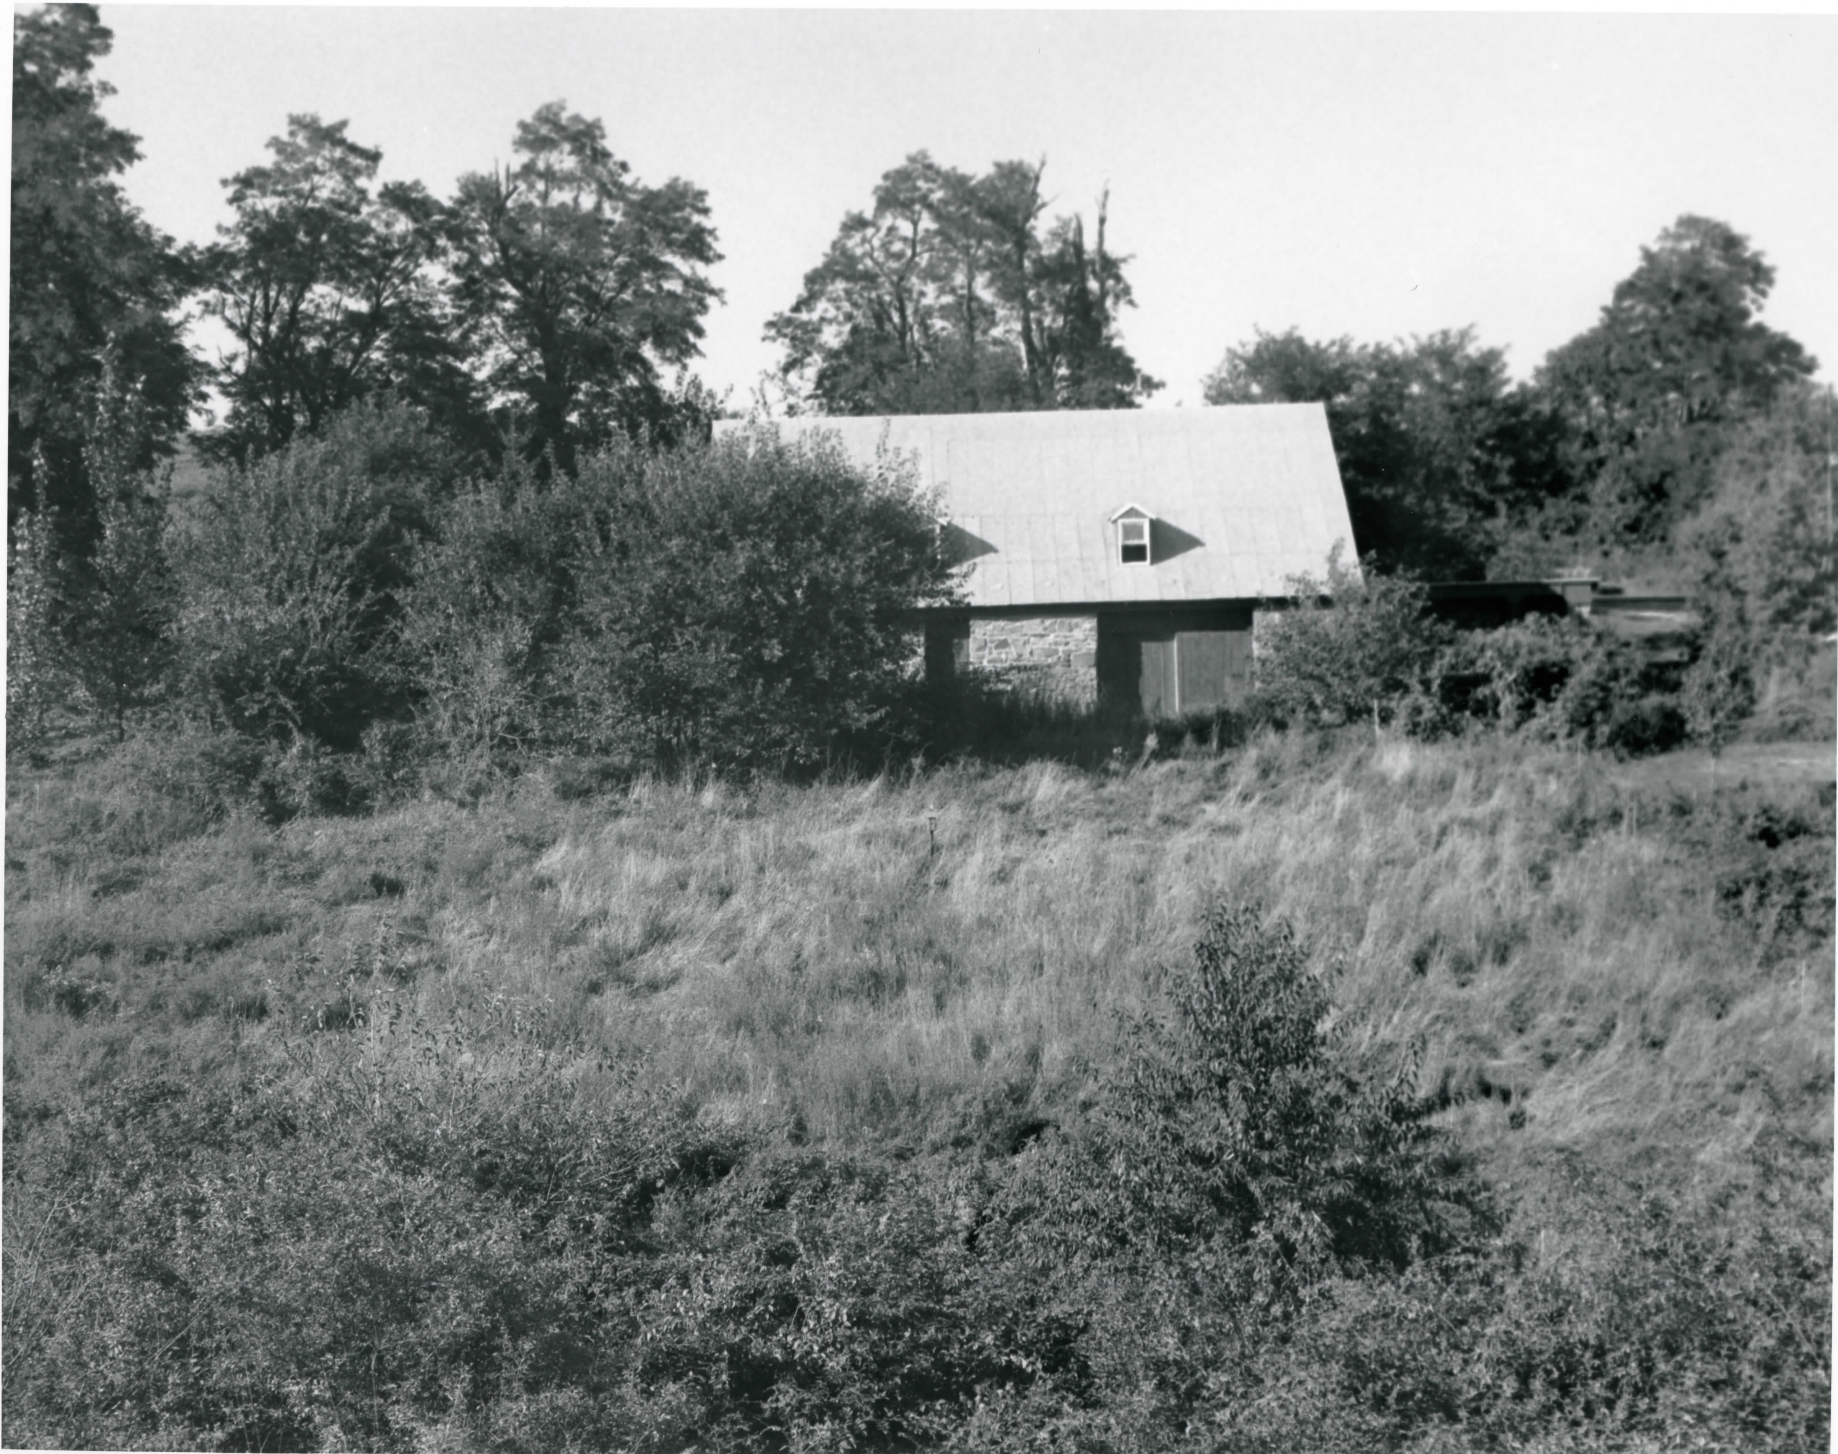
49

P.D. Reconstructed Barn

The barn on the property is a recycled bank barn built on part of the stone foundation of an earlier barn. The foundation dates from the period of German occupancy, too. The present barn was constructed of old materials on the old foundation and ties in well with the rest of the property. It is not a historic building, however, and therefore classifies as a non-contributing structure.

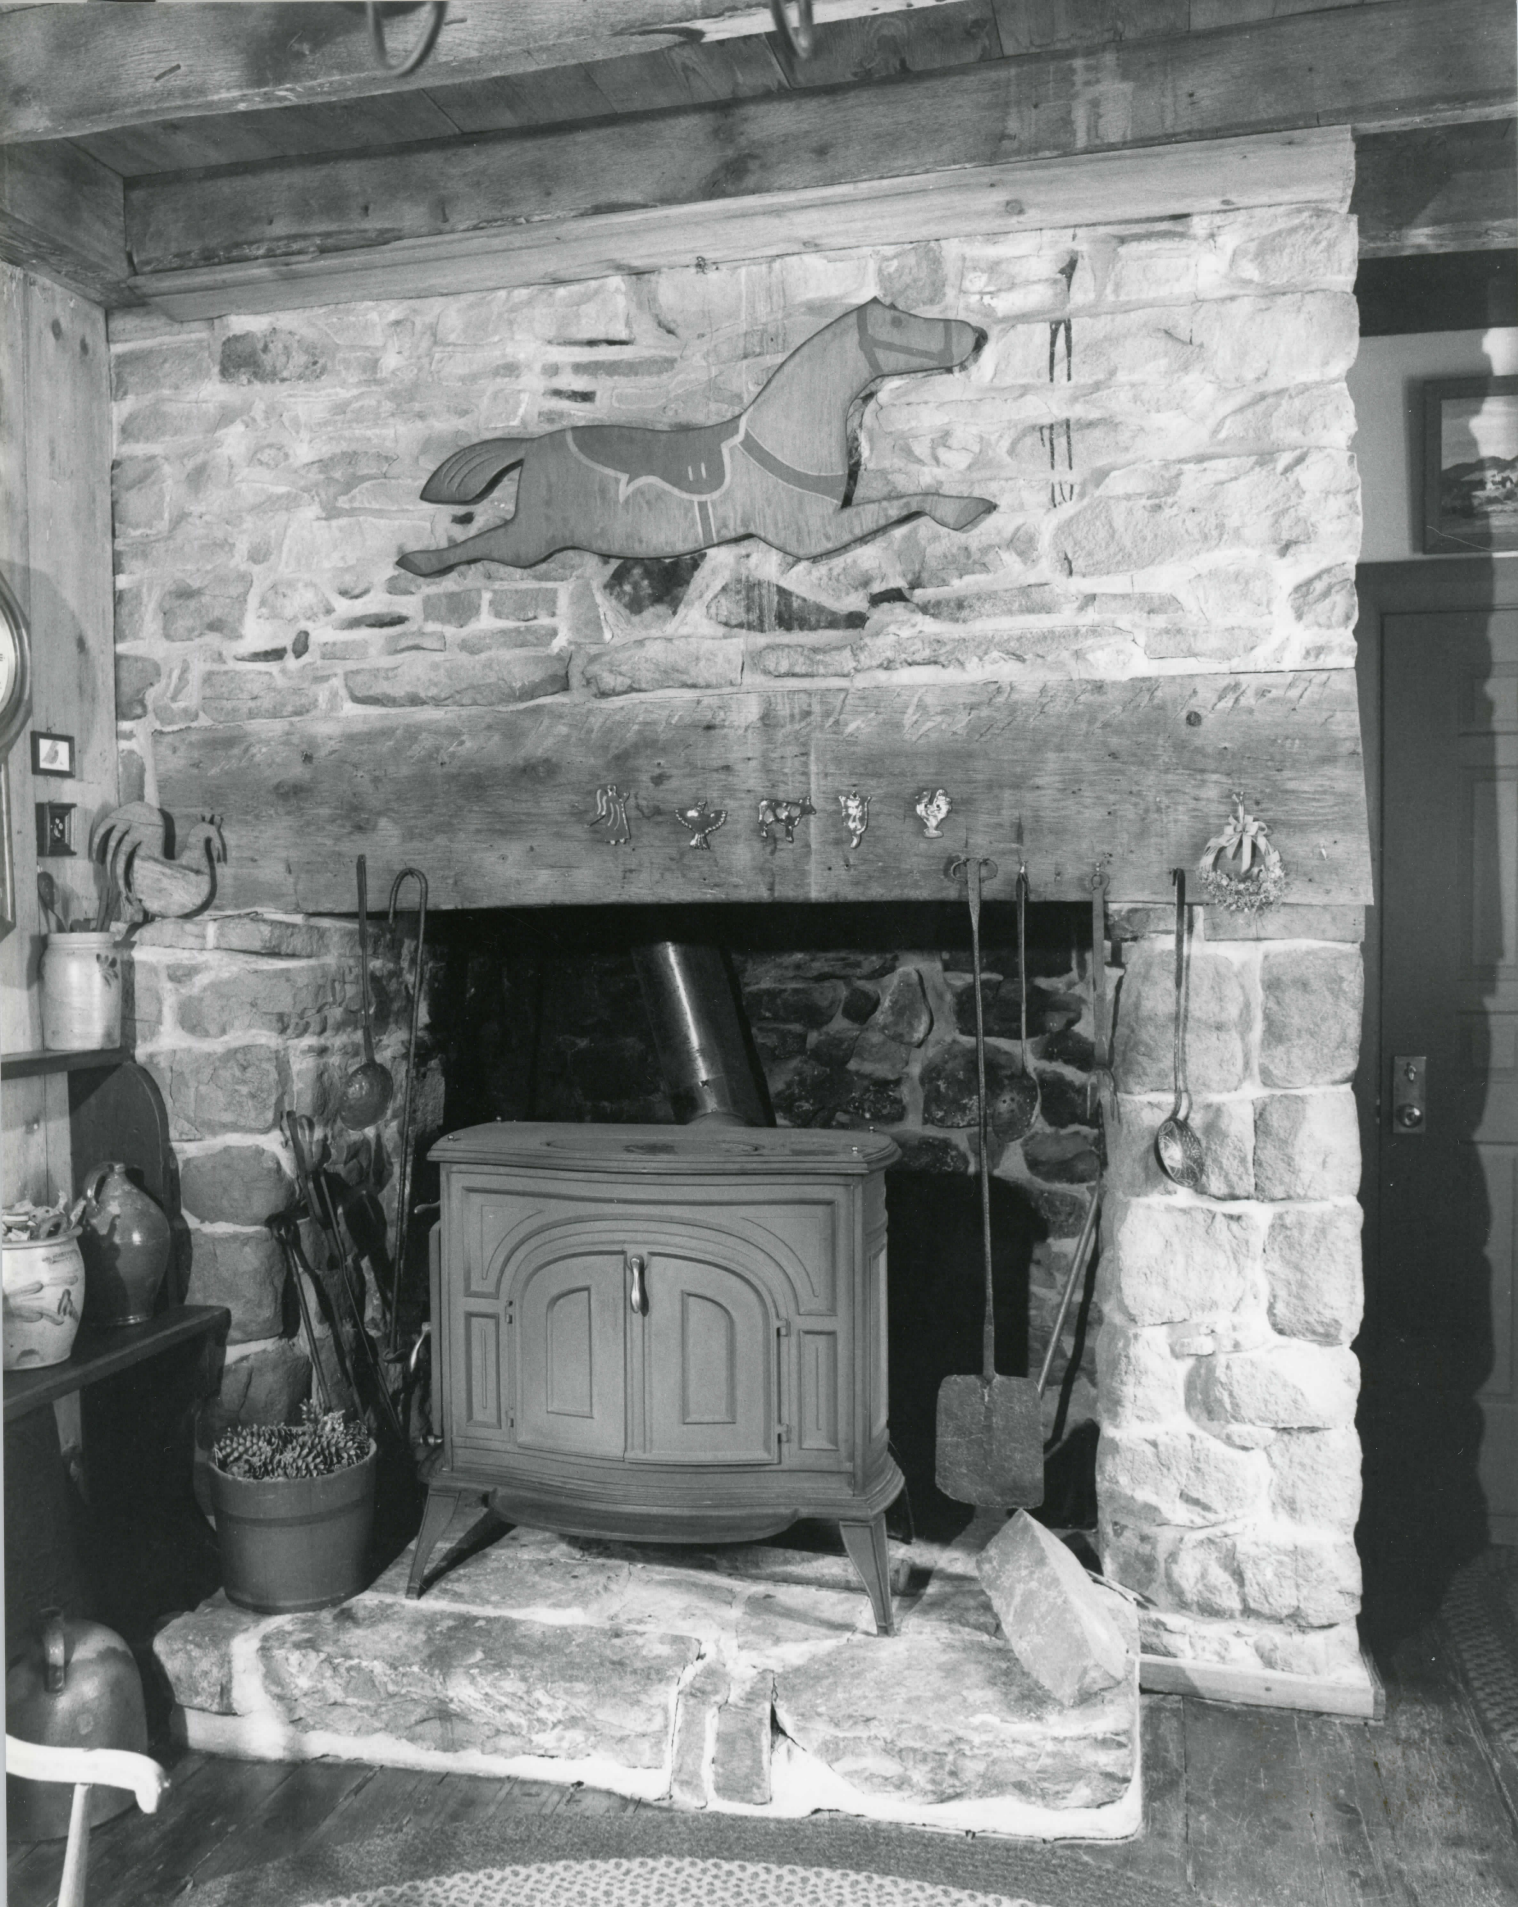
#10

P.D. Walk-in fire place

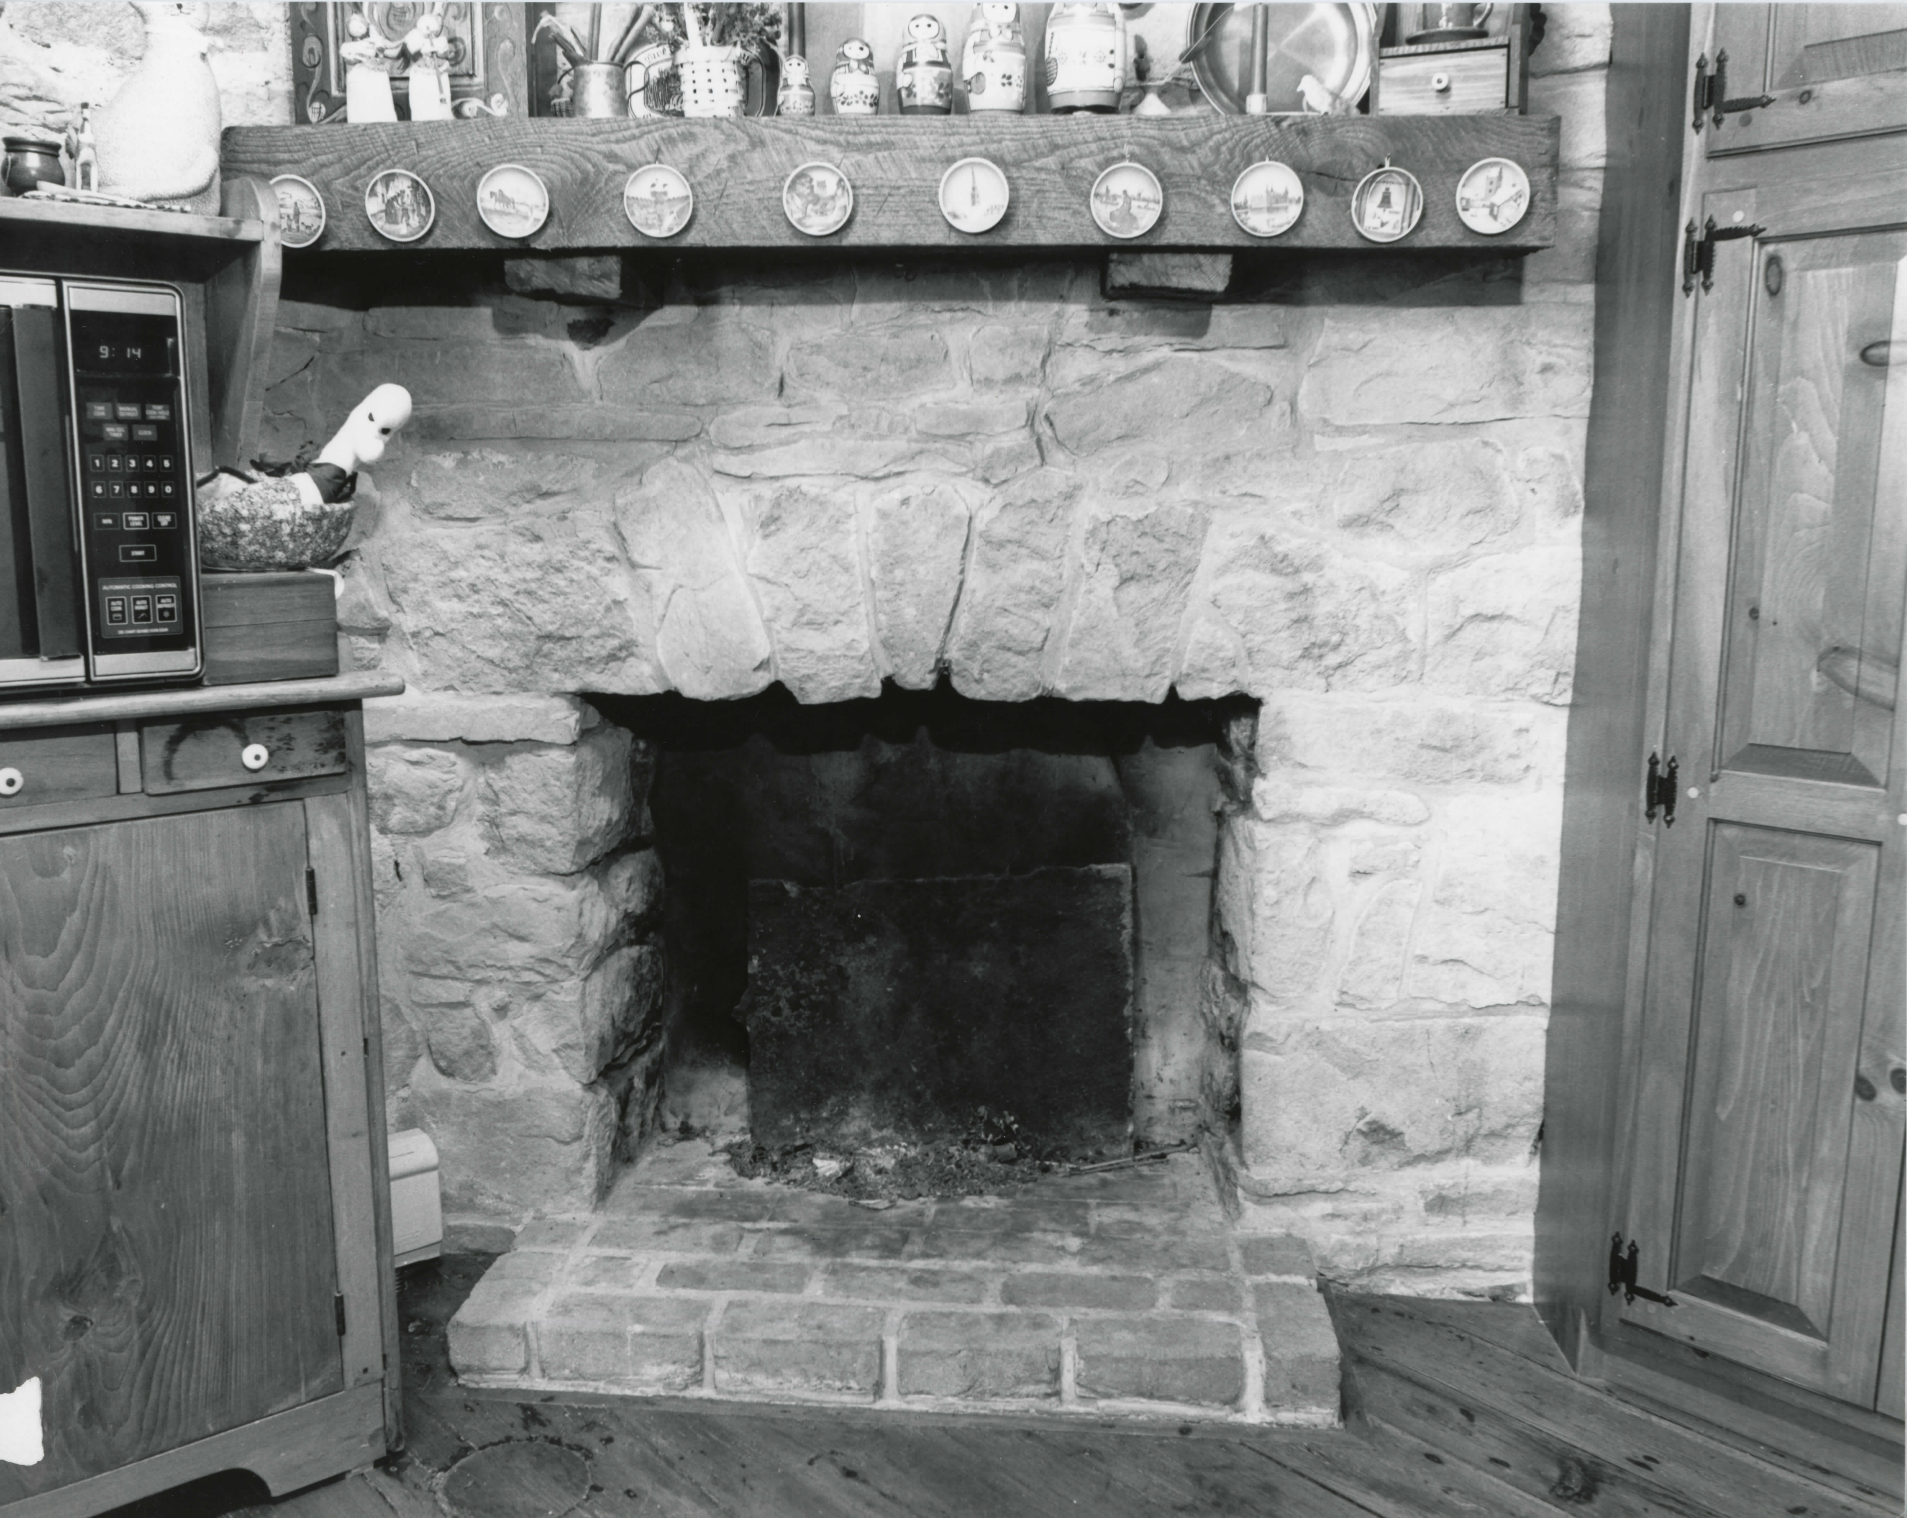
P.D. Stone fire place in
#11 present kitchen

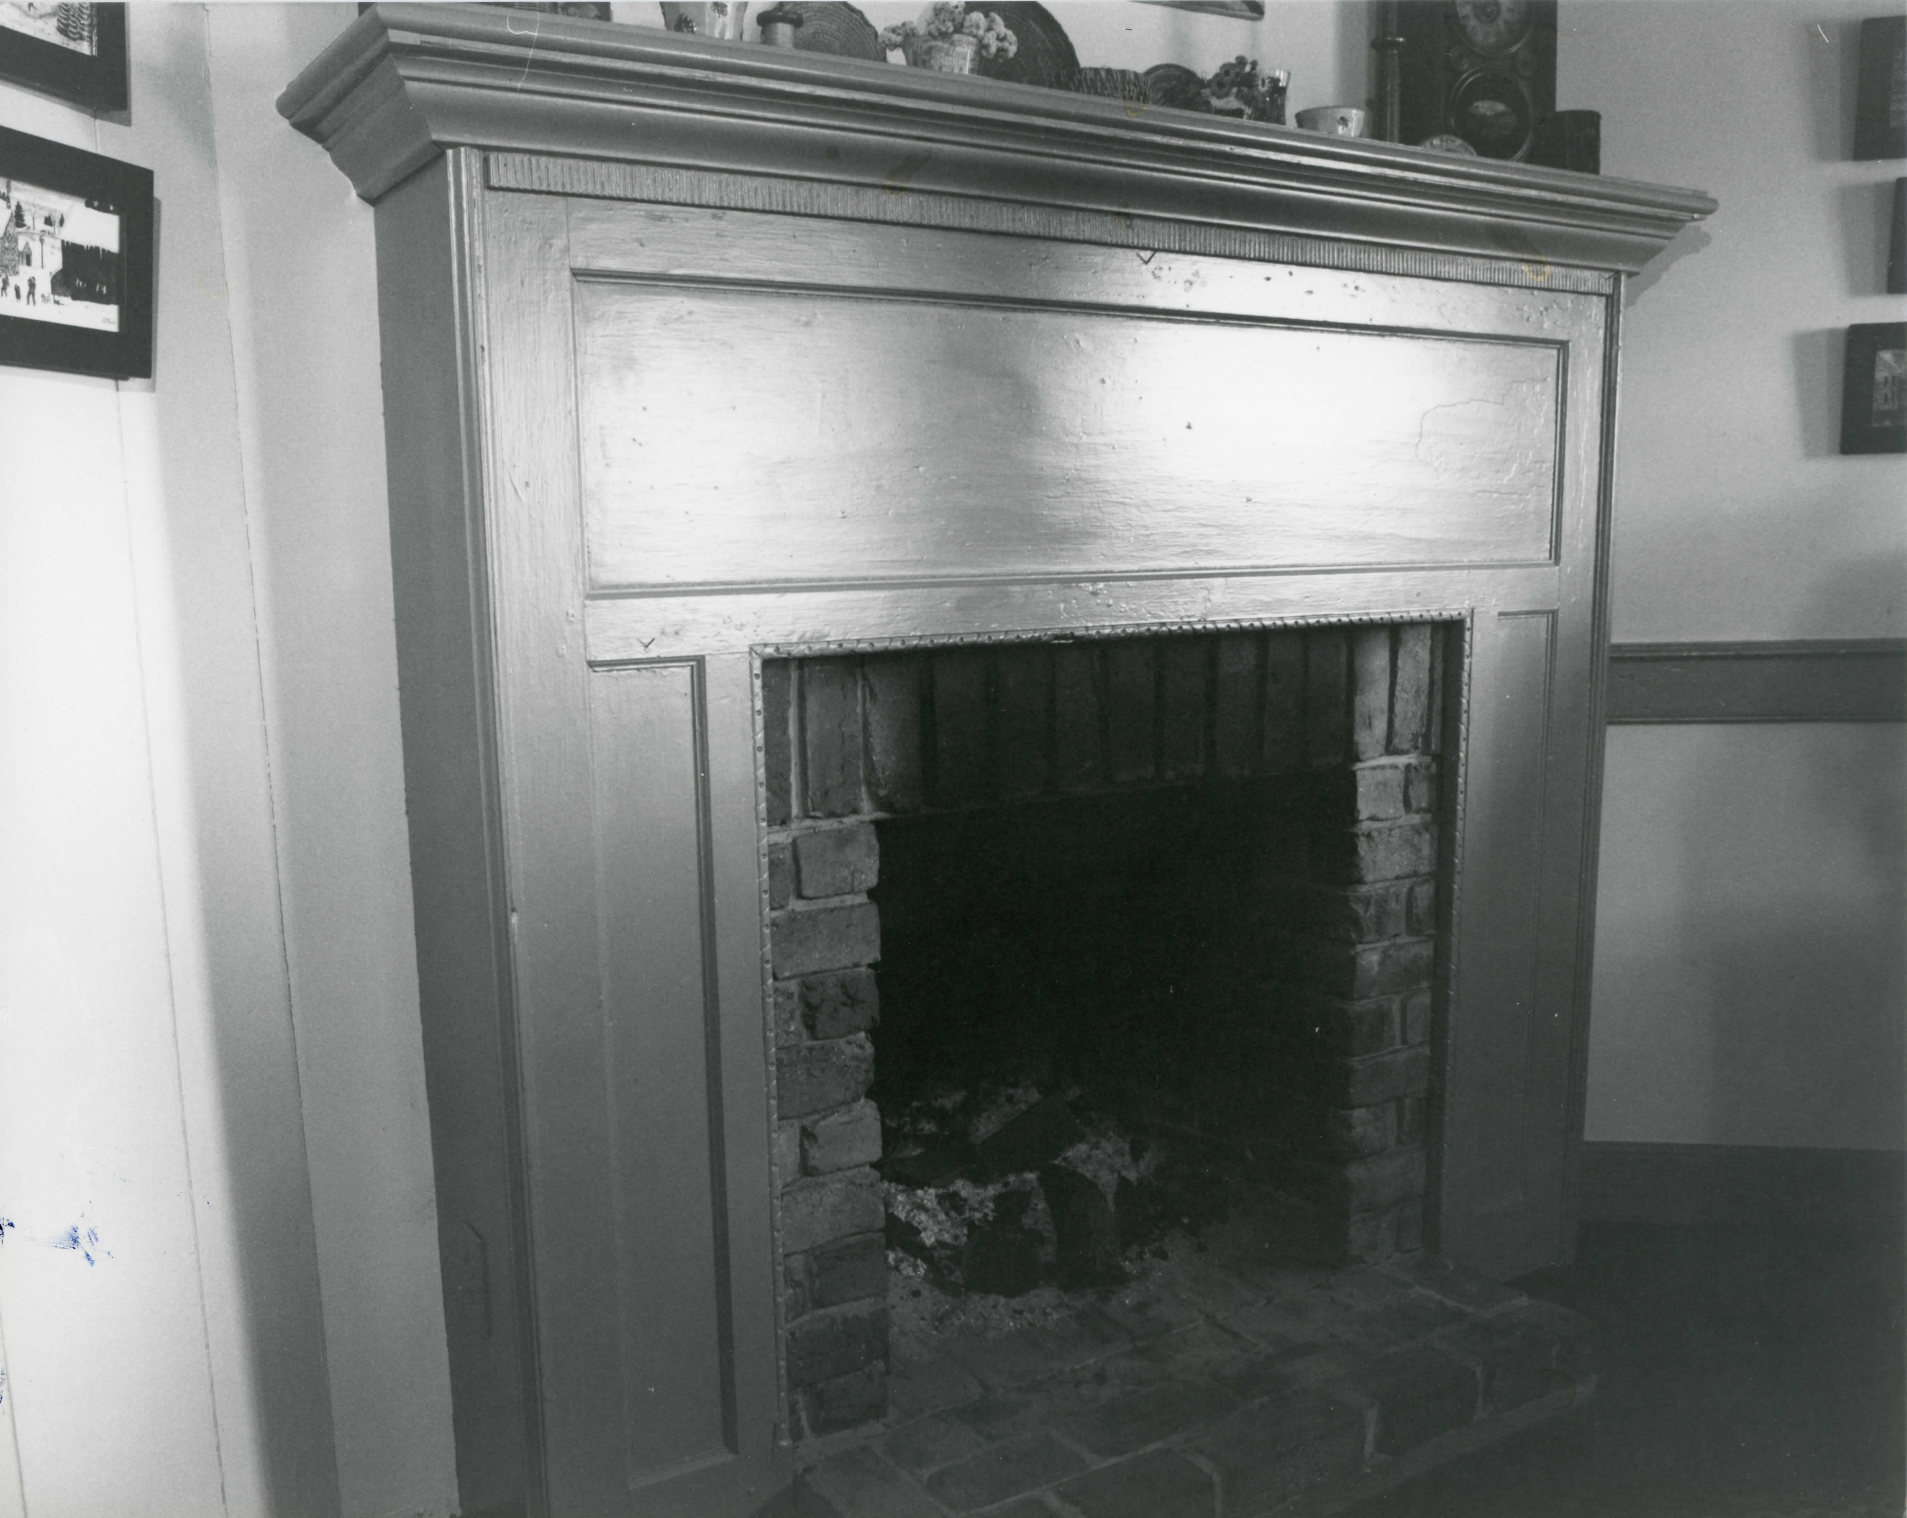
N.L. David Whipple Studio
— P.D. Federal fireplace with
#12 gougework

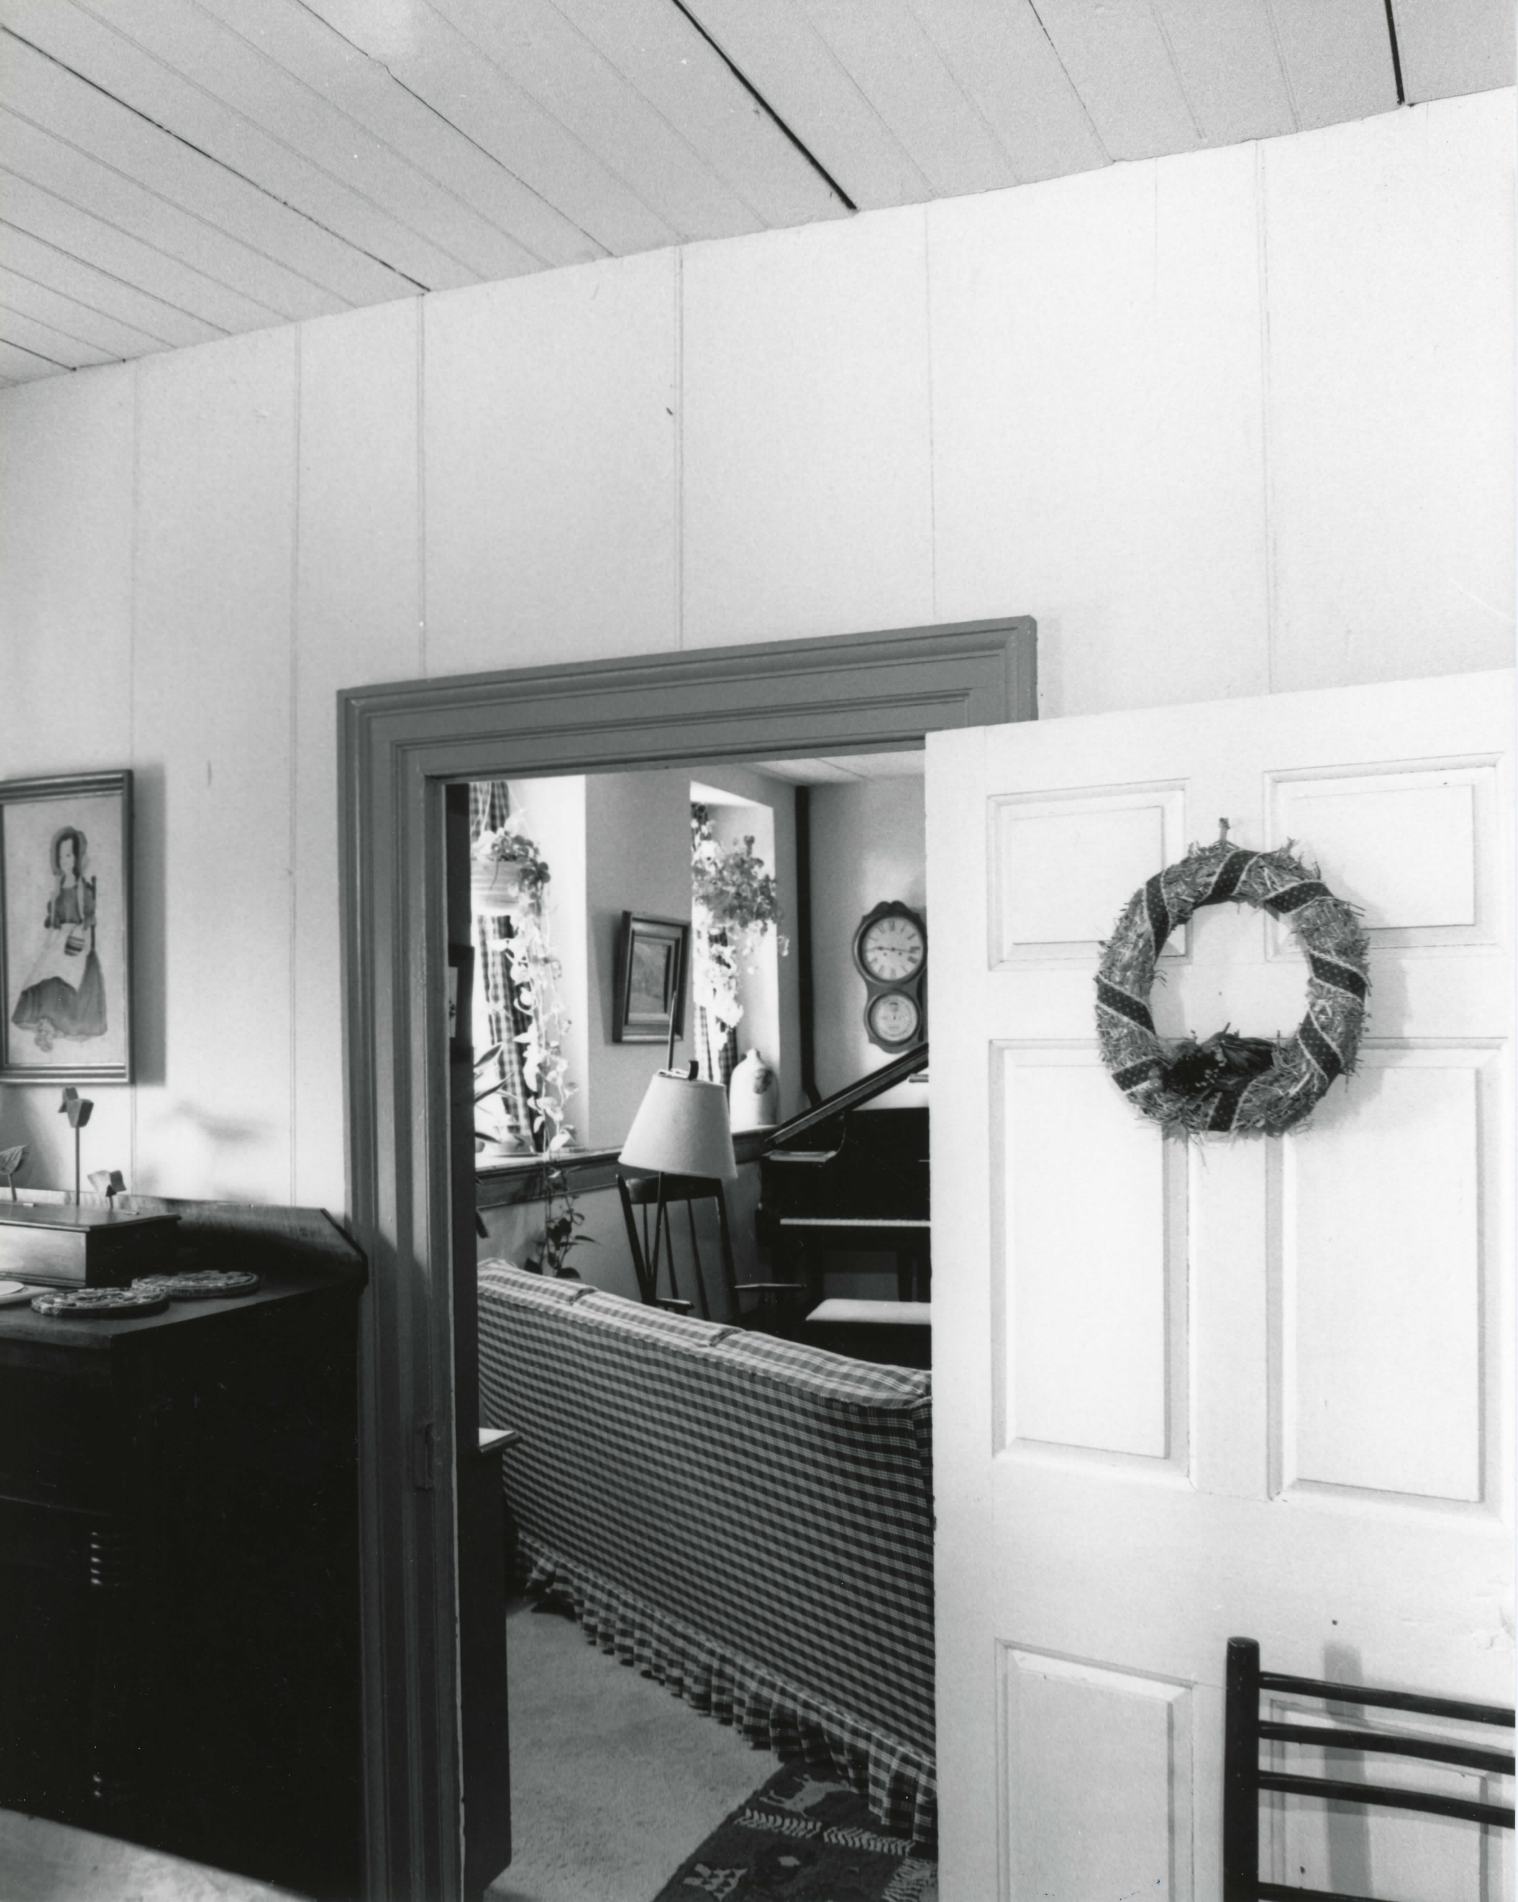
#13

Wall, Board ceiling, 6-
panel interior door
