National Register of Historic Places Registration Form

historic name John Todd House
other names/site number N/A

John Todd House

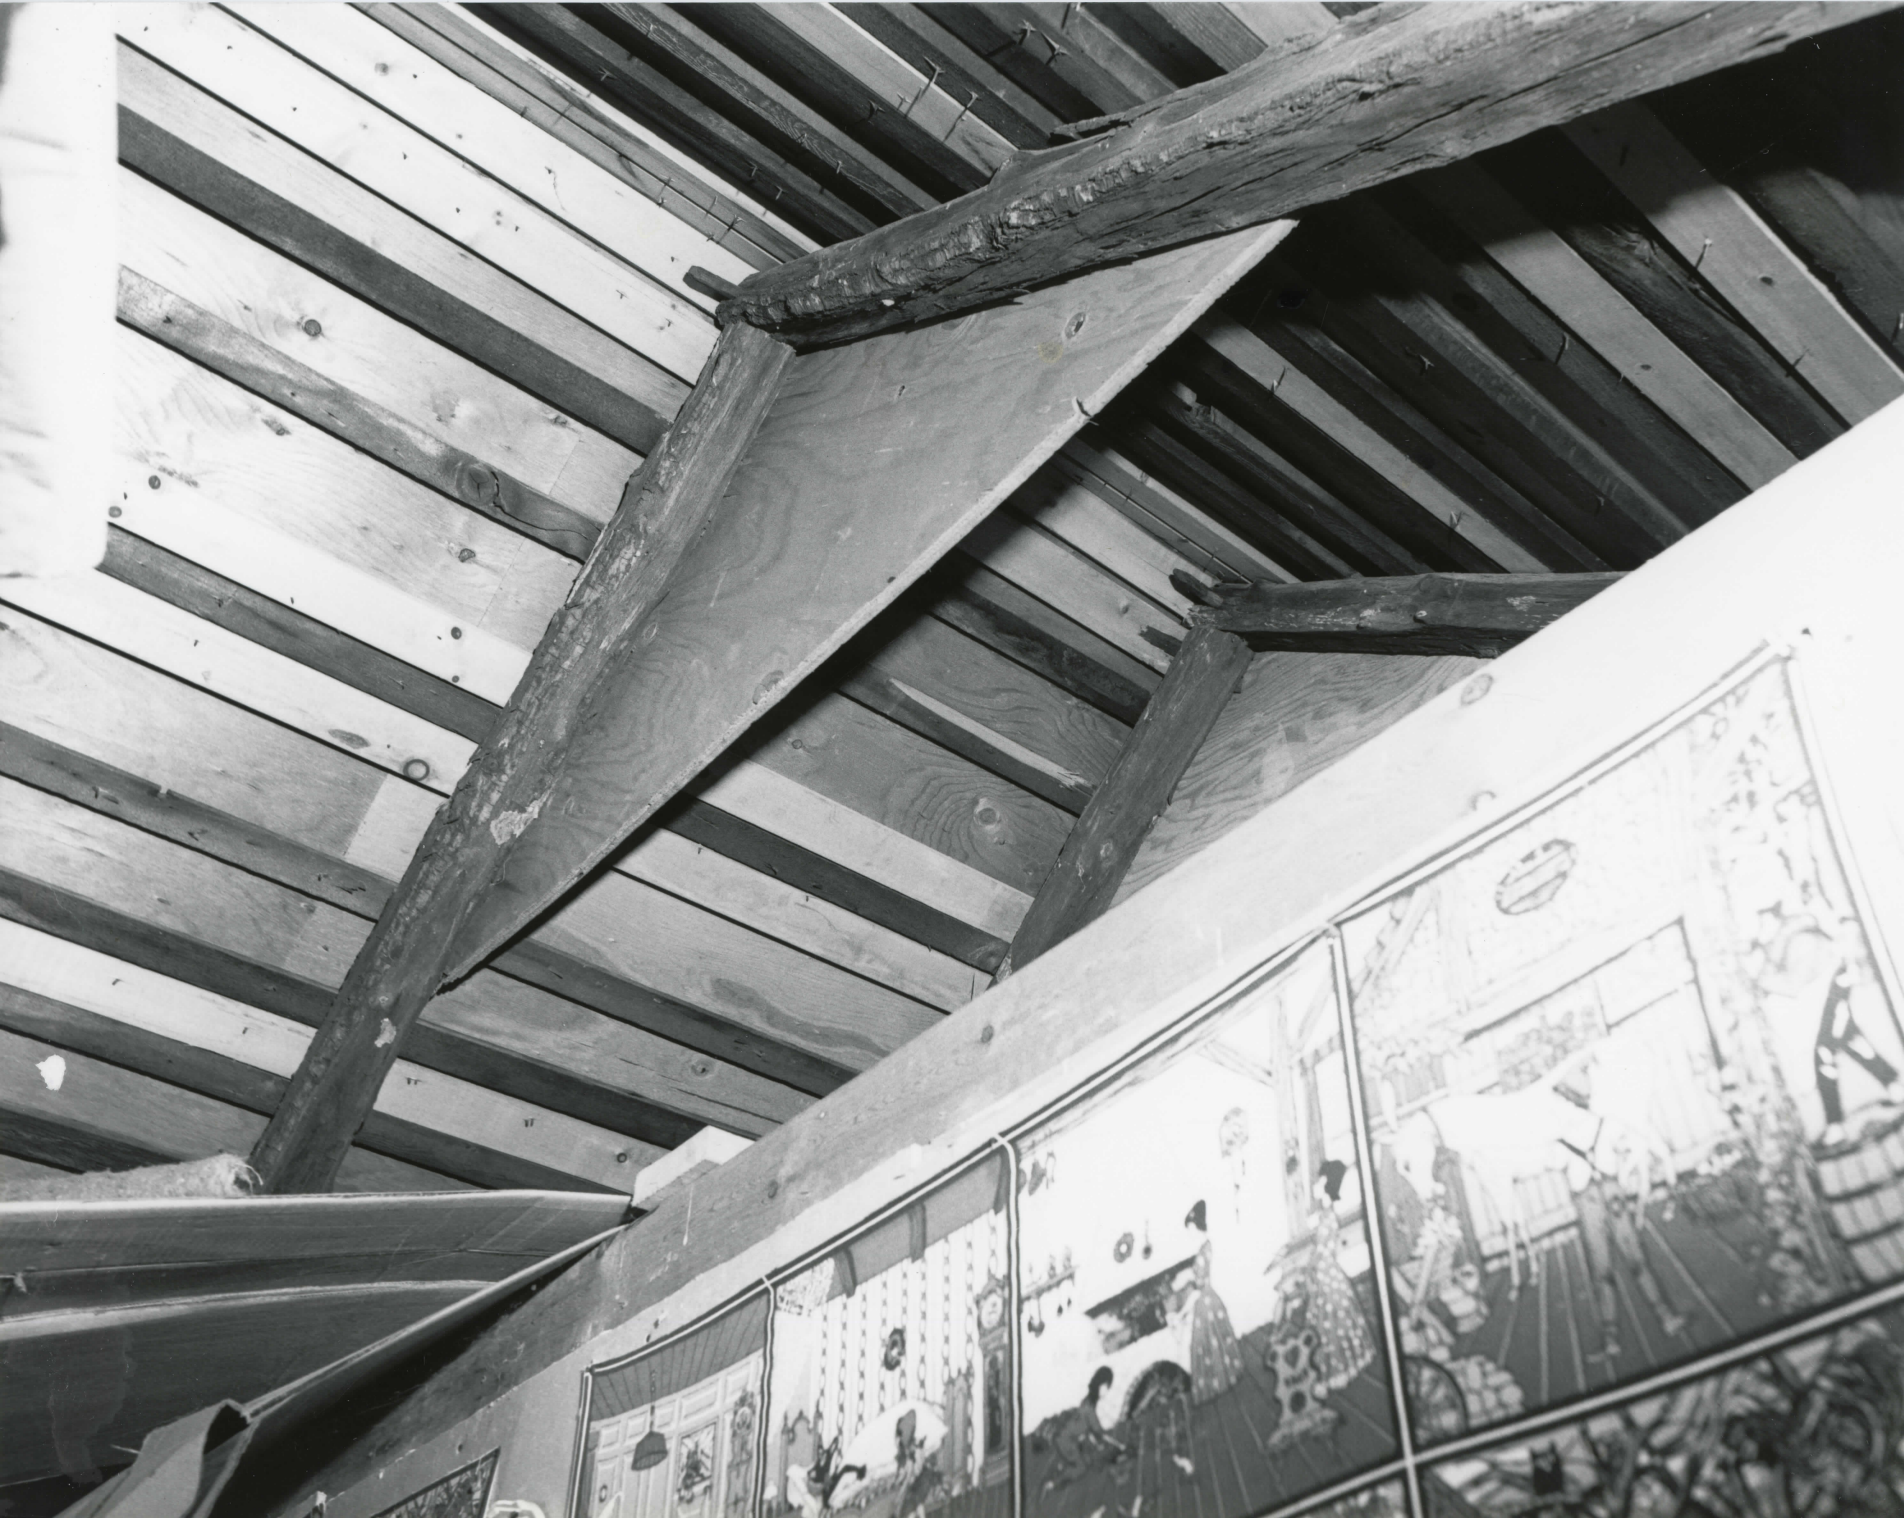
P.D. Attie detail showing
#15 Pinned rafters

The roof construction system employs widely spaced hewn principal rafters which are pegged into hewn tie beams. The rafters are pegged together at the peak of the roof and there is no ridge pole. Purlins run between the rafters to provide support for the roofing. Present roofing is a high quality asphalt shingle. A trap door on the north side of the roof allows access to the roof and the chimneys.

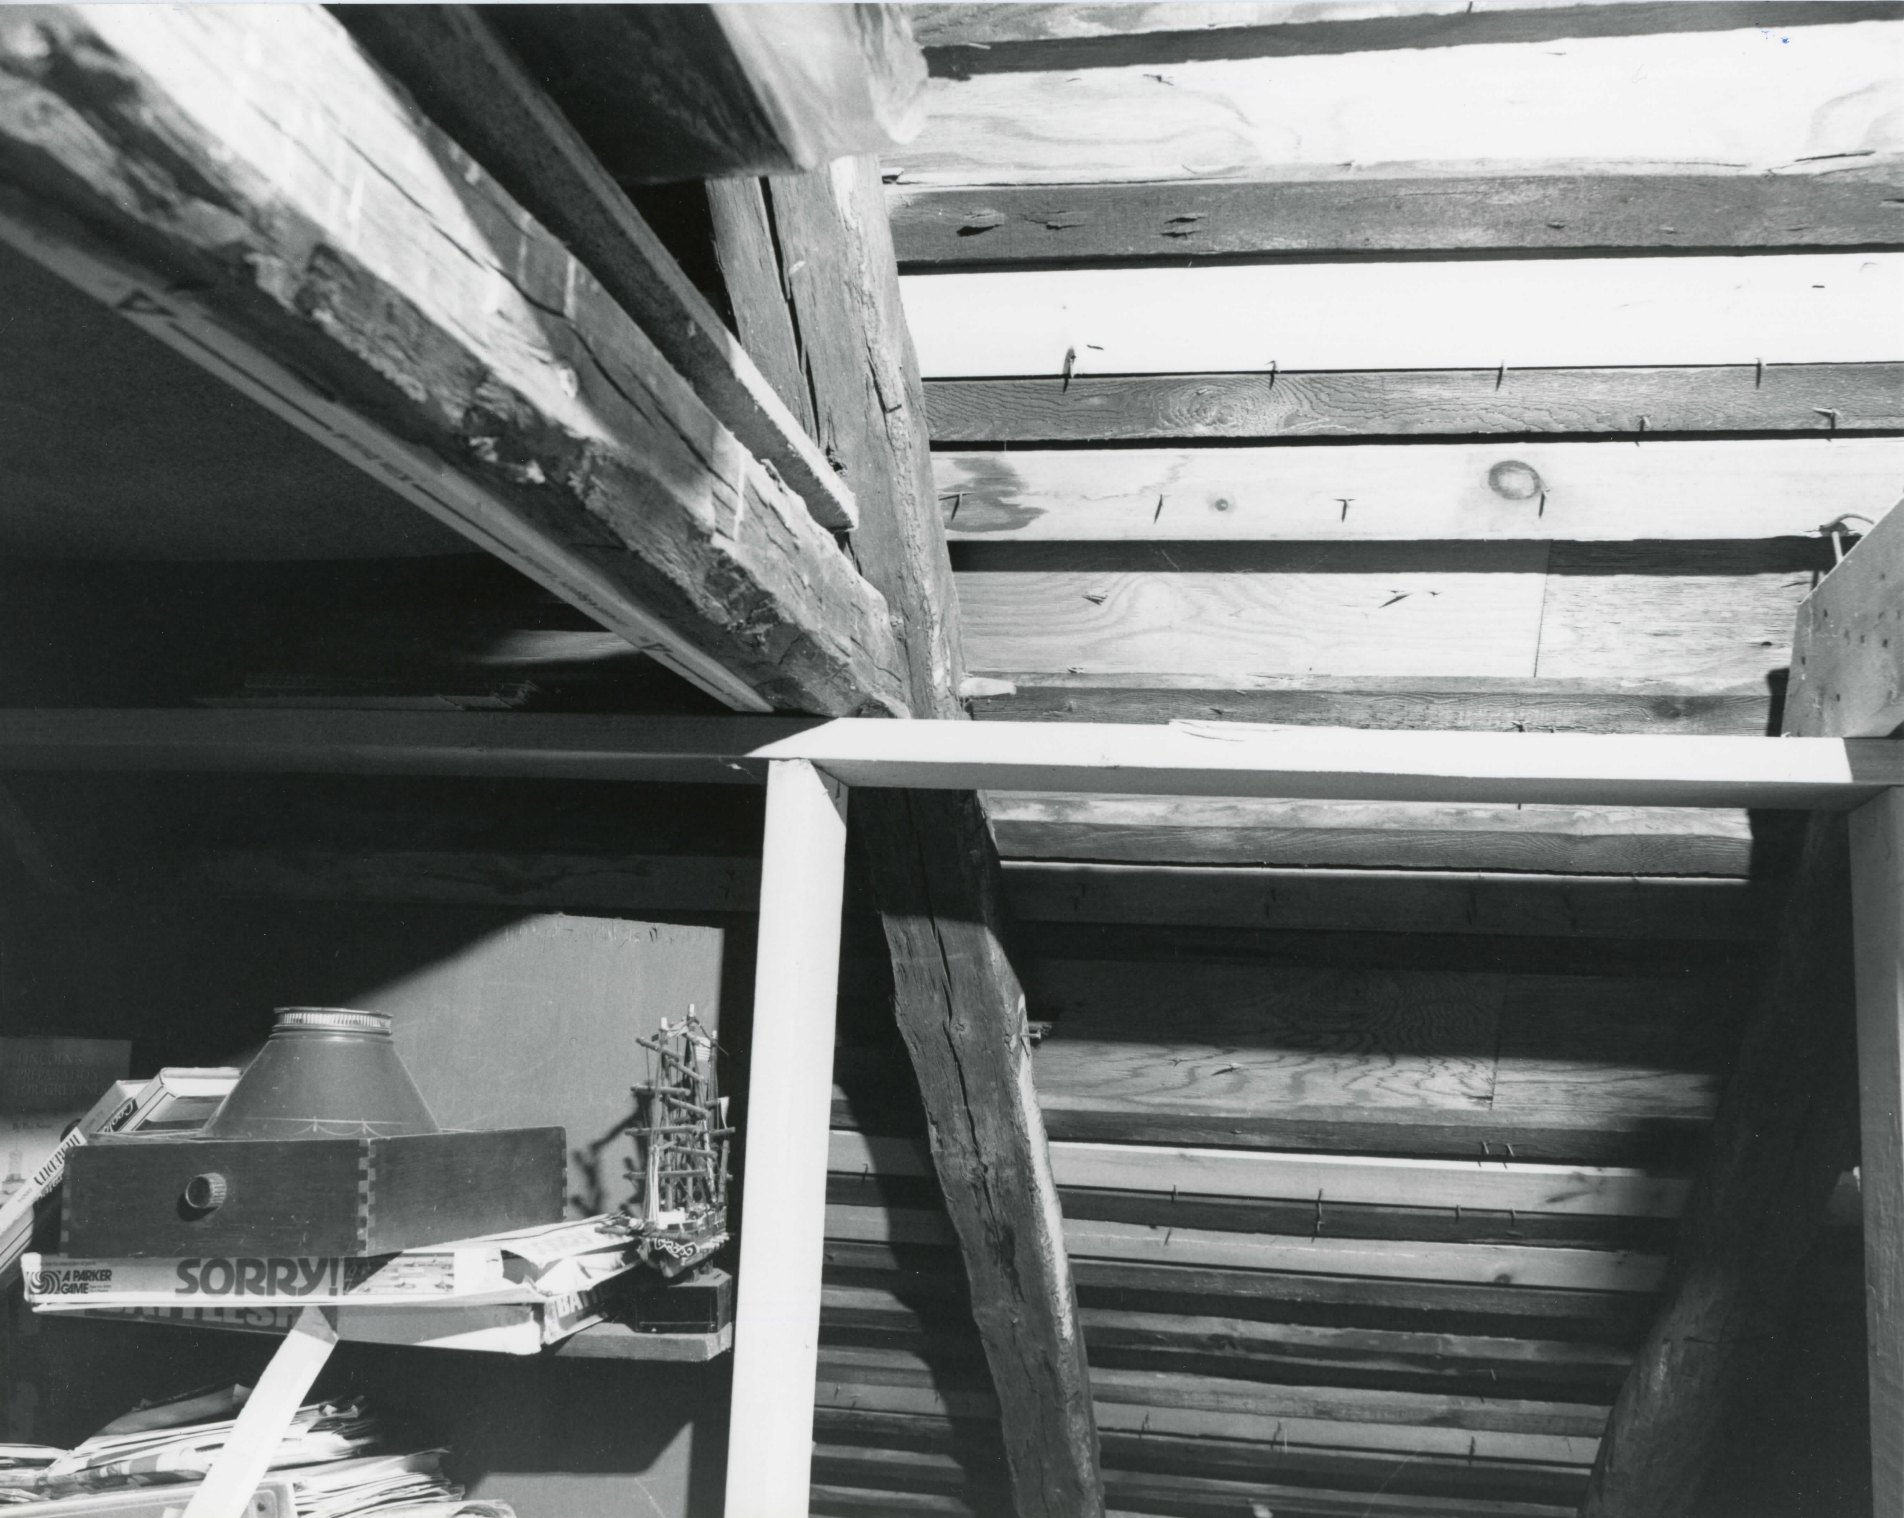
#16

into rafter

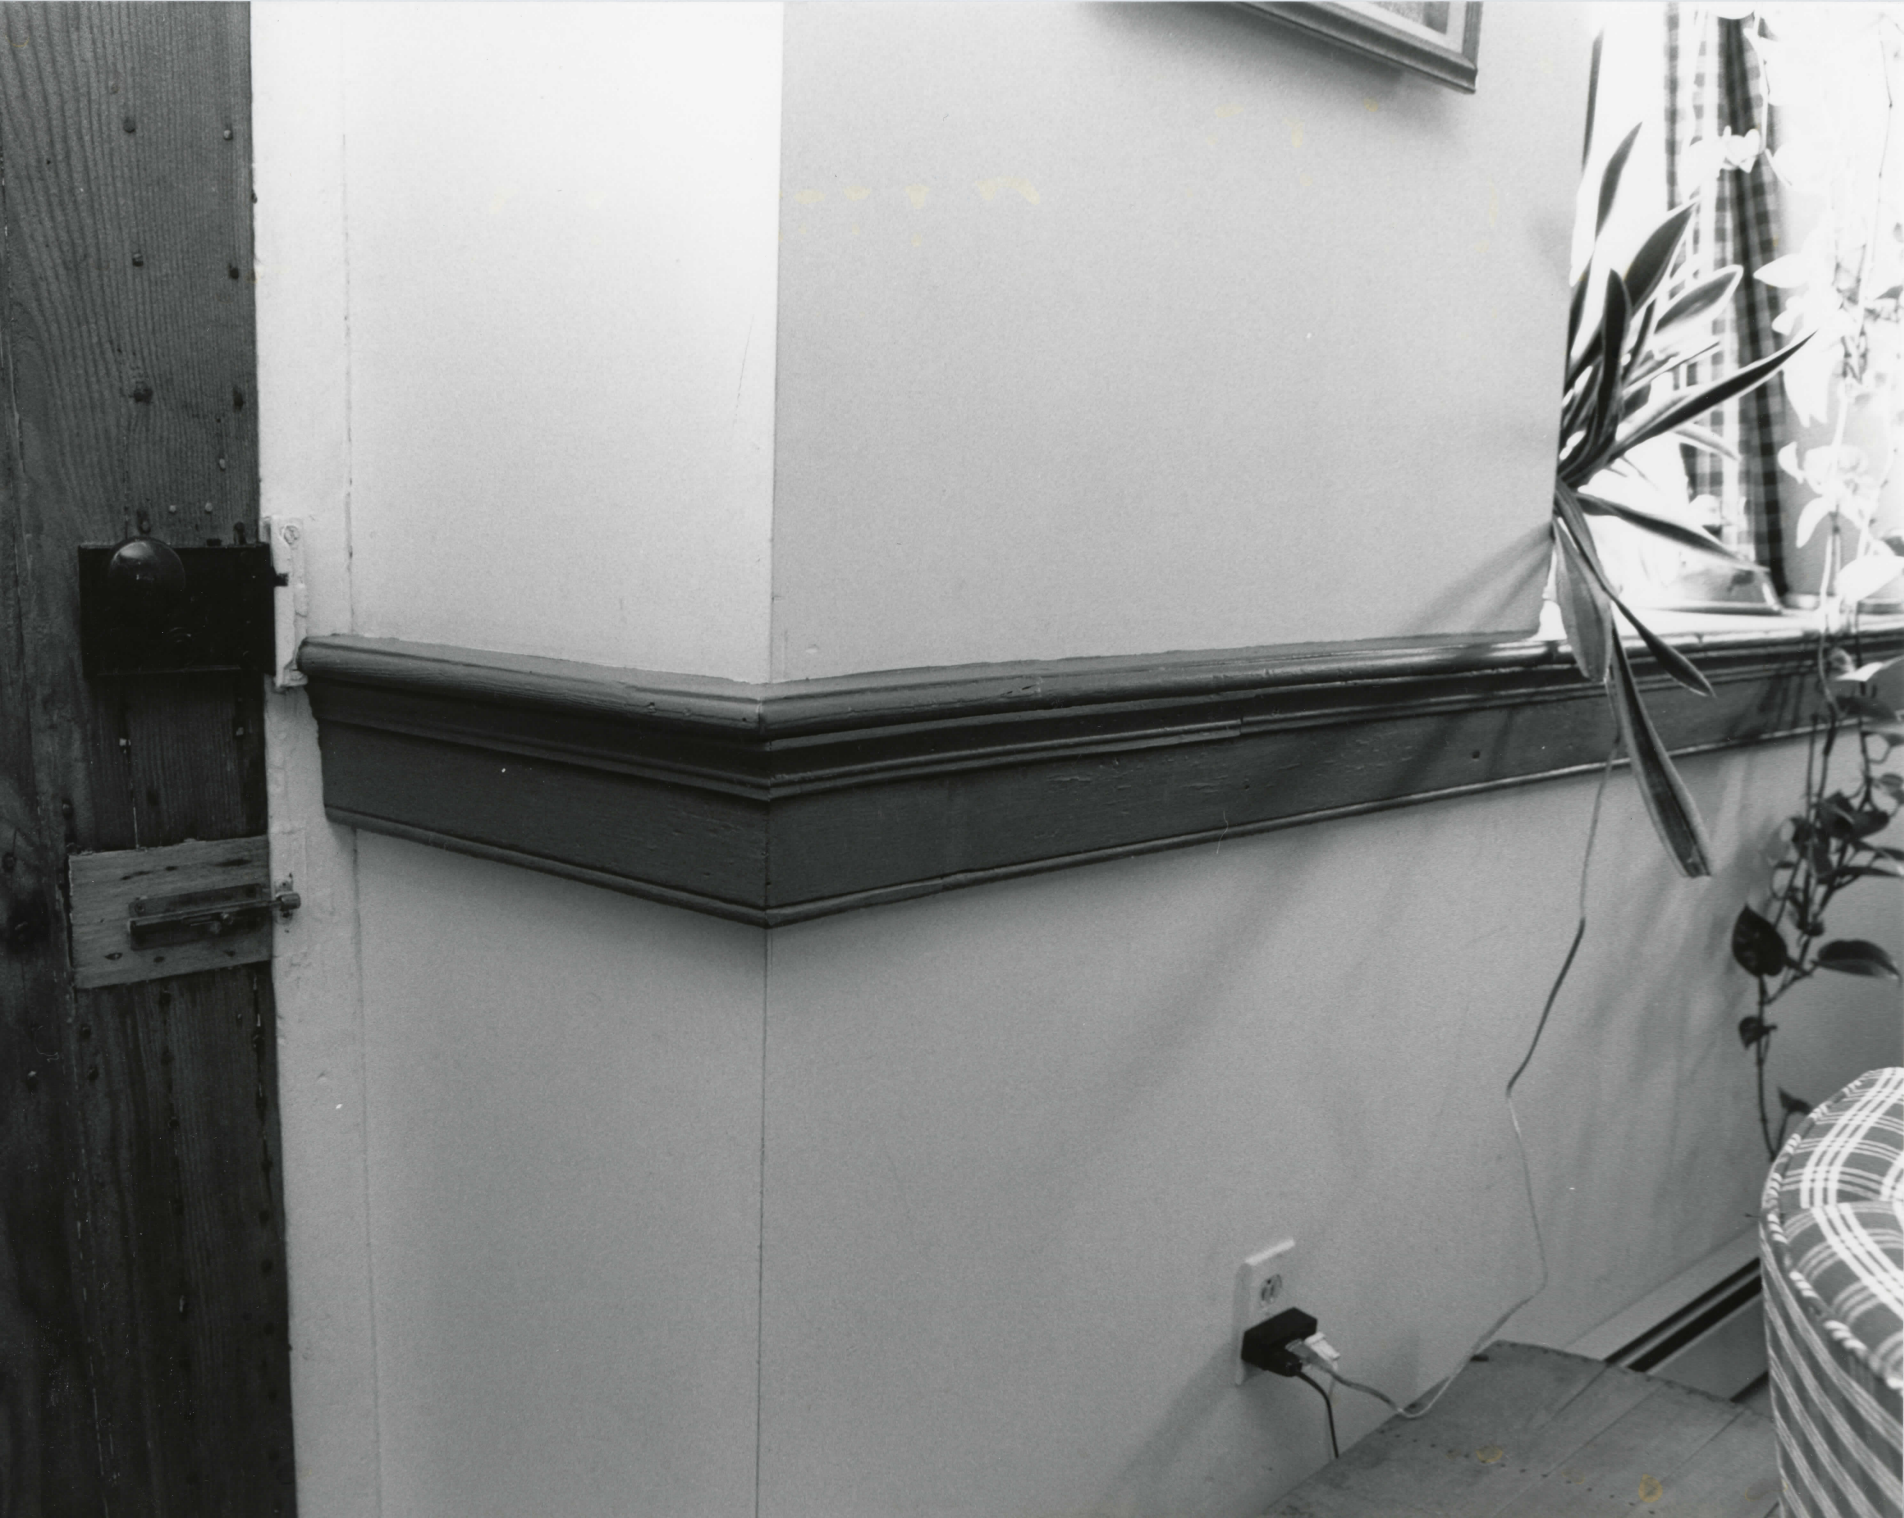
N.H. David Whipple Studio
P.D. Details living room
#17 Chair rail
