National Register of Historic Places
Registration Form

historic name Smith, Henry Farm
other names/site number Hidden Spring Farm

Henry Smith Farm

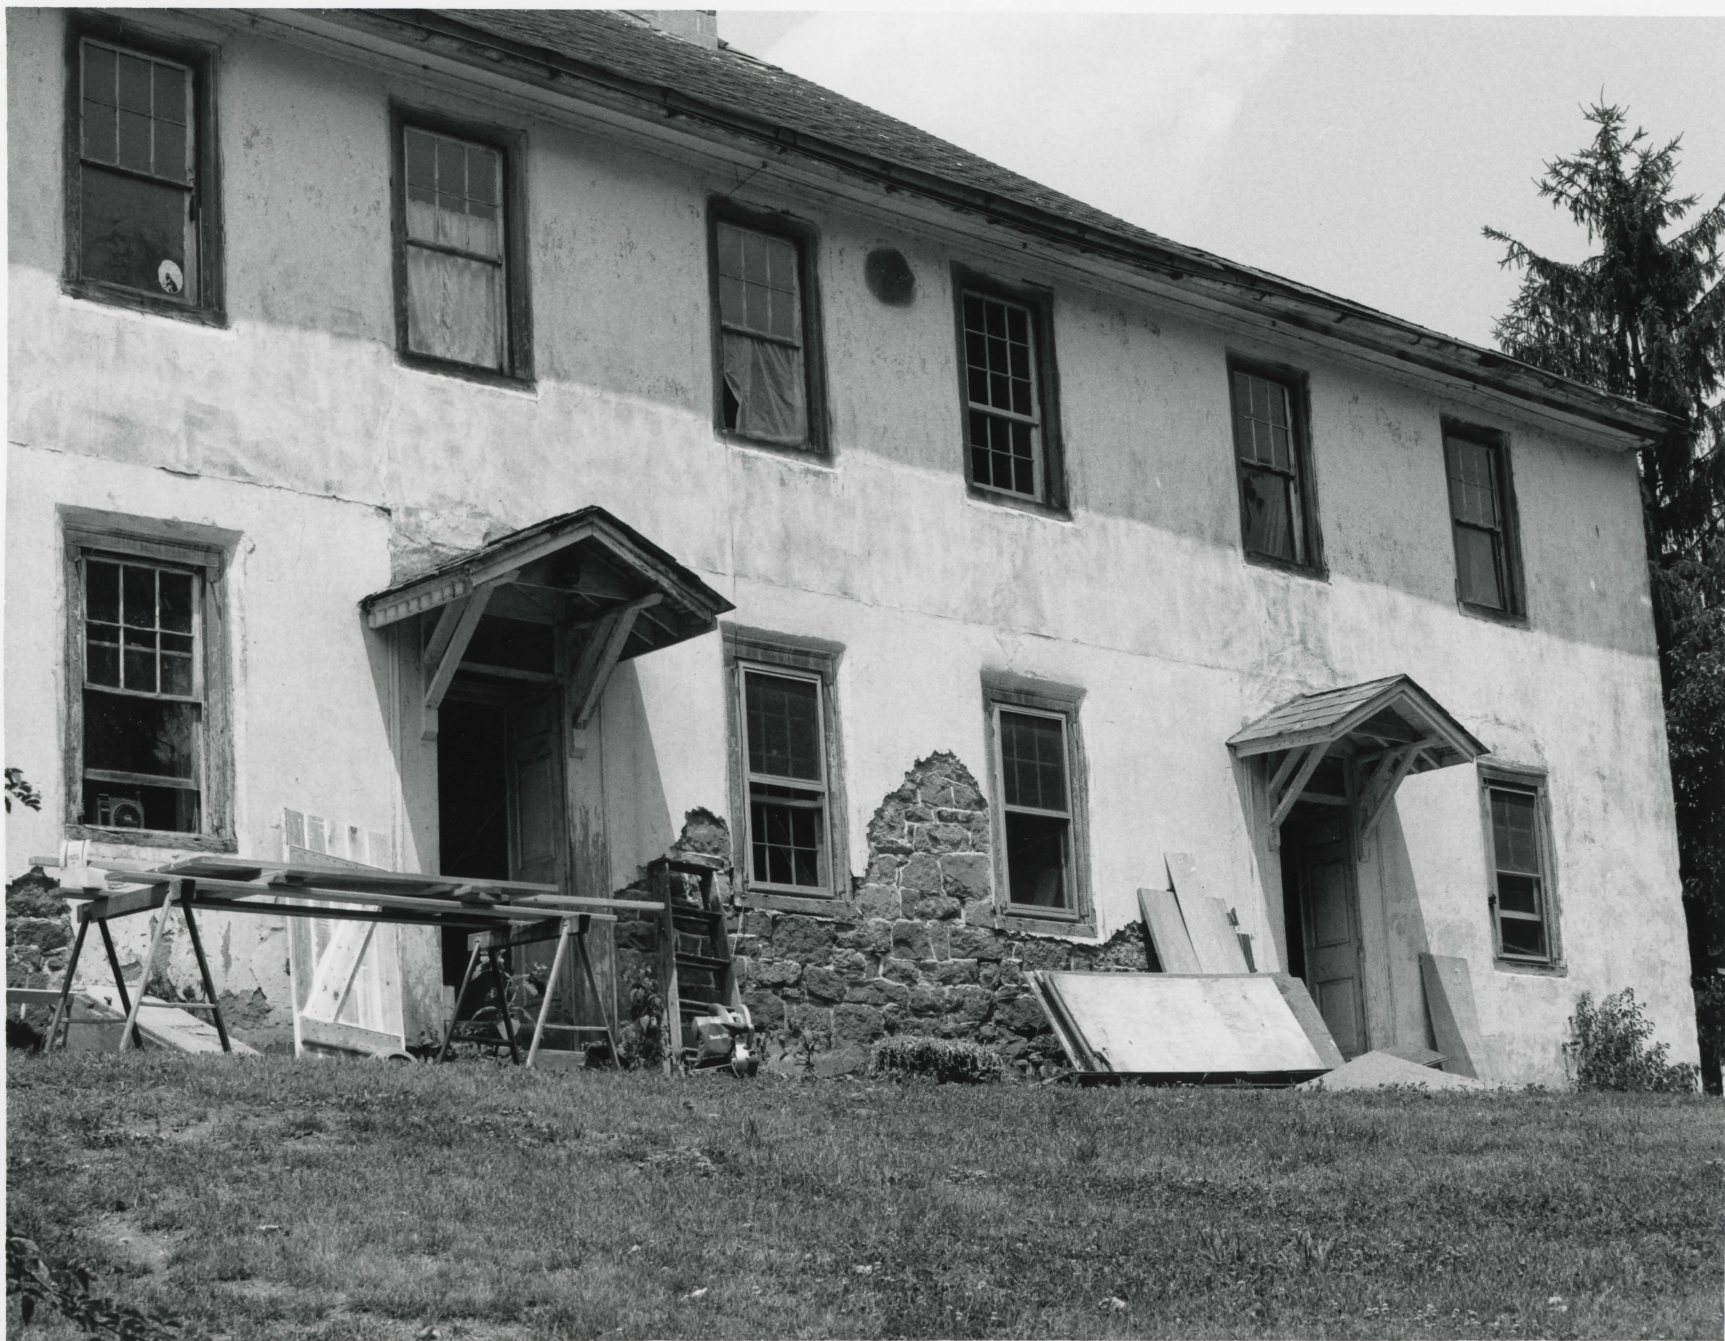
- I - 1. Henry Smith Farm
2. Londonderry Twp., PA
3. Ed Dannels
4. July, 1988
5. Ed Dannels, 950 Swatara Creek Road, Middletown, PA
6. View showing the stuccoed south facade of the house. Note the datestone between the eastern second story windows of the main block. The easternmost two bays (on right) are the kitchen addition. (The westernmost bay is not shown on this photo.) The hoods over the doors appear to be a twentieth-century addition. The raised panel door reveals can be seen beneath these.
7 a
(The first five items are the same for the following photographs.)

The house was entirely stuccoed some time in the nineteenth century. Previous owners began removing the stucco, and the current owners plan on completing this process. Apparently, the hoods over the front doors were added some time in the twentieth century. They are scheduled to be removed as part of the restoration. When the present owners purchased the house, the roofing material on the northern side was slate, put on during the Second Empire period, while standing seam covered the southern side. The owners have replaced the entire roof with cedar shingles.

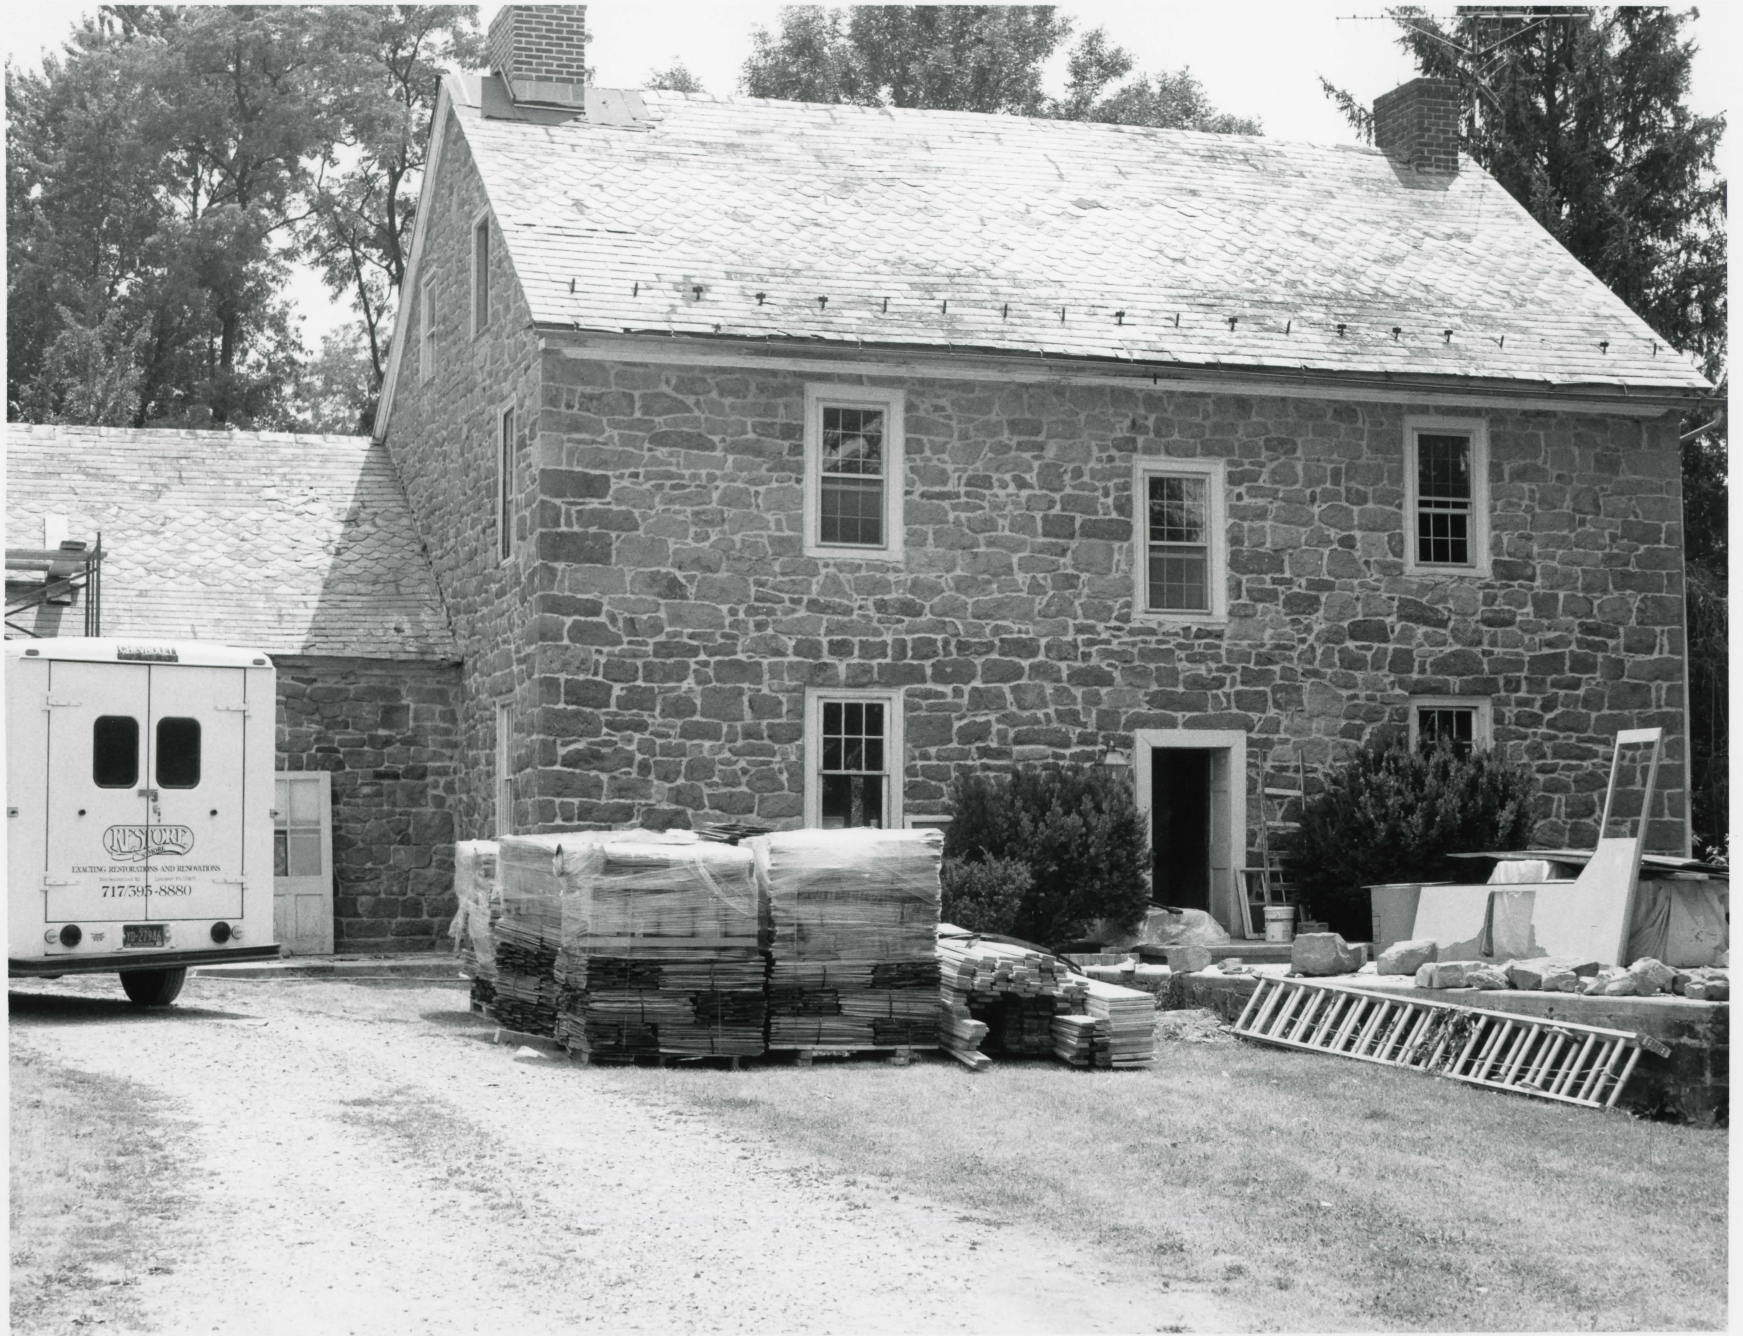
- II - 6. View of the rear of the house showing how the five-bay facade has been reduced to three in the rear. Note the shallow-molded, unadorned cornice, a hold over from the Georgian period, and the fish scale slate roof probably put on during the Second Empire period.
7 a

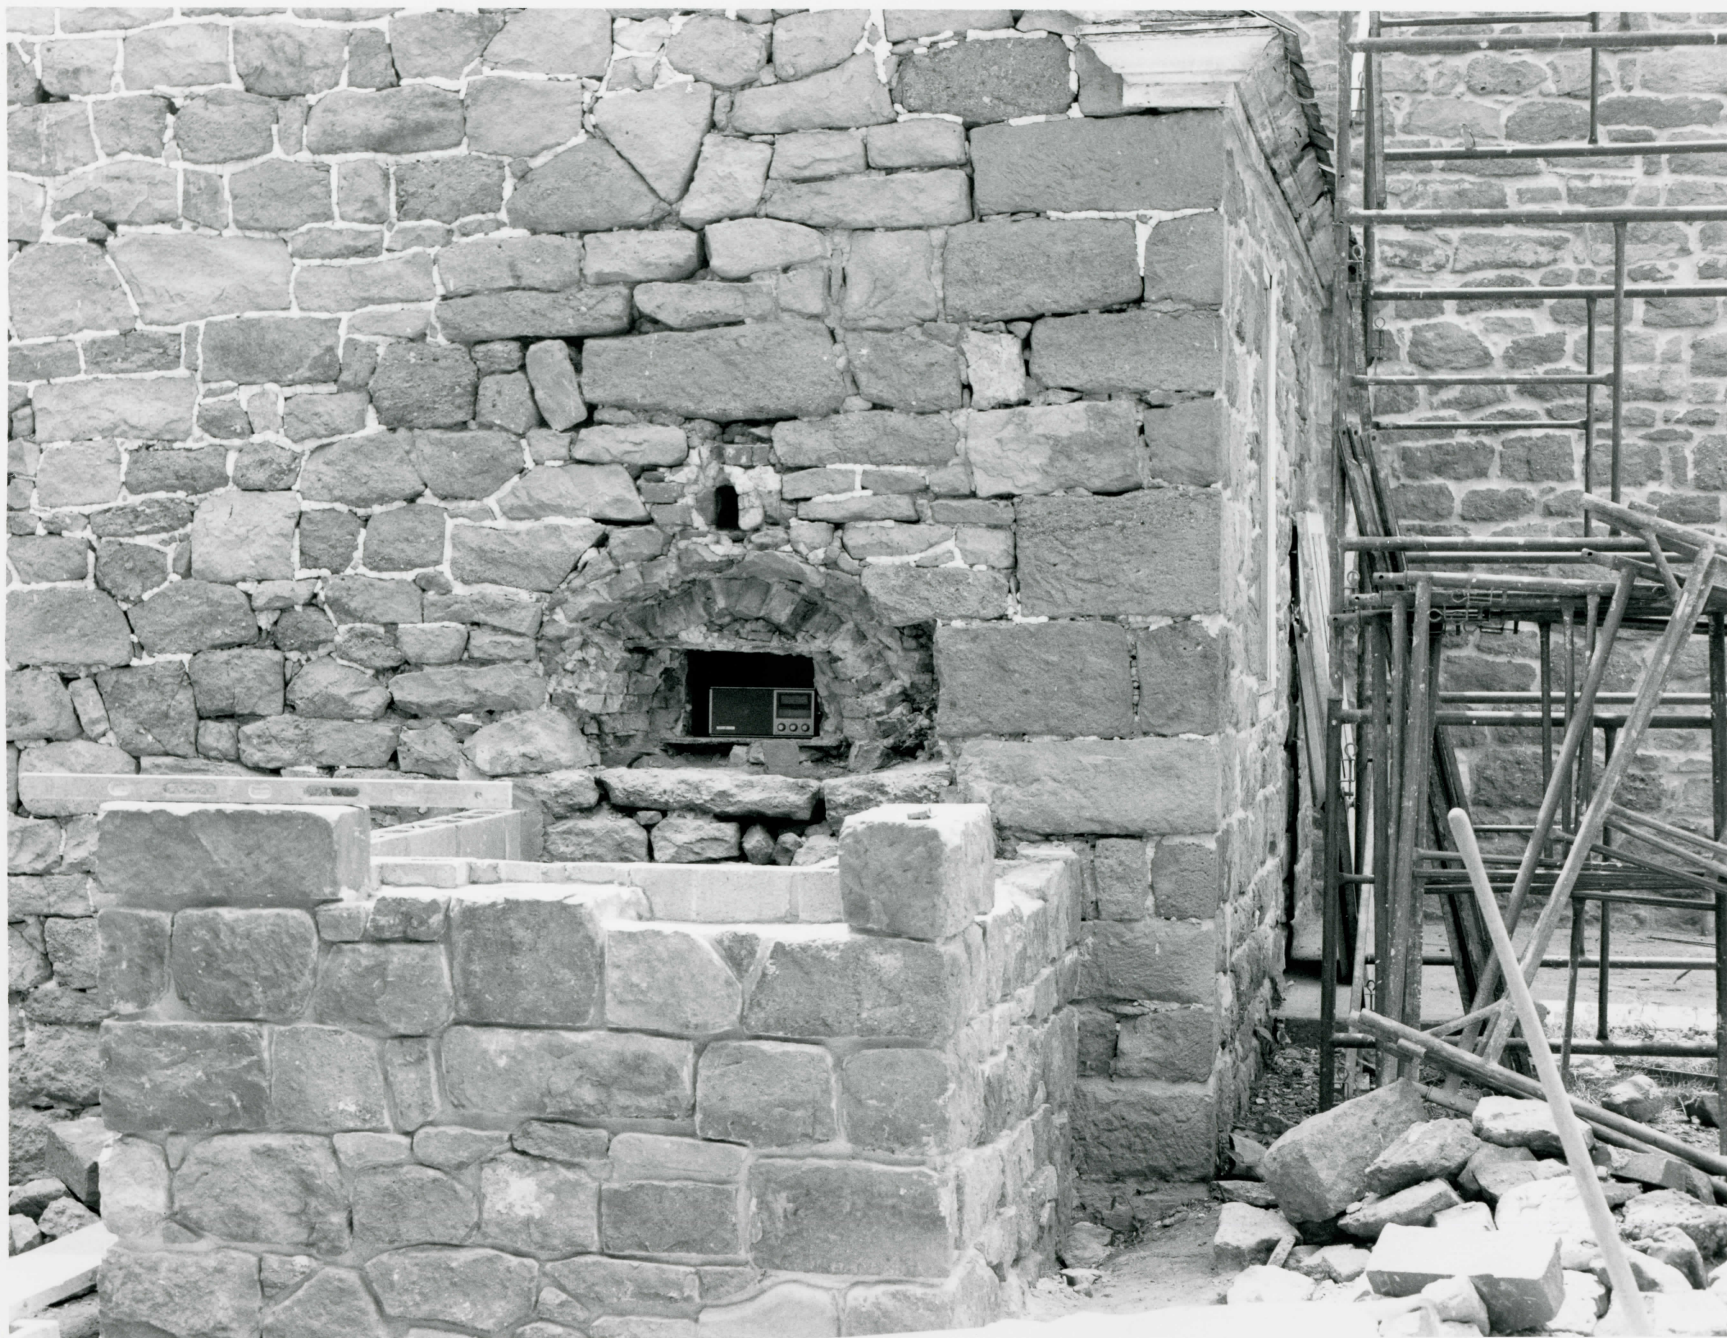
- III - 6. View of the eastern gable end of the kitchen addition showing the placement of the bakeoven which is being rebuilt. Note the original bakeoven door lintel and sill and flue above it.
7 a

The first floor of the kitchen addition features a walk-in fireplace which is covered with vertical battened doors. To the rear of this fireplace is the cast iron door opening into the bake oven which has been restored on its original location. During restoration the original door sill and flue were uncovered. The rebuilding of the bee hive oven incorporated these remnants. Brownstone found in excavation were used for the base of the oven and a gable roof gives protection for the plastered dome. At the south side of the walk-in fireplace are two small closets with simple vertical battened board doors. These occupy the space beneath the narrow dogleg stairs rising to the low room above the kitchen.

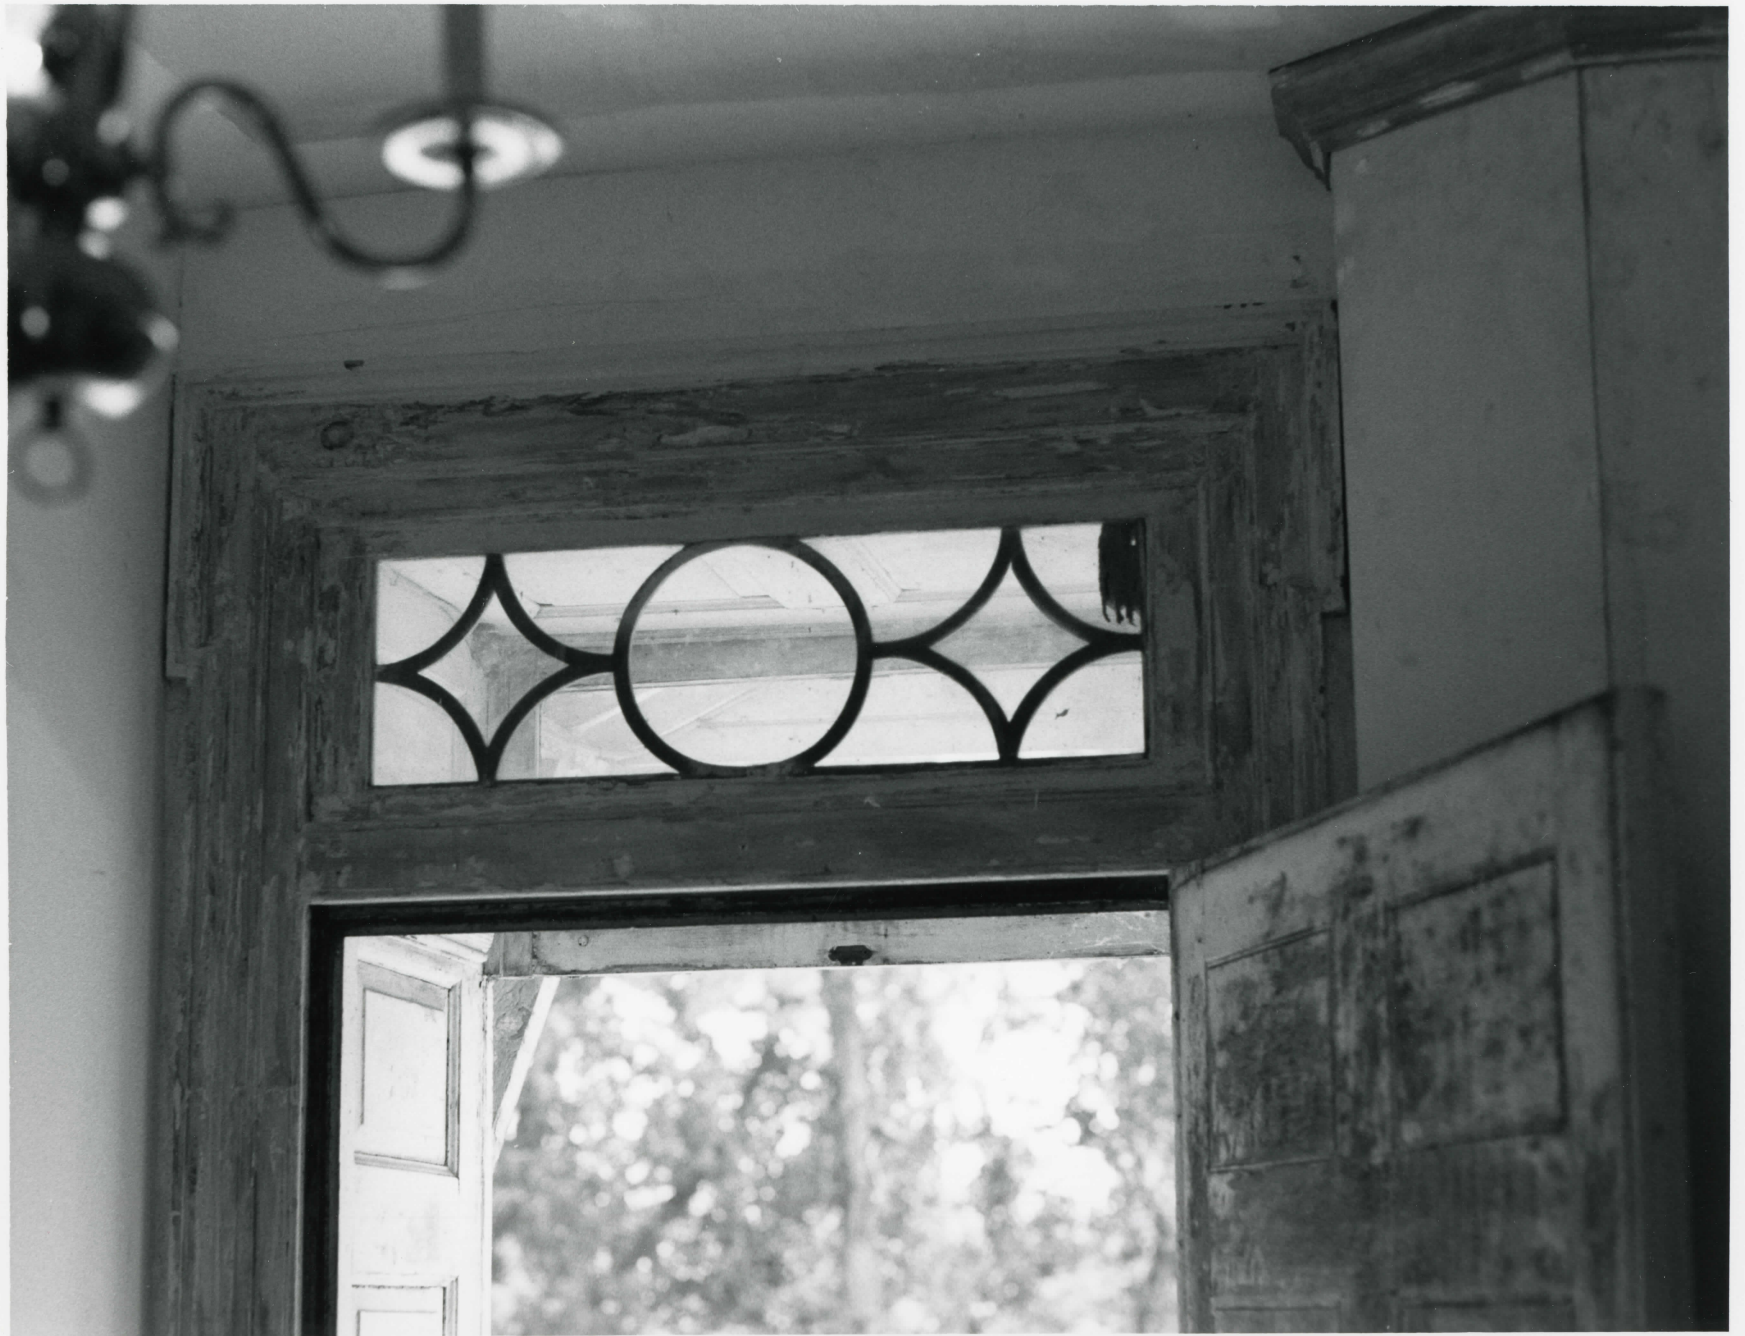
- IV - 6. View from front hall showing detail of front door transom and dog eared framing at top of door. Note also the single-beaded panels of the doors.
7 a

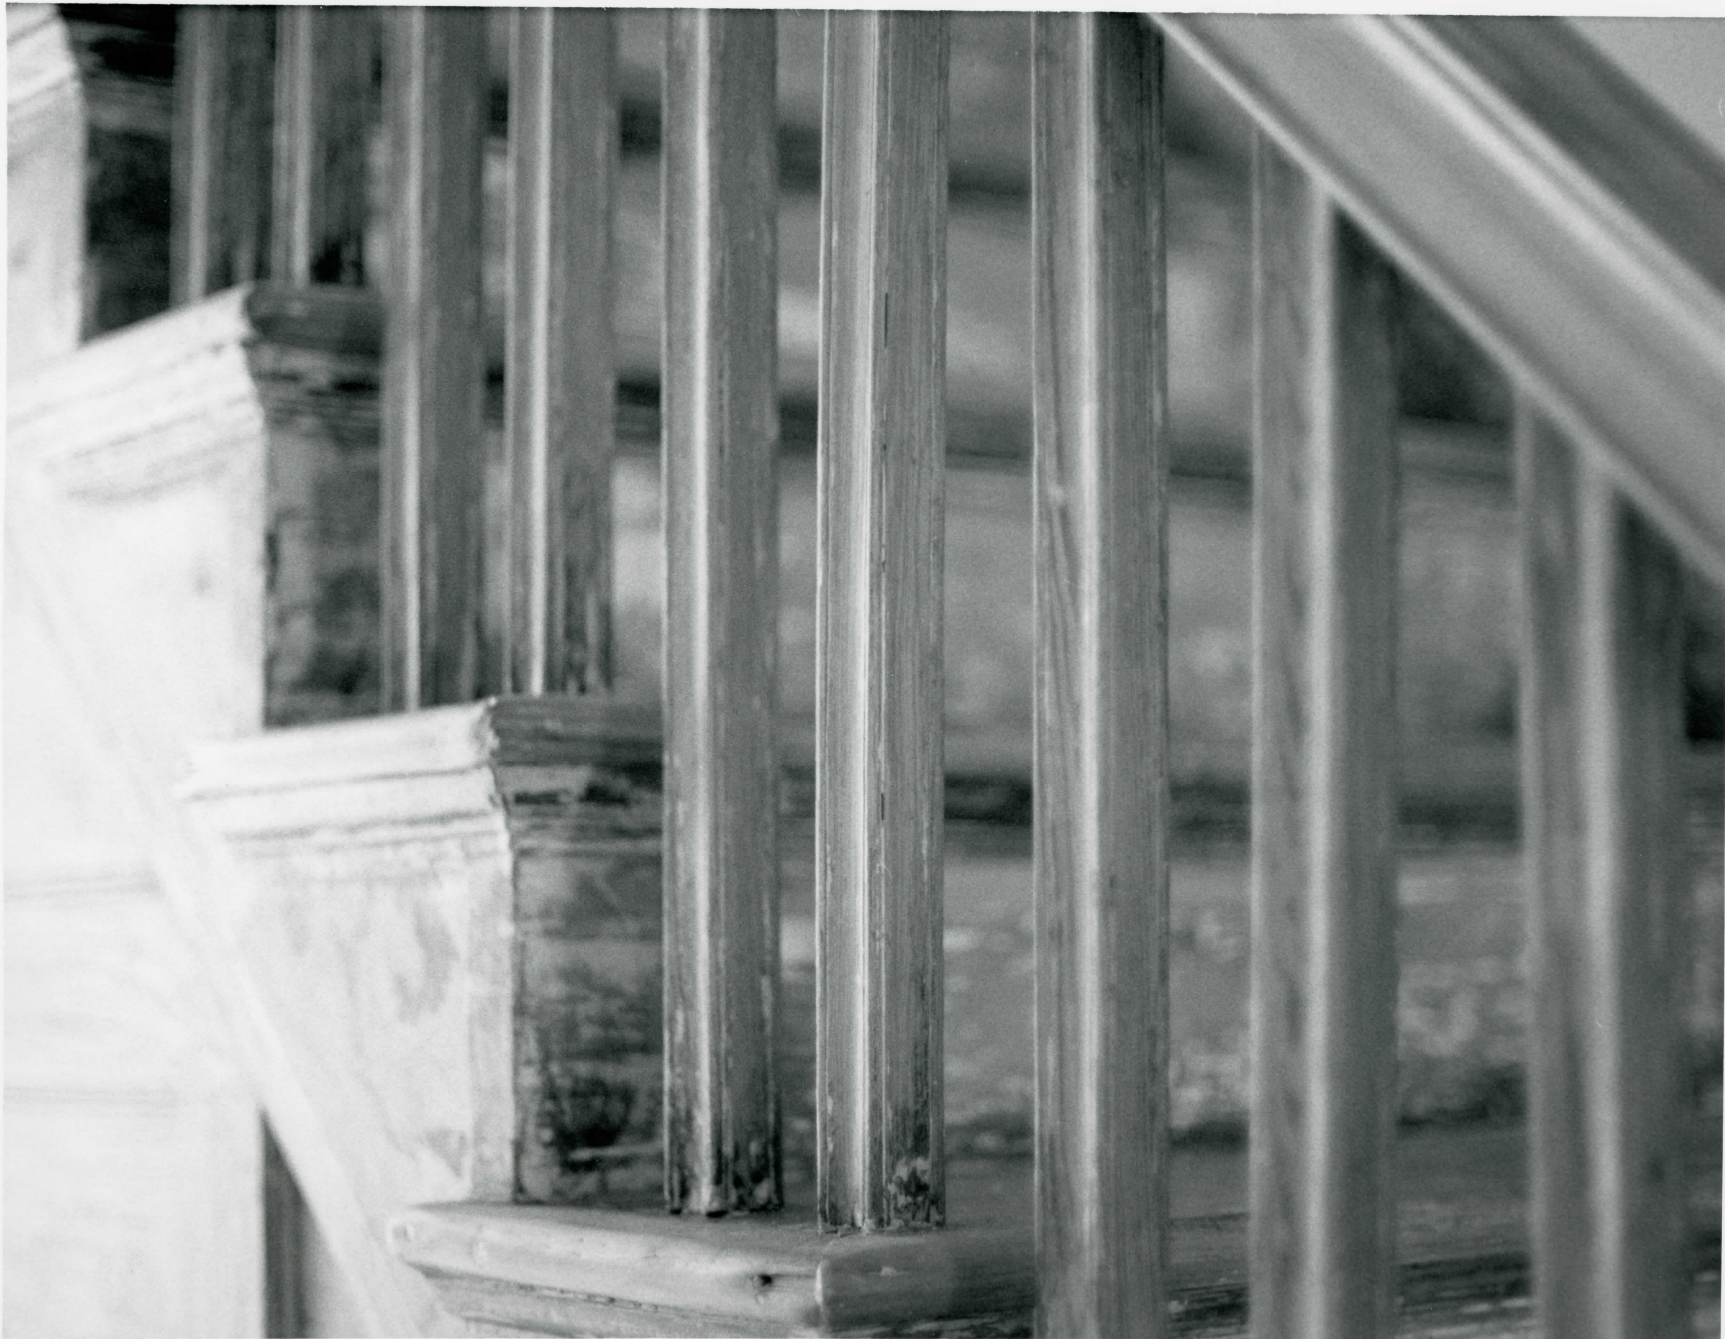
- V - 6. View looking to rear of hall showing detail of the balustrade. Note the fluting and beading of spindles.
7 a
- VI - 6. View of western front parlor showing west wall with fireplace over mantel and arched closet. Note the fluted columns, scalloped medallion, and reeded frieze. (The owners will replace the base of the fireplace surround.)
7 a

All of the door surrounds in the hallway are wide molded and dog-eared except the back door and the door into the northeast room. A stairway displaying fine craftsmanship goes up in the northeast corner of the hall. Instead of the usual turned balusters, these balusters are fluted on all four sides and have beaded edges. A modestly turned newel post and standards guide the open stairway to the attic. The curtain wall beneath the first floor stair has finely executed rectangular and triangular recessed panels.

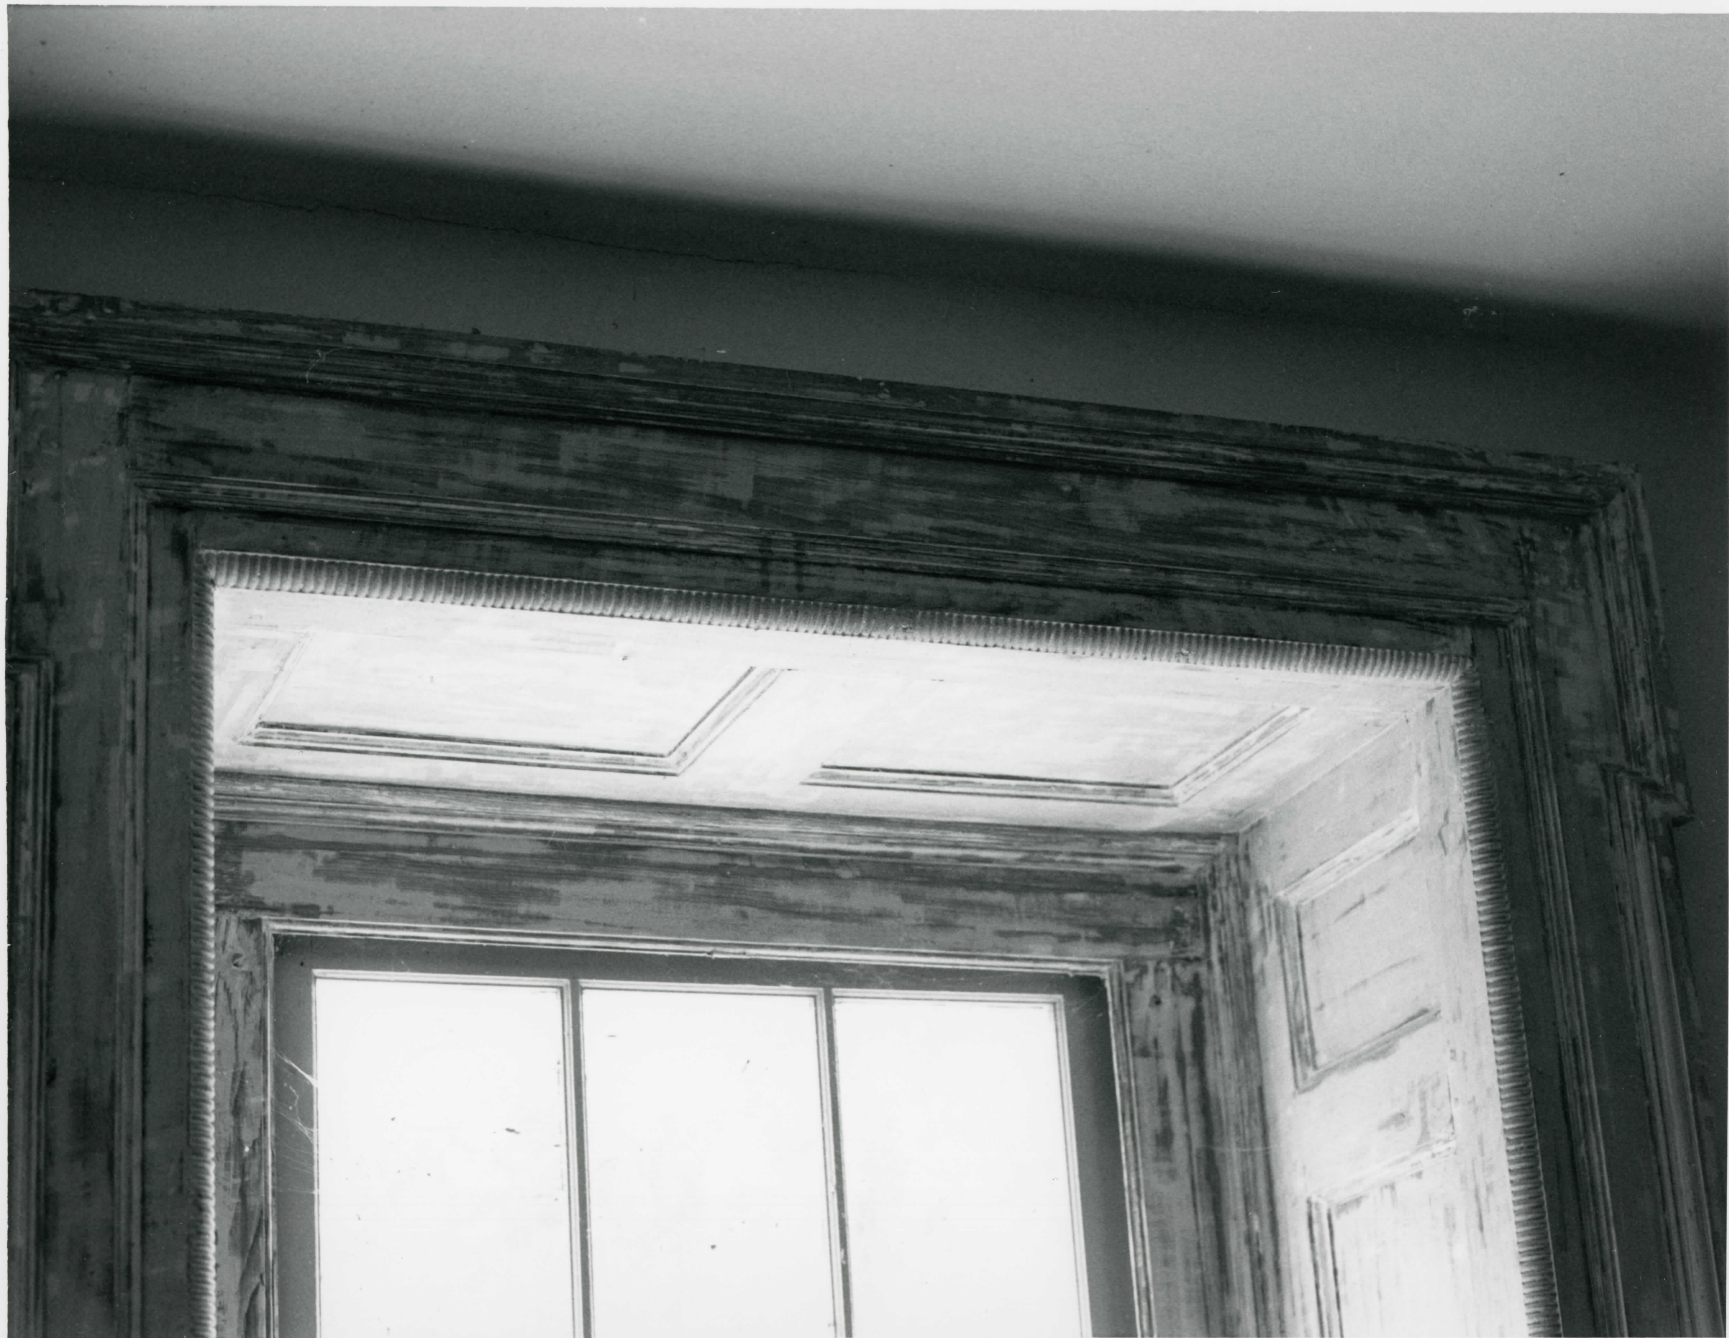
- VII - 6. View of western front parlor window showing framing and recessed reveals. Note the rope-edged inside trim.
7 a

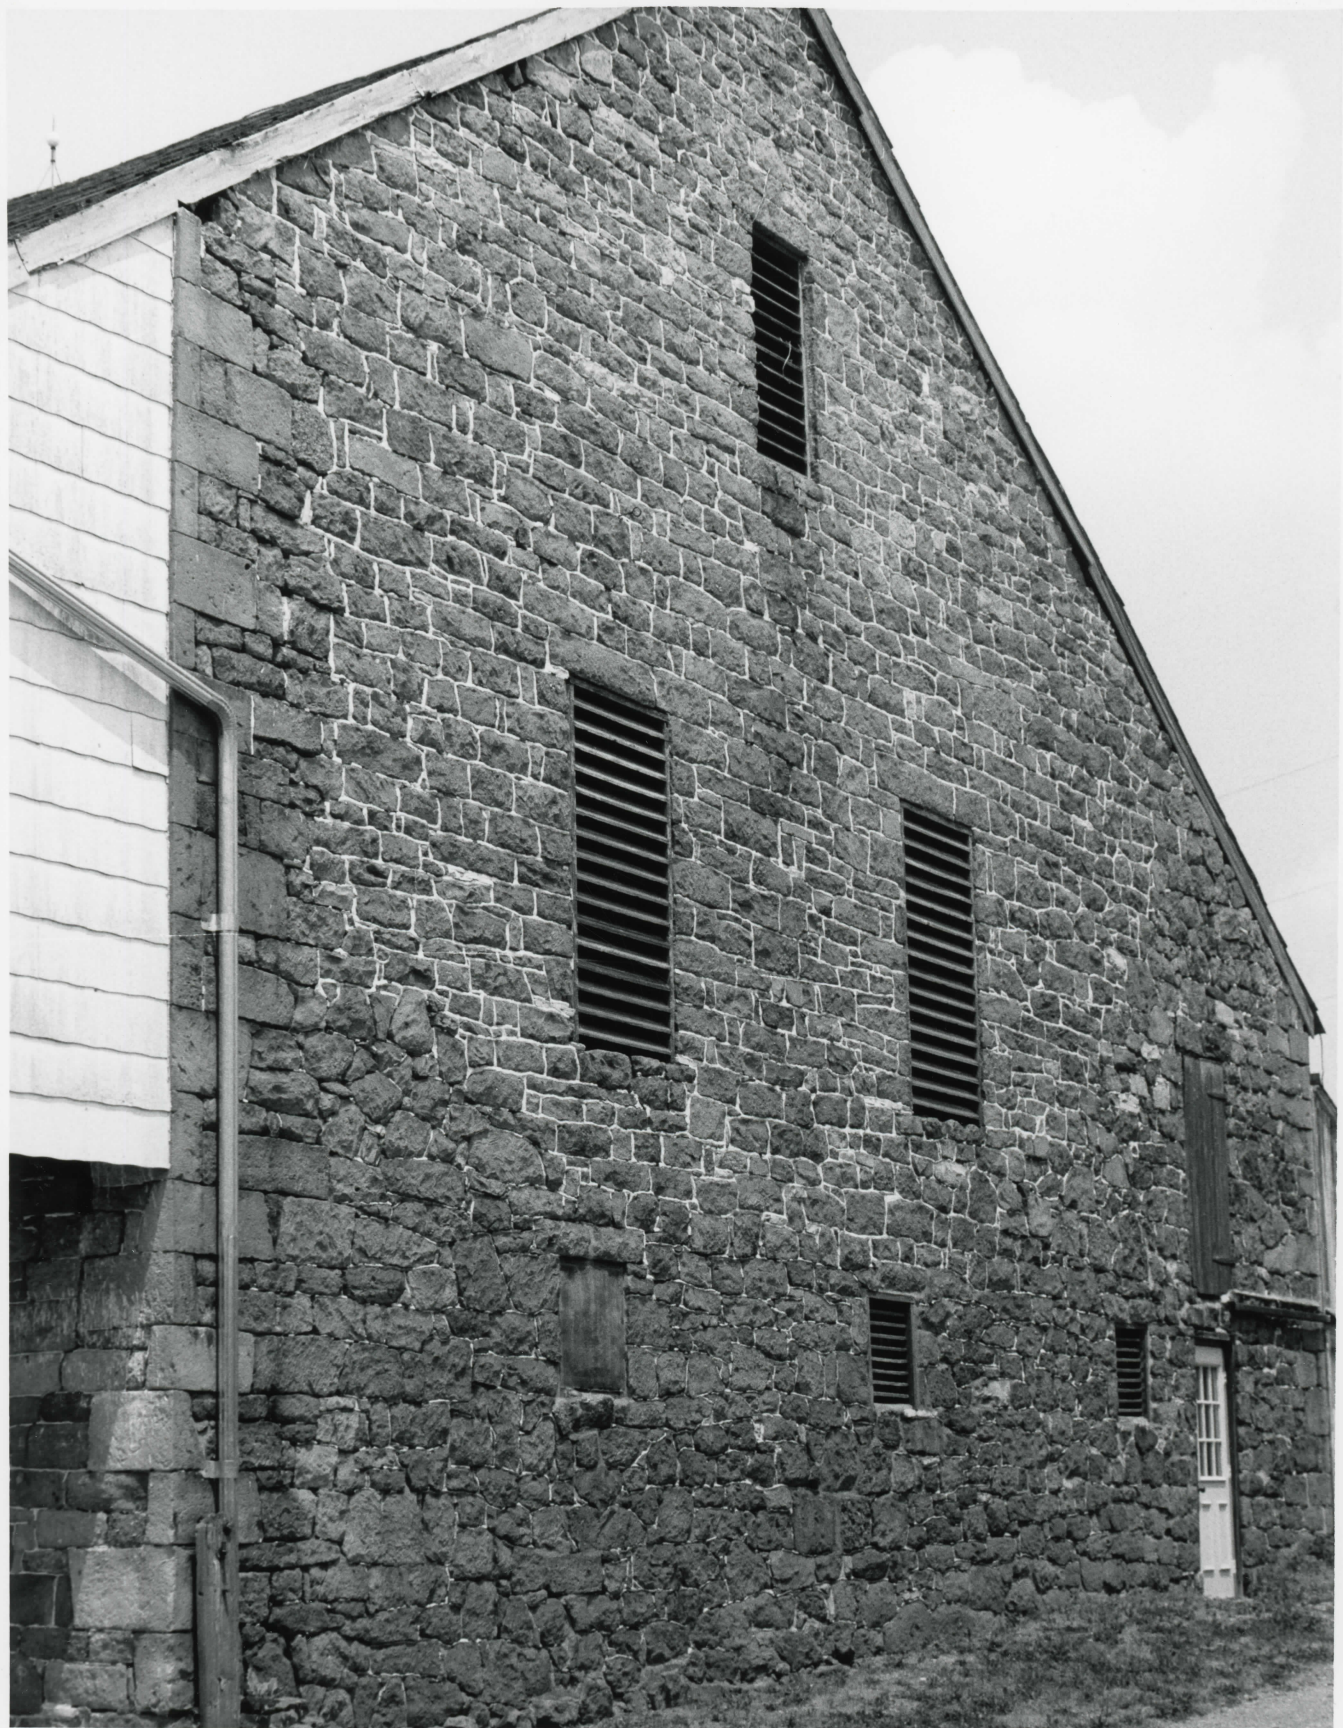
-
- VIII - 6. View of southern gable end of Smith barn. The fine masonry work appears coursed where the mortar is intact. Note the smooth dressed quoins.
7 f

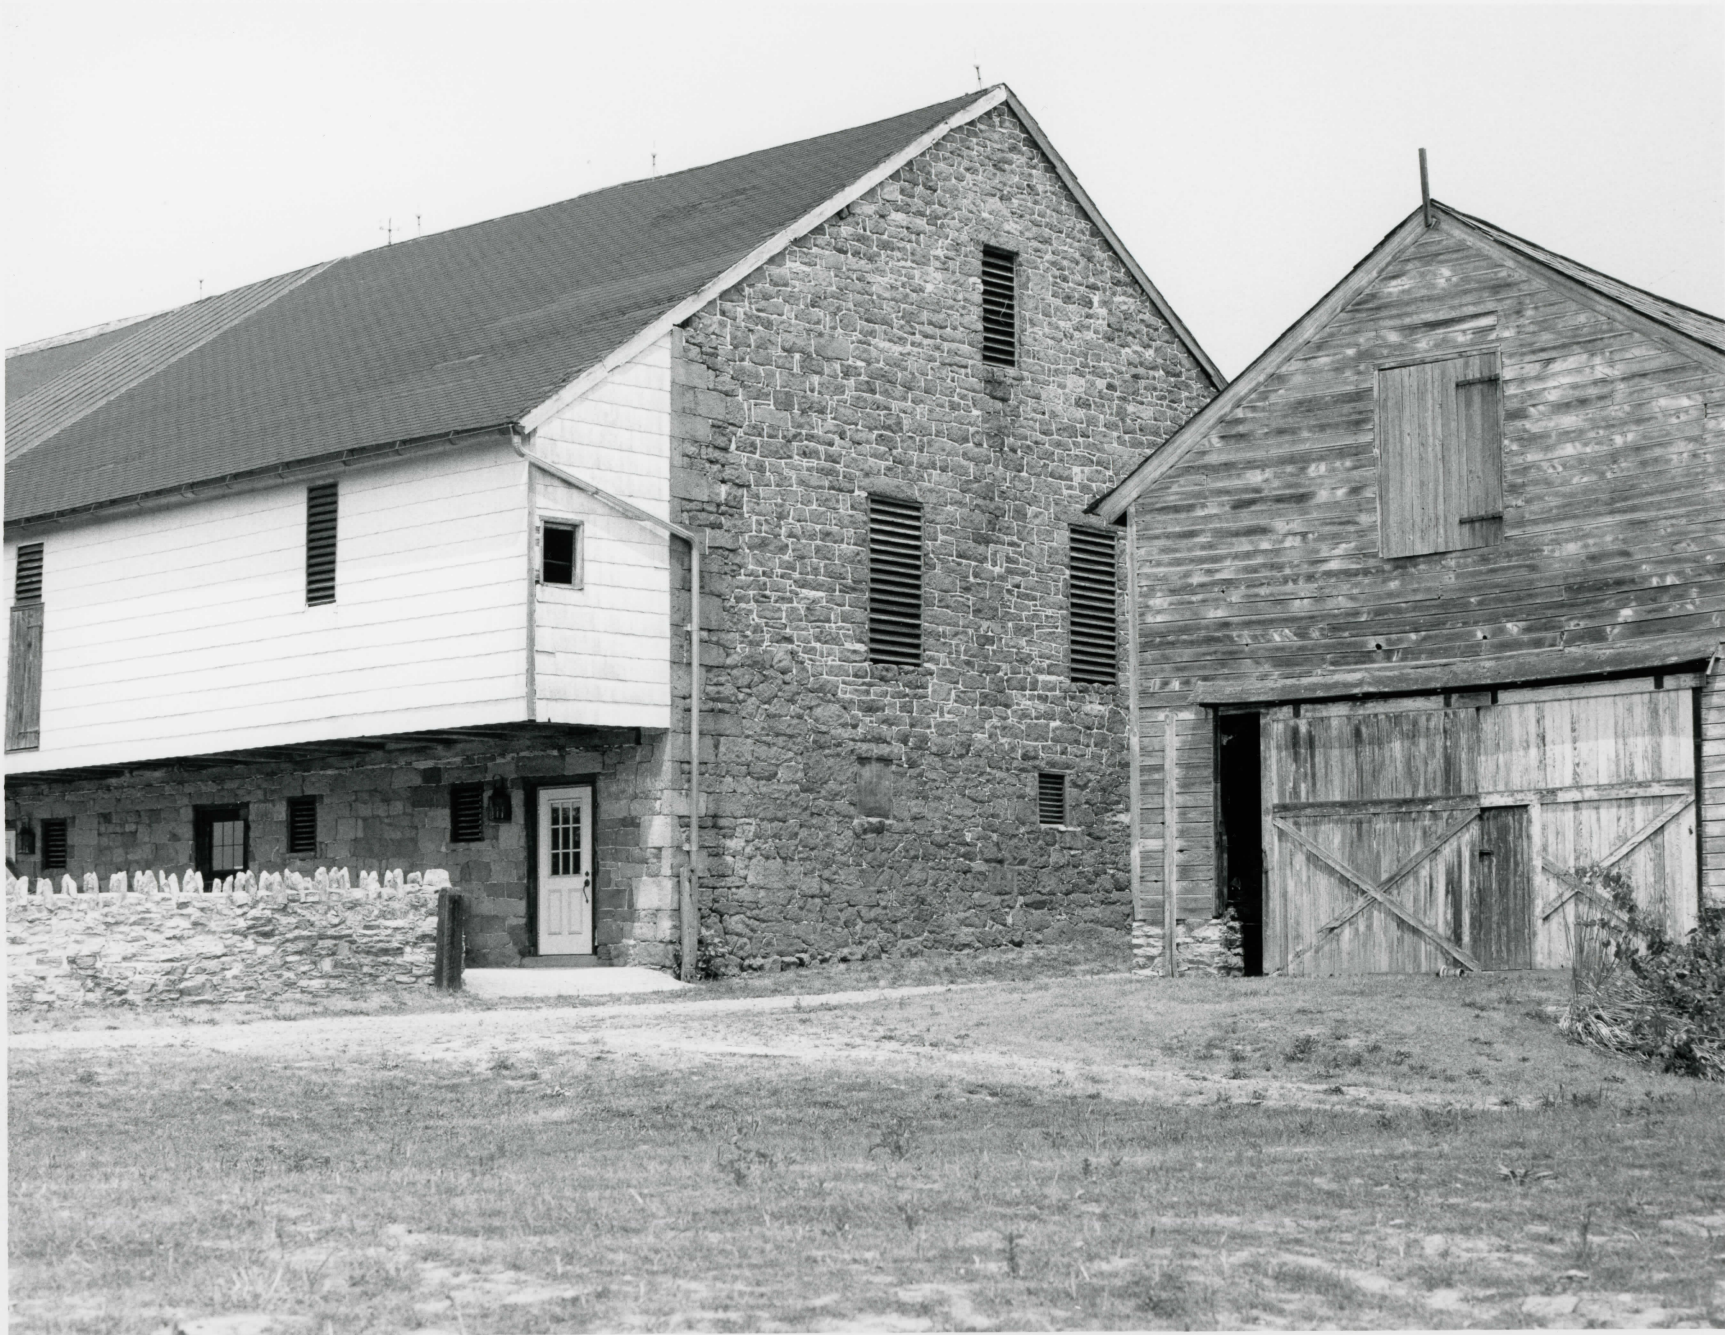
- IX - 6. View from the southwest showing barn, barnyard wall, and wagonshed with corn cribs at each side.
7 f, e
- X - 6. View of northern gable end wall showing the large ventilators indicative of a mid-nineteenth century barn.
7 f

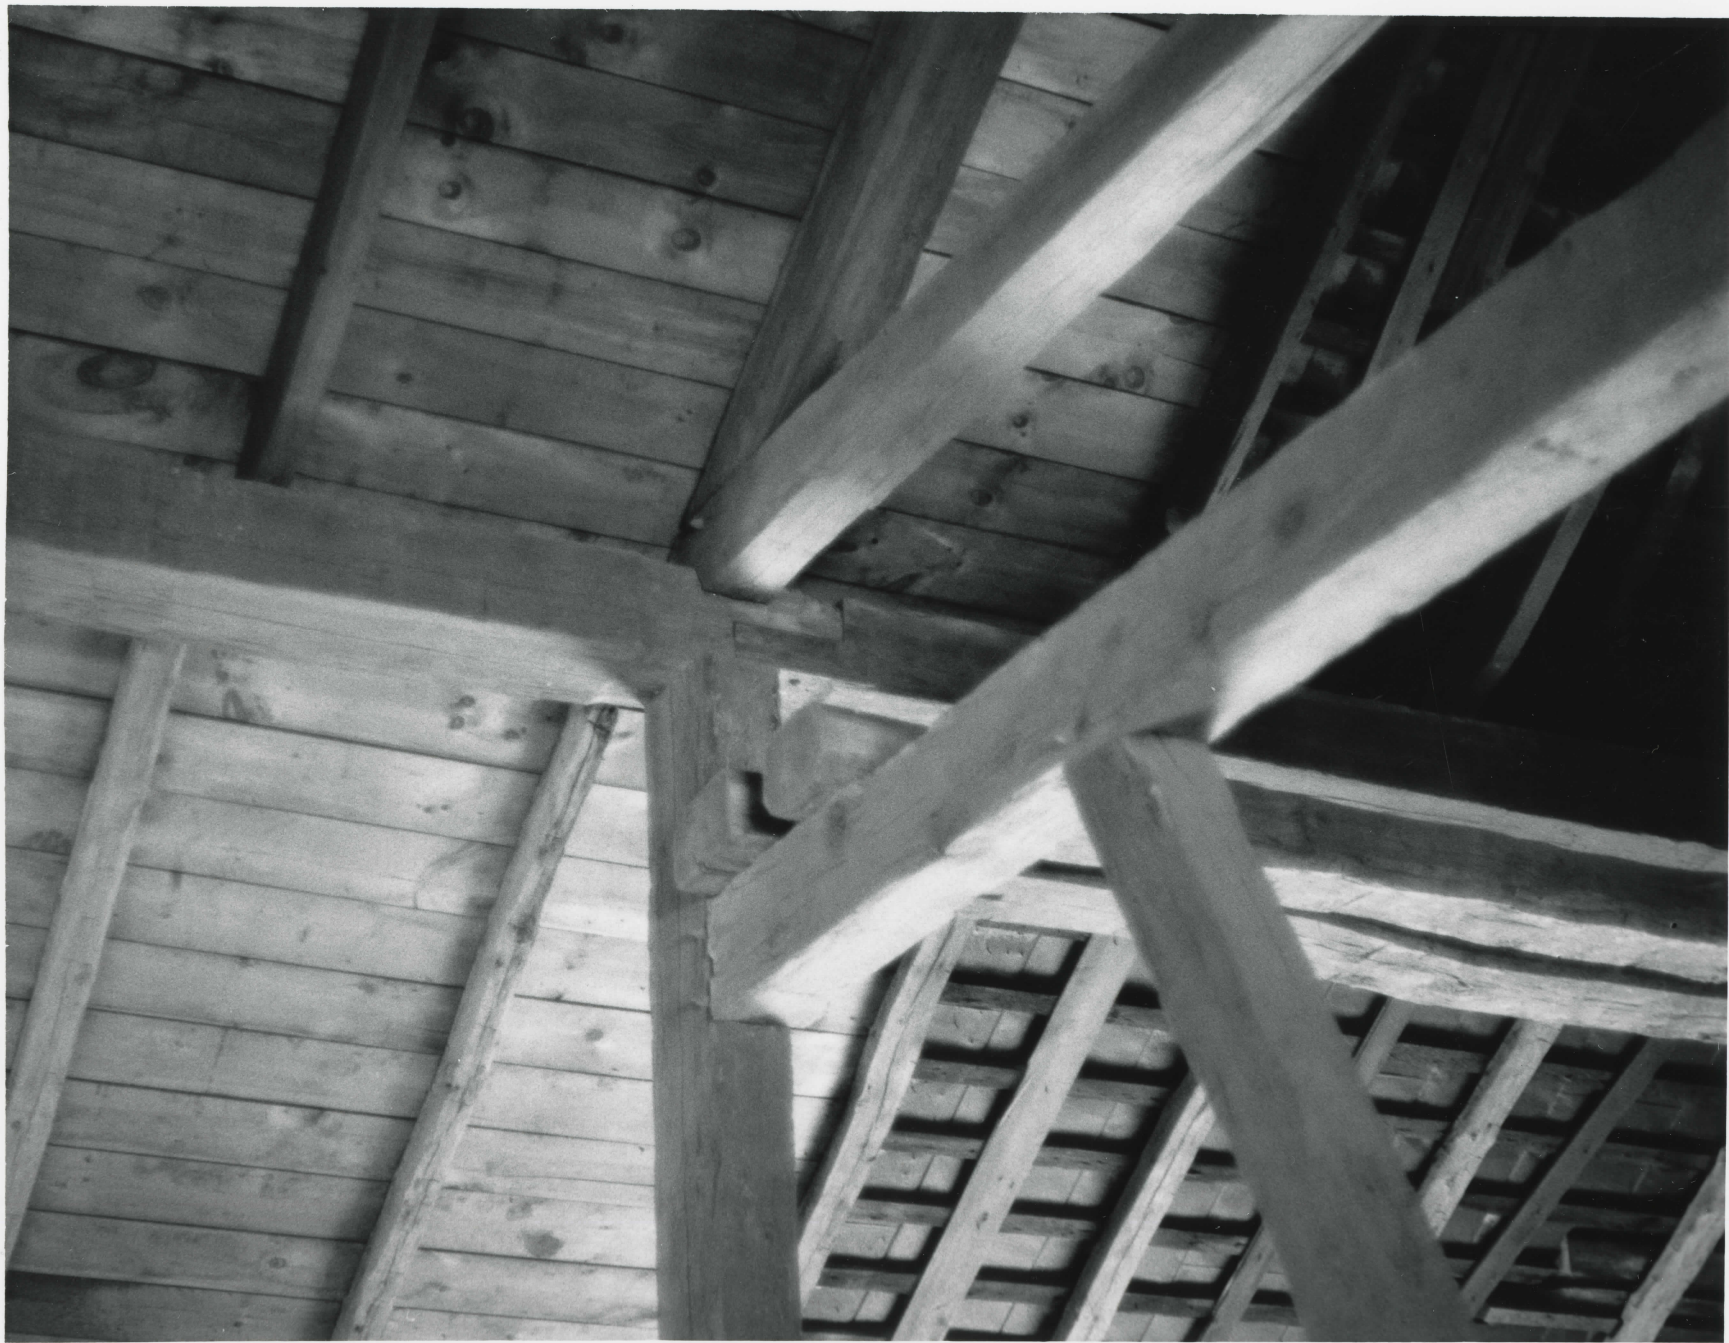
- XI - 6. Interior view of barn showing framing details. Near the center of the photo the upper tie beam can be seen resting on and mortised and tenoned into the splice joint of the plate log. Above this point, the principal rafter is mortised, tenoned, and pegged into the top of the tie beam.
7 f

The barn displays standard construction form in its hewn framing elements. However, the timbers on the threshing floor level are marked with peck marks. This was a Germanic form of labeling the timbers in order that they be reassembled in the correct bent.⁴ The barn's roof truss system consists of principal rafters connected with collars to hold the purlins upon which the common rafters rest. This medieval type of roofing structure was completely unnecessary to carry a load of wooden shingles. It would have been appropriate to carry the weight of a water soaked thatch roof.
