National Register of Historic Places
Registration Form

historic name Smith, Henry Farm
other names/site number Hidden Spring Farm

Henry Smith Farm

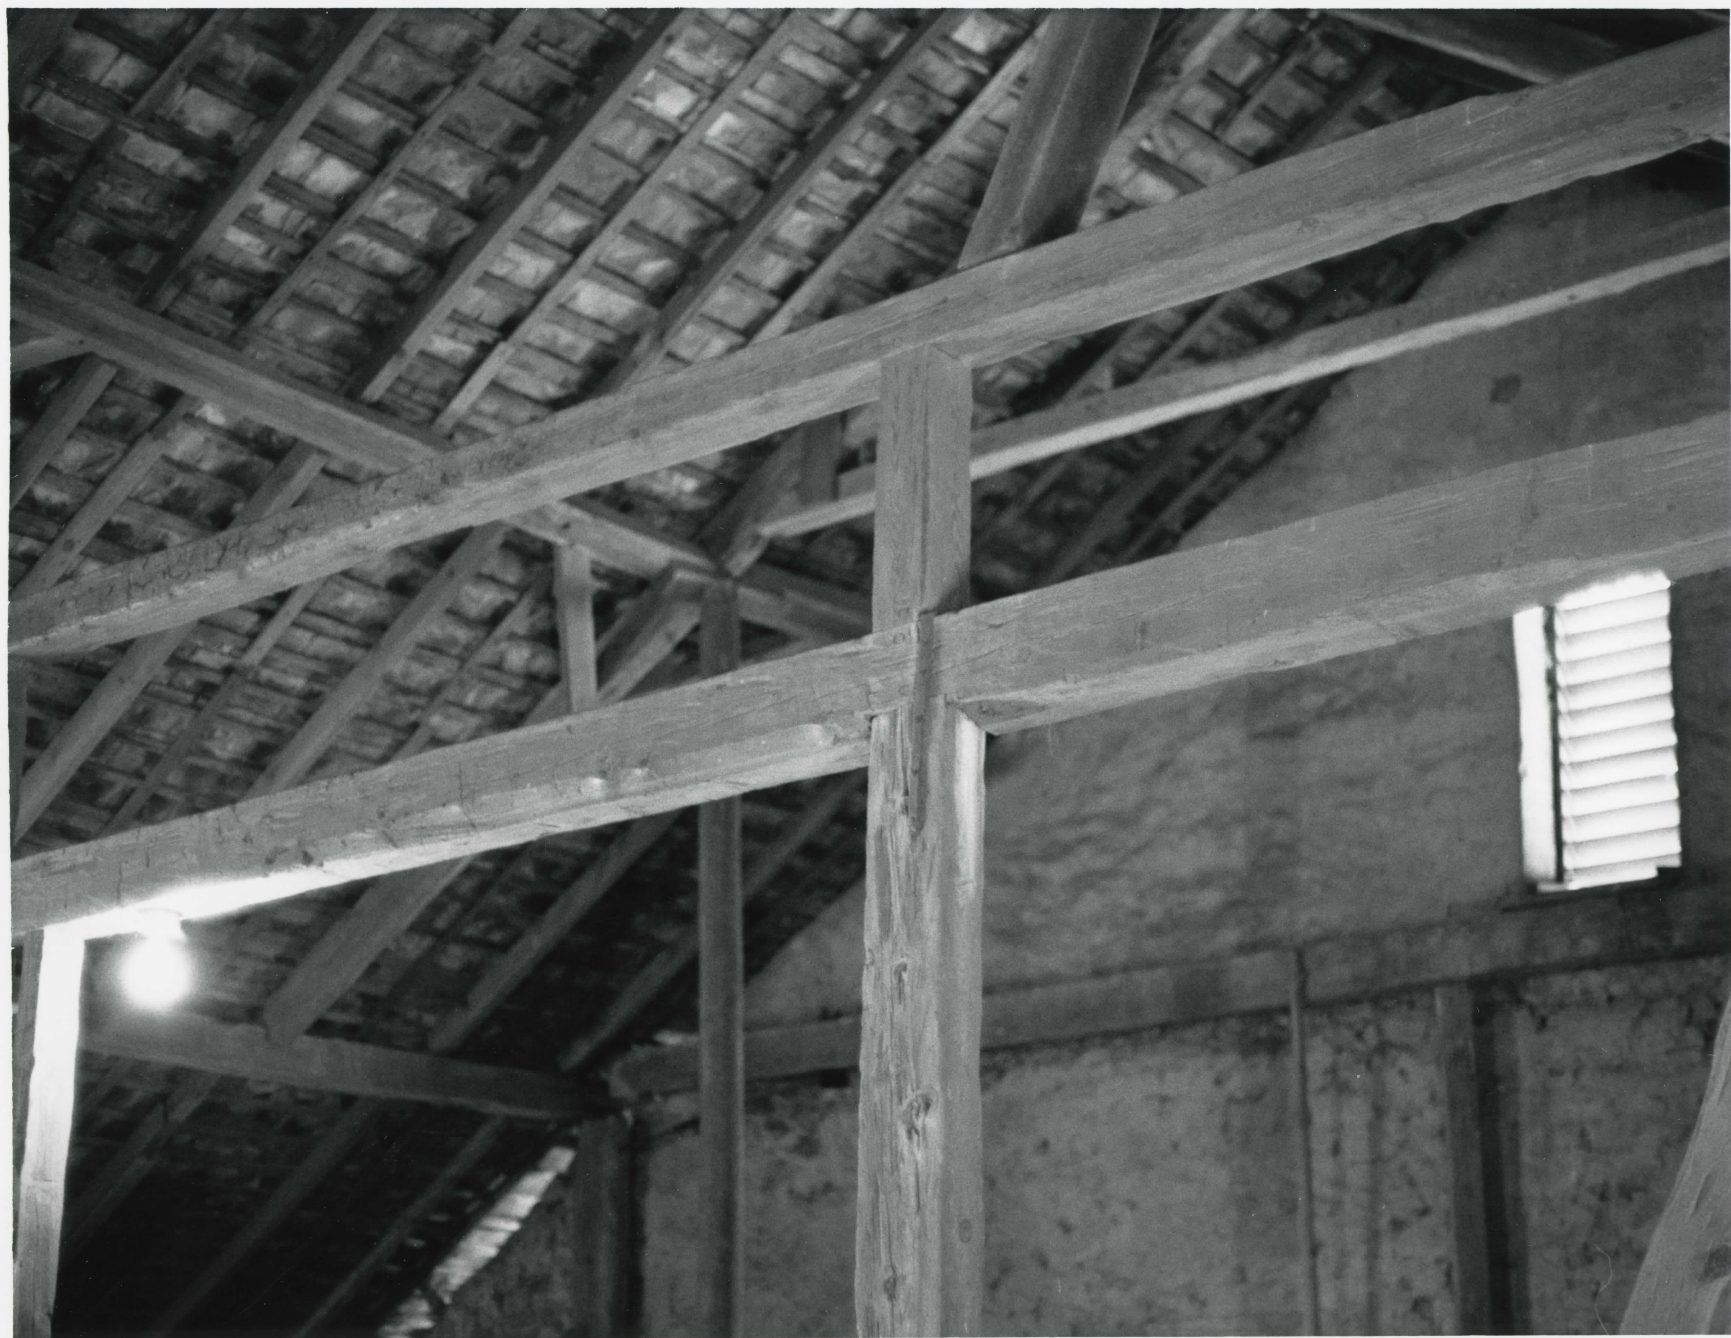
- XII - 6. Interior view of barn showing southern wall and framing details. Note that the central upright is notched into the lower tie beam for extra strength.
7 f

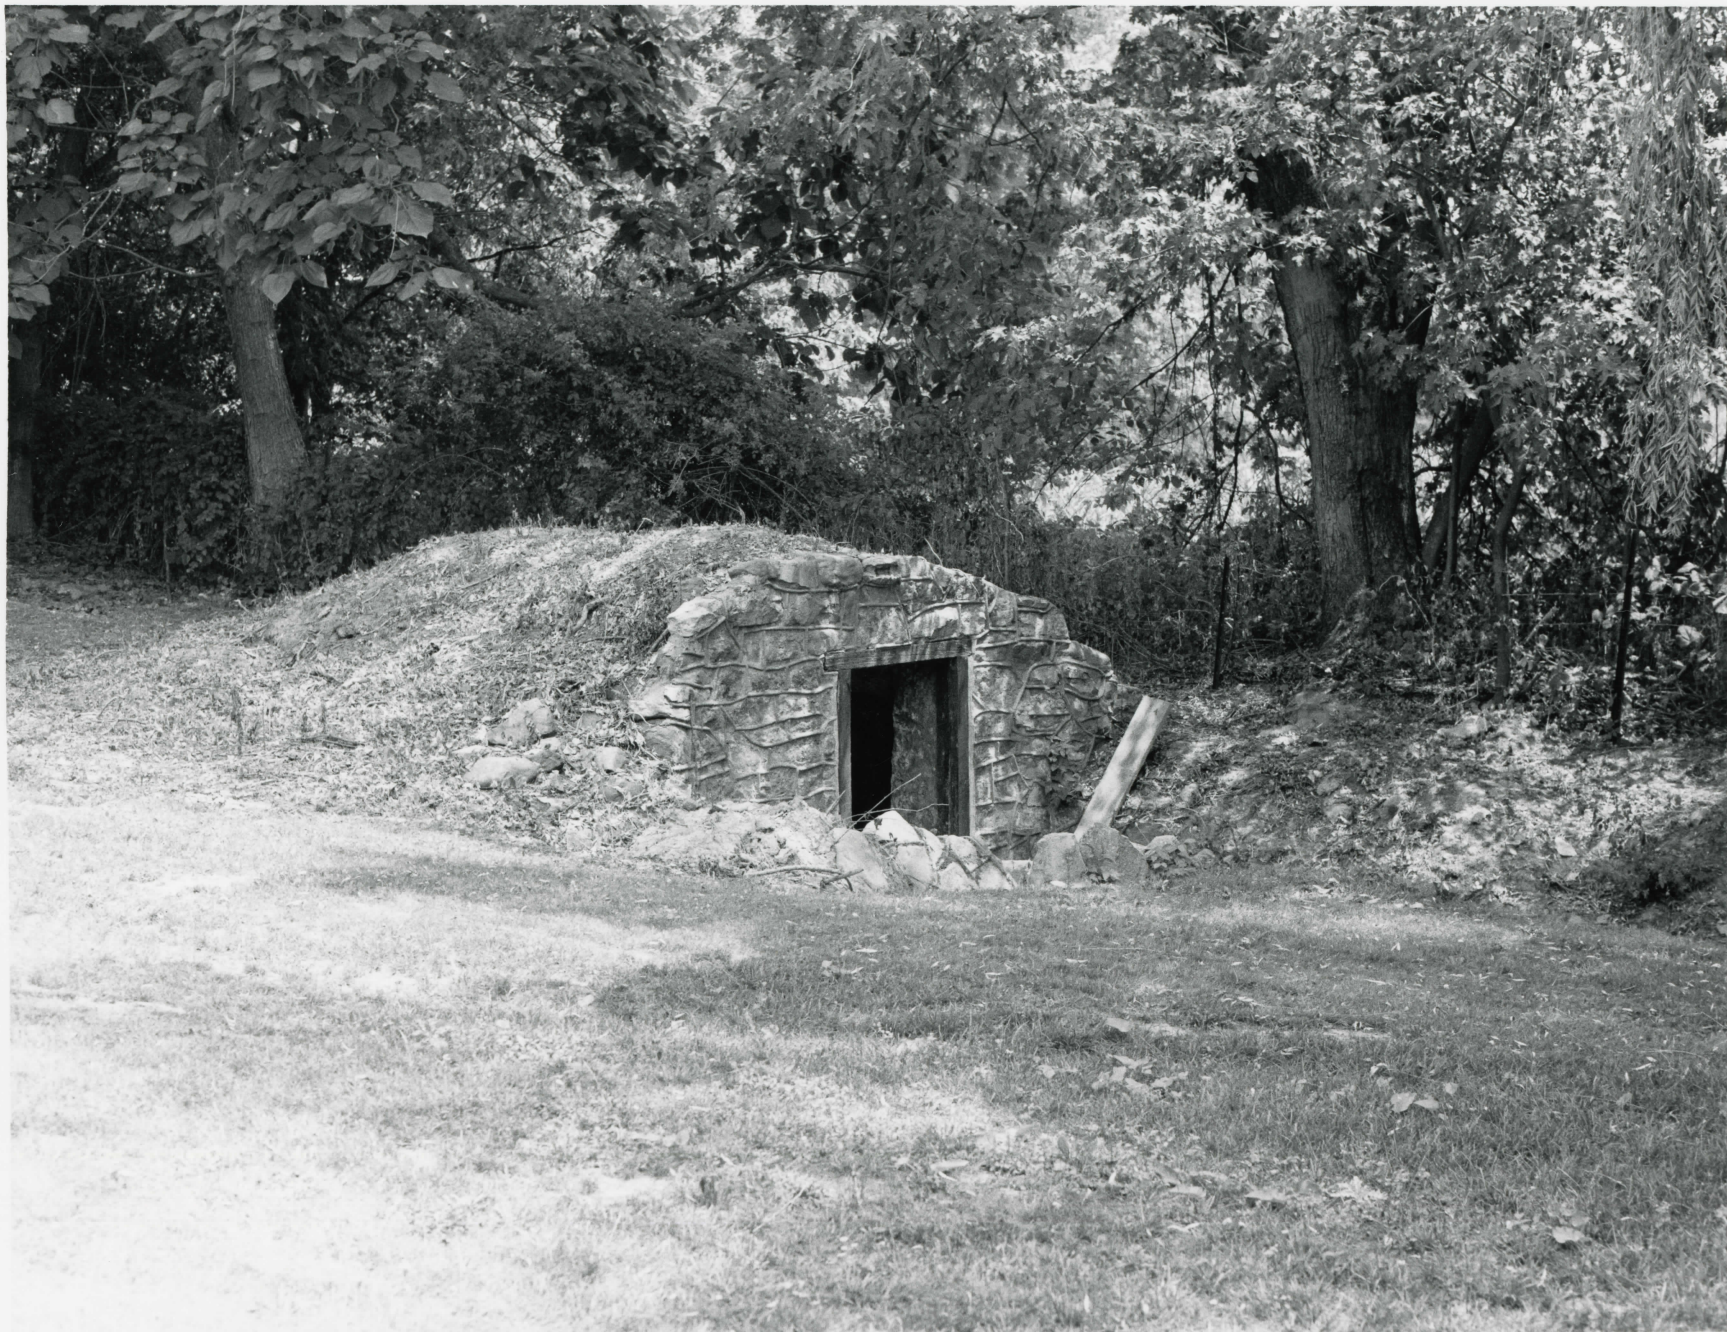
- XIII - 6. View from northwest showing west wall of vaulted cellar.
7 d

The vaulted cellar, situated southeast of the house, is nearly square in shape inside. Only the western rubblestone wall is exposed. An earthen mound covers the remainder of the structure. The interior was plastered and whitewashed. The entrance is through a low door on the west end of the building, and there is one niche on the opposite wall which possibly served to hold storage containers. Evidently a spring flows beneath this structure which supplemented the cooling and storage facilities of the cellar in the house.
