NATIONAL REGISTER OF HISTORIC PLACES
REGISTRATION FORM

historic name: Berwick Armory

Section number: 7 Berwick Armory Page 2

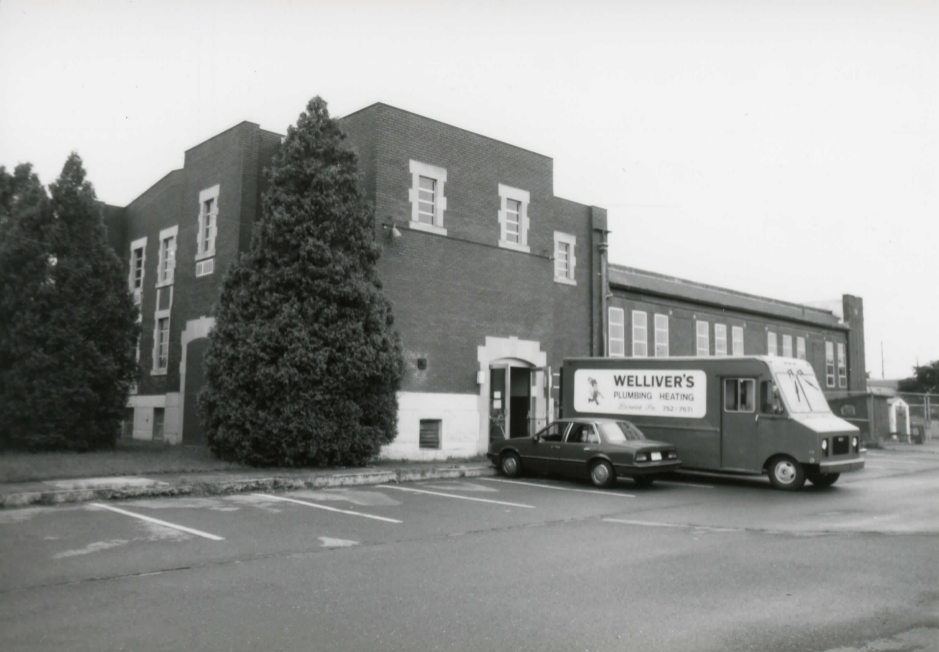
BERWICK ARMORY PA
COLUMBIA COUNTY
FRONT & RIGHT SIDE

Fronted by a small, grassy hill, the front (south) facade of the administrative section faces Third Street and is divided into thirds by two-story, projecting, former, entrance bays. While the second-story windows remain intact, the ground-level doors of these bays have been bricked up. Having a gabled parapet accented by decorative brickwork, the center third contains three windows on the first and second stories and basement, while each end third contains one window on each story.

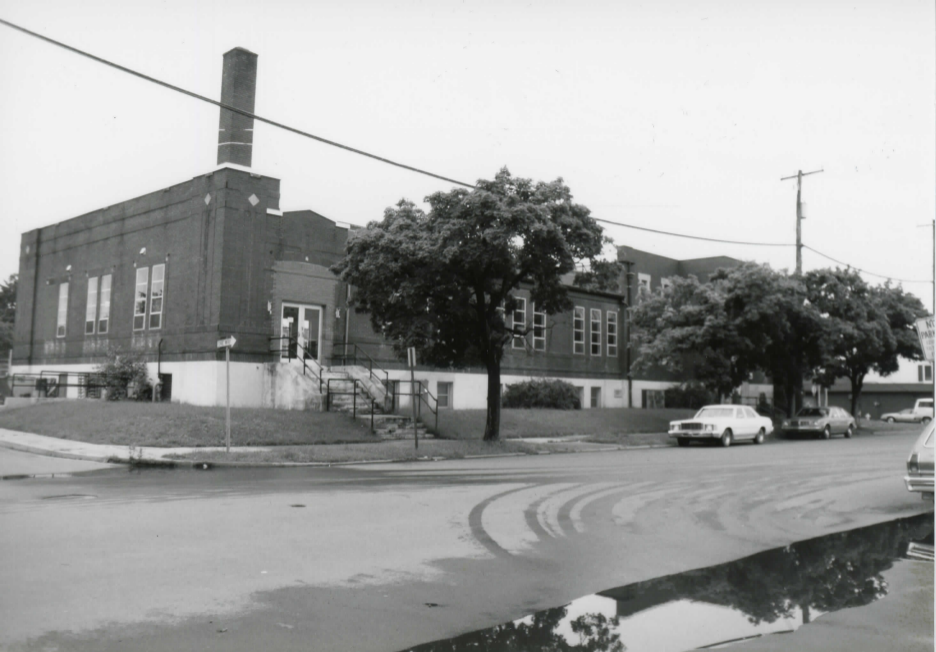
BERNICK ARMORY
COLUMBIA COUNTY
REAR: RIGHT SIDE

Rising in a parapet, the one-story, North elevation of the drill hall has three sets of paired first-story windows and at least one basement window. In the center of the elevation concrete steps lead down to a basement entrance, while slightly projecting wall surfaces appear at the corners, with the right corner supporting a brick chimney.

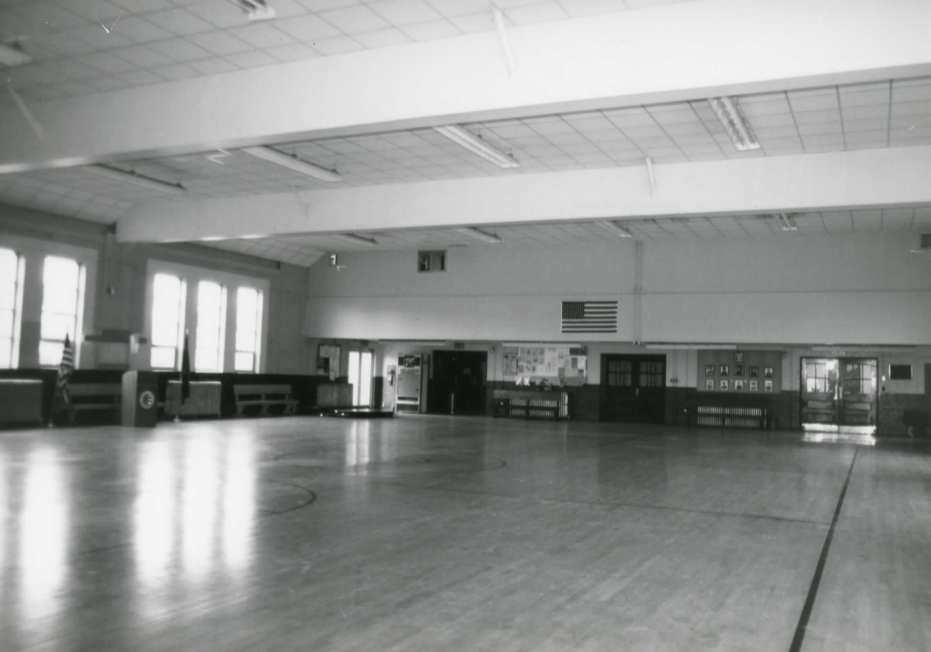
BERWICK ARMORY
COLUMBIA COUNTY
DRILL HALL - 1ST FLOOR

On the interior, the basement of the drill hall includes a kitchen, boiler room, and locker room. The basement of the administrative section has an arms vault and storage rooms. On the first floor, the administrative section is composed of a day room, rest rooms, and storage, with a club room, class room, and offices on the second floor. Located behind the administrative area on the first floor, the drill hall measures approximately 60 x 100 feet. It has a wood floor and a roof that is supported by steel girders.
