National Register of Historic Places
Registration Form

historic name Stupp-Oxenrider Farm

Stupp-Oxenrider Farm

OXENRIDER FARM - BERKS COUNTY, PA

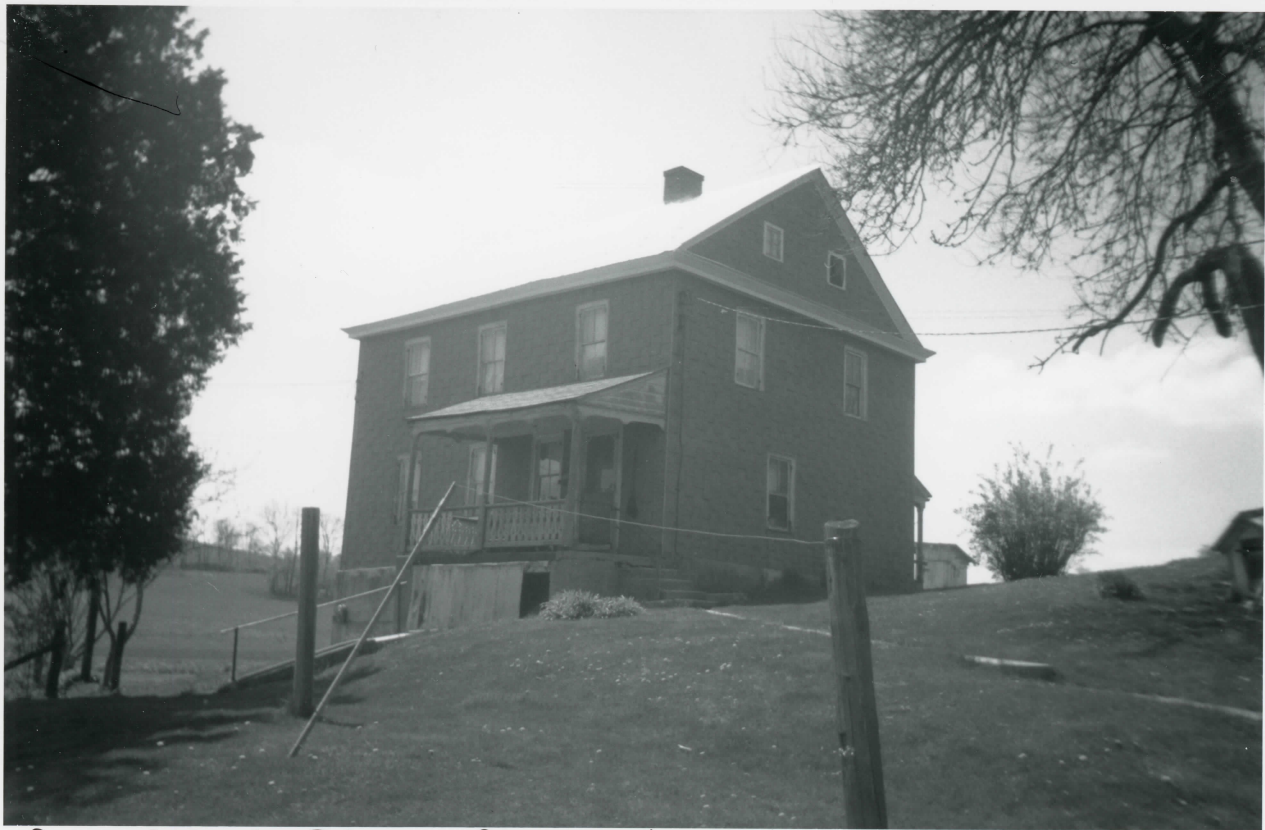
#1

OXENRIDER FARM, BERKS COUNTY, PA
FARM HOUSE, NORTH EAST FACADE

The two-and-one-half story, log, vernacular Swiss bank house consists of four bays, a one-story Victorian style porch on the southeast side, and a one story stoop on the northwest side. The window sashes are two over two, which indicates that they were replaced ca. 1900. The exterior of the house is covered by asphalt siding which was applied ca. 1950. The front and back doors are opposite each other, and enter into the Germanic kuche. The current tin roof, which was previously wood shingle, has snow catchers, and gable end pents on both the north and south ends of the house. The style and construction of the house are consistent with the time period 1770-1790.

The foundation of the house is stone, which comprises the basement level of the house. On the exterior this stone wall is approximately five feet in height. The basement which has nine foot ceilings and a ground floor, served as both a ground cellar and a meat cellar. The basement is divided into three rooms. The partitions are built of twelve to sixteen inch variable width vertical boards. These partitions have doors with wooden hinges. One of these hinges has an unusual small iron hinge on top of it which is shaped like a fish. The summer beam, which runs north to south, measures eleven inches by twelve inches, is chamfered, and rests on a stone shelf which projects from both end walls. There are three small casement-size windows that are at ground level. An exterior door is found on the south side of the basement. The fireplace support faces north and measures nine feet five inches in width, and five feet nine inches in depth and is used for storage. An old pie safe hangs from the ceiling. A plethora of mushroom and rosehead nails protrude from the ceiling beams.

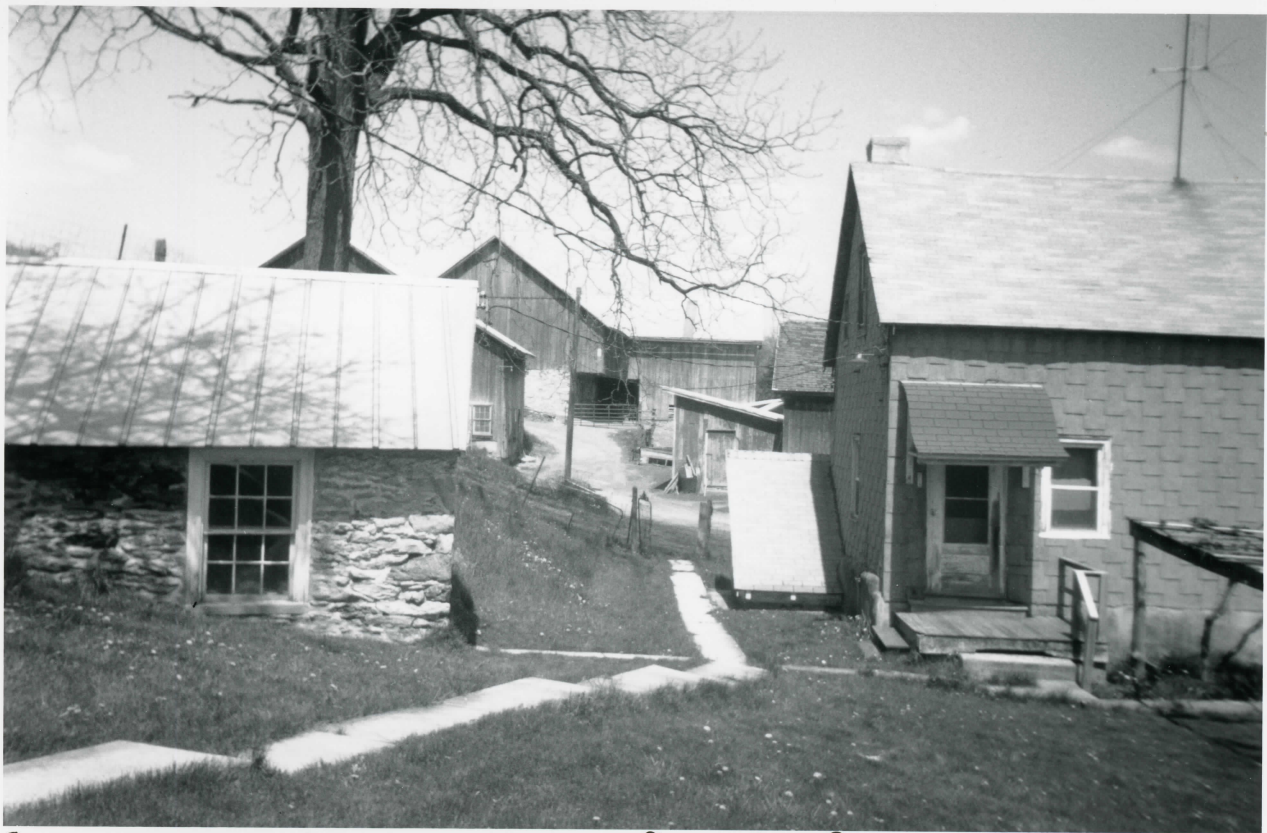
OXENRIIDER FARM, BERKS COUNTY, PA #2
LEFT - BUTCHER HOUSE, BARN, RIGHT - TENANT HOUSE - SOUTH FACADE

The log, two-story, tenant or "grandfathers" house sits north of the main house and faces south. It has three bays and retains its three room plan. The exterior was covered with asphalt siding ca. 1950. The roof is of channel tin. The cornice is plain, as is the window and door trim. The front door has a Victorian bentwood hood. The style and construction of the house are consistent with the time period 1770-1790.

The butcher house/summer kitchen is one-story, and built of stone. The west gable end is banked. This building has a tin roof. The window sashes are nine over six, and the window frames are pegged. A small window exists in the east gable.

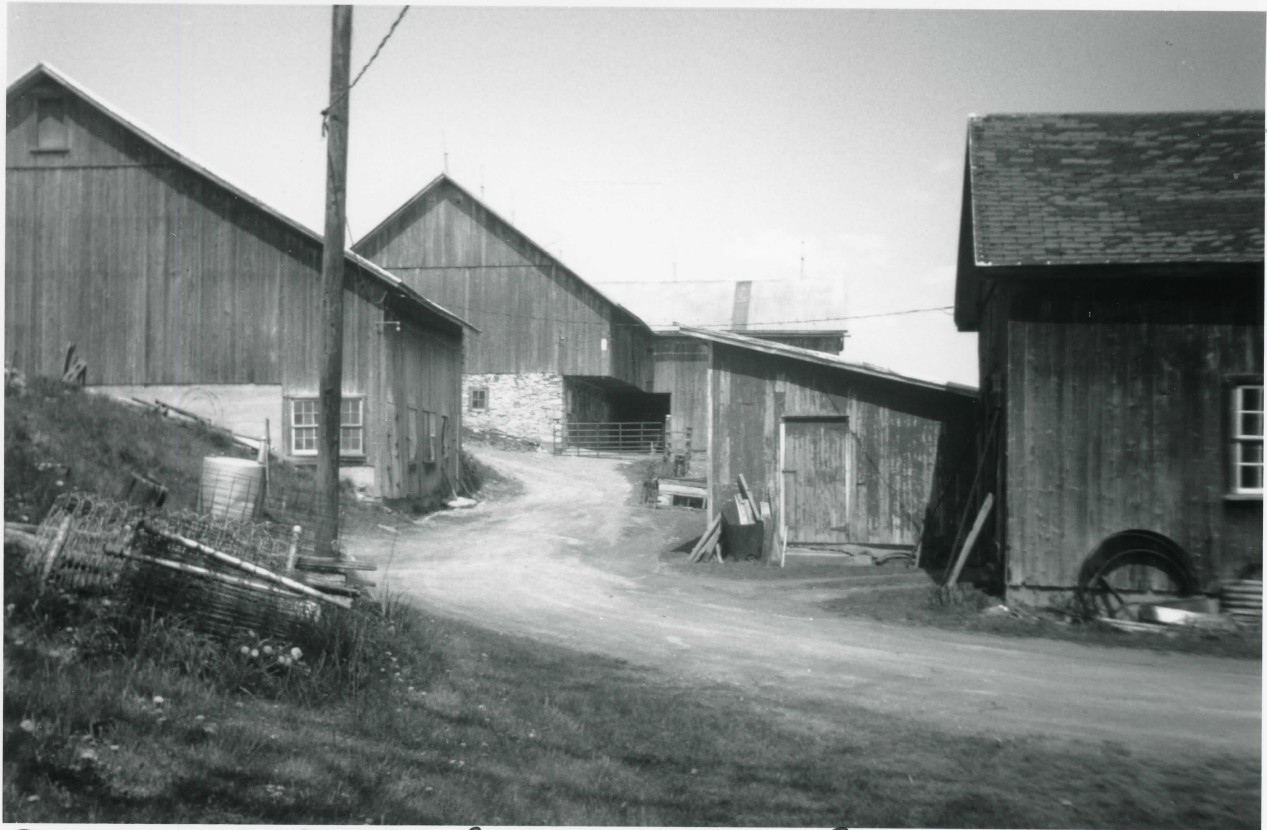
OxENRIDER FARM, BERKS COUNTY, PA - South FACADE #3
L→R, Wagon shed/chickenhouse, BARN, Pig sty, BLACKsmith Shop

The blacksmith shop sits north of the house, half way to the barn. It is a two-story frame building, with an asphalt shingle roof. It is known to have been built by Adam Oxenrider ca. 1915. The main floor of the smithy still contains the original blacksmith forge/hearth and chimney. The smithy retains a plethora of blacksmith and old farm hand tools. An interior stairway leads to a second floor granary. It has two windows on the south side and one on the east side to give light to the forge. It is currently used as a shop and garage.

The wagon shed/chicken house is one-and-one-half stories, banked, and built of tongue-and-groove boards. This building was rebuilt ca. 1916, from some of the original lumber, by Adam Oxenrider. It has a corrugated tin roof. The west banked upper level, is the wagon shed. The chicken house is on the lower east side. Both retain their original uses. It is located halfway between house and barn.

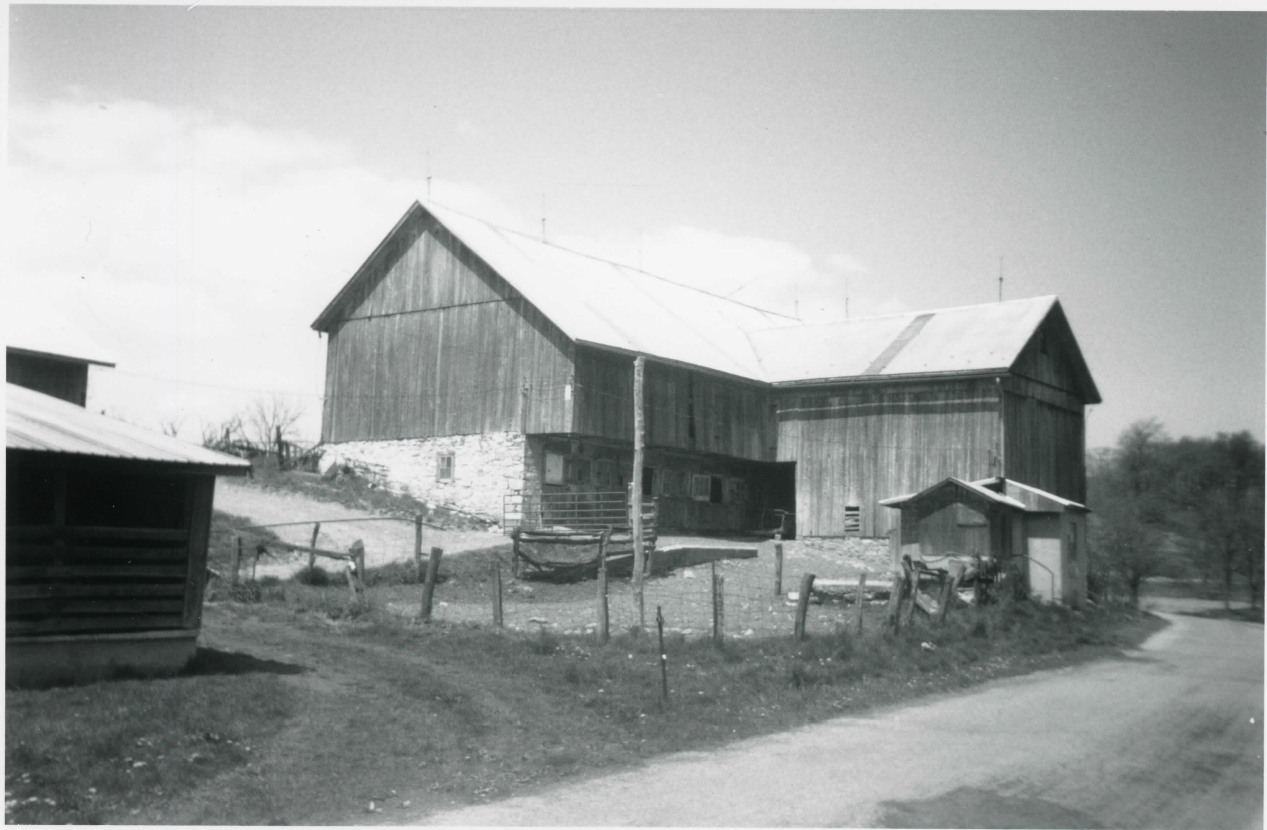
OXENRIDER FARM, BERKS County, PA - SOUTH EAST FACADE #4
BANK BARN AND MILKHOUSE (ON RIGHT), Pig sty on left

The frame bank barn is situated north of the house along Dundore Road. The barn has an asymmetrical roofline profile. The roof is channel tin with snow catchers. The roof truss system is of standard design (Ensminger), and has canted queen posts. Two wooden hay tracts are suspended from the peak, one in the north gable, the other in the south gable. The hay tracts retain carriages and three prong hay hooks.

The ground level of the barn has an open forebay and a cut stone facade. Although this level of the barn was modernized to accommodate a modern dairy operation, the forebay was never enclosed. Windows were added to the barn front to provide the required light. The south and mid section of the ground level have modern stanchions which replace the former wooden stalls and the walkways have been covered with concrete to meet modern sanitation standards. The north end of the barn retains its original stable, wooden troughs, hay racks, and feed bins. There is

The milk house is a one-story building, built of tongue-and-groove boards, in the 1930's, by the Oxenriders. It is located at the front of the barnyard, at the edge of the road. It originally had an interior trough for cooling milk.
