NATIONAL REGISTER OF HISTORIC PLACES
REGISTRATION FORM

historic name ARVONDOR APARTMENTS

street & number 823 23rd Street N/A not for publication

Three-story Apartment Buildings in Ogden,
1908-1928

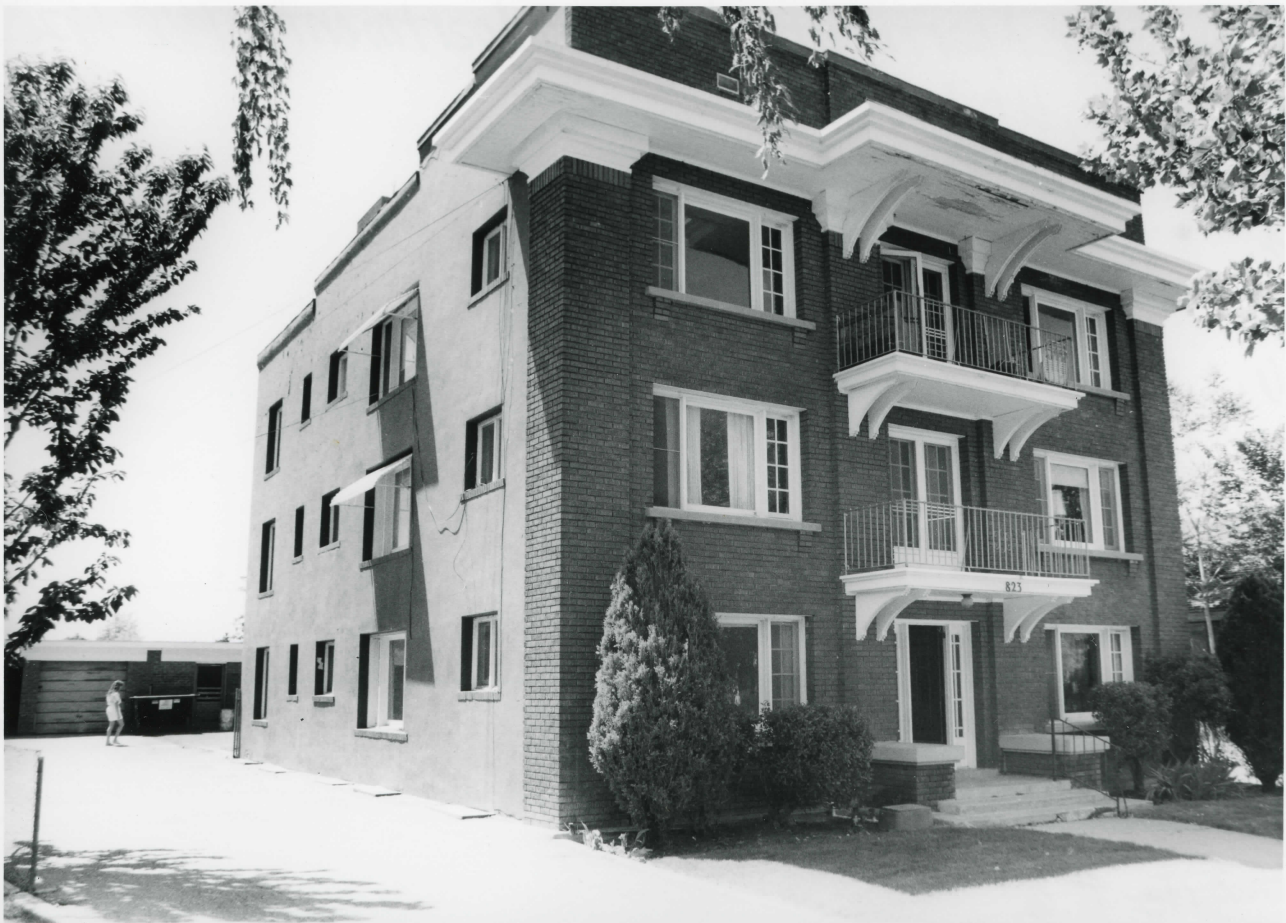
Site # 3

1. Arvondor Apartments / 3-Story Apartments, 1908-1928
2. Ogden, Utah
3. Allen D. Roberts, photographer
4. May, 1987
5. Neg.: Utah State Hist. Soc. Utah
6. View to Southwest
7. photo # 1 of 2

Completed in 1925, the Arvondor Apartments is a 3-story, brick building with a flat roof, concrete foundation, central vestibule/stairway, and modest Prairie School stylistic features. Exterior alterations are minor and do not significantly affect the building's original integrity.

The building footprint is rectangular with the narrow side facing the street. The facade is square or slightly horizontal in emphasis. Its main features are its brick facade, a very deep, bracketed overhanging cornice, cantilevered front balconies, flat-arched Chicago-style windows, and shallow pilasters. Exterior alterations include the addition of aluminum awnings over some of the side windows and wrought iron railing on the front porches. The stuccoing on the side and rear walls is possibly original, though it may be a later alteration (date unknown). Stylistically, the Arvondor shows modest signs of Prairie Style influence integrated into an otherwise non-descript or modern vernacular design.

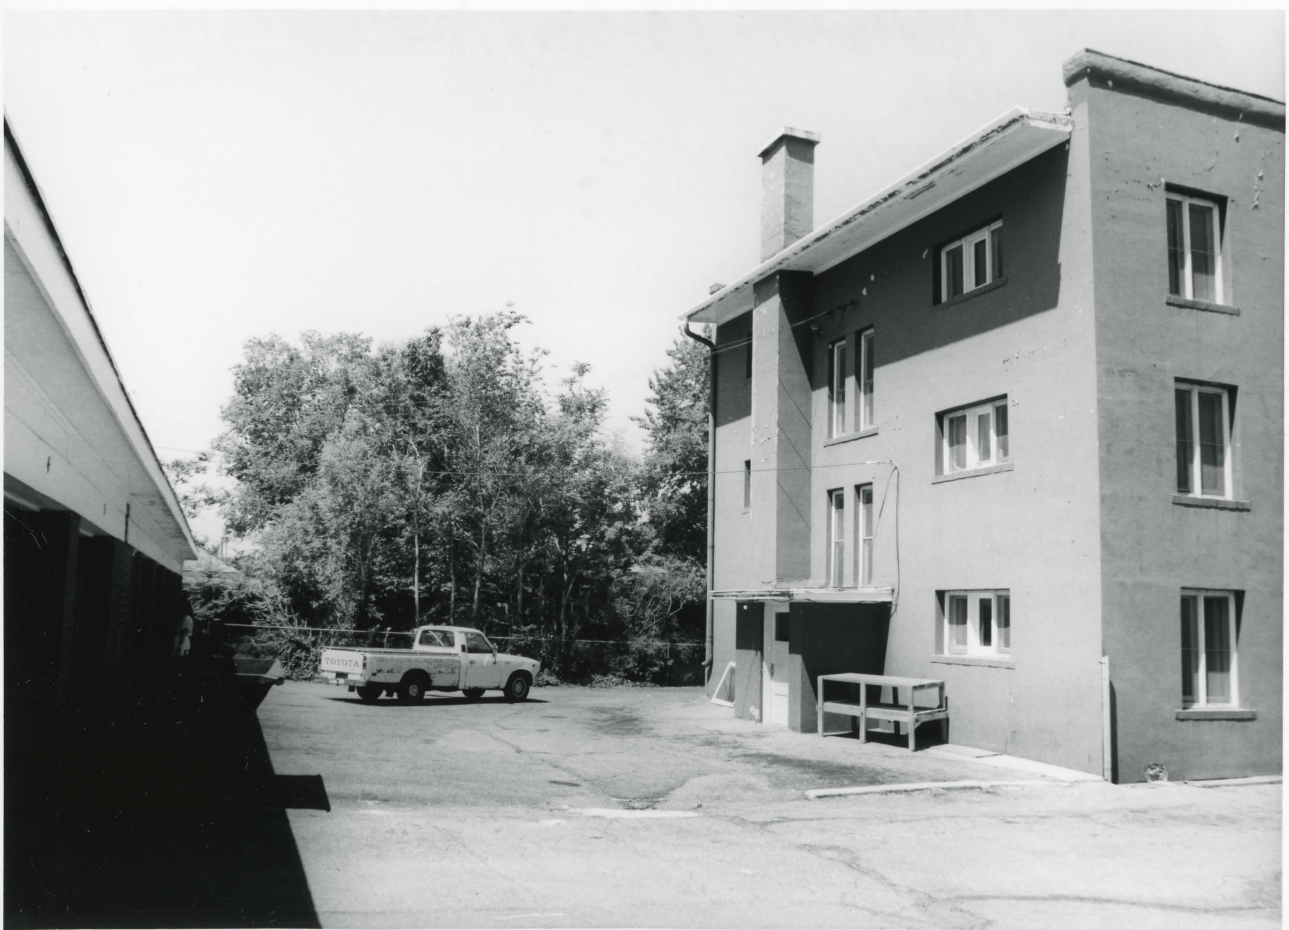
Site # 3

1. Arvondor Apartments / 3-Story Apartments, 1908-1928
2. Ogden, Utah
3. Allen D. Roberts, photographer
4. M24, 1987
5. Neg. - Utah State Hist. Soc.
6. View to Northwest
7. Photo # 2 of 2
