HISTORIC PROPERTY INVENTORY FORM

Historic Common Cornell Farmstead

mmon Marble Ranch

Marble Ranch Grandview, WA.

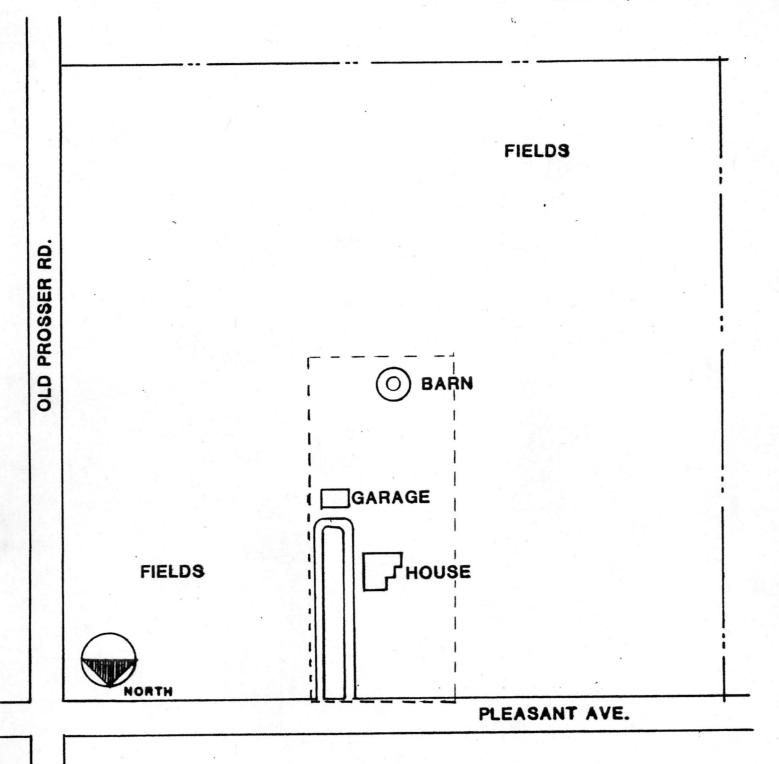
SITE PLAN SCALE: 1' - 200' ---- = Nominated property

Verbal Boundary Description: The nominated property is described thusly: Beginning at the northeast corner of the intersection of Pleasant Avenue and the eastern Marble Ranch drive, proceed directly south along the east edge of said drive approximately 750 feet, then proceed west approximately 300 feet, then proceed north 750 feet to the south edge of Pleasant Avenue; then proceed east along Pleasant Avenue until point of beginning.

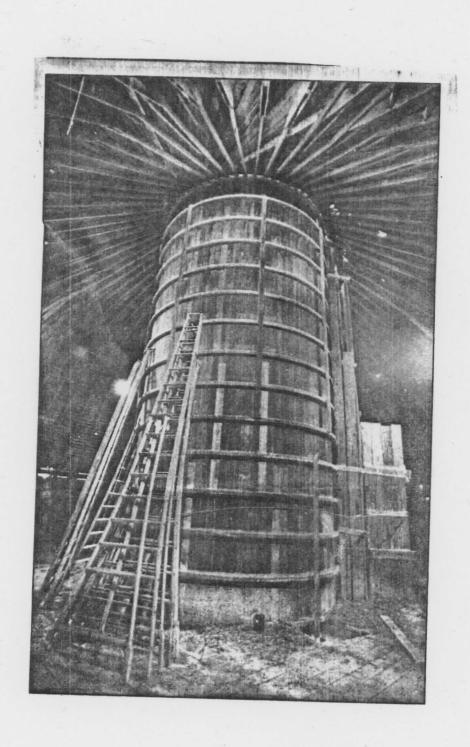
Cornell-Marble Barn: second floor interior, 1986, photo from Yakima Herald-Republic, April 27, 1986, p.1B.

About 500 feet south of the house is the historic round barn. The barn is 200'in circumference, with a centrally placed silo 50' in circumference. The silo rises through the conical gambrel roof and terminates about 25' feet above the barn. The barn rests on a concrete foundation and the walls are supported by light frame construction. The exterior of the barn and silo is sided with vertical tongue and groove wood boards. barn is provided through four sliding wooden doors, symmetrically distributed around the barn. Sixteen fixed sash windows are disposed across the barn. Each window has six lights with wood sash and muntins. The roof is a bellcast gambrel with exposed rafter tails. Four rectangular eyebrow windows are spaced evenly around the circumference of the roof at the intersection of the two sloping planes. The roof is covered with composition shingles which replaced the original wood shingles. The interior of the barn is well preserved. The lower level, accessed through the sliding doors, has original wooden floors and once housed cattle in stanchions arranged around the central silo. A ladder by the silo leads to the second, hay mow level, which has radiating floor joists and flooring. structural elements of the roof are still visible including the rafters and braces spreading out in fan-like fashion from the central silo. Today, the barn is used only for storage.

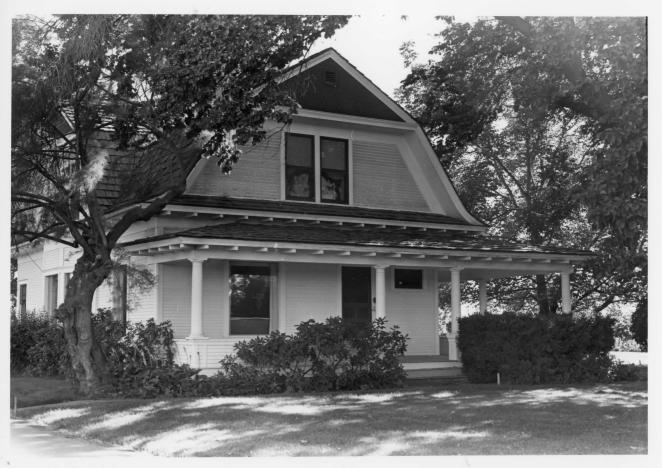
Cornell Farmstead (House) Grandview, Washington

Photographer: Katie Dutcher Taken: September 3, 1986
Negative: OAHP, Olympia, Wa. Looking Southwest
15 (Roll 8, #9) / of 4

enclose the gable ends. A broad front verandah has a hipped roof, enclosed railing, Tuscan columns, and boxed cornice with extended brackets. A side bay window projects beneath the side gambrel gable end. Windows are mostly double hung, one over one sash. A grape trellis at the rear of the house is a recent but sensitive addition. The house is surrounded by large trees. The interior has original woodwork and retains much of its historic character. The formal entrance hall leads to a large wooden staircase with turned balusters. The walls are plaster and lath. A small addition, built about ten years ago, extends off the south end of the house and is used as an office.

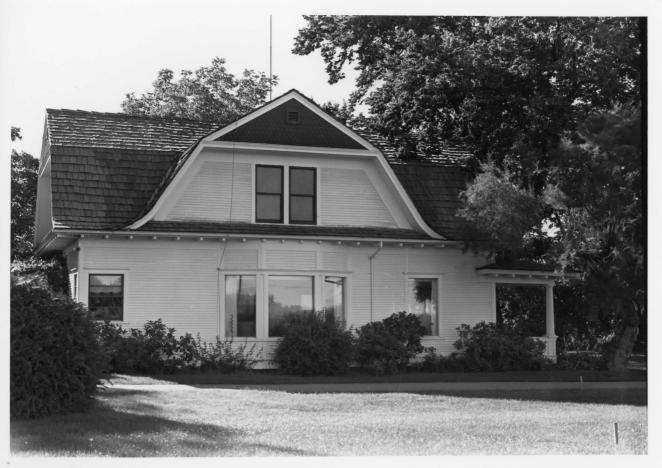
Cornell Farmstead (House) Grandview, WA

Photographer: Katie Dutcher Taken: September 3, 1986
Negative: OAHP, Olympia, Wa. Looking East
16 (Roll 8, #10) 2 of 4

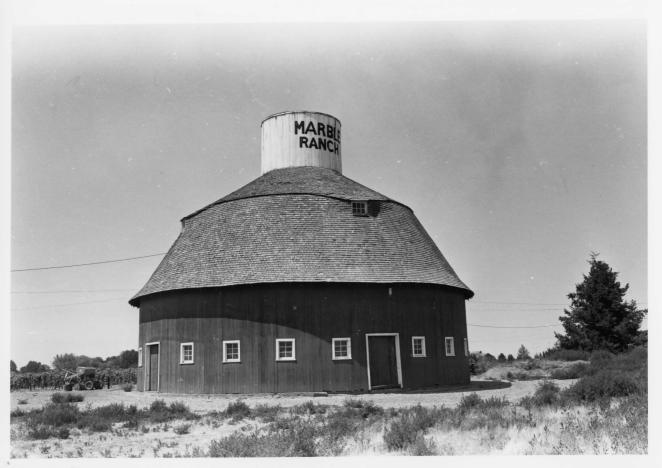
Cornell Farmstead (barn)
Grandview, WA

Looking east

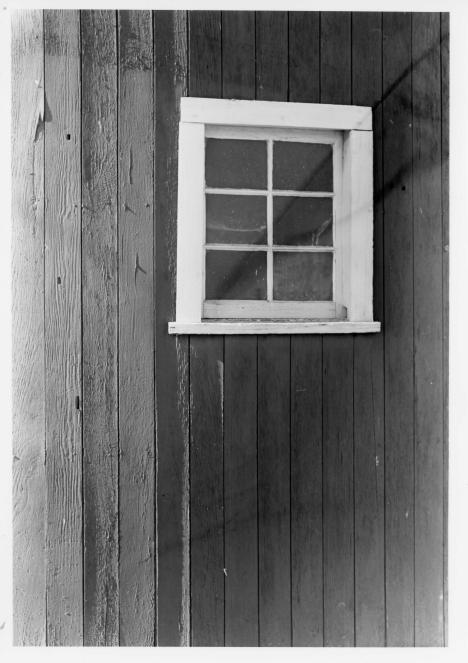
Cornell Farmstead (Barn)
Grandview, Washington

Photographer: Katie Dutcher Taken: September 3, 1986
Negative: OAHP, Olympia, Wa. Detail of Barn window
18 (Roll 8, #13) 4 44
