National Register of Historic Places Registration Form

historic name
other names/site number NISQUALLY ENTRANCE HISTORIC DISTRICT

street & number MOUNT RAINIER NATIONAL PARK
city, town
state WASHINGTON code WA county LEWIS; PIERCE code 041; 053 zip code

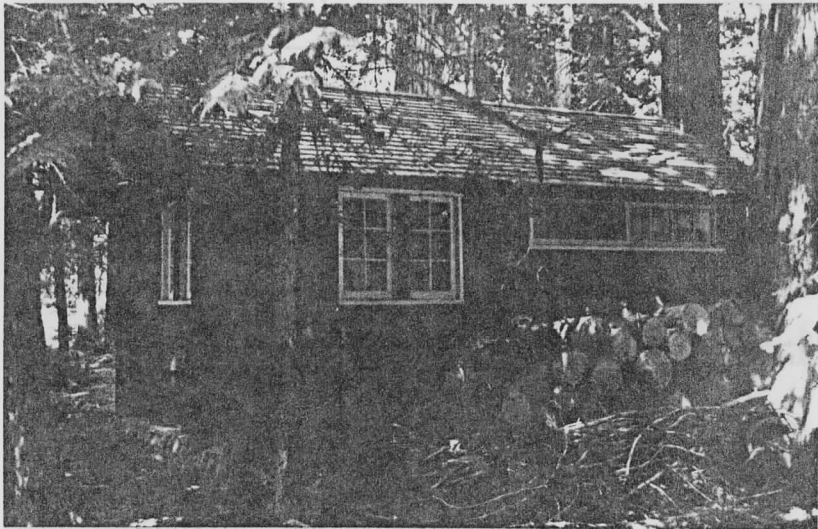
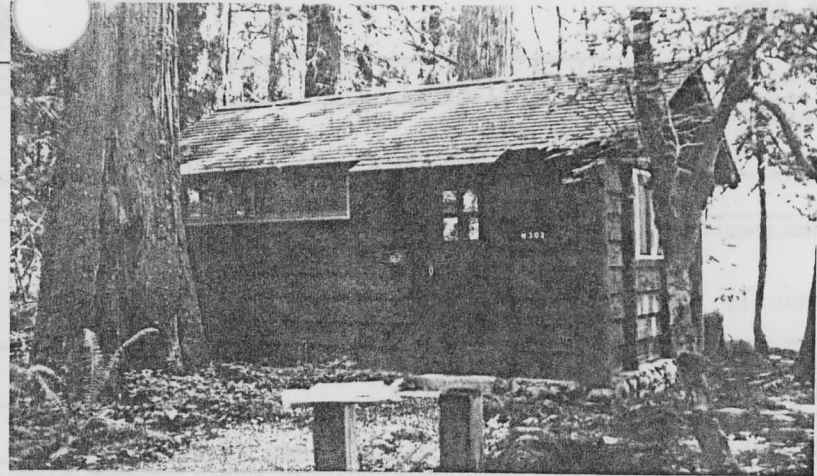
Nisqually Entrance N-302

Wood frame, one-story, one-room, rectangular plan; low-pitched, cedar shingle gable roof with projecting eaves and verges; log rafters; horizontal rough lapped siding, door and window openings framed with whole logs; stone foundation; fixed sashes; finished plywood/wallboard interior; suspended ceiling; concrete floor.

This timber frame building was constructed by the National Park Service in 1927 and originally served as a womens comfort station. The original exterior was comprised of vertical half-log slabs with door and window openings framed with Whole logs. At an unknown date (perhaps the late-fifties or early-sixties) the log slab veneer was replaced with roughed lapped Douglas Fir siding (1x12's). The comfort station was subsequently converted to a storage facility (c.1970).

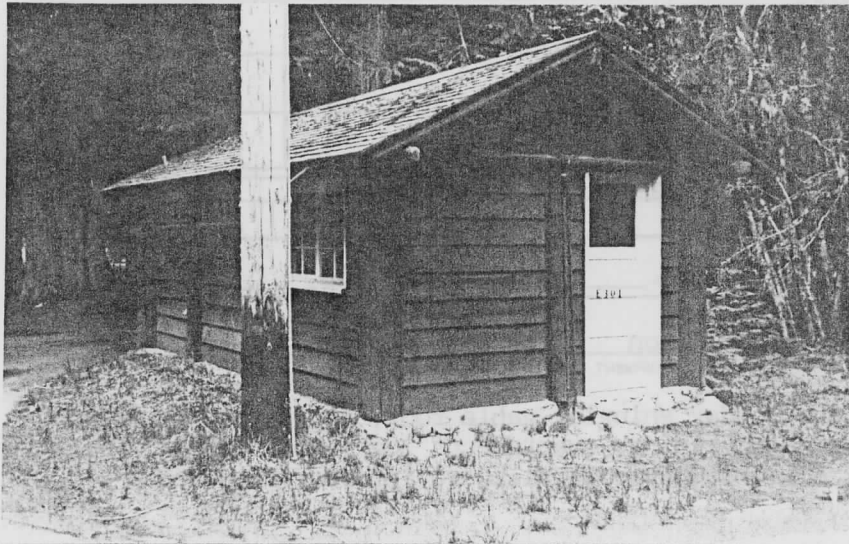
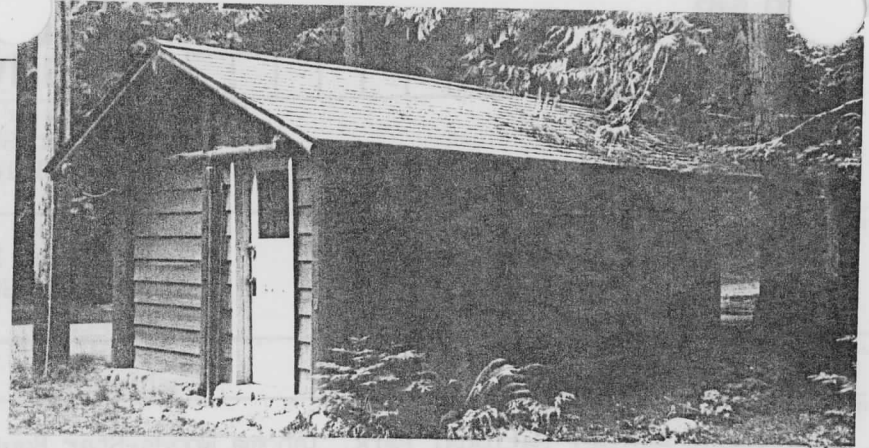
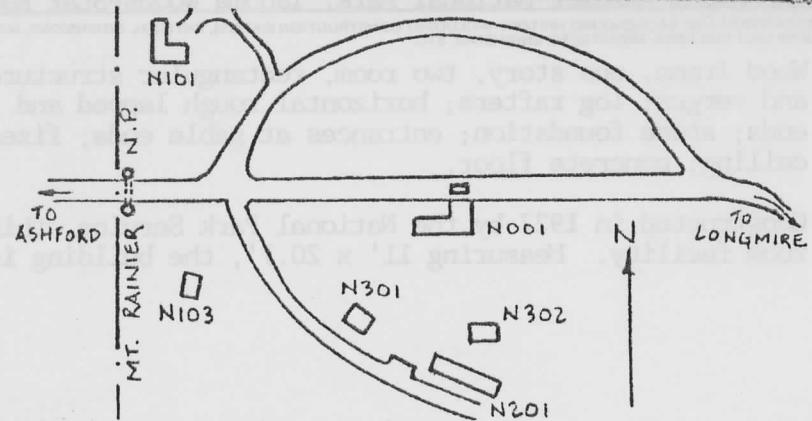
Nisqually Entrance N-301

Wood frame, one story, two room, rectangular structure; low pitched cedar shingle gable roof; projecting eaves and verges; log rafters; horizontal rough lapped and log post and beam siding; quarter-cut log veneer gable ends; stone foundation; entrances at gable ends; fixed windows; finished plywood-wallboard interior; suspended ceiling; concrete floor.

Constructed in 1927 by the National Park Service, this structure was originally a comfort station and a radio room facility. Measuring 11' x 20.7', the building is presently used as an employee laundromat and storage.

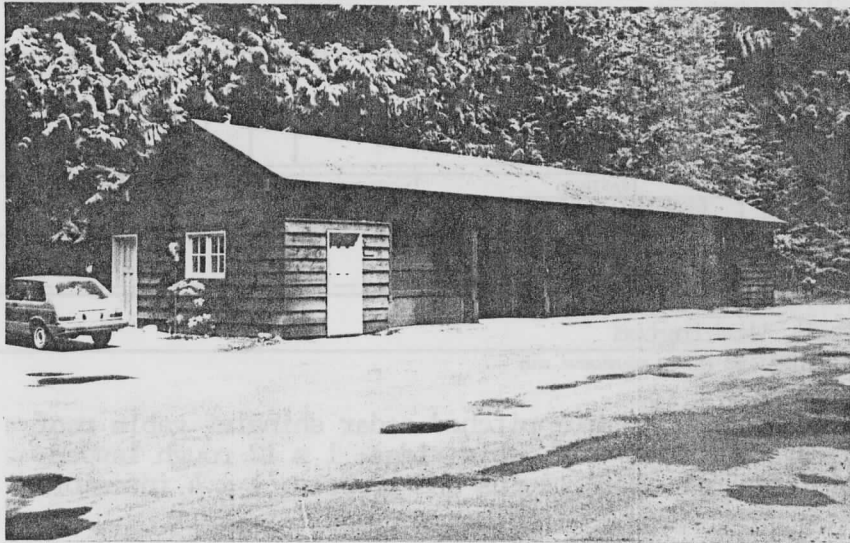
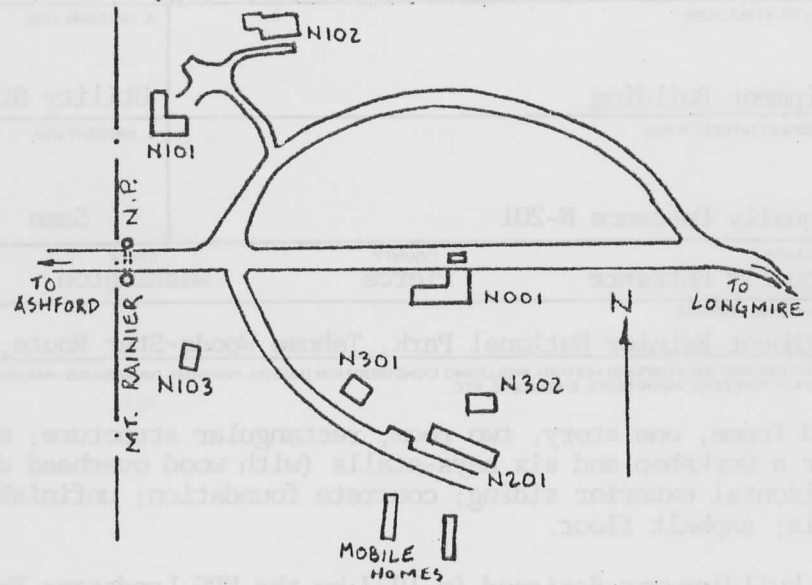
Nisqually Entrance N-201

Wood frame, one story, two room, rectangular structure; modified "saltbox"-medium pitched cedar shingle gable roof over a workshop and six bays-stalls (with wood overhead doors); brick chimney off gable ridge; 1 x 12 rough lapped horizontal exterior siding; concrete foundation; unfinished interior with wood columns and trusses; 1 x 4 interior walls; asphalt floor.

The building was designed in 1927 by the NPS Landscape Engineering Division, under the supervision of D.R. Hull (MORA Drg. No.18). The original plan called for a half log exterior frame with vertical cedar slab infill. Measuring 22.2' x 78.8', the building was constructed in 1934 by the C.W.A. (Civilian Work Administration). The bays were framed with regular grade lumber posts and beams.

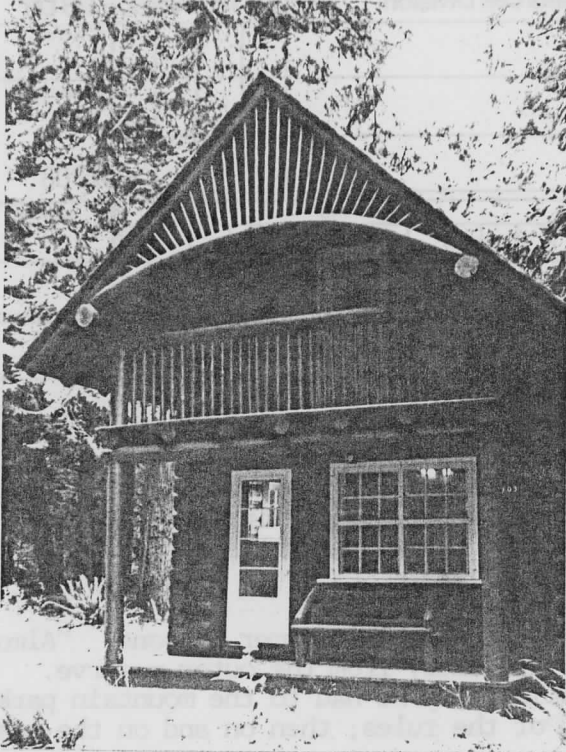
Nisqually Entrance N-103

headquarters. A one-story timber frame addition (c.1909) off the east side may have served as a kitchen. A second addition (c.1910) to the building's rear allegedly served as the superintendent's office. It measured 15' x 16' and contained a medium-pitched gable roof and exterior siding all covered with cedar shingles. This wing was later expanded with the addition of a bathroom and porch. The cabin further served as the superintendent's quarters during the winter months.

administrative functions. It probably served as a ranger residence immediately thereafter. Recently, (c.1980) renovation work was carried out. An interior stairway to the upper floor was installed and new bathroom and kitchen fixtures added. The exterior appears largely returned to its original condition. New thin timber members were constructed along the railing of the second-story porch. Though not original to the cabin's front facade, they harmonize well with the decorative woodworking under the gable end. The remodeled cabin currently serves as a VIP cottage.

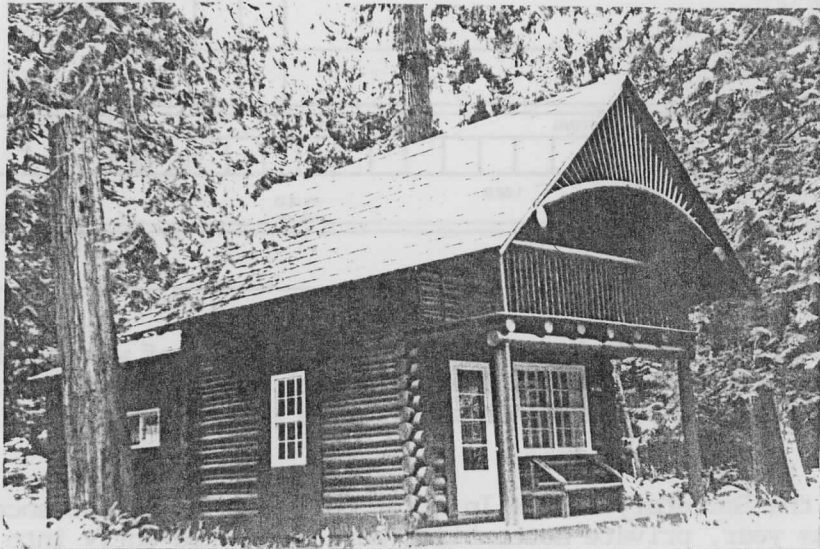
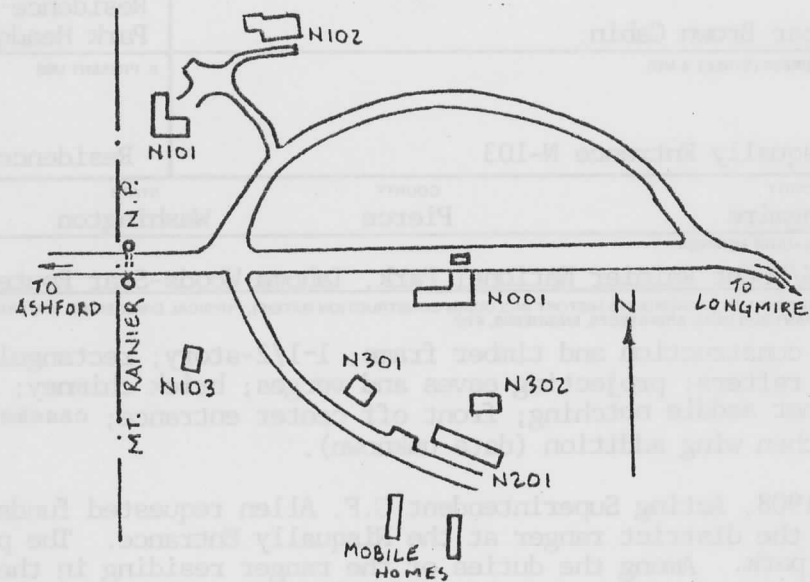
Nisqually Entrance N-103

Log construction and timber frame; 1-1/2-story; rectangular plan; steeply-pitched cedar-shingle gable roof with whole log rafters; projecting eaves and verges; brick chimney; 2-story front porch; whole log walls with wood chinking and corner saddle notching; front off center entrance; casement sashes; exposed log interior walls and ceilings; rear kitchen wing addition (date unknown).

The Oscar Brown Cabin, named after one of the early permanent rangers assigned to the park, is the oldest remaining government-constructed building in the park. The finely-crafted log construction with ornamented wood elements along the front facade, served as a residence and park headquarters until 1916 when a new administrative facility was built at Longmire. It is associated with the early administration of Mount Rainier National Park prior to the formation of the National Park Service (1916). Additionally, the cabin served as the park superintendent's winter residence until 1915. Though recently renovated, the exterior (particularly the distinctive front facade) remains largely unaltered.

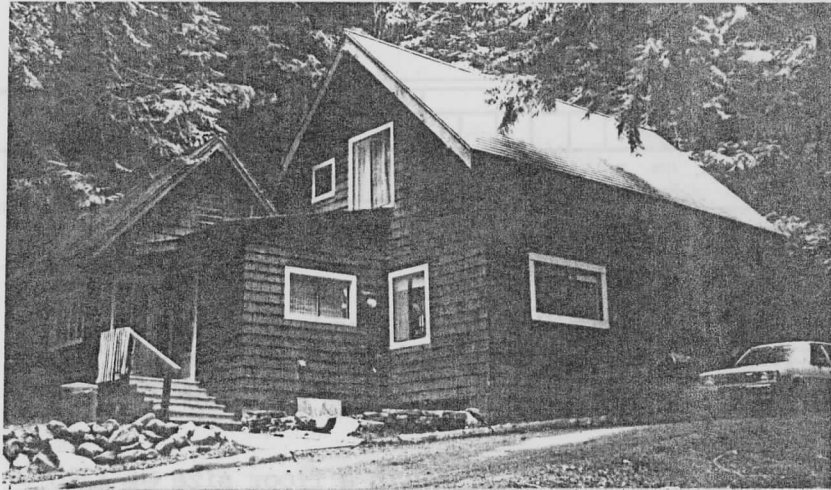
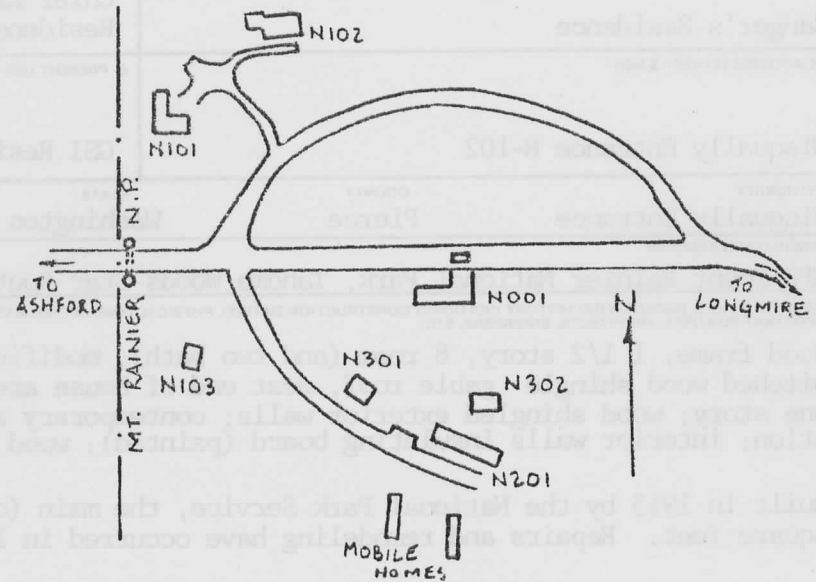
Wood frame, 1 1/2 story, 8 room (and two bath), modified rectangular "split level" plan; main unit has steeply pitched wood shingle gable roof, west end of house are two additions, one with a shed roof, the other gabled, both one story; wood shingled exterior walls; contemporary sliding aluminum windows; recessed front porch; concrete foundation; interior walls insulating board (painted); wood floors.

Built in 1915 by the National Park Service, the main (original) unit measures 20' x 32', with a floor size of 1280 square feet. Repairs and remodeling have occurred in 1958, 1960, 1963, and 1964. A new roof was installed in 1964.

One of the earliest residences in the park, the Chief Ranger's House was constructed the same year as the Park Superintendent's residence (see N-101) at Nisqually Entrance. The superintendent in 1915 was DeWitt L. Reaburn; with his appointment, park management at Mount Rainier took on a degree of professionalism. Both structures are associated with the early administration of Mount Rainier National Park prior to the formation of the National Park Service in 1916.

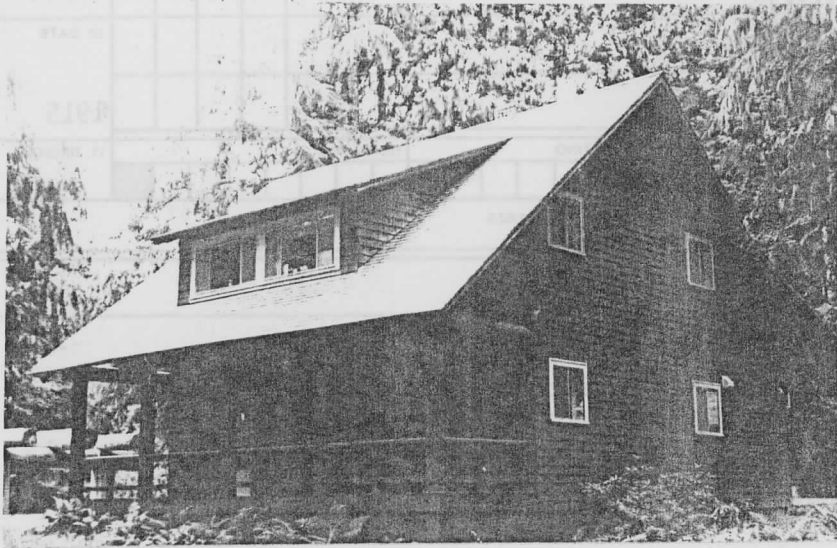
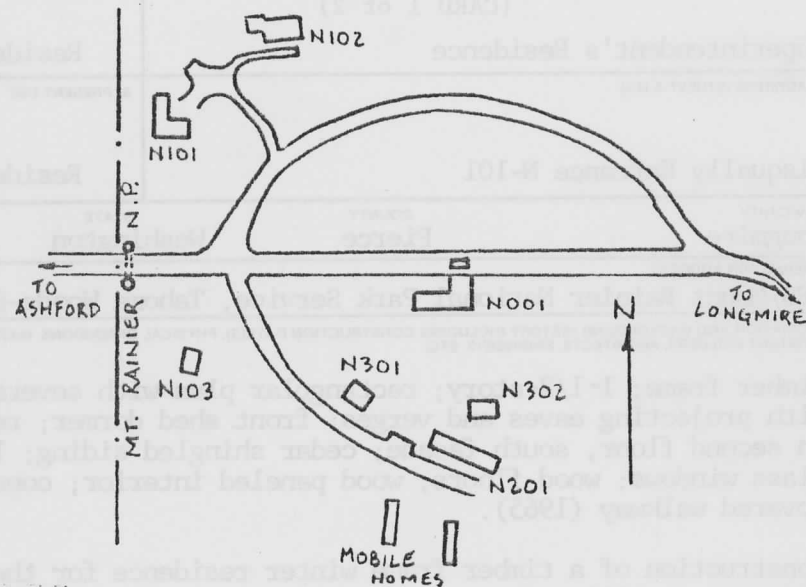
Timber frame; 1-1/2-story; rectangular plan with several additions; steeply-pitched, cedar shingle gable roof with projecting eaves and verges; front shed dormer; rear shed roof extension; brick chimney; recessed balcony on second floor, south facade; cedar shingled siding; 1 story front porch; front off center entrance; sliding glass windows; wood floors; wood paneled interior; concrete and concrete block foundation; garage addition and covered walkway (1965).

Built to serve as the superintendent's winter quarters in 1915, the building has undergone numerous renovations. It has housed the park superintendents and their families year round since 1923.

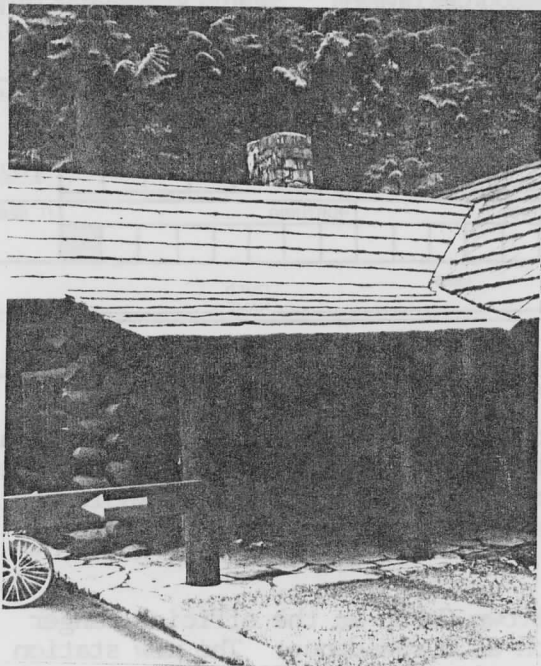
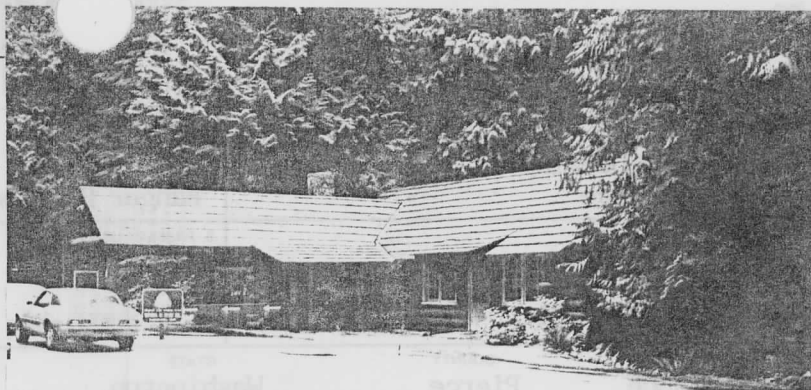
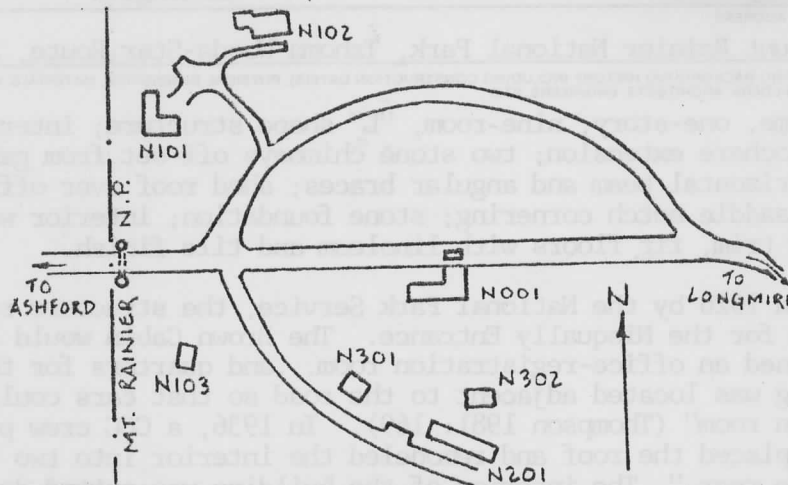
Log-frame, one-story, nine-room, "L" shape structure; intersecting medium-pitched cedar shake gable roofs with a porte-cochere extension; two stone chimneys off-set from gable ridge; log rafters; shed roof over private entrance with horizontal beam and angular braces; shed roof over office entrance with roughly hewn log columns; whole log walls; saddle notch cornering; stone foundation; interior walls are plasterboard (painted insulation board), painted trim, fir floors with linoleum and tile finish.

Built in 1926 by the National Park Service, the structure replaced the Oscar Brown Cabin as the official ranger station for the Nisqually Entrance. The Brown Cabin would continue to function as a residence. The new station "contained an office-registration room...and quarters for three bachelor rangers in the main 22' x 44' unit. The building was located adjacent to the road so that cars could drive immediately to the porch in front of the registration room" (Thompson 1981: 169). In 1936, a CCC crew placed a new masonry foundation under the station. They also replaced the roof and remodeled the interior into two separate residences while maintaining the office space from the rear." The interior of the building was gutted during the remodeling. All walls and ceilings were lined with insulating wallboard and 1 x 4 tongue and groove fir wood floors were installed. New wooden doors replaced the original log ones. All the remodeling was to conform as closely as possible to the original construction.

The Nisqually Entrance Ranger Station was one of the numerous park structures constructed under Major O.A. Tomlinson's superintendency. The station was built from plans drawn by the NPS Landscape Engineering Division, under the supervision of Dan R. Hull. The plans for the 1937 remodeling, and porte-cochere addition, were drawn by the NPS Branch of Plans and Design in San Francisco, under the supervision of Acting Chief Architect, W.G. Carnes. The entrance station became a model for others constructed later in the park.
