National Register of Historic Places Registration Form

other names/site number LONGMIRE HISTORIC DISTRICT

street & number MOUNT RAINIER NATIONAL PARK

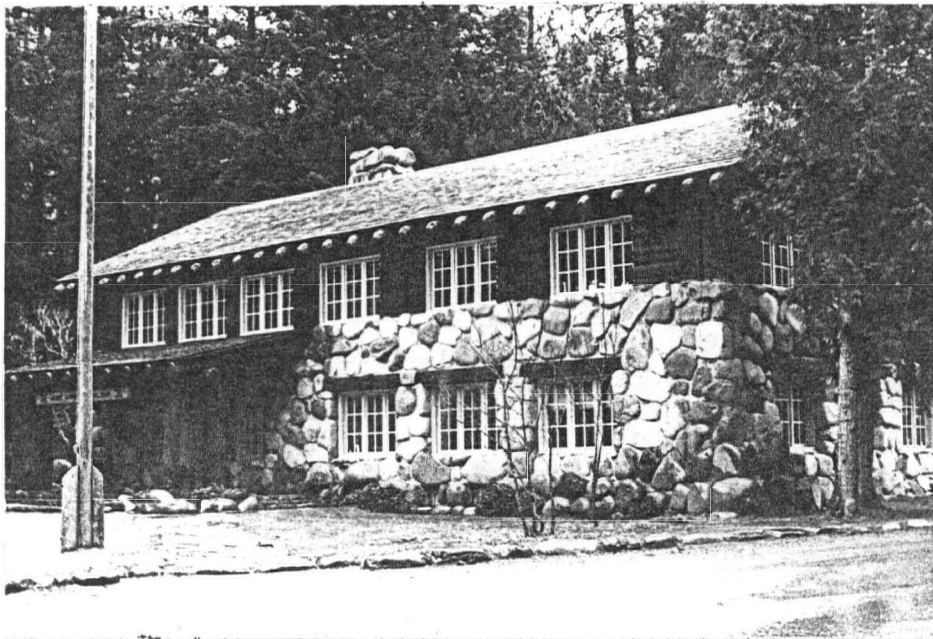
17. PHOTOS AND SKETCH MAP OF LOCATION

The most striking portion of the building (generally measuring 37' x 68') was the first story, boulder-masonry veneer. Local glacial boulders were employed with the more massive stones embedded in concrete at the base. The size was decreased upward to the second story. Stones were battered at the building's corners to lend a solid appearance and mask the "essentially rectangular foundation lines." The second story, horizontal log slab veneer arising at sill level was joined at the corners by massive vertical logs. Projecting whole log rafters with whittled ends were connected to the non-visible standard timbers forming the rafters. The roof was covered with cedar shingles. These elements combined to create a structure highly sensitive to the forested landscape.

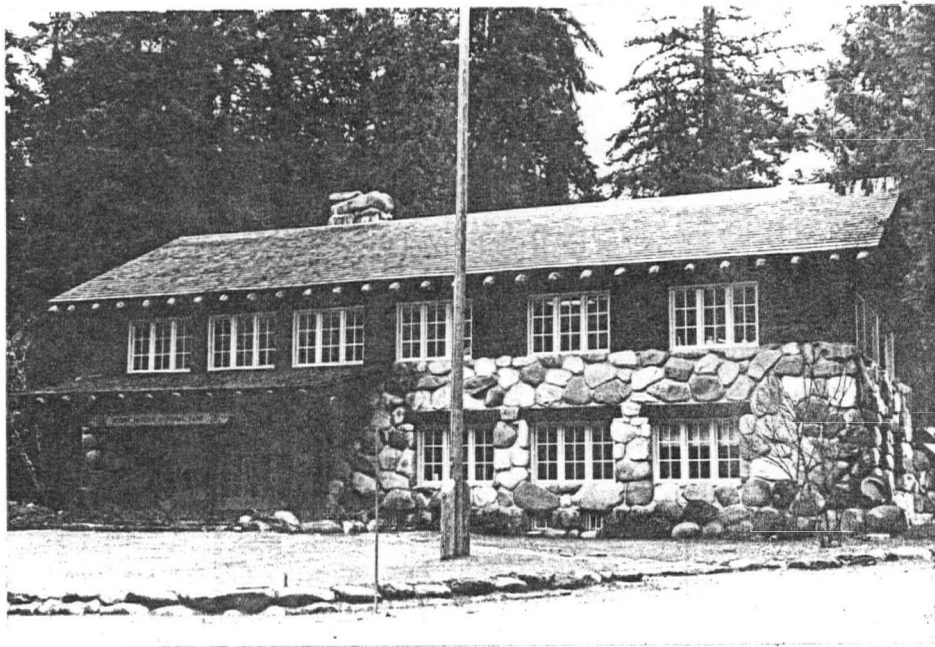
Upon its completion, the Longmire Administration Building was perhaps the most widely acclaimed building in the park. Its design was supervised by Thomas C. Vint, Chief Architect of the National Park Service, Western Division, Branch of Plans and Design. Vint was responsible for continuation of "non-intrusive" rustic architecture: in the West's National Parks between 1927 and 1937. Associate Landscape Architect E.A. Davidson worked under Vint on the landscape development of Mount Rainier National Park including the administration building. The distinctive glacial boulder veneer and log work, set in the forested environment, is a product of their collaboration.

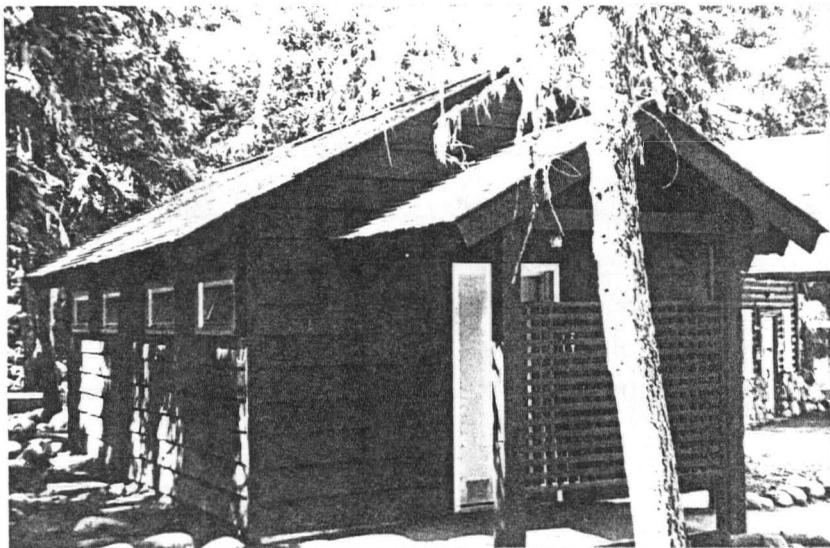
## 17. PHOTOS AND SKETCH MAP OF LOCATION

Timber-frame; 1-story; rectangular plan; medium-pitched cedar shingle gable roof with projecting eaves and verges; porches with cedar shingled gable roof at each entrance; rough lapped Douglas Fir siding; front center entrances at each end; pivot windows; marlite walls and ceilings; concrete floor covered with tiles; concrete foundation.

Comfort Station L-003 was built as part of the Longmire plaza improvement in the twenties. It is the oldest remaining comfort station in the park.

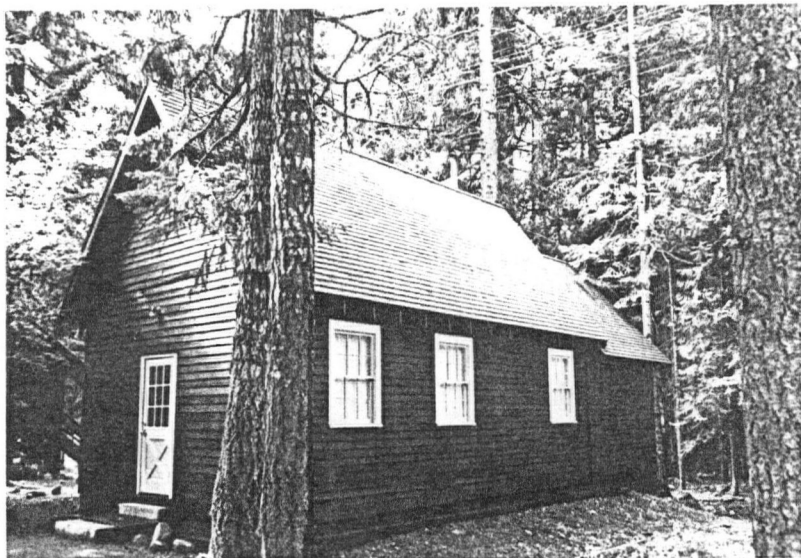
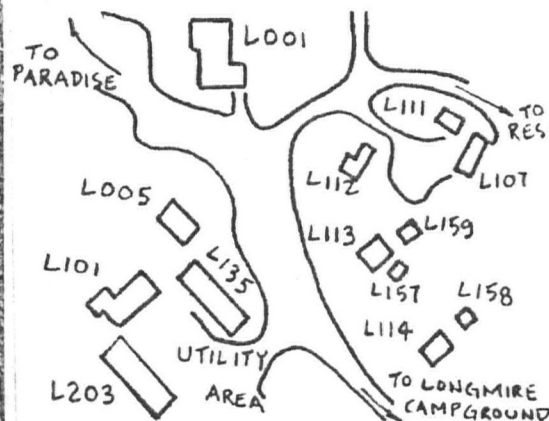
~~XXXXXXXX~~ exterior building lines remain largely intact except for the new foundation.

This timber frame building is perhaps the oldest extant government structure at Longmire. Originally serving as a community kitchen, it was converted to a library in the twenties. The building presently functions in this role.

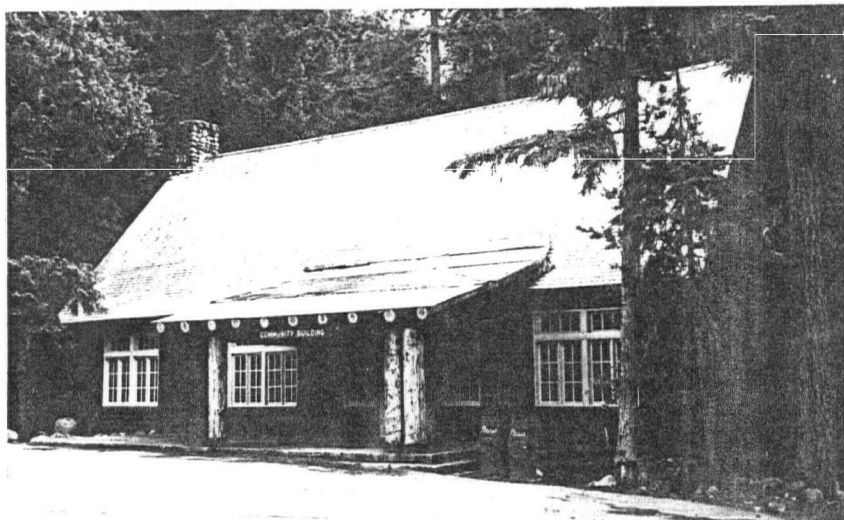
## 17. PHOTOS AND SKETCH MAP OF LOCATION

The Community House completed in 1927 was the crowning achievement in the construction of the Longmire Public Auto-Camp (1924-27). For decades it served as the center for cultural and social activities at Longmire. The building, designed by the NPS Western Division Branch of Plans and Design, Thomas C. Vint, Chief Architect, typifies the theme of non-intrusive, "rustic" architecture prevalent in America's parks in the twenties and thirties. It remains largely unaltered and functions in much the same role (though less extensively used) as originally intended.

Timber-frame; 2-story; modified "T"-plan; steeply-pitched cedar shingle gable roof with projecting verges; stone masonry chimney; log slab walls; whole log posts and beams; whole log rafters; shed roof front porch; shed roof rear dormer; rear wing containing steeply pitched gable roof; stone masonry chimney and stove pipe chimney; board and batten exterior siding; interior of main hall contains exposed post and beams; wood floors, log slab walls; rear wing interior (residence) contains two stories; bathrooms, kitchens, bedrooms and living rooms; two rear porches; foundation walls for entire structure of stone (glacial boulders) and concrete.

Revisions to the original design were required to stay within the \$3,000 appropriation for construction. The NPS architects were forced to reduce the building's size and modify the "rustic" detailing. Construction commenced in

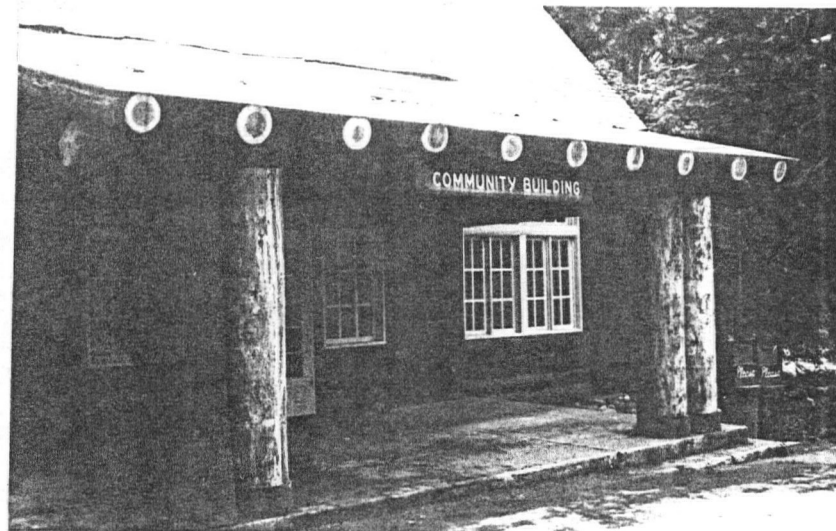
17. PHOTOS AND SKETCH MAP OF LOCATION

considered the social "hub" of Longmire, the main hall is still used for lectures and meetings. A number of alterations have occurred to the building. In 1942, an entire new wood floor was installed to replace the original (suffering from severe rot). The projecting whole log rafters also deteriorating from rot were cut back to under the eaves. At an unknown date, the exposed whole log ridge beam was removed. Recently, the log slab walls were removed for the placement of insulation and re-installed (as original). The shed roof on the porch was rebuilt (1982) with the addition of metal flashing. New whole log posts replaced several deteriorated ones. Again with the exception of eliminating the projecting log rafters, the porch appears as originally constructed. The interior framing remains as originally designed and built.

Superintendent Tomlinson reported the favorable reception for the Community House by the public. Several years after its opening, the building, though praised for its early achieving rustic "park character," was criticized for the thinness of its roof shingles and stone in the masonry chimney, and "almost mechanical stiffness" of the projecting log rafters (their ends being merely sawn instead of whittled). Nonetheless, the building proved quite popular among visitors and NPS employees. The Community Building currently serves in its original role though in a reduced capacity. While no

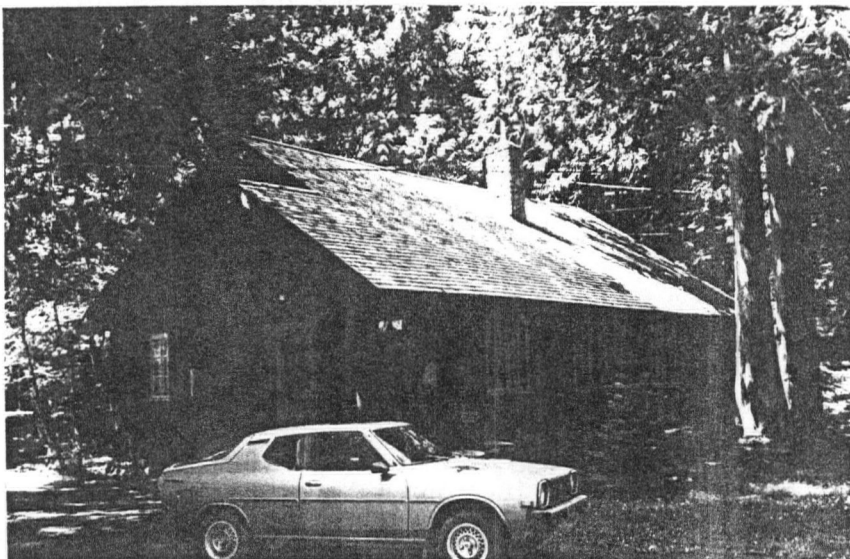
17. PHOTOS AND SKETCH MAP OF LOCATION

Wood-frame, 1-1/2 story, eight-room (and bath), rectangular bungalow; steeply-pitched cedar shingle gable roof intersects with gable roof over post and beam frame front porch; stone veneer brick chimney off gable ridge; exterior cedar shake siding over 1 x 12 horizontal lapped board; stone foundation; interior walls are finished wallboard; wood floor.

L-109 was constructed from the standard cottage plan as were numerous other residences built at Longmire during that period. These residences were part of the general development plan for Longmire requested by Superintendent Tomlinson and drawn up by the National Park Service's Landscape Design Office in San Francisco, under the supervision of Chief Landscape Architect T.C. Vint.

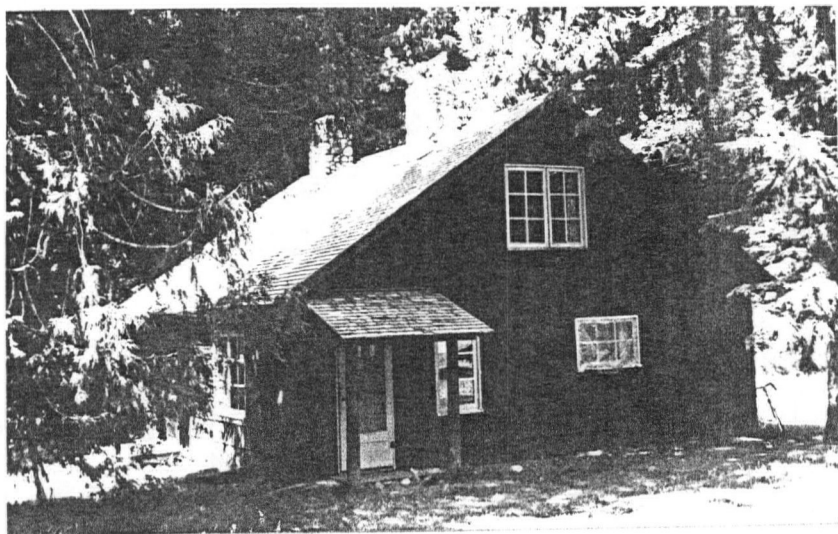
17. PHOTOS AND SKETCH MAP OF LOCATION

Wood-frame, 1-1/2 story, 9-room (and two baths) rectangular duplex; steeply-pitched cedar shake gable roof with shed roof extension off front gable slope over small front stoop; two stone chimneys on gable ridge; exterior cedar shingles over 1 x 12 rough lapped board; stone and wood foundation; interior walls are wallboard; wood floors.

The cottage was one of the first constructed at Longmire for park employees. It was a component of the first planned residential development at Longmire that was proposed during Superintendent Roger Toll's administration (1919-20).

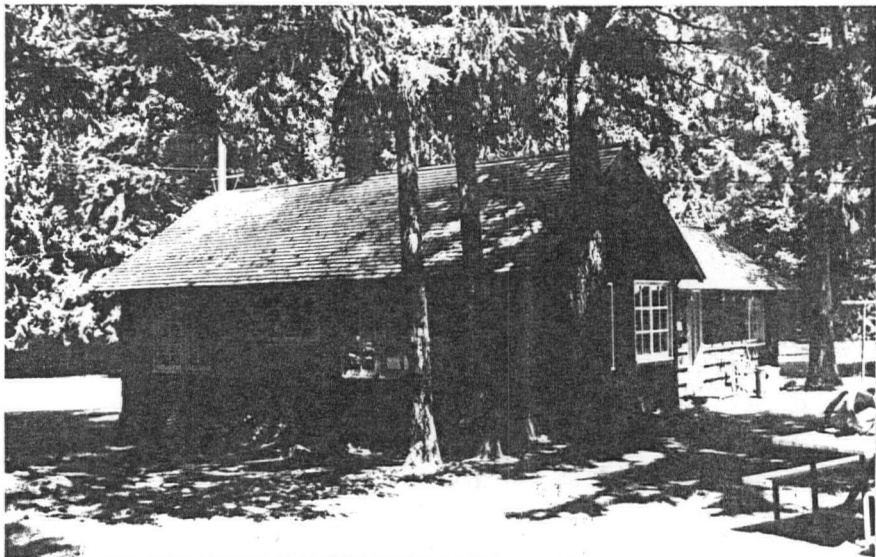
## 17. PHOTOS AND SKETCH MAP OF LOCATION

During Superintendent Roger Toll's administration (1919-20), the National Park Service's Landscape Architect in Washington, D.C., was requested to prepare location plans for employee housing at Longmire (Superintendent 1920). Acting Superintendent Clarence Nelson, in his annual report for 1922, also recommended the construction of residences at Longmire to replace temporary tent quarters. This cottage, measuring 44.5' x 30' with the stem of the 'L' measuring 17'4" x 11'3", was one of the four cottages built by the Park Service at Longmire in 1923. Total floor size of L-112 is 987 square feet. The one story, front porch is 6.5' x 10.5', with hewn log columns, wood decking, and a low cedar shaked wall. The cottage was remodeled in 1953, a 14' x 26' bedroom and a new chimney were added, the interior was finished with plywood, and new floor joists and a fir floor were installed. The roof was resingled in 1977.

The cottage was one of the first constructed at Longmire for park employees. It was a component of the first planned residential development at Longmire that was proposed during Superintendent Roger Toll's administration (1919-20).

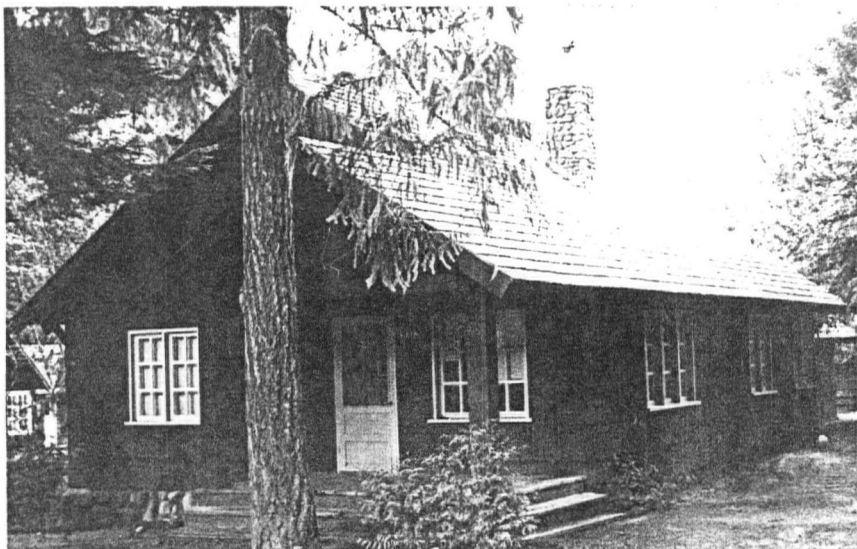
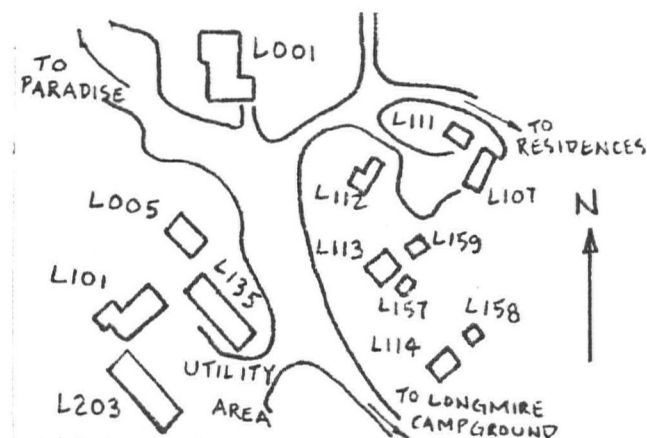
## 17. PHOTOS AND SKETCH MAP OF LOCATION

Wood-frame, 1-1/2 story, 8-room (and bath), rectangular bungalow; medium-pitched cedar shingle gable roof intersects with gable roof over open post and beam frame front porch; stone veneer brick chimney off gable ridge; exterior cedar shake siding over 1 x 12 horizontal lapped board; finished interior wallboard; wood floors; stone foundation.

The construction of L-113 was part of the initial development plan for Longmire requested by Superintendent Tomlinson and drawn up by the National Park Service's Landscape Design Office in San Francisco, under the supervision of Chief Landscape Architect T.C. Vint.

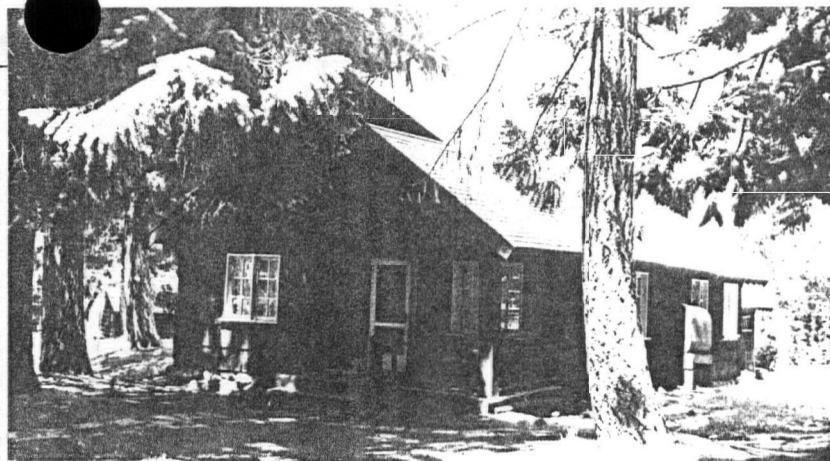
## 17. PHOTOS AND SKETCH MAP OF LOCATION

Wood-frame, 1-1/2 story, 8-rooms (and bath), rectangular bungalow; medium-pitched cedar shingle gable roof intersects with gable roof over open post and beam frame front porch; projecting eaves and verges; modified cut-stone chimney off gable ridge; metal wood stove pipe on roof slope; exterior cedar shake siding over 1 x 12 horizontal rough lapped board; finished interior wallboard; wood floors; double and triple sash casement windows with mullions; stone foundation.

The construction of L-115 was part of the initial development plan for Longmire requested by Superintendent Tomlinson and drawn up by the National Park Service's Landscape Design Office in San Francisco under the supervision of Chief Landscape Architect T.C. Vint

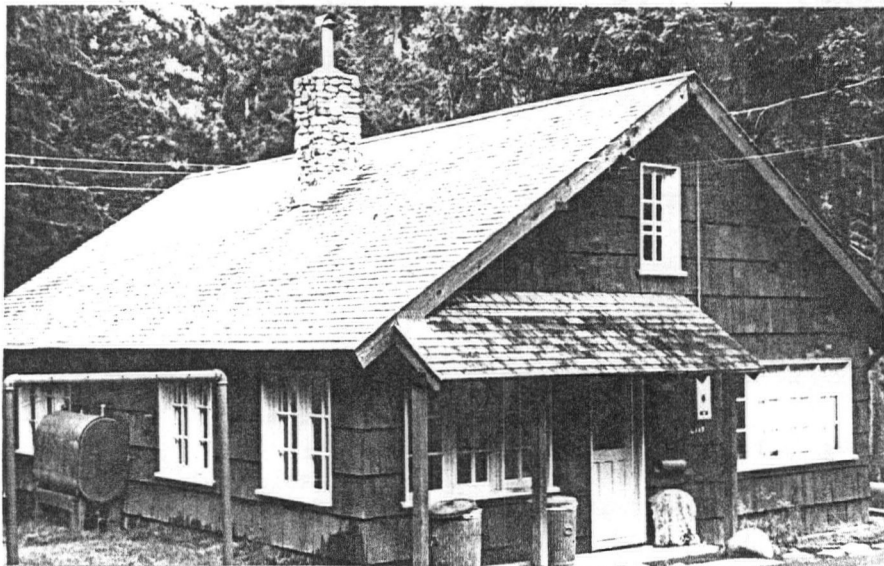
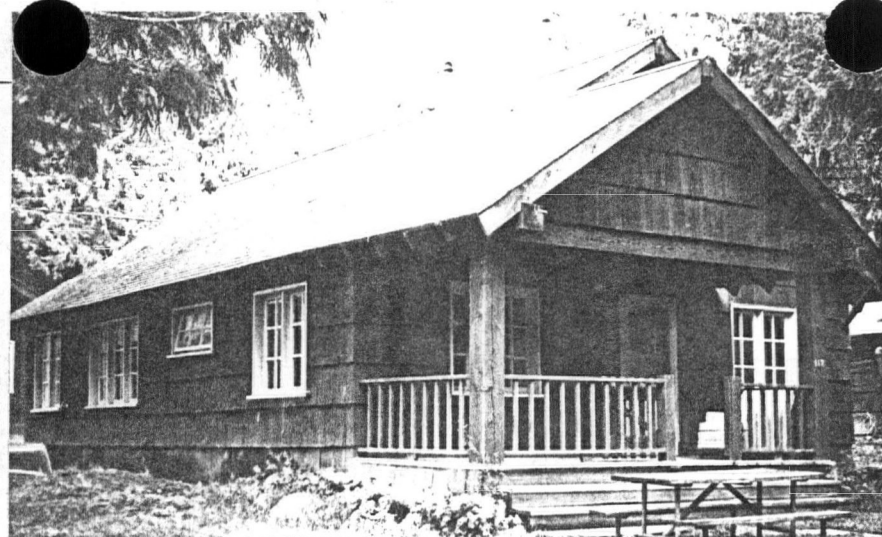
17. PHOTOS AND SKETCH MAP OF LOCATION

Wood-frame, 1-1/2 story, 8-rooms (and bath), rectangular bungalow; medium-pitched cedar shingle gable roof intersects with gable roof over open post and beam frame front porch; stone veneer brick chimney located off gable ridge; exterior cedar shake siding; finished interior wallboard; double and triple sash casement windows with mullions; wood floors; boulder foundation.

The construction of L-117 was part of the initial development plan for Longmire requested by Superintendent Tomlinson and drawn up by the National Park Service's Landscape Design Office in San Francisco, under the supervision of Chief Landscape Architect T.C. Vint and his assistant E.A. Davidson.

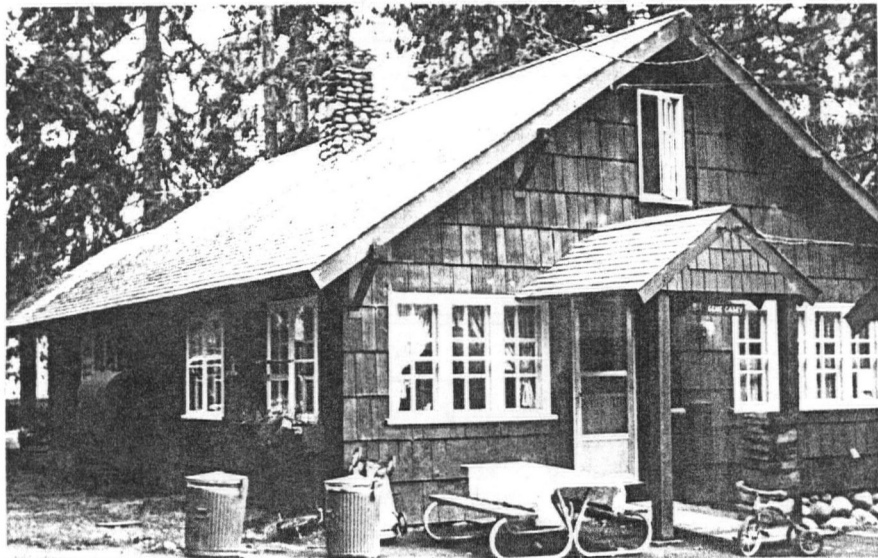
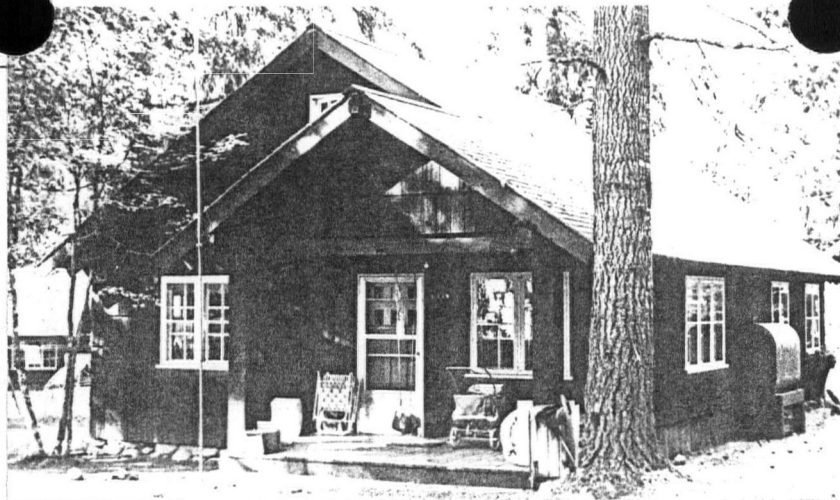
17. PHOTOS AND SKETCH MAP OF LOCATION

Wood-frame, 1-1/2 story, 8-room (and bath), rectangular bungalow; medium pitched main gable roof intersects with gable roof over post and beam frame front porch; cedar roof shingles; stone veneer brick chimney off gable ridge; cedar shake exterior siding over 1 x 12 horizontal lapped board; double and triple sash casement windows with mullions; finished interior wallboard; wood floors; stone foundation.

The construction of this residence was part of the on-going development plan for Longmire requested by Superintendent Tomlinson and drawn up by the National Park Service's Landscape Design Office in San Francisco, under the supervision of Chief Landscape Architect T.C. Vint and Associate Landscape Architect E.A. Davidson.

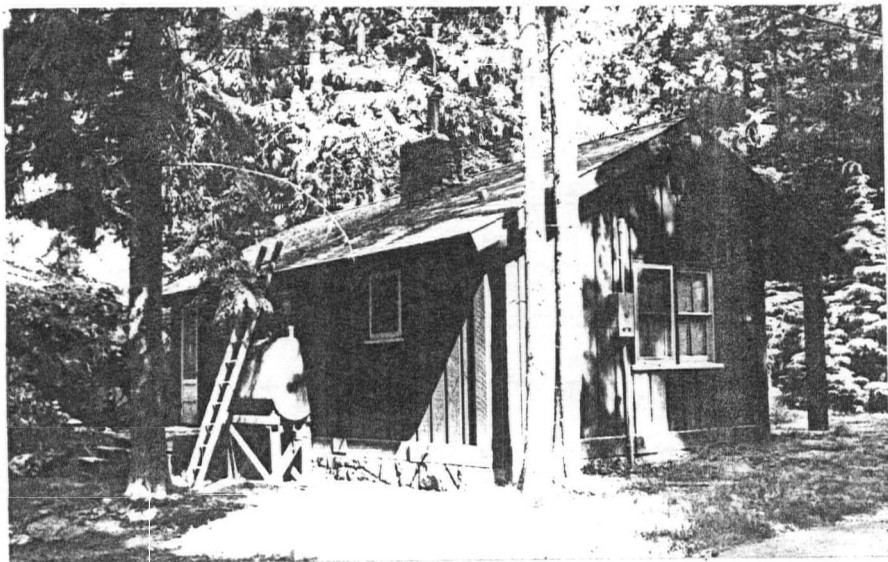
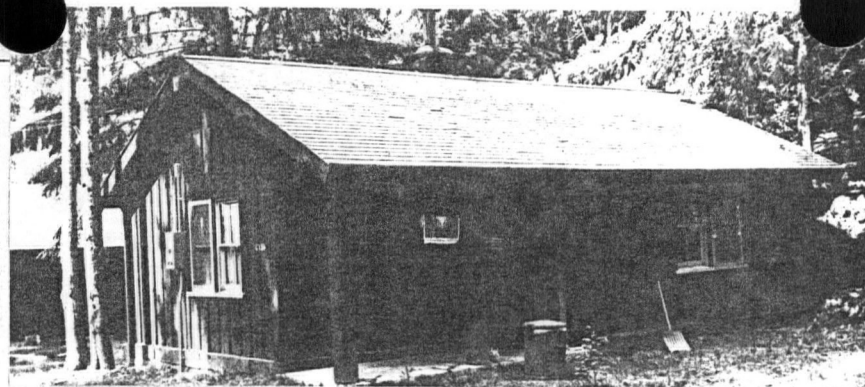
## 17. PHOTOS AND SKETCH MAP OF LOCATION

Wood-frame, one-story, four-rooms (and bath), rectangular structure; low-pitch gable roof extends over a recessed porch; cedar roof shingles; stone veneer brick chimney; exterior walls are vertical board and batten; finished interior wallboard; wood floors, stone-concrete foundation.

L-120 is one of the numerous structures built by the CCC in the park (Thompson 1981; MORA DRG. NO.2014, 2 sheets). The construction of this cottage was part of the on-going development plan for Longmire requested by Superintendent Tomlinson and prepared by the NPS Branch of Plans and Design in San Francisco, under the supervision of Chief Landscape Architect T.C. Vint,

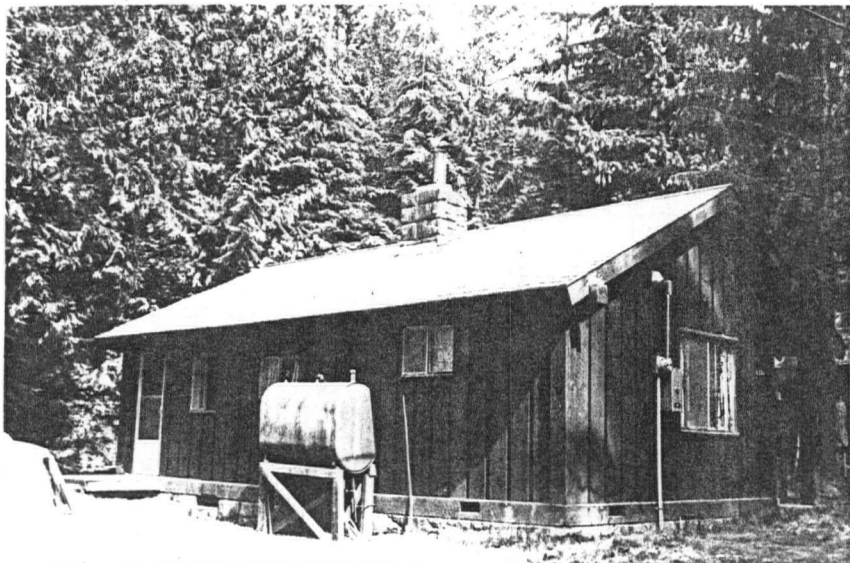
## 17. PHOTOS AND SKETCH MAP OF LOCATION

Wood-frame, one-story, four-rooms (and bath), rectangular structure; low-pitch gable roof extends over a recessed (umbrage) porch; cedar roof shingles; stone veneer brick chimney; exterior walls are vertical board and batten; finished interior wallboard; wood floors, stone-concrete foundation.

L-121 is one of the numerous structures built by the CCC in the park (Thompson 1981; MORA DRG. NO.2014, 2 sheets). The construction of this cottage was part of the on-going development plan for Longmire requested by Superintendent Tomlinson and prepared by the NPS Branch of Plans and Design in San Francisco, under the supervision of Chief Landscape Architect T.C. Vint,

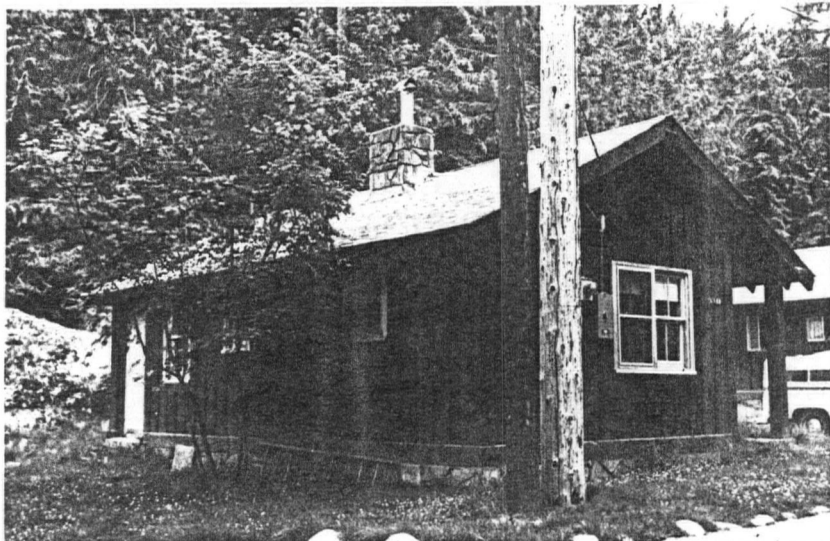
17. PHOTOS AND SKETCH MAP OF LOCATION

Wood-frame, one-story, four-rooms (and bath), rectangular structure; low-pitch gable roof extends over a recessed porch; cedar roof shingles; stone veneer brick chimney; exterior walls are vertical board and batten; finished interior wallboard; wood floors, stone-concrete foundation.

L-122 is one of the numerous structures built by the CCC in the park (Thompson 1981; MORA DRG. NO.2014, 2 sheets). The construction of this cottage was part of the on-going development plan for Longmire requested by Superintendent Tomlinson and prepared by the NPS Branch of Plans and Design in San Francisco, under the supervision of Chief Landscape Architect T.C. Vint,

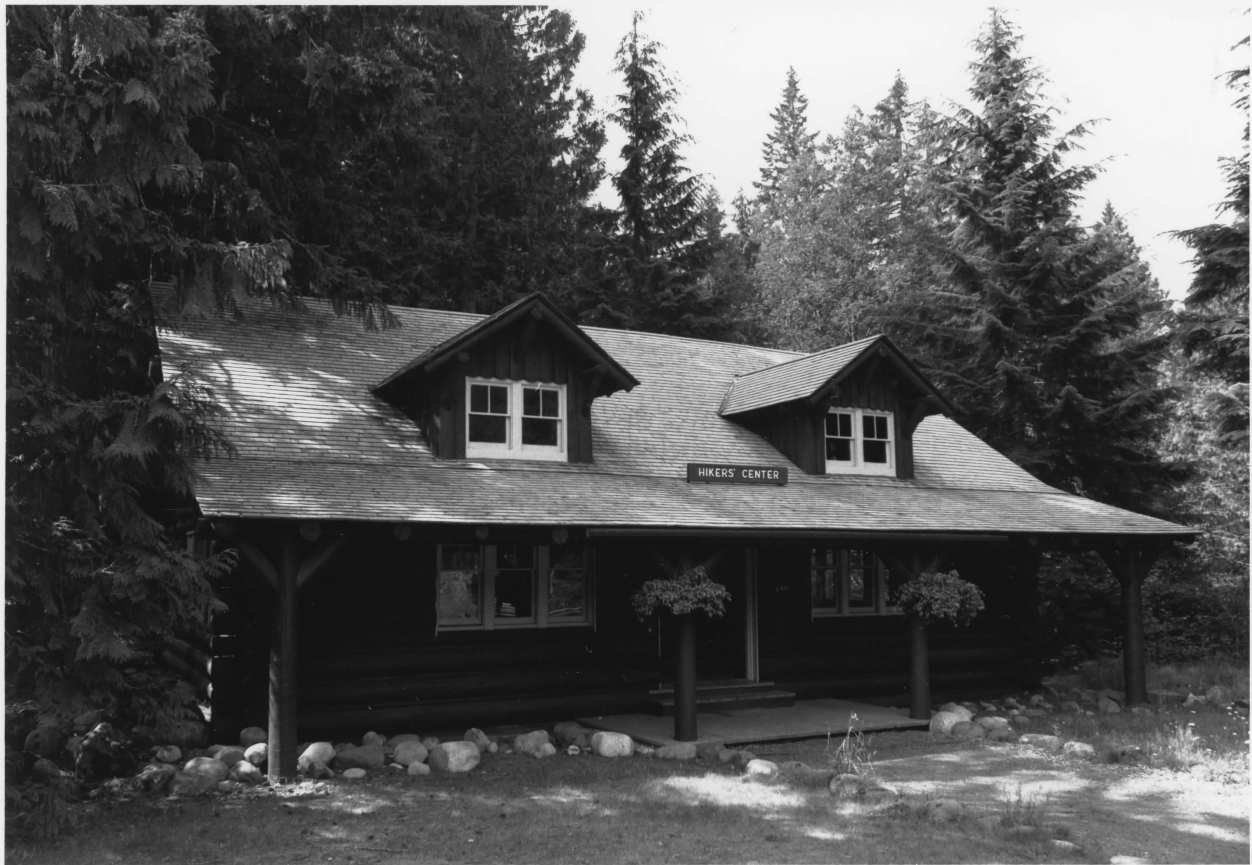
Photo 11

Hiker's Center

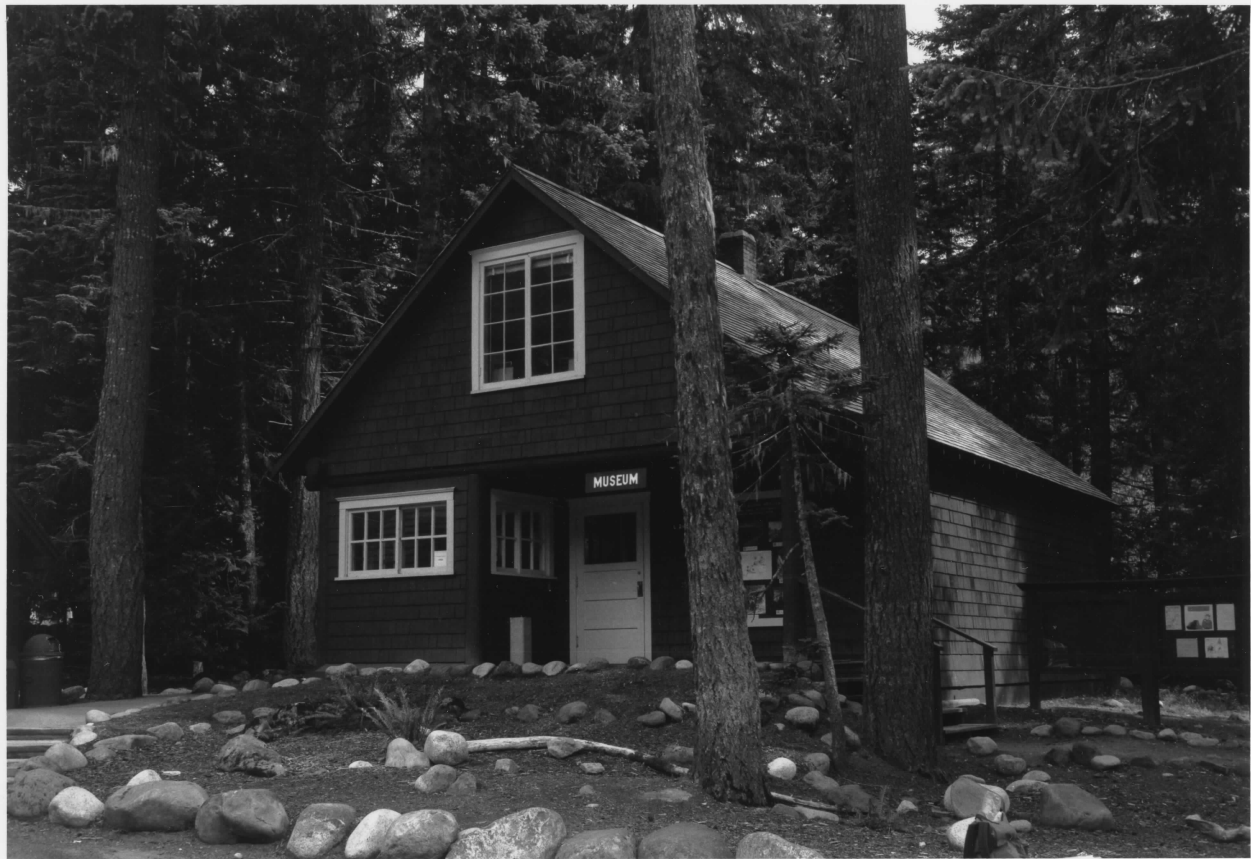
Photo 14

MUSEUM

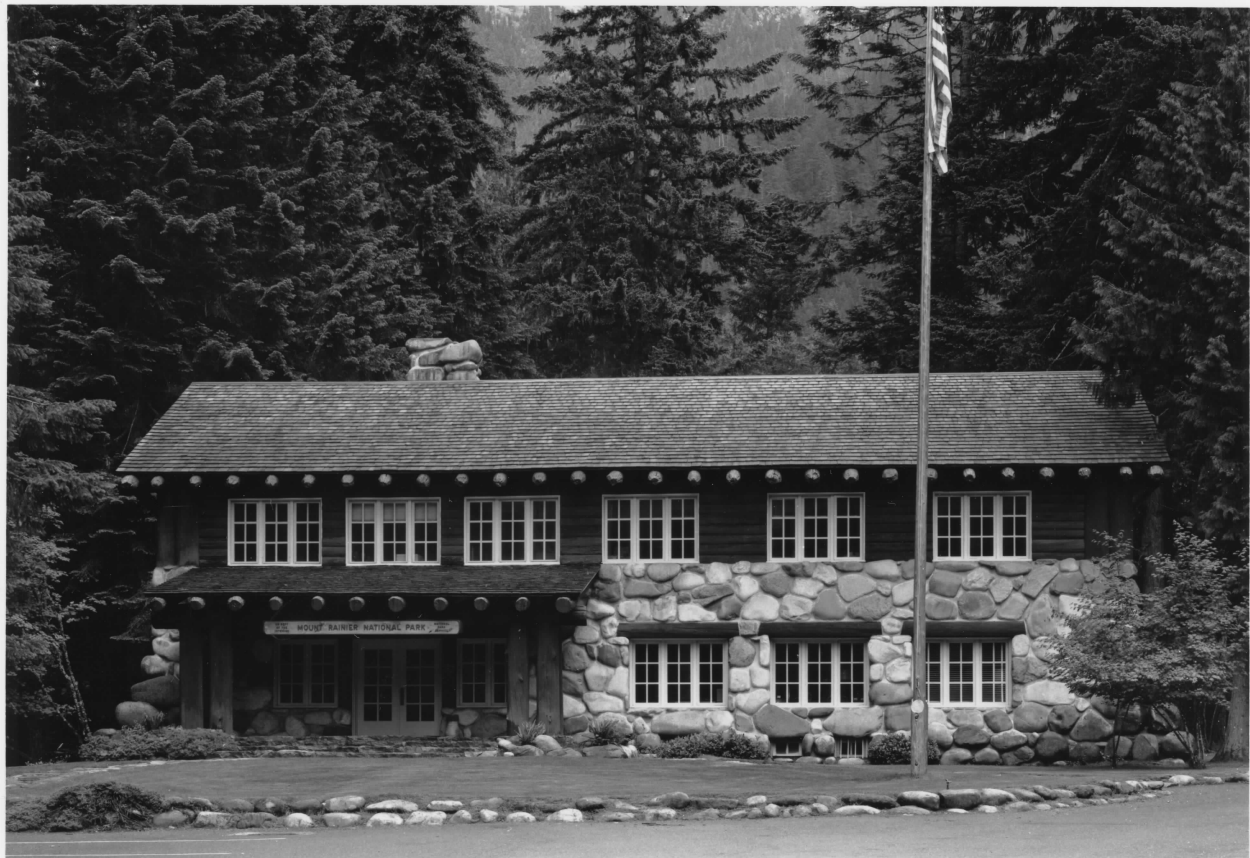
#8

Langmuir Administration Bldg.

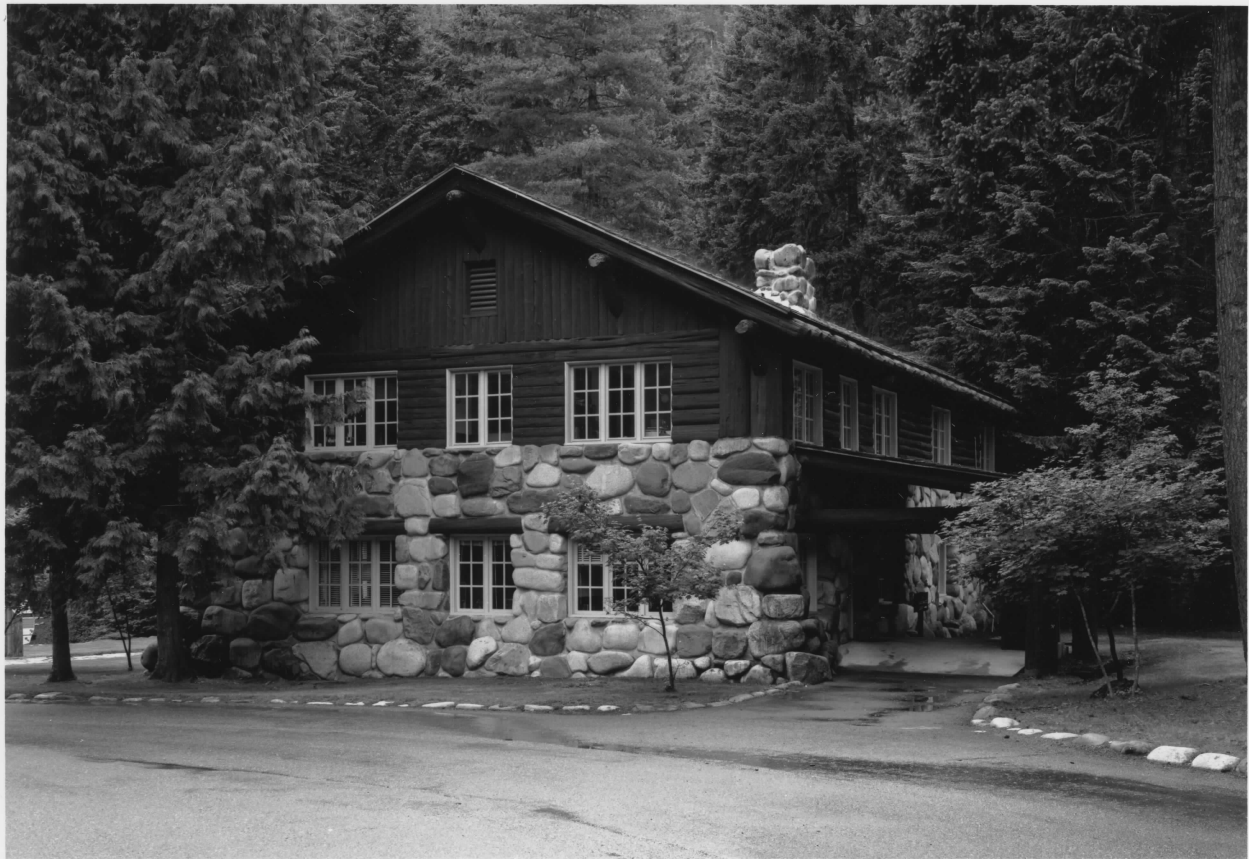
#9

Administration Bldg.

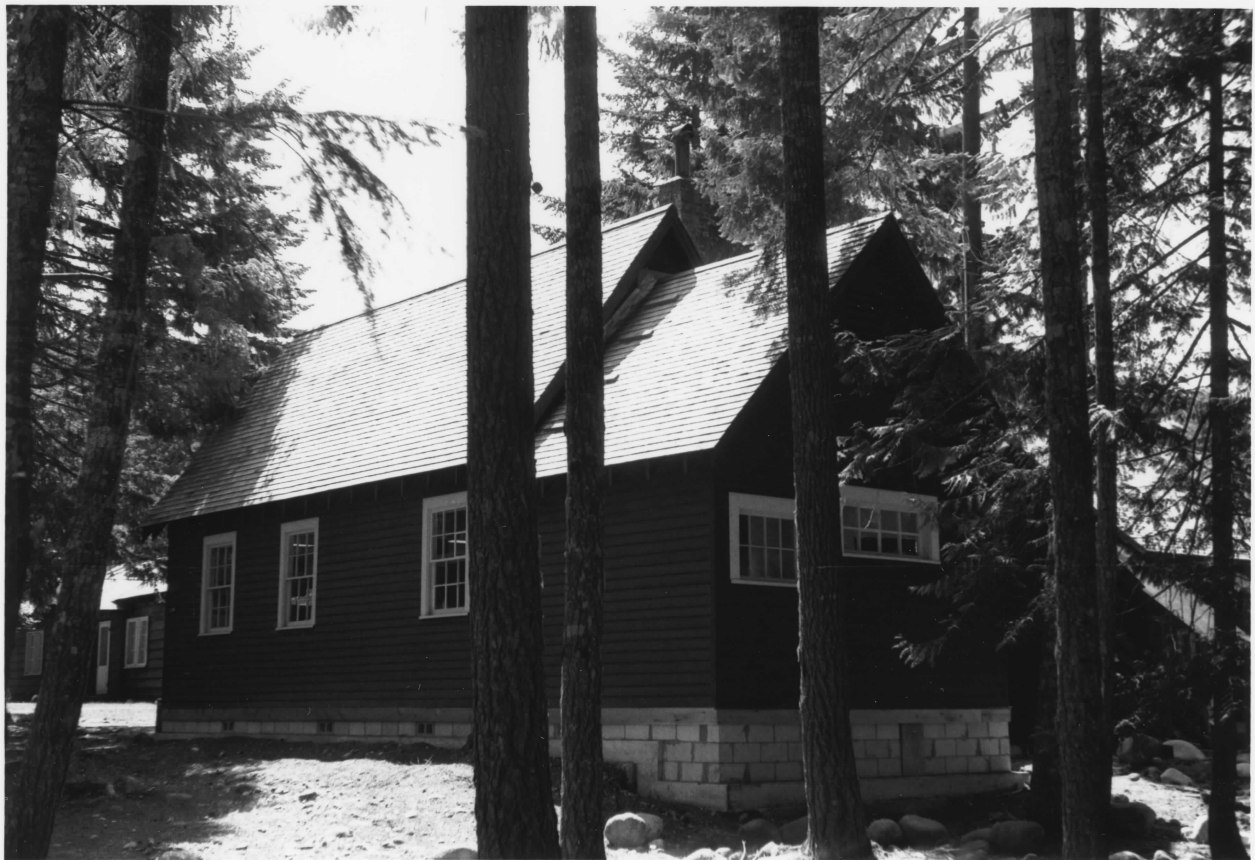
Photo 14

Langmuir Library

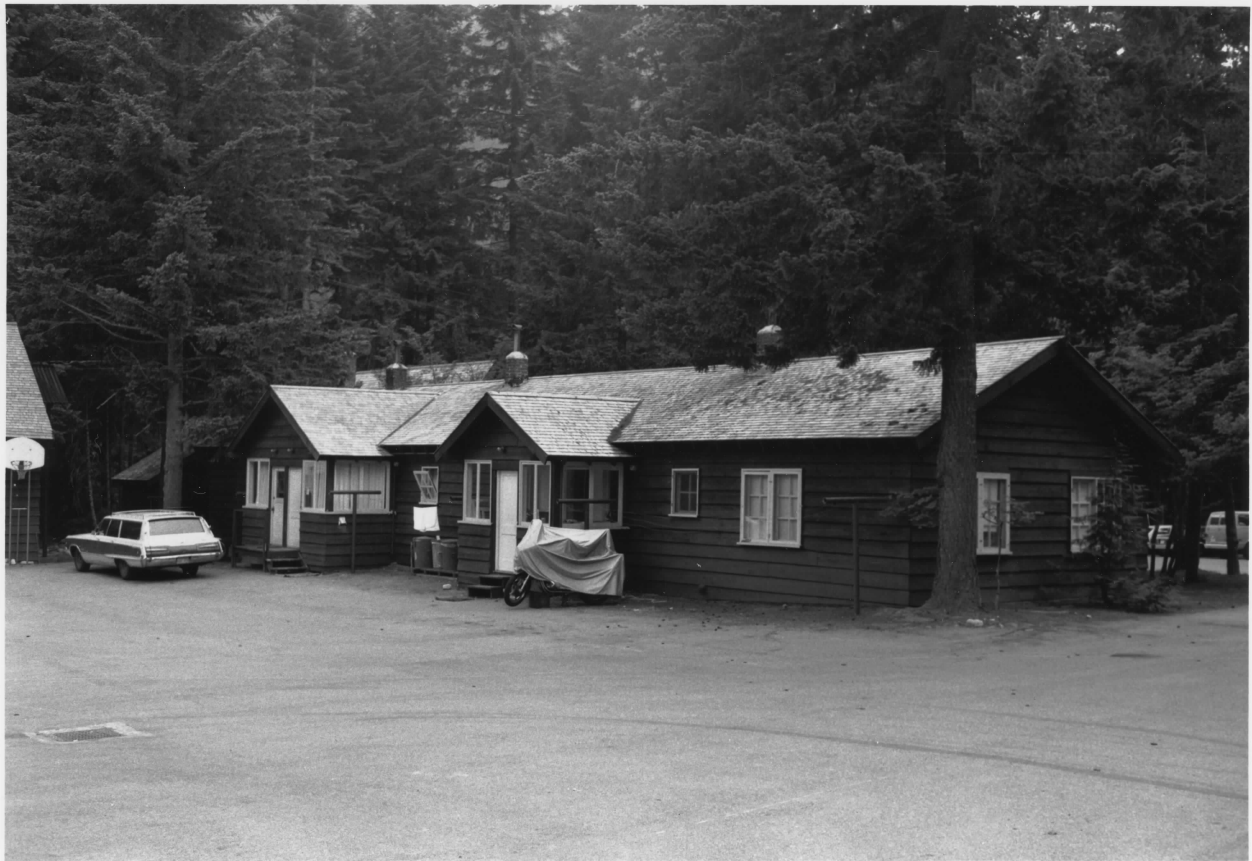
Photo 19

Apartment Bldg.

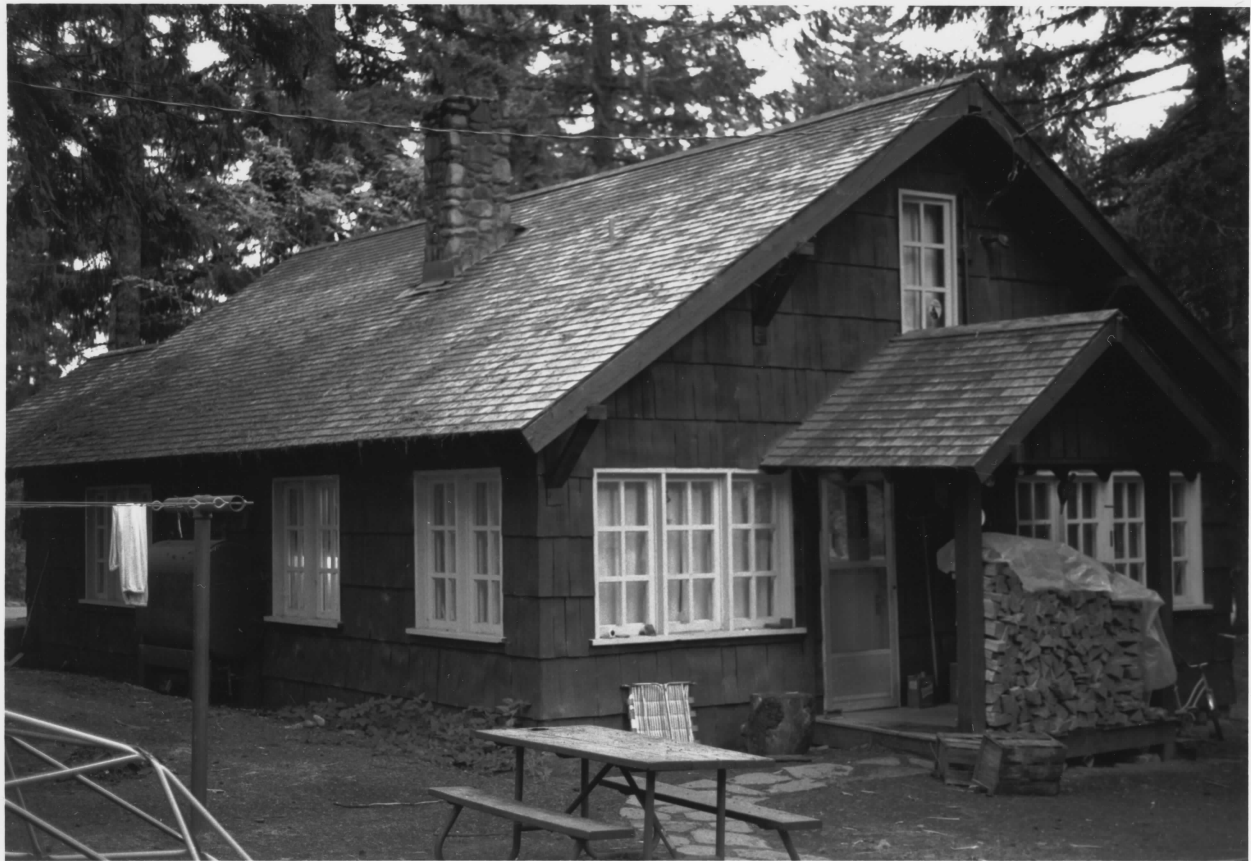
Photo 20

Langmuir Residence L-118

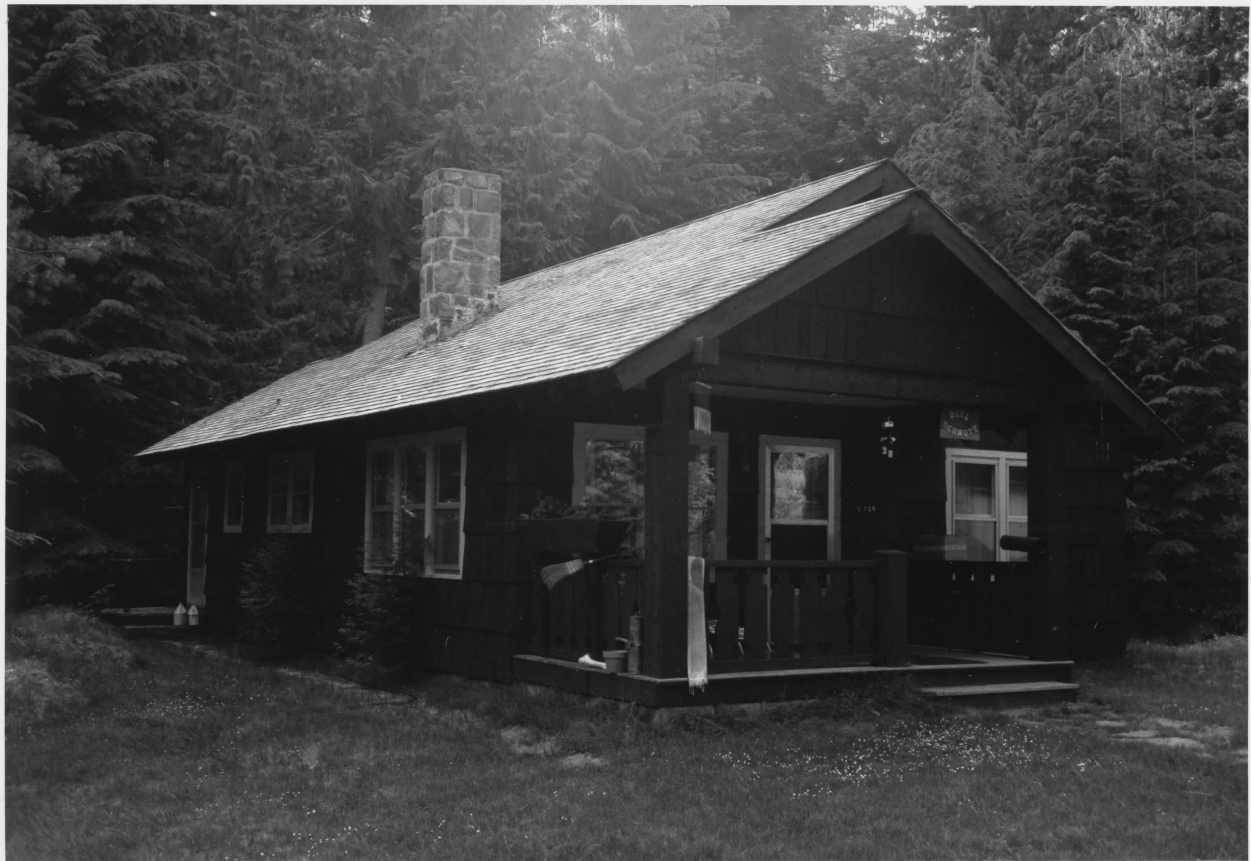
Photo 25

Residence L-129

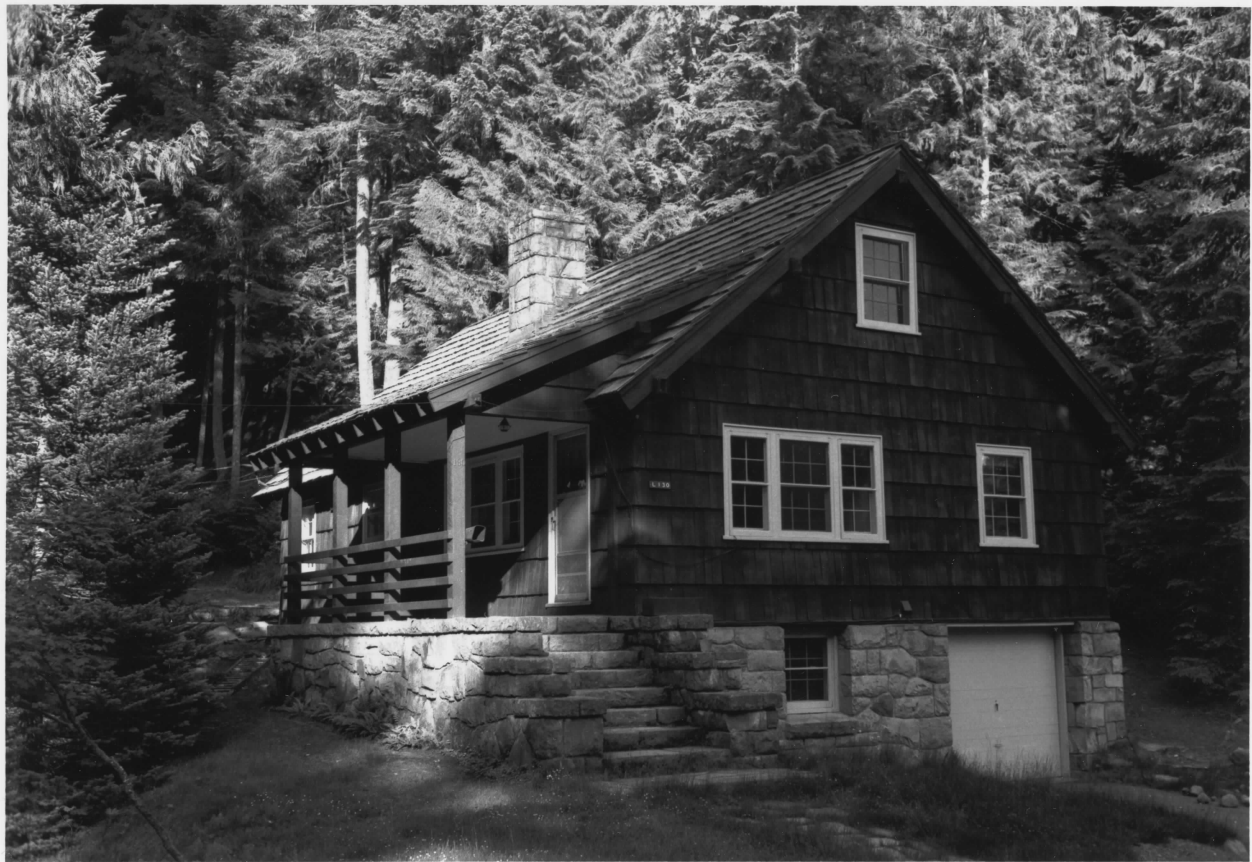
Photo 26

Residence L-130
