National Register of Historic Places Registration Form

other names/site number LONGMIRE HISTORIC DISTRICT

street & number MOUNT RAINIER NATIONAL PARK

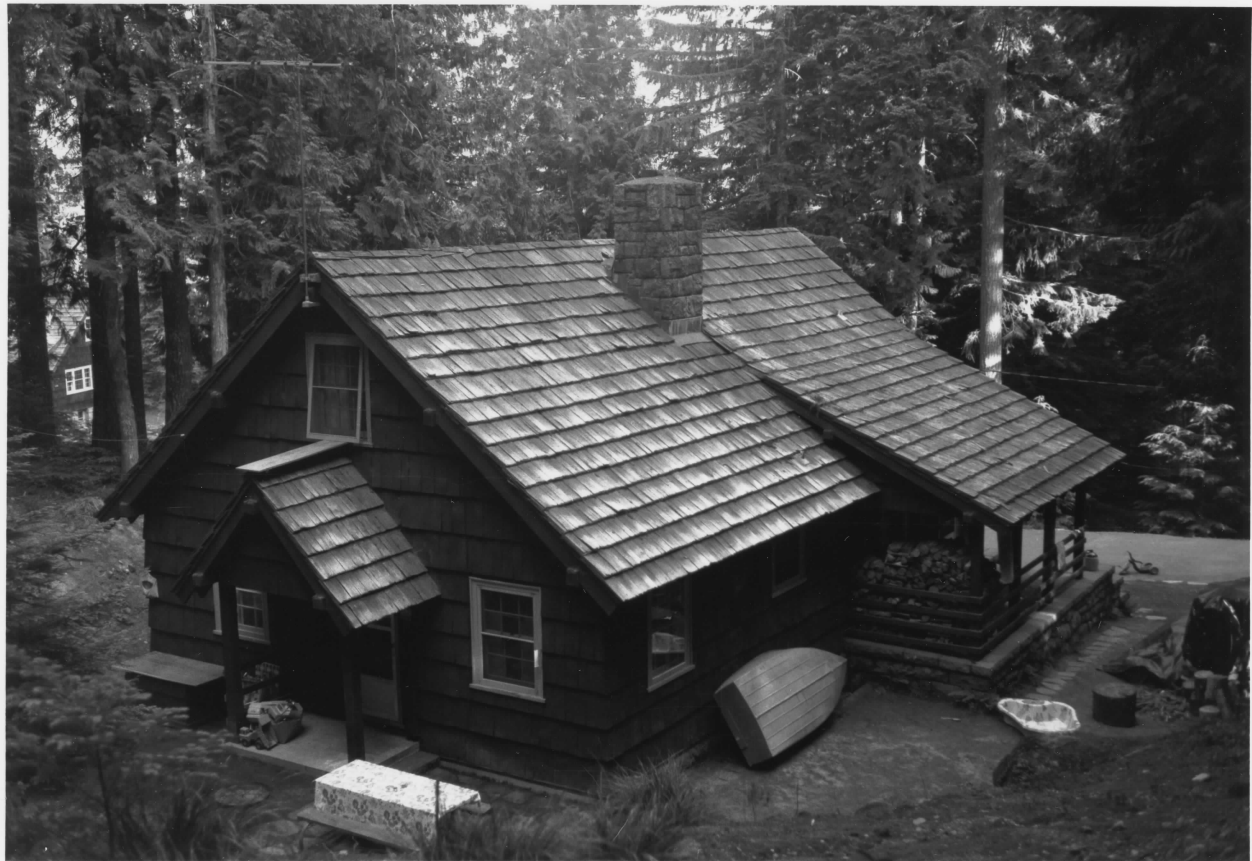
Photo 27

Residence L-130

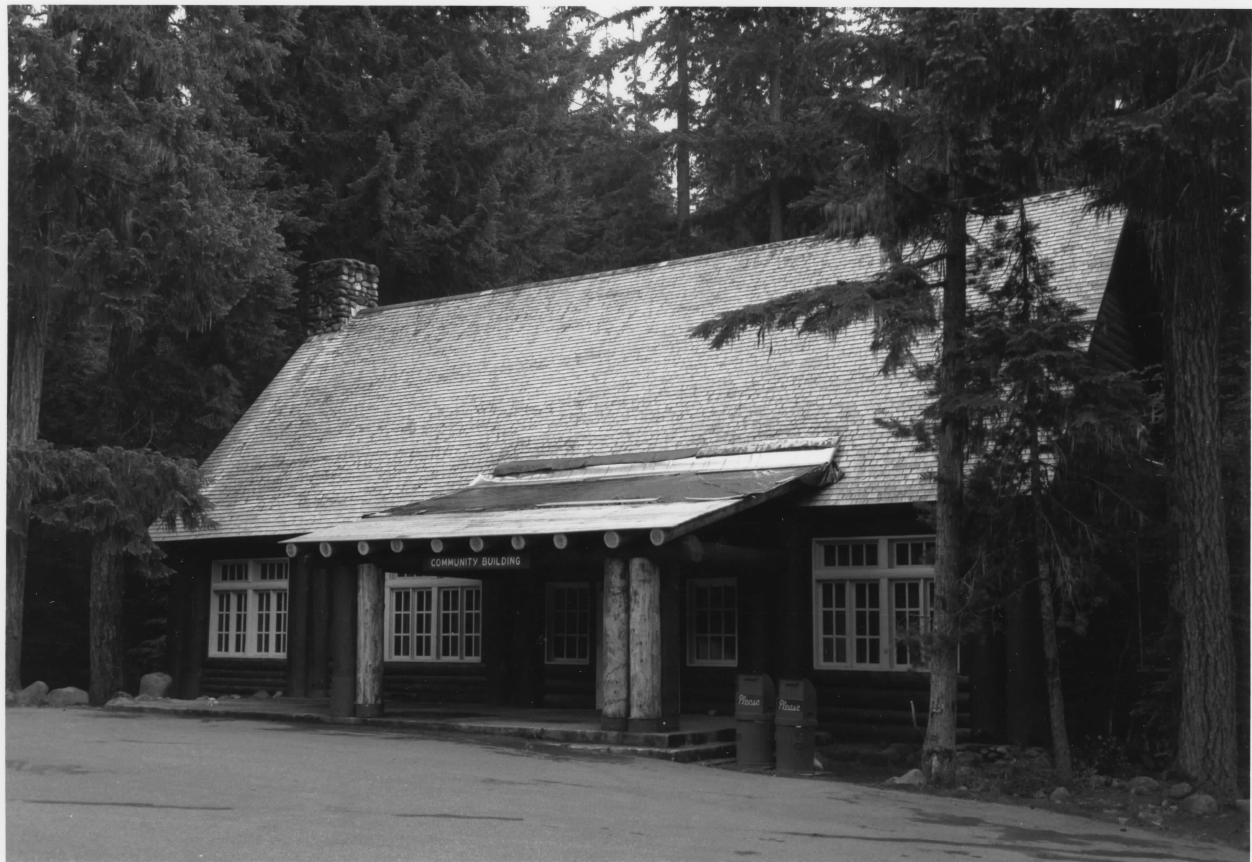
Photo 29

Community Bldg.

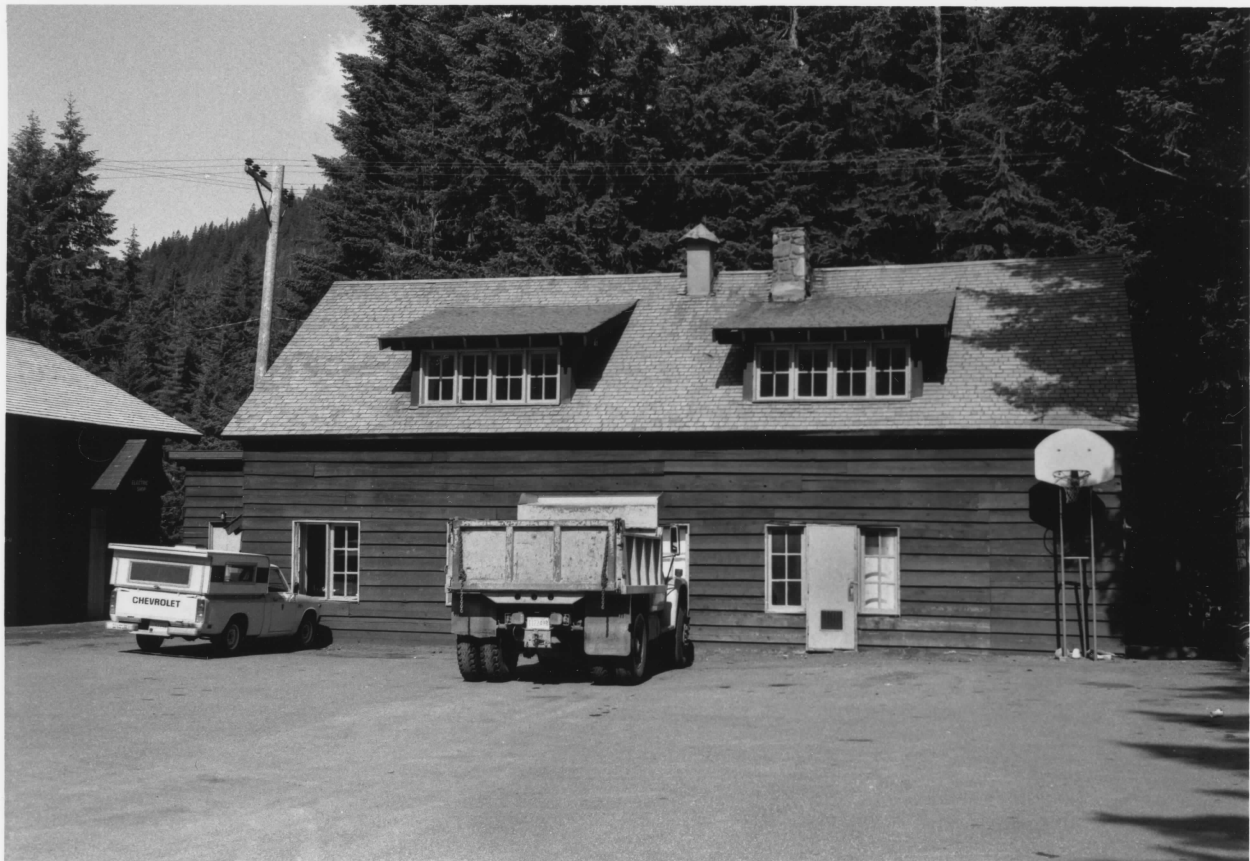
#27

Longmire Dormitory C-101
