National Register of Historic Places  
Inventory—Nomination Form

historic Chapline Street Row Historic District

2301--2323

city, town Wheeling vicinity of

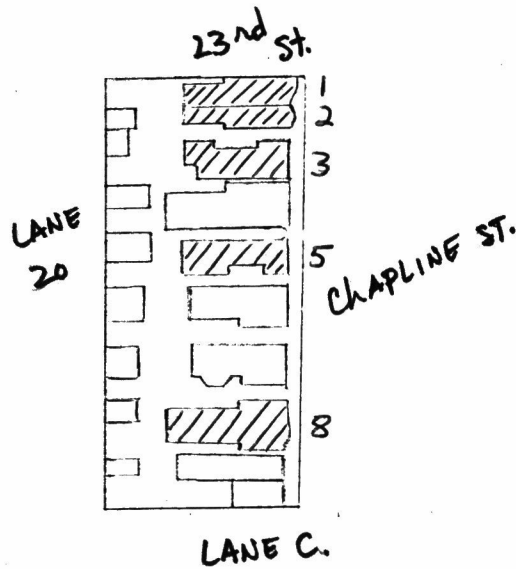
# CHAPLINE STREET ROW PIVOTAL BUILDINGS

Buildings of National, Major, and Pivotal Significance (numbers refer to the numbers used on the maps).

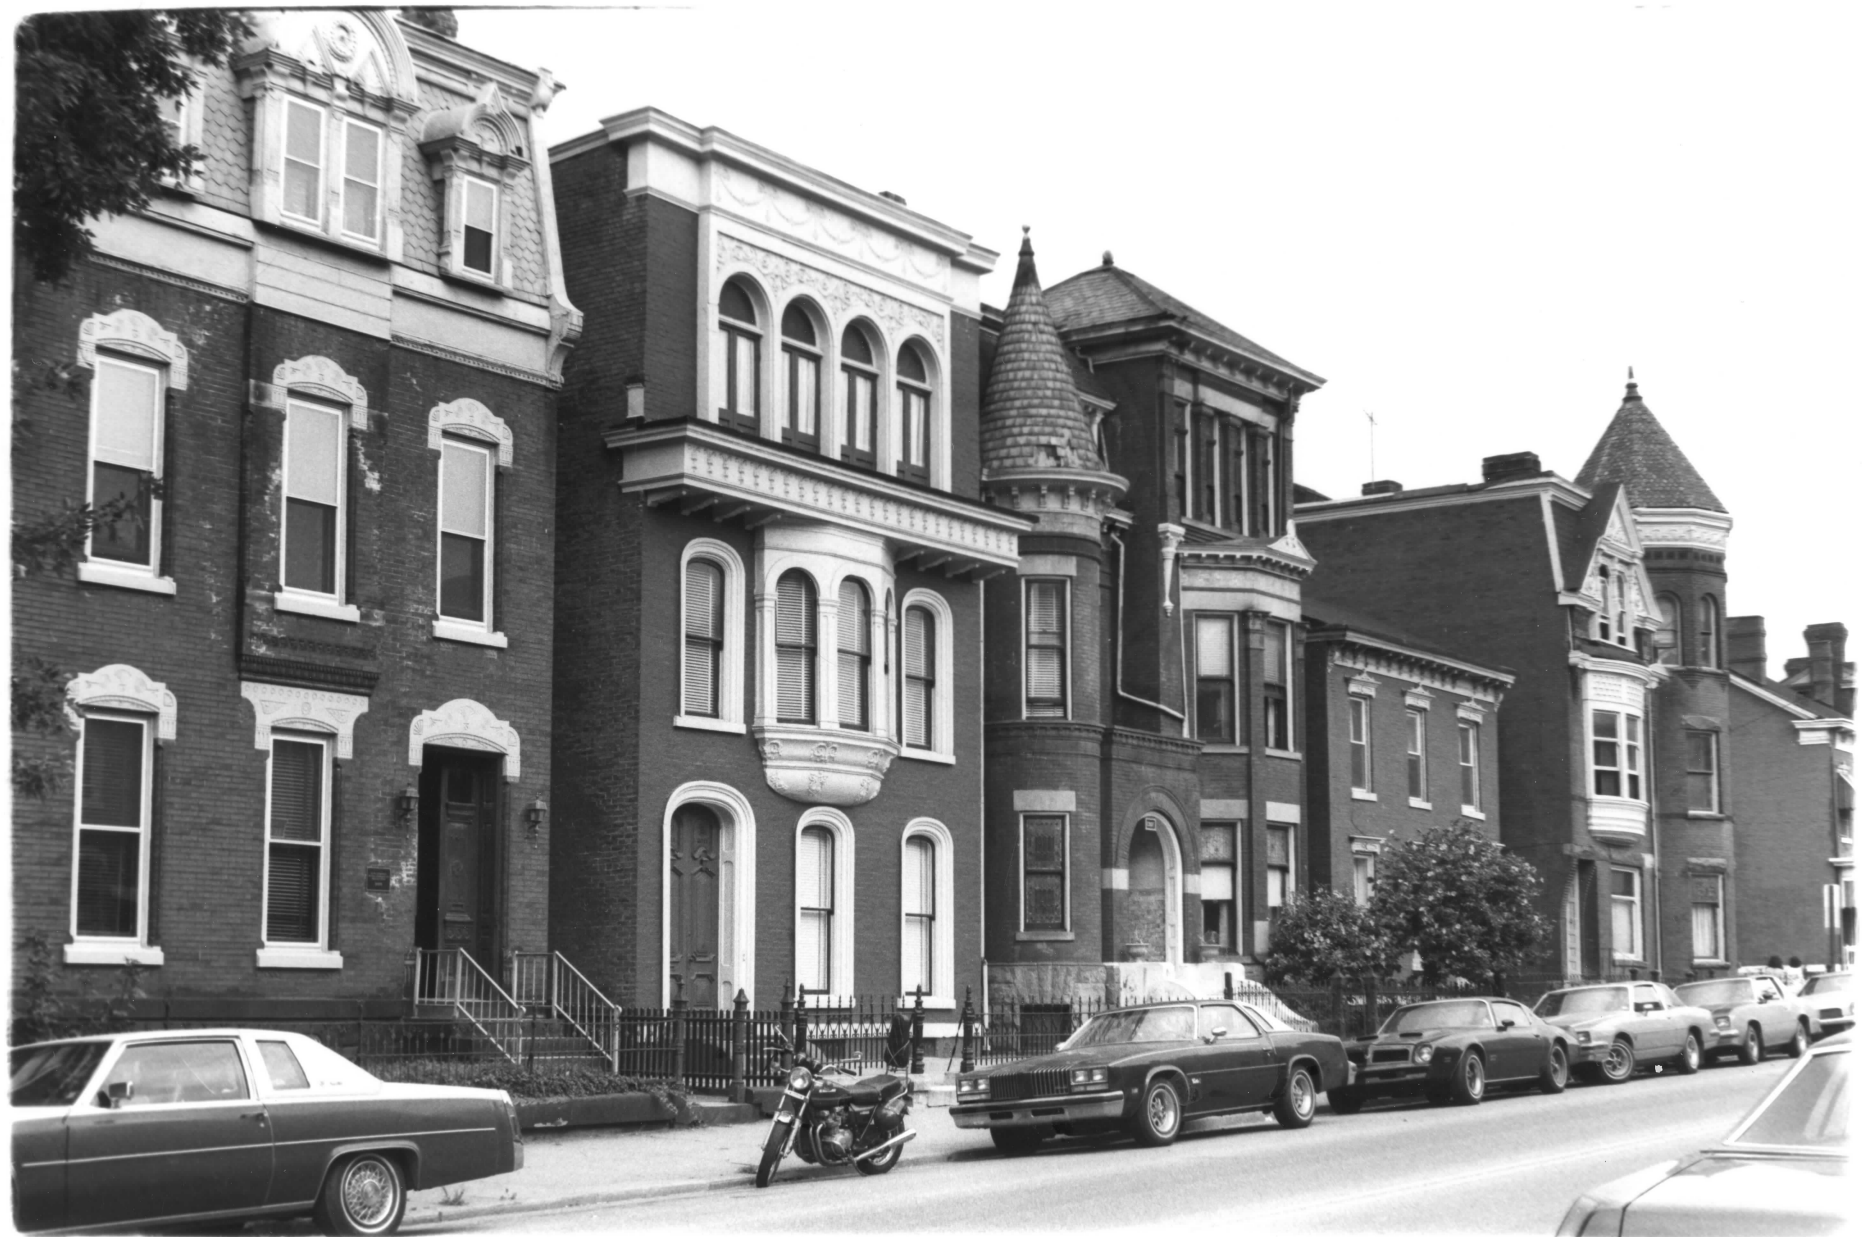
*Photo 2 of 6*

PROPERTY NAME : Chapline Street Row  
LOCATION : Wheeling, West Virginia  
Ohio County  
PHOTO CREDIT : Kathy Oliver, Oglebay Institute  
DATE OF PHOTO : August 23, 1983  
NEGATIVE FILED AT : DEPT. OF CULTURE & HISTORY,  
HISTORIC PRESERVATION UNIT, THE CULTURAL CENTER,  
CAPITOL COMPLEX, CHARLESTON, W.VA. 25305  
, DESCRIPTION OF PHOTO : left to right: 2313, 2311,  
2307, 2305, 2301-2303 Chapline St.  
DIRECTION OF PHOTO : looking northwest

1.&2. Wells House, c.1889, 2301-2303 Chapline Street.

No. 2301-Front: Recessed pier capped with curved pediment, adjoining round tower, transformed to nonagonal at top and capped with entablature and pyramidal roof;

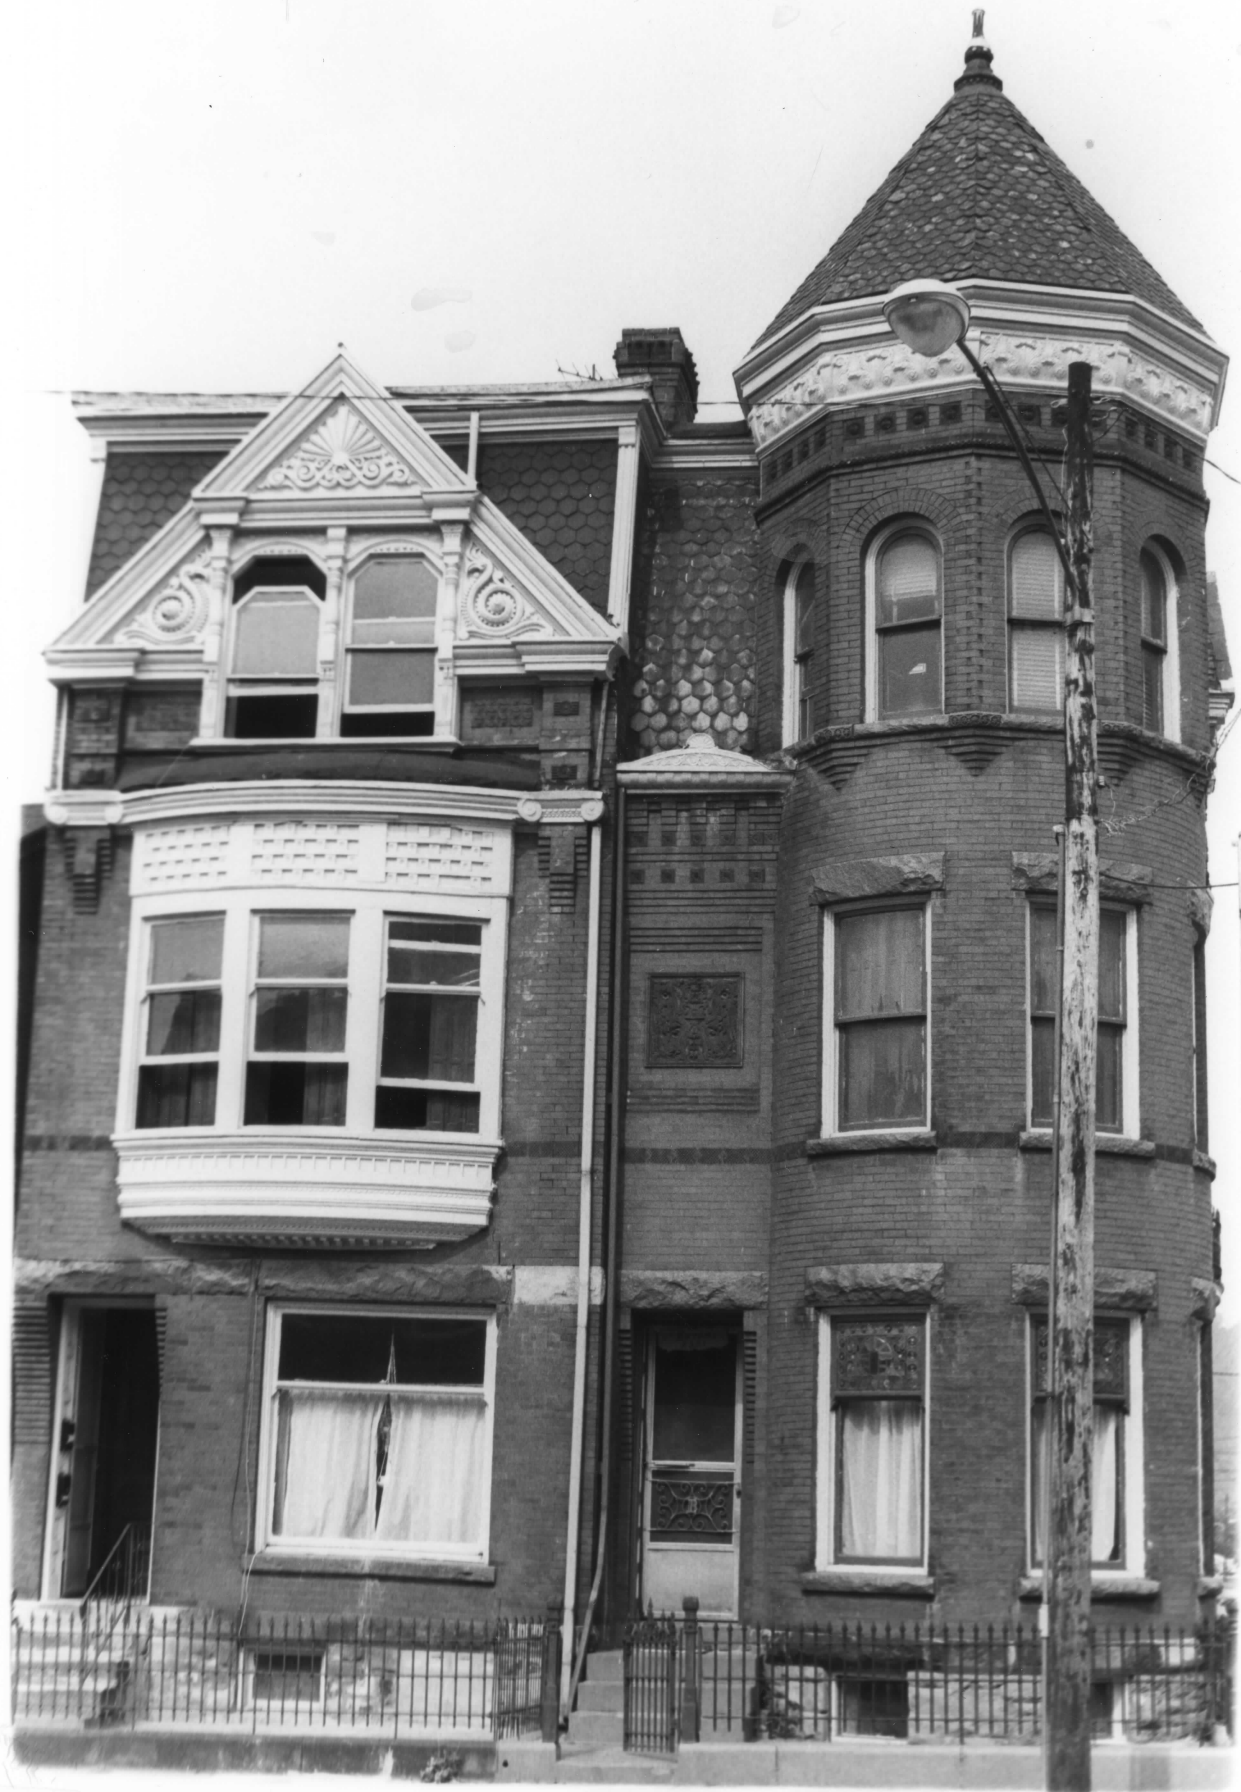
*Photo 3 of 6*

PROPERTY NAME : Chapline Street Row  
LOCATION : Wheeling, West Virginia  
Ohio County  
PHOTO CREDIT : Kathy Oliver, Oglebay Institute  
DATE OF PHOTO : August 23, 1983  
NEGATIVE FILED AT : DEPT. OF CULTURE & HISTORY,  
HISTORIC PRESERVATION UNIT, THE CULTURAL CENTER,  
CAPITOL COMPLEX, CHARLESTON, W.VA. 25305  
DESCRIPTION OF PHOTO : 2301-2303 Chapline St.  
(note profile of open sash window)

Windows: Many rectangular openings in 1st and 2nd stories, round arch or angled corner heads in 3rd story, openings in masonry framed with rock-face sills and lintels, all sills lugged, windows in wood framed variously, wood sash double hung, of ratio 1/1 except 1/2 for 1st story tower, and 2nd story bay windows, leaded glass in upper sash of 1st story tower windows;

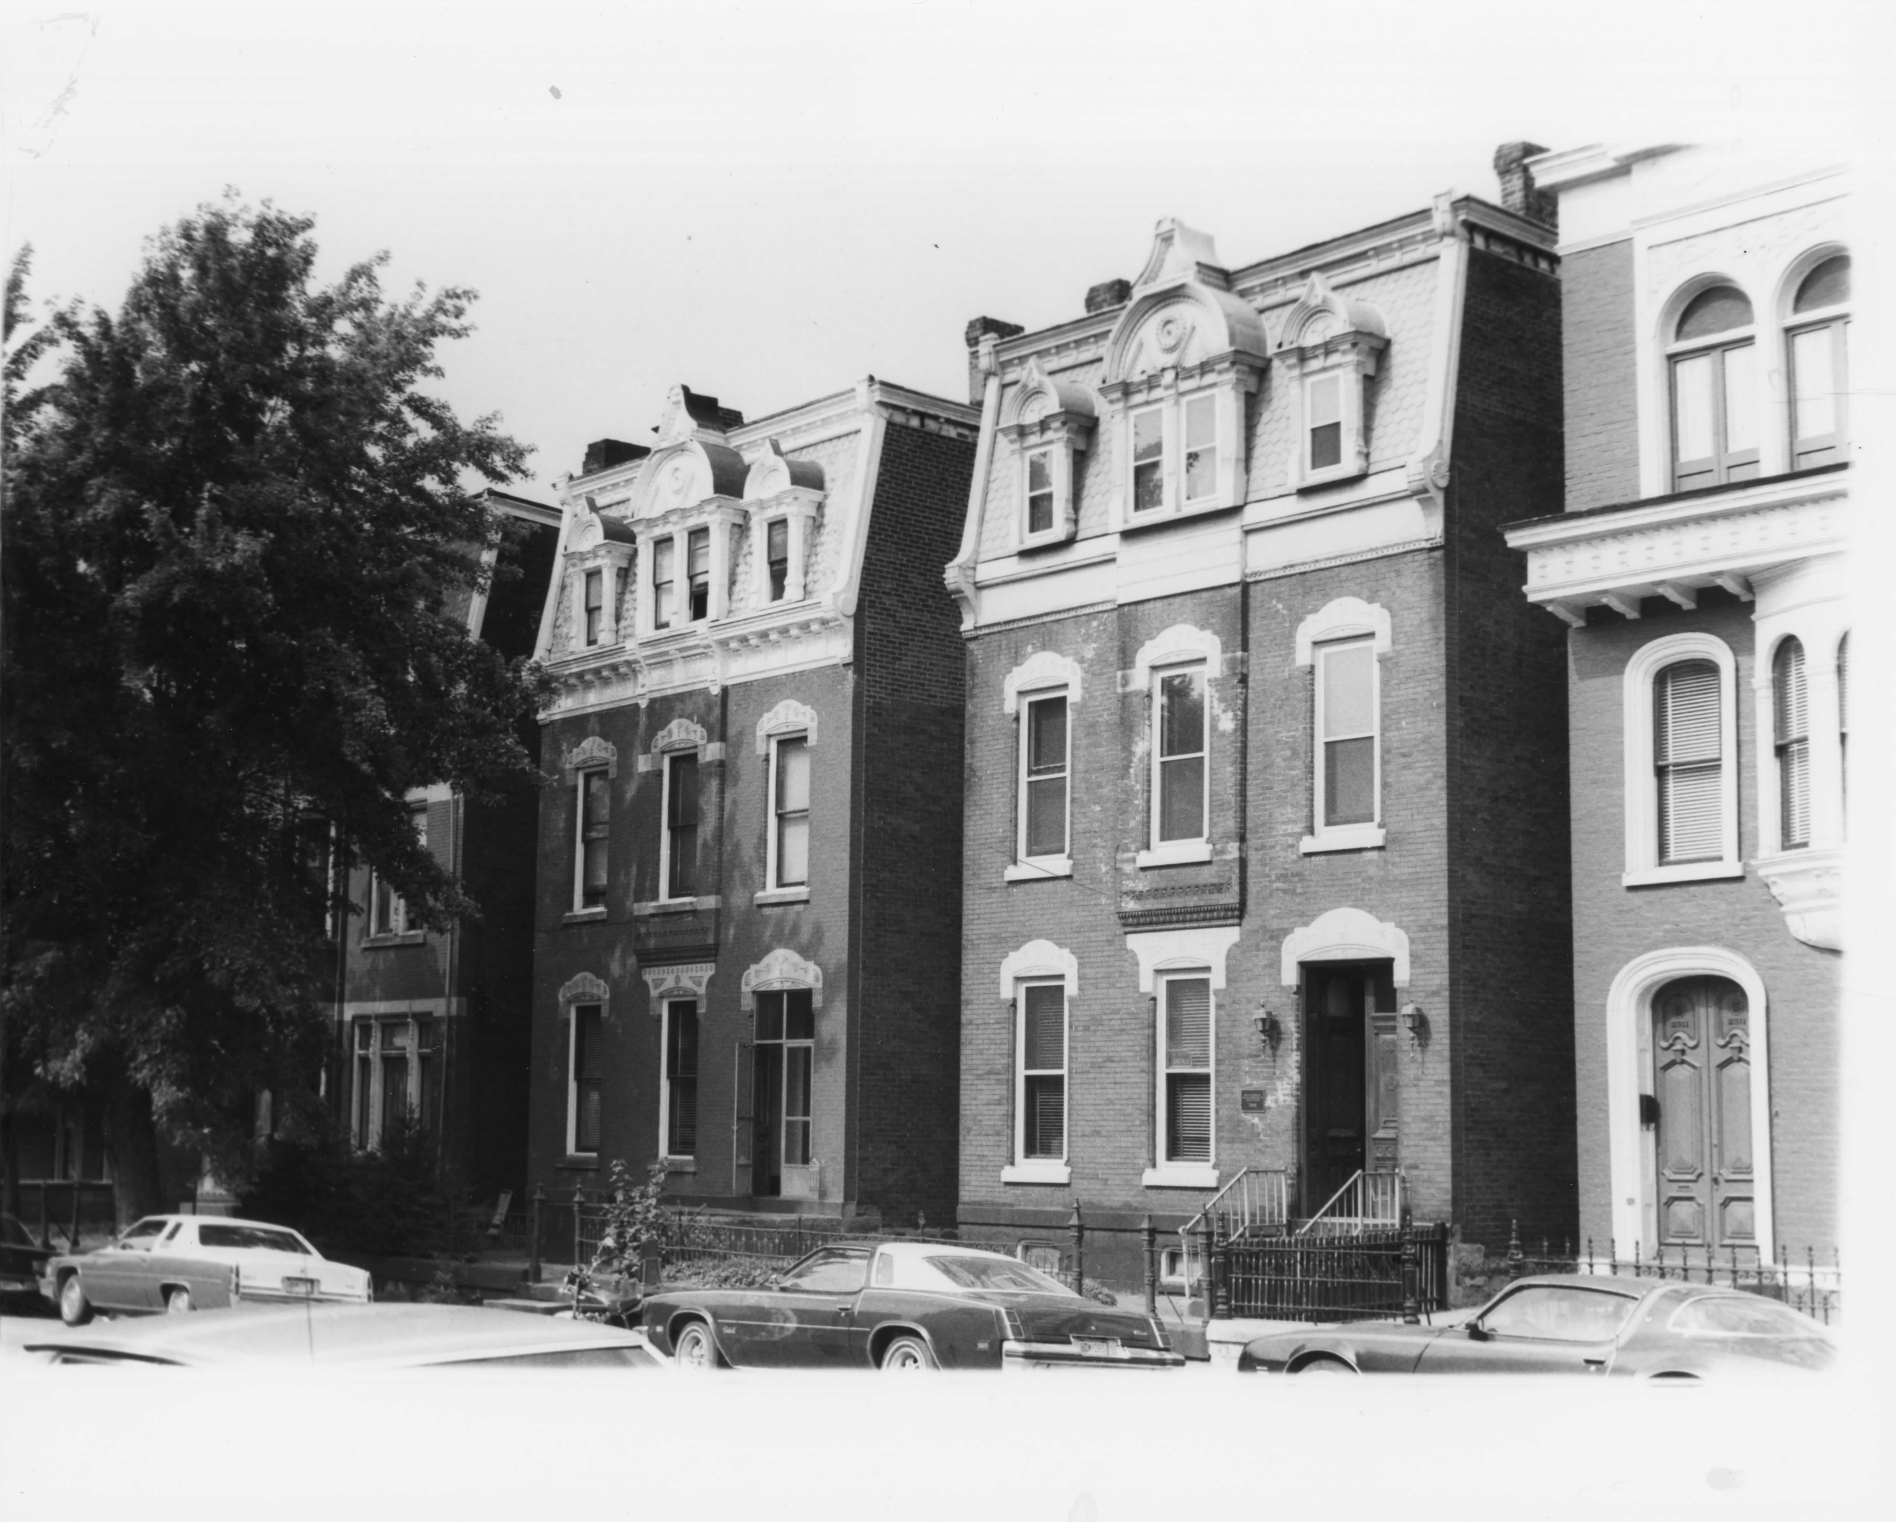
*Photo 4 of 6*

PROPERTY NAME : Chapline Street Row  
LOCATION : Wheeling, West Virginia  
Ohio County  
PHOTO CREDIT : Kathy Oliver, Oglebay Institute  
DATE OF PHOTO : August 23, 1983  
NEGATIVE FILED AT : DEPT. OF CULTURE & HISTORY,  
HISTORIC PRESERVATION UNIT, THE CULTURAL CENTER,  
CAPITOL COMPLEX, CHARLESTON, W.VA. 25305  
DESCRIPTION OF PHOTO : left to right: corner of  
2319, 2315, 2313, and corner of 2311 Chapline St.  
DIRECTION OF PHOTO : looking southwest

5. DELBRUEGGE-SCHMULBACH HOUSE, c. 1868; addition c. 1883, 2311 Chapline Street. (The dates have been selected based upon all known available historical information and an architectural evaluation.)

Front Elevation: Single structural unit of masonry divided with wide band at 2/3rds of height: Wall unit with base of dressed stone field with cut stone cap, painted brown, with shaft of brick painted brown; with wide blocky entablature-like band at 2nd story ceiling line painted buff, entablature supported on flat moulded carved brackets, frieze of sheet metal or "compo" with multiple repeats of raised sprays of leaf and bud patterns, cornice moulded; wall unit capped with entablature painted buff, of moulded string wide frieze of sheet metal or "compo" decorated with raised pendant and swag reliefs combining leaf buds, rosettes and ribbons, cornice of plain and moulded wood;

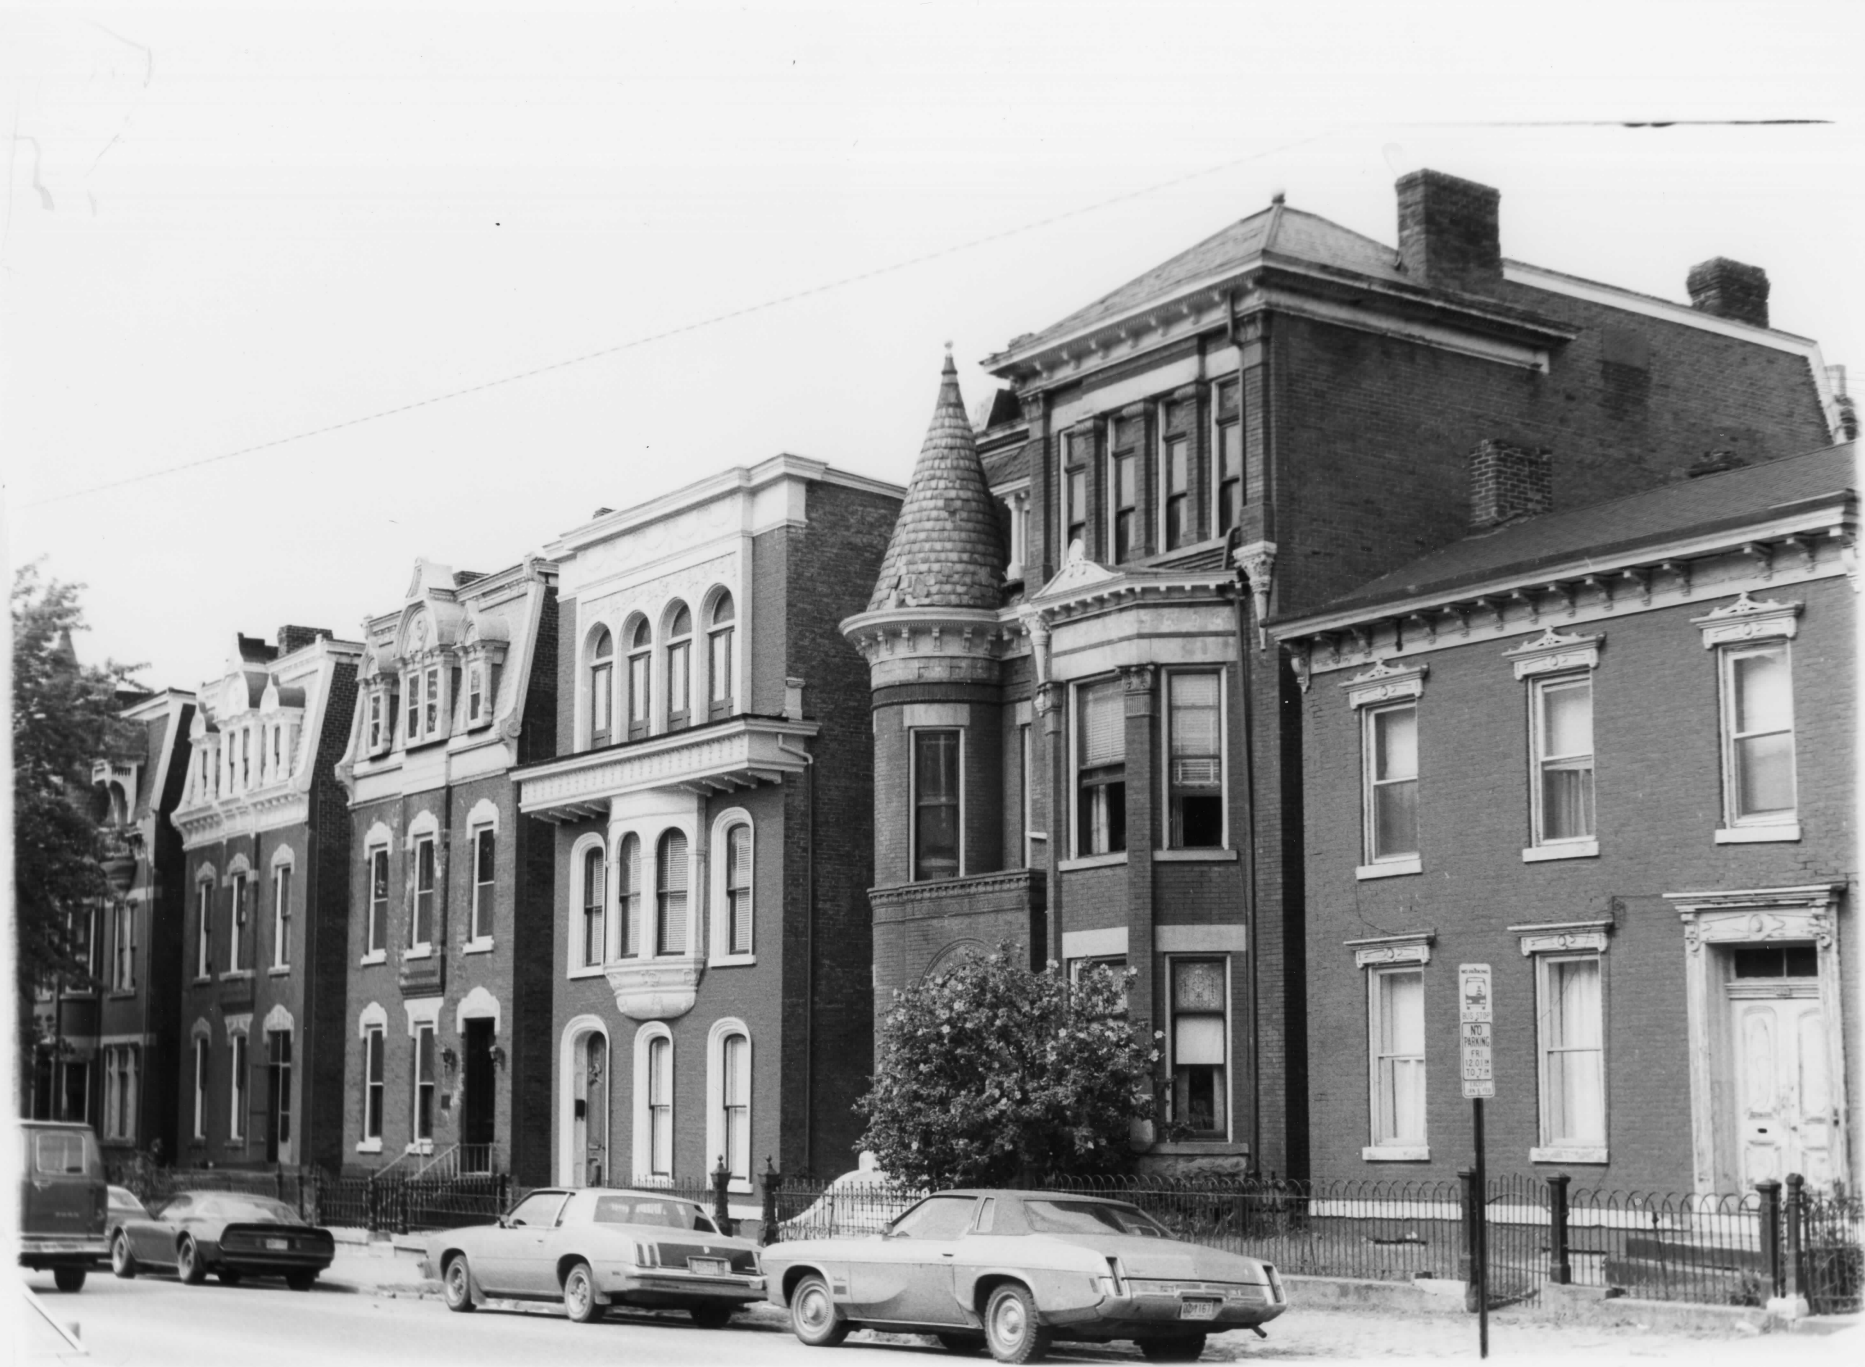
*Photo 5 of 6*

PROPERTY NAME : Chapline Street Row  
LOCATION : Wheeling, West Virginia  
Ohio County  
PHOTO CREDIT : Kathy Oliver, Oglebay Institute  
DATE OF PHOTO : August 23, 1983  
NEGATIVE FILED AT : DEPT. OF CULTURE & HISTORY,  
HISTORIC PRESERVATION UNIT, THE CULTURAL CENTER,  
CAPITOL COMPLEX, CHARLESTON, W.VA. 25305  
DESCRIPTION OF PHOTO : corner of 2319, 2315, 2313,  
2311, 2307, 2305 Chapline St.  
DIRECTION OF PHOTO : looking southwest

3. MOORE HOUSE, C. 1868, 2305 Chapline Street, built as a home for Nancy Moore.

Front Elevation: Single structural unit of masonry, painted red with

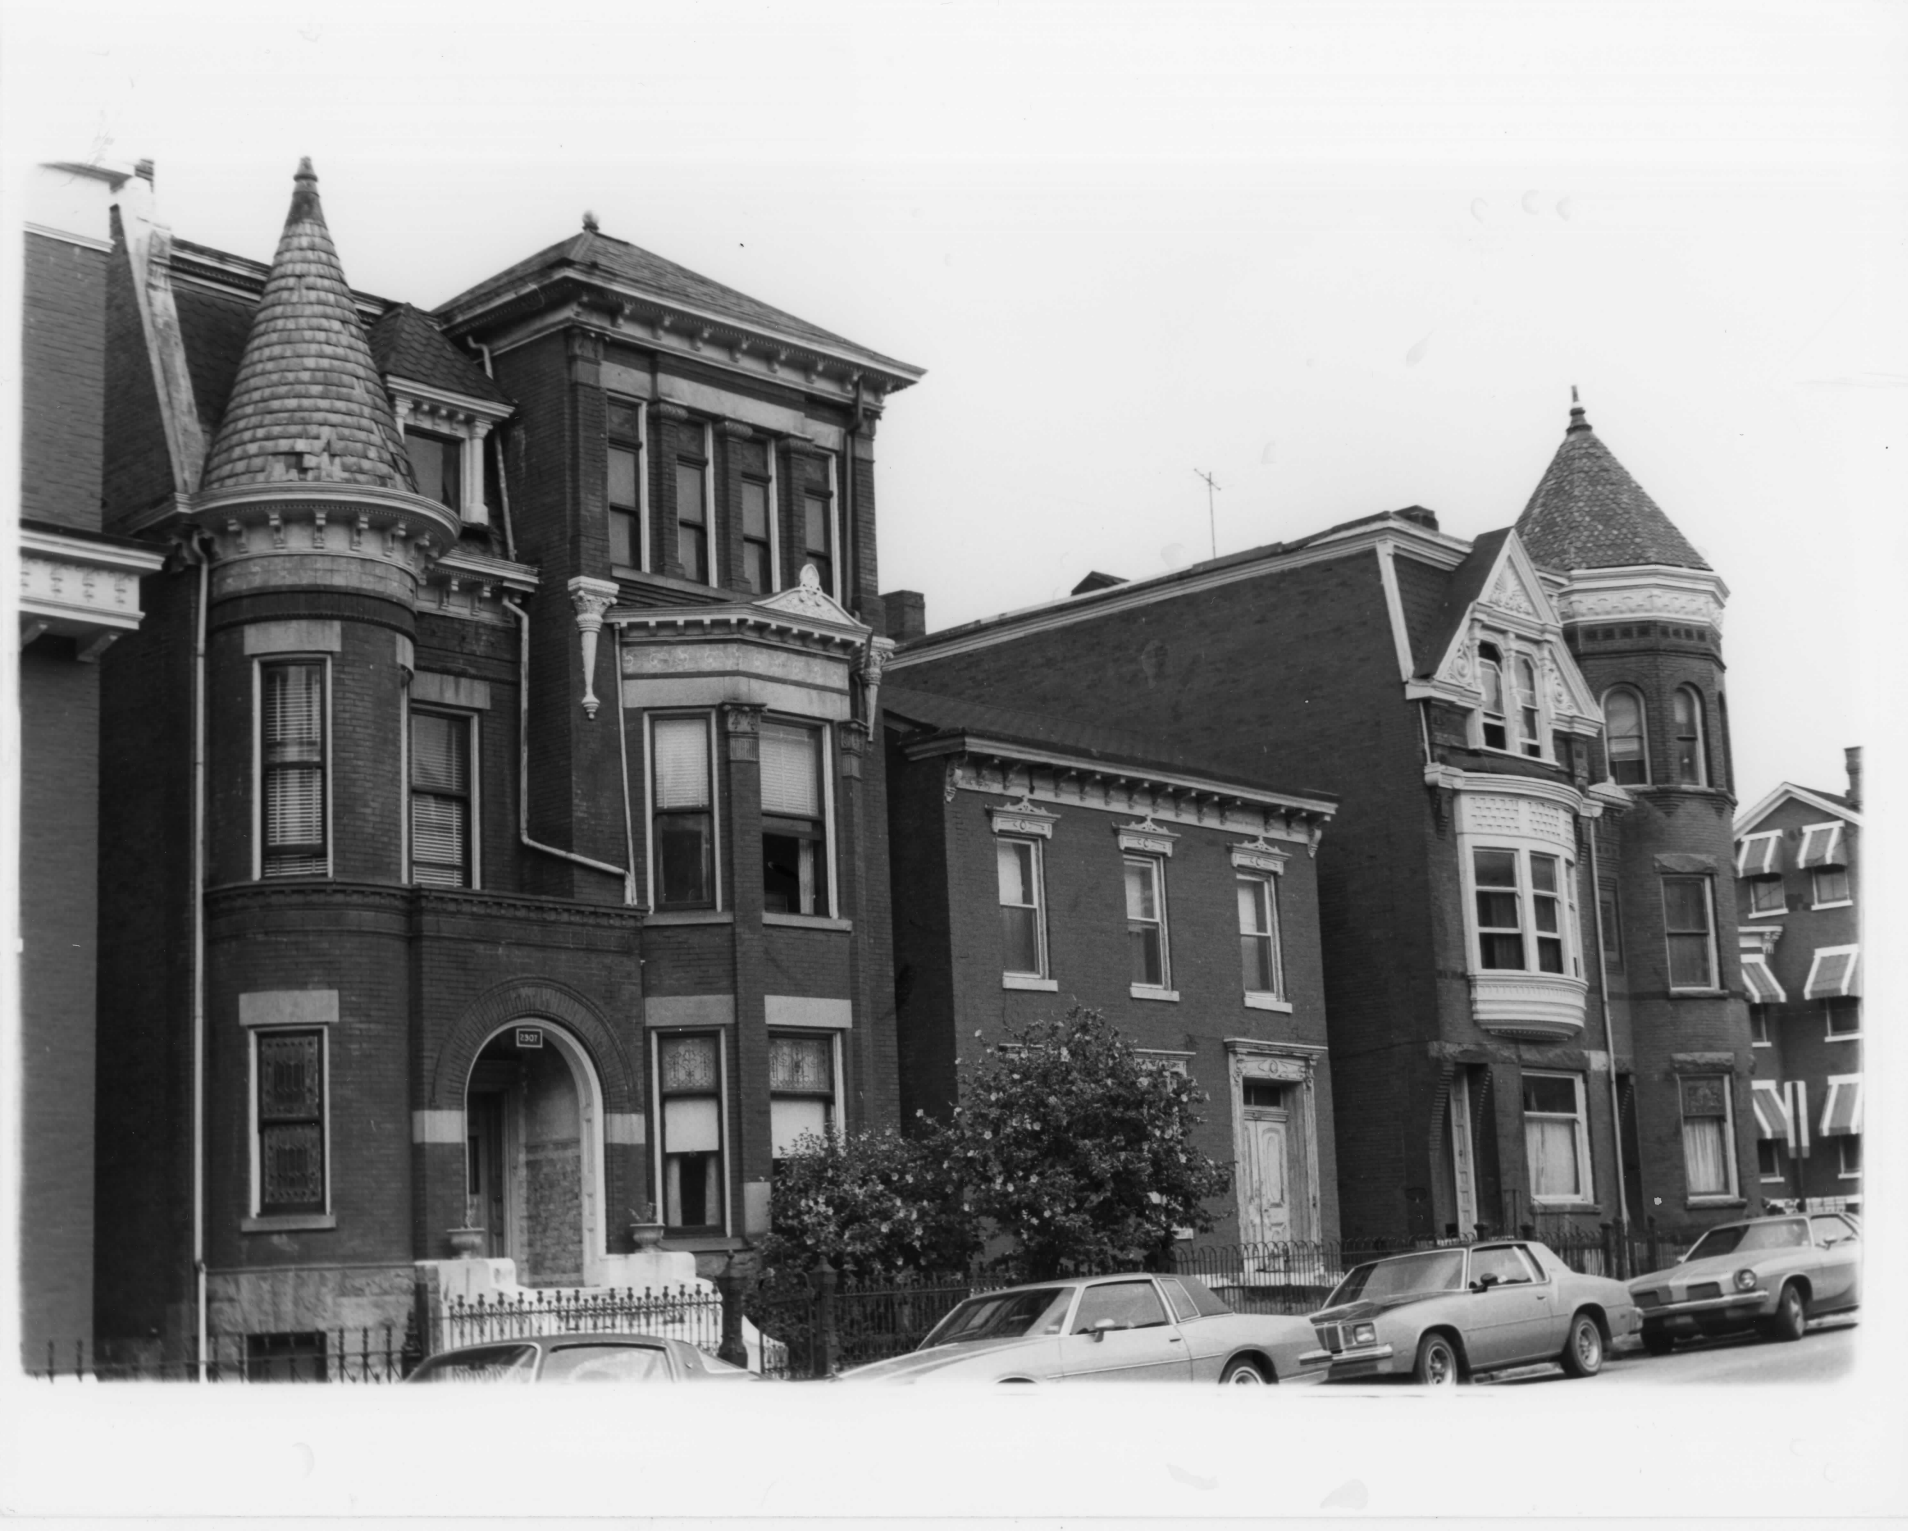
*Photo 6 of 6*

PROPERTY NAME : Chapline Street Row  
LOCATION : Wheeling, West Virginia  
Ohio County  
PHOTO CREDIT : Kathy Oliver, Oglebay Institute  
DATE OF PHOTO : August 23, 1983  
NEGATIVE FILED AT : DEPT. OF CULTURE & HISTORY,  
HISTORIC PRESERVATION UNIT, THE CULTURAL CENTER,  
CAPITOL COMPLEX, CHARLESTON, W.VA. 25305  
DESCRIPTION OF PHOTO : left to right-2307, 2305,  
& 2301-2303 Chapline St.  
DIRECTION OF PHOTO : looking northwest
