## **NIMA Imagery Analysis Report**

### **No Gun-Ri, Republic of Korea**

**6 August 1950 and 19 September 1950**

**NIMA Imagery Analysis  
Review and Comments  
on the Republic of Korea's  
No Gun-Ri Investigation Team's  
"Analysis on Overhead Imagery"  
(Date of Imagery 06 August 1950)**

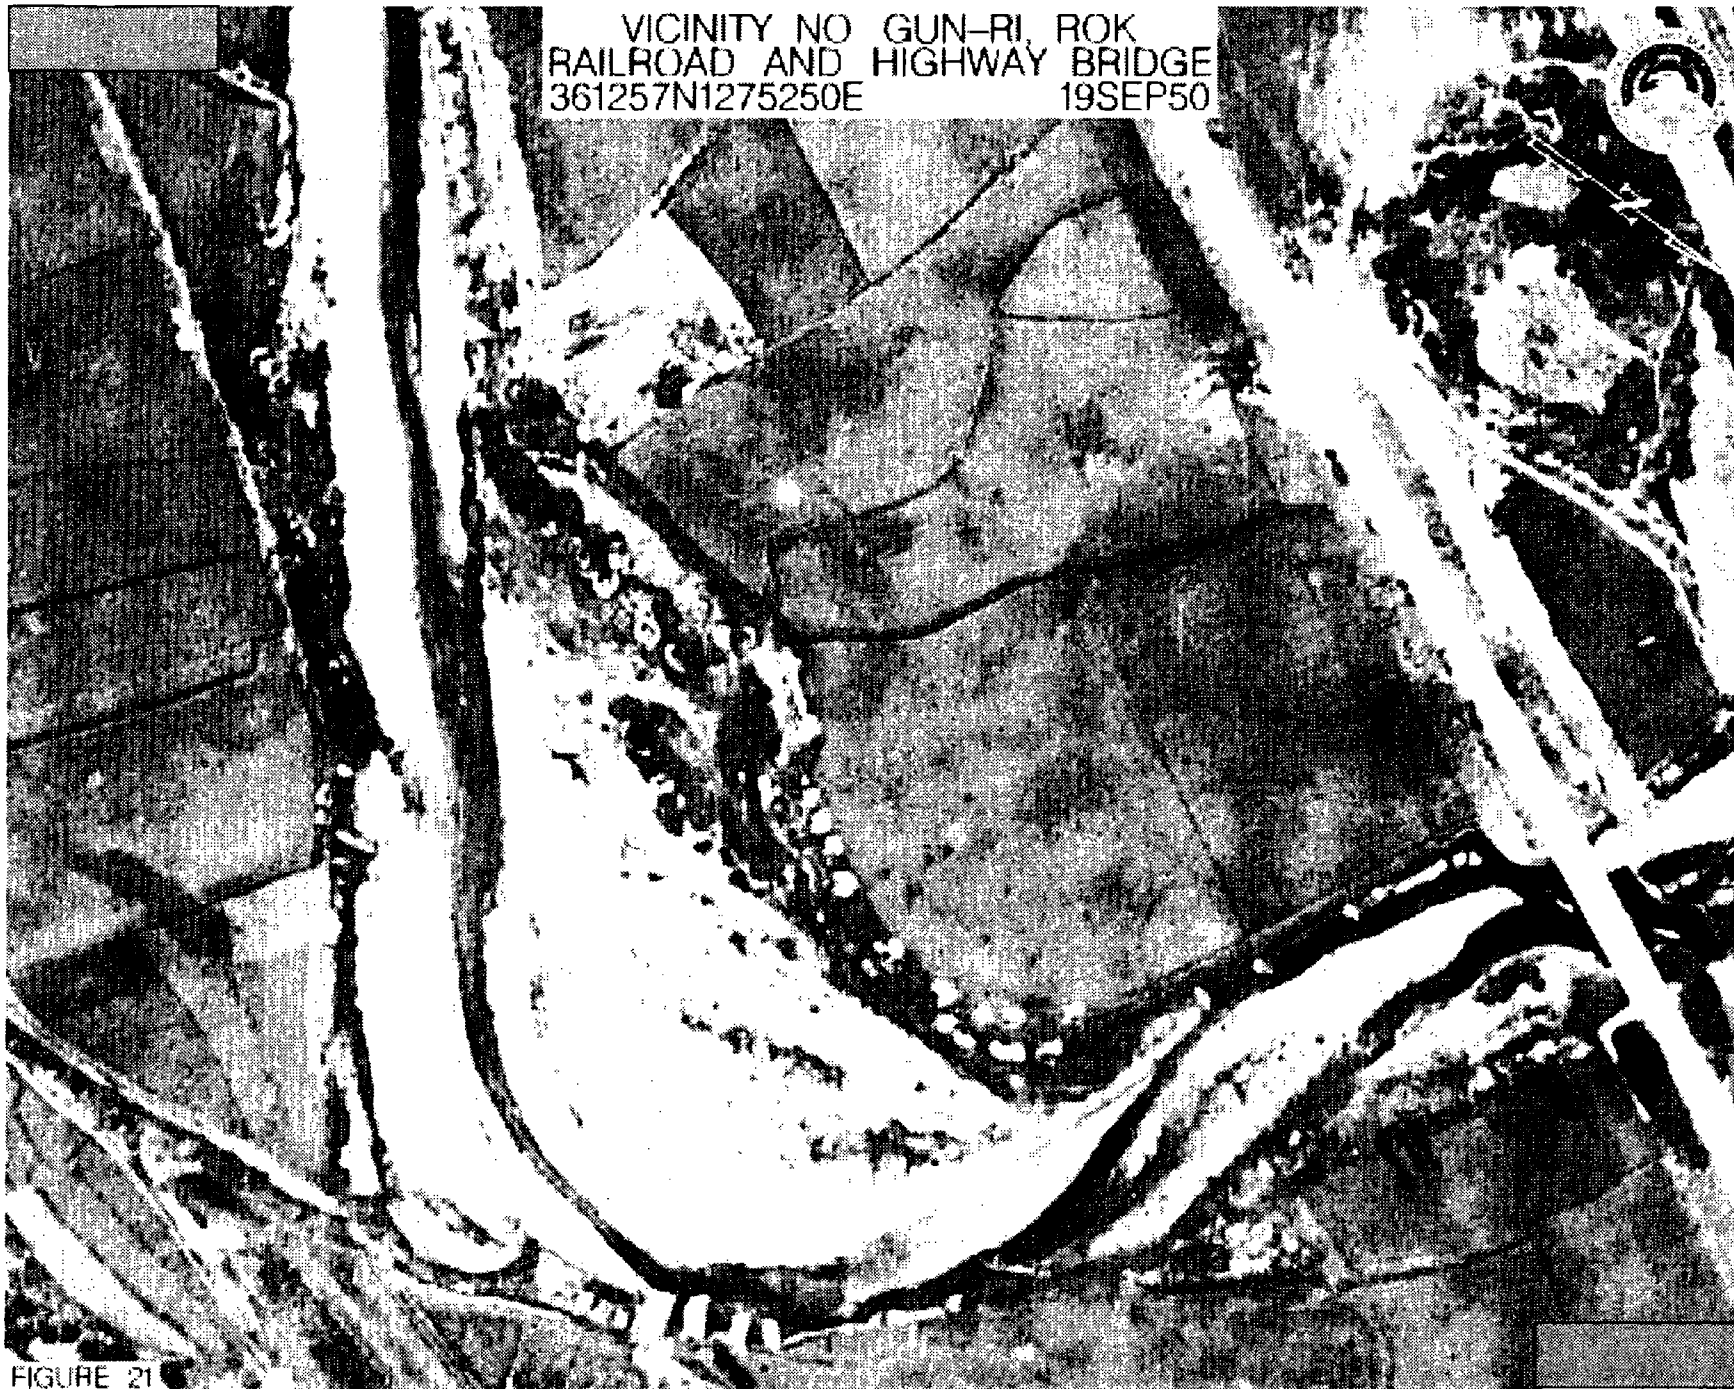
FIGURE 21

1. There were still no indications of mass graves in the vicinity of the No Gun-Ri Railroad bridge.
2. The previously identified fighting positions (foxholes) were still visible along the river, extending from the river bend east of the highway bridge along the river/stream bank to the southwest (Figure 21). The heavy concentration of fighting positions noted at 361229N 1275259E remained. Stereoscopic examination of the fighting positions revealed that the majority were still open (meaning not filled in or covered over) (Figure 22). Most of the positions were showing the effects of weathering, having begun to collapse over time.

VICINITY NO GUN-RI, ROK  
RAILROAD AND HIGHWAY BRIDGE  
361257N1275250E 19SEP50

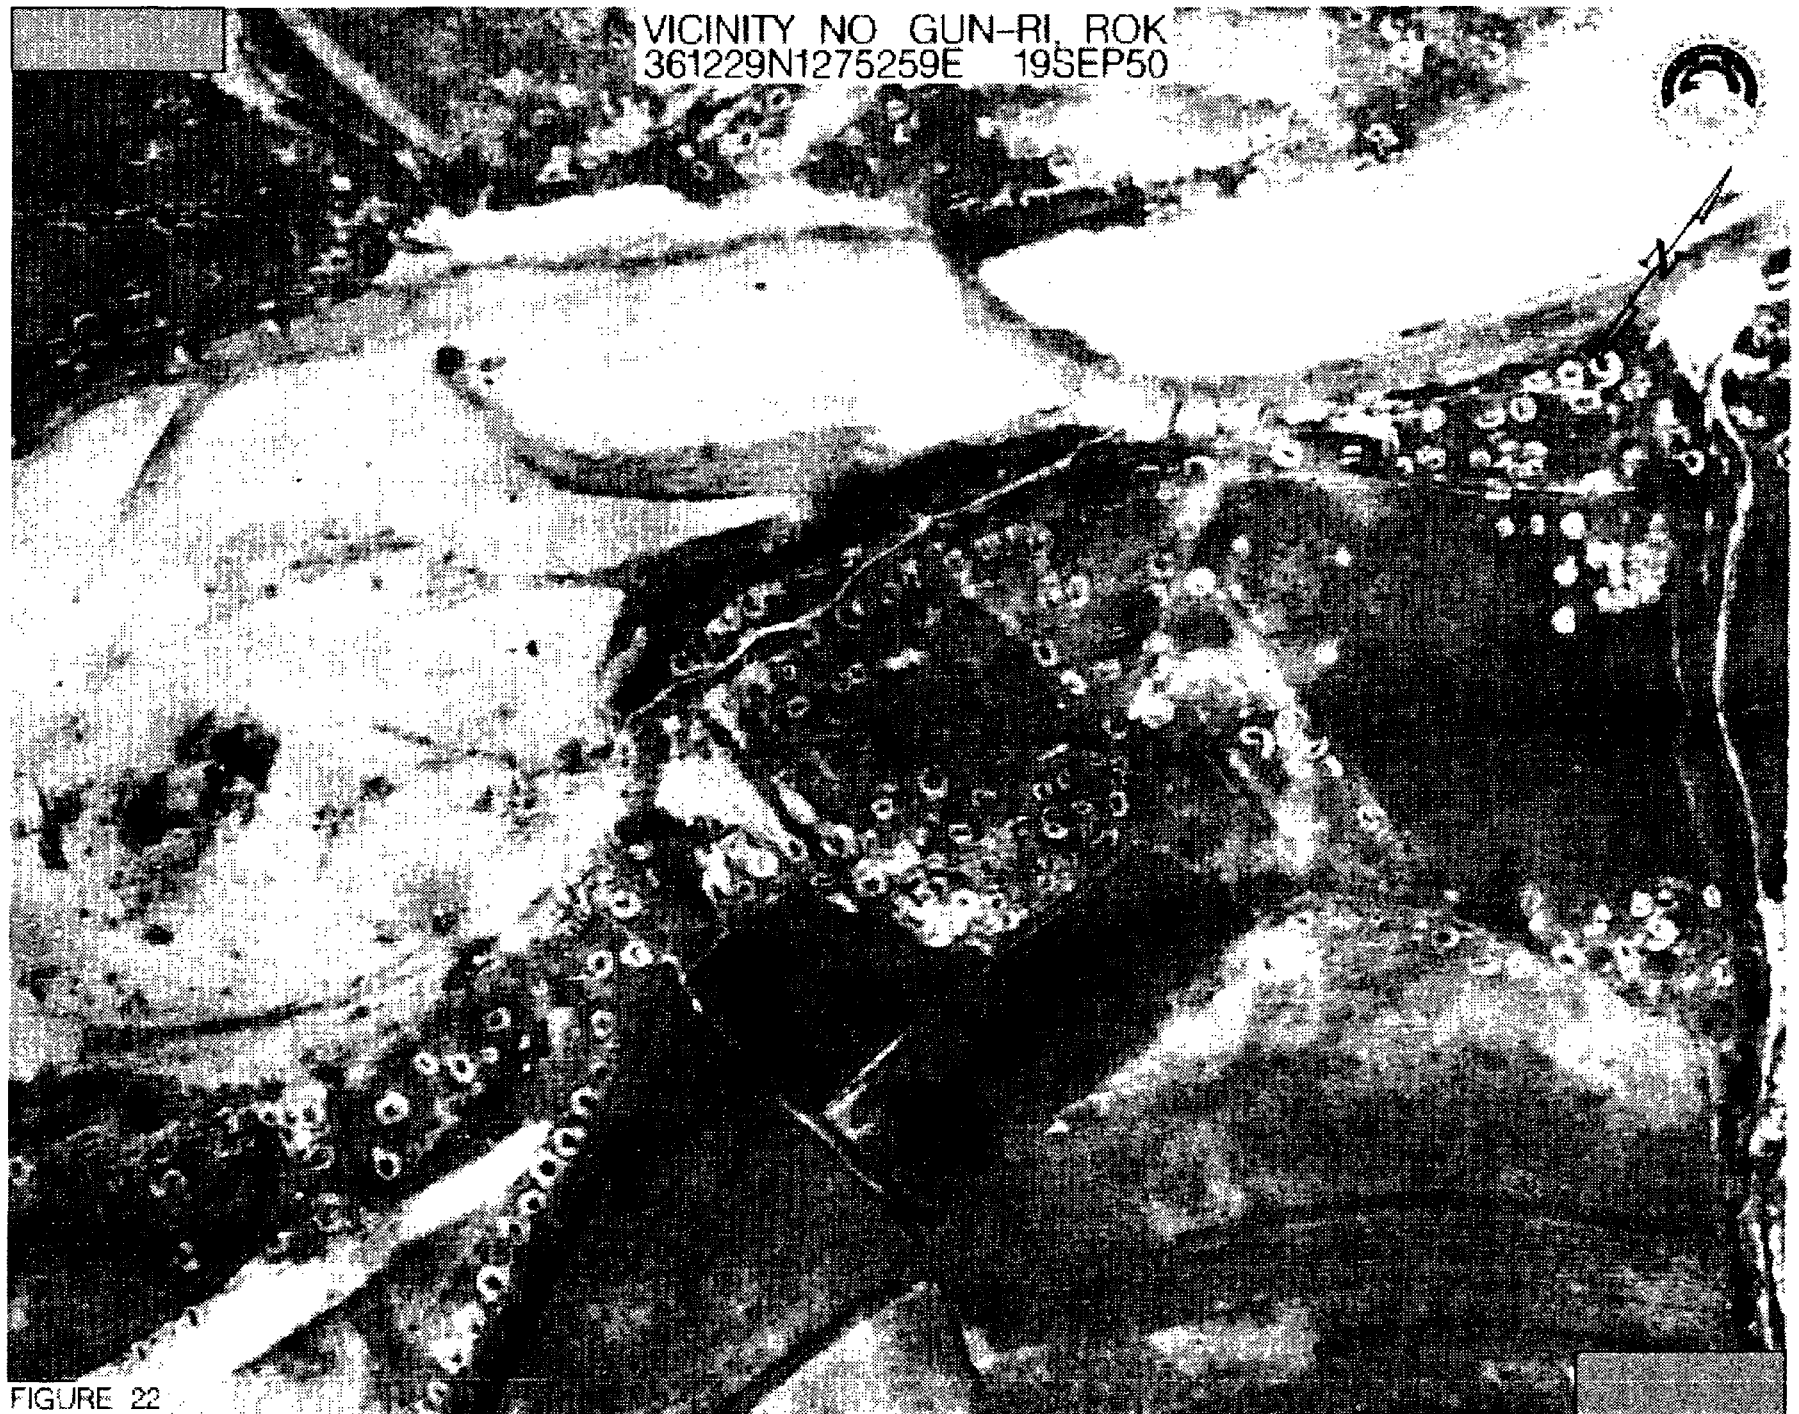
VICINITY NO GUN-RI, ROK  
361229N1275259E 19SEP50

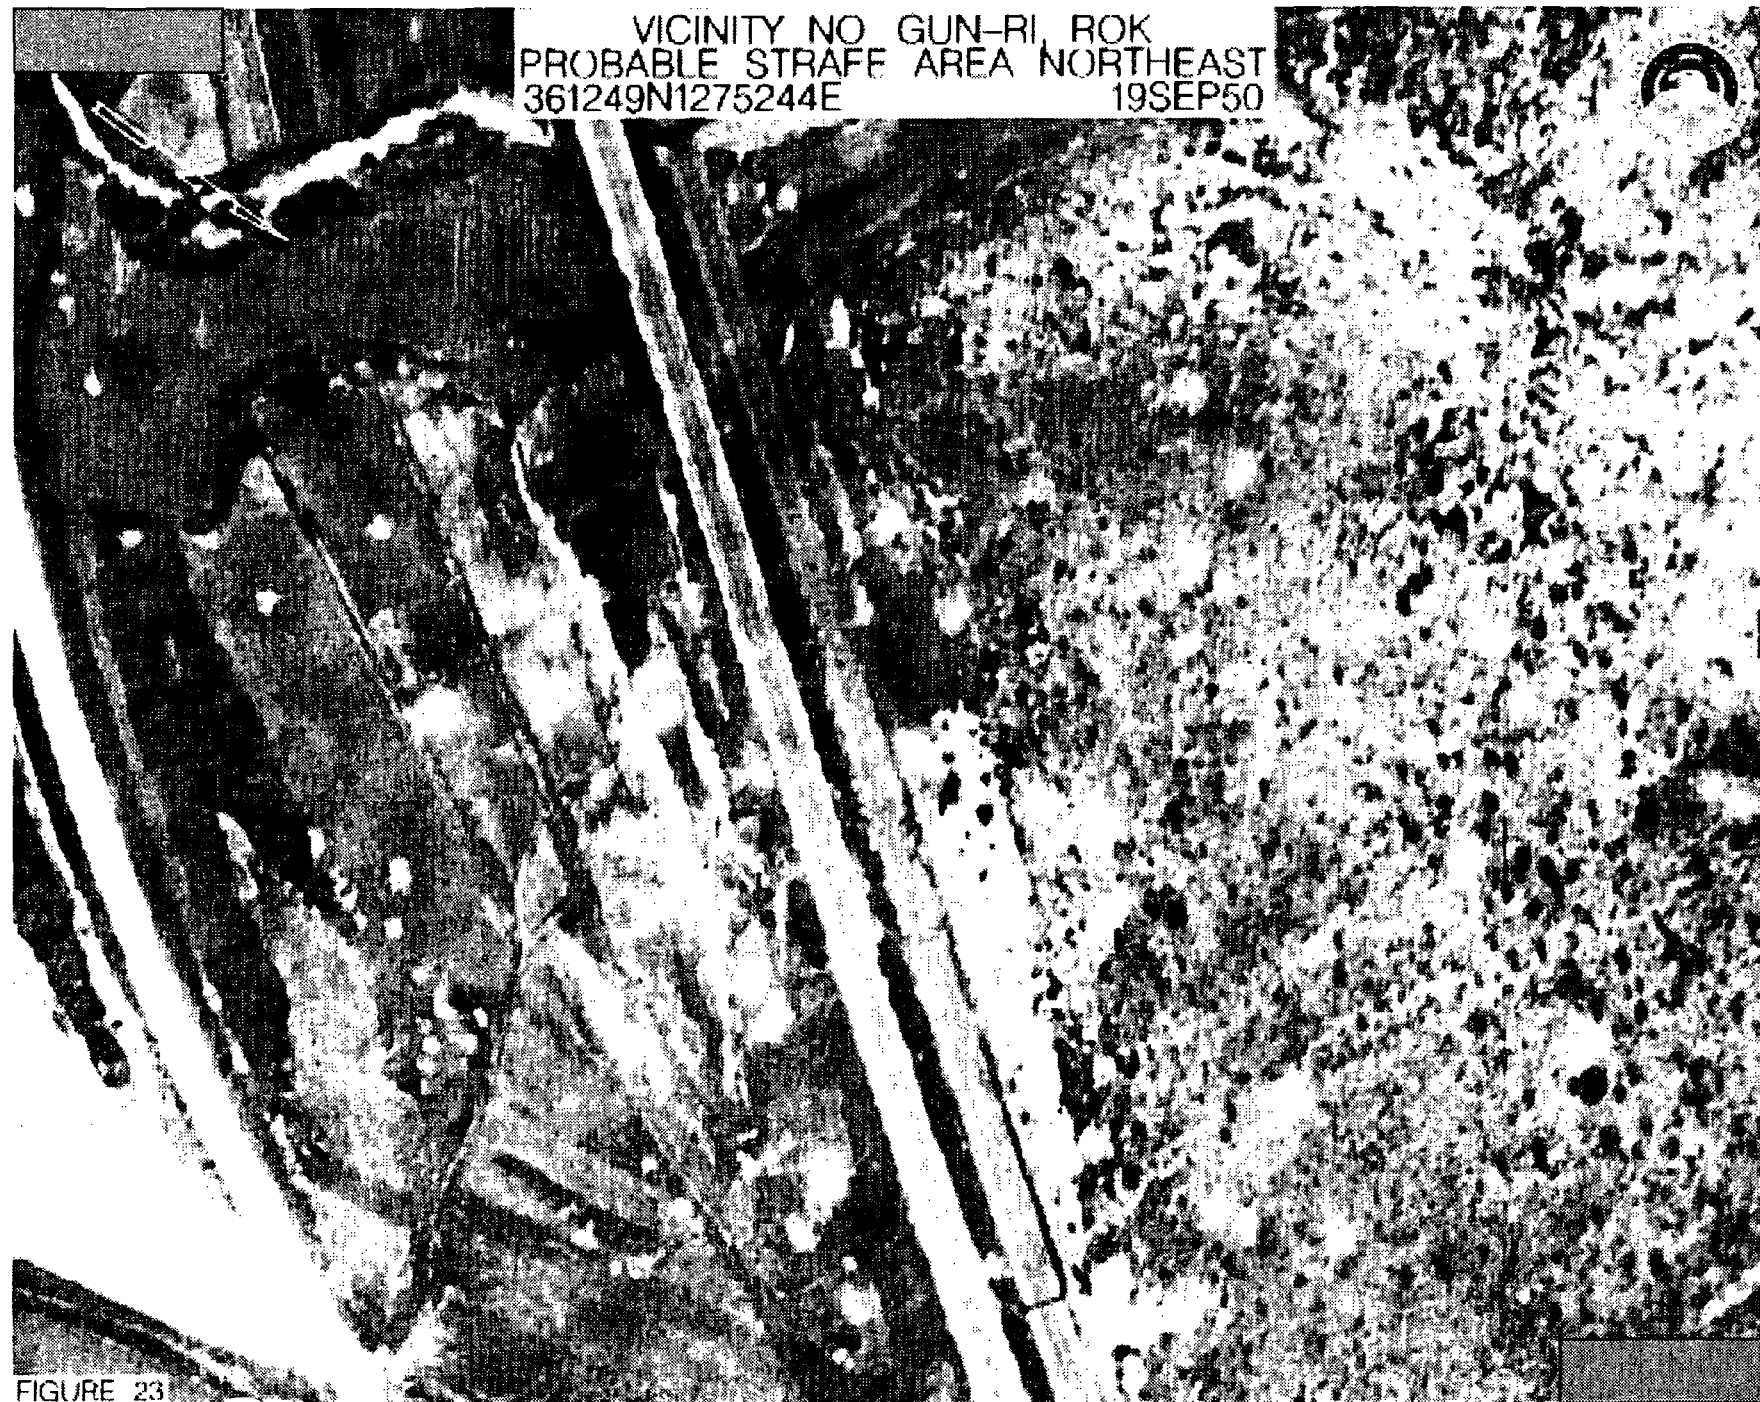
FIGURE 23

1. The imagery signature of probable strafing noted on the 6 August 1950 imagery was less evident on 19 September 1950.
2. The probable northeast strafed area located at 361249N 1275244E (Figure 23), still exhibited the effects of the probable strafing; the ground surface between the rails appeared uneven and presented a "pockmarked" feel when viewed in stereo. The time interval between 6 August and 19 September 1950 allowed the scene to "weather" -- returning the rail bed in the probable strafed area to a more uniform gray tone. The rails through the probable strafed area appeared intact, however at one location it appeared that the tracks may have been bowed outward slightly and several of the cross ties appeared to be missing and broken. Some probable gouges or craters were still visible along the embankment walls.

VICINITY NO GUN-RI, ROK  
PROBABLE STRAFE AREA NORTHEAST  
361249N1275244E 19SEP50

4. It should be noted that most of the craters in both areas caused by other munitions of various types showed this same weathering effect, darkening in the later coverage.

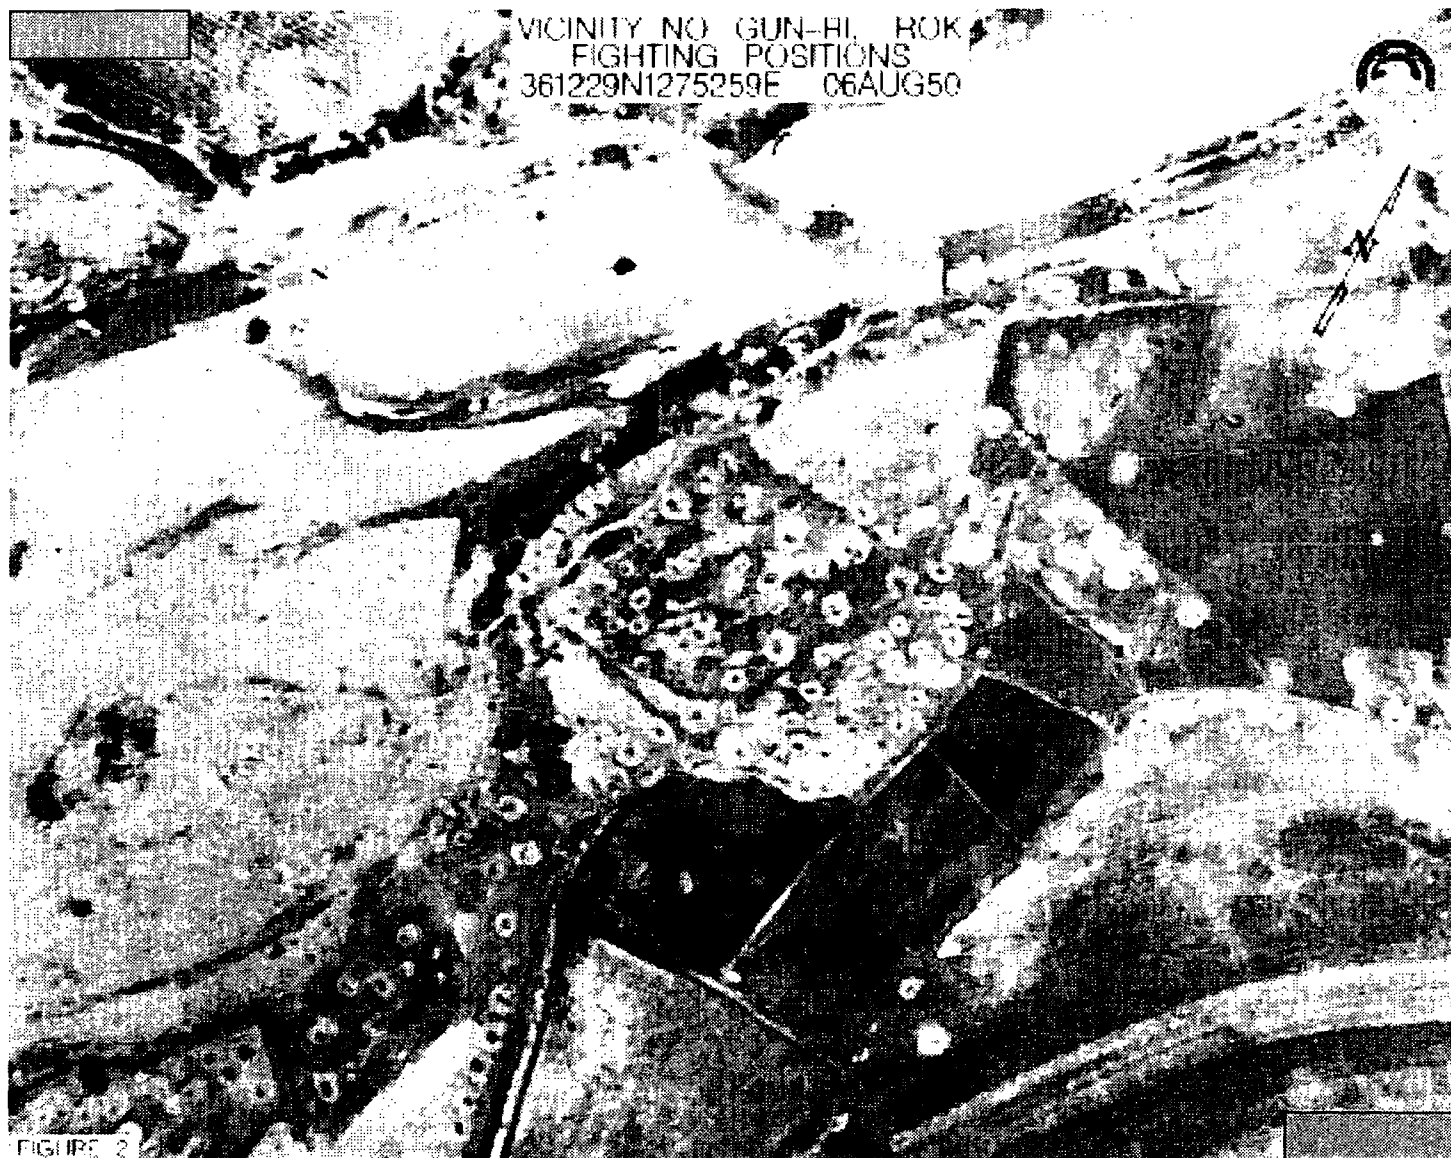
FIGURE 1

VICINITY NO GUN-HI, HOK  
RAILROAD AND HIGHWAY BRIDGES  
361257N1275250E 06AUG50

2. The text of the Republic of Korea's No Gun-Ri Investigation Team's "Analysis on Overhead Imagary" (sic) has been reproduced **exactly** and indicated by italicized print within the text of this report (Appendix A is a ROK government document and will not be reproduced for the final report. Requests for release of this document should be submitted to the Korean government), while the NIMA imagery analyst's findings and comments are in regular print. Most of the Korean Image Analysis Team (KIAT) comments concern the imagery frames in the vicinity of the No Gun-Ri railroad bridge (Figure 1).

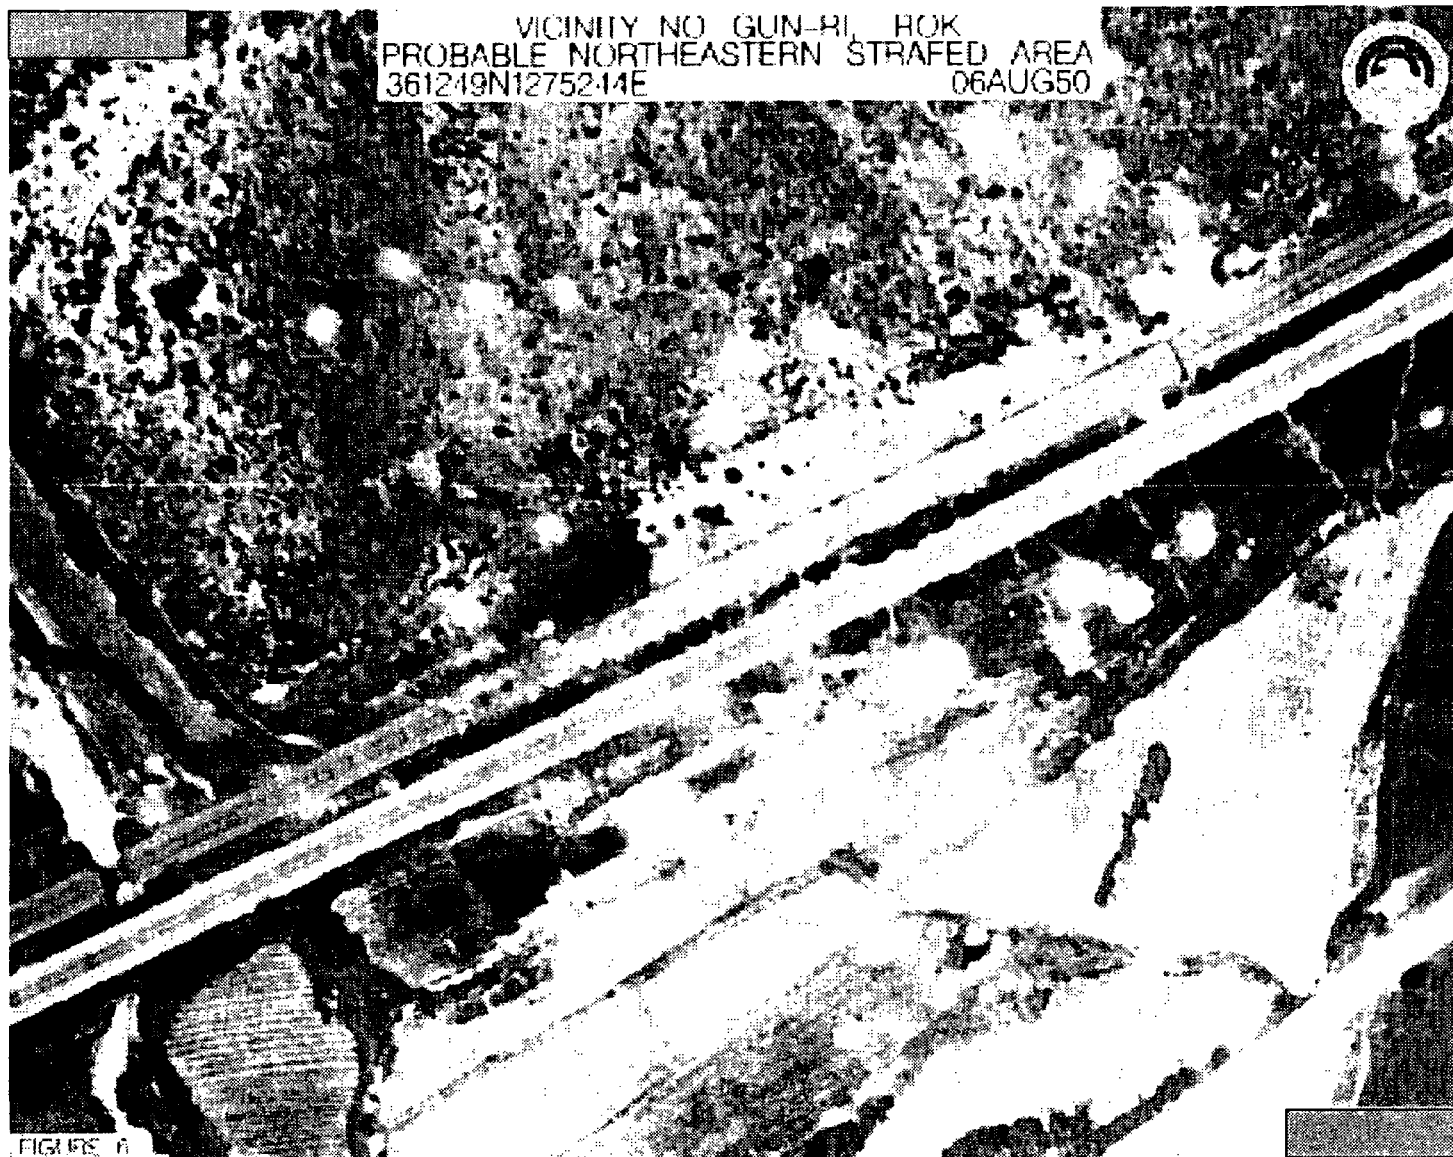
FIGURE 5

VICINITY NO GUN-RI, HOK  
PROBABLE NORTHEASTERN STRAFED AREA  
361249N1275214E 06AUG50
