# A/T Gear Position Indicator Panel

## Adjustment

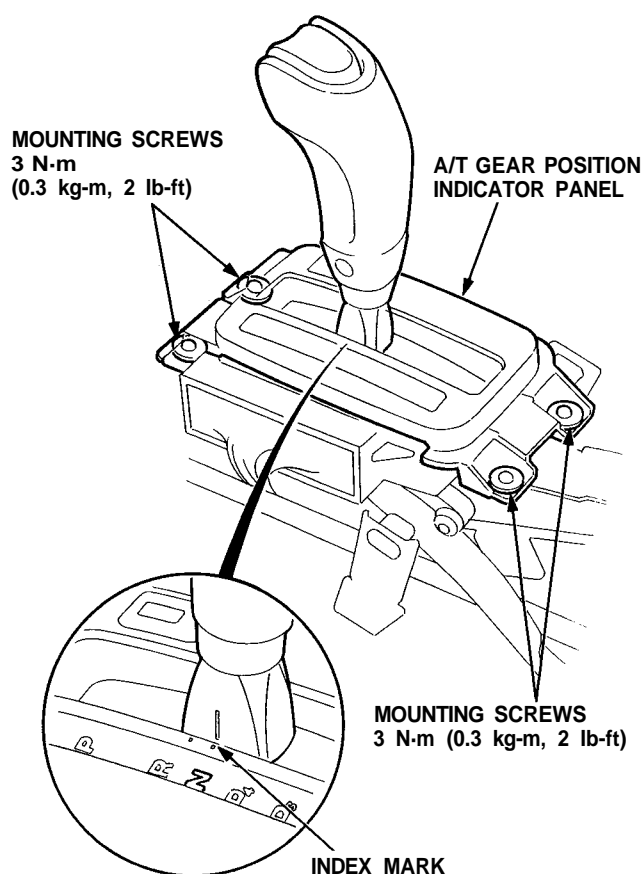
NOTE: Whenever the A/T gear position indicator panel is removed, reinstall the panel as described above.
