# Aspirator Fan Motor

## Removal

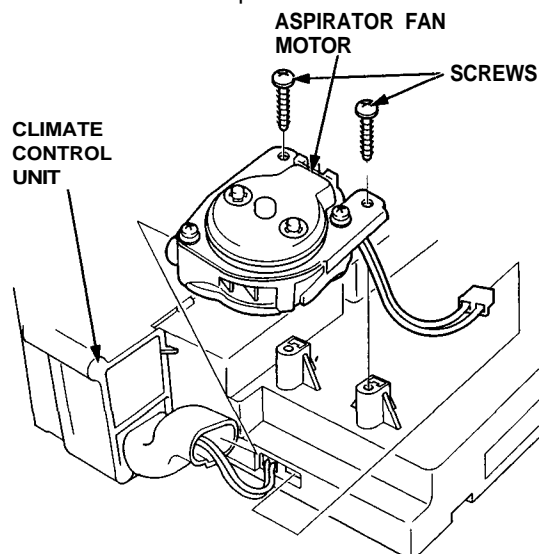
2. Disconnect the aspirator fan connector as shown.

3. Remove the mounting screws, then remove the aspirator fan motor.

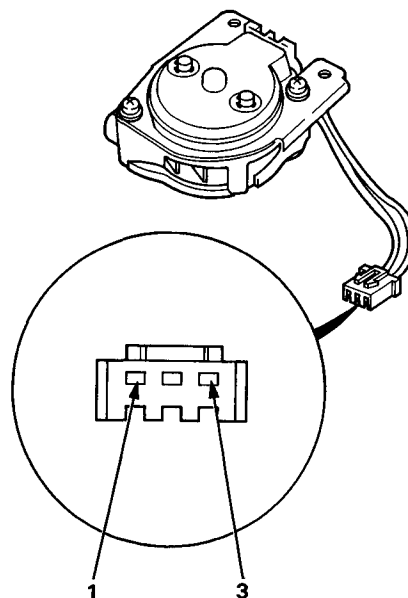
Connect battery power to the No. 1 terminal of the connector, and connect the No. 3 terminal to ground. The fan should run.
