Ignition System

Spark Plug Inspection

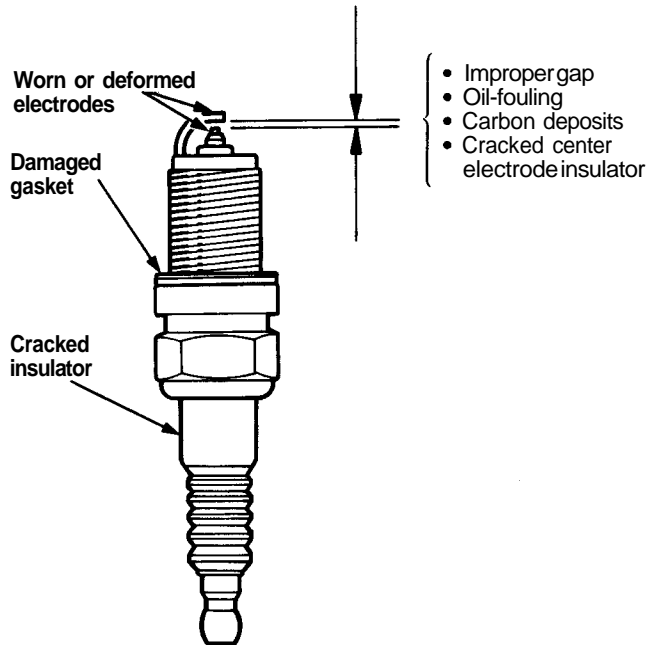
1. Inspect the electrodes and ceramic insulator for:

Burned or worn electrodes may be caused by:

- Advanced ignition timing
- Loose spark plug
- Too low plug heat range
- Insufficient cooling

Fouled plug may be caused by:

- Retarded ignition timing
- Oil in combustion chamber
- Incorrect spark plug gap
- Too high plug heat range
- Excessive idling/low speed running
- Clogged air cleaner element
- Deteriorated ignition coil

2. Make sure that the 1.3 mm (0.051 in.) plug gauge does not fit into the gap of the platinum tip plug. If the gauge fits into the gap, do not attempt to adjust the side electrode. Replace the plug.

Standard	1.1 $\begin{smallmatrix} +0 \\ -0.1 \end{smallmatrix}$ mm (0.043 $\begin{smallmatrix} +0 \\ -0.004 \end{smallmatrix}$ in)
Service Limit	1.3 mm (0.051 in)

3. Replace the plug at the specified interval, or if the center electrode is rounded as shown below:
