Stereo Sound System

Cable Reel Harness Test

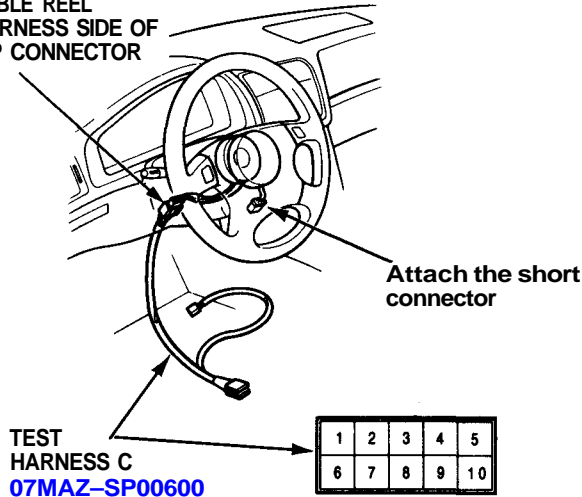
1. Disconnect the cable reel 7-P connector from the SRS main harness, and connect the Test Harness C only to the cable reel side of the 7-P connector.

CABLE REEL
HARNESS SIDE OF
7-P CONNECTOR

TEST
HARNESS C
07MAZ-SP00600

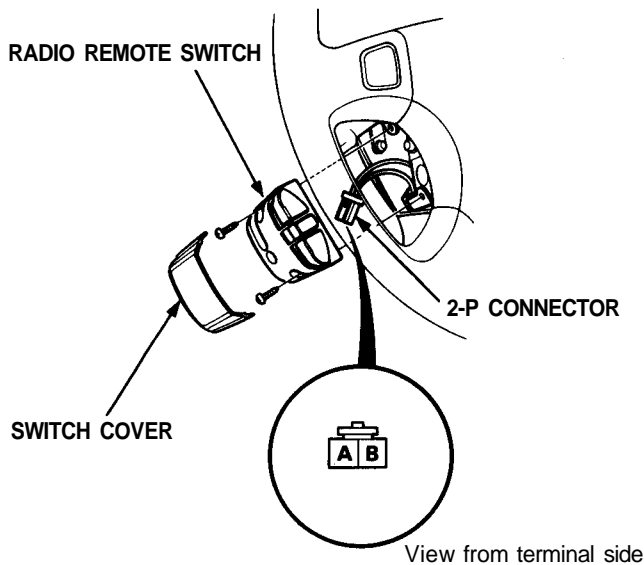
2. Separate the radio remote switch (see page 23-235).
3. Disconnect the 2-P connector from the radio remote switch.

4. Check for continuity between the No. 7 and B terminals. There should be continuity.

- If there is no continuity, replace the cable reel.
- If there is continuity, go to step 5.

5. Check for continuity between the A terminal and body ground. There should be continuity.

If there is no continuity, go to step 6.

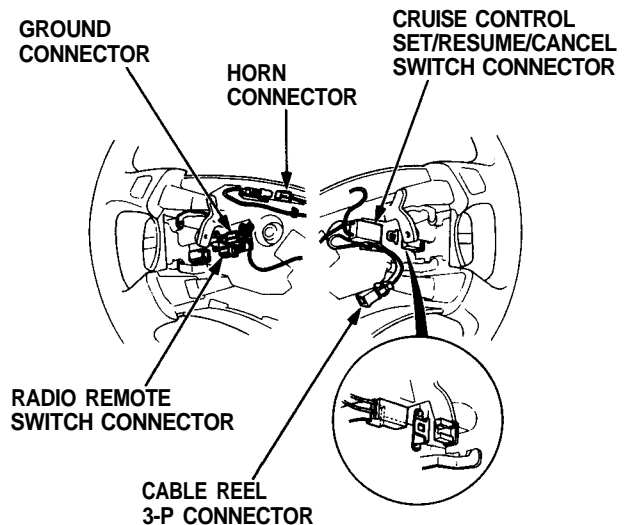
7. Disconnect the ground connector, then check for continuity between the A terminal and ground connector. There should be continuity.

If there is no continuity, replace the cable reel.
