## The Mechanical Performance of Sn-Pb Solder Joints on LTCC Substrates

Failure mode analysis was a critical metric for assessing the roles of interfaces. bulk solder, and the ceramic on mechanical performance

BY P. VIANCO, S. WILLIAMS, A. KILGO, B. McKENZIE, W. PRICE, AND E. GUERRERO

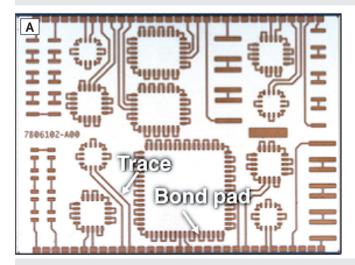
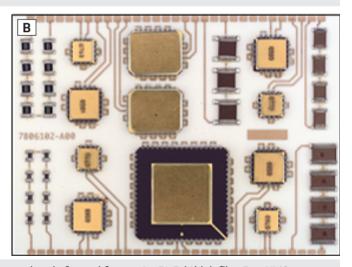
Fig. 2 — A — Photograph shows an alumina substrate having traces and pads formed from a Au-Pt-Pd thick film. B — HMC assembly is shown with the components soldered to the bond pads.

Electronics based on ceramic PCBs are referred to as hybrid microcircuits (HMCs). Traditionally, HMCs used an alumina ceramic substrate, an example of which is shown in Fig. 2A. Traces and bond pads were created from pastes that were a combination of metal particles, typically Ag, Au-Pd, or Au-Pt-Pd alloy; a glass frit; and organic binders. The circuit pattern was formed by printing the paste through a screen or stencil sheet that duplicated that pattern. Once the paste was printed on the ceramic surface, it was dried to drive off the organic binder and then fired at 850°-900°C for 15–30 min in air. The firing step sintered the metal particles together to form an electrically conductive layer; it also caused the glass frit to melt and diffuse to the metal layer/ceramic surface, where it bonded the two materials together. Lastly, the ceramic substrate was assembled with components using the same soldering processes as are used with traditional laminate PCBs, creating the HMC assembly shown in Fig. 2B.

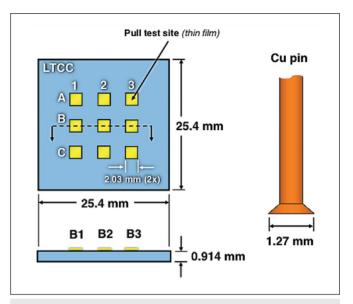
Fig. 4 — LTCC pull test specimen and the Cu pin.

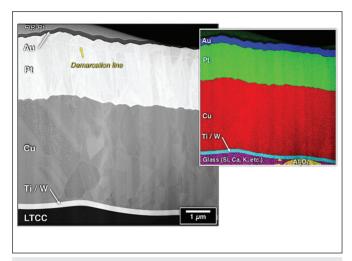
Fig. 6 — STEM image shows the as-deposited, Ti/W-Cu-Pt-Au layer. A faint demarcation line is identified in the layer. The inset picture is the annular spectral image that identifies the elements by color, including the different phases in the LTCC.

The Ti/W-Cu-Pt-Au thin film was evaluated using scanning transmission electron microscopy (STEM). The specimen was prepared by the focused ion-beam (FIB) cutting process using gallium (Ga) ions. The STEM image is shown in Fig. 6. The Cu and Pt layers developed with largely columnar grain structures. A small demarcation line was observed near the top of the Pt layer. The columnar grain structure appeared to be continuous across the line, which implies that the source of the artifact did not significantly interrupt the deposition process and, as such, did not introduce a material defect in the Pt layer.

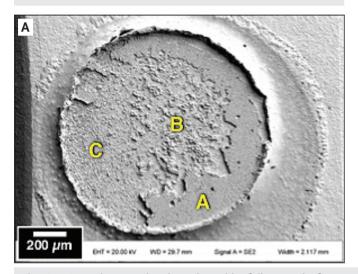
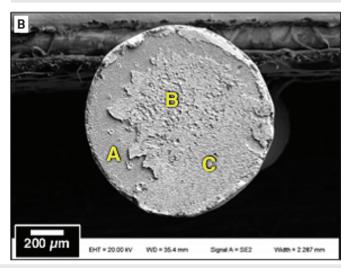
Fig. 10 — SEM photographs show the solder failure mode, fracture surfaces belonging to — A — the thin film pad on the LTCC substrate and B — the corresponding pin. The letters "A," "B," and "C" denote the three surface topographies. The soldering process parameters were 215°C and 15 s.

solder failure (blue bar) is illustrated by the SEM images in Fig. 10. Figure 10A, B show the fracture surfaces on the LTCC pad and pin sides of the solder joint, respectively. This joint was made using the process conditions of 215°C and 15 s. Three distinctive regions were identified on the fracture surfaces by the letters "A," "B," and "C." Their physical metallurgies were determined with the assistance of the energy-dispersive x-ray (EDX) technique.

Region A had a relatively smooth topography in Fig. 10. That topography resulted from intergranular fracture as shown by the higher magnification SEM image in Fig. 11. The accompanying EDX elemental maps indicate the fracture surface was comprised primarily of Au, Cu, and Sn. Although intermittent areas showed only the Sn signal (white circles), by and large, the fracture surface showed all three elements to overlap with one another (cyan circles). The same surface to-

pography and elemental distributions were repeated on the pin side of the fracture (region A, Fig. 10B).

The failure mode morphology of region A resulted from fracture through the  $(\mathrm{Cu,Au})_x\mathrm{Sn}_y$  IMC layer that formed at the solder/Cu pin interface. The Au layer, which topped the thinfilm stack on the LTCC substrate, dissolved into the molten Sn-Pb solder. While the solder was molten, as well as following solidification, a driving force developed for Au to diffuse to the solder/Cu interface where it was incorporated into the IMC layer. Note that the contribution by solid-state diffusion had taken place at room temperature.

Regions B and C were very similar. Their relative heights versus that of region A in Fig. 10 indicated the fracture surface was closer to the solder/thin film interface. The primary difference between regions B and C was that region B included a greater percentage of failure within the ductile

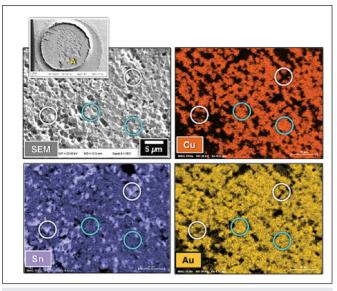
Fig. 11 — High-magnification SEM image of region A (see the inset picture) is shown, together with the EDX maps of Cu, Sn, and Au that predominated the fracture surface (process conditions: 215°C and 15 s). These data were obtained from the pad (LTCC) side of the failure.

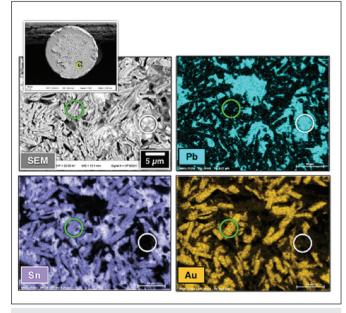
Fig. 13 — High-magnification SEM image shows the region C (see the inset picture) together with the EDX maps of Sn, Au, and Pb (process conditions: 215°C and 15 s). These data were obtained from the pin side of the failure.

To confirm the above hypothesis, SEM and EDX data were analyzed of the region C on the pin side of the fracture. Those results are shown in Fig. 13. Platinum was not detected on the *fracture surface.* However, there was a significant Au presence. The Pb signal (white circles) is due to localized fracture in the adjoining Sn-Pb solder field as noted earlier. The remaining fracture surface was comprised primarily of overlapping Sn and Au signals. These findings, when coupled with those of the fracture surface on the pad side (Fig. 12), indicate the Au was not fully dissolved from atop the Pt layer by the molten solder. Rather, some Au remained and reacted with Sn to form a Au, Sn, IMC layer. The C-region failure mode originated from fracture along the interface between the Au, Sn, IMC layer and

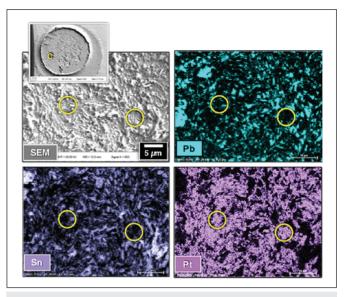
Fig. 12 — High-magnification SEM image of region C (see the inset picture) is shown, together with the EDX maps of Sn. Pt. and Pb on the fracture surface (process conditions: 215°C and 15 s). These data were obtained from the pad (LTCC) side of the failure.

A high-magnification SEM image is shown in Fig. 12 of region C. The EDX maps show the fracture surface to be comprised predominantly of Pt and, to a lesser extent, Sn. Lead (Pb) was also observed, which reflected an intermittent fracture in the adjacent Sn-Pb solder. At first glance, the data suggest that fracture occurred along a Pt<sub>x</sub>Sn<sub>y</sub> IMC layer that formed at the solder/Pt interface after the Au had been dissolved away. However, the yellow circles show there is minimal coincidence between the Pt and Sn signals, which implies that the fracture path did not have a significant association with a Pt<sub>x</sub>Sn<sub>y</sub> IMC layer.

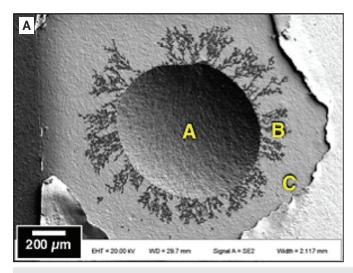
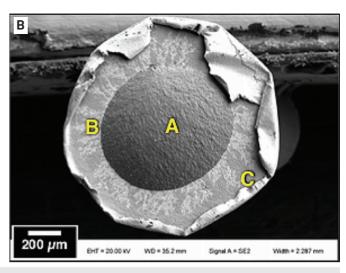
Fig. 14 — SEM photographs show the complementary fracture surfaces of the following: A — The thin film pad on the LTCC substrate; B — the pin that together illustrates the "LTCC divot" failure mode. The A region is the divot itself; the B region is a fractal pattern comprised of a mixture of both the "thin-film peeling" and "thin-film delamination" failure modes. The C region is solely the thin-film peeling mode. The soldering process parameters were 215°C and 15 s.

The divot failure mode is illustrated by the complementary SEM images in Fig. 14. Failure initiation occurred in the bulk LTCC material, which is indicated by the letter A in both images. As the LTCC fracture expanded from the pad center (Fig. 14A), it transitioned into the "fractal" pattern (B) that is the combination of thin-film delamination and thin-film peeling. As the crack approached the outer edge of the joint, a second transition took place whereby separation was entirely thin-film delamination (C). This behavior was documented as an "LTCC divot" failure mode because it predominates the LTCC fracture. Also, given the rapid nature of the LTCC fracture, the remaining fracture surface may not reflect the intrinsic failure mode of the joint in the absence of the LTCC divot fracture.

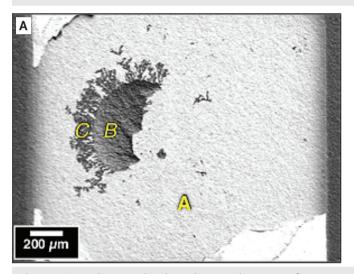
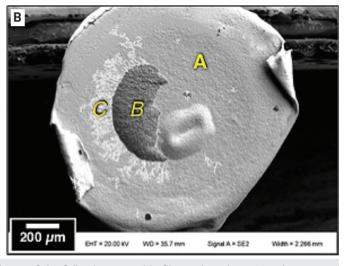
Fig. 15 — SEM photographs show the complementary fracture surfaces of the following: A — Thin film pad on the LTCC substrate; B — the pin showing the "thin-film peeling" failure mode. The A region identifies the film peeling mode. The secondary fracture paths were the LTCC divot (B) and the fractal patterns of thin film delamination and thin-film peeling (C). The soldering process parameters were 240°C and 15 s.

The thin-film peeling failure mode is illustrated by the SEM images in Fig. 15 and, specifically, location A. This sample was fabricated at 240°C and 15 s. The LTCC pad and pin sides of the fracture are shown in (A) and (B), respectively. A small divot (B) and associated "fractal pattern" (C) were observed in both images. However, the latter fracture paths were secondary to the thin-film peeling mode.

The fracture surface appeared to be relatively featureless at the magnifications used in Fig. 15. A high-magnification

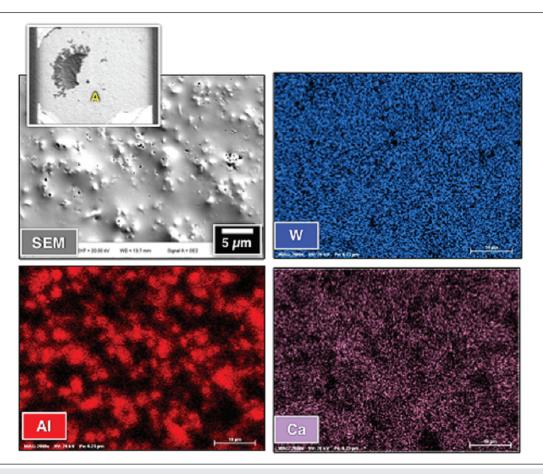
Fig. 16 — High-magnification SEM image of region A (see the inset picture) is shown, together with the EDX maps of W, Al, and Ca (process conditions: 240°C and 15 s). These data were obtained from the LTCC pad side of the failure.

SEM image is shown of the fracture surface in Fig. 16 (LTCC side). The corresponding EDX maps, together with those from the pin side of the fracture, confirmed that failure took place at the Ti/W-Cu interface. Residual Cu was not observed on the exposed Ti/W film to within the detection limits of the EDX technique.

At the higher magnification level of Fig. 16, the fracture surface showed significant relief. The Ti/W layer is only 0.200  $\mu m$  thick so that it replicates the surface topography of the LTCC substrate. The limited thickness of the Ti/W layer also permitted the x-ray signal to sample the chemistry of the LTCC underneath it. The protrusions of the film correspond to the alumina phase of the LTCC (Al map). The glass phase is represented by the Ca signal because the Si signal, which would be generated by the primary constituent of the glass material, silica (SiO\_2), is overlapped by the W line of the Ti/W film.

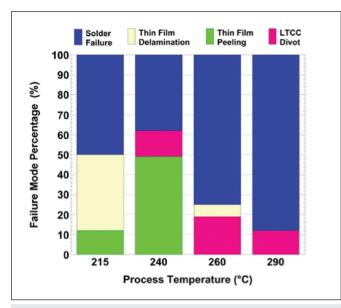
Fig. 17 — Bar chart shows the percentage of the observed failure modes as a function of solder temperature for a soldering time of 60 s.

The failure mode percentage data appearing in Fig. 17 were obtained from test sites soldered for 60 s. The thin-film peeling appeared at the soldering temperature of 215°C; it was no longer observed at 260°C, as recorded at 15 s — Fig. 9. The failure mode percentages were nearly identical at 240°C. At the soldering temperatures of 260° and 290°C, there were a significant increase in the solder failure mode at the expense of the other three modes. This trend implies that, with increasing soldering temperature, the interfaces associated with the thin-film structures and the bulk LTCC (divots) had lesser roles in the fracture behavior while the solder joint microstructural features — bulk solder and IMC reaction layers — had greater effects on mechanical performance.

The details of the fracture surface morphologies associated with the failure modes in Fig. 17 were generally similar to those discussed in association with Figs. 10–16. The failure mode data in Fig. 17 (60 s) were compared to the pull strength results in Fig. 8. The pull strength decreased slightly between 215° and 240°C, which happened to coincide with the increase in the thin-film peeling mode from 12 to

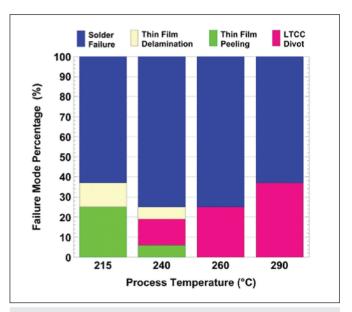
Fig. 18 — Bar chart shows the percentage of the observed failure modes as a function of solder temperature for a soldering time of 120 s.

The failure mode percentages are shown in Fig. 18 for the longest soldering time of 120 s. The thin-film peeling mode was observed at the soldering temperatures of 215° and 240°C; it increased at the former temperature and decreased at the latter temperature when compared to the 60-s solder time results in Fig. 17. Moreover, the solder failure mode increased, significantly, at the two lowest soldering temperatures when compared to either of the two shorter soldering times. At the

The failure mode trends in Fig. 18 were compared to the pull strength data in Fig. 8. A reduced pull strength was observed at 215°C that coincided with the increased prevalence of the solder failure mode. The pull strength was unchanged at the soldering temperatures of 240° and 260°C as was also the case for the dominance of the solder failure mode. In addition, the increased frequency of LTCC divots between these temperatures was not reflected by a change to the pull strength. A slight drop in pull strength was observed at 290°C. However, the slight increase in the LTCC divot failure mode (Fig. 18) cannot be confidently asserted as the cause. Rather, the solder failure mode with its dependence on the Sn-Pb microstructure and IMC layers likely caused the drop in the pull strength.

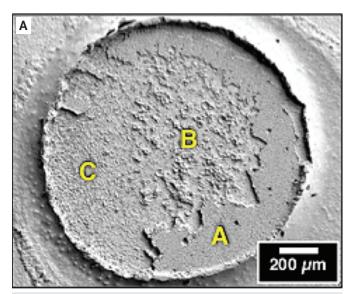
Fig. 19 — SEM photographs illustrate the changes to the fracture surfaces and, specifically, the proportions of regions A, B, and C as a function of soldering process conditions: A — 215°C, 15 s; B - 215°C, 60 s; and C - 290°C, 120 s.

On the other hand, the fracture surfaces associated with the solder failure mode did change as a function of the soldering parameters in two manners. First, the proportion of the fracture area represented by region A (Fig. 10) increased with severity of the soldering conditions. Recall that region A results from separation in the IMC layer that formed at the solder/Cu pin interface. This trend is illustrated in Fig. 19, which shows the surfaces on the pad (LTCC) side of the fracture path for the range of soldering conditions: a) 215°C, 15 s;

b) 215°C, 60 s; and c) 290°C, 120 s. Note that region A has increased at the expense of the combined regions, B plus C.

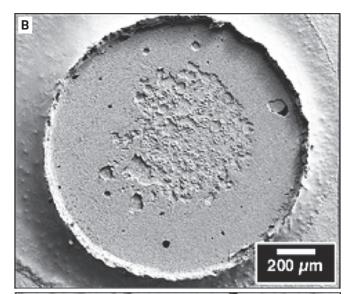
Fig. 20 — SEM photographs shows an increased roughness to the fracture surface topography of region A as a function of soldering conditions:  $A = 215^{\circ}C$ , 60 s;  $B = 290^{\circ}C$ , 120 s.

Second, the details of the fracture surface topography belonging to region A changed as a function of soldering conditions. This behavior is illustrated in Fig. 20, which shows the region A fracture surface generated by the following soldering parameters: a) 215°C, 60 s and b) 290°C, 120 s. The smooth topography in Fig. 20A has changed to a rougher topography in Fig. 20B. The latter surface was attributed to an increased growth of the (Cu, Au)<sub>x</sub>Sn<sub>v</sub> IMC layer caused by the prolonged exposure to molten solder.

A review was made of the EDX data, the goal of which was to determine whether the topographical changes to region A as illustrated in Fig. 20, were likewise accompanied by chemistry changes to the associated (Cu, Au), Sn, IMC layer. A decrease was observed in the Au signal relative to that of Cu with the increased severity of the soldering conditions. In the absence of cross-section analyses, it could only be hypothesized that the higher soldering temperature allowed the Au to reach a higher concentration in the Sn-Pb solder, which reduced its concentration in the (Cu, Au)<sub>x</sub>Sn<sub>y</sub> IMC layer formation. Because the reduction in the Au content of the IMC layer would cause the latter to become less brittle, the increased propensi-
