Intrinsyx Environmental

Combining nature with engineered solutions for sustainable environmental remediation

Phytoremediation

Enhanced Phytoremediation

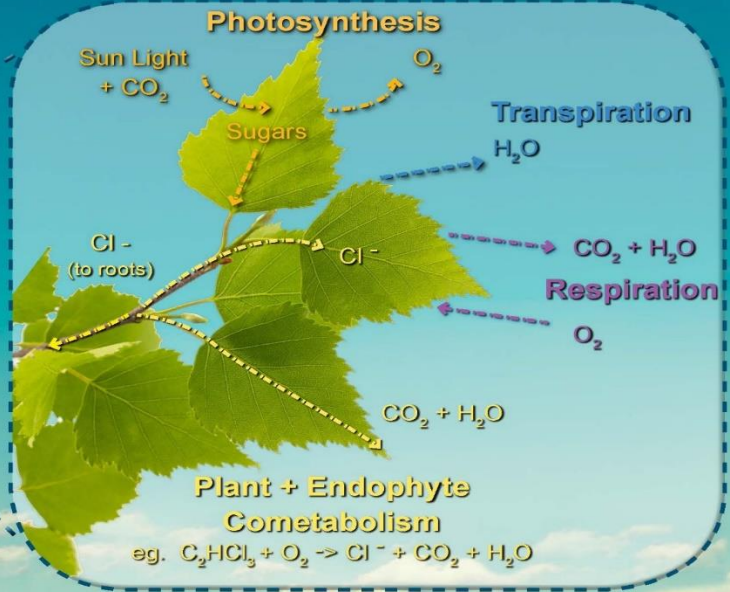
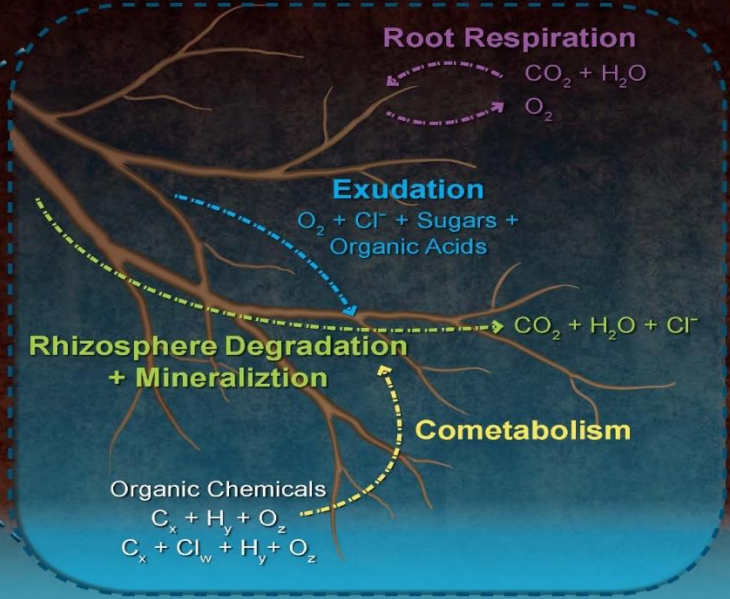
Sequestration + Mineralization
Organic Chemicals + Metals

Uptake + Phytoextraction
Water + Contaminants

Xylem
 $H_2O + \text{Nutrients}$

Transpiration

Rhizosphere Degradation

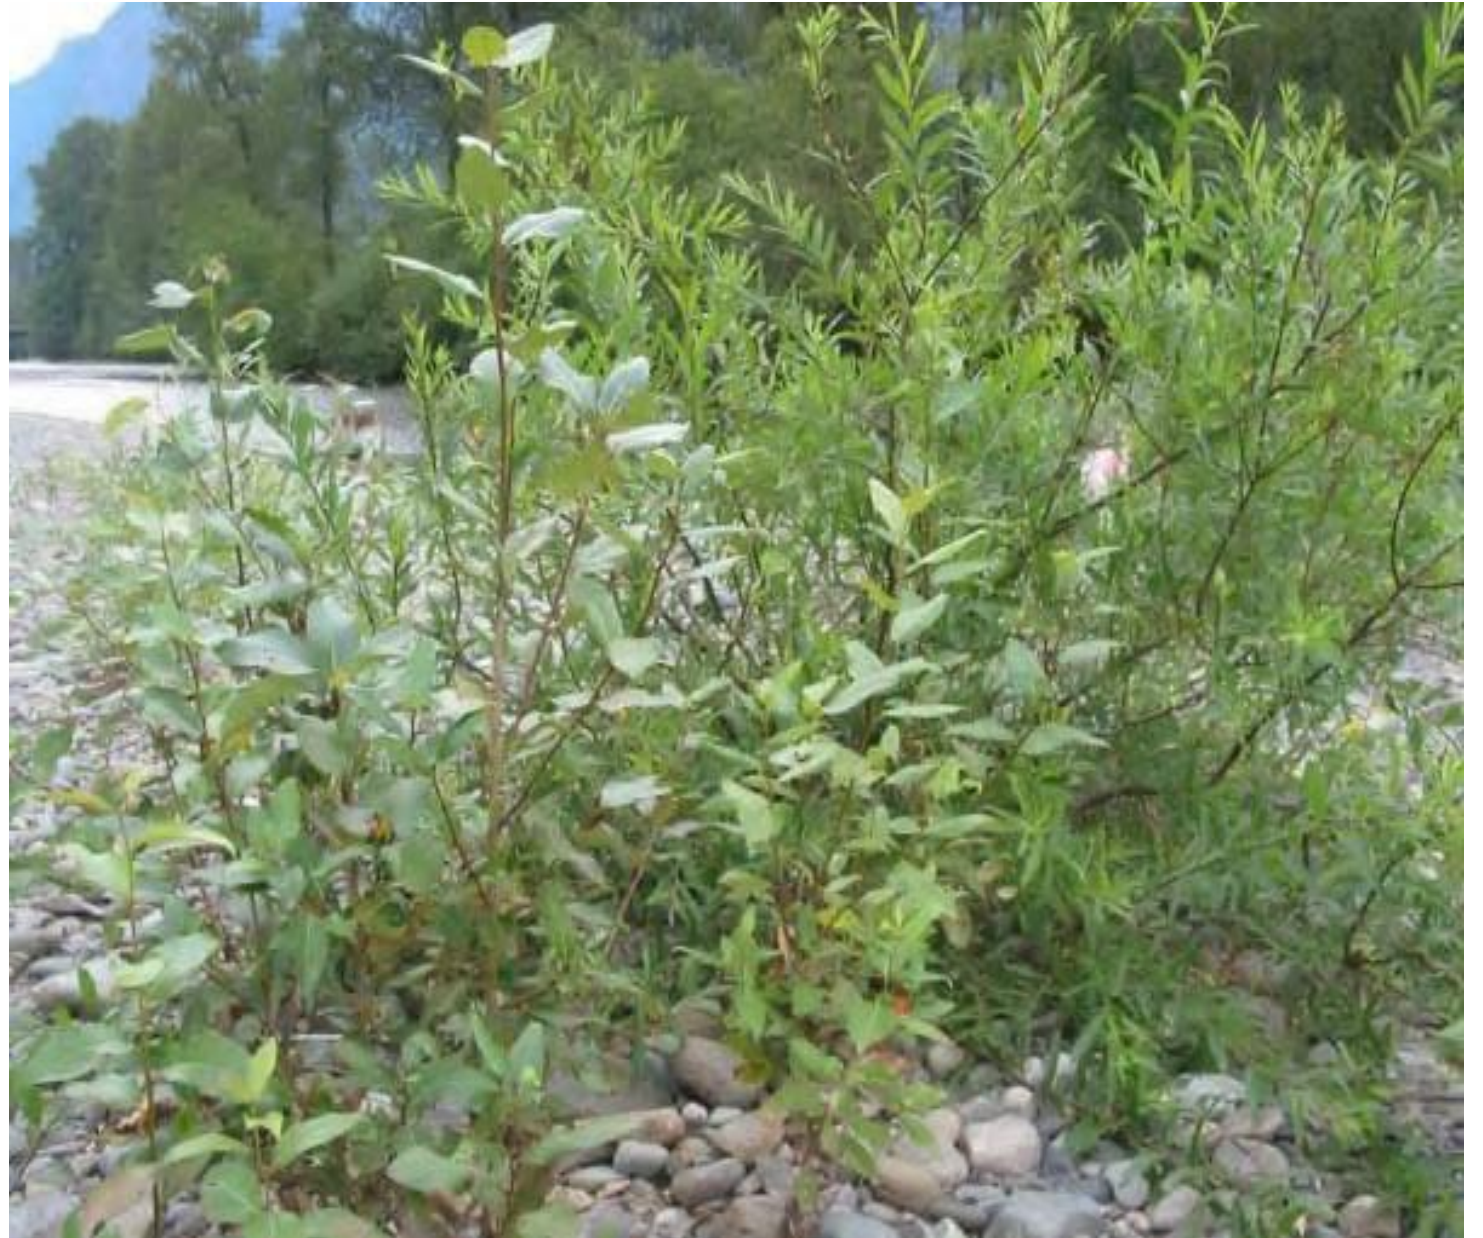
Inoculation of Endophyte Bacteria into Trees

- Grow in extreme environments
- Increased biomass
- Tolerance to pollutants
- Enhanced contaminant degradation
- Increase carbon sequestration
- Improve water use efficiency

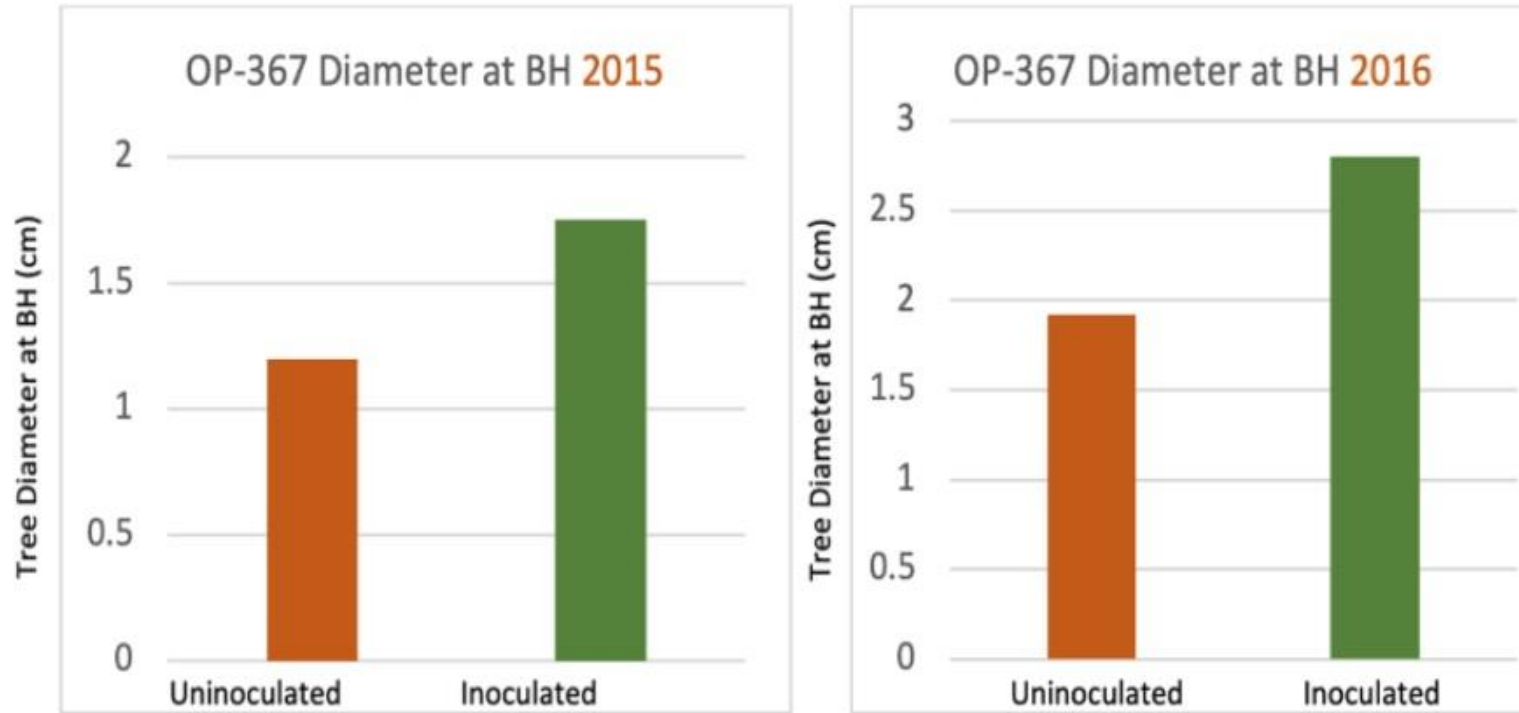
Growth Benefits from Endophyte Inoculation

Tree trunk diameter at breast height (cm)

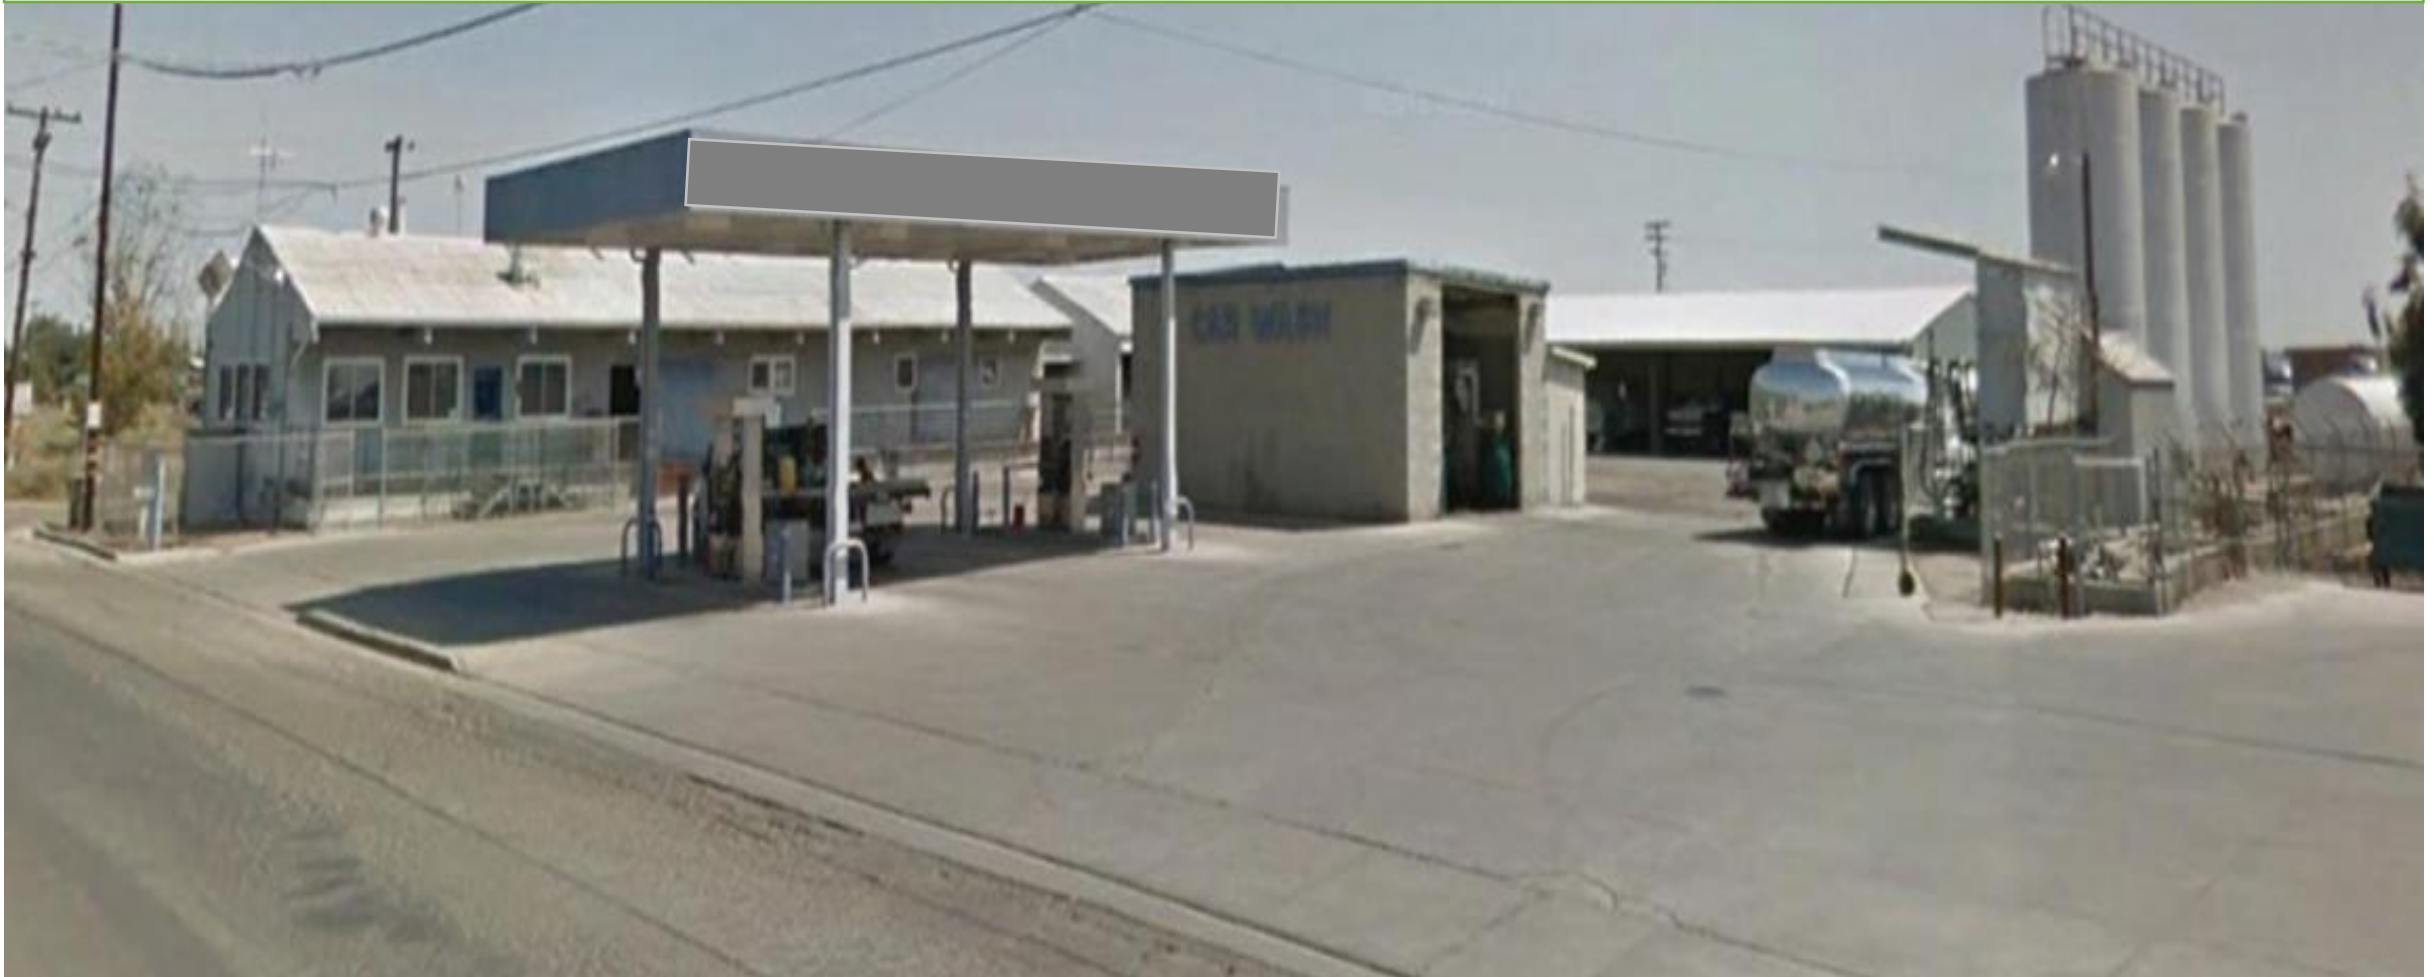
Phytoremediation Pre- and Post-Endophytes

Endophyte Root Drench Tree Rescue using PD1 on **blue rows**

RESULT: Increase in tree health and survival rate

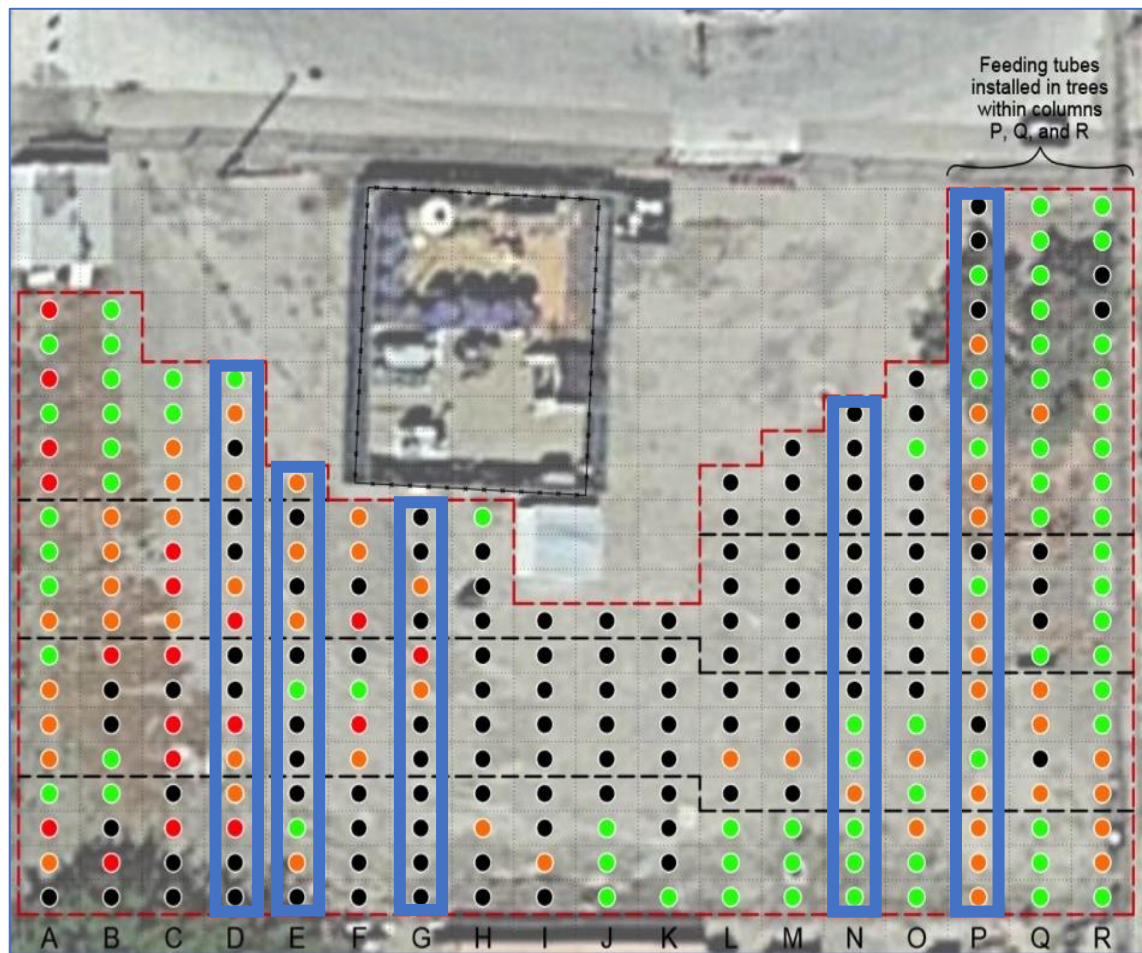
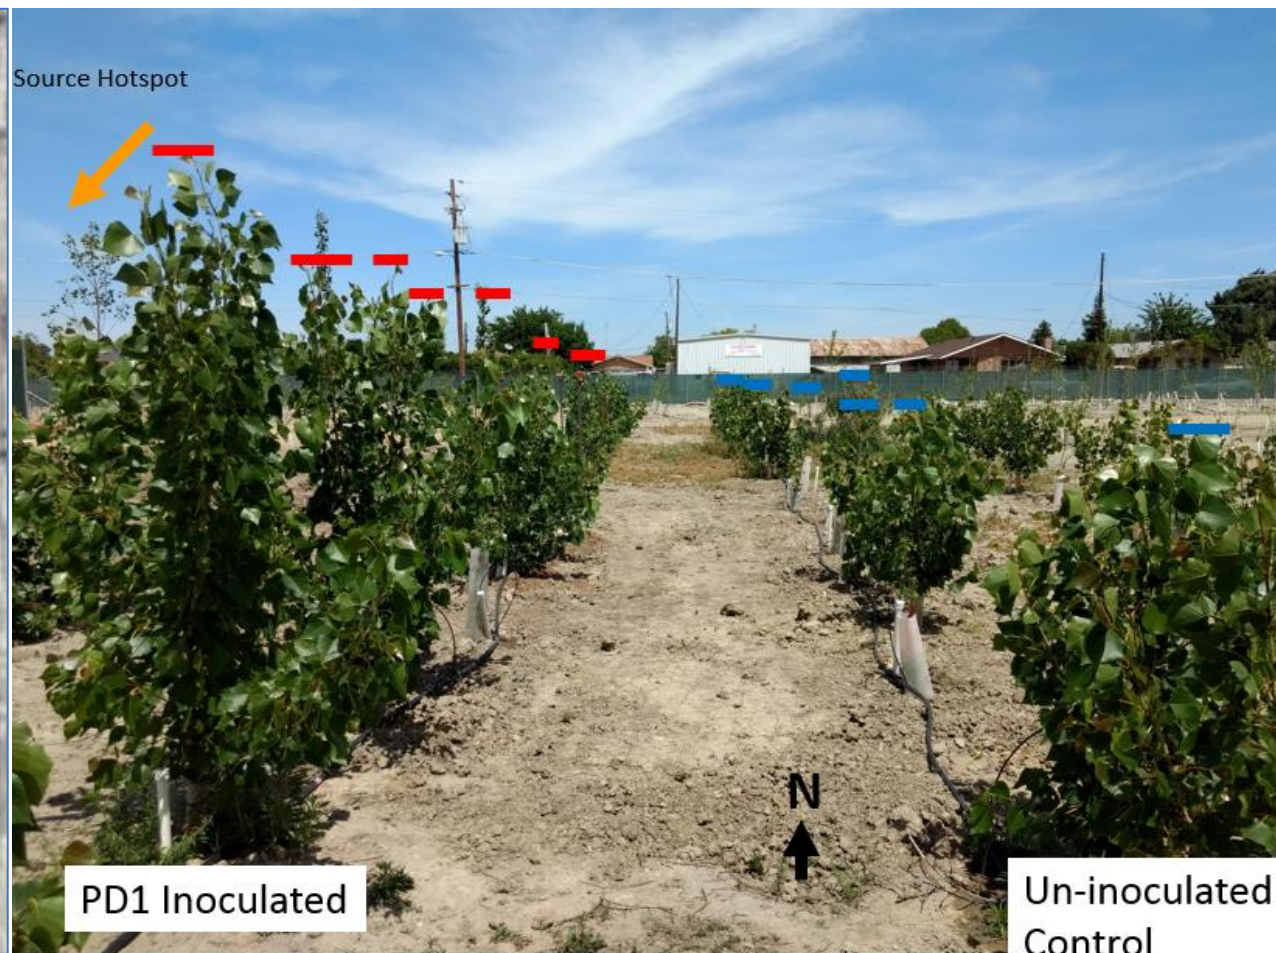
Trees Dead: ●

Trees Dying: ●

Trees Severely Stressed: ●

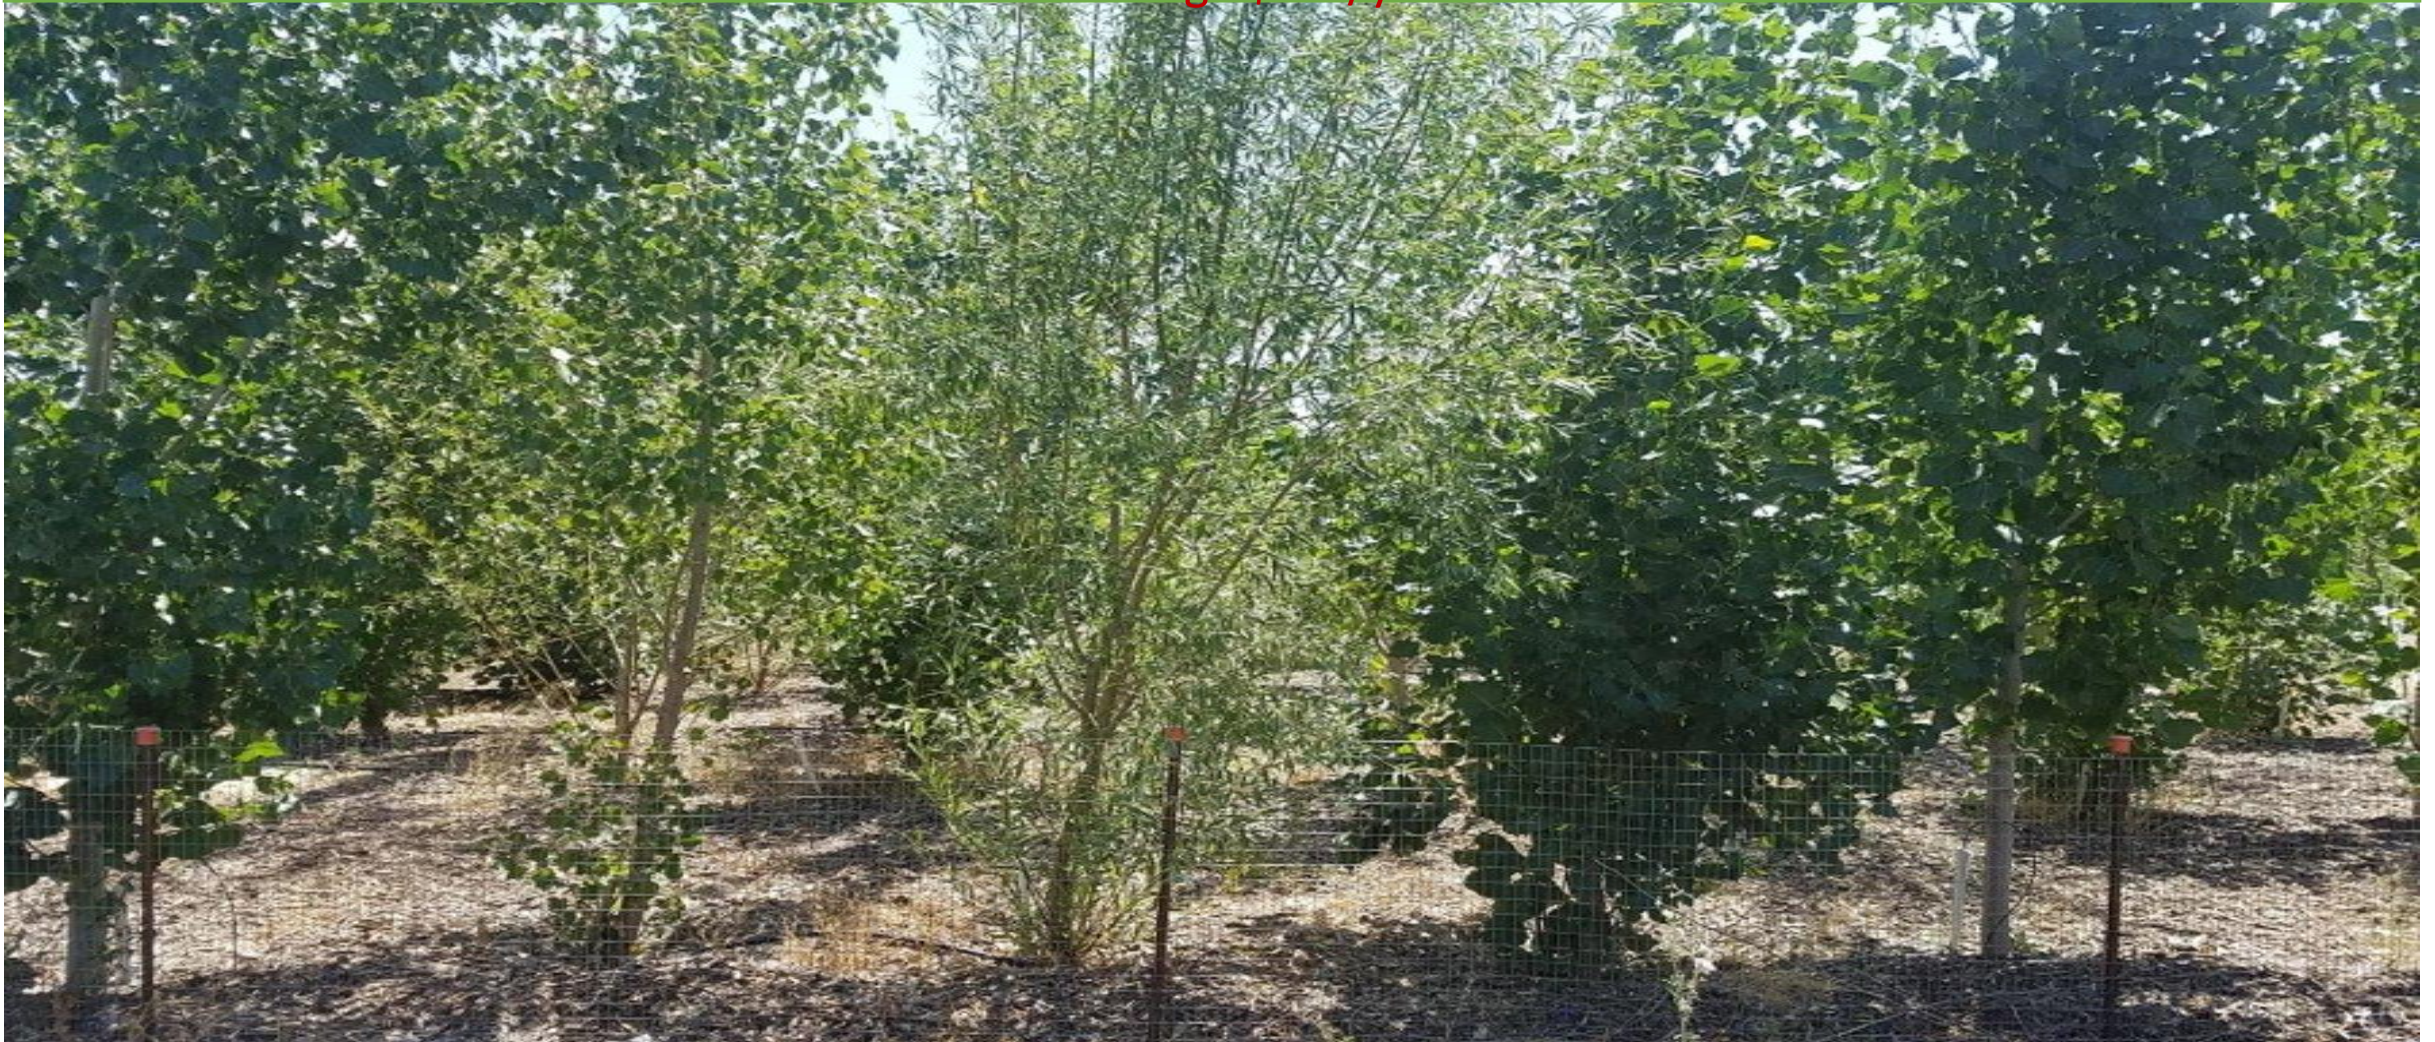
Results of Dos Palos site

State Water Board authorized shut-off of SVE and Pump & Treat System

Positive impact on neighborhood community

Client saving ~\$1M/year

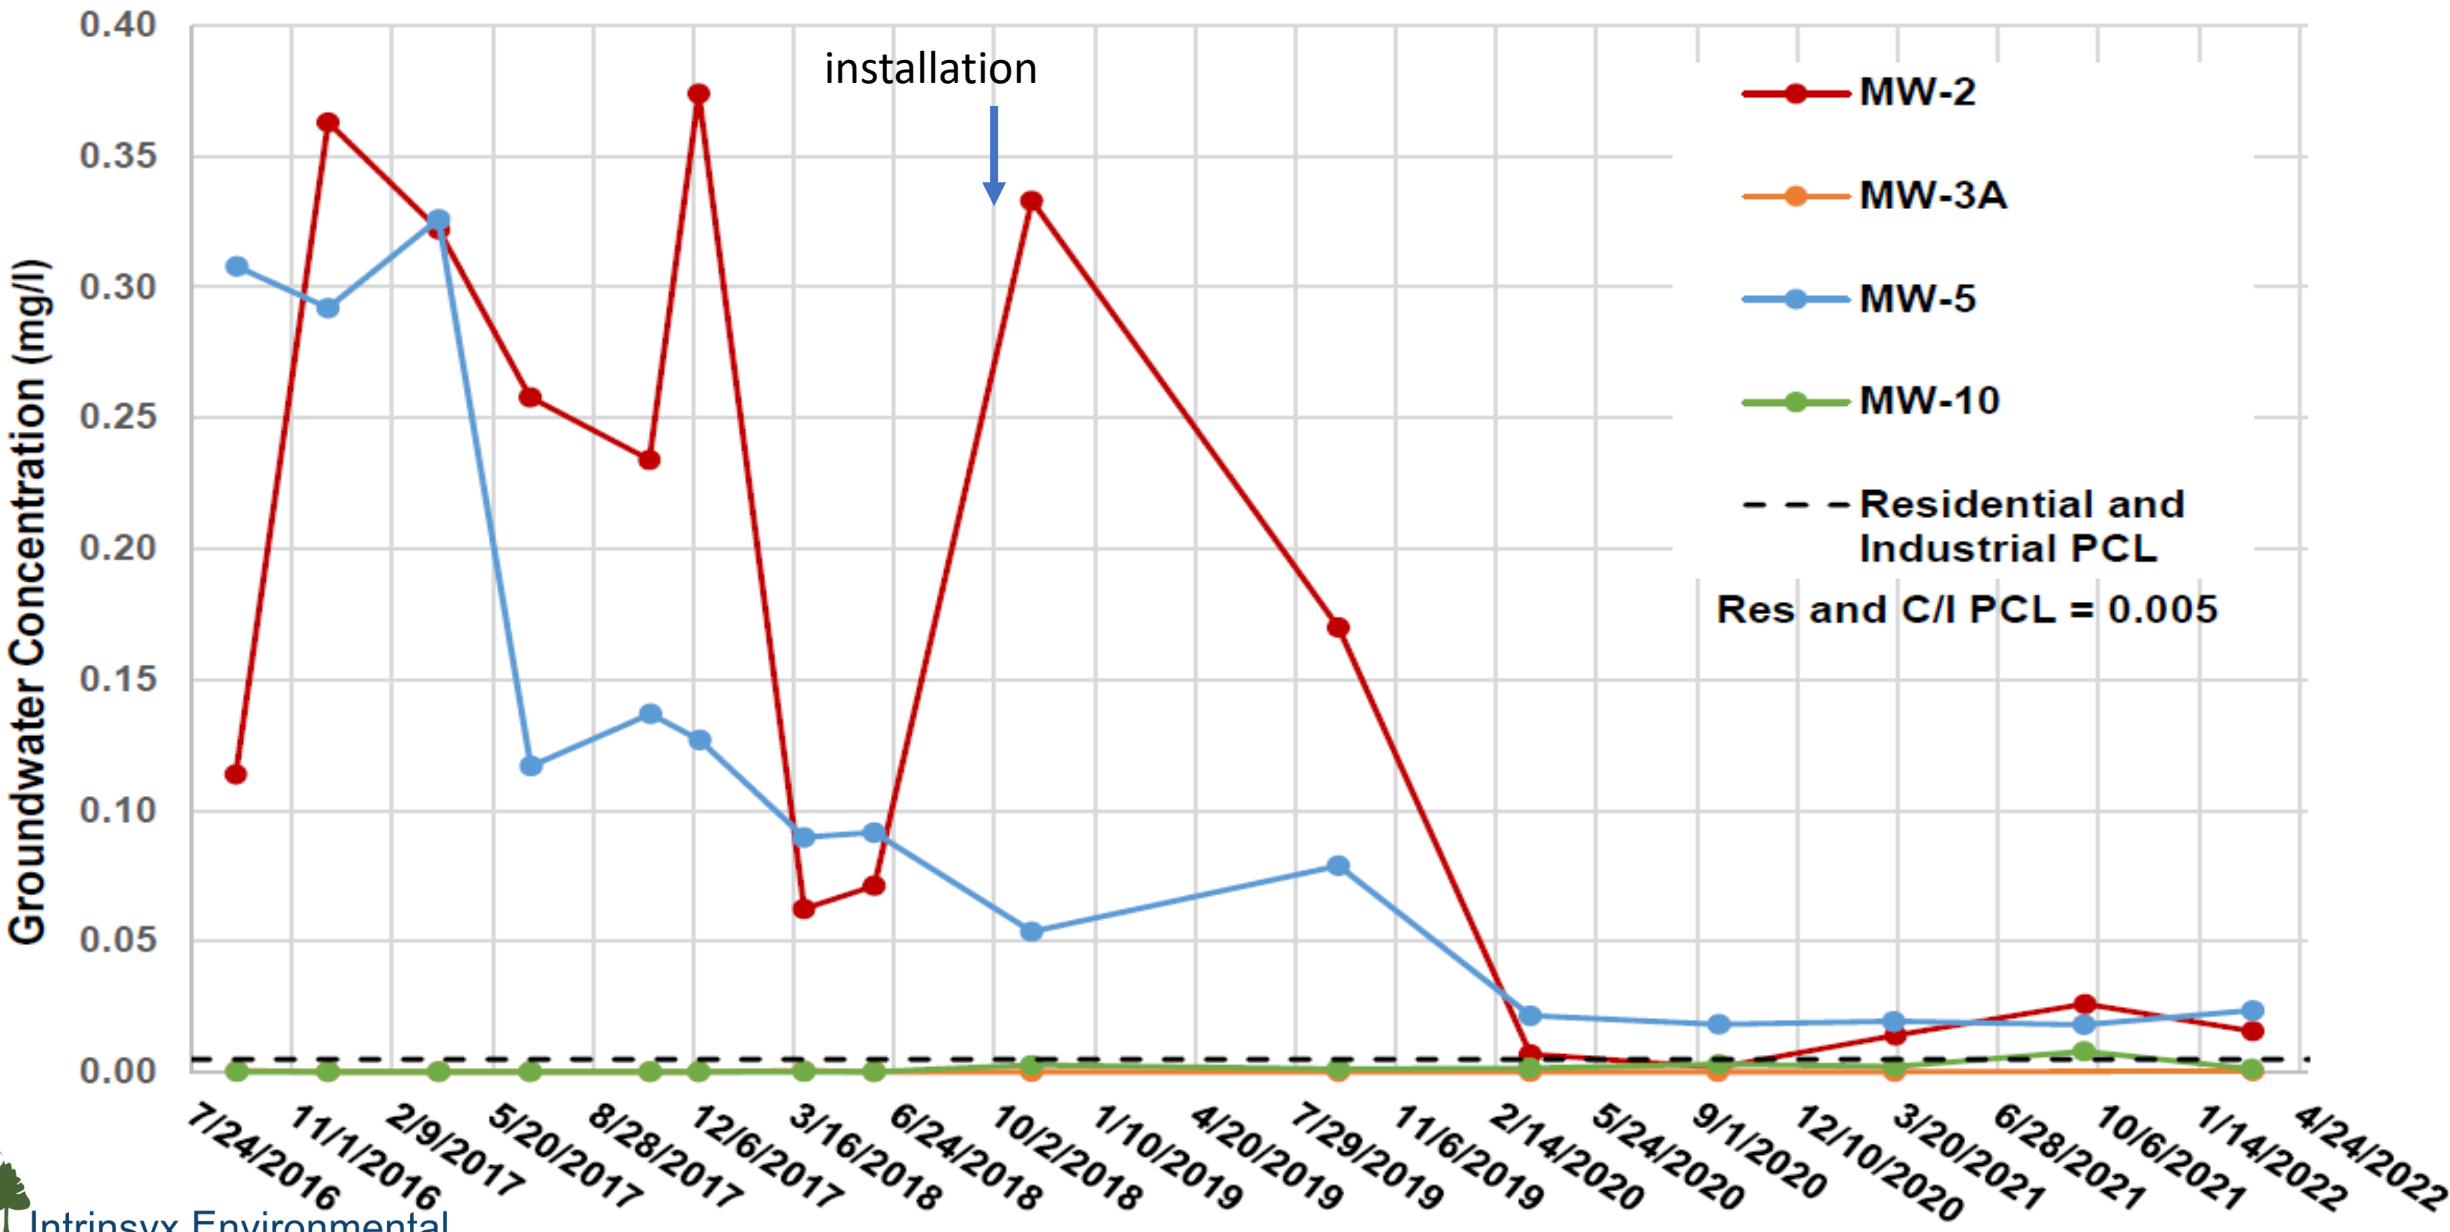
Benzene Concentrations in Groundwater Versus Time

RESULTS: Reductions in benzene and ethylbenzene in ground water within 2 years of planting

Monitor Wells MW-2, MW-3A, MW-5 and MW-10

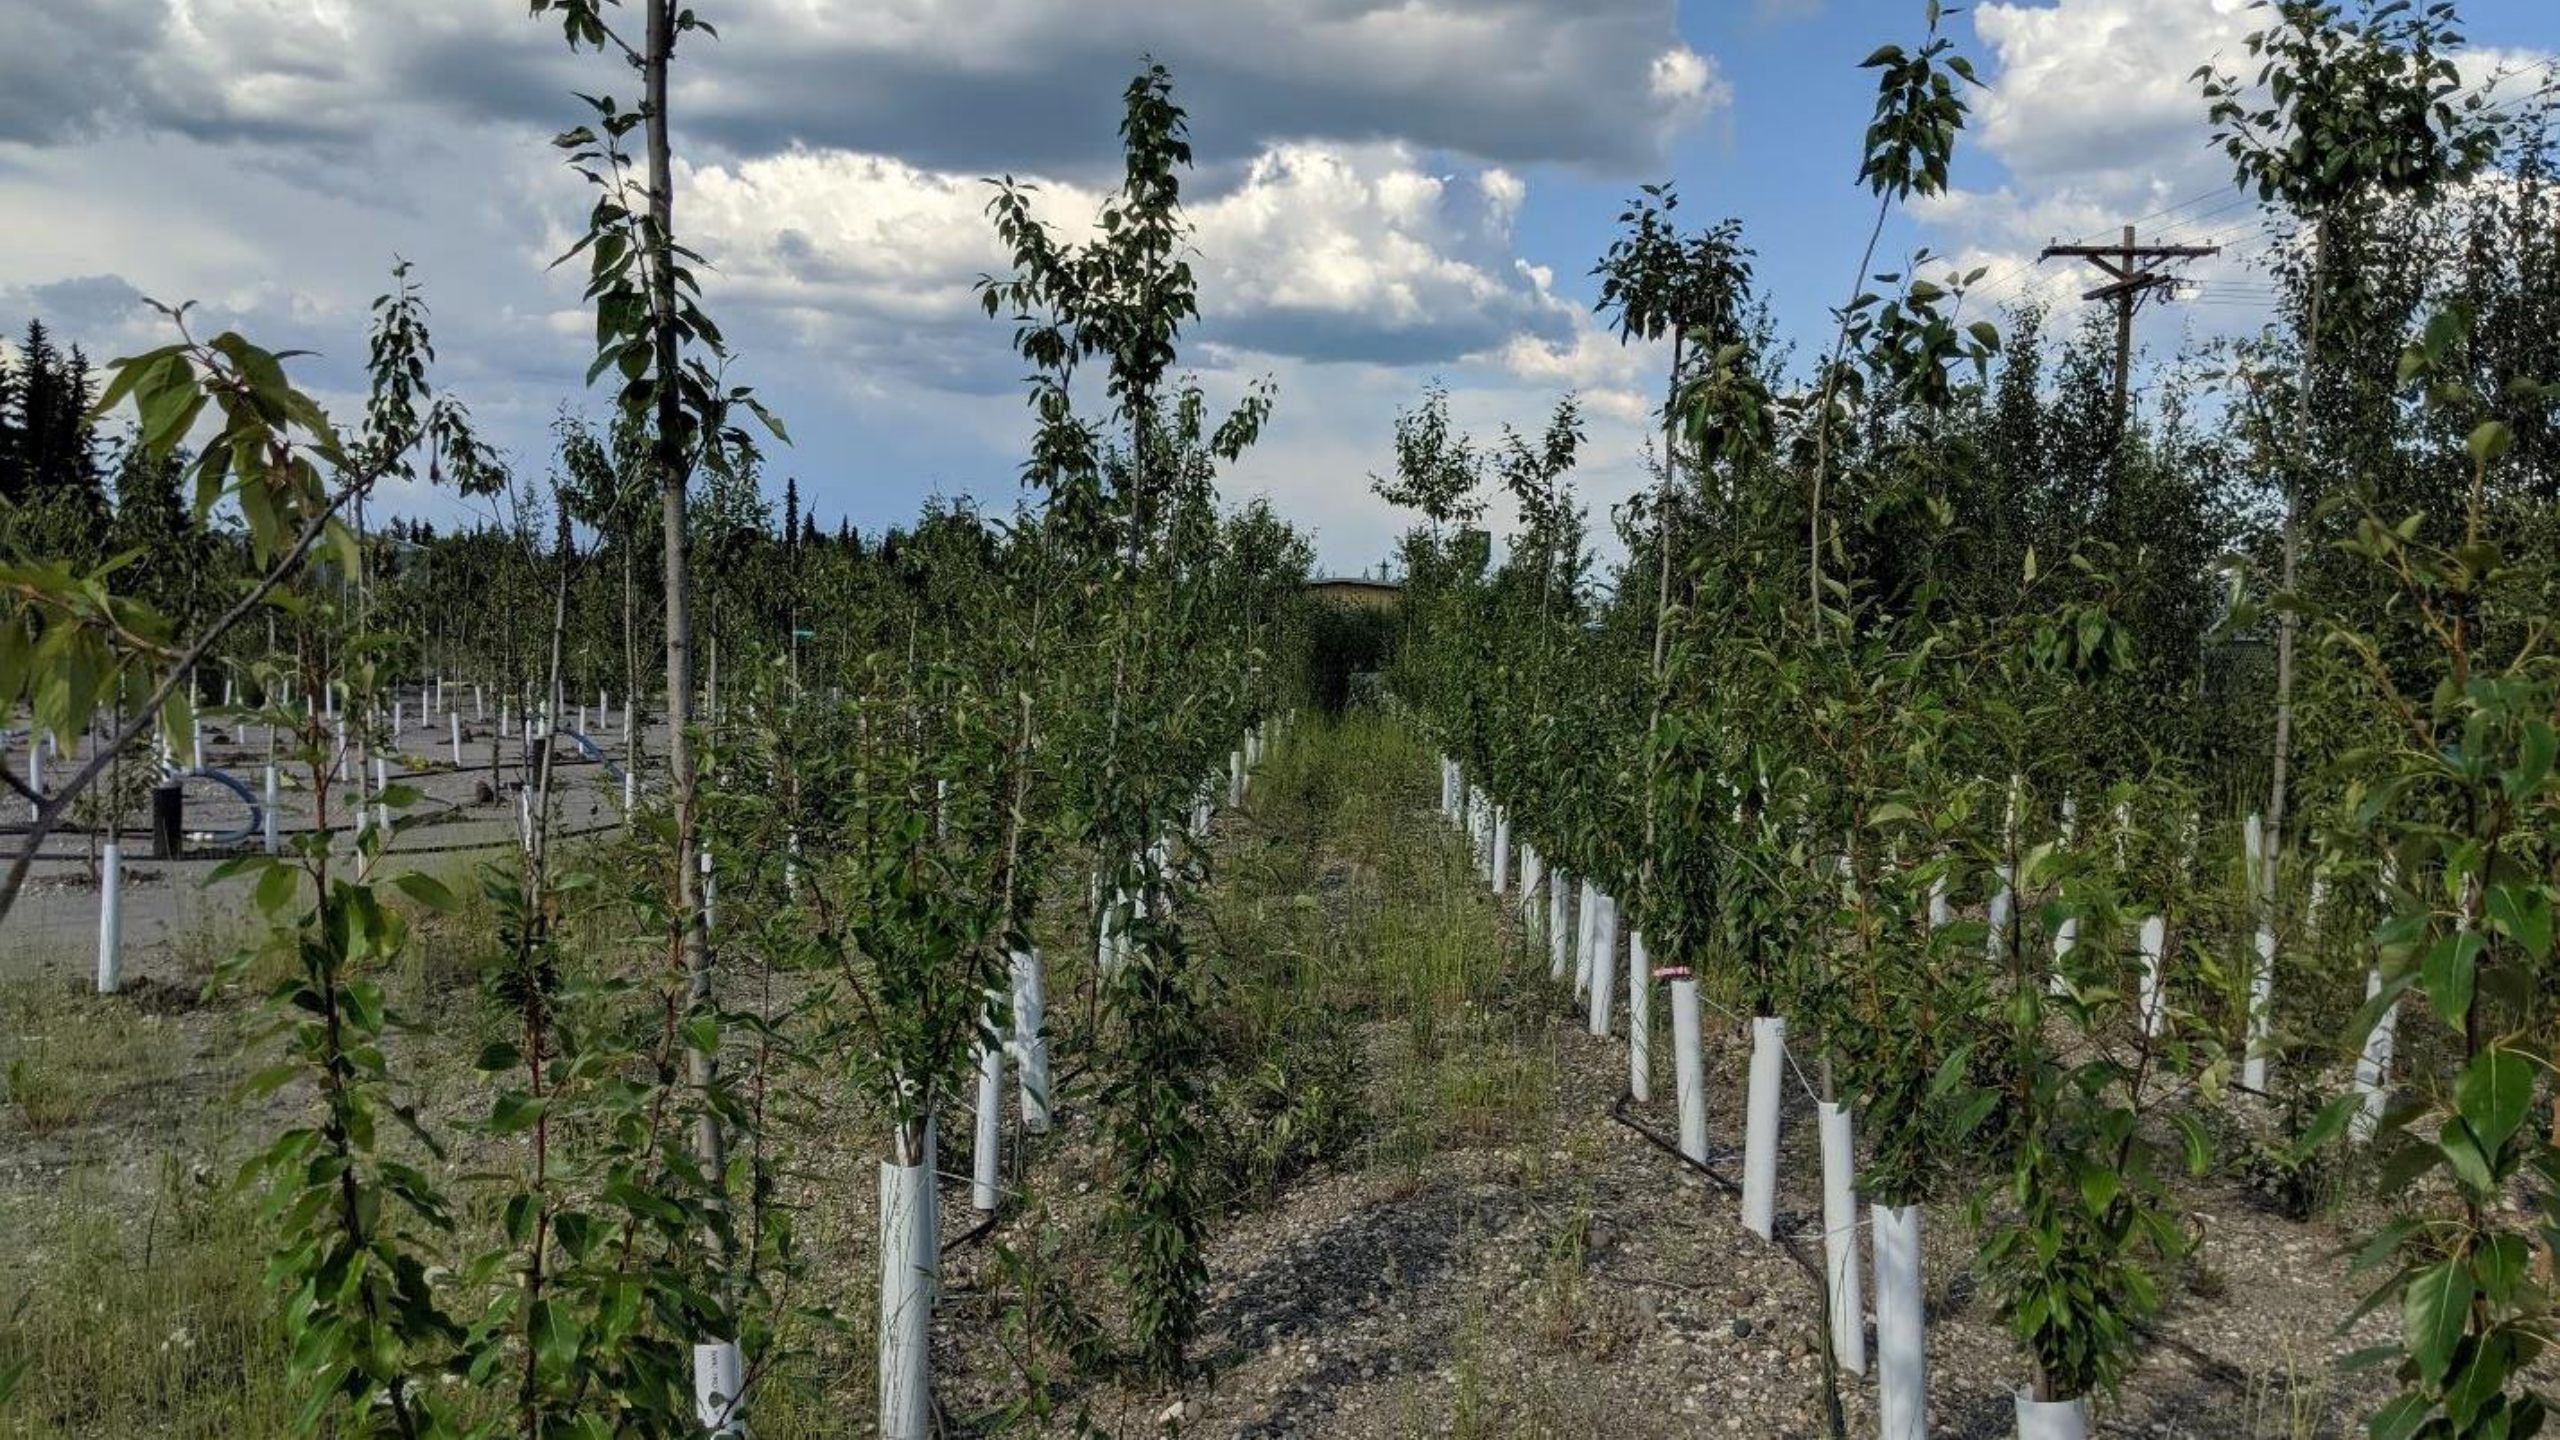
Major Alaska Airport

Diesel fuel, TPH, benzene, EDC (chlorinated solvent) in groundwater and soil

Contaminants are being degraded, trees are surviving well
Regulators approve of current progress of phytoremediation
Phytoremediation system is expanding in 2023

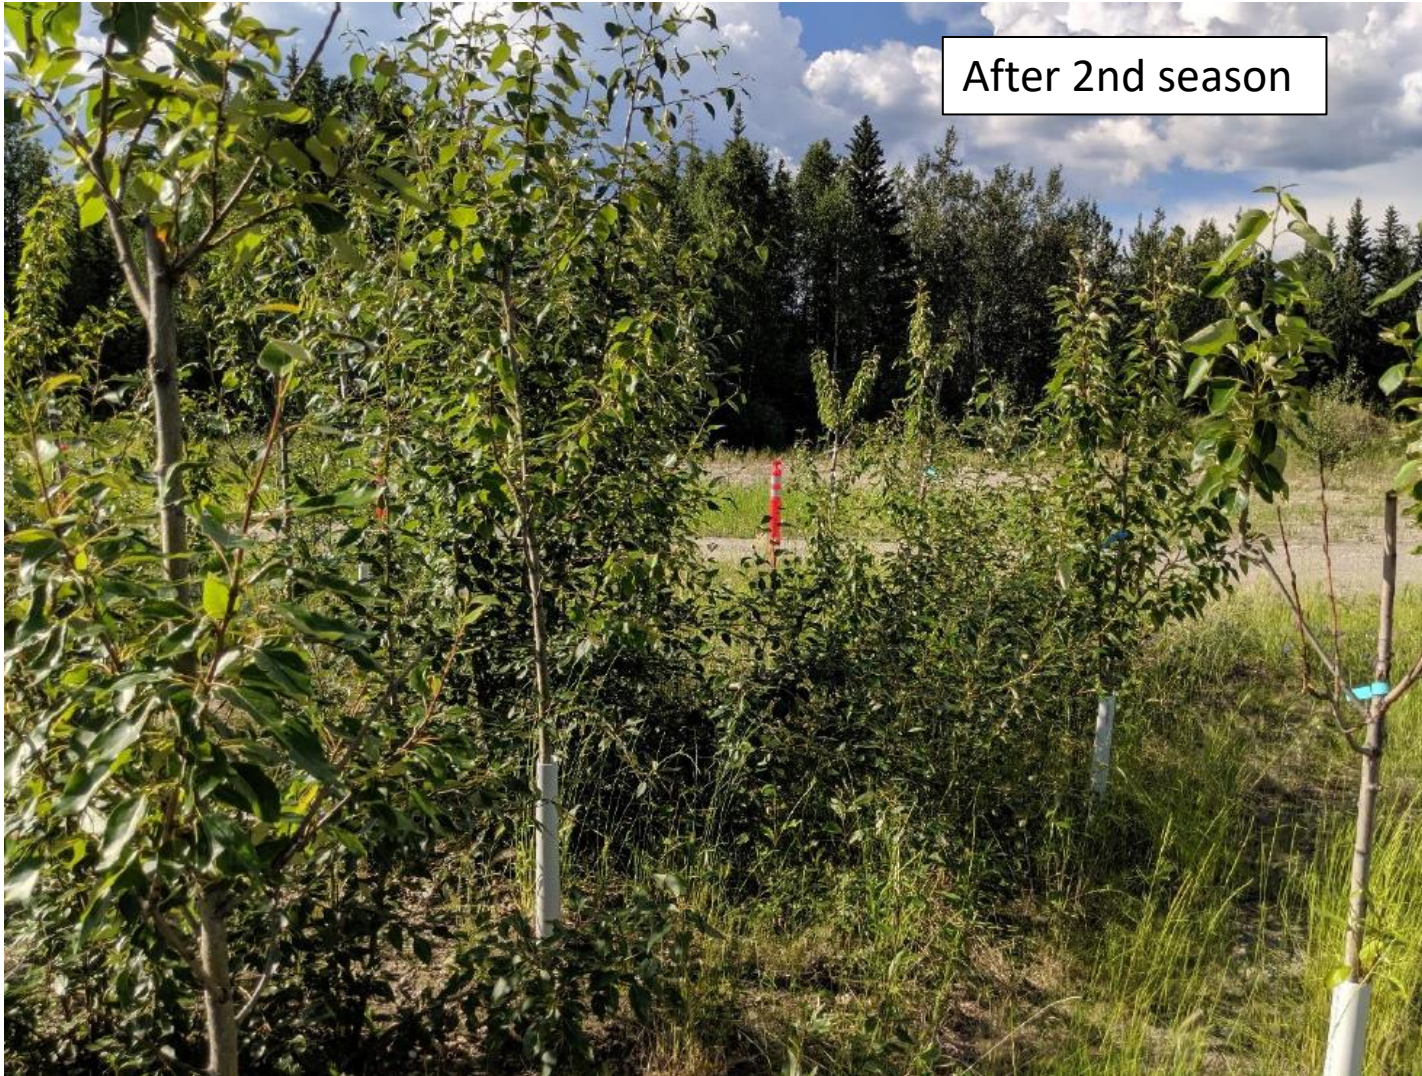
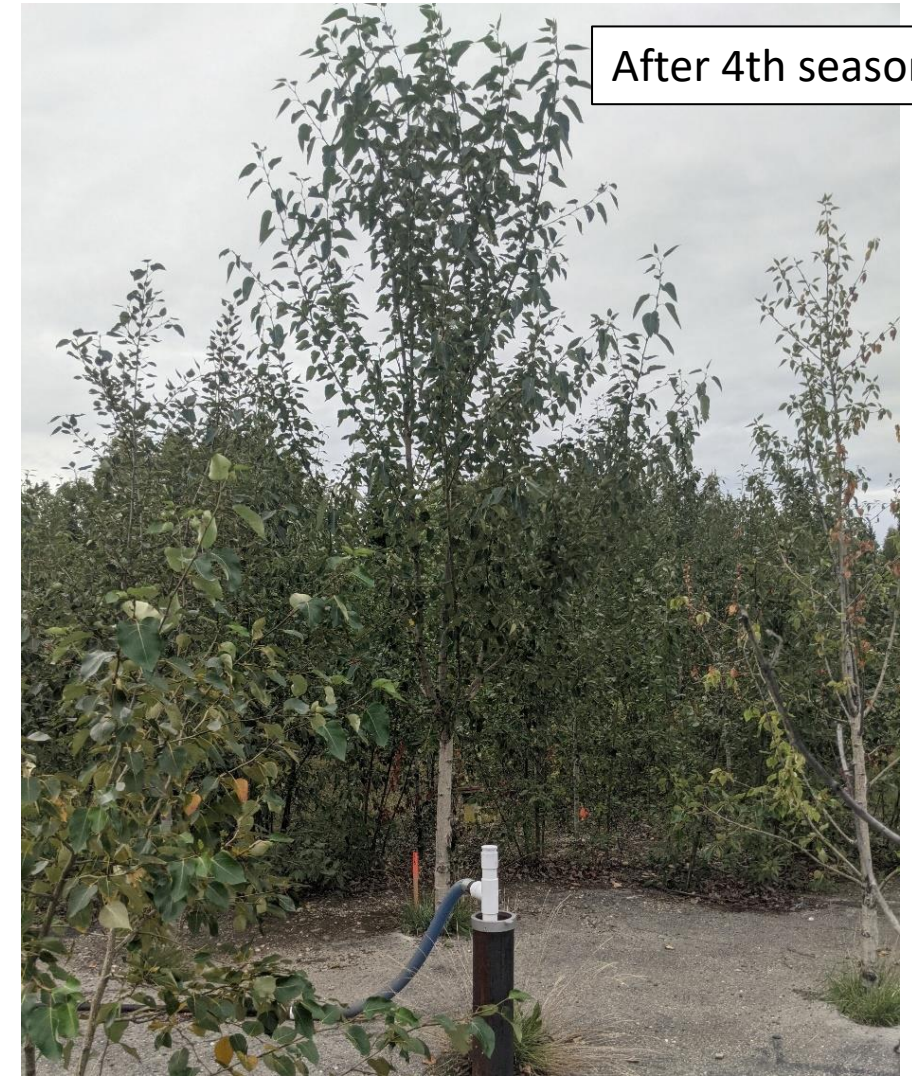
TCE Site Former Manufacturing Facility

Danville, Illinois

- Trees planted in augured holes through asphalt
- current discussion of site closure
- City turning remediated site into park

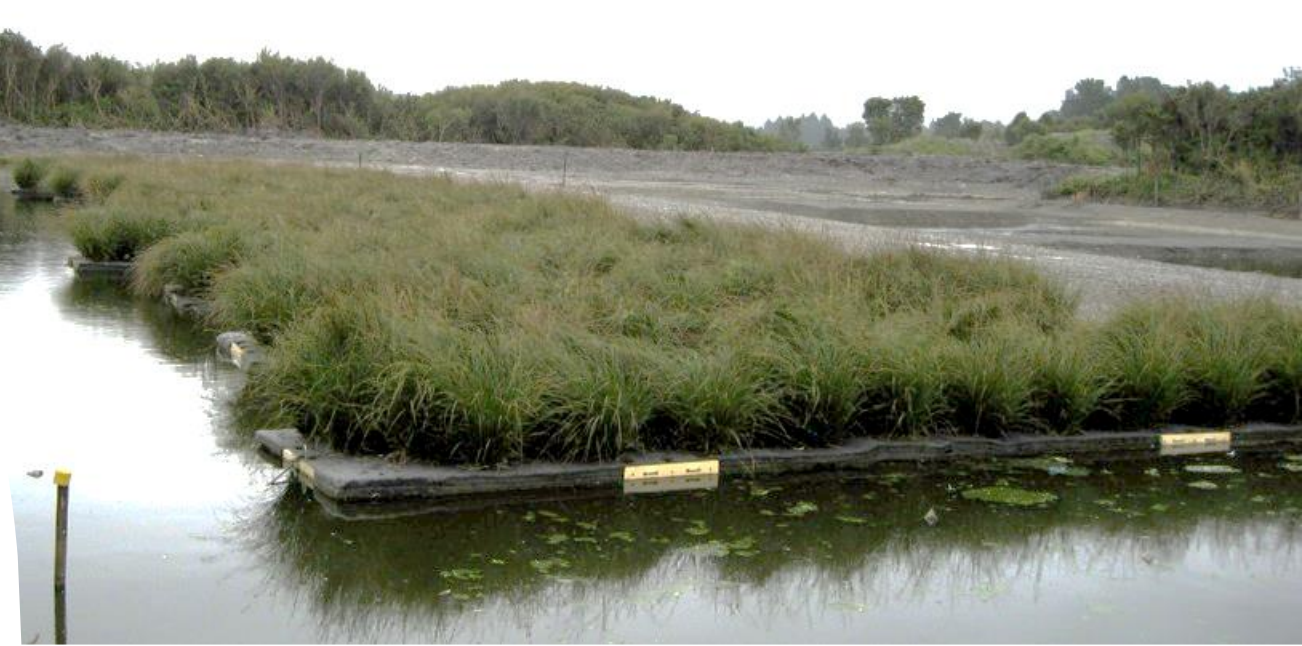
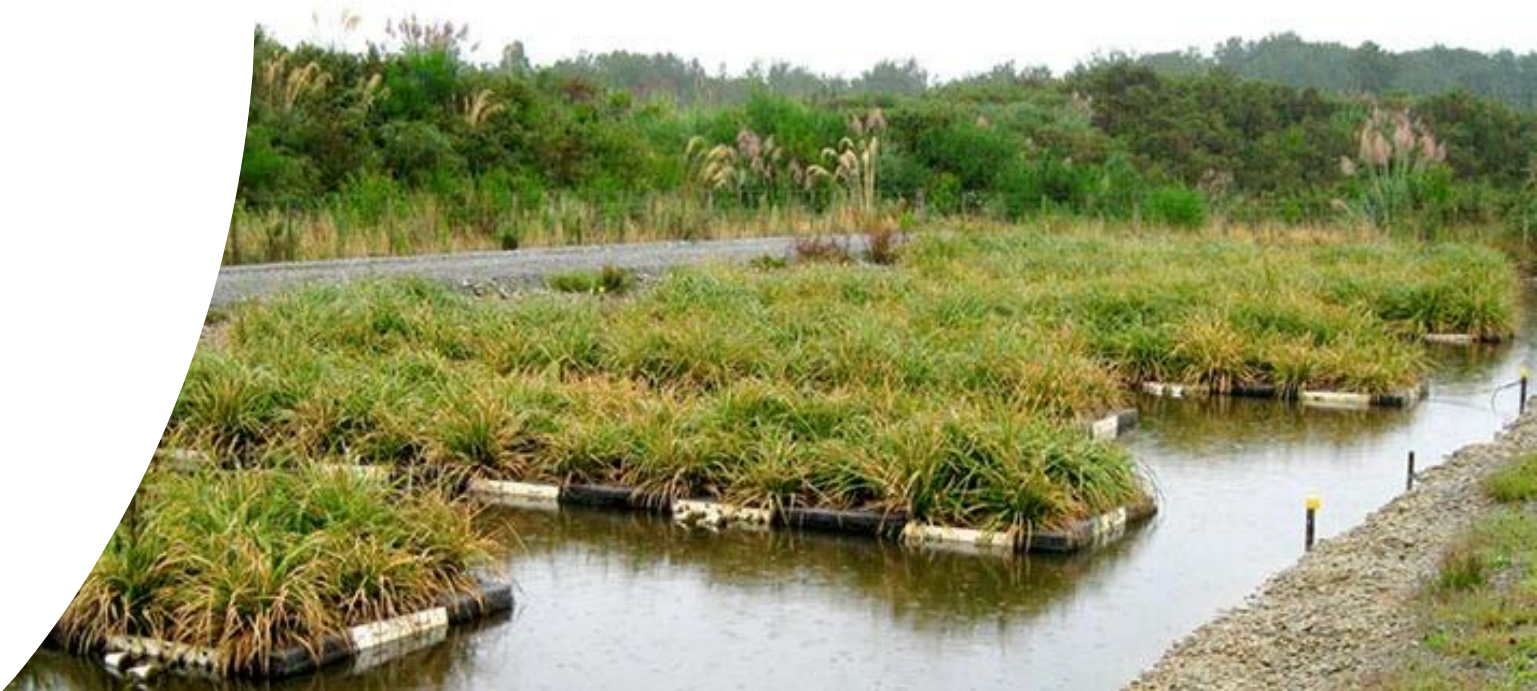
Rhizofiltration

Surface Water and Wastewater

- Root-zone water treatment
- In-situ—lakes, ponds, reservoirs
- Effluent treatment
- Floating wetlands
- Sub-surface-flow wetlands
