Intrinsyx Environmental

Combining nature with engineered solutions for sustainable environmental remediation

Phytoremediation

Enhanced Phytoremediation

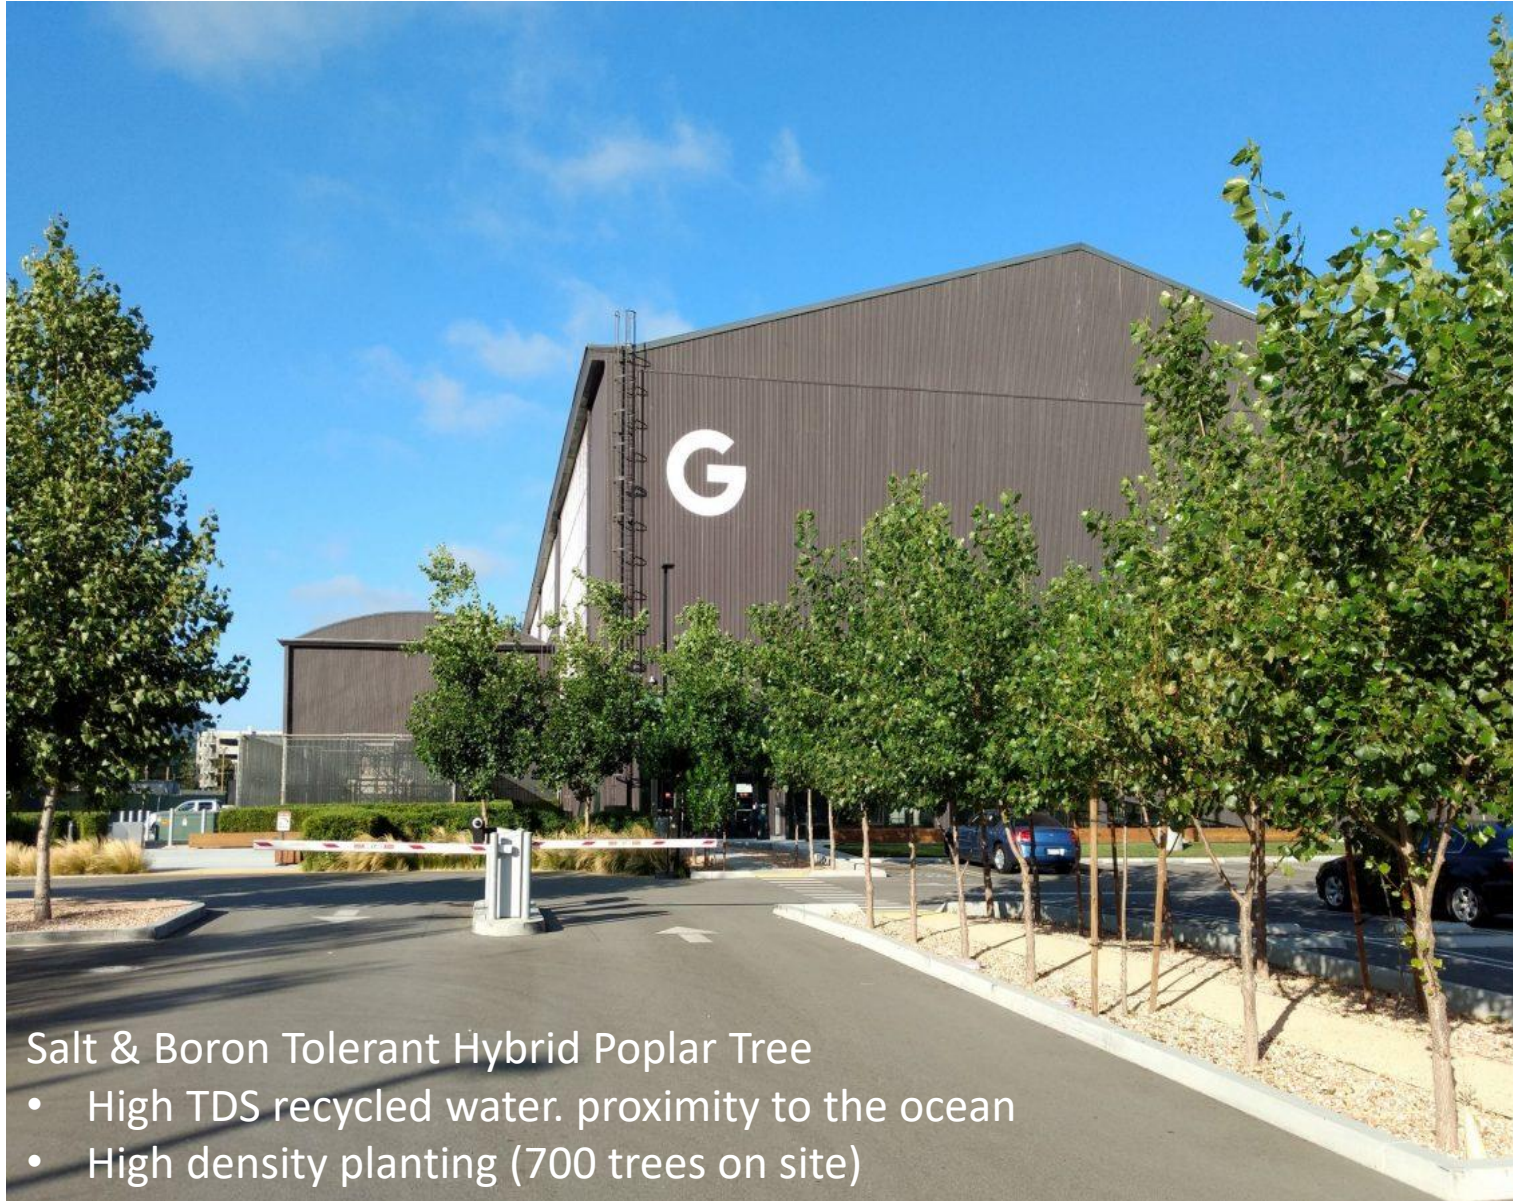
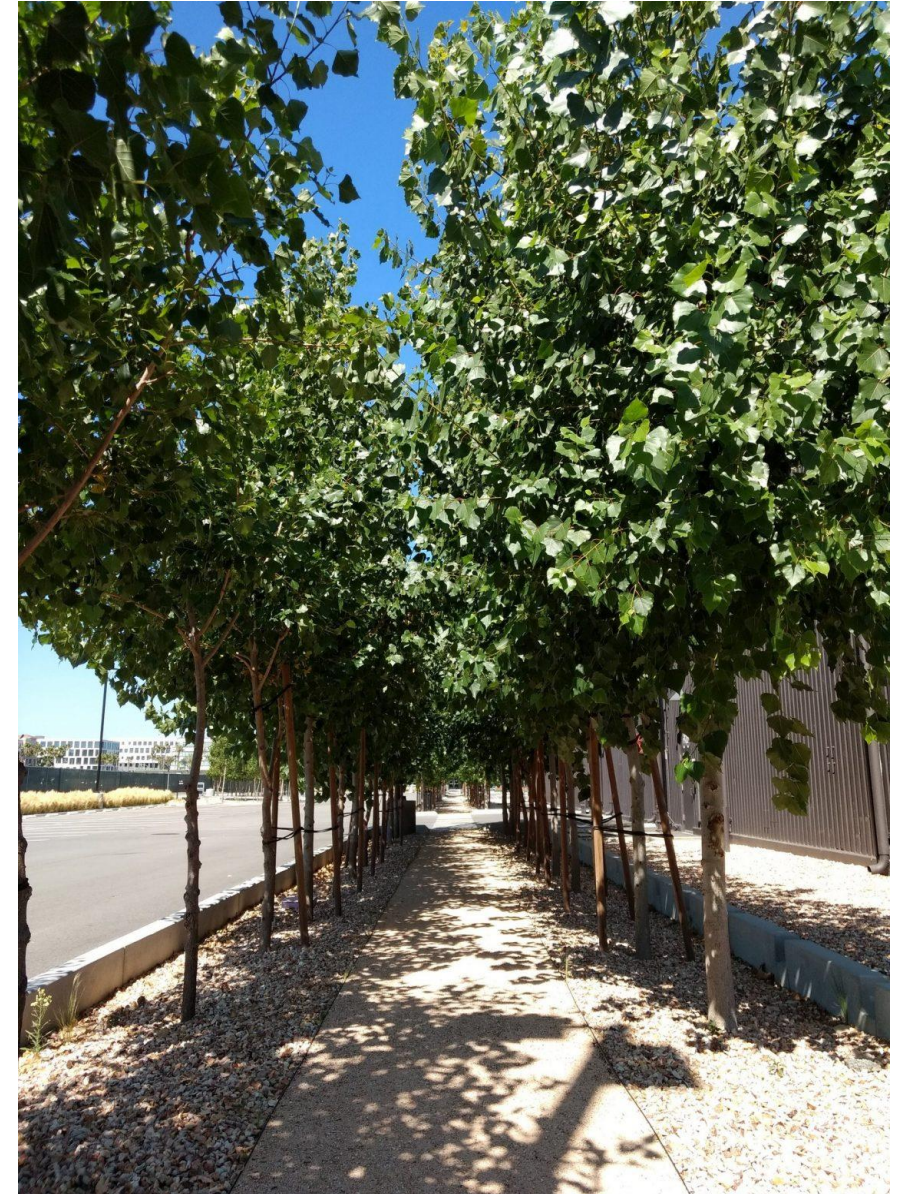
Redevelopment Site

- TCE & 1,4-Dioxane Mixed Waste in the ground water
- Functional Landscaping
- Howard Hughes Facility Legacy Site

Functional Landscaping – Increased value – Reduced Heat Island Effect

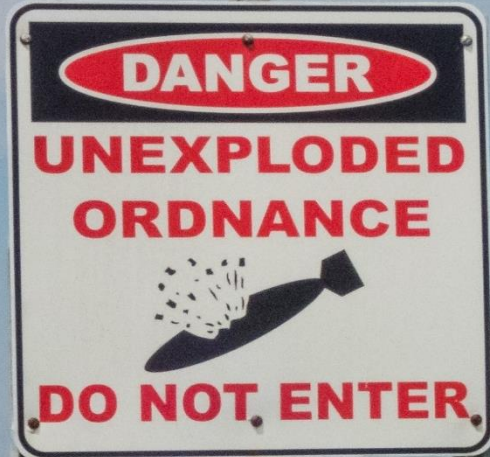
RDX, TNT, Nitrates, and UXO Sites

- Aerial Seeding and endophyte application has been proven in the field
- Tractor-driven application (Seeding +inoculating)
- Plants + endophytes will degrade TNT/RDX and thriving in diverse environments
- Looking for new sites to help refine tools
