Permeable Reactive Barriers in a Residential Setting

Watertown, CT

Retail Petroleum Station

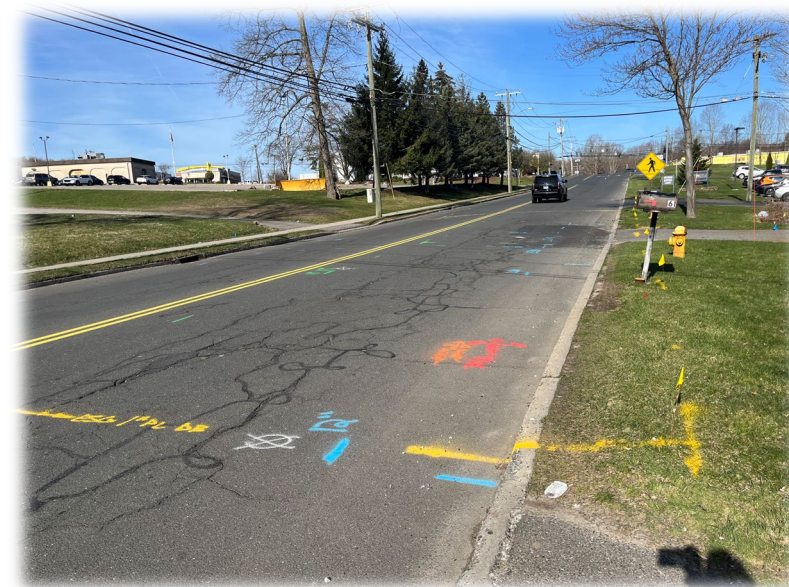
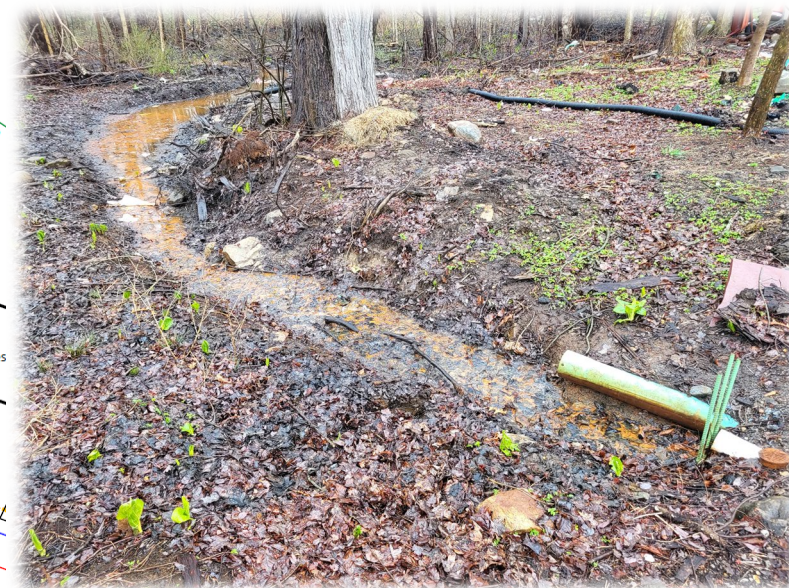
Water Line Repair / Impacts to Residential Properties

- Petroleum contamination discovered during hydrant repair ~300' from Site
- CTDEEP ERU installed 5 monitoring wells in the immediate area
- Elevated AVOCs & PAHs identified in groundwater
- Contaminated groundwater discharging to wetlands via footing drains
- Residents complaining of petroleum odors in backyard
- 9 additional monitoring wells installed across the area

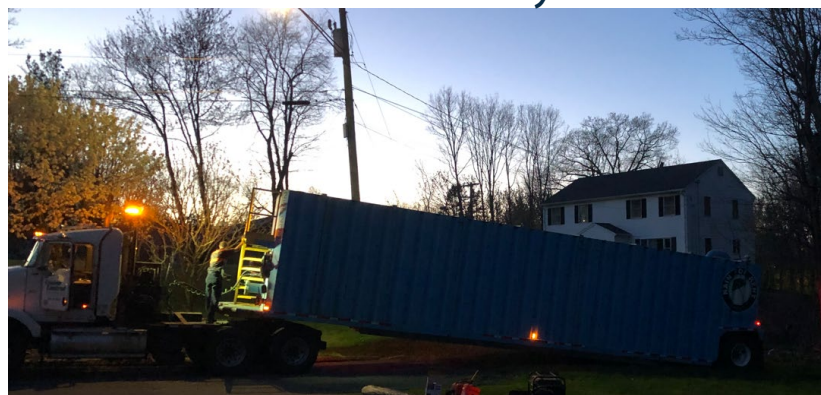
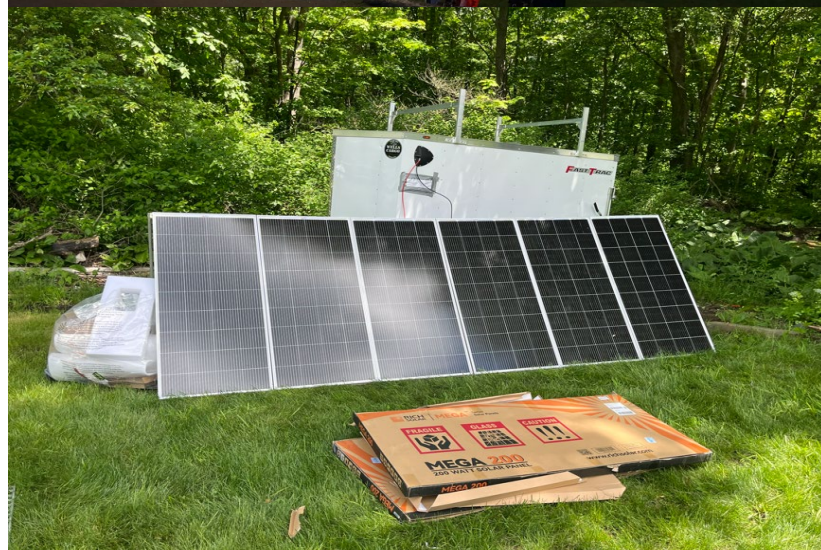
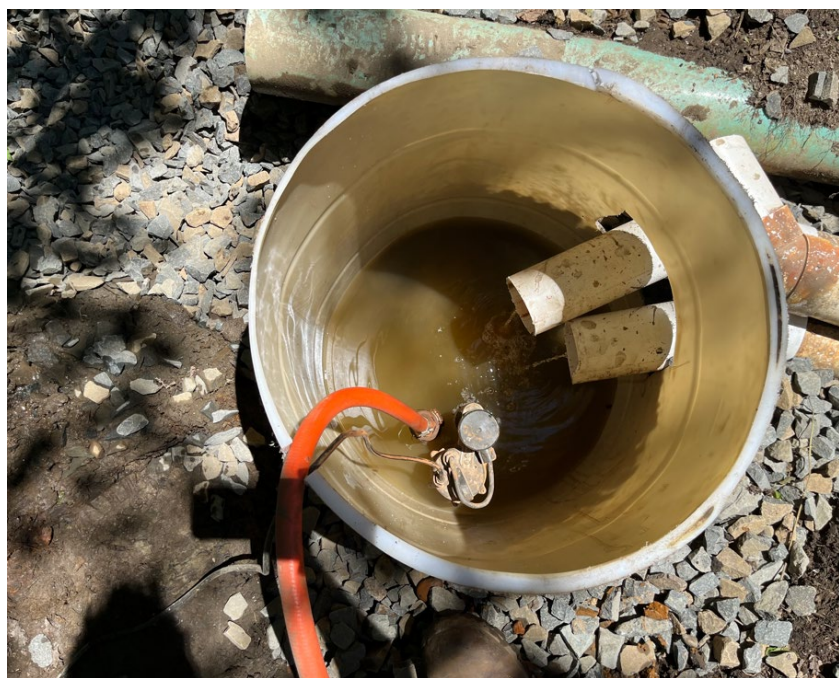
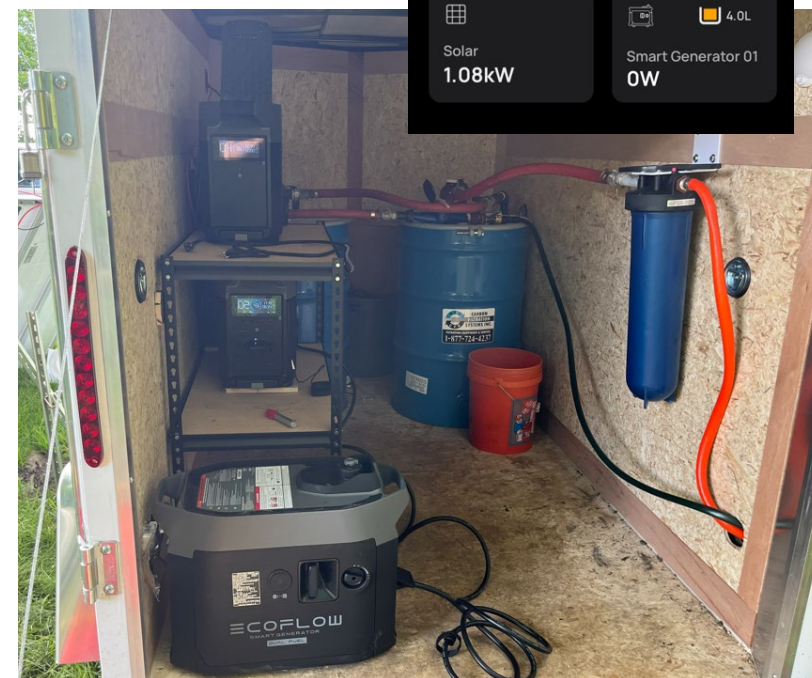
Groundwater Pump & Treat System

- Collection sump installed to collect footing drain discharge
- Water initially containerized in 21,000-gallon frac
- Treatment system implemented - sediment filter / GAC
- Challenges included power source and remote telemetry - Wi-Fi hotspot added for remote monitoring
- Custom-built solar array constructed with battery bank and backup propane generator

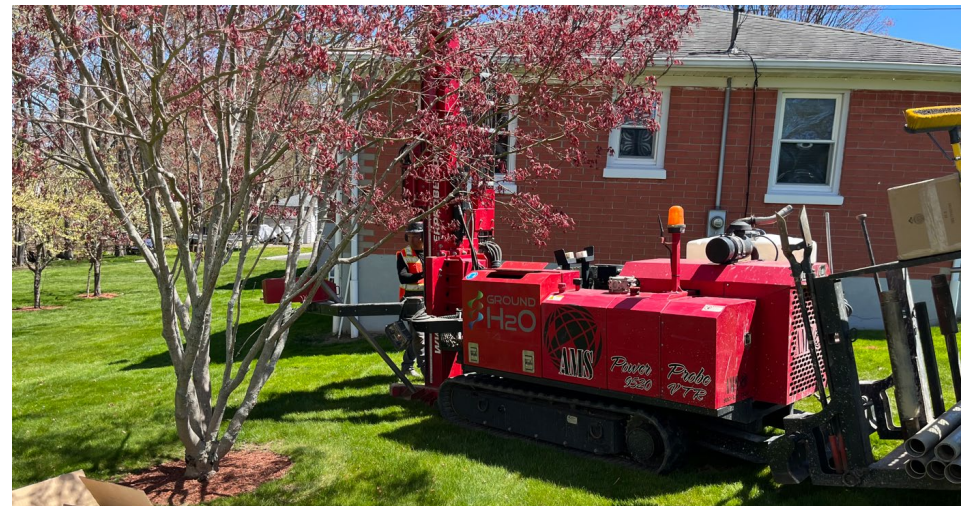
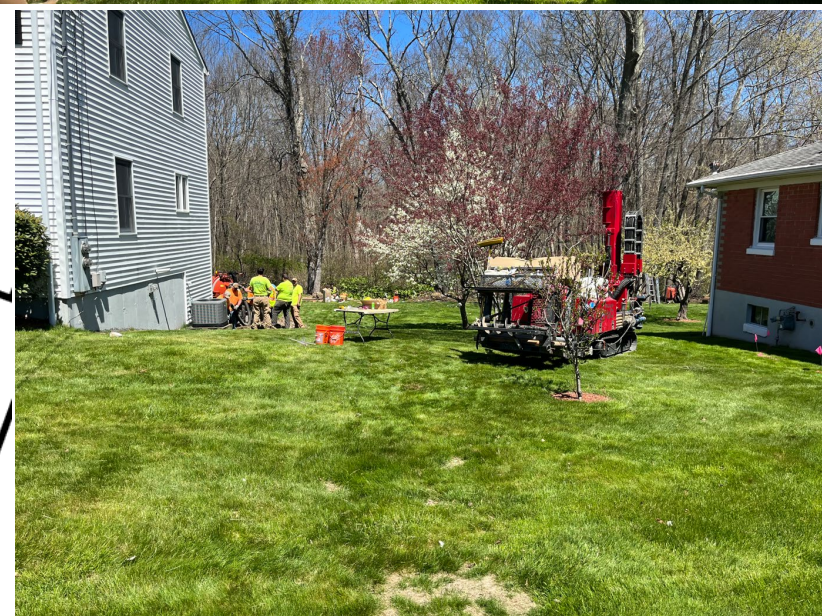
Remedial Design Characterization

- 23 soil borings advanced across the residential properties
- Interior soil vapor characterization in residential basement, as well as indoor/outdoor air quality sampling
- Area-wide groundwater characterization
- Geological evaluation of soil strata

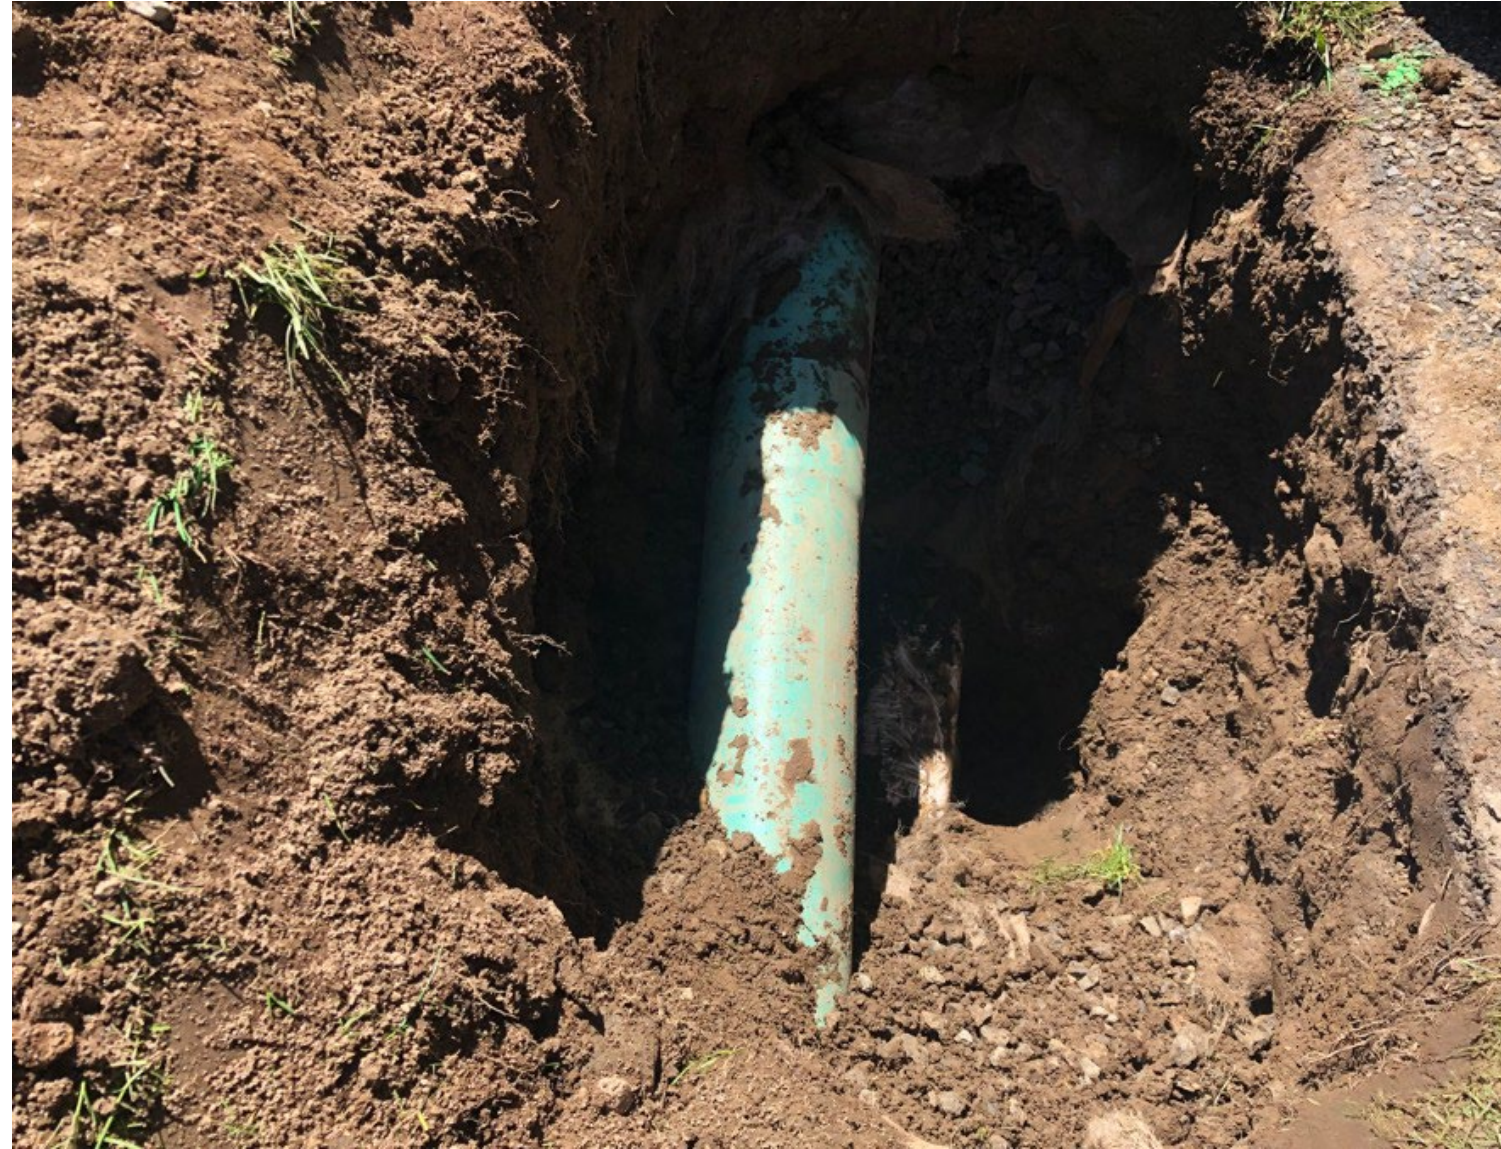
Geology

- Soil in the area classified as till
- Sand with 30-40% silt 0-10'
- Becoming extremely dense >10'
- Utility corridors bedded with crushed stone
- Bedrock >30'
- Roadway built up with imported fill in 1980s
