Restoration of

Sierra Sue II

AIRCORPS AVIATION

Sierra Sue II is one of the most exciting examples of a P-51 Mustang surviving to date, join us in this picture tour as we explain some of our favorite detail put into the restoration of this North American P-51D-20 WWII Fighter.

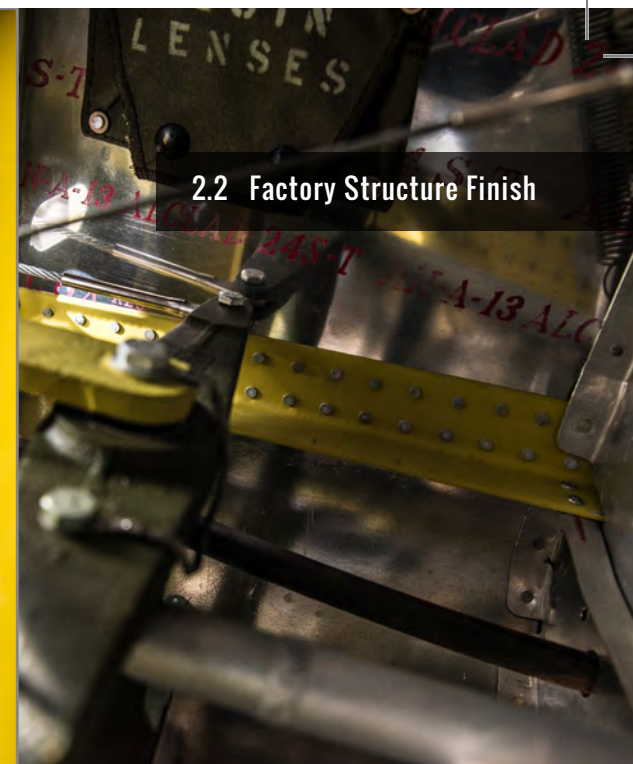
Aft Compartment

2.2 Factory Structure Finish

All structure was either left bare or painted in the correct color zinc chromate as identified when the aircraft was disassembled.

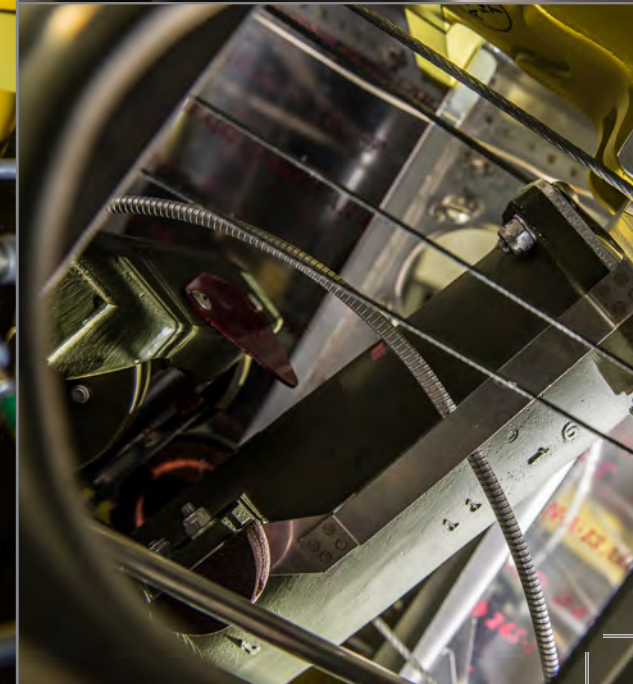
5.5 Functioning Oxygen System

Tested, inspected and functioning Low Pressure Oxygen System.

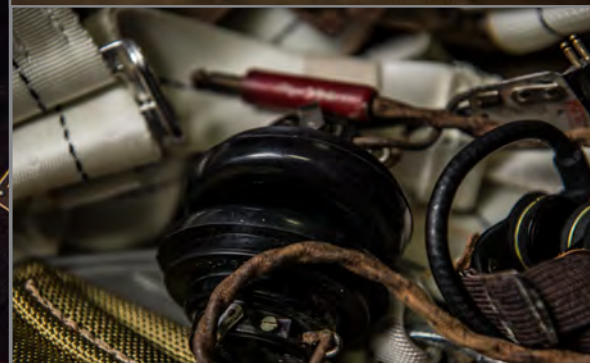
4.2 Cockpit Furnishings

Original accessories including - flare pouch, drop message bag, original WWII flight envelope, mooring case, check off lists and flare gun & pouch.

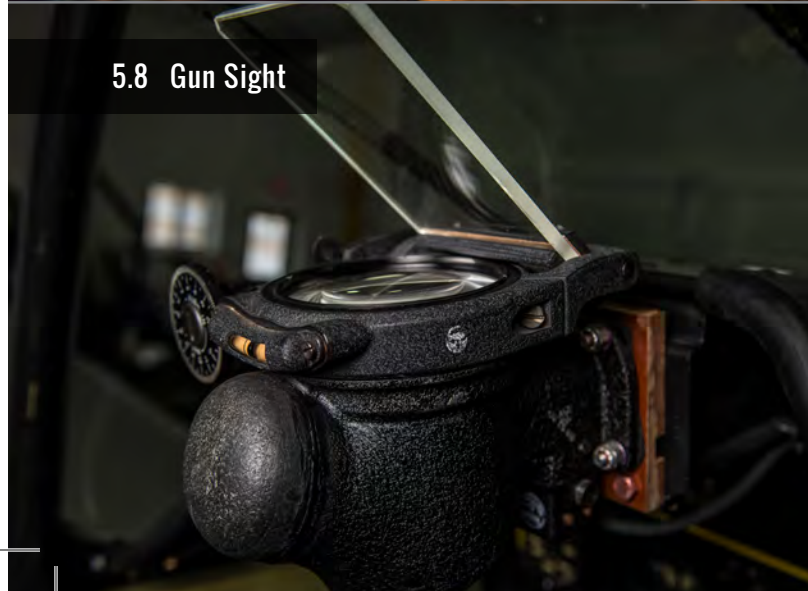
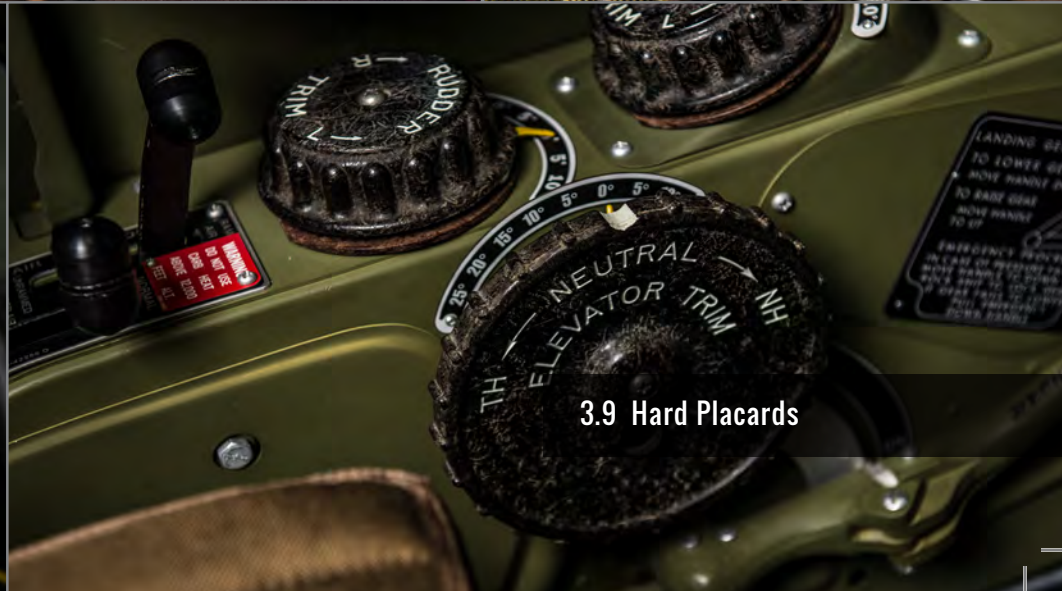
5.8 Gun Sight

Stock N-9 sight as it would have left the factory.

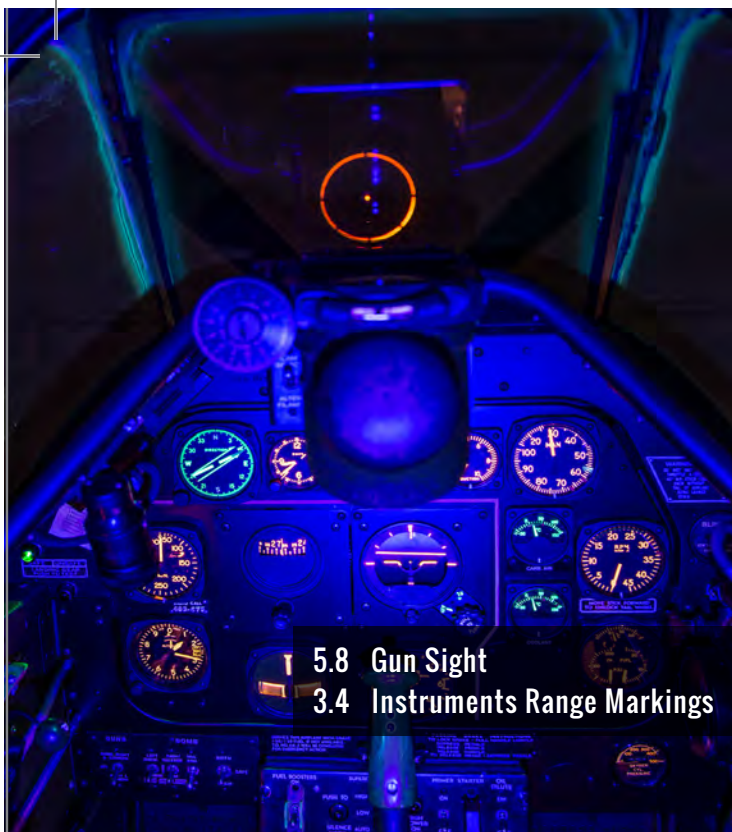
3.9 Hard Placards

Correct Type fonts developed from original parts and printed on phenolic, acid etched and filled and sometimes a combination of all.

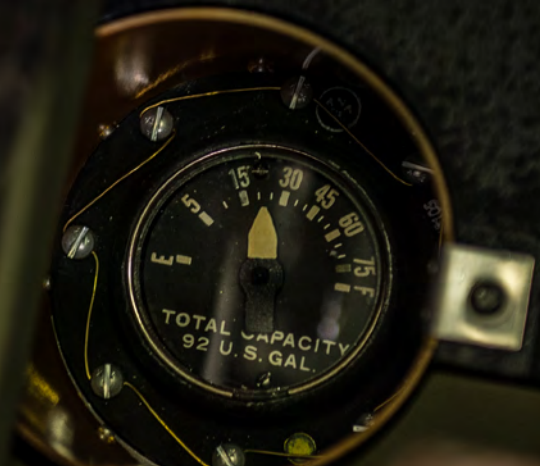
Cockpit Continued

4.2 Cockpit Furnishings

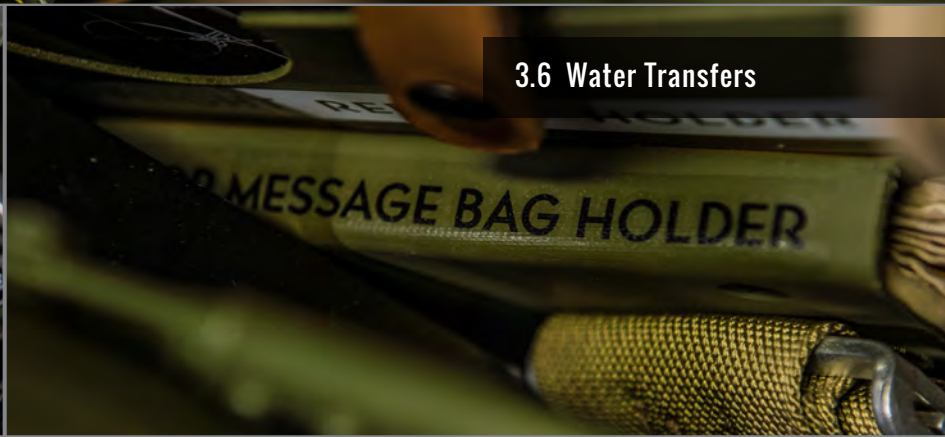
3.6 Water Transfers

Production of actual Water transfers, not stickers, complete set throughout aircraft - consisting of hundreds of different markings.

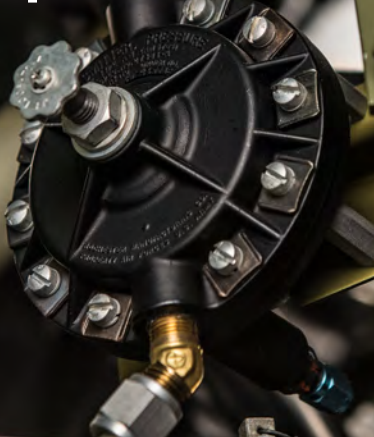
Engine Compartment

1.8 Induction system

All induction components original as per drawings no components removed for ease of servicing. All assemblies spot welded per the drawings.

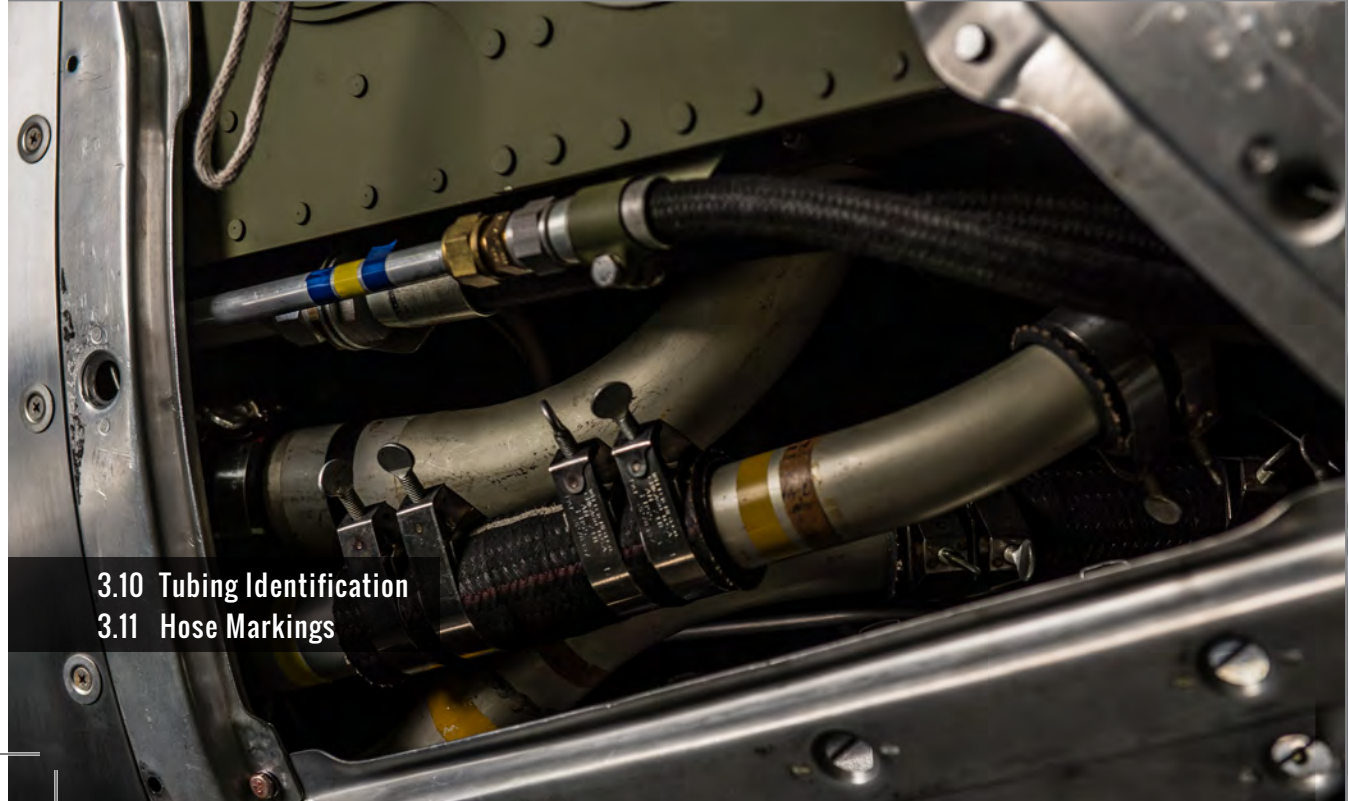
3.10 Tubing Identification
3.11 Hose Markings

Markings on fluid systems tubing.

Markings on hoses identifying the hose type and material.

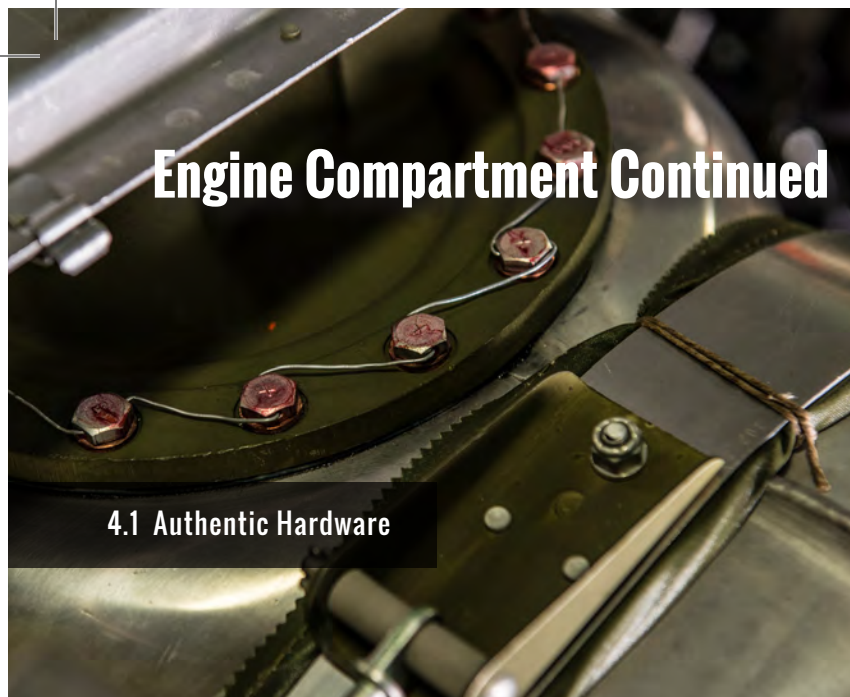
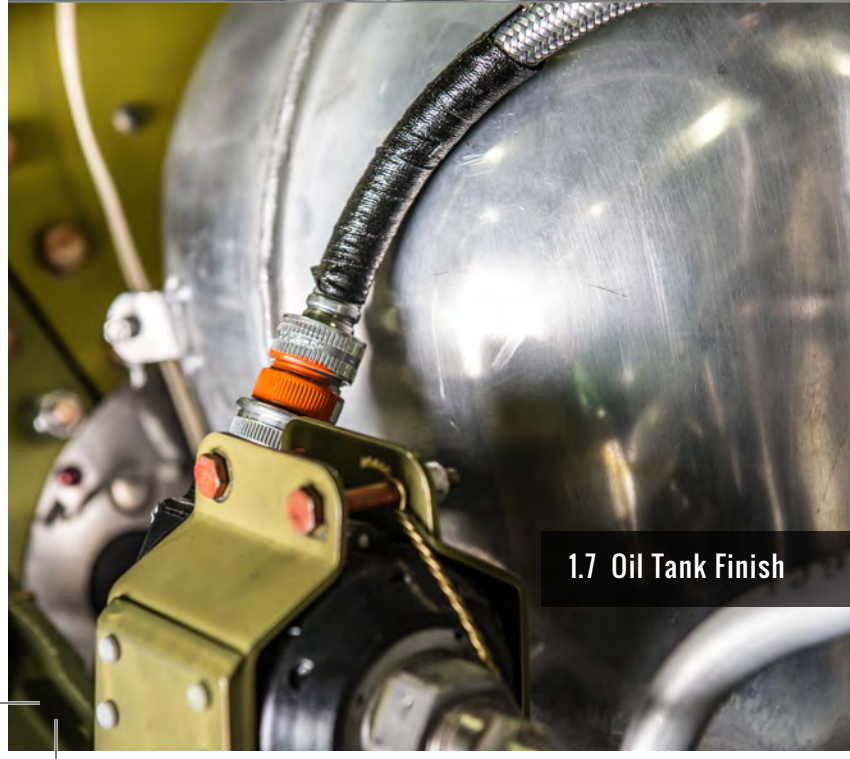
Engine Compartment Continued

4.1 Authentic Hardware

1.5 QEC Markings

1.7 Oil Tank Finish

Quick Engine change marks painted in Orange on all engine removal points.

Oil tank bare metal as per original drawings.

Complete set of period authentic correct CAD 1 hardware. Each piece of hardware called out is accurate to what the drawings call for, we used ESNA brand red inserts for the nylon nut plates and nuts, the bolts are 1940s vintage with the Rockford Screw, and period correct head markings. From Spline Nuts, Electrical Terminals, and dzus fasteners through the hi-shears, electrical clips, switches, and breakers the aircraft is restored with the originality down to each piece of hardware as if it had just left the factory. Hardware dyed to stay consistent with colors found throughout the dis-assembly.

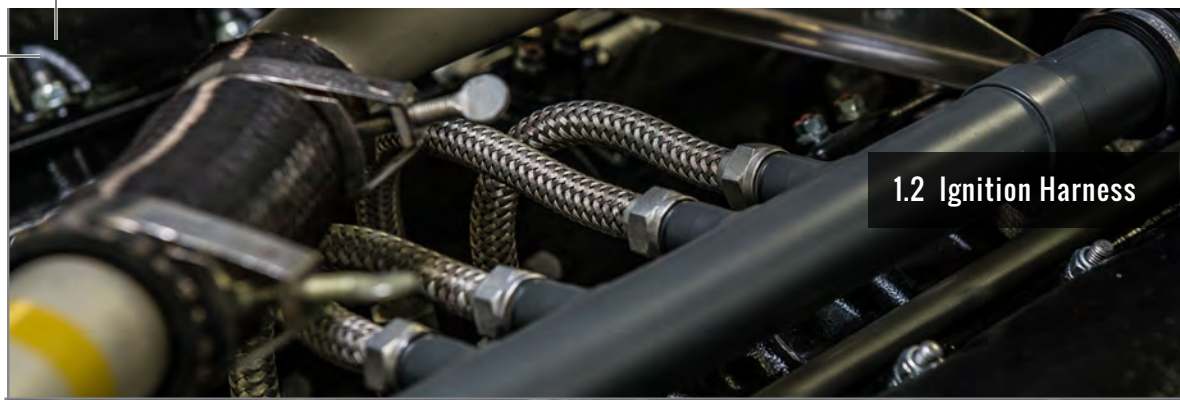
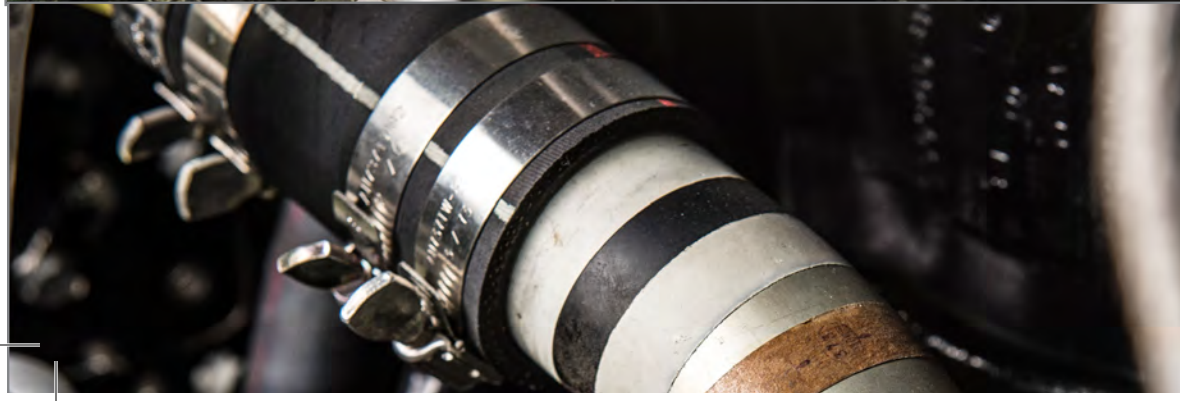
1.2 Ignition Harness

Painted engine grey enamel.

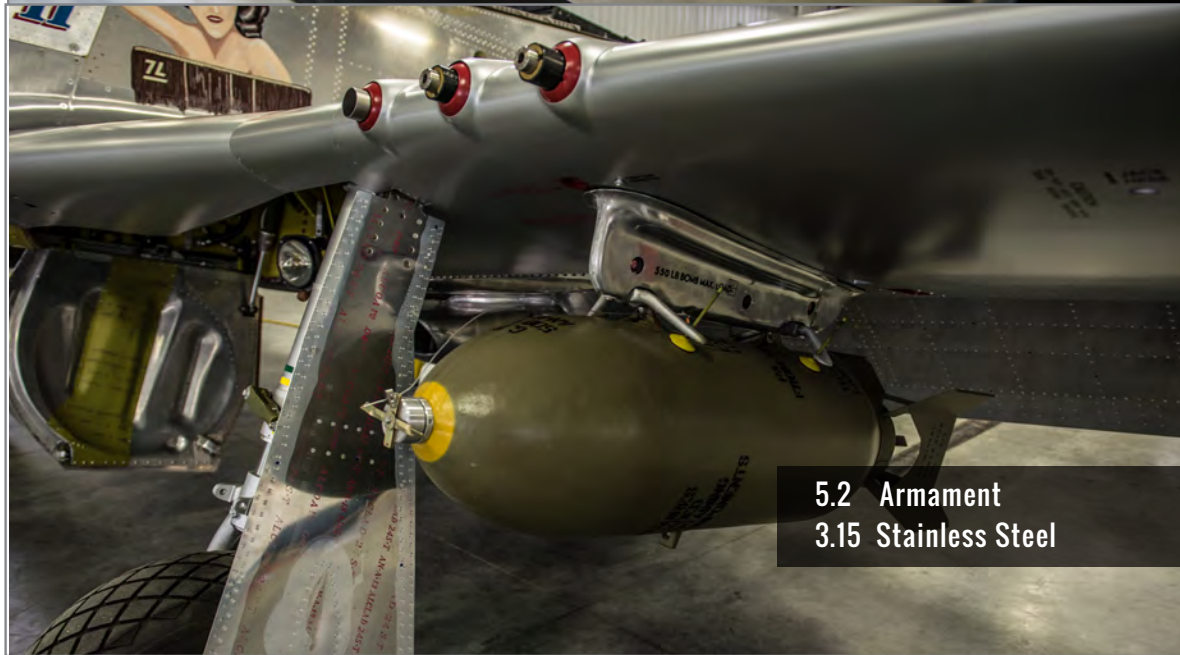
5.2 Armament
3.15 Stainless Steel

Stainless steel components were primed with zinc chromate where in contact with aluminum, this is most noticeable on the inner clam shell gear doors.

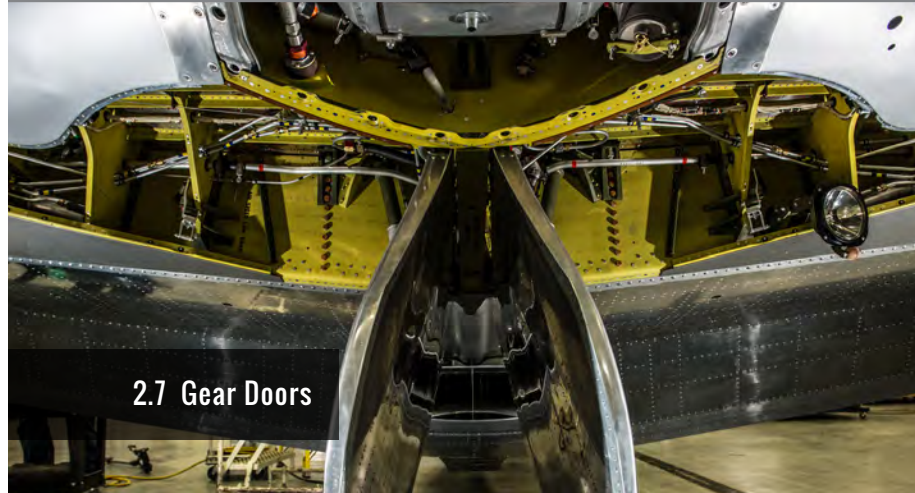
Gear Well

2.7 Gear Doors

Special form was made to stretch landing gear doors skins to fit the door contour without the commonly seen kink.

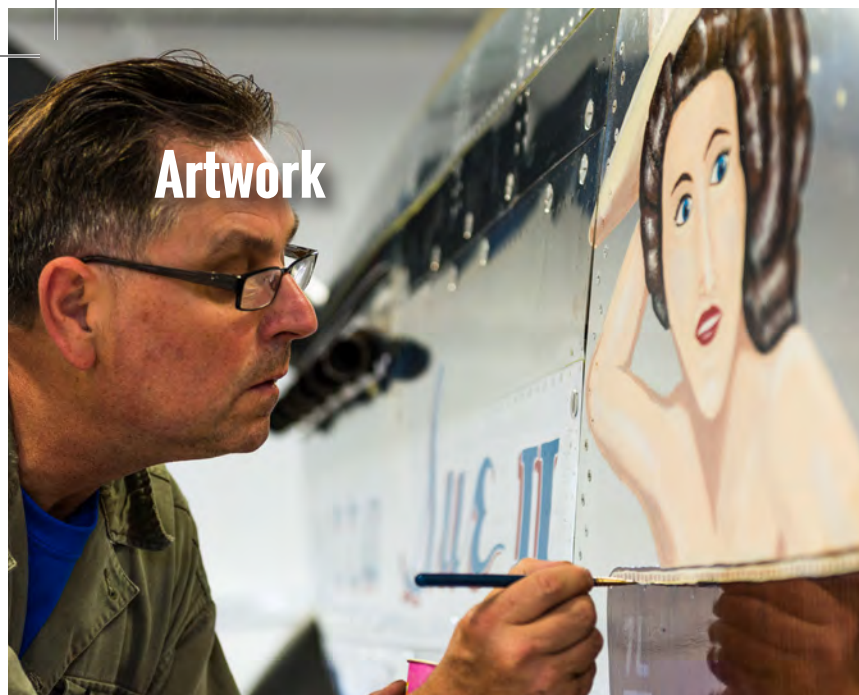
3.12 Nose Art

Completed by hand painting as it would have been originally and even though the original art was not done well it was still duplicated exactly the same.

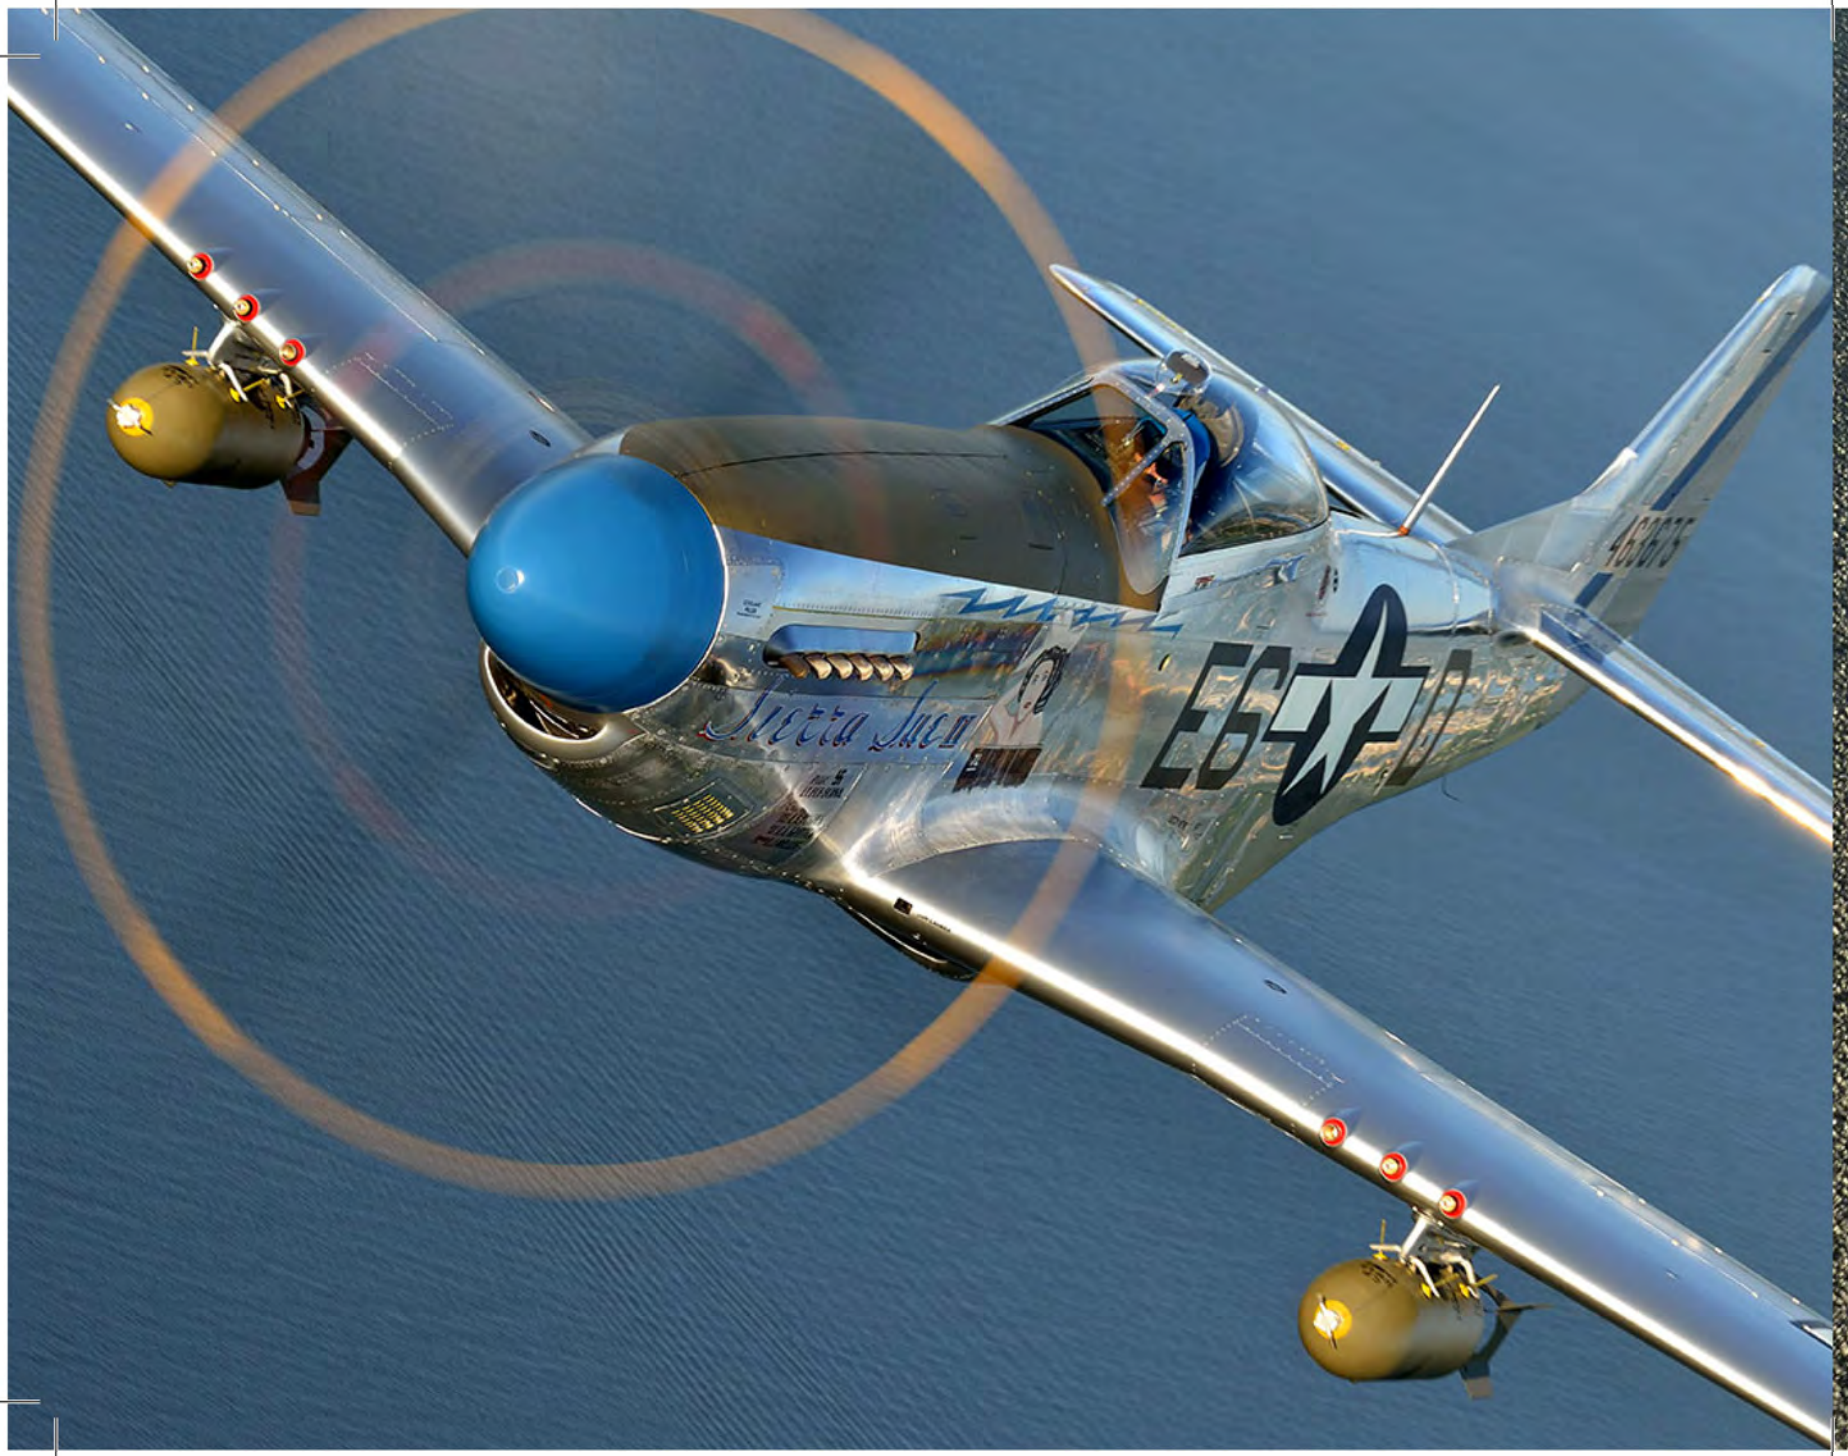
2.1 AN Spec Rivets
2.6 Difficult Rivets

Used rivets from an original WWII rivet manufacturer produced period authentic Dichromate, clear anodized & blue rivets used throughout restoration.

Care and precision that went into setting every rivet including making special dies to do the ailerons.
