## TWIN HOME INSPECTION

14041 Loma Rica Dr  
Grass Valley, CA 95945

07/30/2025

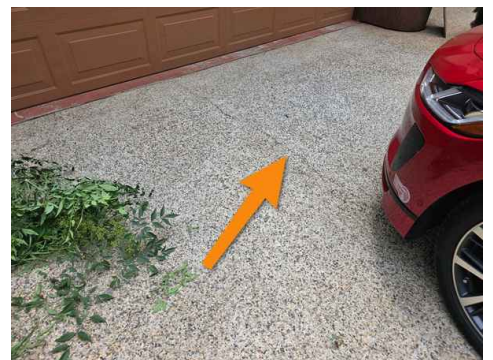
Driveway

**TYPICAL CRACKS**

Cracks noted in the driveway, these cracks are considered typical.

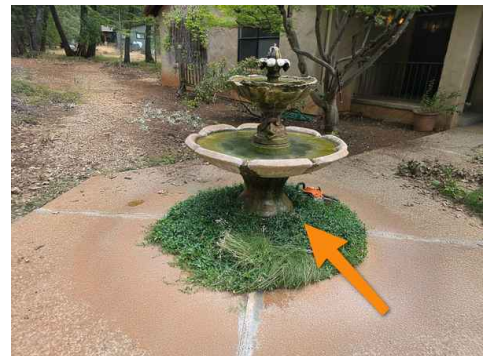
### WATER FEATURE

A water feature/fountain is installed on the property. Safety and proper function of the pump and/or other related components are not included in the visual home inspection.

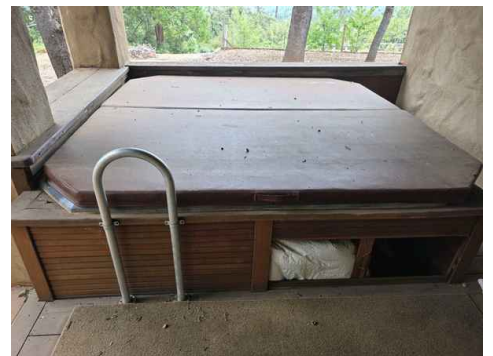
### SPA - NO INSPECT

The spa is not apart of this inspection.

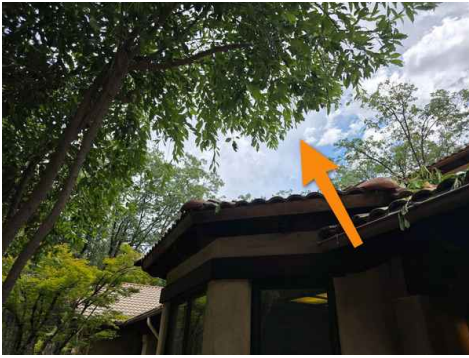
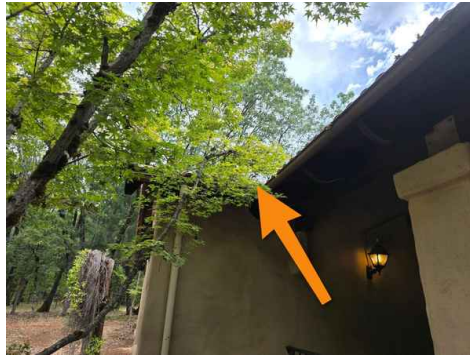
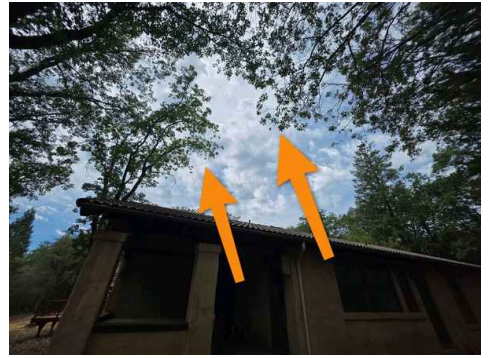
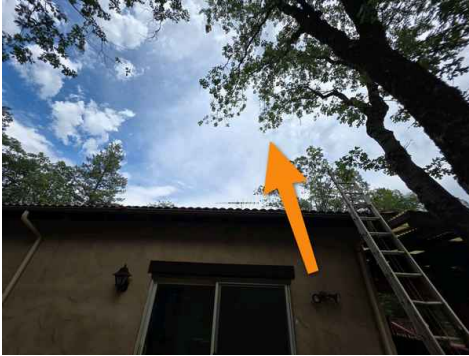
#### 2.2.1 Landscaping

Items Needing Attention

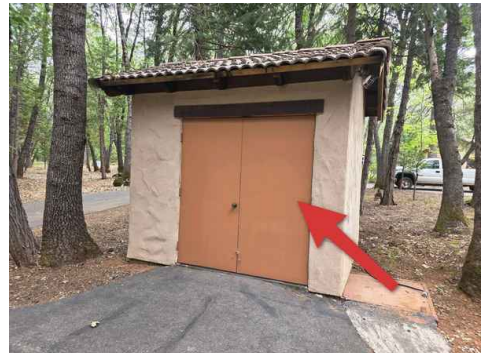
A shed is located on the property. Sheds and storage buildings are not part of the main structure and therefore not inspected unless requested. Electrical components noted in the shed. As a courtesy, the inspector briefly inspected the outlets and/or light fixtures. The electrical components and/or light fixtures are in need of repair or replacement. We recommend further evaluation of a qualified contractor.

Contact a qualified professional.

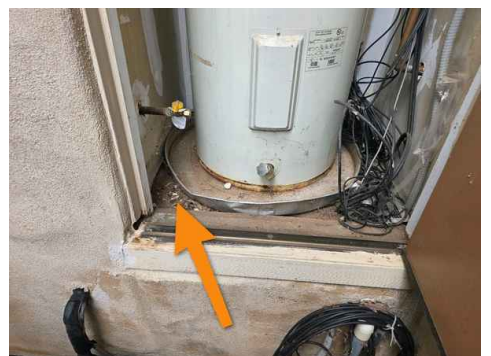
Evidence of rodent activity was noted. Unable to determine if signs are from current or previous infestation. It is recommended to contact a pest control company for further evaluation.

Contact a qualified professional.

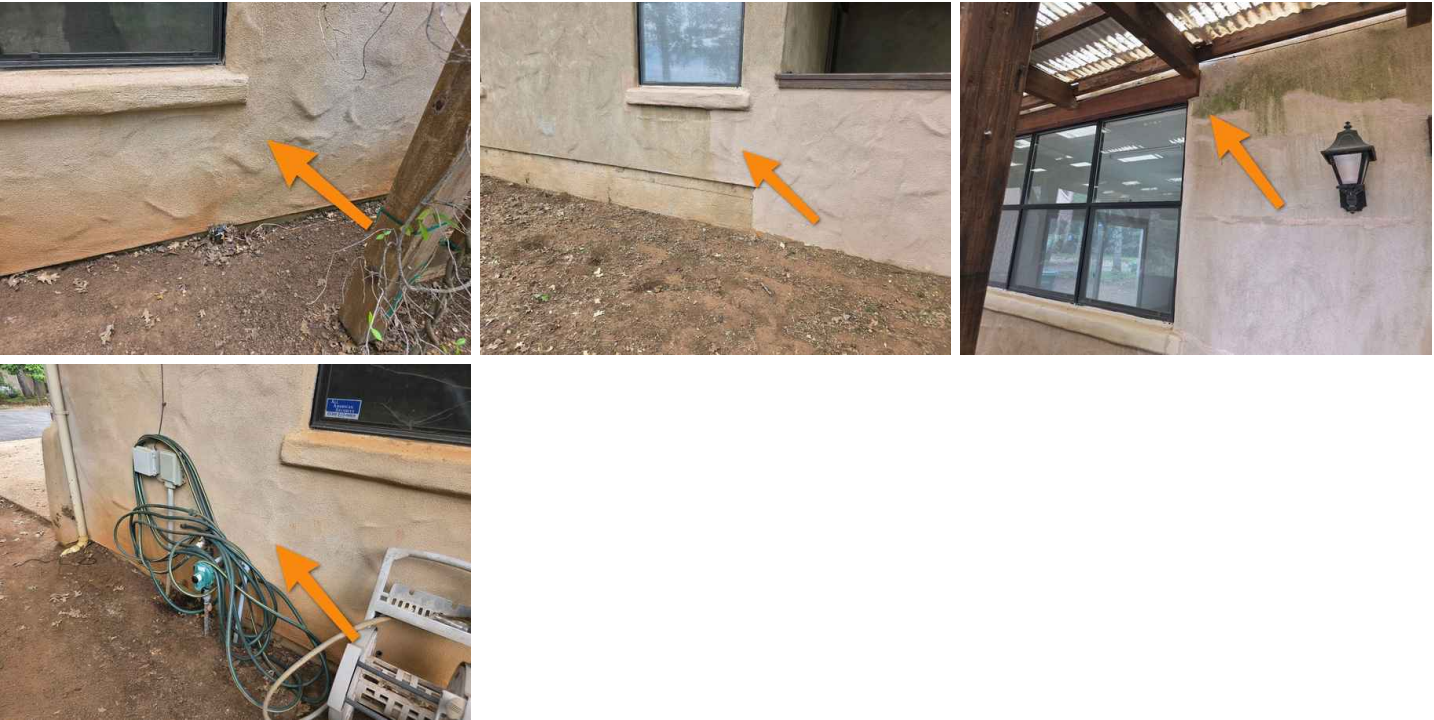
Exterior Walls  
**TYPICAL**  
Typical cracks were noted. These cracks are considered normal settling cracks.

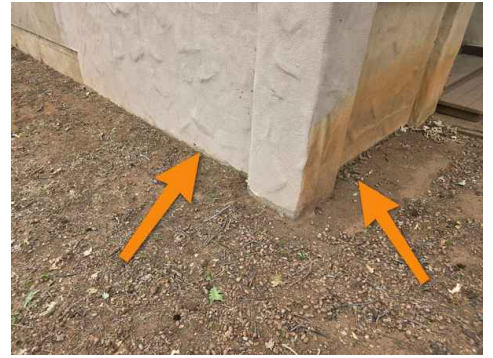
**STUCCO BELOW GRADE - OLDER HOME**

As per building standards at the time of construction, the stucco extends into the soil. This condition is known to wick moisture up the wall causing damage to the texture coat and eventually, in extreme cases, the wood structure of the wall. No flaking and/or peeling noted at the stucco finish/texture coat. Recommend monitoring to ensure no moisture related damages occur in the future.

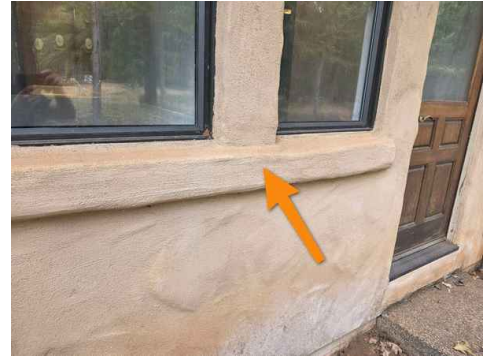
**TYPICAL CRACKS**

Typical cracks noted in the exterior trim

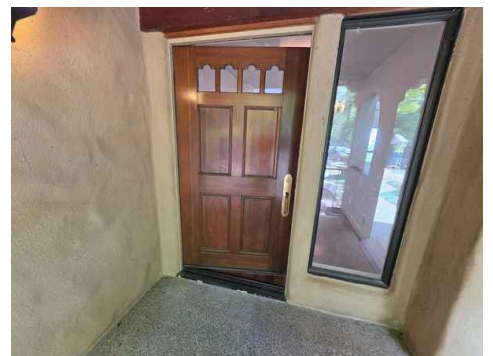
**NONE**

Doorbell not installed

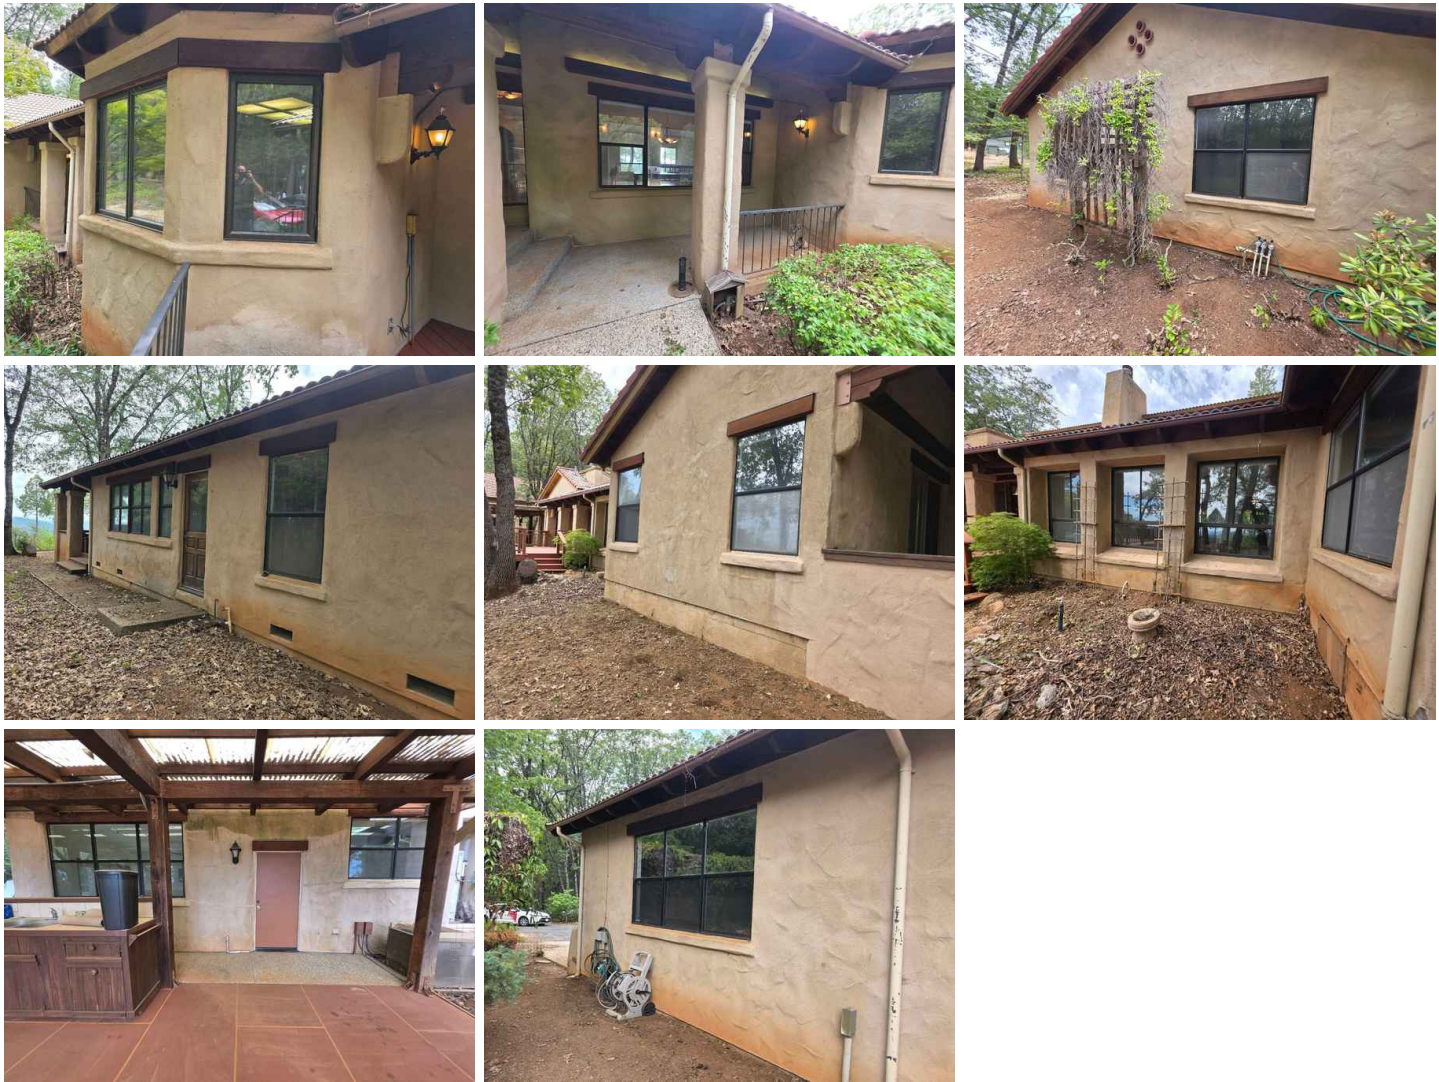
RETROFIT WINDOWS

Some or all of the windows have been replaced. Water-tightness will be dependent upon the proper installation of the flashings and/or caulking which cannot be assessed by a visual inspection. Only a qualified window contractor will be able to ensure correct installation.

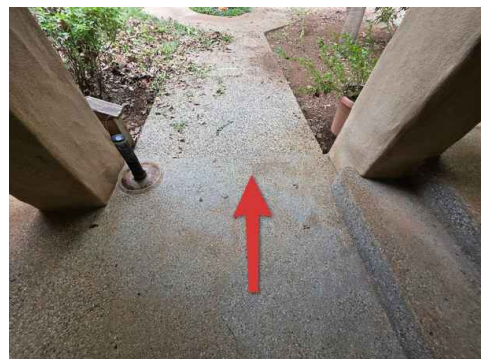
The raised/settled portion of the patio appears to be from an excessive settlement or movement in the soil due to age and/or roots from the surrounding landscape. The uplifting of the concrete is a trip hazard and should be repaired for safety.

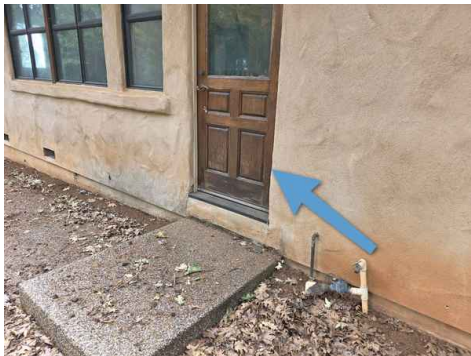
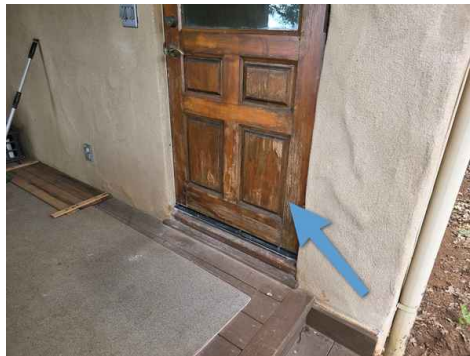
## 3.7.2 Exterior Doors

**WEATHERED**

Items Needing Maintenance

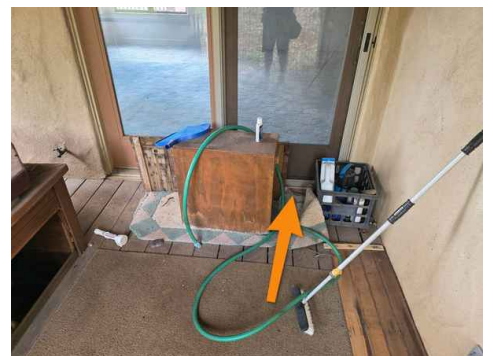
## 3.8.1 Screen Doors

**SCREEN DOOR - ROLLERS/GUIDES**

Items Needing Attention

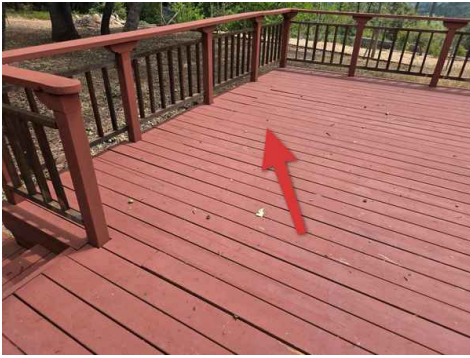
## 3.9.1 Decks / Porches

**TRIP HAZARD**

Safety Observation

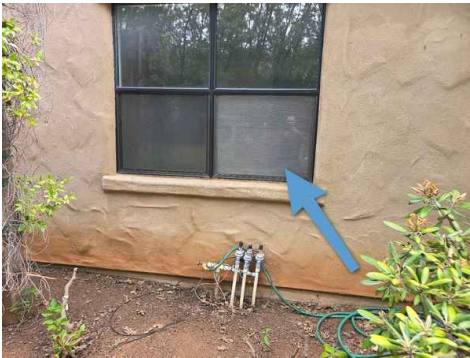
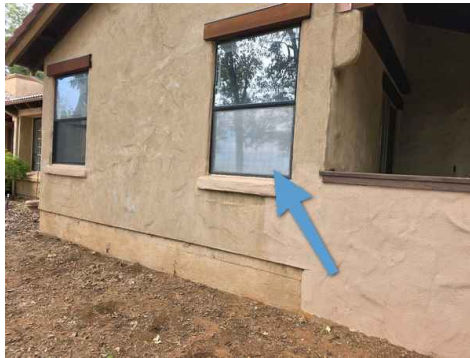
## 3.14.1 Windows

**SCREEN DAMAGED**

## Recommendation

Contact a qualified professional.

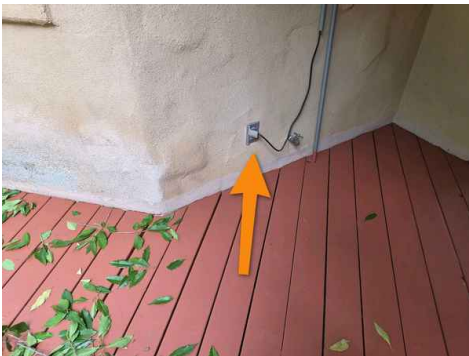
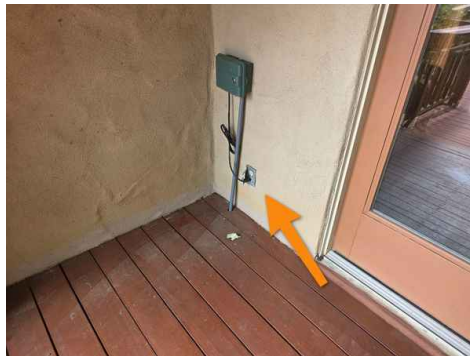
## 3.15.2 Outlets/Electrical

**BUBBLE COVER NEEDED**

Items Needing Attention

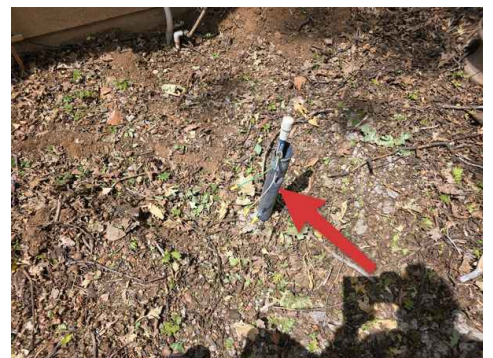
## 3.15.3 Outlets/Electrical

**ABANDONED**

Safety Observation

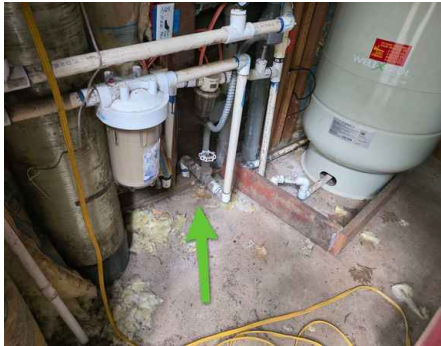
**Main Water Supply: Main shut-off location**  
At Well

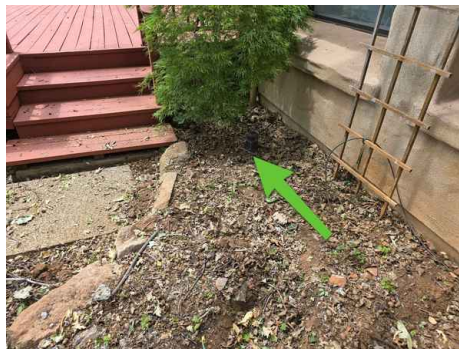
**Waste Lines: Waste Riser/Clean-Out Location**  
Back

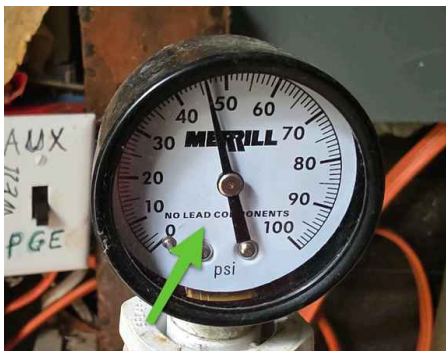
**Main Water Supply: Pressure Tested - S/F**

Water pressure was checked at an exterior hose bib. Water pressure appears to be adequate at the time of the inspection.

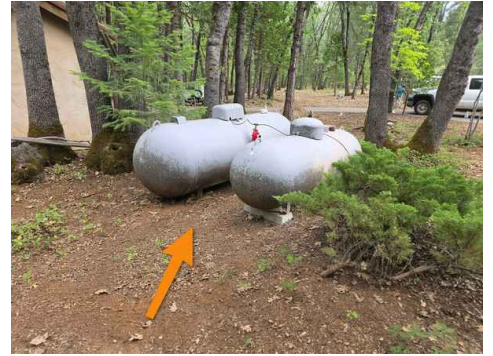
**TANK(S) LEASED**

The inspection of the propane tank is beyond the scope of a visual inspection. Propane tanks are usually leased and the responsibility of the service provider to ensure safety, proper installation, and operation of the tank, valves, and pressure regulator(s). Recommend contacting the leasing company to check service records and any safety inspection that may have been performed.

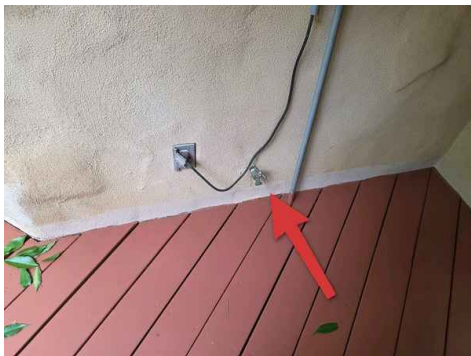
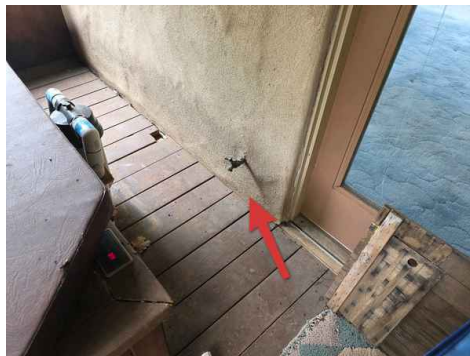
**BACKFLOW MISSING**

The required Backflow preventer is not installed. This may allow water used for landscaping and other exterior uses to back into a potable water supply. Recommend reinstalling the required backflow preventer.

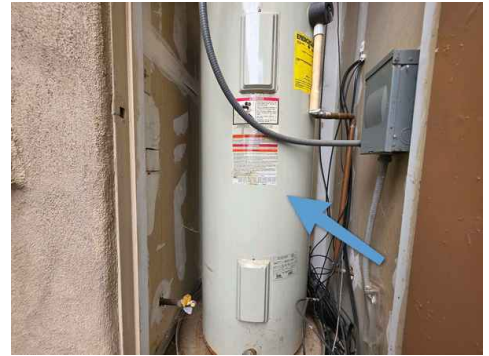
### 5.1.1 General

The estimated useful life for most water heaters is 8-12 years. This water heater appeared to be near / at / beyond this age and/or its useful lifespan and may need replacing at any time. Recommend budgeting for a replacement in the near future, or considering replacement now before any leaks occur. The client should be aware that significant flooding can occur if the water heater fails. If not replaced now, consider having a qualified person install a catch pan and drain or a water alarm to help prevent damage if water does leak.

Contact a qualified plumbing contractor.

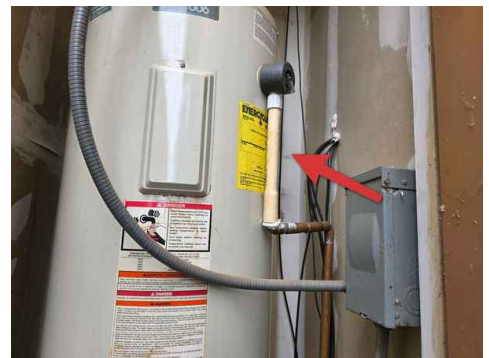
### 5.2.1 TPR Valve/Drain line

The TPR drain pipe does not appear to be the correct material for this function. TPR drain lines are required to be constructed of copper or temperature-rated PVC materials. Recommend further review and repairs by a qualified contractor.

Contact a qualified professional.

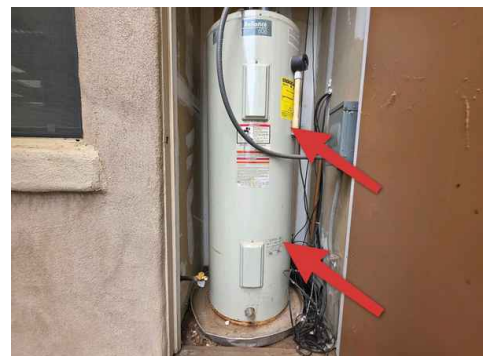
### 5.3.1 Seismic straps

#### **MISSING**

The water heater did not have earthquake straps installed. This is a potential safety hazard in the event of an earthquake. Recommend further evaluation by a qualified contractor.

Contact a qualified professional.

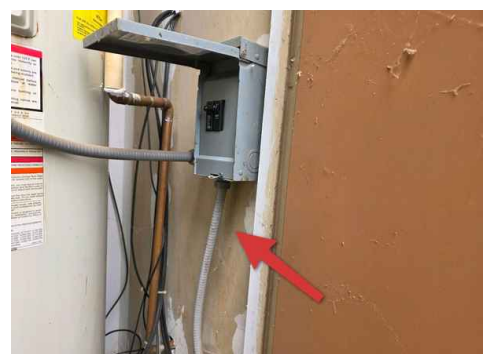
### 5.6.1 Disconnect

#### **CONDUIT LOOSE AT WALL**

The conduit is loose to the wall and should be secured to protect against accidental damage.

Contact a qualified professional.

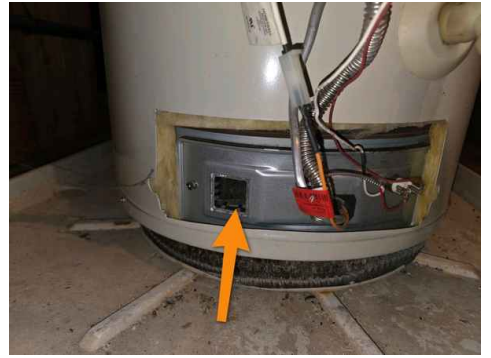
**SERVICEABLE - CLOSED SYSTEM**

The burn chamber is enclosed only allowing a small window for viewing. The visible portions of the burn chamber, burner, and flame appear serviceable and functional at the time of the inspection.

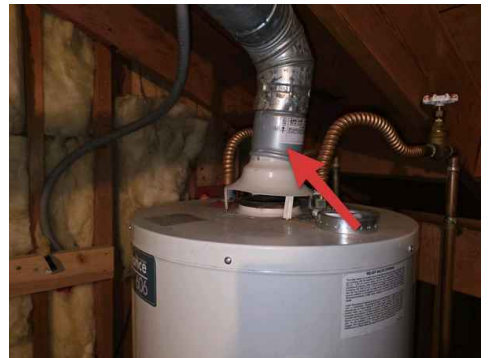
**MISSING FASTENERS**

The vent pipe is required to be secured at each connection point. The required screws are not installed. Recommend securing the vent pipe connections as required.

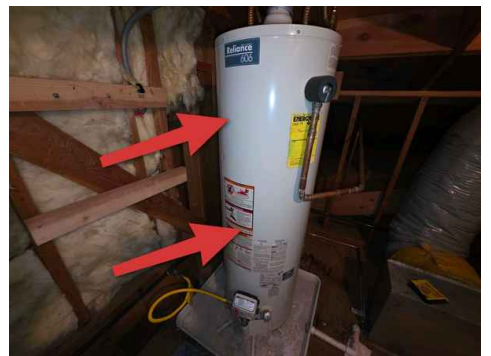
## 6.7.1 Seismic straps

**MISSING**

The water heater did not have earthquake straps installed. This is a potential safety hazard in the event of an earthquake. Recommend further evaluation by a qualified contractor.

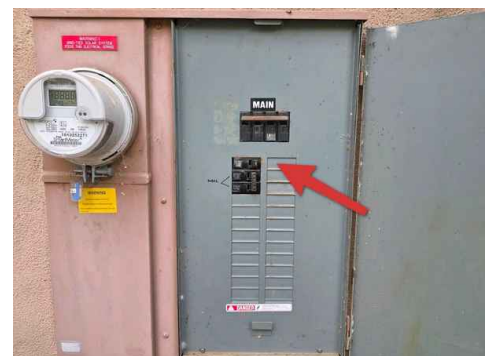
### 7.2.1 Main Panel

#### **LABELS/LEGEND MISSING, FADED**

Labeling is incomplete and or fading, recommend further evaluation and repairs by a qualified contractor for safer reasons.

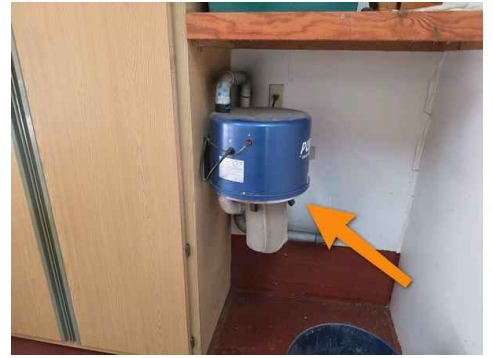
**NOT TESTED**

A central vacuum system was noted, but not tested. The testing of a central vacuum system is a specialized procedure beyond the scope of the visual home inspection.

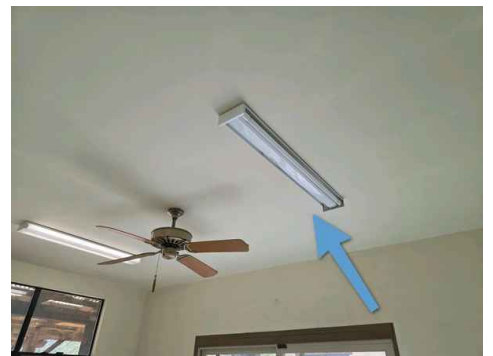
## 8.8.1 Light Fixtures

**GLOBES OR COVERS MISSING, BROKEN**

One or more globes or covers for light fixtures were missing or damaged. Recommend replacing as necessary to avoid exposed bulbs.

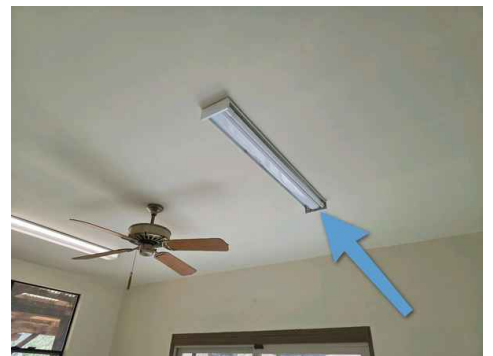
## 8.8.2 Light Fixtures

**LIGHTS INOPERABLE**

One or more light fixtures were inoperable. Recommend further evaluation by replacing bulbs.

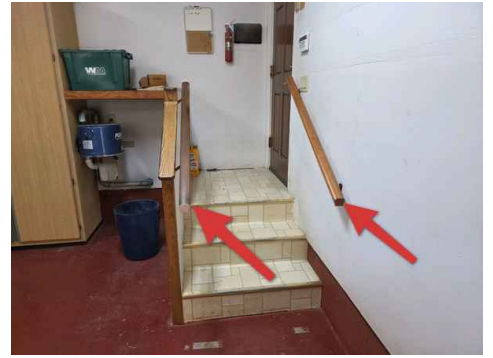
## 8.12.1 Garage-house steps

**HANDRAIL - NO RETURNS**

One or more handrails had no returns installed, where ends of handrails turn and connect to adjacent walls or back into the neso objects or clothing will not catch on the open ends. This is a safety hazard. Recommend that a qualified person install returns per standard building practices.

Contact a qualified professional.

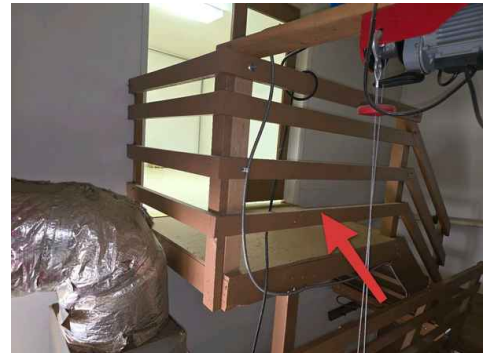
8.12.2 Garage-house steps

**GUARDRAILS/BALUSTERS 4"- NOT REQUIRED**

Although not required at the time of build the guardrails at one or more locations with drop-offs higher than 36 inches had gaps that were too large. This poses a safety hazard for children (e.g. falling, getting stuck in railing). Guardrails should not have gaps or voids that allow passage of a sphere equal to or greater than 4 inches in diameter, or 6 inches in diameter at triangular spaces between stair edges and guardrails. At a minimum, the client should be aware of this hazard. Recommend that a qualified contractor repair or replace guardrails per standard building practices.

Contact a qualified professional.

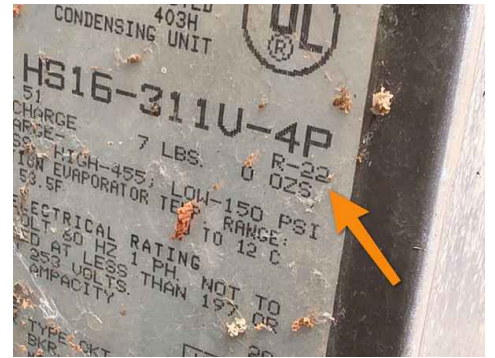
Air Conditioning  
**OLD UNIT**

Unit is old. Coolant for this unit may no longer be available. This may not allow for repairs if coolant level becomes low due to a leak and require replacement.

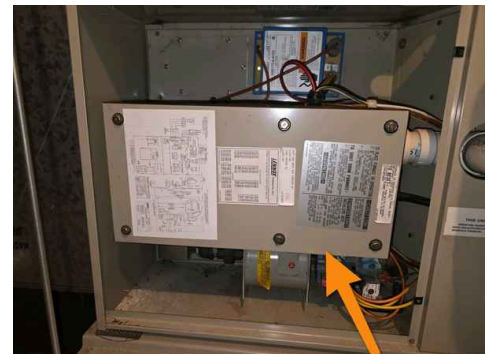
### CLOSED SYSTEM

Closed System - Unable to fully inspect.

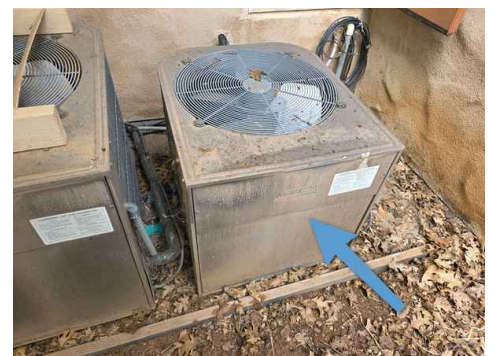
9.3.1 Suction Line

### INSULATION

Suction line insulation damaged/missing at the condenser.

Contact a qualified professional.

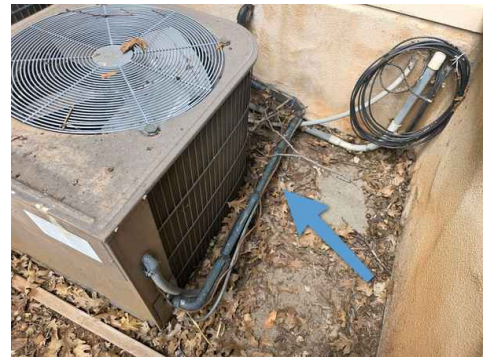
9.4.1 Disconnect (AC)

### CONDUIT LOOSE AT WALL

The conduit is loose to the wall and should be secured to protect against accidental damage.

Contact a qualified professional.

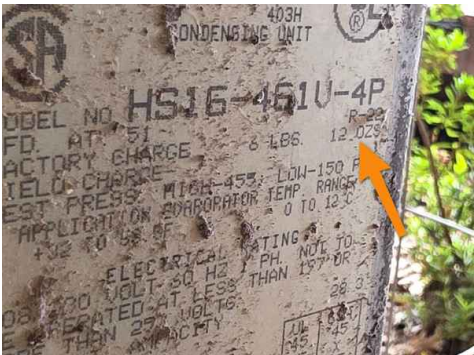
Air Conditioning

OLD UNIT

Unit is old. Coolant for this unit may no longer be available. This may not allow for repairs if coolant level becomes low due to a leak and require replacement.

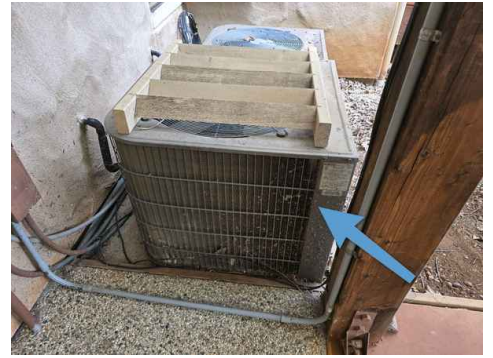
## 10.2.1 Condenser

**FINS DAMAGED - MINOR**

Minor fin damage to the condenser coil noted. This may effects the overall efficiency and operation of the condenser. If excessive, a comb can be purchased at a local hardware store to straighten the coils or a professional can be contacted to perform the necessary repairs.

Contact a qualified professional.

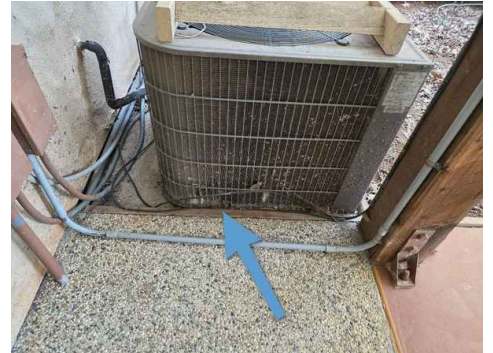
## 10.2.2 Condenser

**FINS DIRTY**

The unit has been allowed to get dirty. Dirt and debris buildup on the condenser coils block air flow reducing the efficiency of the unit. Recommend regular cleaning with a garden hose to ensure proper air flow and efficiency of the AC system

Contact a qualified professional.

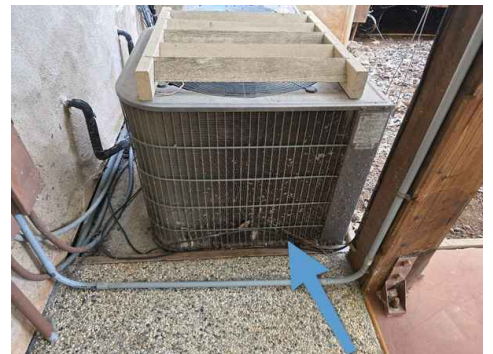
## 10.3.1 Suction Line

**INSULATION**

Suction line insulation damaged/missing at the condenser.

Contact a qualified professional.

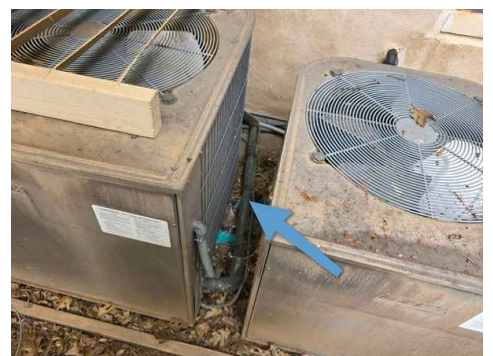
## 10.4.1 Disconnect (AC)

**CONDUIT LOOSE AT WALL**

The conduit is loose to the wall and should be secured to protect against accidental damage.

Contact a qualified professional.

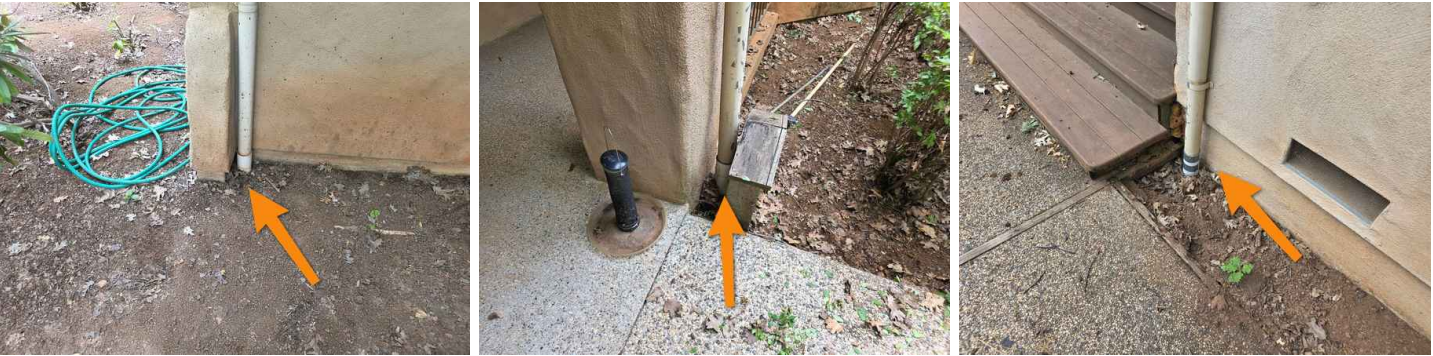
### SUBSURFACE - NO TEST

Subsurface drain system noted, but not tested. The testing of a subsurface drainage system is beyond the scope of a visual home inspection.

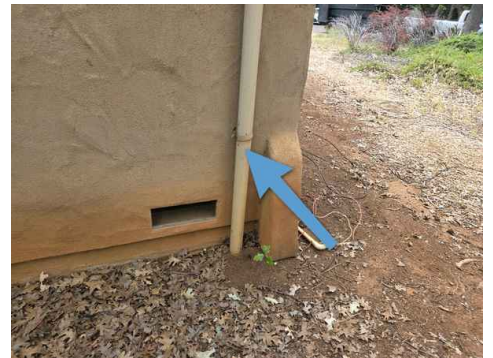
### 12.1.2 Gutters / Downspouts / Extensions

#### **STAINS, PAST LEAKS**

Stains were found on one or more gutters that indicate past leaks have occurred. Recommend further evaluation by a qualified contractor.

Contact a qualified professional.

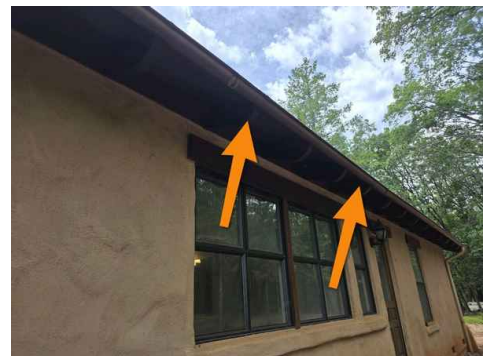
### 12.1.3 Gutters / Downspouts / Extensions

One or more gutters had a substandard slope so that significant amounts of water accumulate in them rather than draining through the downspouts. This can cause gutters to overflow, especially when debris such as leaves or needles has accumulated in them. Recommend further evaluation by a qualified contractor.

Contact a qualified professional.

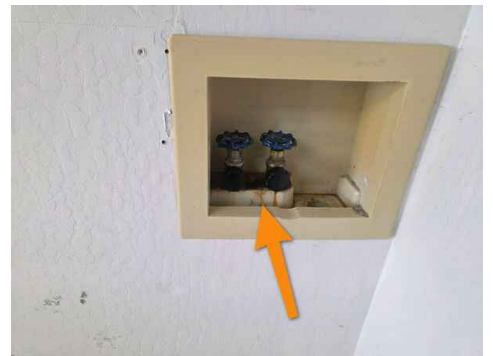
### **NOT TESTED**

The washer hose bibs were not tested.

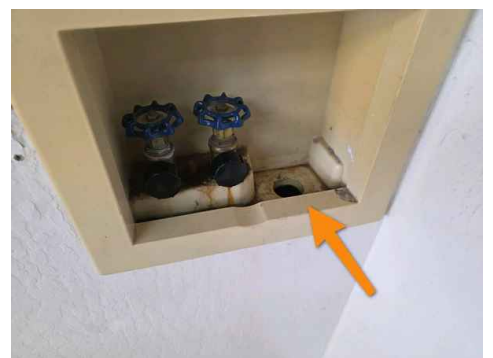
### **NOT TESTED**

The drain lines were not tested

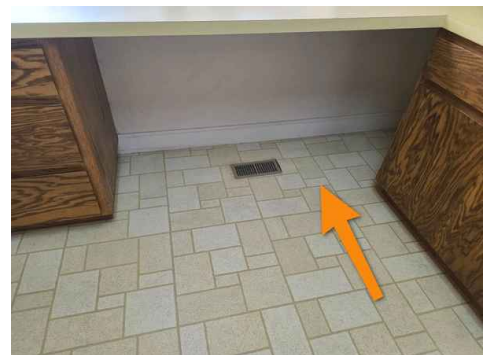
## 13.12.1 Floors

**VINYL DAMAGE**

The vinyl floor is damaged or pulling up. Recommend further evaluation by a qualified contractor.

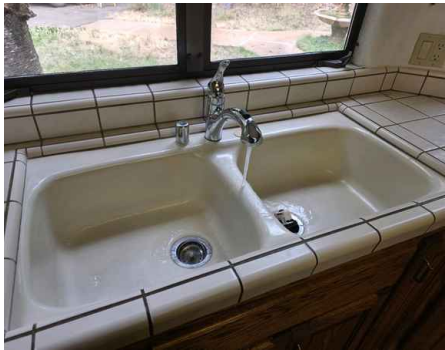
**Fixtures and Sink: Serviceable**

Sinks and drains appear serviceable at the time of inspection.

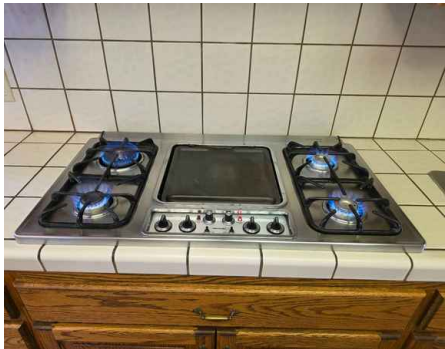
**Range/Cooktop/Oven: Cooktop Serviceable**

Serviceable and functional at the time of the inspection.

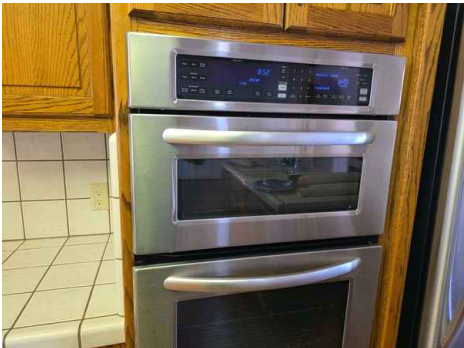
**Microwave: Serviceable**

Microwave was serviceable and functional at the time of the inspection.

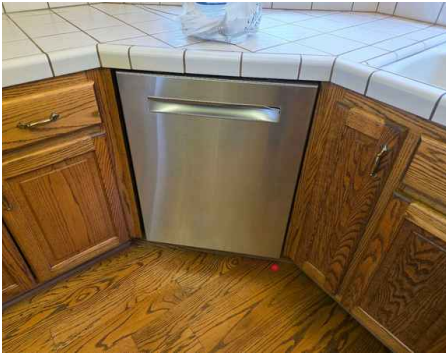
**Dishwasher: Serviceable Partial Test**

Unit appears serviceable and functional. Partial test only. Dishwasher was run for a partial cycle to ensure fill, agitate and drain function.

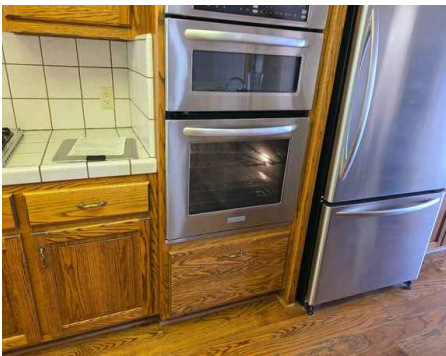
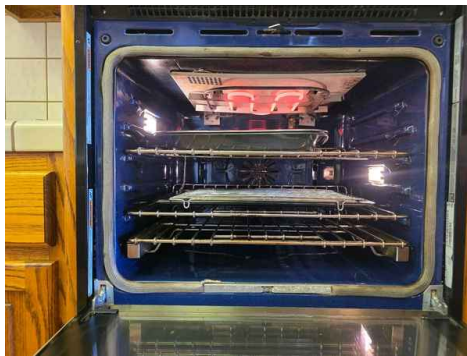
**Range/Cooktop/Oven: Oven Servicable**

Appears serviceable and functional at the time of the inspection.

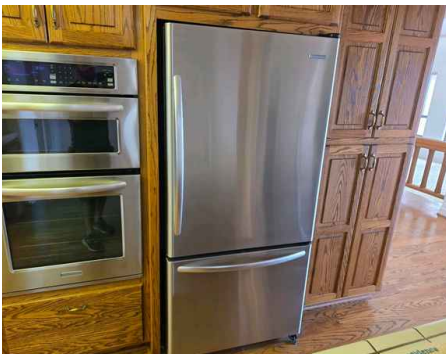
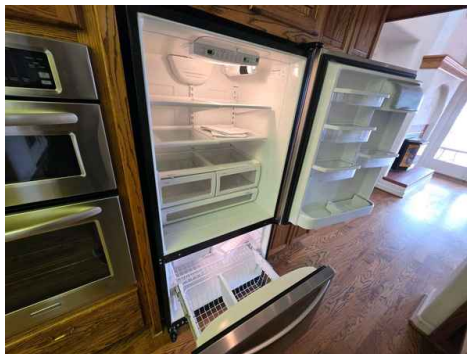
**Refrigerator: Serviceable**

Refrigerator was serviceable and functional at the time of the inspection.

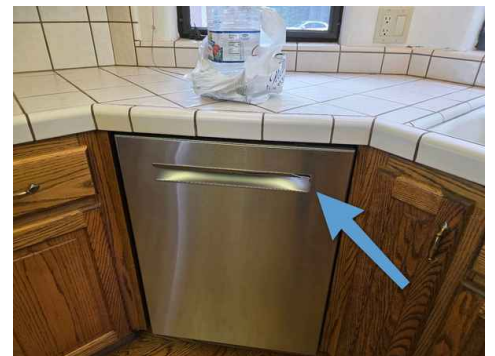
### 14.3.1 Dishwasher

#### DAMAGE

Minor damage noted

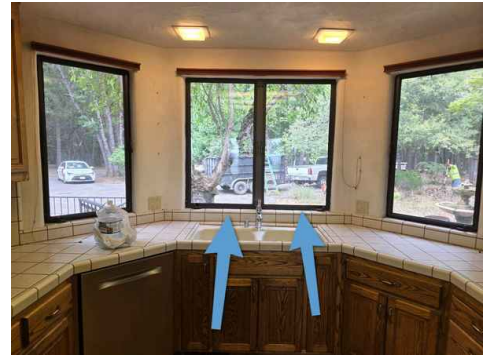
### 14.9.1 Windows & Skylights

#### MISSING SCREENS

Screens were missing from some / many windows.

Contact a qualified professional.

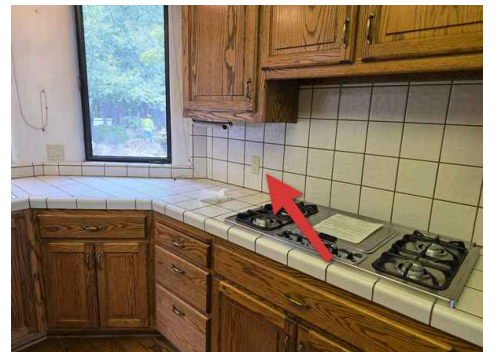
## 14.12.2 Outlets/Electrical

**BROKEN, LOOSE, DAMAGED - OUTLET**

One or more receptacles were broken, loose or damaged. This is a potential shock or fire hazard. Recommend that a qualified electrician replace such receptacles as necessary.

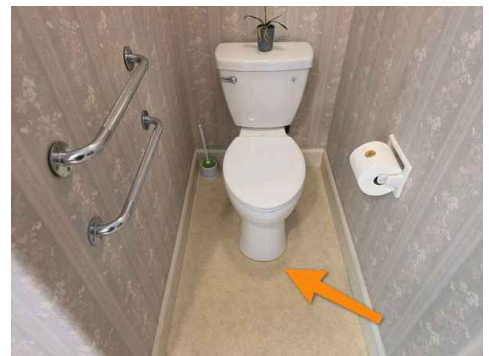
## 15.4.1 Toilets

Caulk around the base of the toilet was missing, substandard and/or deteriorated. Recommend caulking around the base leaving about 3" behind uncaulked in the event of the toilet leaking and knowing it is leaking

Contact a qualified professional.

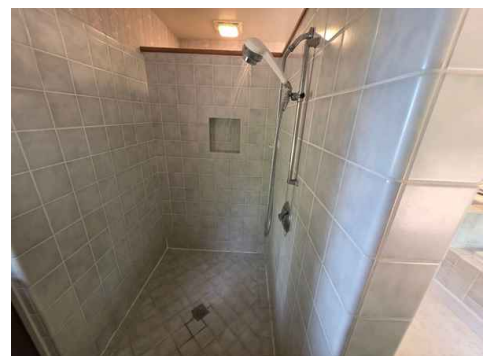
## 15.6.1 Showers

The shower head connection was dripping when the shower was turned on. Recommend applying teflon tape for a better seal. If that doesn't solve it, recommend that a qualified person repair as necessary.

Contact a qualified professional.

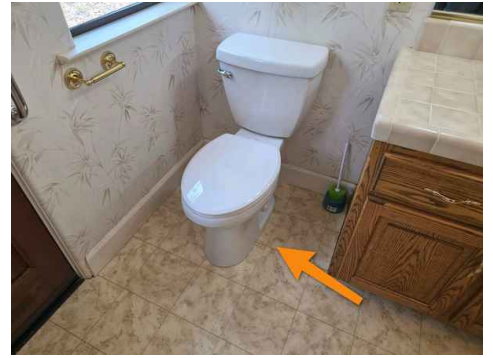
16.4.1 Toilets

### NO OR BAD CAULK AT BASE

Caulk around the base of the toilet was missing, substandard and/or deteriorated. Recommend caulking around the base leaving about 3" behind uncaulked in the event of the toilet leaking and knowing it is leaking

Contact a qualified professional.

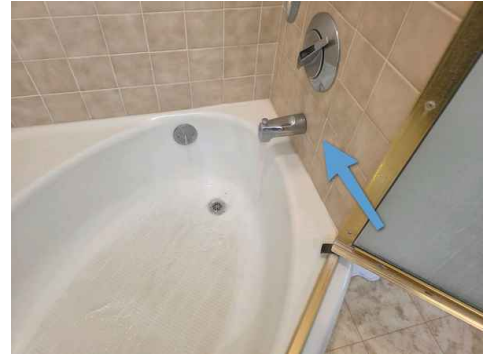
Caulk was missing around the base of the bathtub spout, or there was a gap behind it. Water may enter the wall structure behind the bathtub. Recommend that a qualified person repair as necessary to eliminate the gap. For example, by installing or replacing caulk if the gap is small enough. For larger gaps, a shorter spout nipple or an escutcheon plate can be installed.

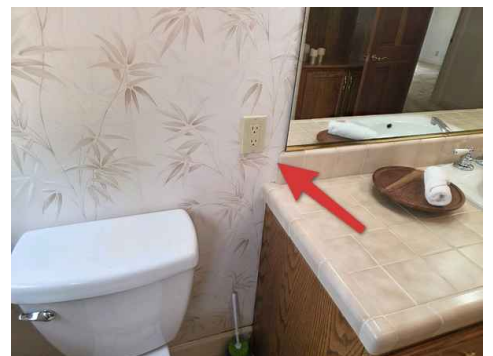
**LOOSE**

One or more electric receptacles are loose. Wire conductors can be damaged as a result. Recommend that a qualified electrician repair as needed.

Contact a qualified electrical contractor.

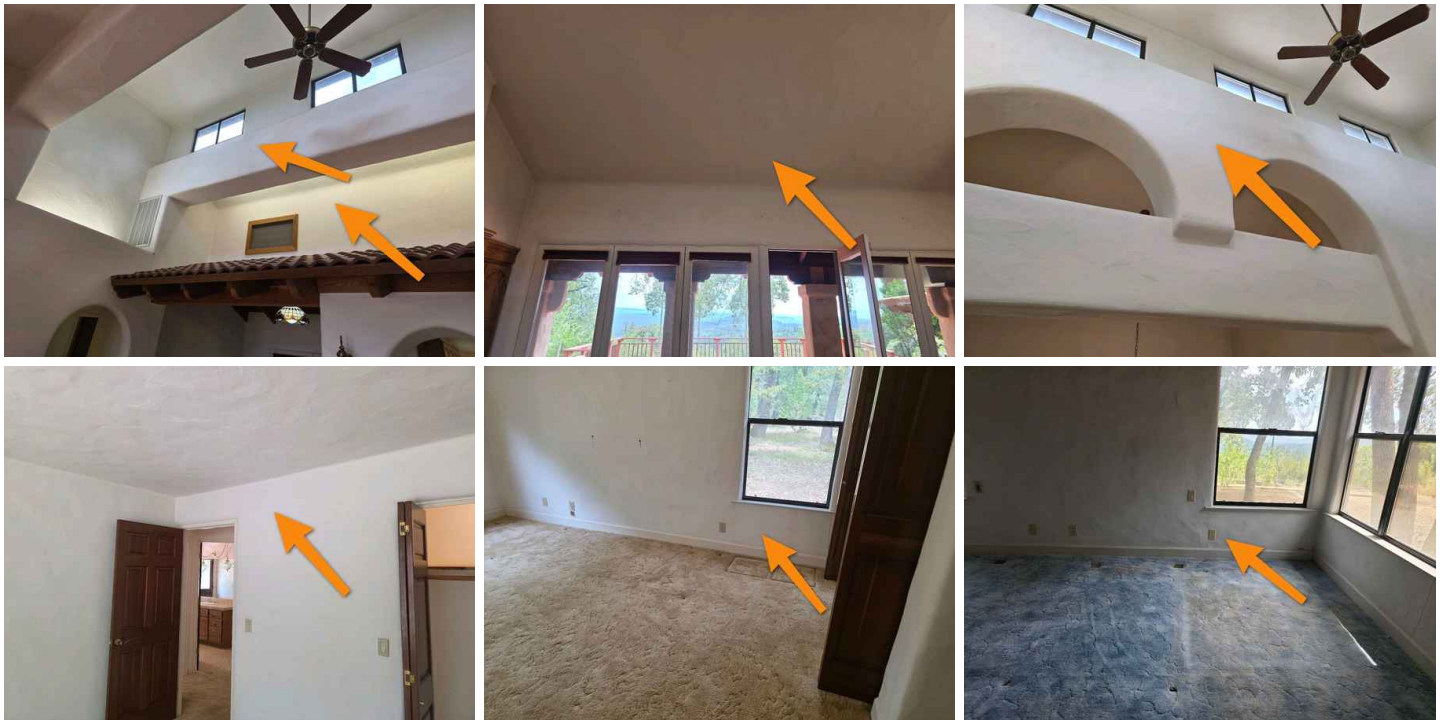
Walls & Ceilings  
**TYPICAL CRACKS, NAIL POPS**  
Minor cracks, nail pops and/or blemishes were found in walls and/or ceilings in one or more areas. Cracks and nail pops are common, are often caused by lumber shrinkage or minor settlement, and can be more or less noticeable depending on changes in humidity. They did not appear to be a structural concern, but the client may wish to repair these for aesthetic reasons.

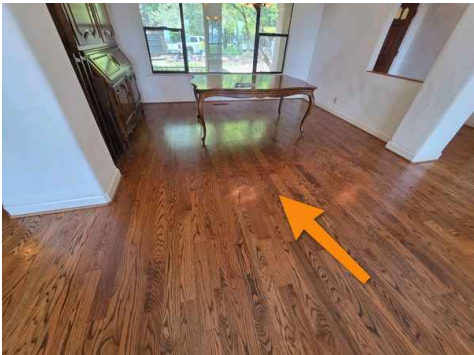
FLOOR POPS

Floor pops/squeaks noted. Generally floor pops/squeaks are from normal structural settlement.

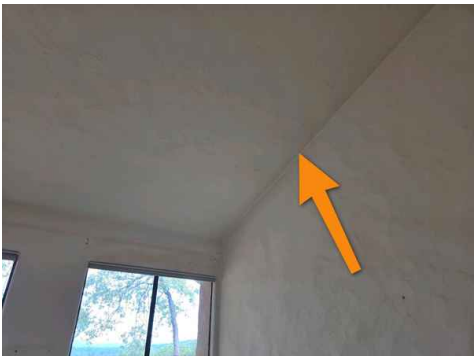
18.3.1 Walls & Ceilings

CEILING - DRY STAINS, MONITOR

Stains were found in one or more ceiling areas. No elevated levels of moisture were found. If moisture is noticed in the future, recommend that a qualified contractor evaluate and repair as needed.

Contact a qualified professional.

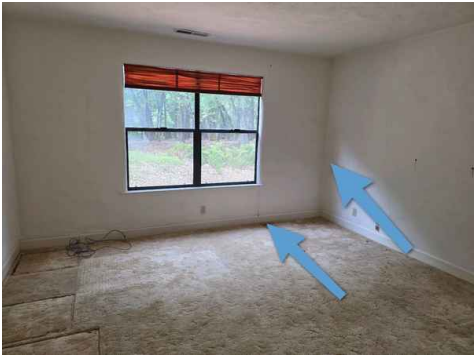
18.3.2 Walls & Ceilings

WALLS STAINED - PREVIOUS

Previous Leak - The stains are dry and do not appear to be an active leak.

Recommendation  
Contact a qualified professional.

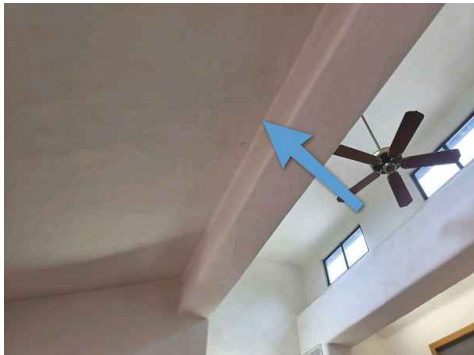
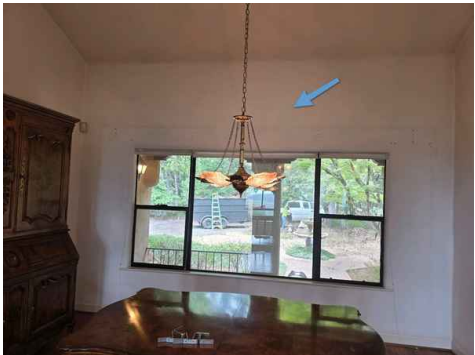
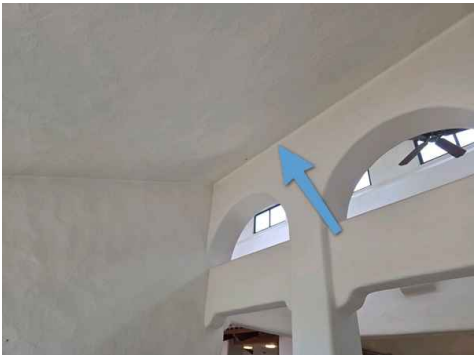
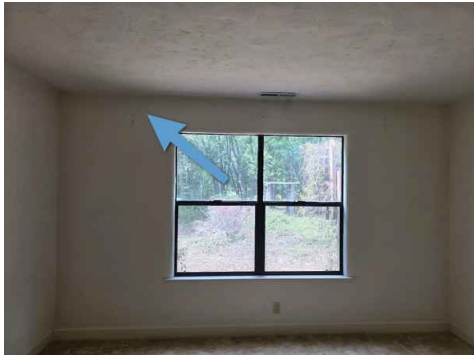
18.3.3 Walls & Ceilings  
**MINOR DAMAGE**  
Minor damage noted

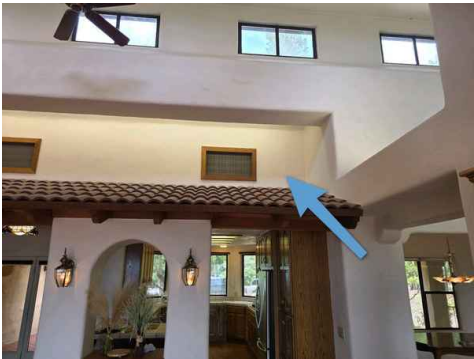
18.3.4 Walls & Ceilings  
**MAJOR CRACKS**

A larger than usual crack was noted. No structural failure was noted, however a structural analysis was not conducted. For absolute certainty a qualified contractor can be contacted for further review and possible repairs.

Recommendation  
Contact a qualified professional.

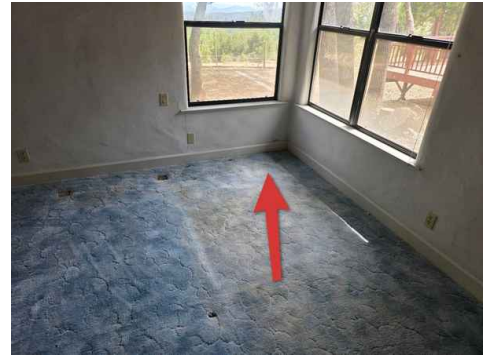
**MOLD**

Mold like growth noted. Certain types of mold are known to the state of California to cause health problems. It is beyond the scope and impossible to determine the presence or species of mold during a visual home inspection as your inspector is not an expert. For absolute certainty, identification and proper remediation, recommend further testing by a qualified mold inspector.

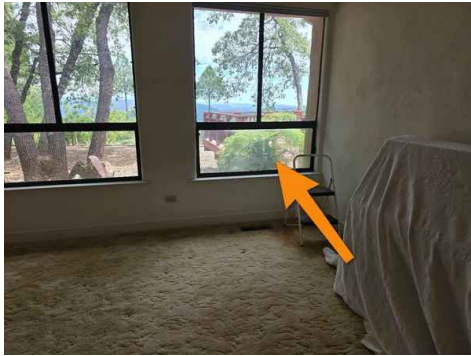
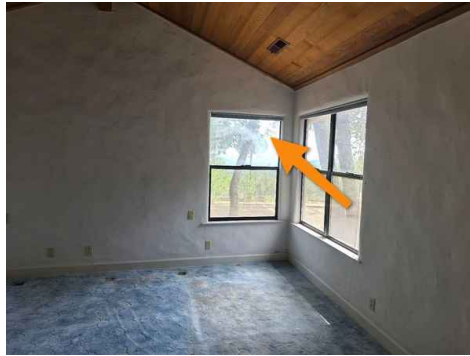
**THERMAL SEAL**

At least one window or associated hardware needs repair. The thermal seal is broken. Although it is keeping the elements out, it has lost its R rating and is no longer an insulator. This condition will be a source of heat/cool loss throughout the year, driving up the energy costs of the home. Recommend further review and repairs by a qualified contractor.

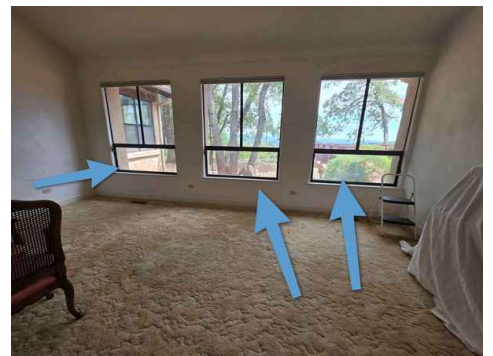
**MISSING SCREENS**

Screens were missing from *some / many* windows.

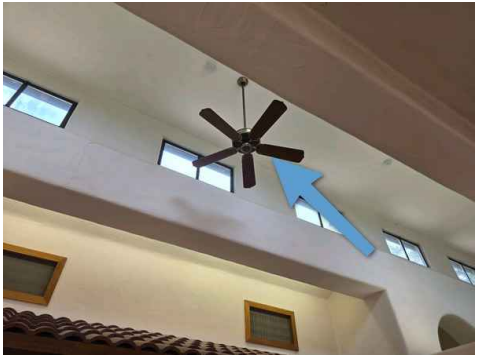
## 18.5.1 Light Fixtures &amp; Fans

**CEILING FAN INOPERABLE OR SWITCH NOT FOUND**

One or more ceiling fans appeared to be inoperable, did not respond to the remote or the inspector was unable to find normal controls with which to operate the fan(s). Recommend asking the property owner about their operation, and if necessary, that a qualified electrician evaluate and repair.

Recommendation  
Contact a qualified professional.
