## TWIN HOME INSPECTION

14041 Loma Rica Dr  
Grass Valley, CA 95945

07/30/2025

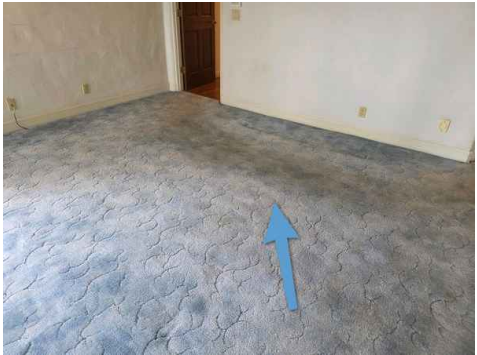
18.8.1 Floors  
**CARPET STAINS**

Carpeting in one or more areas was stained or soiled. Recommend having carpeting professionally cleaned as necessary.

Recommendation  
Contact a qualified cleaning service.

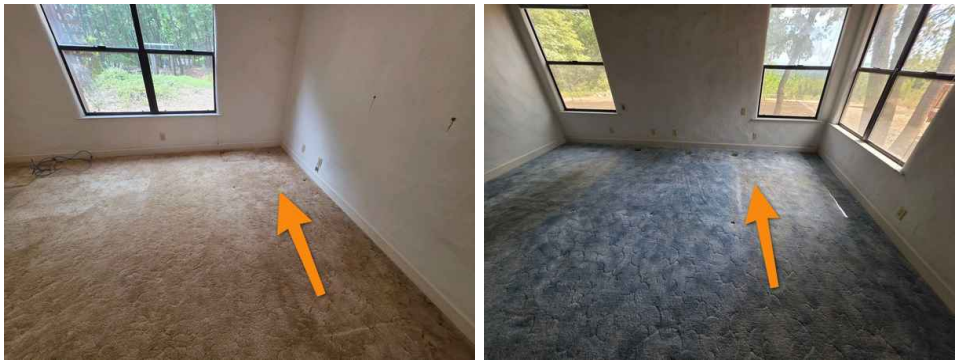
18.8.2 Floors  
**CARPET DAMAGED OR DETERIORATED**

Carpeting in one or more areas was damaged or deteriorated. Recommend that a qualified contractor replace as necessary.

Recommendation  
Contact a qualified flooring contractor

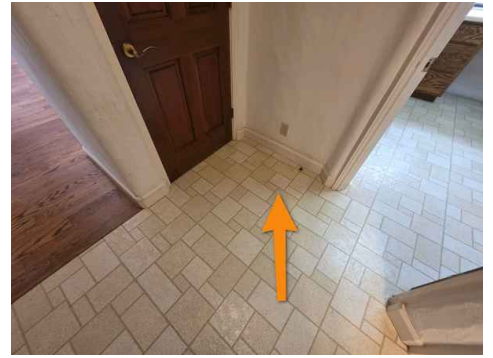
Vinyl, or linoleum flooring in one or more areas was damaged, deteriorated, or curling. Recommend that a qualified contractor replace or repair flooring as necessary.

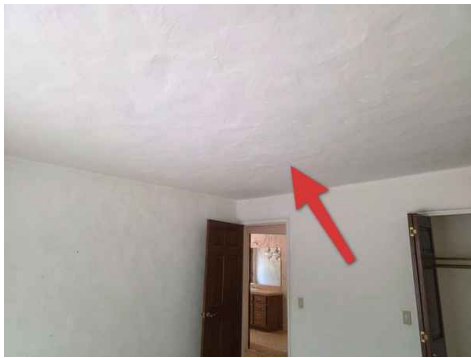
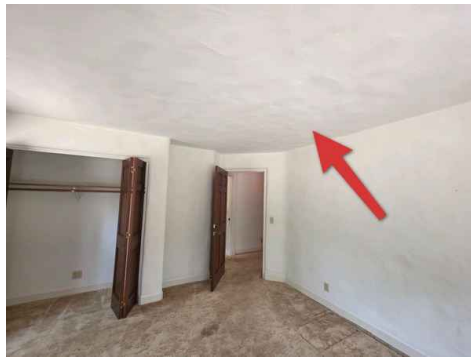
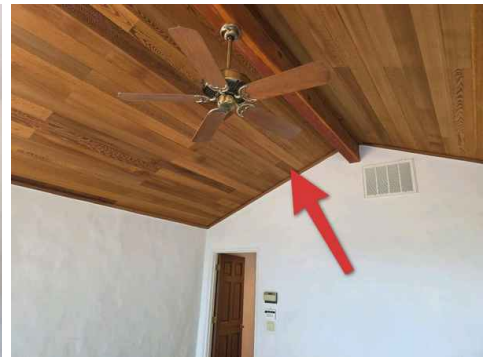
**MISSING - NOT REQUIRED**

Though it may not have been required at the time of construction, it is recommended additional smoke detectors be installed in all bedrooms. Recommend installing the required smoke detectors in each main hall (1st and 2nd story) and in all bedrooms.

Recommended DIY Project

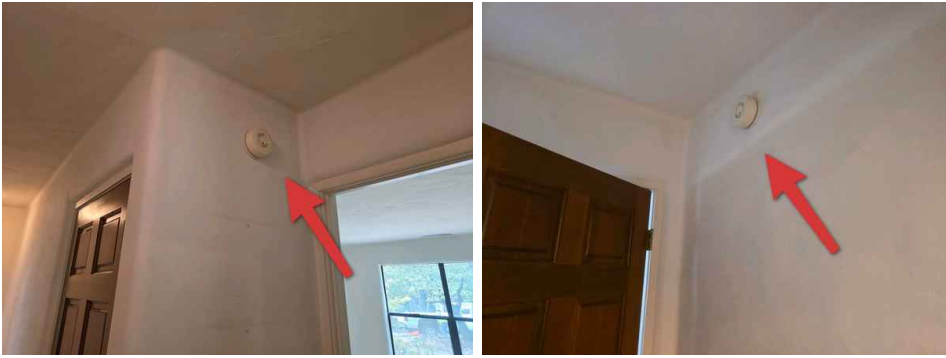
**10 YEARS OLD**

Based on the age of this structure and the appearance of existing smoke alarms, the alarms may have been installed more than 10 years ago. According to [National Fire Protection Association](#), aging smoke alarms don't operate as efficiently and often are the source for nuisance alarms. Older smoke alarms are estimated to have a 30% probability of failure within the first 10 years. Newer smoke alarms do better but should be replaced after 10 years. Unless you know that the smoke alarms are new, replacing them when moving into a new residence is also recommended by NFPA.

Recommended DIY Project

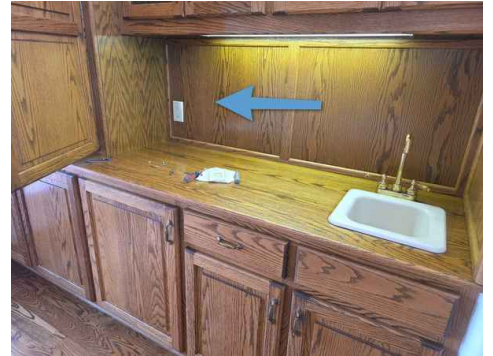
**GFCI - NOT REQUIRED**

Though not required prior to 1993, Ground Fault Circuit Interrupter (GFCI) outlets are recommended for installation at all wet bar outlets.

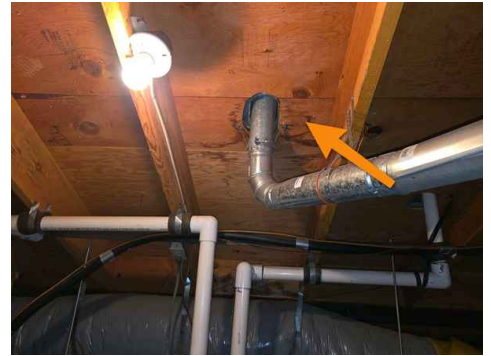
**STAINS - UNKNOWN**

Moisture staining noted on the roof decking. Stains are dry, could not determine if this is a current or previous leak. Recommend further review by a qualified contractor.

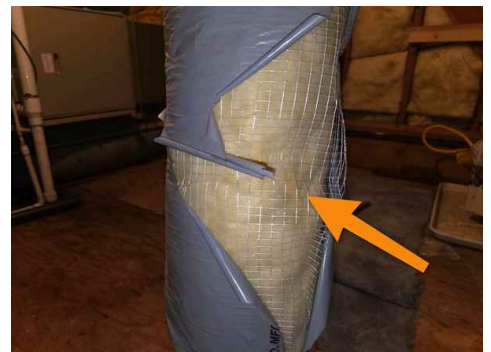
**NO/DAMAGED VAPOR BARRIER**

The plastic vapor barrier wrapped around the distribution ducting is damaged, deteriorated or missing. The vapor barrier is required so that condensation does not occur on the duct pipe material.

Recommend re-wrapping the distribution ducting as needed.

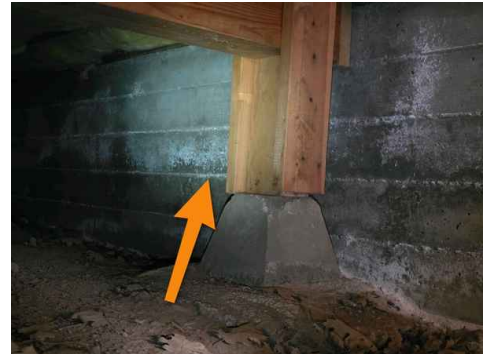
**EFFLORESCENCE NOTED**

- Efflorescence is a powdery or crystalline deposit—usually white, gray, brown, or yellow—on or underneath the surface of various types of masonry.
- It is the result of water dissolving certain salts, migrating to the surface of the masonry, and evaporating to leave behind salty deposits.
- Although unsightly, it is usually not a threat to the masonry unless treated improperly.
- Efflorescence can often be prevented with the right construction methods or treated when it becomes visible.

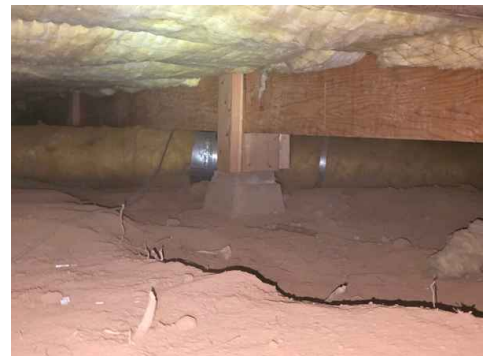
**RESTRICTED ACCESS**

Not all areas were accessible. Ductwork, obstructions, and/or limited clearance between the soil and framing limited inspection. If a more complete evaluation of the crawlspace is required, recommend consulting a qualified contractor to remove dirt in the tight areas to allow for access.

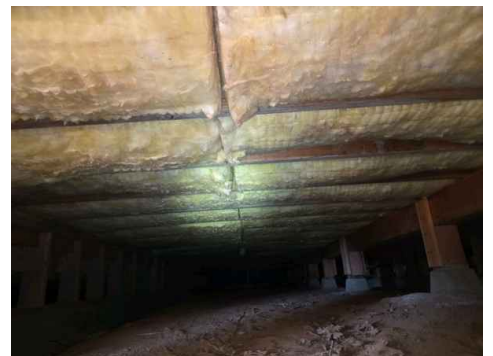
**NO VISUAL**

The substructure is not fully visible due to restricted access and/or insulation blocking view.

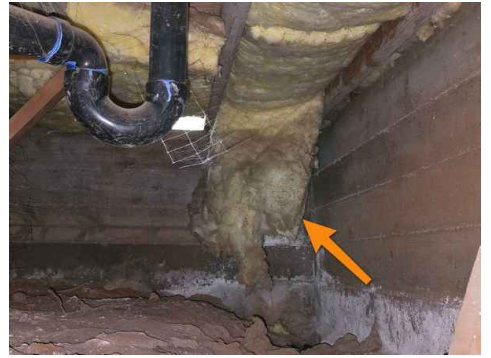
**MISSING/FALLING DOWN**

Portions of the insulation is damaged or falling down. Suggest securing or replacing insulation as needed.

Contact a qualified professional.

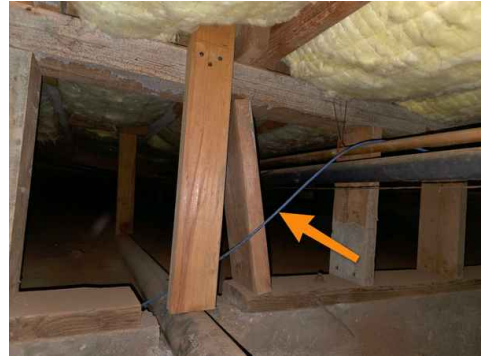
**UNSECURE**

Some piers and posts are improperly or unsecured. Recommend further review and repair by a qualified contractor.

Contact a qualified professional.

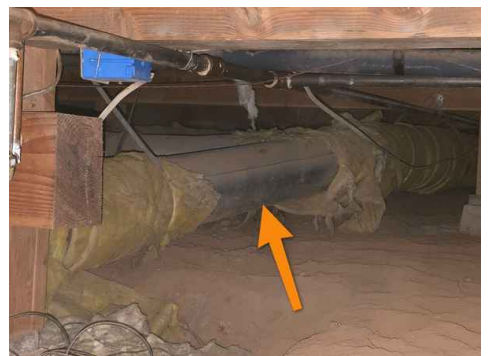
**INSULATION MISSING, DETERIORATED**

Contact a qualified HVAC professional.
