OFFICE OF THE INSPECTOR GENERAL
CITY OF BALTIMORE

Investigative
Report Synopsis

OIG Case # 26-0022-I

Site Visit DOT Signs and Markings Facility

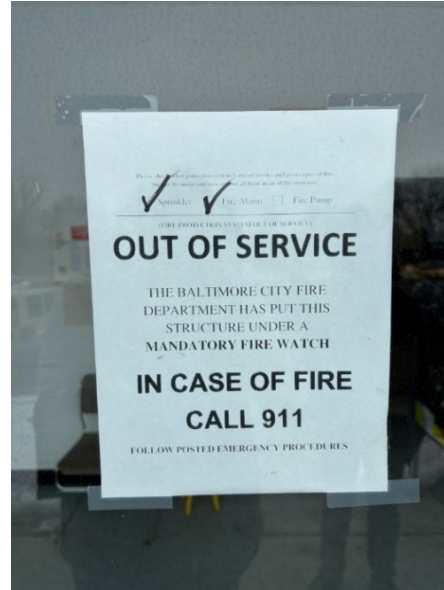
Figures 2&3: Front door of DOT Facility and fire watch sign from February 17, 2026, OIG site visit

The OIG conducted a site visit to the DOT facility on February 17, 2026. Affixed to the entrance door was a fire watch sign noting that the facility does not have working sprinklers or alarm system (Figures 2&3). When the OIG asked DOT personnel about the fire watch they stated the building has been like this for years.

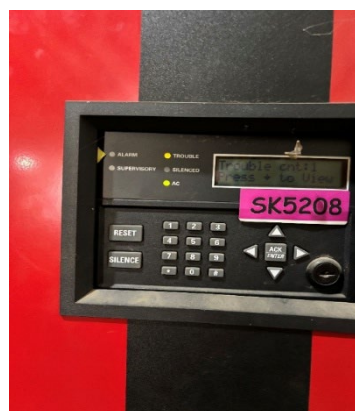
Figures 4 & 5: Expired (2019) fire extinguisher and fire alarm system control pad from 2024 BCFD inspection

After the site visit and becoming aware of the fire watch, the OIG obtained the original BCFD report that documented the initial violations of International Fire Code (IFC) including an expired extinguisher (Figure 4) and alarm system malfunction (Figure 5). The photos depicted an extinguisher that was last checked in 2019 and was expired by three years at the time of BCFD’s inspection. The alarm control pad indicated “trouble” on the screen and was lit up next to the word trouble in a user notification.

The OIG found in the BCFD entry that many of the issues have persisted since 2019. Upon speaking with BCFD personnel, the OIG learned that these issues were not known until the 2024 inspection which forced BCFD to put

the building under a Level II fire watch.
