# **OFFICE OF THE INSPECTOR GENERAL**

## **CITY OF BALTIMORE**

## **Investigative Report Synopsis**

**OIG Case # 27-0001-I**

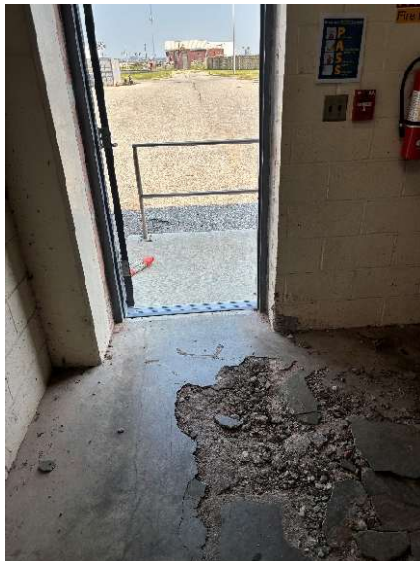
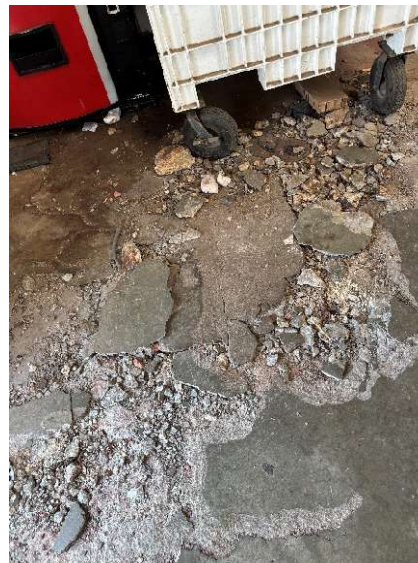
On July 1, 2026, the OIG visited various sections of the Patapsco Plant and spoke to DPW employees onsite. The OIG visited a building that employees referred to as the Return 2 building at the Patapsco Plant. At a door entrance that employees used, the OIG observed cracked and broken concrete flooring (Figures 1 and 2).

*Figures 1 and 2: Flooring at doorway*

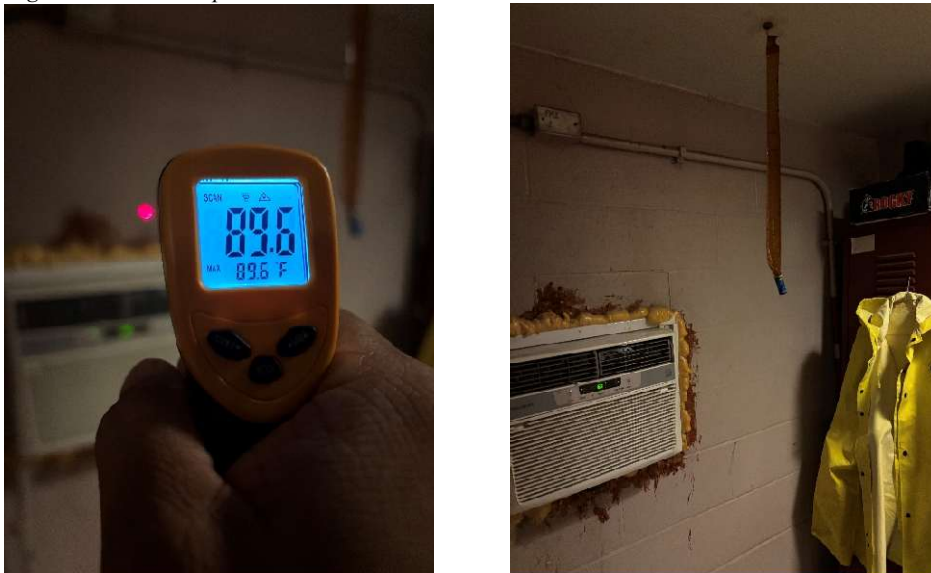
The air-conditioning in the main hallways appeared to work and was cooling the area, but employees reported that it typically does not cool the building. During the site visit, the OIG observed maintenance being performed on the building's air-conditioning. The building's main air-conditioning system does not extend to the men's locker room and other areas. The temperature inside the men's locker room was 89.6°F (Figure 3). The air-conditioner affixed to the wall and secured with seemingly spray foam was

not working despite being set at 60°F (Figure 4). A water cooler was also located in a hallway with water in it.

*Figures 3 and 4: Temperature and air-conditioner in men's locker room area*

With the Code Red Extreme Heat Alert in effect through July 4, 2026, and the National Weather Service's forecast of a [104°F temperature for July 2<sup>nd</sup>](#), the OIG recommended immediate action to be taken to explore alternatives and long-term solutions for reoccurring temperature concerns throughout the summer months.

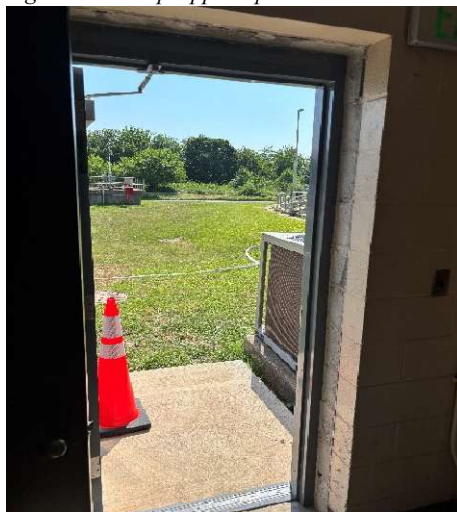
An employee on-site explained that the doors are propped open because there is poor ventilation for the chemicals being used. The employee described being able to see a chemical haze upon arrival in the building (Figure 8).

*Figure 8: Door propped open due to chemical smell*

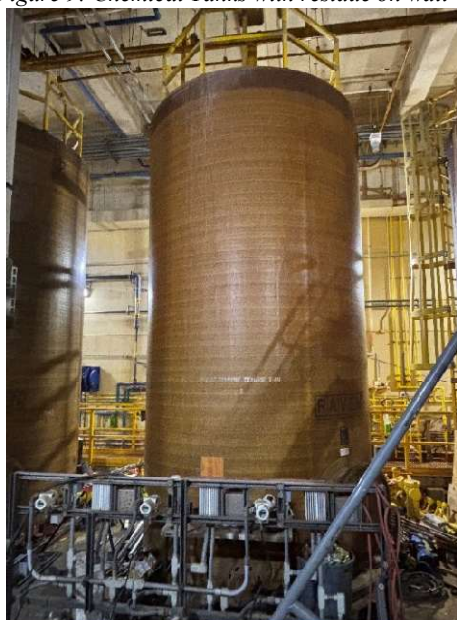
According to an employee, chemicals are used to bind the sludge together inside the building. The chemical room is in the basement of the building. The OIG observed large tanks of the chemicals, which the employee explained contain [ferric chloride](#) and polymer (Figure 9). The OIG observed a ventilation fan that was not working, and the employee reported it has been broken for several years (Figure 10). This may violate Occupational Safety and Health regulations regarding ventilation.<sup>2</sup> The employee stated ferric chloride residue stayed on the walls behind the tanks.

*Figure 9: Chemical Tanks with residue on wall*

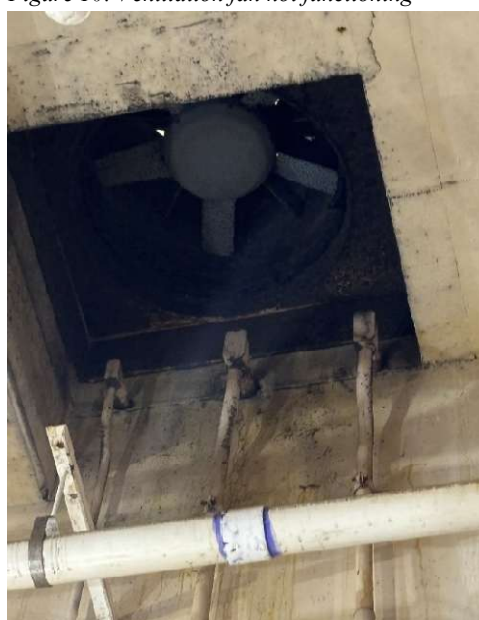
*Figure 10: Ventilation fan not functioning*

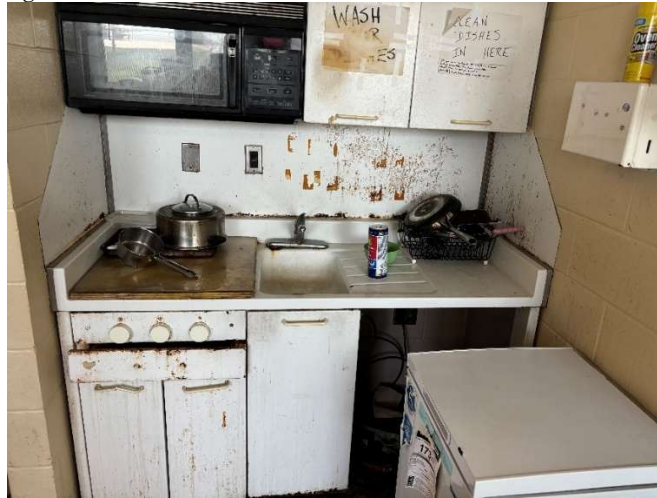
In the employee breakroom, a newer stove was observed, but the kitchen sink, microwave and prep area, were rusting and dirty (Figure 11). The vents in the employee breakroom had an unknown black particulate matter on them (Figures 12&13).

*Figure 11: Kitchen sink and microwave area*

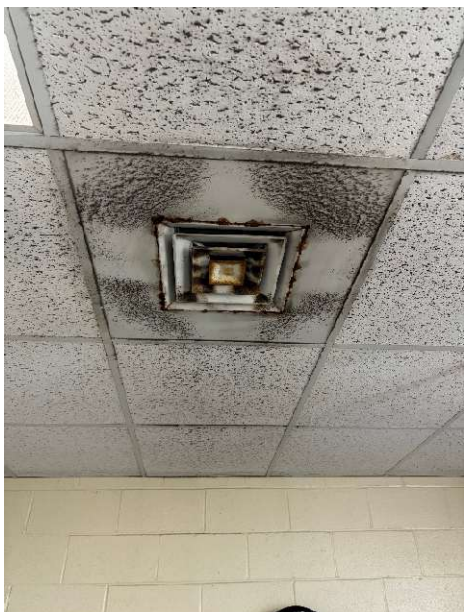
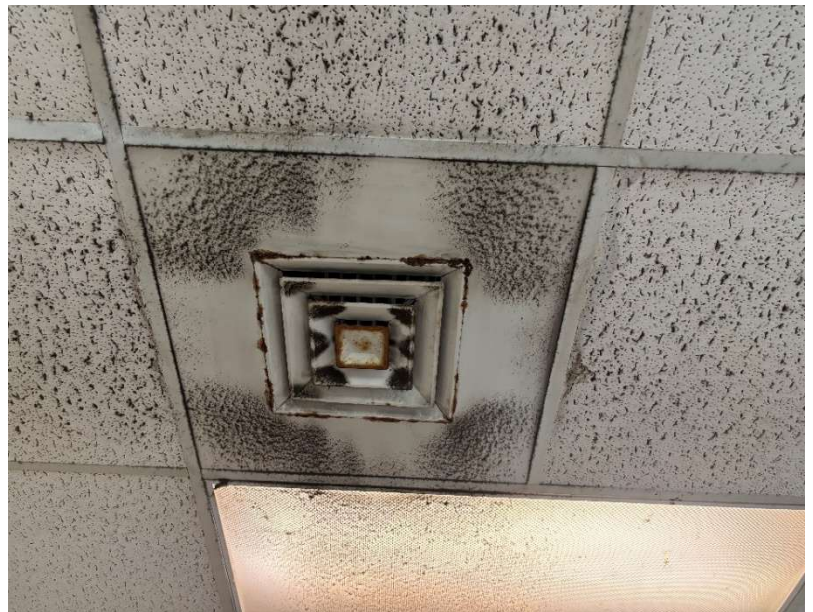
*Figures 12&13: Unknown black particulate matter on vents*

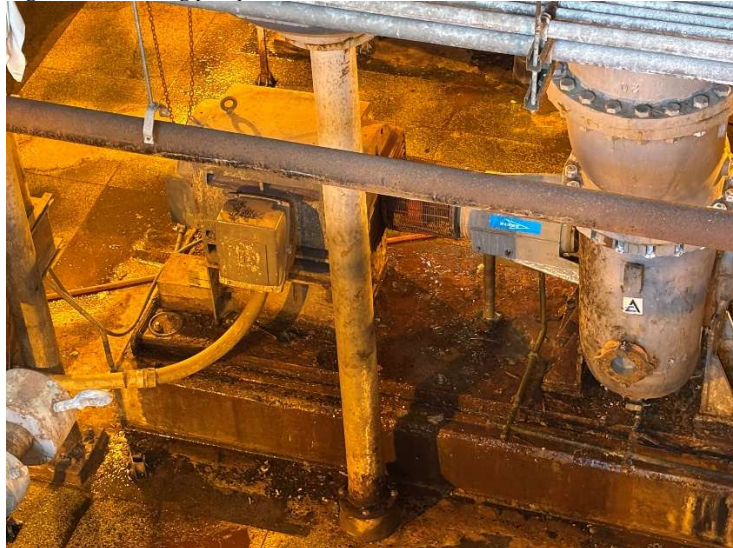
The OIG visited the Pump and Blower building at the Patapsco Plant. The OIG observed a pump that was leaking and pooling on the floor (Figure 14 & Exhibit 1).<sup>4</sup> One employee stated it was leaking, while another employee claimed the pump was supposed to be “dripping” and someone would come to clean it up (Figure 14). The pump area can be visible from the men’s locker room.

*Figure 14: Leaking pump*

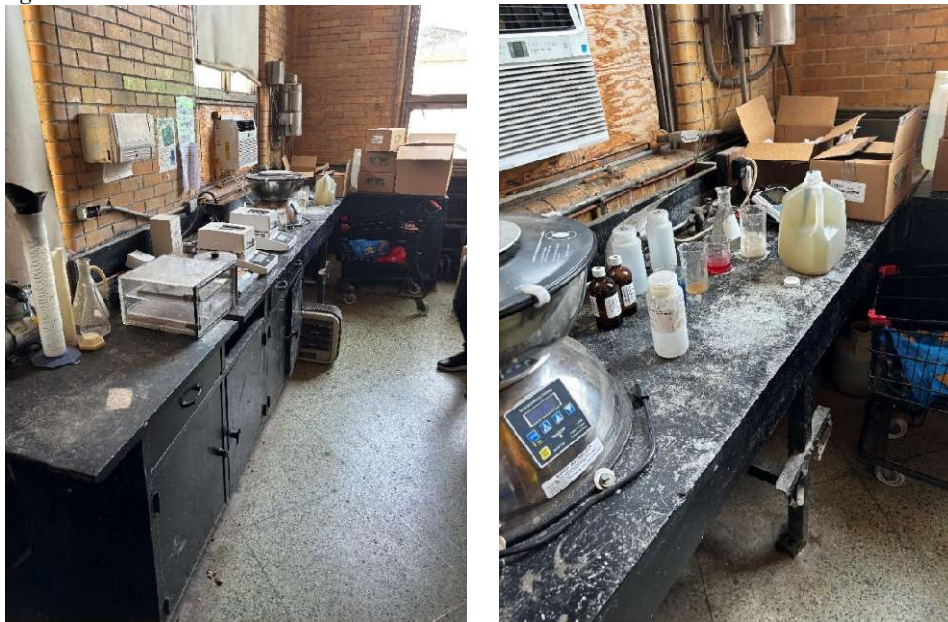
The chemical lab room had an air conditioner affixed to the wall which worked and cooled the room. However, it was reported that there was no working water system in the room, causing the eyewash station to be inoperable and making it difficult to clean the room (Figures 15-17).

*Figures 15-16: Chemical lab room*

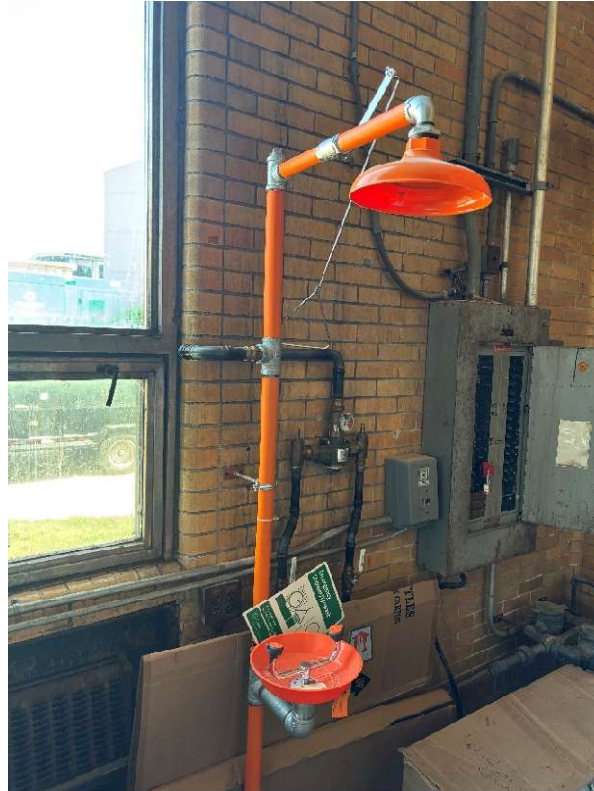
*Figure 17: Eyewash station*

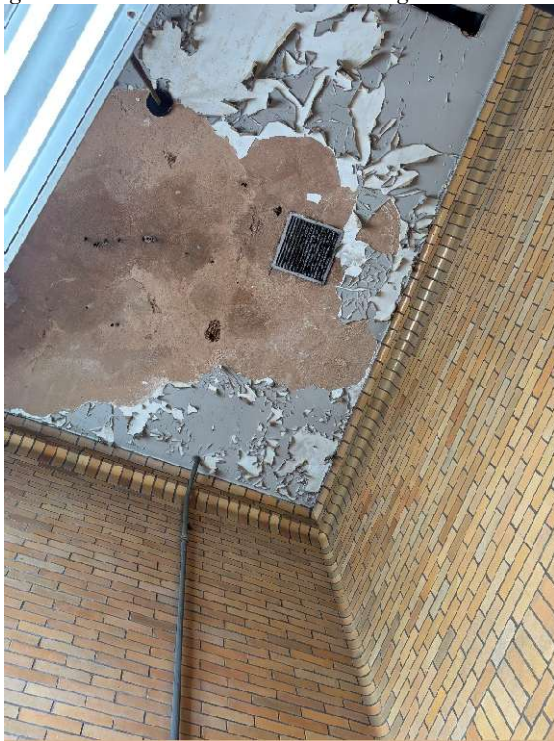
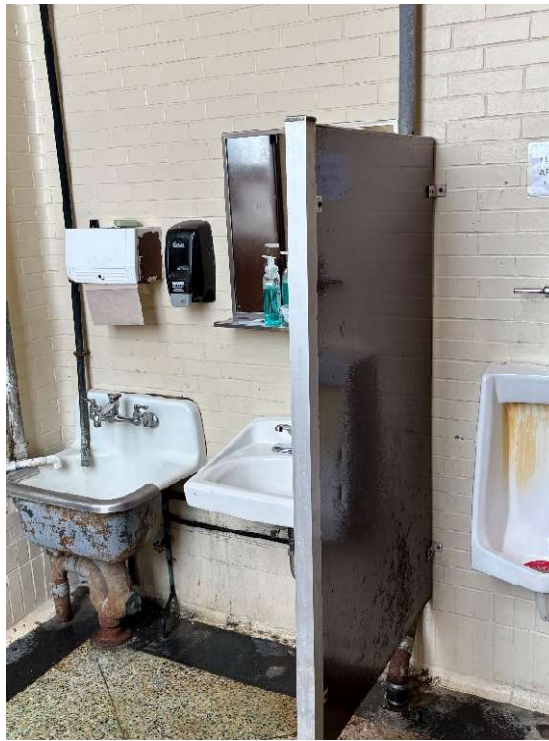
The bathroom in the building also appeared dirty, and there was paint flaking from the ceiling.

*Figures 19&20: Bathroom area and ceiling*
