ADDITIVE BRAZE PREFORMS

Take Turbine Repair to a New Dimension

*How a new technique is transforming
previously unrepairable components*

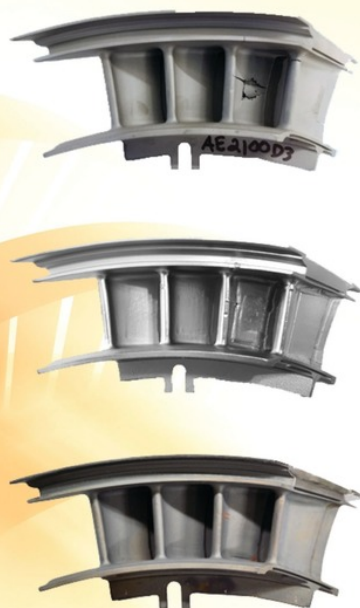
An AE2100 NGV with airfoil damage, after brazing, and after blending and coating.

to promote increased heat exchange and turbulate the cooling air. Damage on the airfoil resulted in a significant impact on the internal cooling geometry, leading to a loss of cooling efficiency and the potential of debris damaging components downstream. To repair this damage, AIM MRO used an additive process that produces high-resolution 3D preforms. This involved adding layers of metal powder and binder on top of each other to create the desired shape. With this capability, it was possible to design WGB patches that included complex cooling features integrated into a patch to restore both internal and external features. The 3D preform patch was brazed much like the AE3007 repair method and then blended to final configuration requirements. This method resulted in a repair that successfully met all metrics set by the program, including internal and external geometry, joint integrity, and cooling airflow. Evaluation of the repaired component showed that a controlled braze flow process, result-

ing in internal air passage with complex geometries, could feasibly be repaired using 3D sintered patches.
