Inspection Report

Property Address:
5201 Old Drybridge Rd
Sandston VA 23150

Burgess Inspections Inc.

Date: 6/7/2021	Time: 09:45:00 AM	Report ID: 060721MS
Property: 5201 Old Drybridge Rd Sandston VA 23150	Customer: Linda Marshall	Real Estate Professional: W. O. (Dubby) Isgett Isgett Auction Marketing

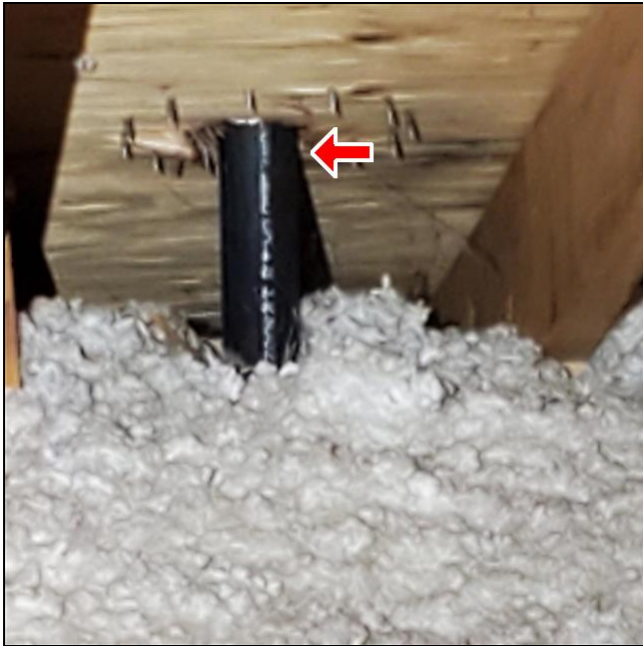
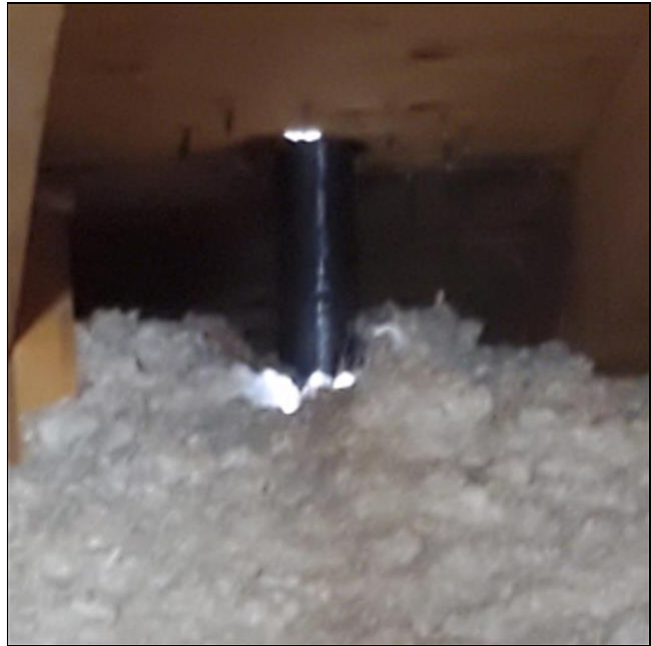
1.2 Item 1(Picture)

Daylight showing at the rear vent stack - unable to view if there is a compromised boot or if this was light shining through, but not compromised. Recommend a qualified roofing contractor correct as needed.

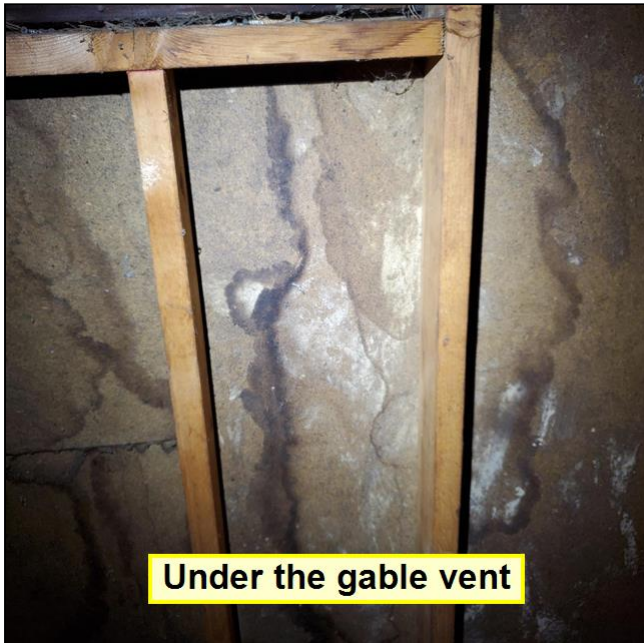
2.0 Item 3(Picture)

(3) Water stains were noted in the attic. There was no moisture at this time and they appeared to be old, however it is beyond the scope of this inspection to determine this or if they will leak in the future. If you have any concerns I would recommend having them further examined by a licensed roofer and repair if needed.

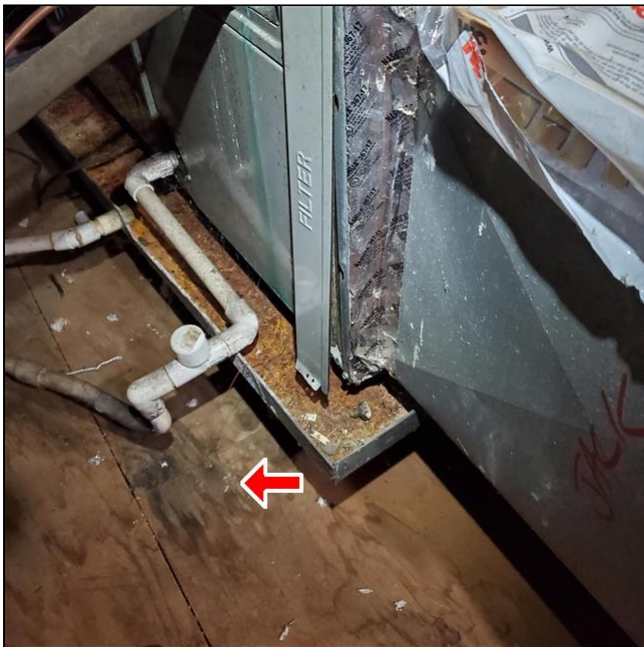
2.0 Item 4(Picture)

(4) There are some moisture stains present in the attic at the area of the overflow pan for the air exchanger. The stains appear to be old, but is beyond the scope of this inspection to determine that. If there is further concern about these stains, I recommend consulting with a qualified licensed HVAC contractor.

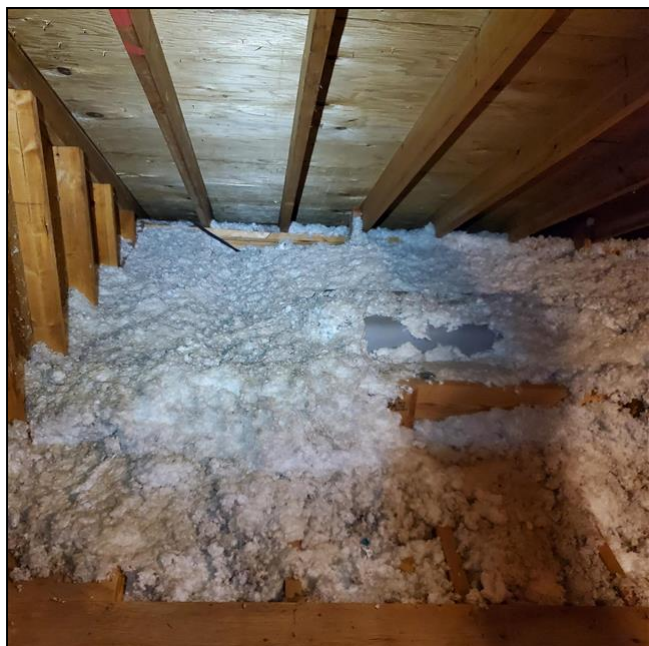
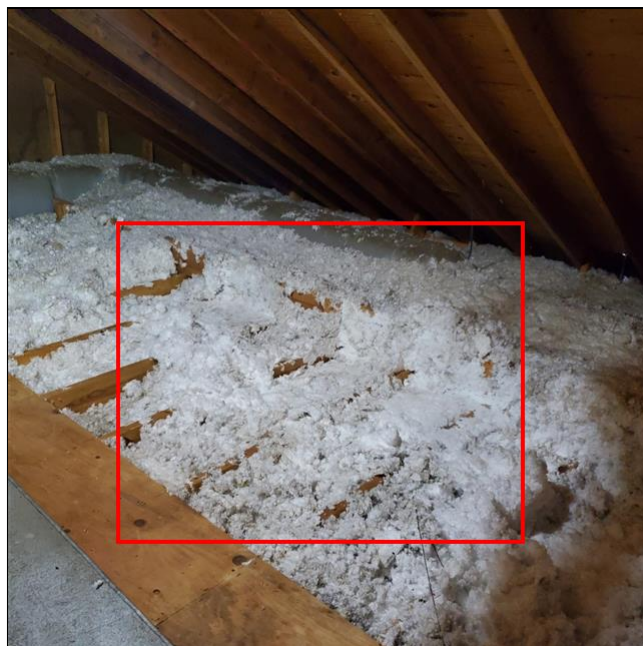
2.1 Item 1(Picture)

some insulation has been compressed by stored items - recommend resetting the coverage as needed.

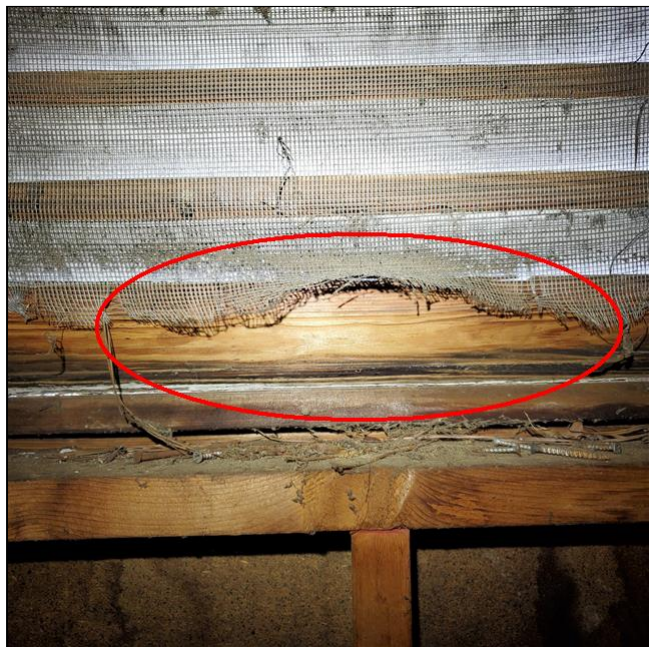
2.2 Item 1(Picture)

Gable screen in the attic is torn and could allow/pest/insects entry into the attic. Secure as needed.

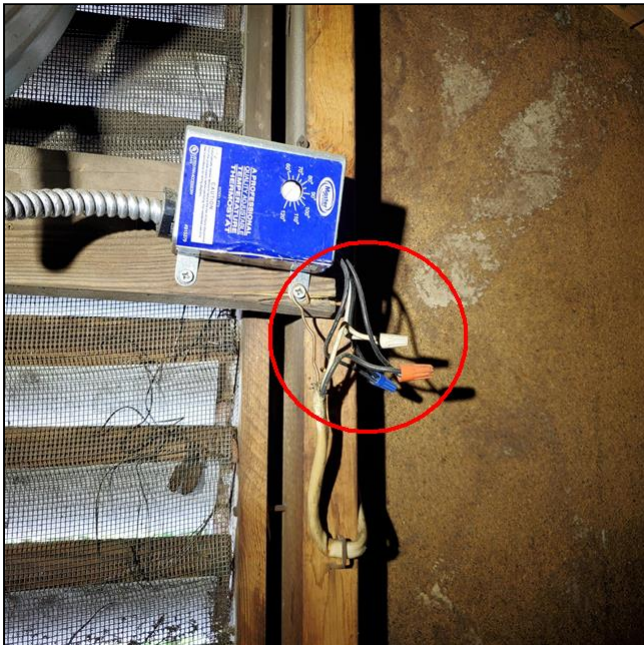
2.4 Item 1(Picture)

Junction wires at the attic thermostatic fan should be boxed. \$75

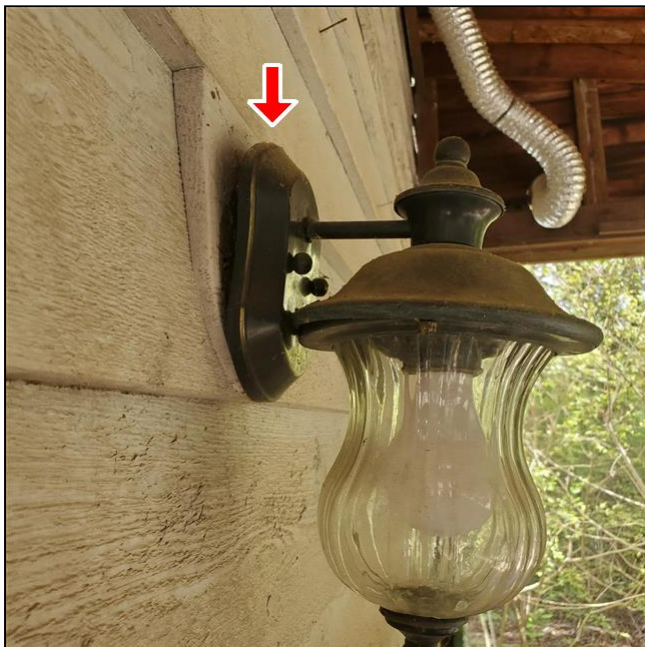
3.0 Item 1(Picture)

- 🏠 (2) Have a qualified person apply a sealant around the base of the light fixture(s) to prevent any moisture from entering behind the base of the fixture. \$75

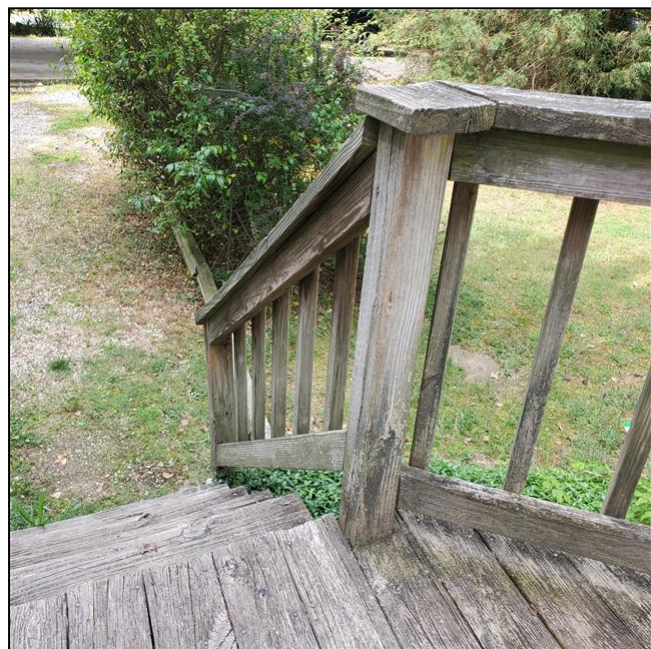
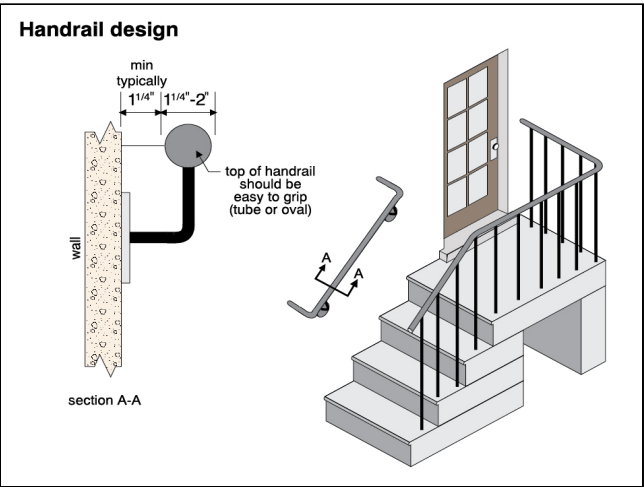
3.4 Item 1(Picture)

(2) As a safety upgrade to bring up to today's current standards I recommend to add a graspable handrail at the steps pictured.

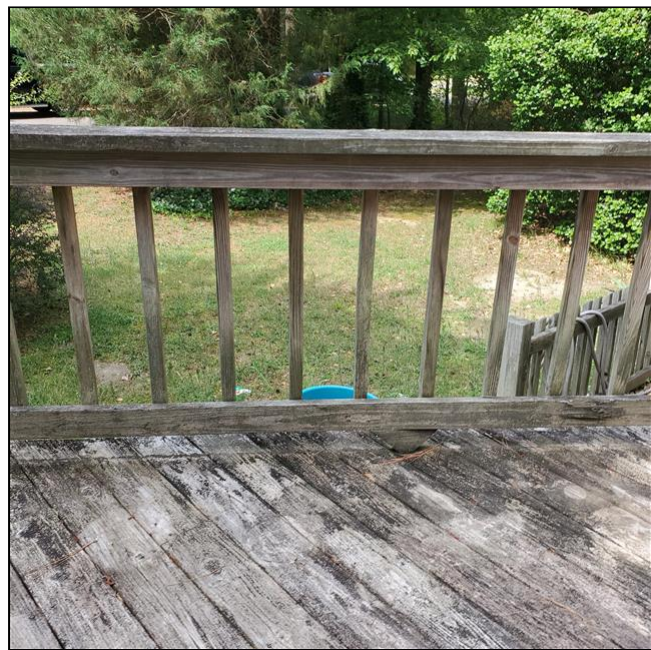
3.4 Item 3(Picture)

(3) As a recommended safety upgrade, I would reduce the spindle spacing on the porch/deck so that openings are no larger than 4 inches at any place along the guardrail. This separation of the pickets has changed over the years and it is beyond the scope of this report to determine what the separation was when the home was built.

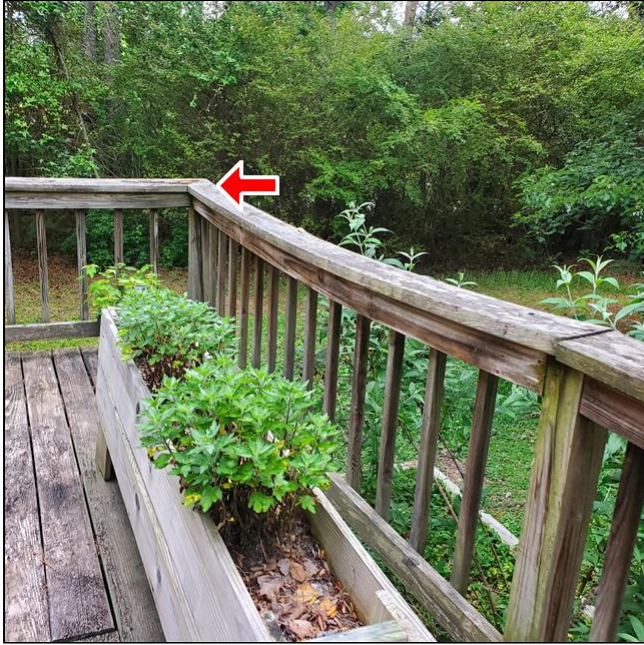
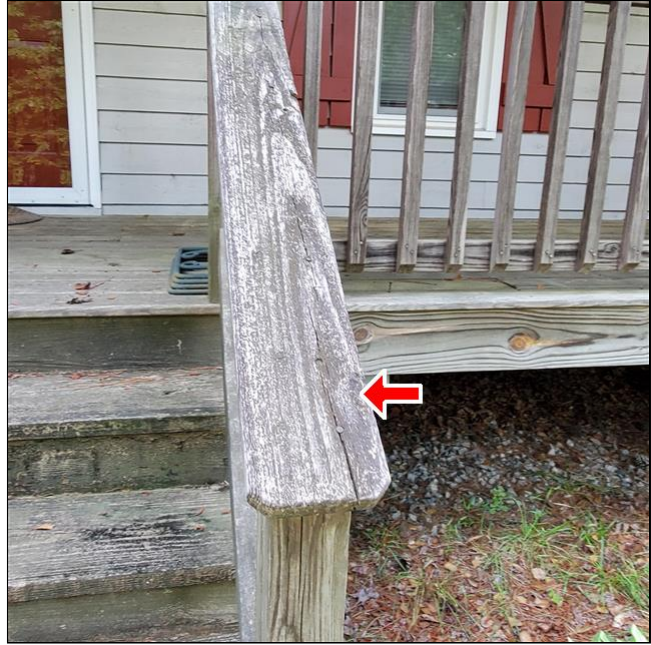
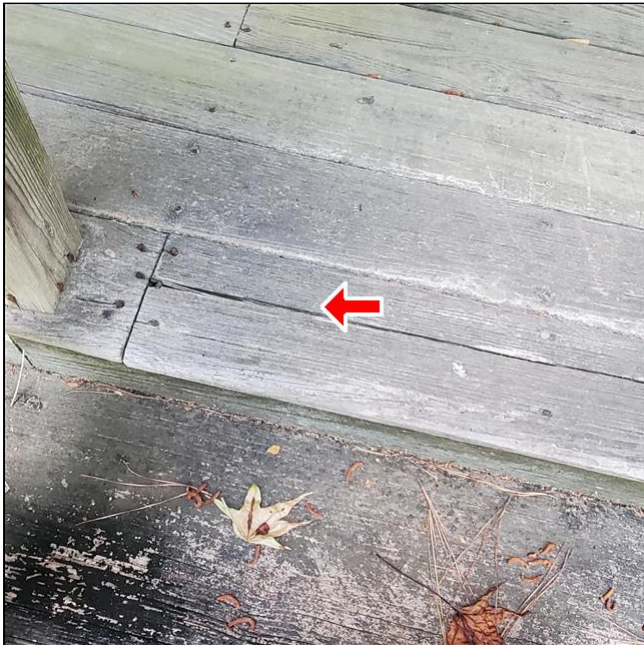
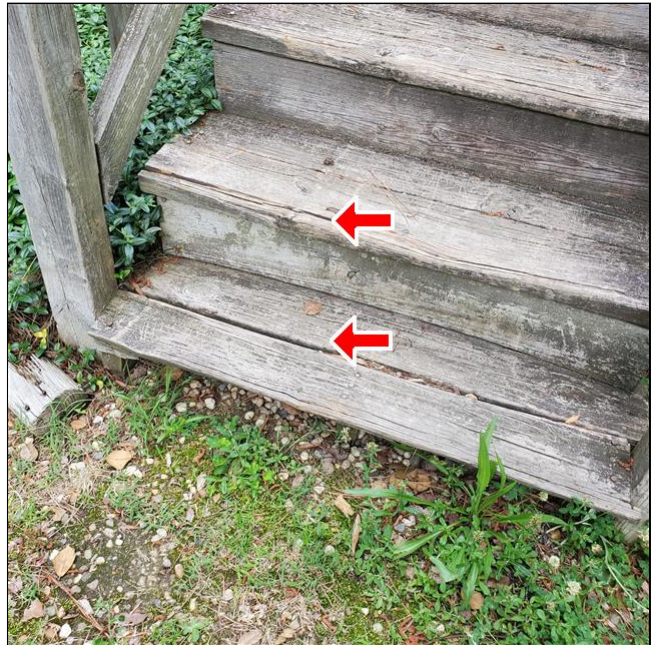
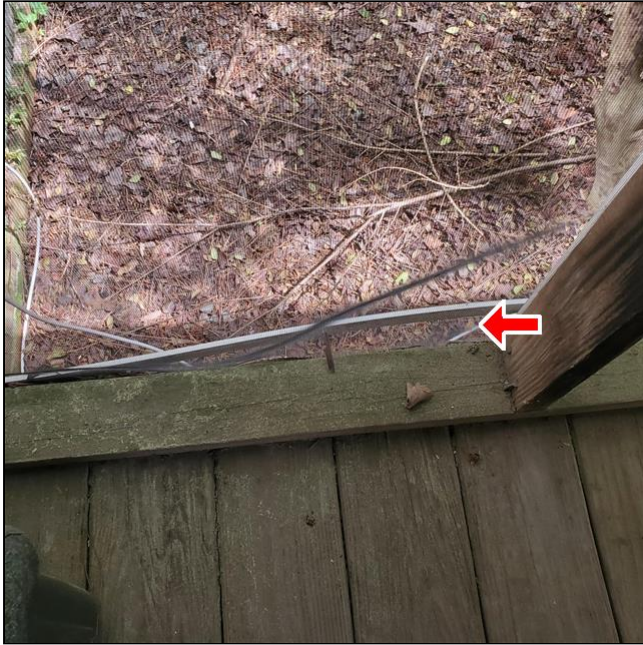
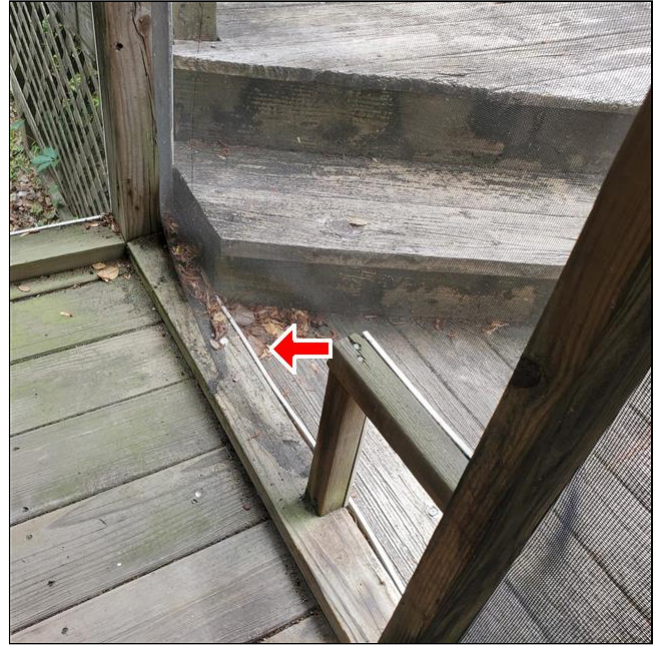
🏠 (4) The top rail at the rear deck is damaged.

Split handrail at the front porch Correct all damaged rails as needed.

Screen and trim damaged at the rear porch exterior

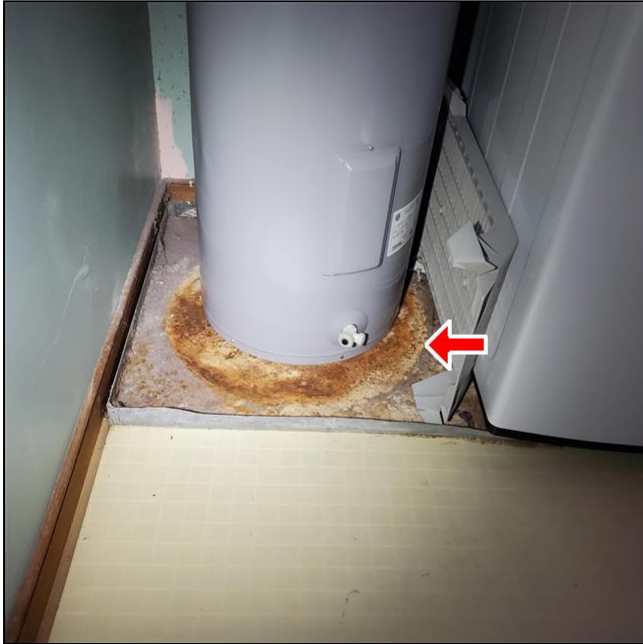
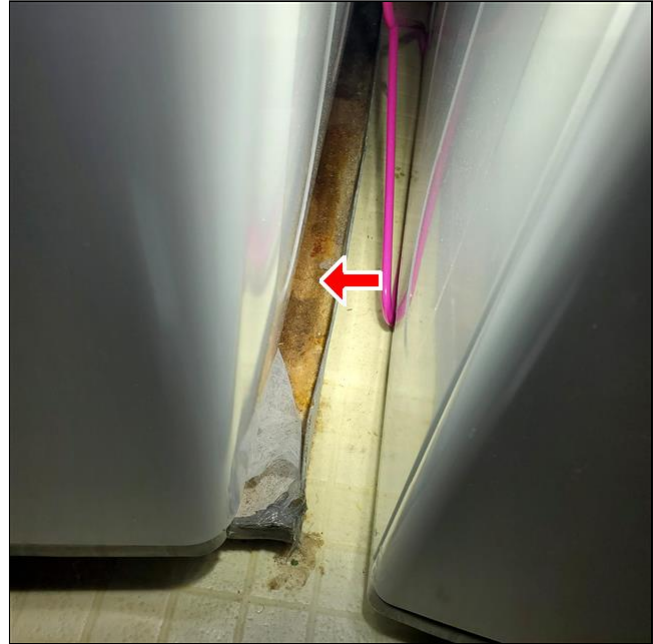
4.6 Item 1(Picture)

(2) The washer / water heater pan has rust in it and indicates a prior problem - I am unable to determine if the pan is compromised and recommend replacement.

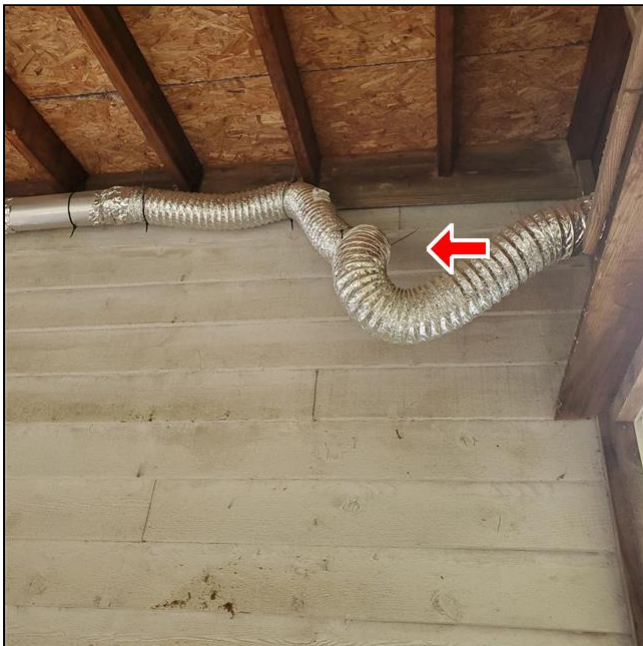
4.7 Item 1(Picture)

(1) As a recommended upgrade, I would use metal duct for the dryer and keep it as straight as possible.

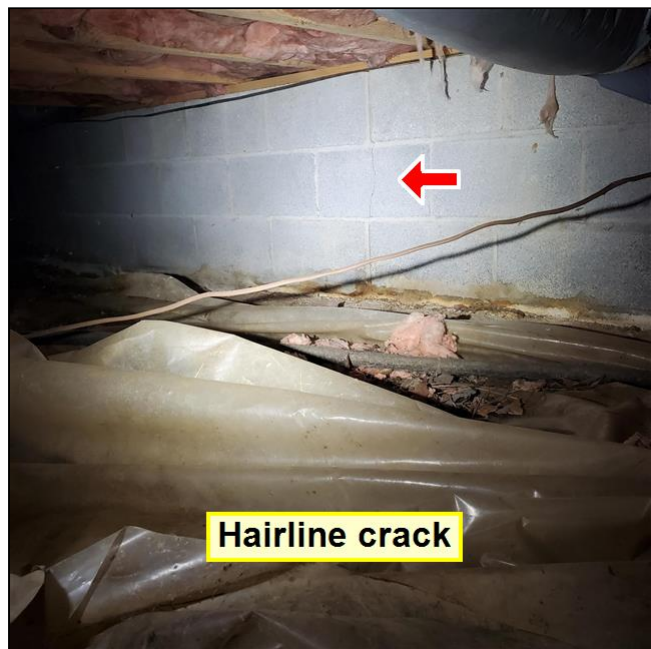
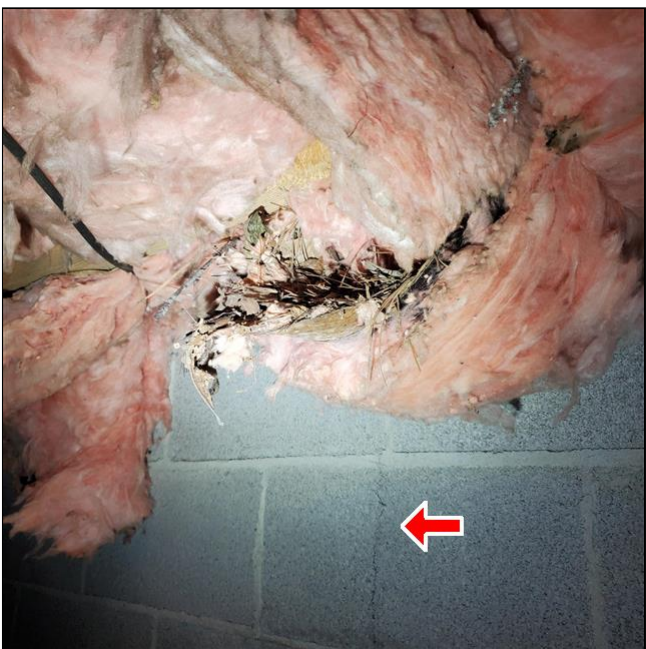
7.0 Item 1(Picture)

There were hairline cracks noted in the foundation mainly at front and left sides. These appear to be from normal settlement, however it is beyond the scope of this inspection to determine this. There was no displacement. If you have any concerns I would recommend having them further evaluated by a licensed person in this field and corrected if needed.

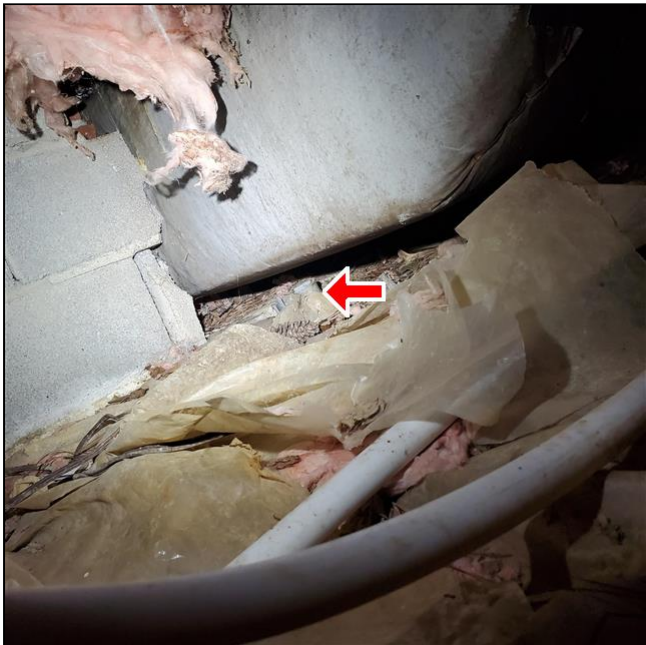
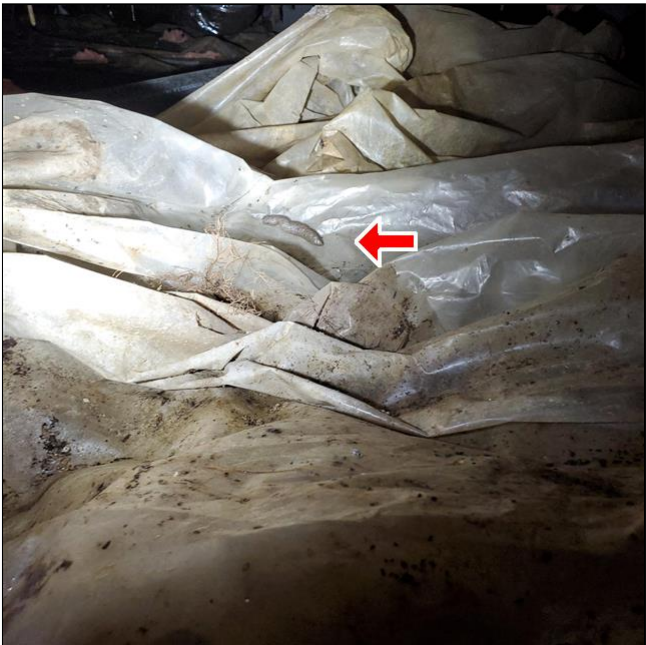
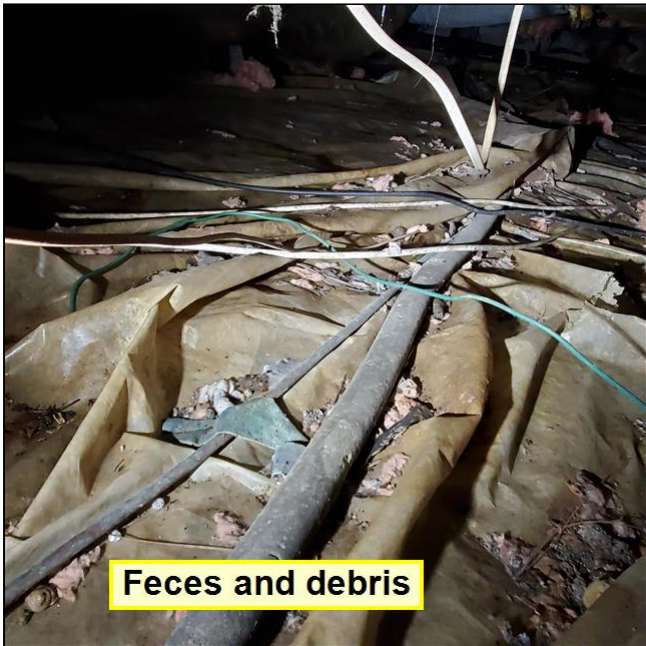
🏠 (2) There are signs of an animal living in the crawl space. There are feces on the surface of the crawl space in random areas. Have a qualified person or company to remove the feces and research the source of a possible rodent living in the crawl space area.

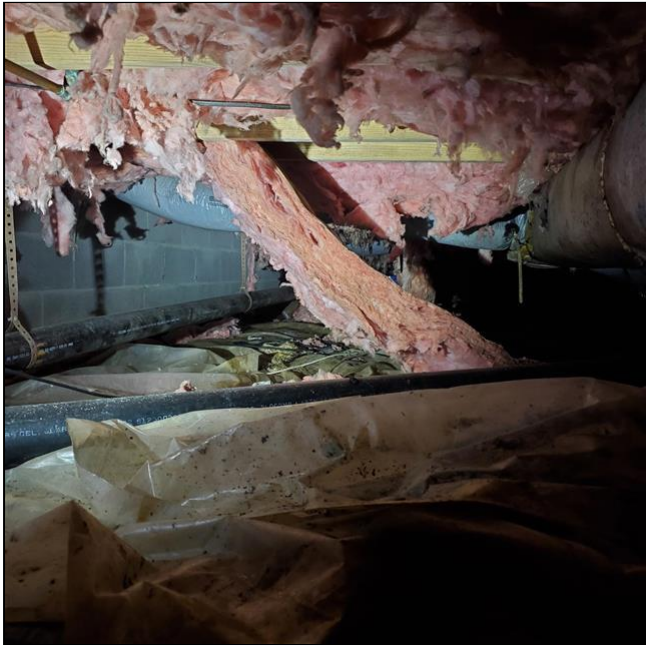
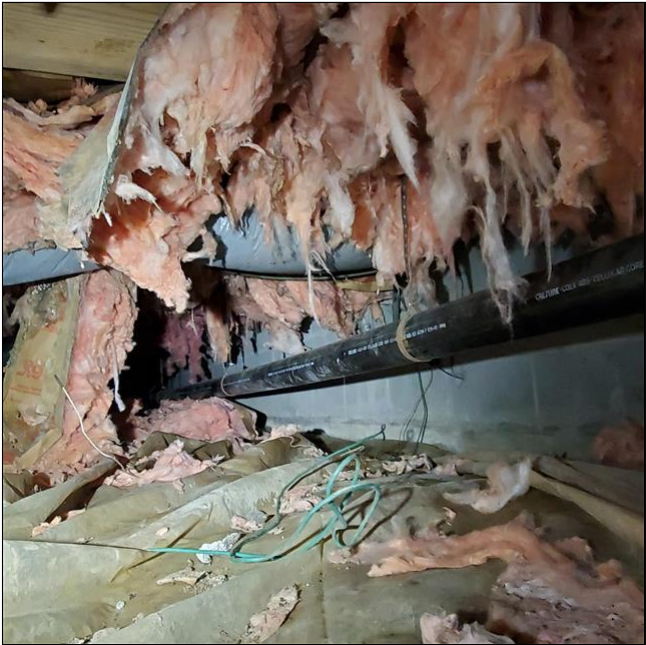
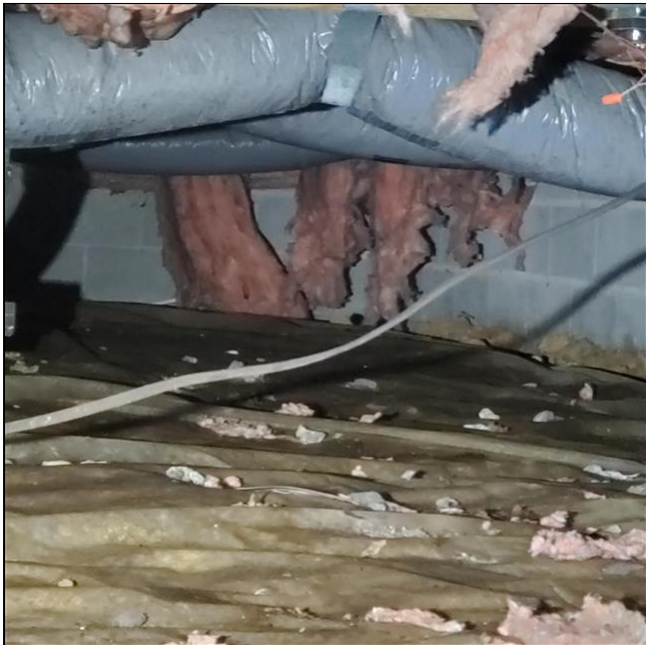
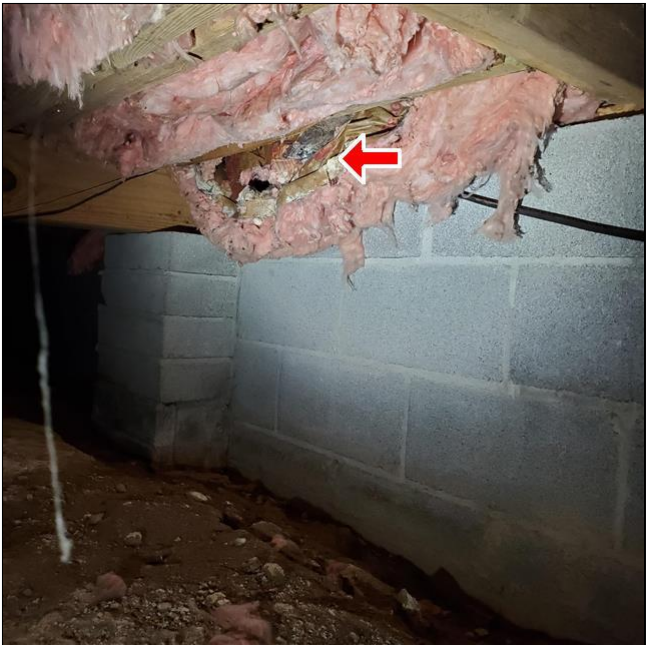
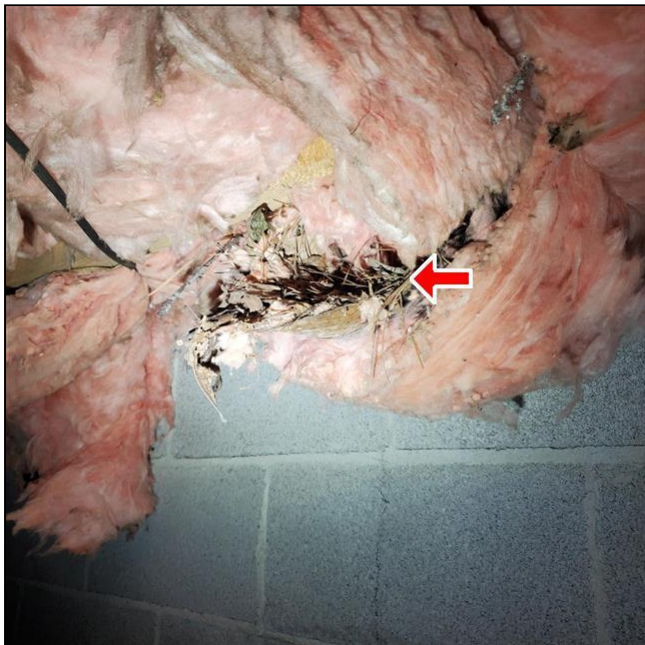
🏠 The condition of the insulation indicates that moisture has effected the insulation and has caused it to hang/drop. Have a qualified/licensed contractor in this field correct the cause of the moisture problem. Repairs may include replacing the damaged insulation when the cause is corrected.

There was a strong urine odor in the crawlspace and evidence of pests - nesting debris/feces etc.

Insulation may need to be replaced. Recommend getting a price quote from a qualified professional in this field.

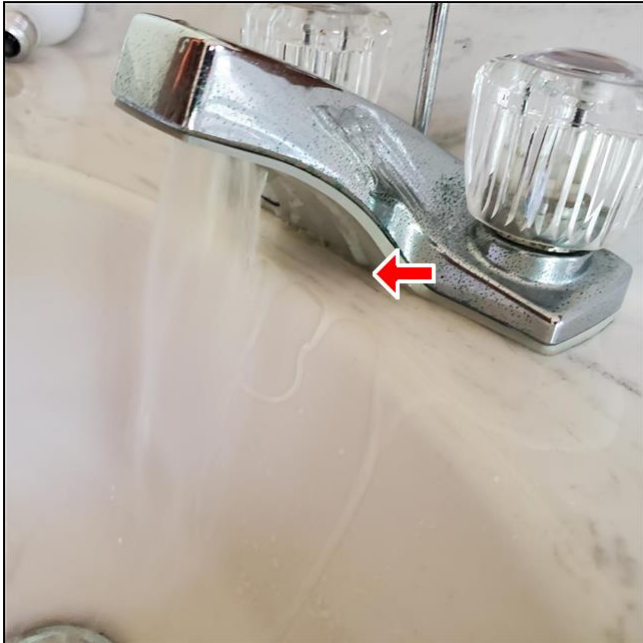
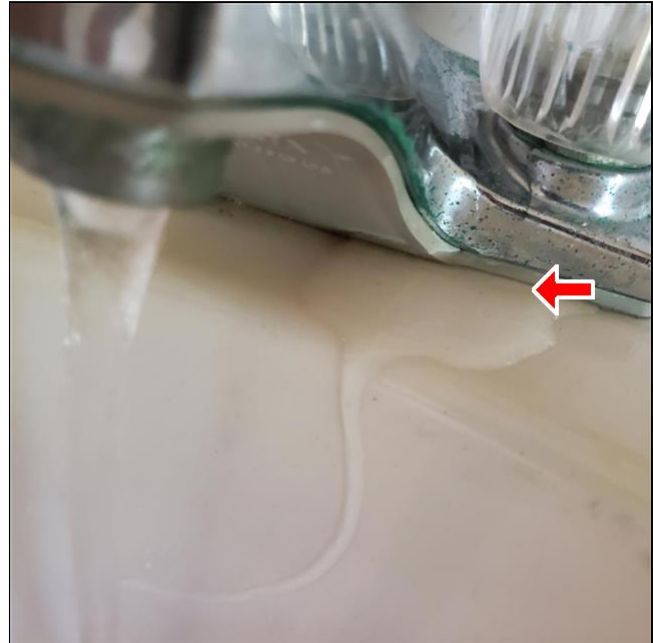
8.1 Item 1(Picture)

(1) Leaks noted at the controls of the master bathroom sinks. \$150-\$300

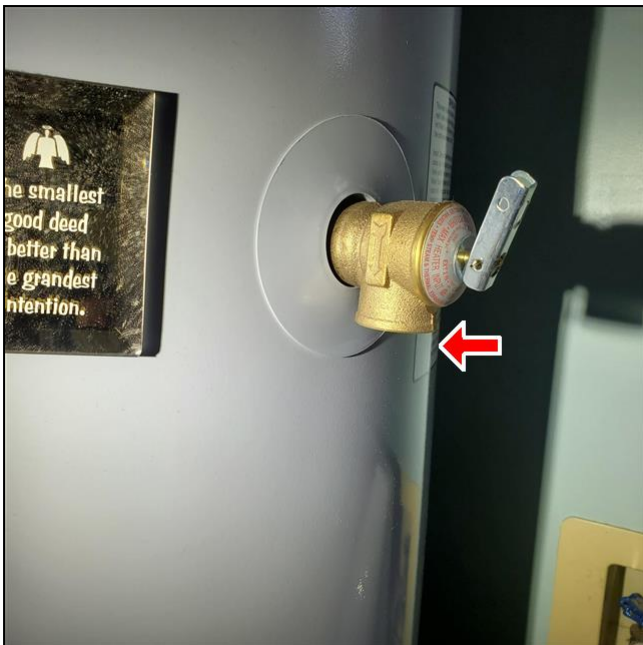
8.2 Item 1(Picture)

(1) There was no pressure relief valve extension. This should be installed by a licensed plumber. Estimated cost \$75 - \$100

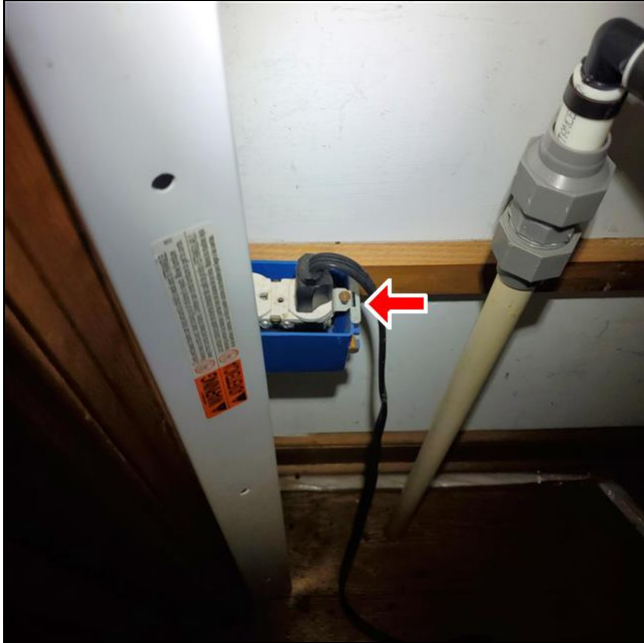
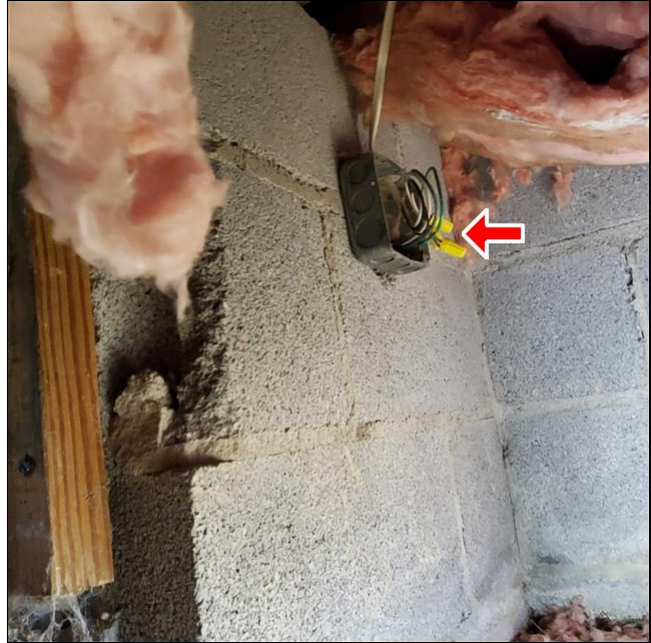
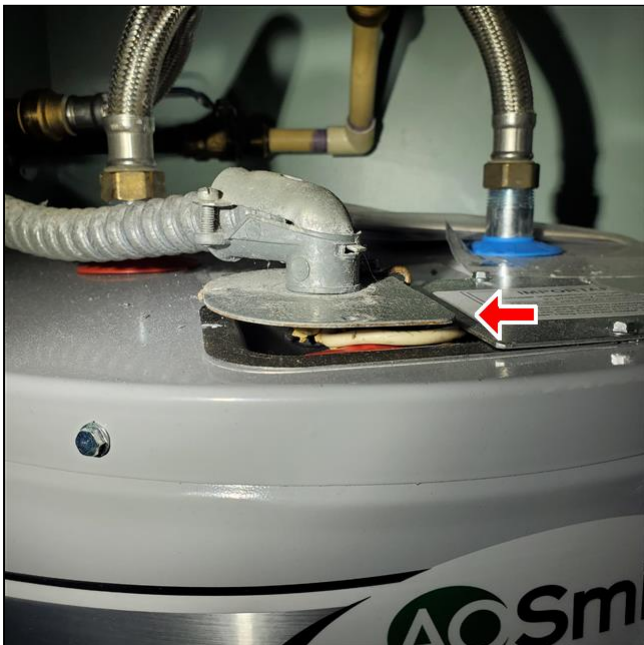
🔧 (1) Missing outlet cover - closet in the kitchen.

Power feed to the water heater is loose

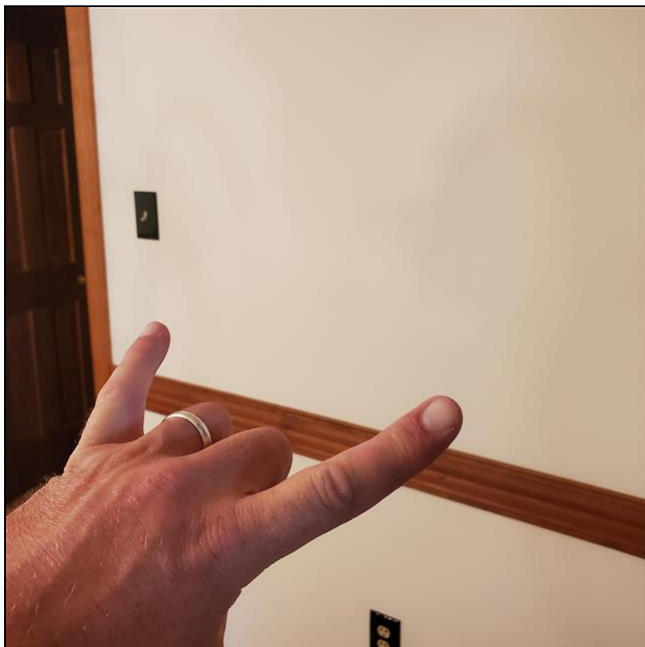
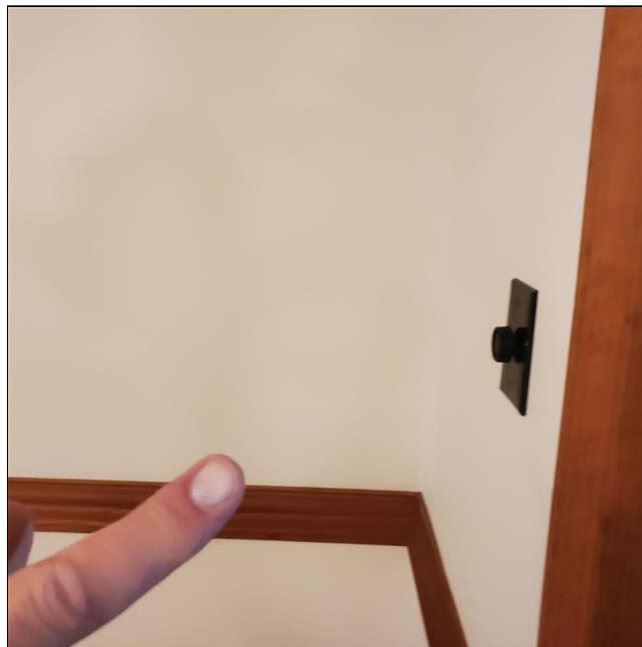
9.3 Item 4(Picture)

- ⚡ (3) Dining room 3 way switch did not work as expected - there has been a dimmer installed which may compromise the intent of a 3 way switch.

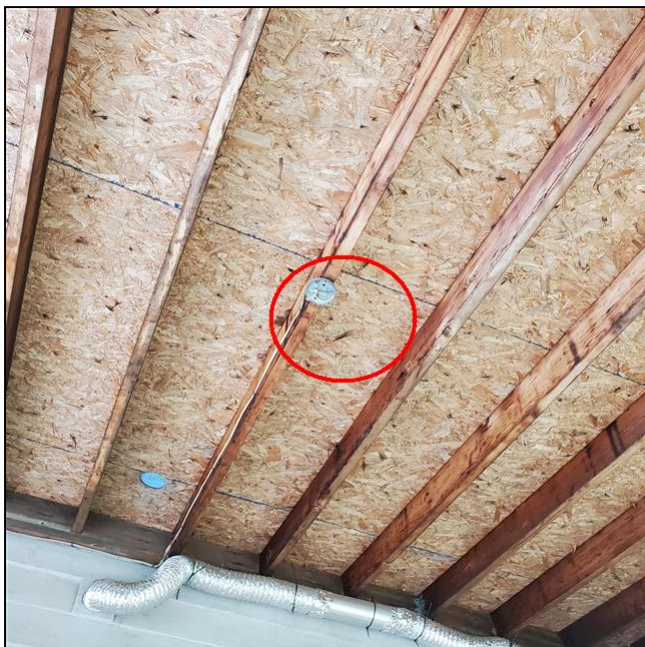
9.3 Item 6(Picture)

- ⚡ (4) Light or fan missing at the rear porch ceiling

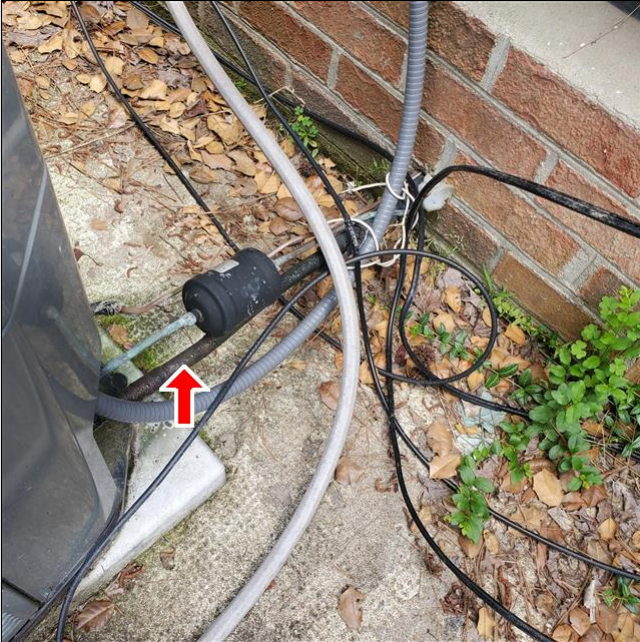
10.3 Item 1(Picture)

(4) The foam sleeve on suction line is missing/damaged in area(s) at the outside unit. Missing foam on suction line can cause energy loss and condensation. Service or repair as needed by a qualified HVAC contractor. \$75-\$100

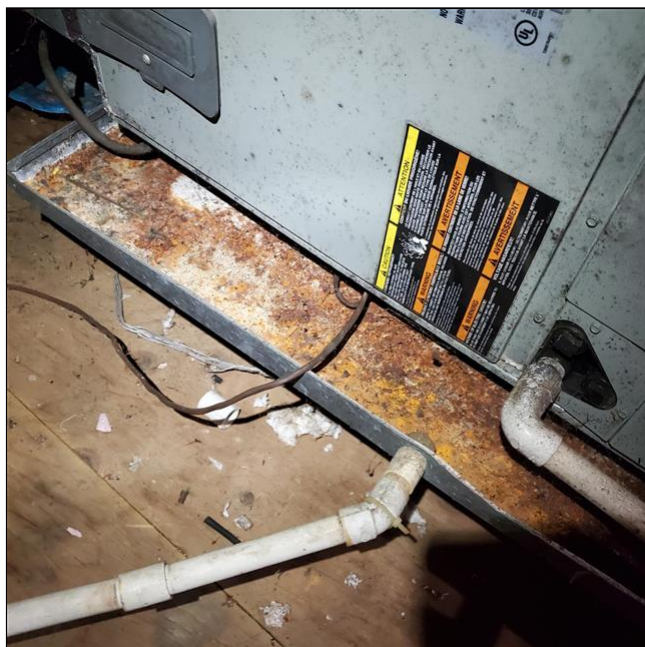
10.3 Item 2(Picture)

(5) The overflow pan has rust in it. This is an indication that the overflow line has stopped up. Recommend having the HVAC system serviced and repaired as needed by a licensed HVAC contractor.

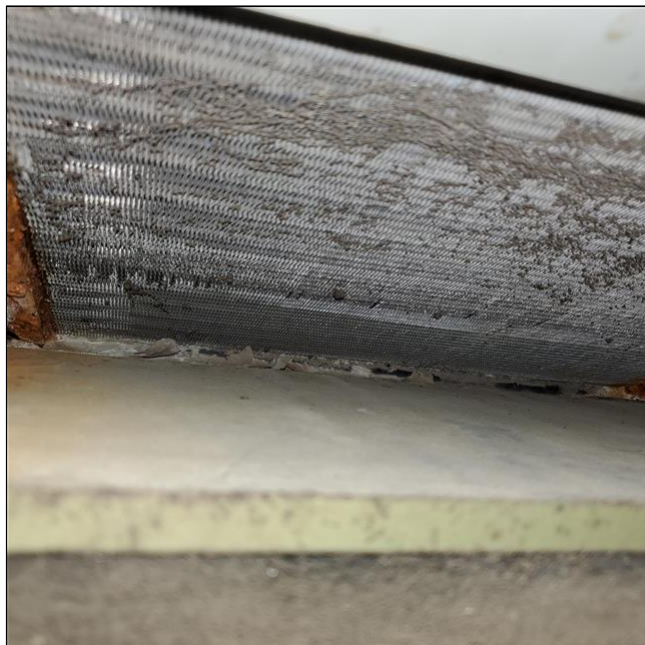
10.3 Item 3(Picture)

(6) The inside coil was dirty and should be cleaned by a licensed professional in this field. \$300-\$500

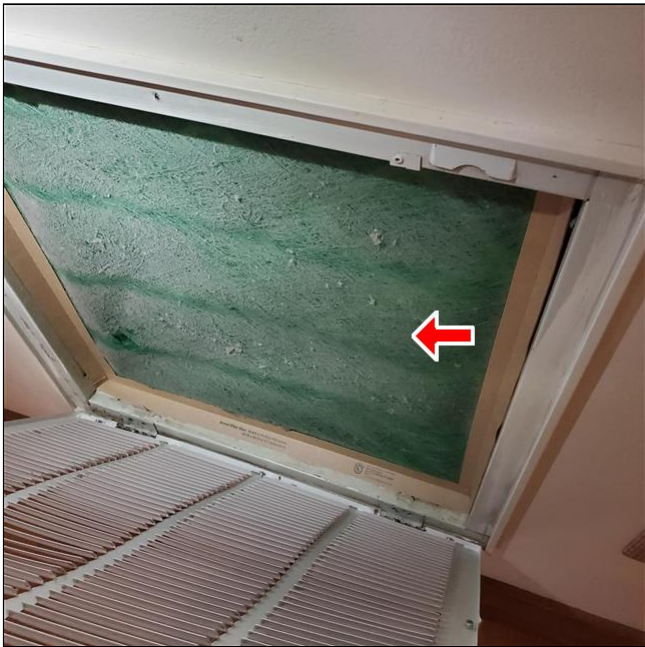
10.4 Item 1(Picture)

(1) The disposable filters were clogged and dirty - both systems. The filters need to be replaced. I recommend replacing as needed using a qualified person.

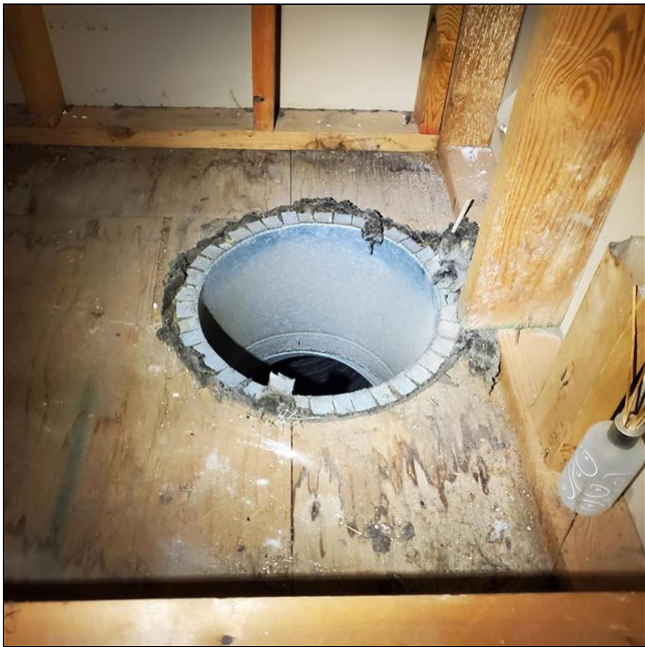
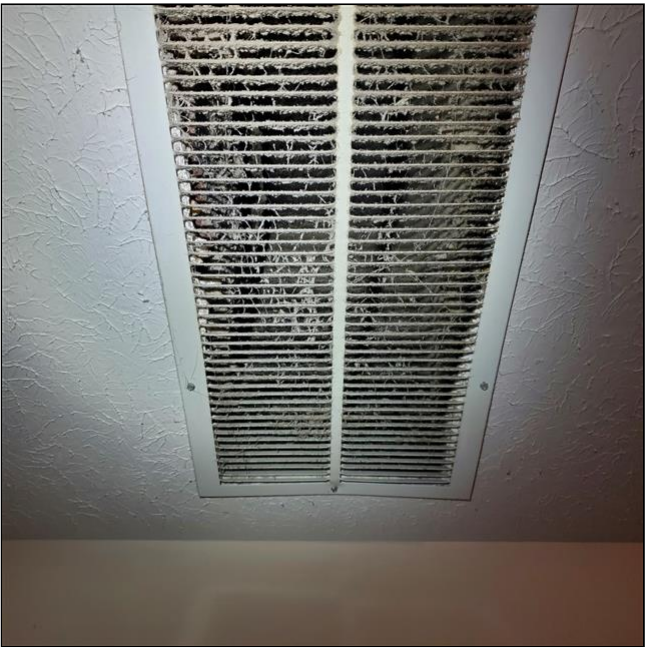
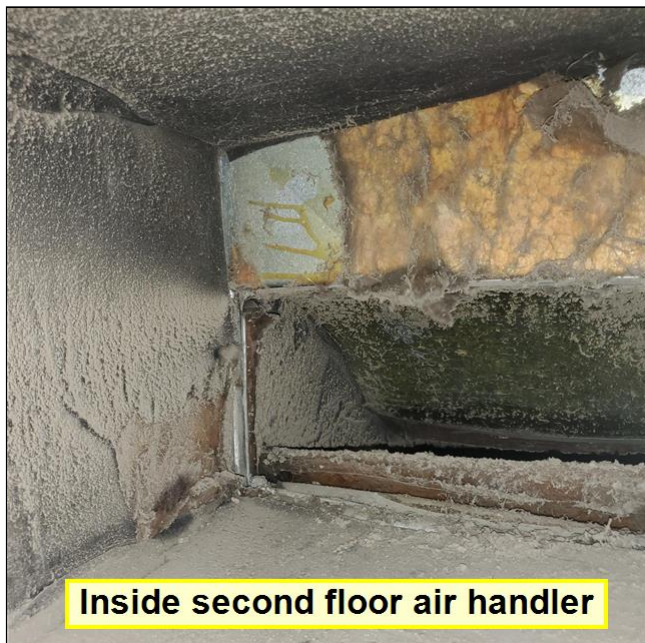
(2) The ducts are dirty. Recommend having them cleaned by a qualified person in this field.

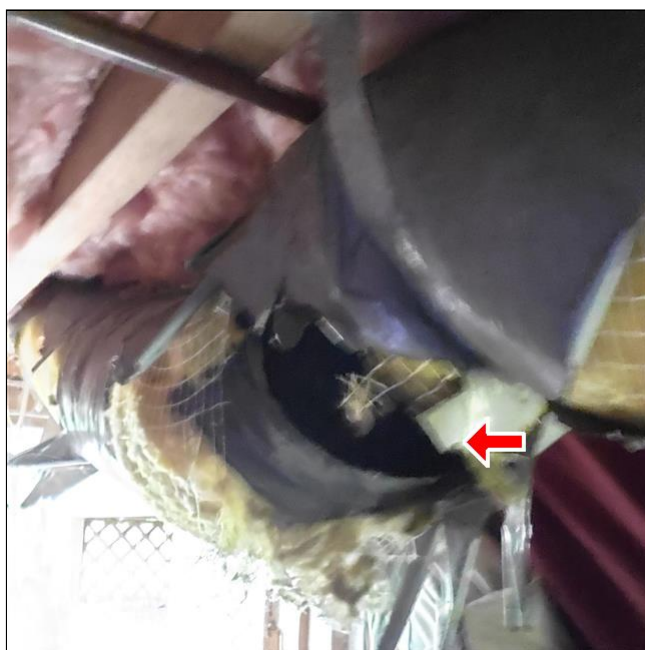
10.4 Item 5(Picture)

(3) Duct in the crawlspace is detached - just inside the rear left crawlspace door

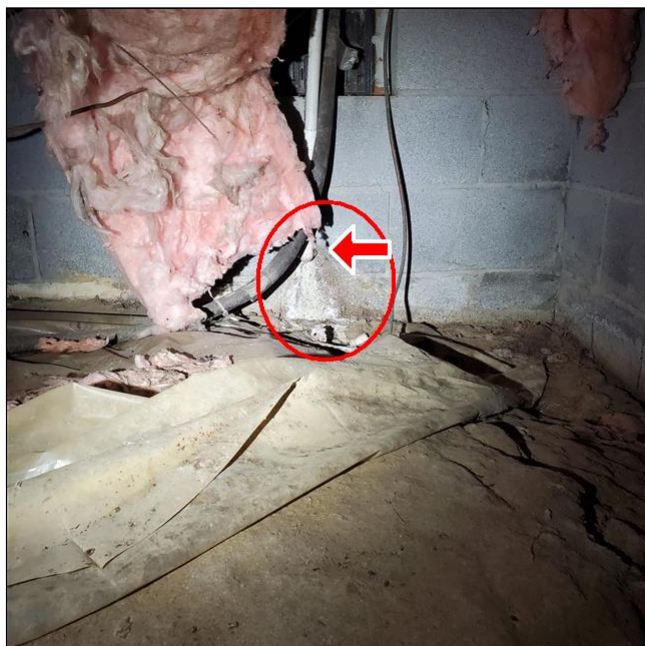
10.4 Item 6(Picture)

(4) Condensate line at the front left corner of the home is leaking - this should be discharging to the exterior.
