## Inspection Report

**Property Address:**  
5311 Hemlock Rd  
Quinton VA 23141

**Burgess Inspections Inc.**

<b>Date:</b> 7/15/2021	<b>Time:</b> 12:00 AM	<b>Report ID:</b> 071521MSp
<b>Property:</b> 5311 Hemlock Rd Quinton VA 23141	<b>Customer:</b> Phoniex Guthrie	<b>Real Estate Professional:</b> W. O. (Dubby) Isgett Isgett Auction Marketing

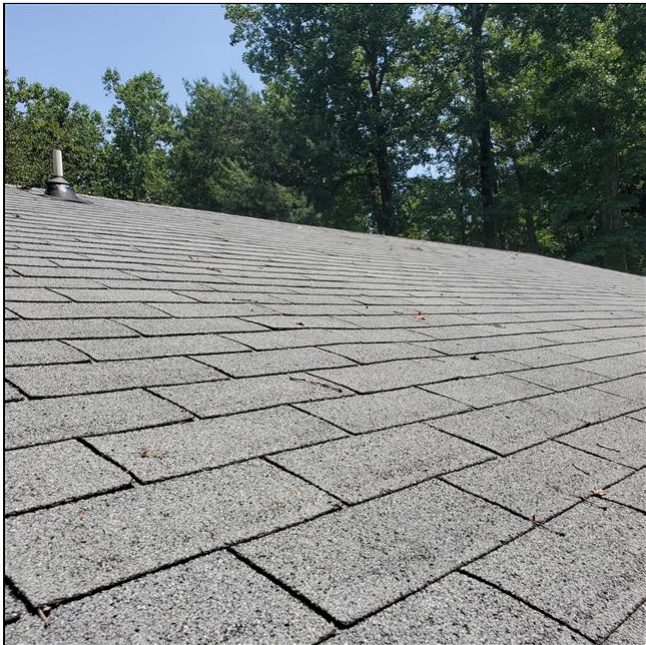
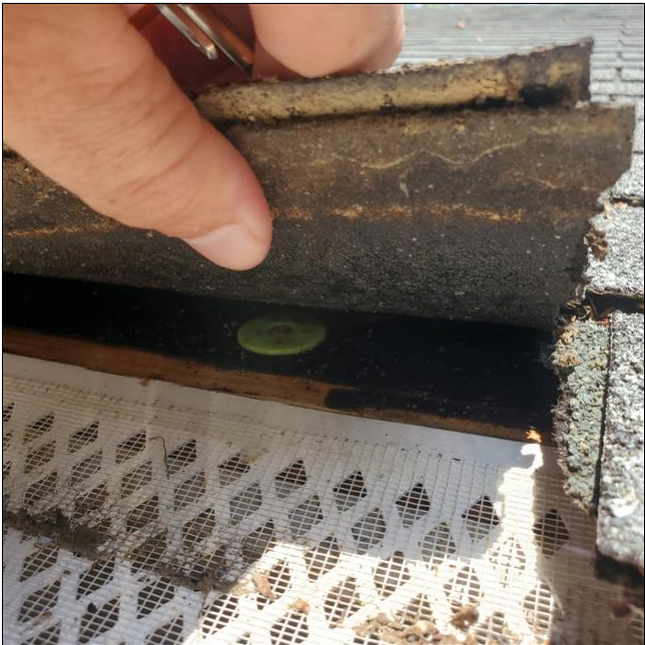
1.0 Item 1(Picture)

Roof covering is old. I recommend getting a qualified roofing company to provide a detailed price quote for a roof covering replacement.

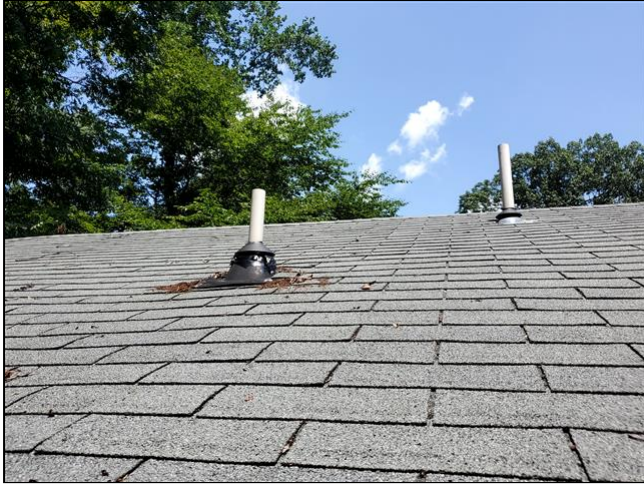
1.2 Item 1(Picture)

The plumbing boot (s) have tape wrapped around the pipe and do not appear to be standard vent boot repairs. Correct all as needed. Refer to photos for examples. \$300- \$400

The plumbing boot (s) have tape wrapped around the pipe and do not appear to be standard vent boot repairs. Correct all as needed. Refer to photos for examples. \$300- \$400

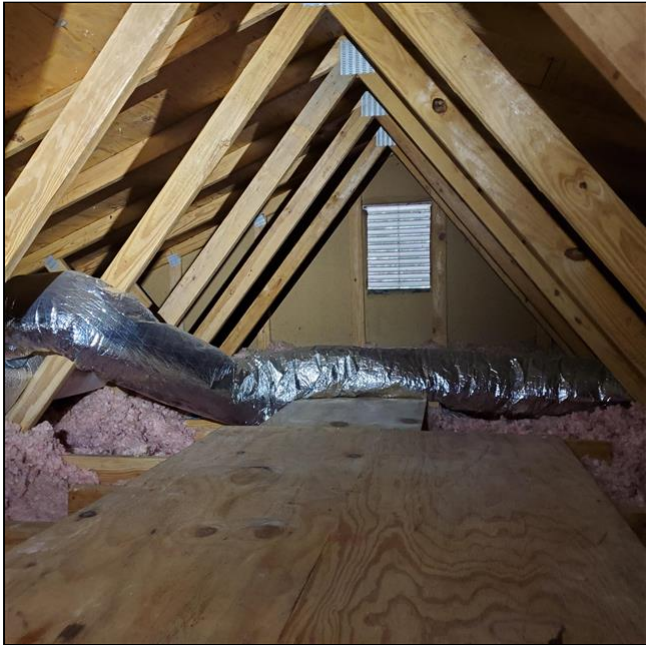
2.0 Item 1(Picture)

**Comments:** Inspected  
(1) The attic is in good condition.

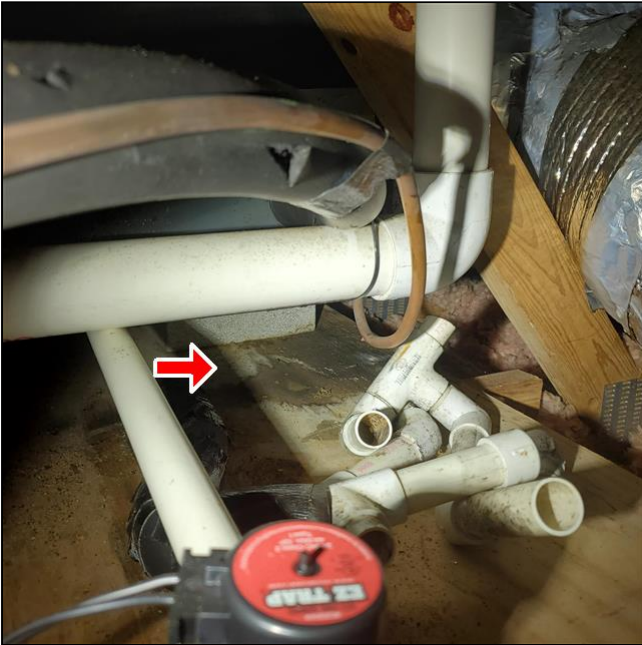
2.0 Item 2(Picture)

(3) There are some moisture stains present in the attic at the area of the overflow pan for the air exchanger. The stains appear to be old, but is beyond the scope of this inspection to determine that. If there is further concern about these stains, I recommend consulting with a qualified licensed HVAC contractor.

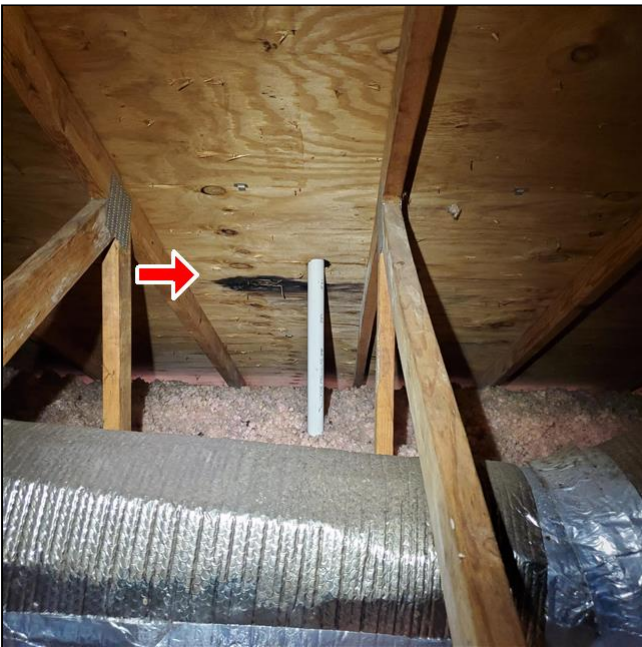
2.0 Item 3(Picture)

(4) There are signs of leaks on the roof. It appears to be old, but it is beyond the scope of this inspection to determine if this correct. Sometimes a roof will not leak until the wind blows the water in a certain direction. If you have concerns about this roof leaking in the future, I recommend having it checked by a qualified person.

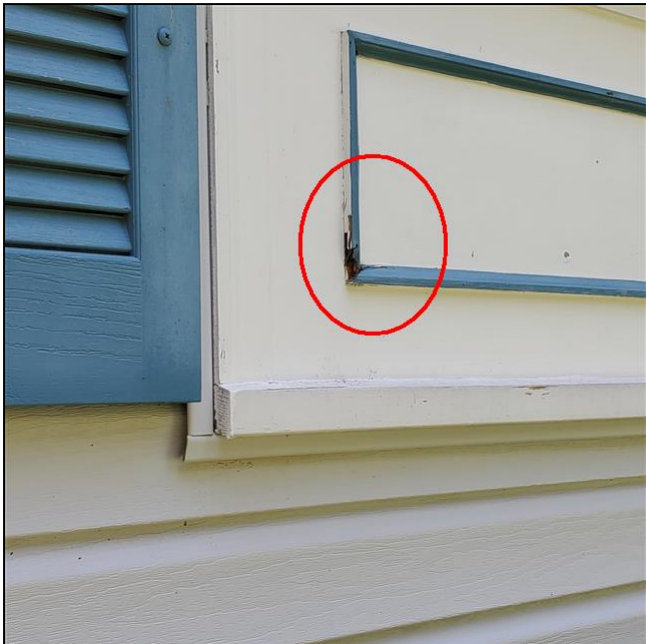
3.0 Item 1(Picture)

Minor amount of rot at the wood trim under the front left window. \$75-\$100

Minor amount of rot at the wood trim under the front left window. \$75-\$100

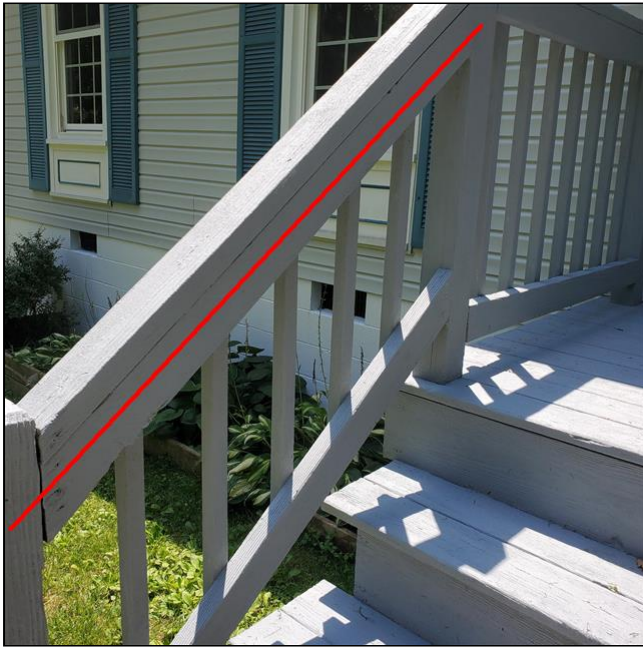
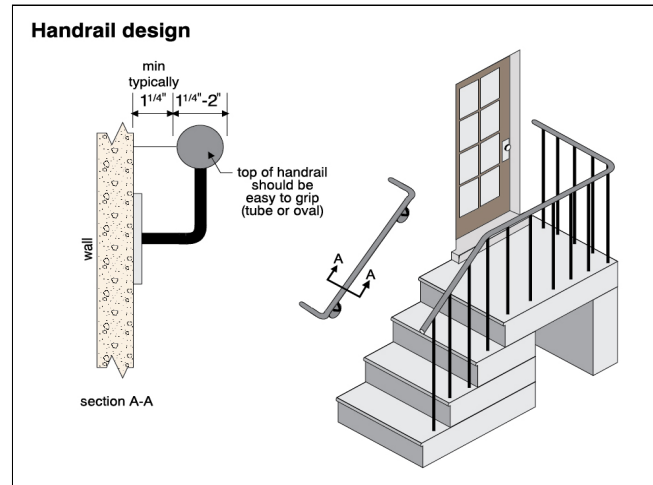
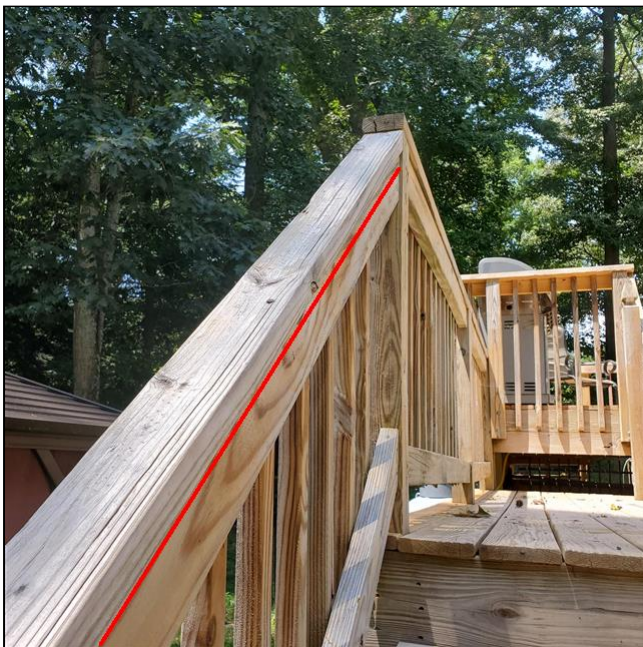
3.4 Item 1(Picture)

(1) As a safety upgrade to bring up to today's current standards I recommend to add a graspable handrail at the steps pictured.

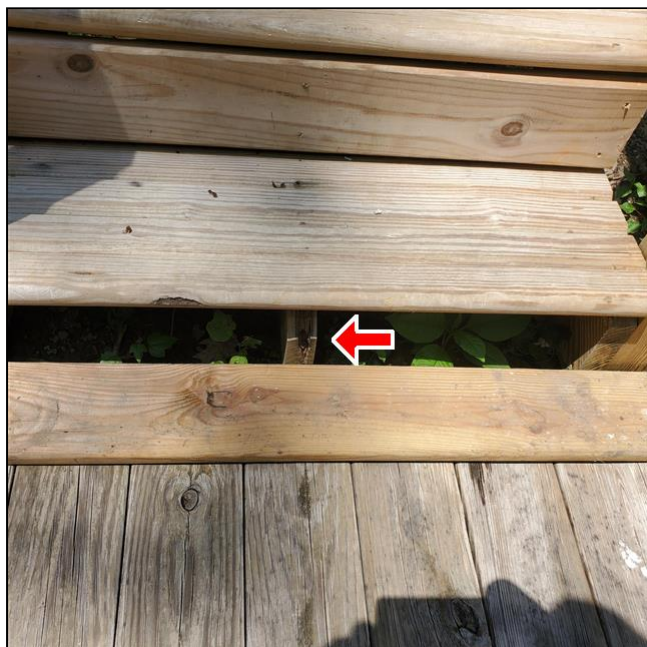
3.4 Item 4(Picture)

(3) There were multiple stair stringers at the rear deck steps that are splitting. Correct all as needed. See photos for examples. \$150- \$200 +/-

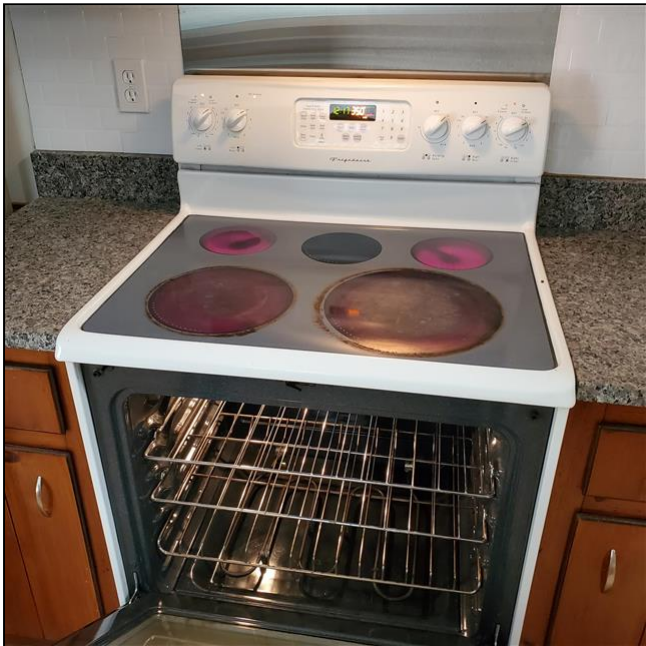
4.1 Item 1(Picture)

(1) At the time of the inspection there were no cracks noted on the range top.

(2) I turned on all of the heat elements and the oven element. All of the elements and lights worked at the time of inspection. The ratings of the actual oven temperatures were not tested to verify the actual temperatures represented by the settings.

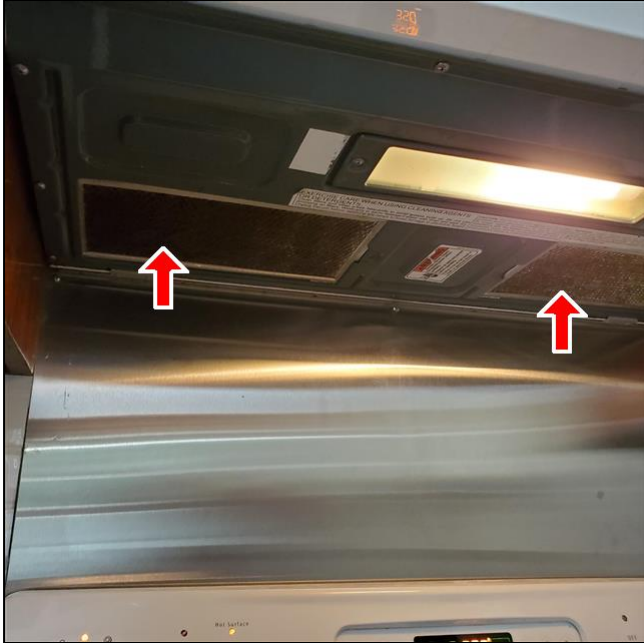
4.2 Item 1(Picture)

- (1) Microwave functions as the range hood in this kitchen.
- (2) Recommend cleaning of the filter and inside the vent as needed.

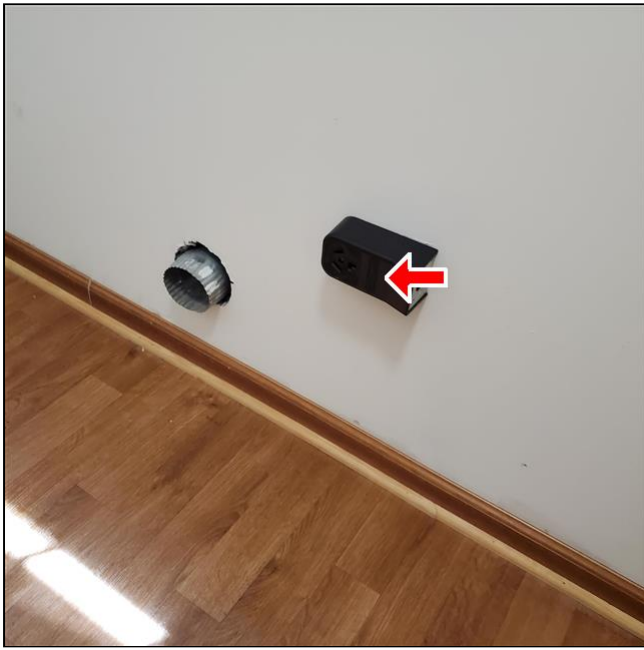
4.7 Item 1(Picture)

- (1) The dryer was not hooked up for operation at the time of inspection.

(2) The dryer receptacle is a 3 prong outlet. Newer dryers require a 4 prong outlet.

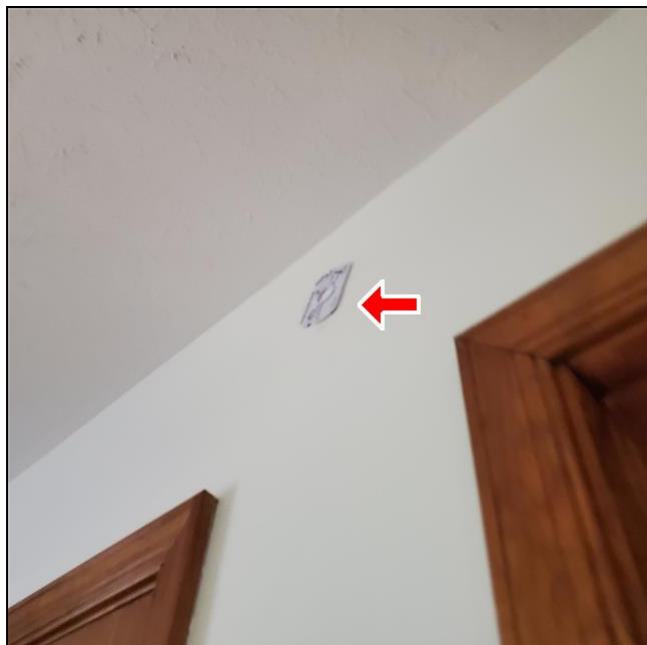
5.7 Item 1(Picture)

(4) Smoke detectors were noted to be missing or damaged in the home. Have a qualified licensed contractor correct all as needed.

Estimated cost \$75-\$100

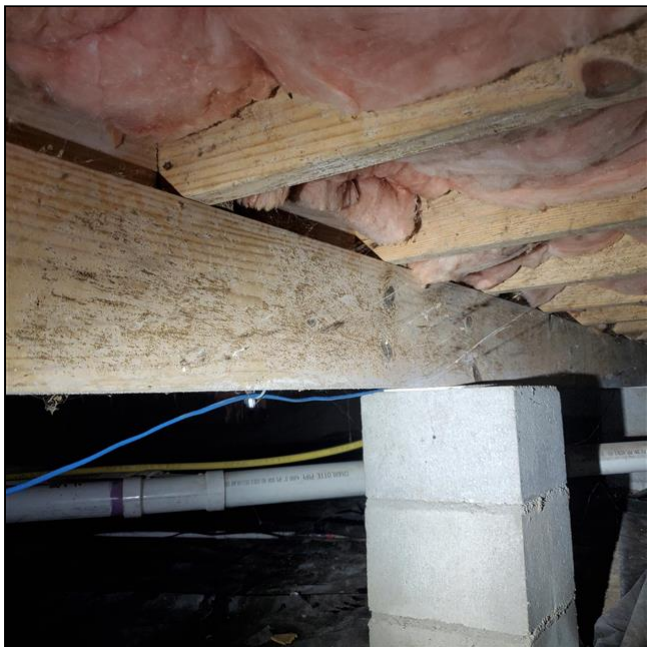
7.1 Item 1(Picture)

(1) All crawl spaces have microbial growth to some degree and this one is no exception. People are effected by microbial growth differently, depending on a persons immune system. If you have any concerns there are companies that specialize in this and I suggest you consult with them.

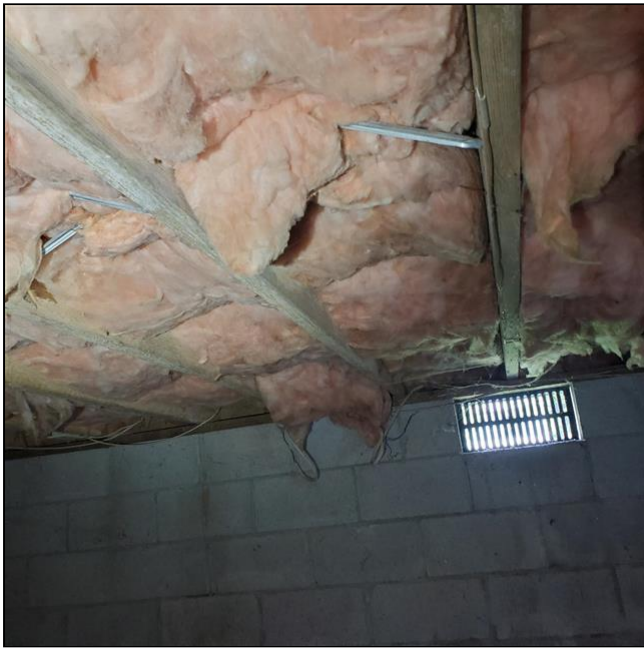
7.5 Item 1(Picture)

The floor insulation is in good condition.

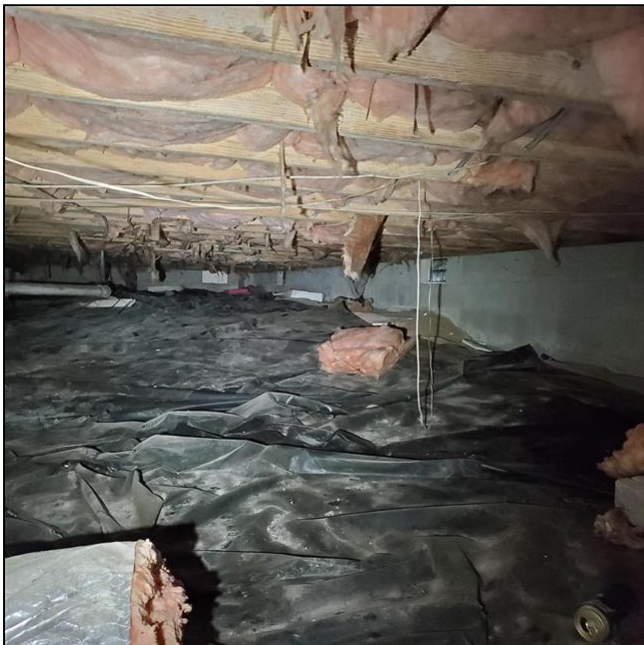
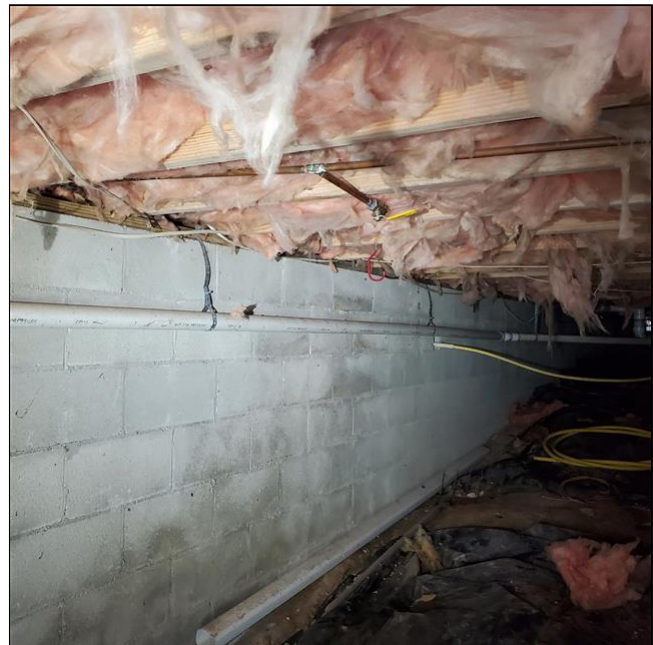
7.6 Item 1(Picture)

The vapor barrier is present in the crawl space but is missing in some areas or does not cover 100% of the ground. The vapor barrier should lap at least 6" or more and go to the foundation walls at all areas. Also, it helps keep the vapor barrier in place if the material is pinned down with landscaping pins, taped at the seams, taped at the walls and around all piers.

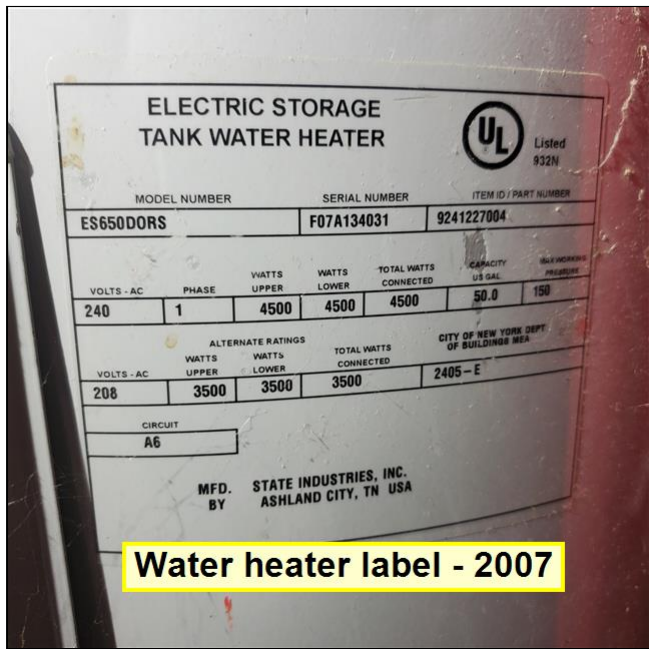
8.2 Item 1(Picture)

The water heater was working properly at the time of inspection. There was no visible rust or defects to the appliance. There was no signs of electrical issues, deterioration, or arcing at the time of the inspection.

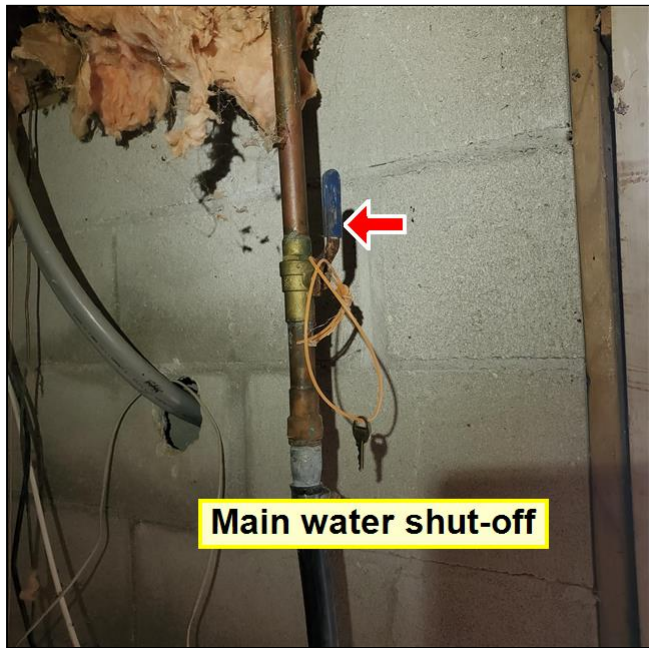
8.3 Item 1(Picture)

The main water shut off is located in the crawl space.

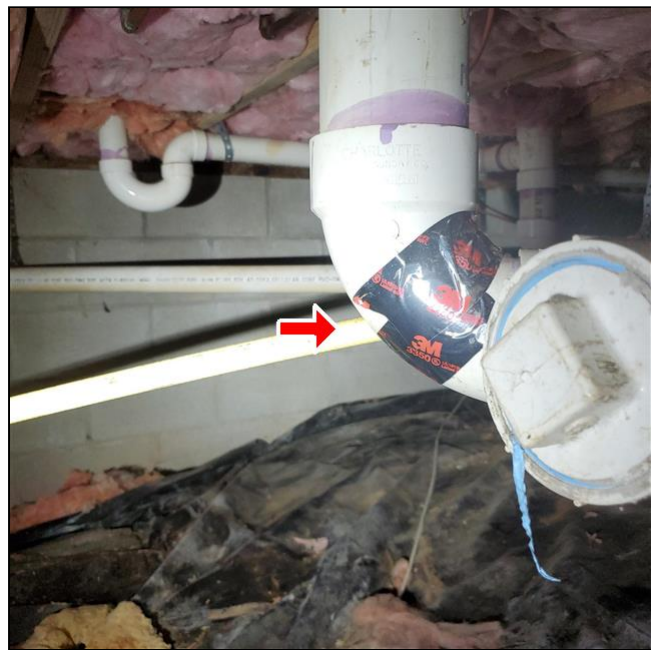
8.4 Item 1(Picture)

- (1) Nearly all CCST manufactures now require bonding of their pipe directly to the grounding system close to the service entrance with minimum #6 copper at an attempt to handle the intensity of direct or indirect lightning strikes. The intent is to dissipate the current to ground. There was no evidence of direct bonding on the incoming gas line. Recommend to have a licensed electrical contractor to add the direct bonding if necessary. contractor shall provide cost for corrections.
- (2) Fuel line in the crawlspace supported by tape to a waste line. Secure the gas line with proper hangers for this material.

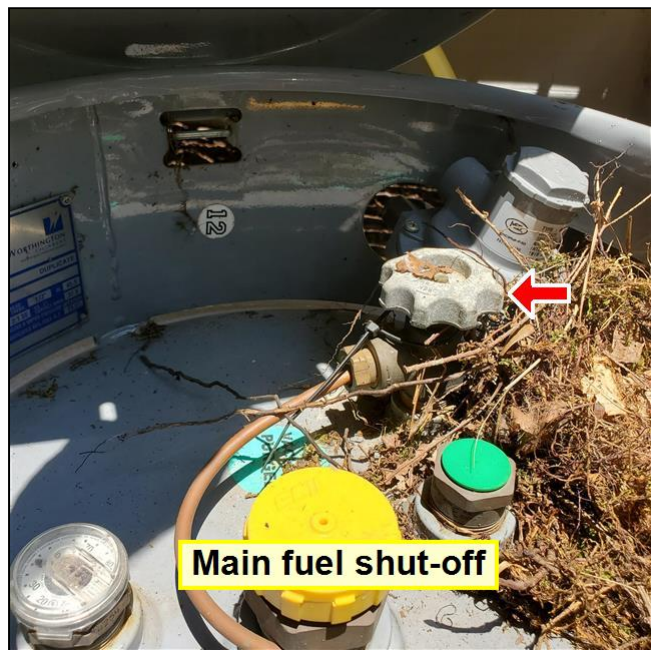
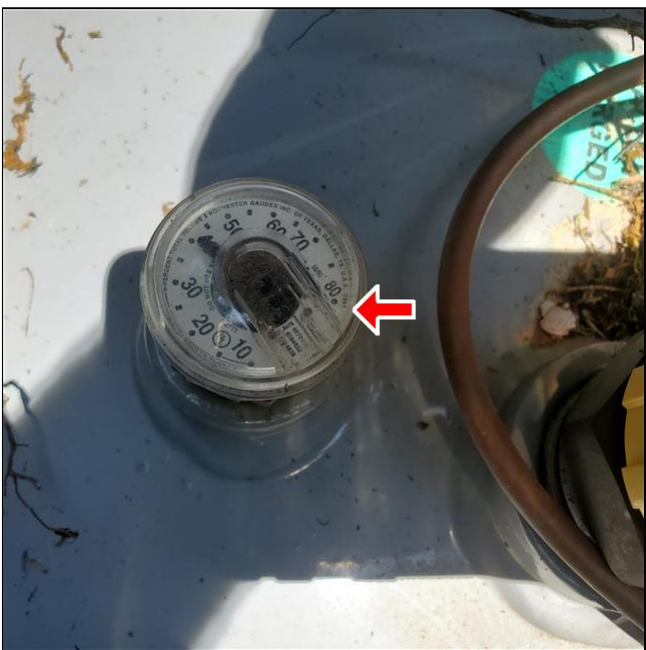
8.5 Item 1(Picture)

**Comments:** Inspected  
The main fuel shut off is at propane tank outside.

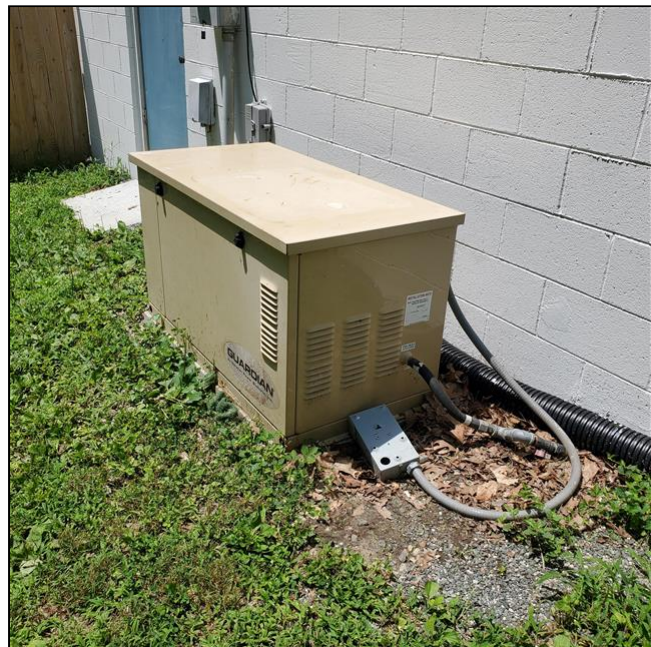
9.1 Item 1(Picture)

The generator and its components were not a part of this inspection. Have this system further evaluated by a licensed electrician if you have concerns.

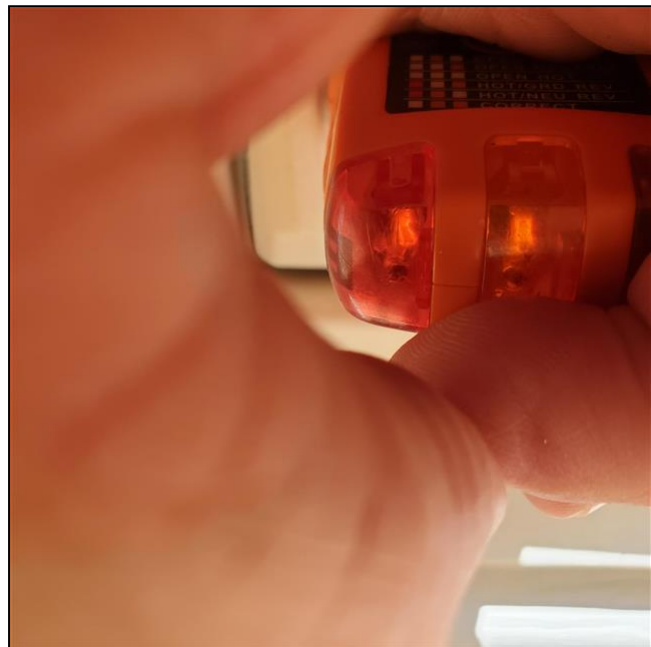
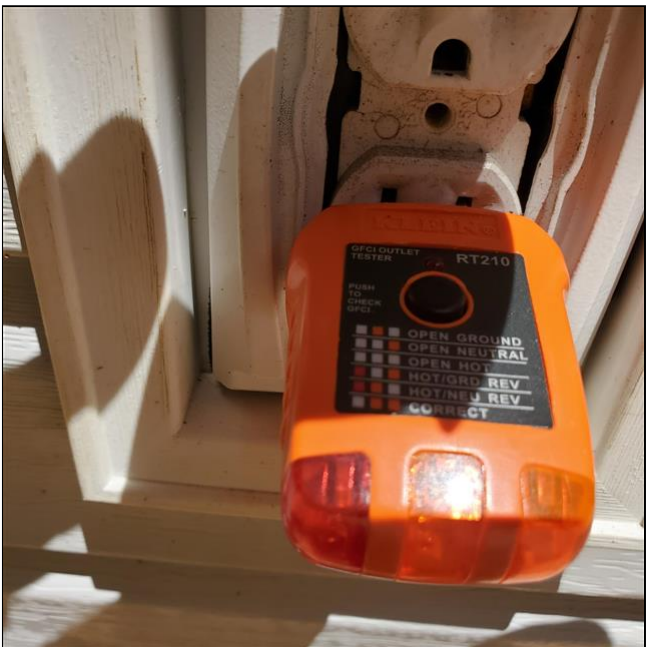
9.3 Item 1(Picture)

(1) Hot/neutral reversed indicated on the rear exterior outlet. \$125

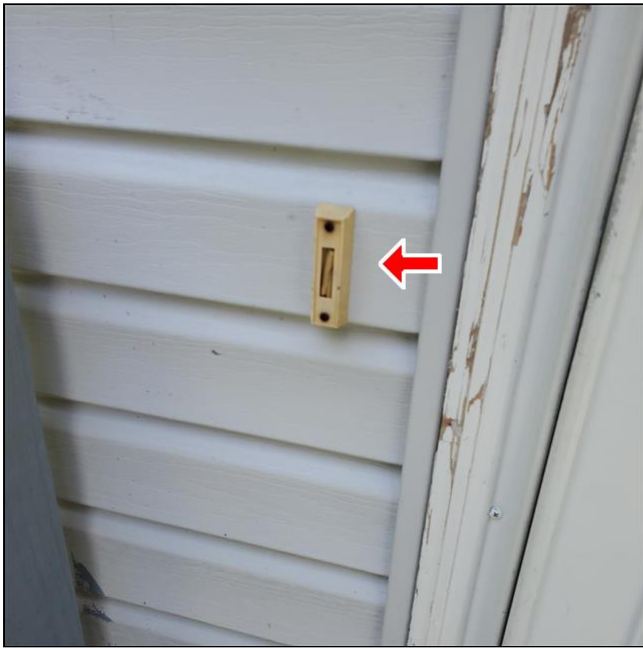
9.3 Item 3(Picture)

⚡ (2) Doorbell damaged \$75

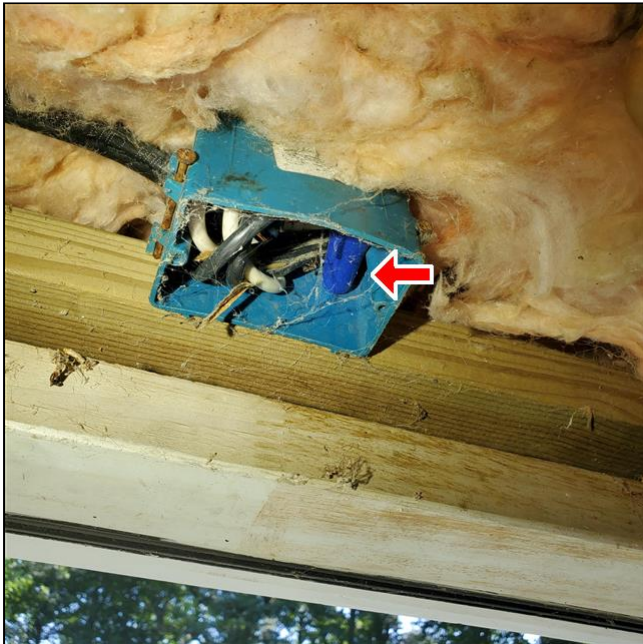
9.3 Item 4(Picture)

⚡ (3) Junction box not covered - just inside the crawlspace door.

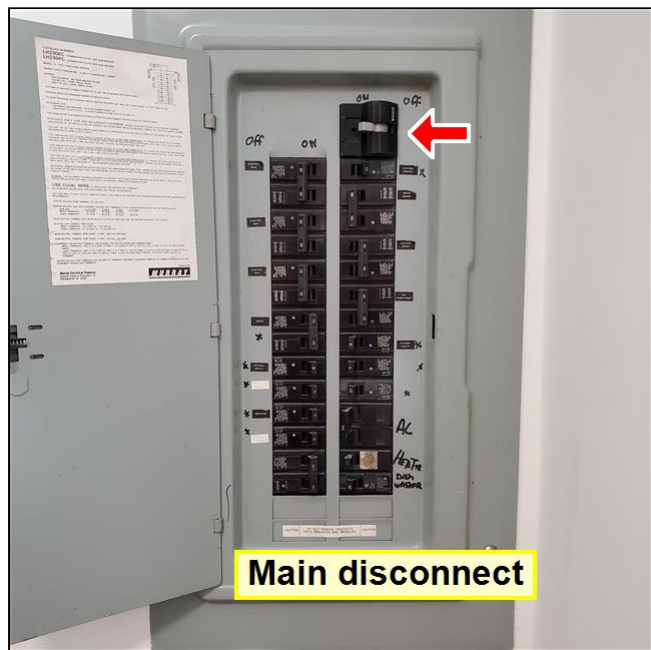
9.6 Item 1(Picture)

Main panel is located in the utility room.

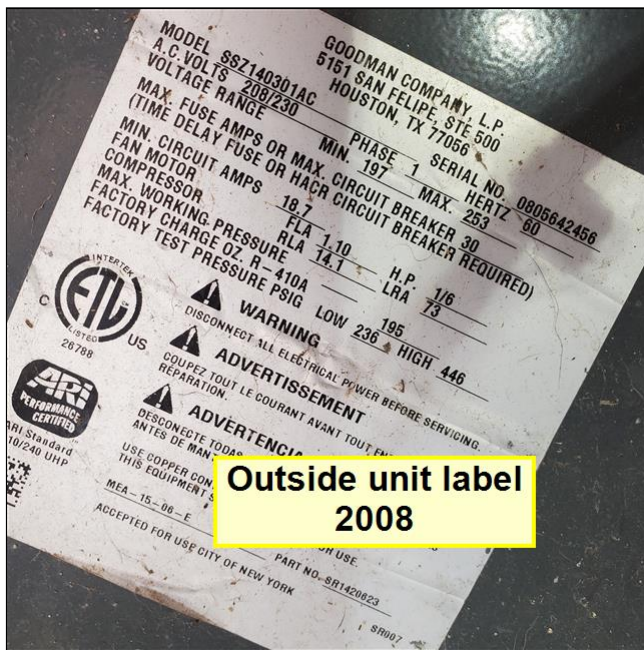
10.0 Item 1(Picture)

(1) Recommend annual service for the HVAC system for the best efficiency and longevity.
