Top Choice Inspectors

Residential Inspection Report

14525 Aiken Ride View , Colorado Springs, Colorado 80926

June 28, 2024 09:00 am

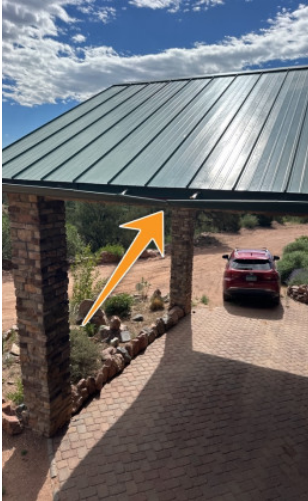
Damaged (General) - Coverings

The roof coverings showed signs of damage, and wear. I recommend a qualified roofing professional to evaluate and repair.

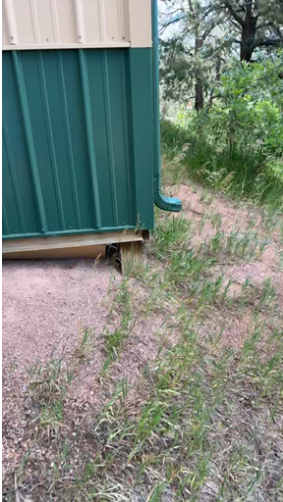
Downspouts Draining Near Foundation - Gutters

One or more downspouts drain too close to the home's foundation, or are damaged resulting in run-off spillage. This can result in excessive moisture in the soil at the foundation, which can lead to foundation/structural movement. I recommend adjusting the downspout extensions to drain at least 6 feet from the foundation.

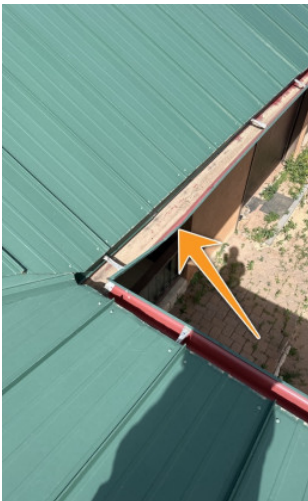
Damaged - Gutters

Sections of the gutters were damaged. This can result in excessive moisture in the soil at the foundation, which can lead to foundation/structural movement. I recommend having a qualified contractor evaluate and repair.

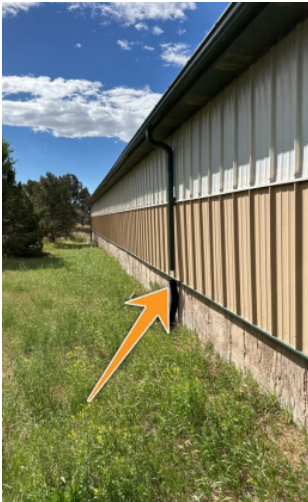
Detached Downspout - Gutters

One or more downspouts around the property were detached at the time of the inspection. Recommend repair or replacement.

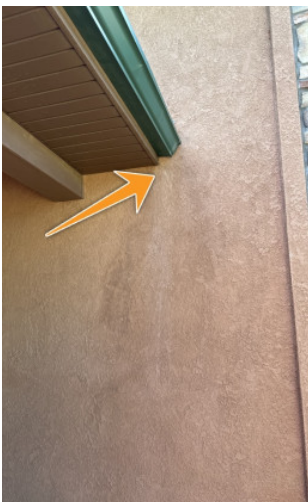
Gutter Leaking

A leaking gutter was observed at the time of the inspection. Recommend evaluation and repair as necessary.

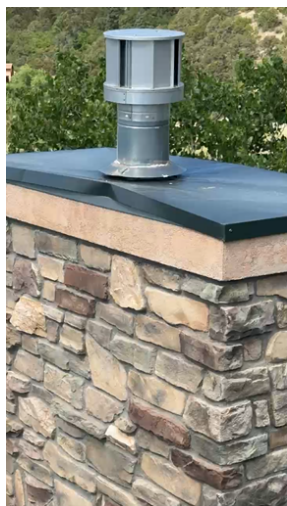
Deteriorated Crown - Chimney

The chimney crown was deteriorated at the time of the inspection. Recommend repair/replacement of chimney crown to protect interior from water damage.

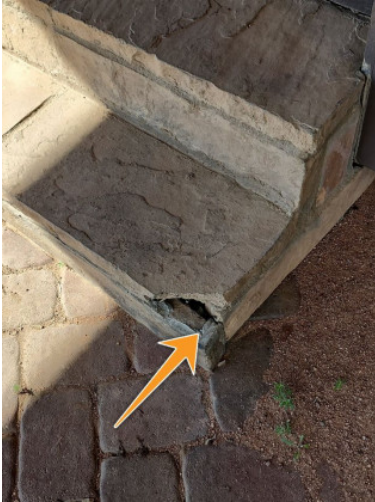
Damaged Steps

the steps were damaged.

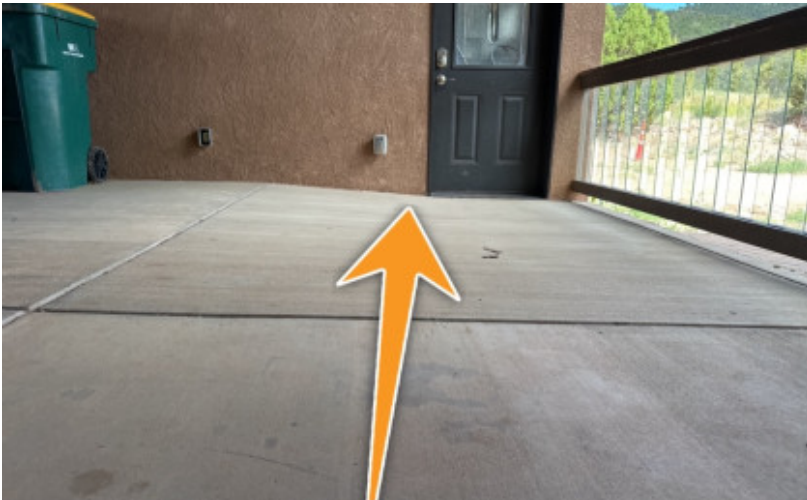
I observed some minor cracks in the cement. This is very typical due to soil movement. I would consider these cracks cosmetic, but I do recommend using a sealant to prevent water intrusion. Monitor and maintain as necessary.

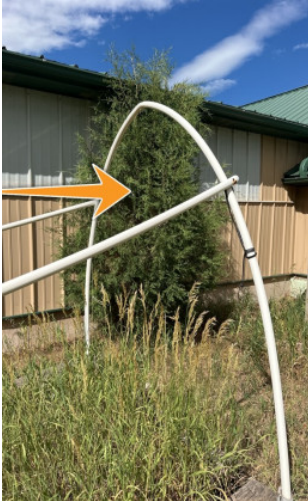
Vegetation- Near Siding/Foundation

Vegetation is growing too close to the home. The root systems can cause major foundation issues, the leaves can clog gutters, increasing the amount of water around the foundation can cause issues, and the branches can cause accelerated wear on the siding. Recommend clearing vegetation within 10' of the home.

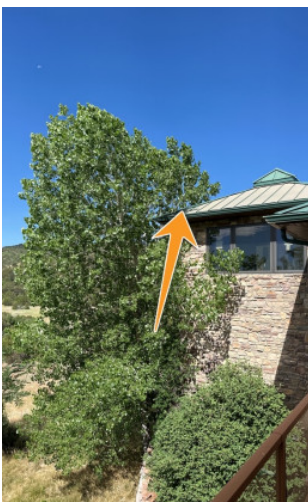
Overhanging Roof - Vegetation

Trees observed overhanging the roof. This can cause damage to the roof when large limbs

fall during high winds or other adverse weather. It can also clog gutters/downspouts if debris is not cleaned out regularly. I recommend trimming trees which overhang roofs.

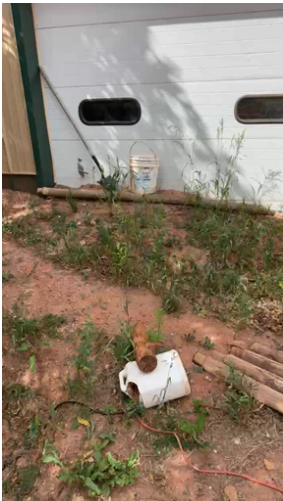
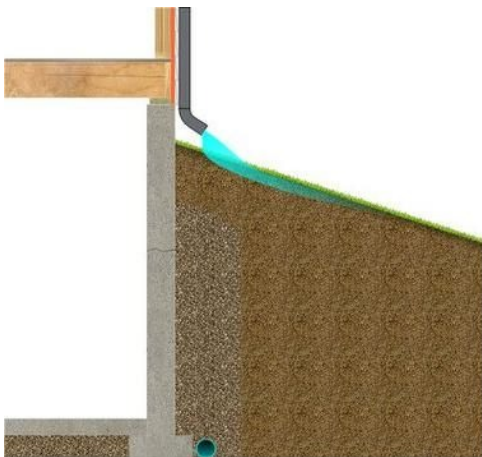
Negative Grading - Landscaping

POSITIVE DRAINAGE

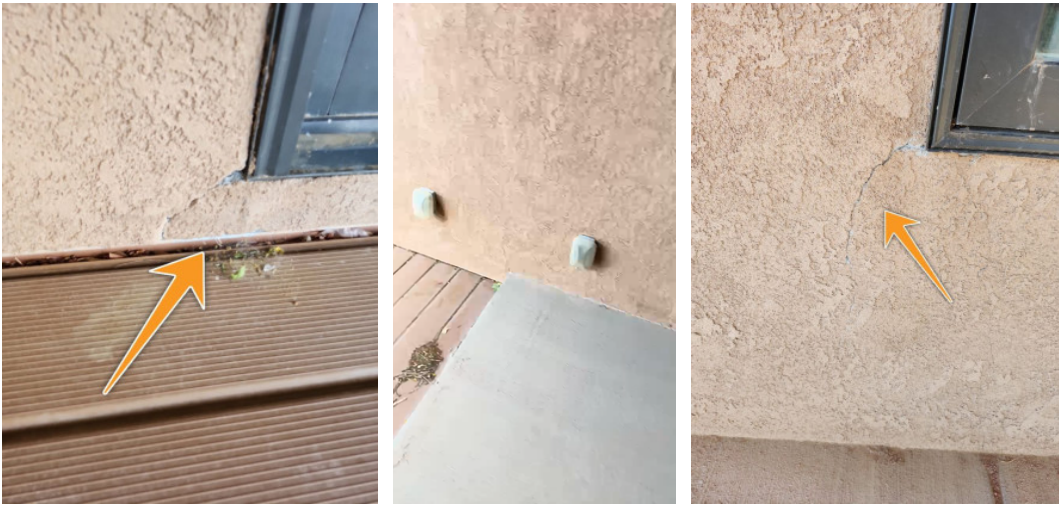
The stucco siding showed cracking in one or more places. This is a result of temperature changes, and typical as homes age. I recommend patching, sealing, replacing, or monitoring areas of cracking depending on severity and siding material in question.

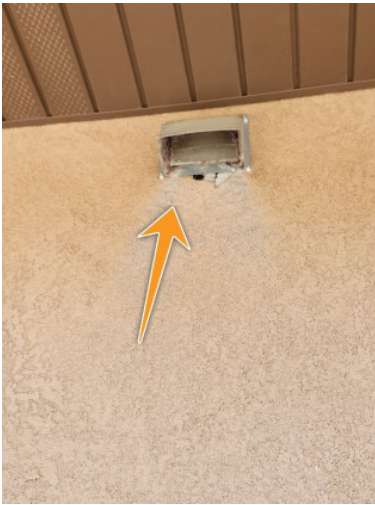
Gaps in the siding and trim should be sealed to prevent moisture, pest, or rodent intrusion.

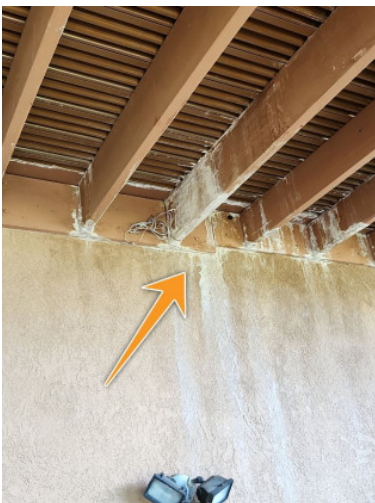
There's evidence of moisture staining in the stucco recommend monitoring repair if needed.

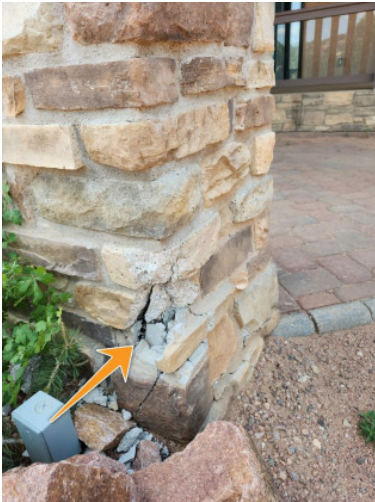
At the time of inspection, some cracking was noted in the stone veneer. This is not a structural component of the home. Recommend performing any necessary maintenance for the upkeep of the stone exterior..

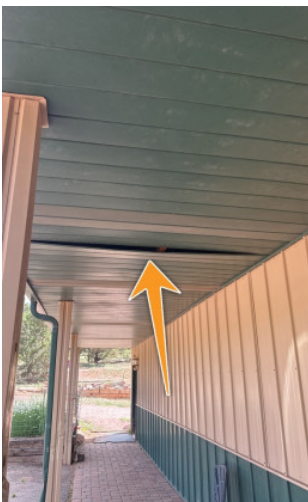
Loose - Soffit / Fascia

One or more sections of the soffit and/or fascia are loose. Recommend securing.

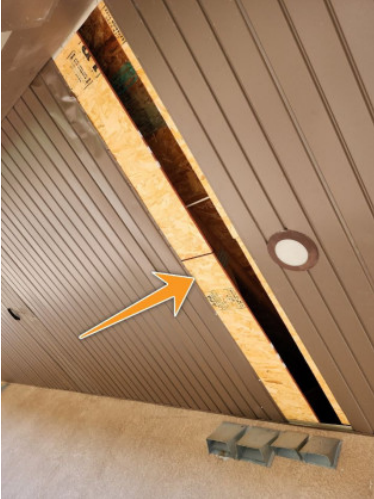
Gap - Soffit / Fascia

There is opening, gap or hole in fascia / soffit which should be repaired or sealed. This can allow water intrusion and pest infestation as well as deterioration of the surrounding material.

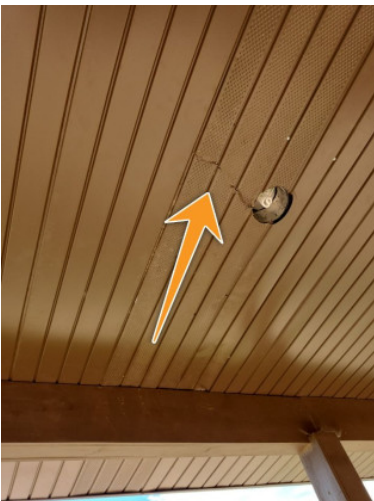
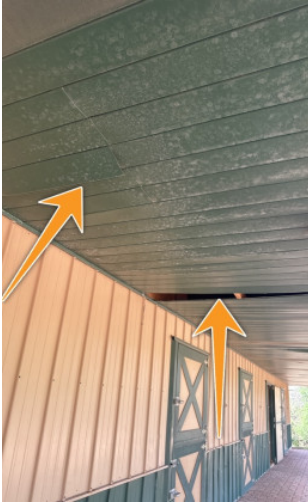
Damaged - Soffit / Fascia

One or more sections of the soffit and/or fascia are damaged. Recommend repair or replacement.

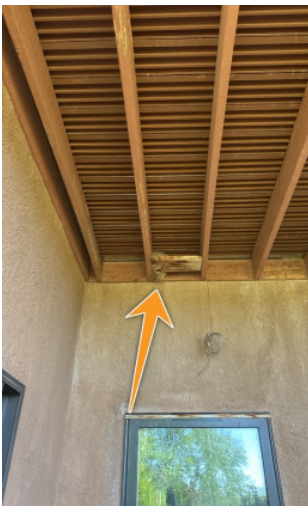
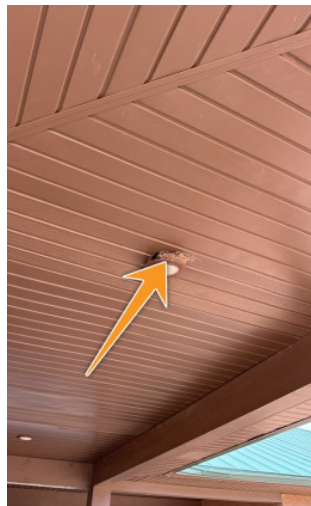
Bird Nests

One or more bird nest was observed at the time of the inspection. Recommend evaluation and repair as necessary.

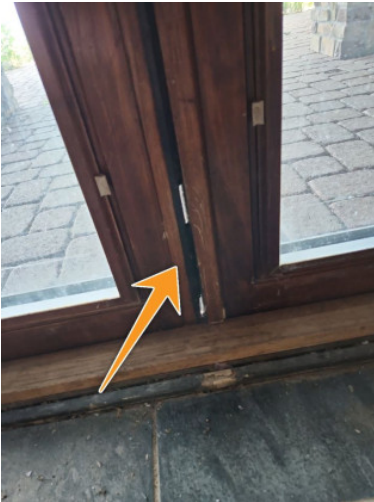
When inspecting the home's exterior doors, the weatherstripping was in need of repair or possibly replacement. Proper weatherstripping should not allow air or light in around the door, which makes for great efficiency. I recommend regaining that lost efficiency by repairing or replacing the weatherstripping.

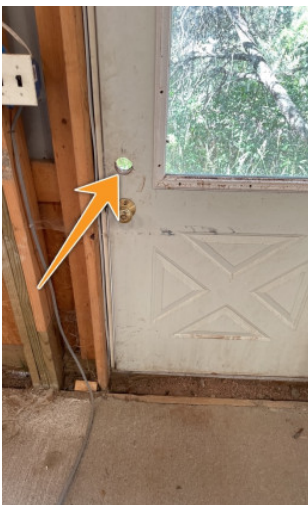
No deadbolt - Exterior Doors

No dead bolt on the exterior door. I recommend installing for safety on all exterior doors.

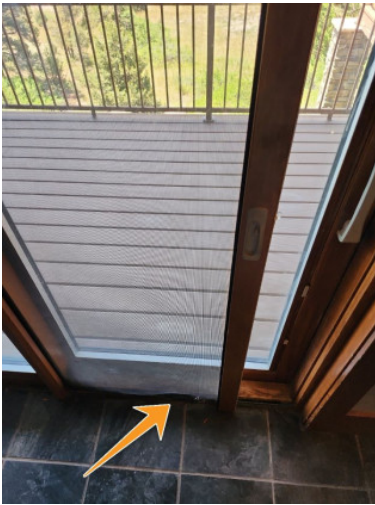
The sliding glass door screen appears to be damaged. Recommend repair or replacement.

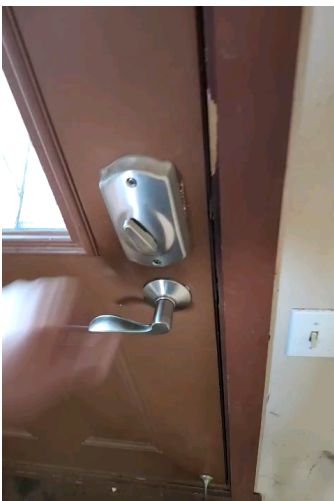
Lock Inoperable

Recommend adjusting strike plate or deadbolt to allow for it to fully lock.

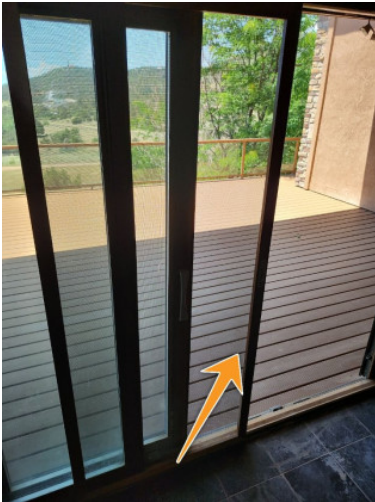
Recommend adjusting or lubricating track as needed on screen door to allow for a smooth operation.

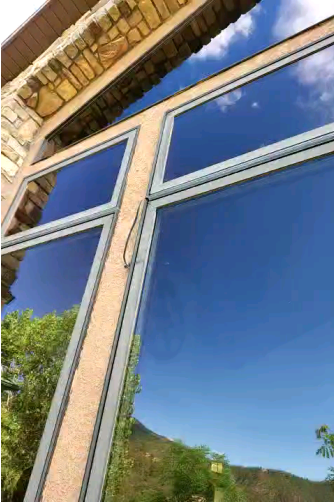
Damaged Frames - Windows

The window frames appeared to be damaged on the exterior. I recommend repair or replacement as needed.

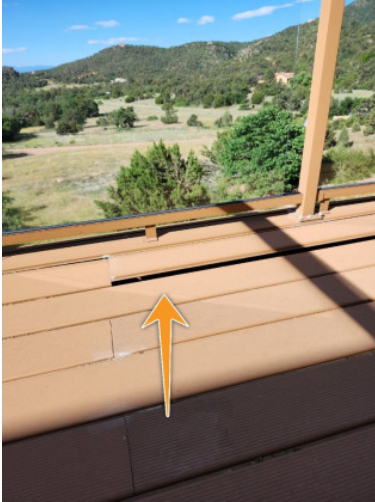
While inspecting the deck, one or more of the deck boards were loose. I recommend re-securing those boards.

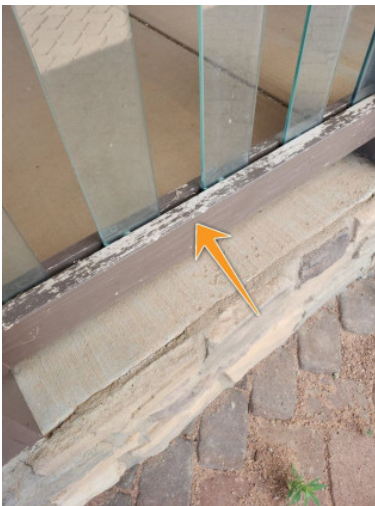
The exterior structure is showing signs of weathering and/or water damage. It's important to keep it sealed, not only for visual reasons but also to prevent any water intrusion and rotting. I recommend applying a water sealant to extend life. Here is a helpful article on staining & sealing.

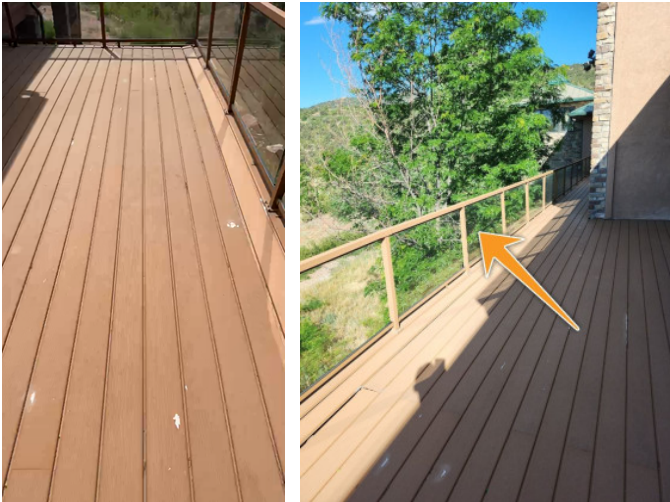
I recommend securing the loose handrails as needed.

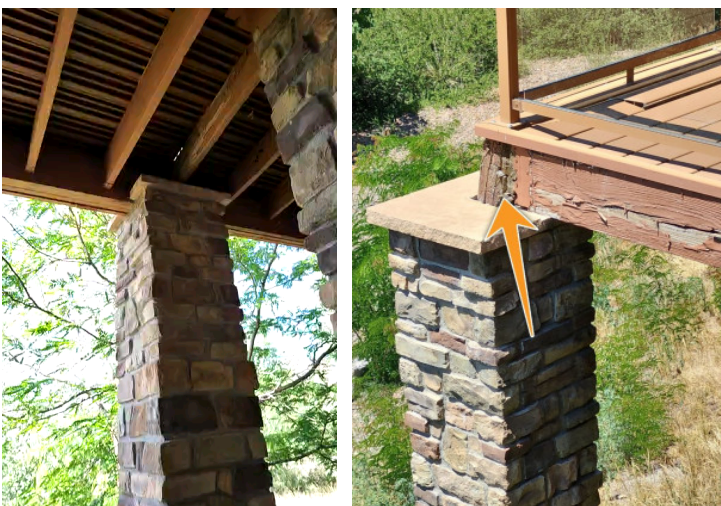
Slight deterioration in some of joists boards was visible during the inspection

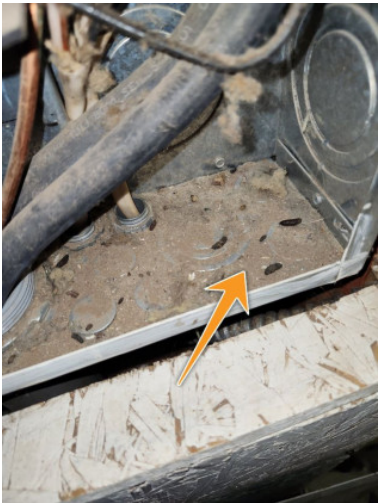
Evidence of rodents in the garage. Recommend evaluation as needed

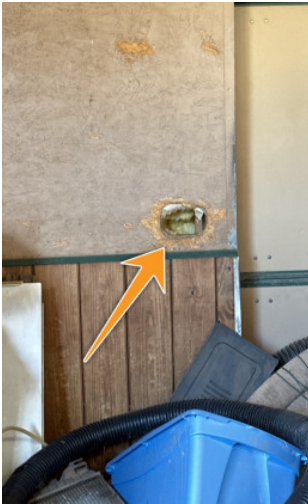
Damage - Non-Firewall Garage

The drywall was damaged in the garage. Recommend repair.

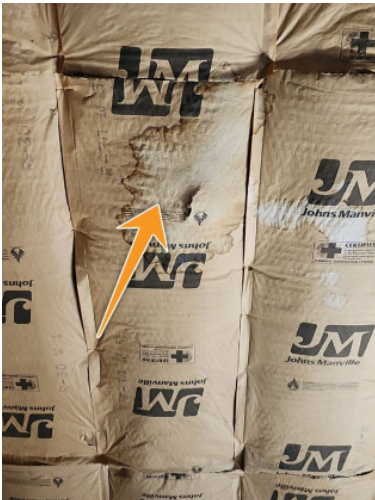
Moisture stains - Fire Rated Walls & Ceilings Garage

There appears to be moisture staining in the garage. Recommend asking seller history and to monitor.

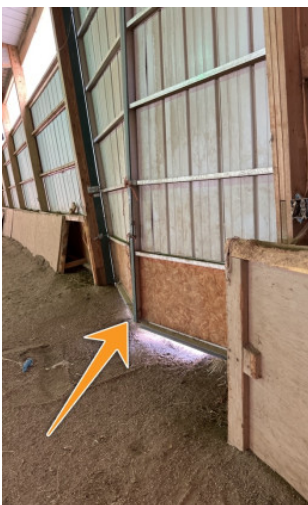
Damage - Garage Door

The garage door has slight damage which was not causing any problems with the opening of the door at the time of inspection.

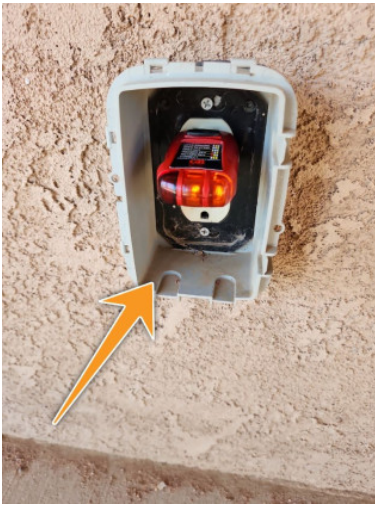
Recommend adding weatherproof cover.

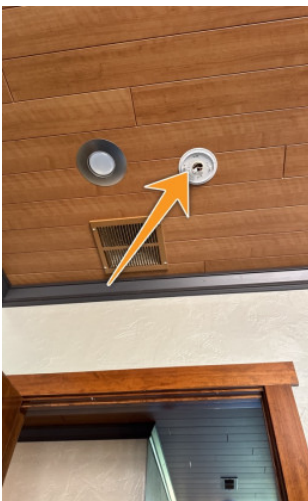
Smoke detector- missing

A smoke detector was missing. Recommend a new smoke detector be added.

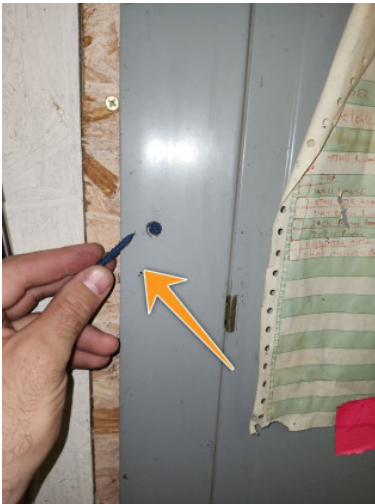
Pointed screws are securing the main panel cover. This is a safety hazard. I recommend replacing with flat tipped screws. I did not fully remove the dead front cover because all screws were pointed and I would not have been able to resecure the cover safely. I recommend having an electrician evaluate the panel.

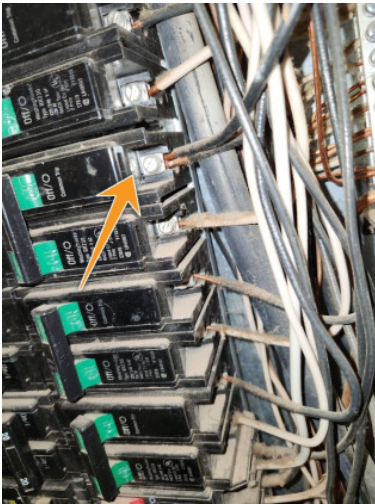
One or more breakers in the panel were double tapped. I recommend evaluation and repair by a licensed electrician.

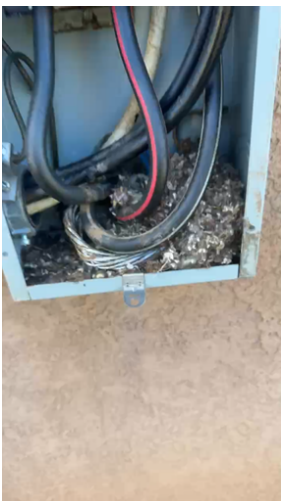
Evidence of Pests

At the time of inspection there appeared to be signs of pests that had got into the electrical panel. I recommend removal of any debris in the panel, and closing any potential gaps to avoid pests getting in in the future.

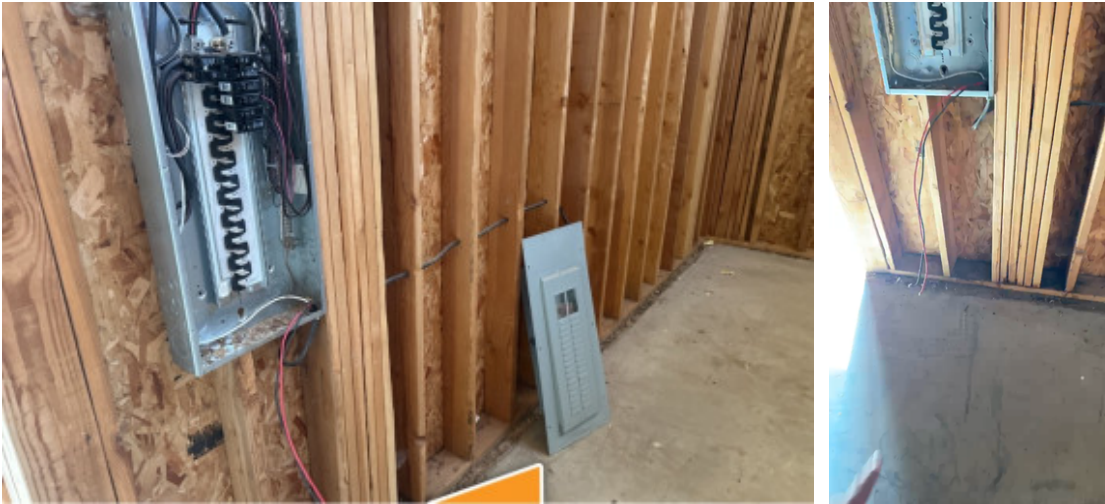
At the time of inspection there was no front cover for the electrical panel. This typically has all the labels for the panel as well as the legend listing what breakers are acceptable to be installed per manufacturer standards. Recommend a qualified electrician evaluate and properly cover and label panel.

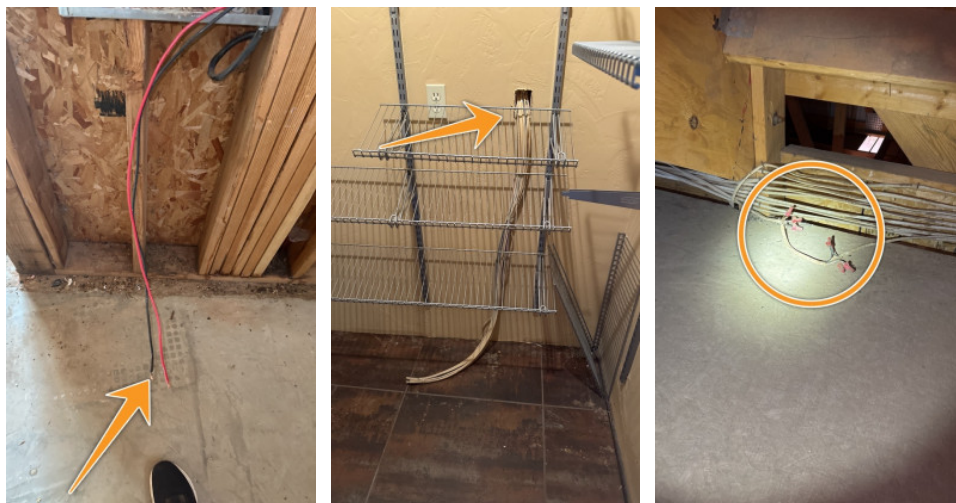
There is unsafe and exposed wiring visible and present during the home inspection. I recommend a licensed electrician repair and secure properly.

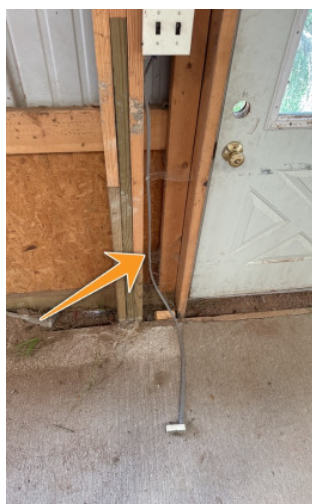
Permanent Extension Cord Wiring

There appears to be use of permanent extension cords as wiring. This is not allowed. I recommend a licensed electrician to hardwire.

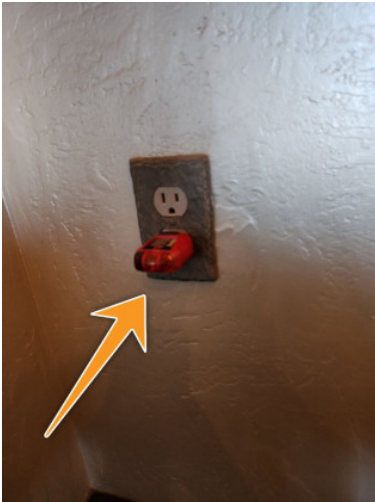
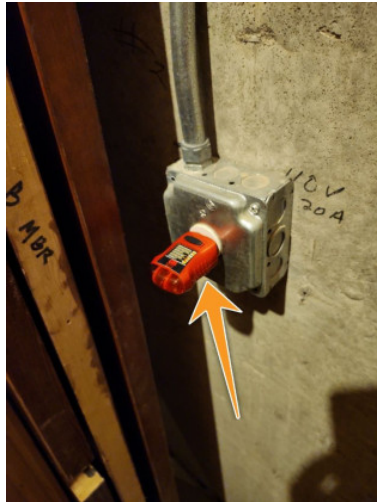
All accessible receptacles in the home were tested to ensure that they had power. One or more were not functioning. I recommend repair/replacement.

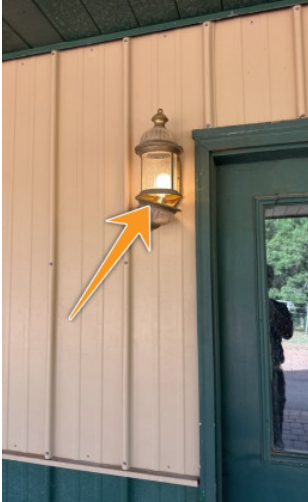
Damaged - Light Fixture

At the time of inspection, there were one or more light fixtures that were damaged. I recommend repairing or replacing the damaged fixtures.

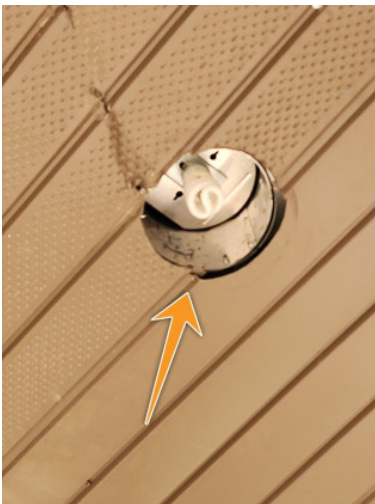
There appears to be a missing light fixture with exposed wiring recommend repair or replacement of light fixture.

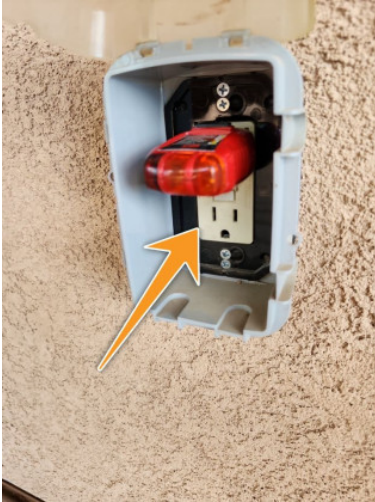
a GFCI would not reset. recommend replacement by a qualified electrician

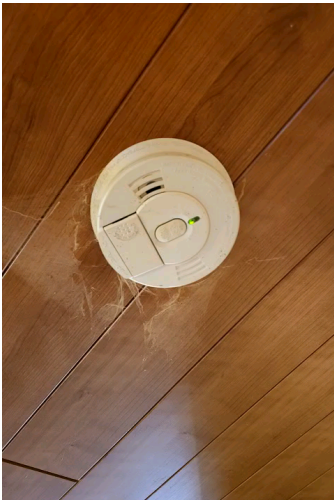
DEFICIENCY 5.21

Expired - Smoke Detectors

The smoke detectors appeared older as evidenced by the yellowing of the plastic and may be expired. I recommend replacing every 10 years per manufacuters requirements.

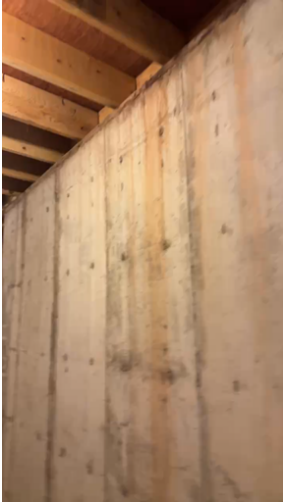
DEFICIENCY 6.1

Efflorescence - Foundation

Foundation showed efflorescence, which is the chalky residue left on concrete, stone, and block when moisture passes through it. This is normal in moderation with foundations. Excessive efflorescence indicates concerns with poor drainage or grading around the home which can lead to structural issues. Monitor.

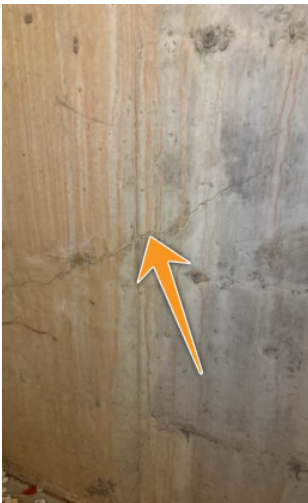
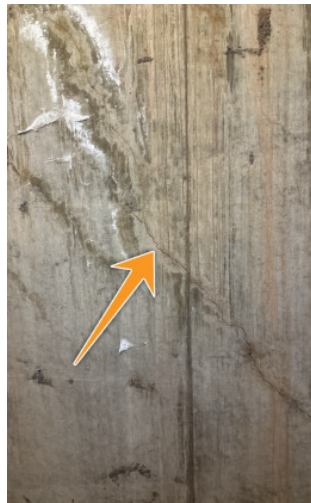
DEFICIENCY 6.2

Cracks - Minor - Foundation

Minor cracking was noted at the foundation. This is common as concrete ages and shrinkage surface cracks are normal. I recommend sealing then monitoring for more serious shifting/displacement. Here is an informational article on foundation cracks. If you are concerned with the structural integrity of the home, I recommend consulting a structural engineer.

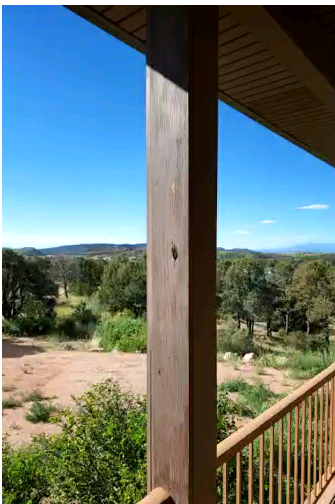
DEFICIENCY 6.3

Not Properly Attached - Column/Foundation

The structural support column was not anchored to the floor or the beam recommend anchoring properly.

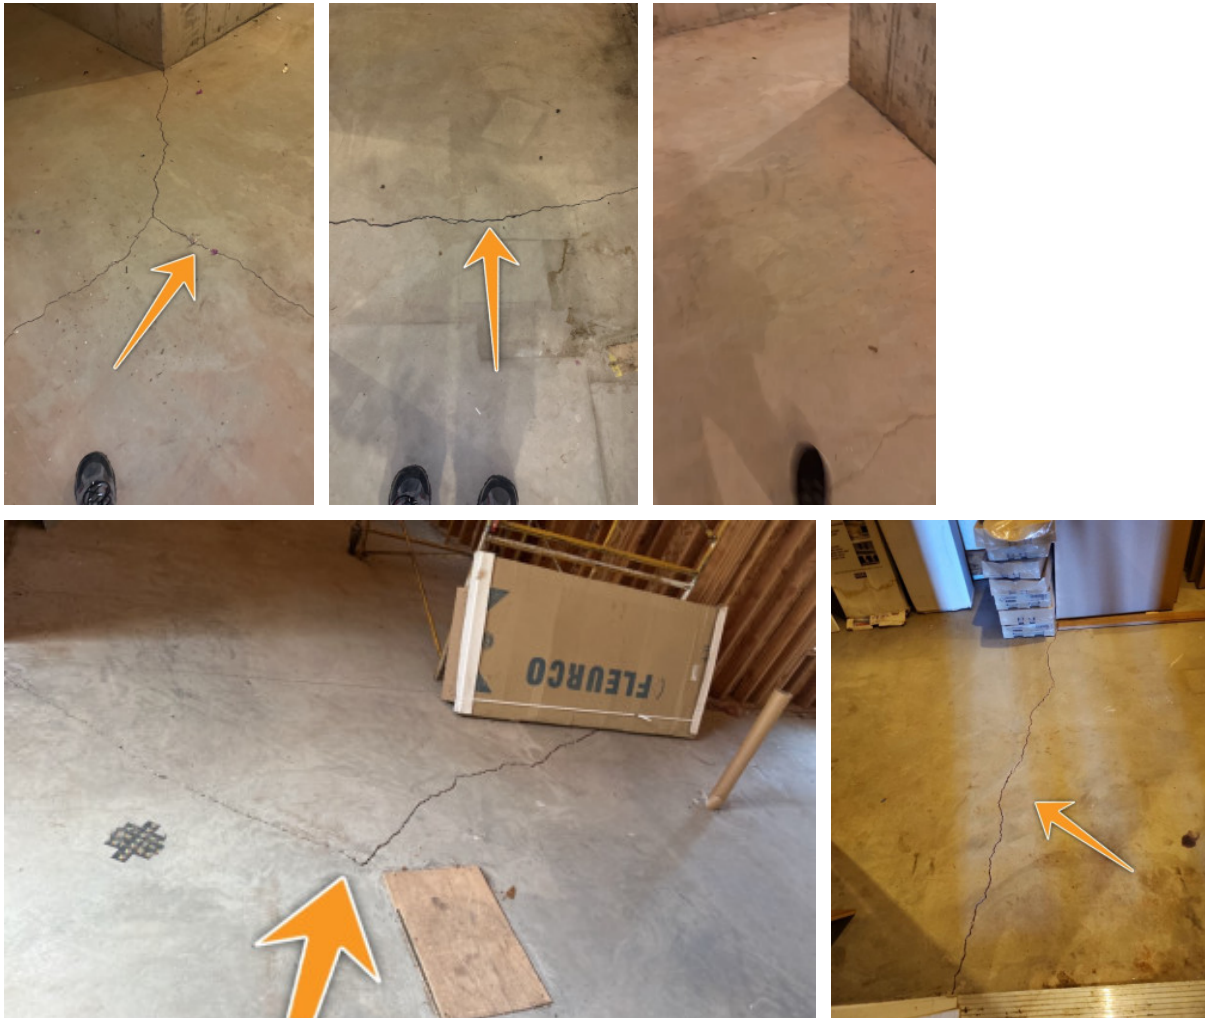
There is evidence of typical cracking in the basement concrete slab. Recommend sealing the cracks and monitoring for further movement.

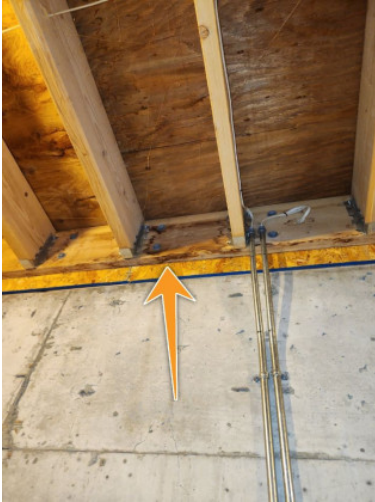
There is evidence of moisture staining on the sub floor and the floor joists, recommend evaluation of damage and repair to prevent further moisture damage.

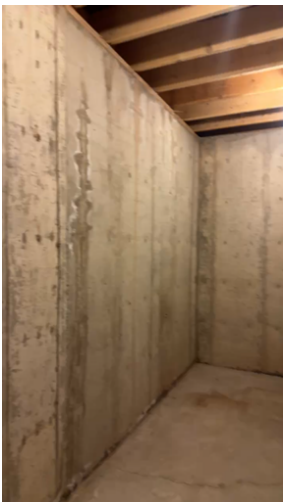
DEFICIENCY 6.6

Settling Cracks - Walls/Ceiling

All homes will settle from time to time. I observed typical settling cracks in several locations on the walls and ceiling. I recommend monitoring moving forward. If there are further structural concerns, I recommend evaluation by a licensed contractor.

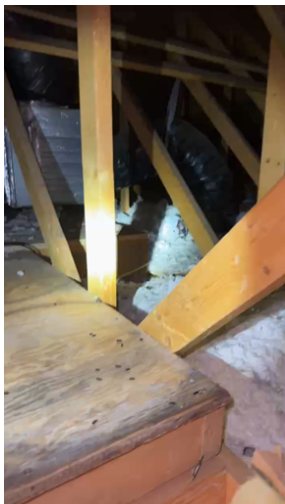
DEFICIENCY 6.7

Evidence of Rodents

Evidence of rodents was observed in the attic. Recommend evaluation by a pest control company. OBJ

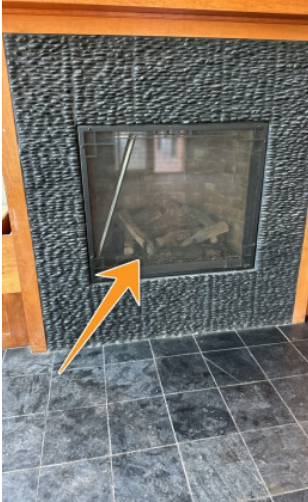
Pilot Light Out - Fireplace

During the inspection the pilot light was not lit in the fireplace. We are not able to light pilot lights unfortunately.

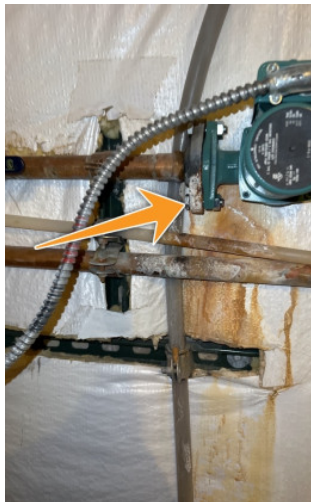
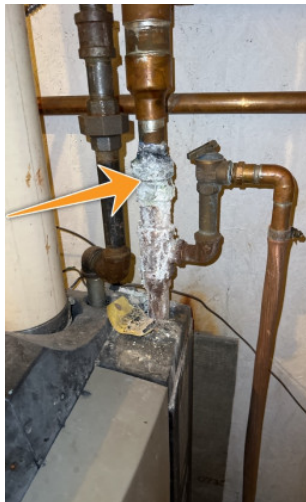
DEFICIENCY 7.3

Signs of Water Leaks - Furnace/Boiler

This could be an old issue but there are signs of past leaks. I recommend verifying it has been serviced recently.

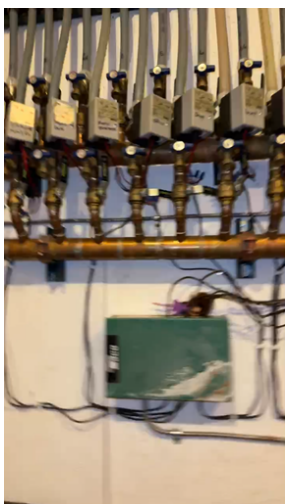
DEFICIENCY 7.4

Clain/Maintainance and Annual Servicing - Boiler

The boiler system in the home may require maintenance per the manufacturer's requirements. Recommend asking seller for history on boiler, which would include maintenance schedule and/or have a licensed boiler technician evaluate and service per manufacturer requirements.

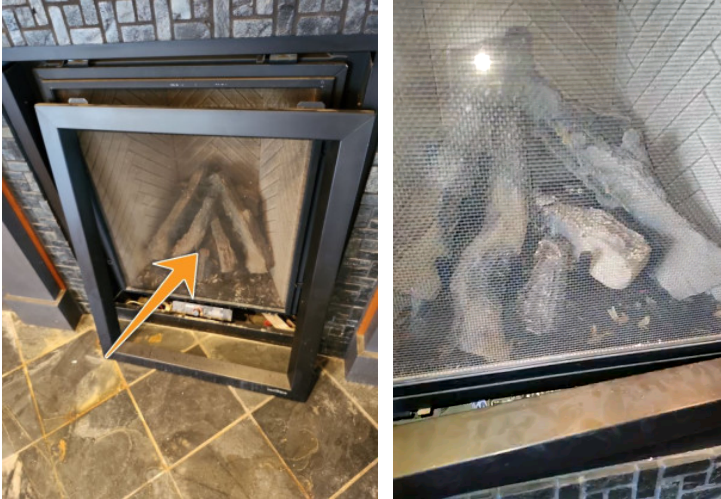
DEFICIENCY 7.5

Unable To Test - Gas Fireplace

Recommend verifying that the fireplaces operates prior to closing.

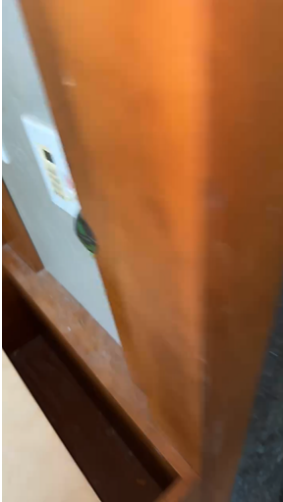
DEFICIENCY 7.6

Inoperable - Fireplace

The fireplace does not turn on. This is likely a very simple issue. I recommend a fireplace contractor to service, or recommend seller provide proof that it is in working condition.

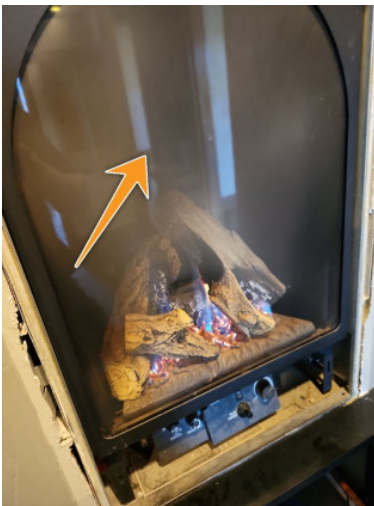
The glass on the gas fireplace was foggy at the time of the inspection. Recommend cleaning of glass.

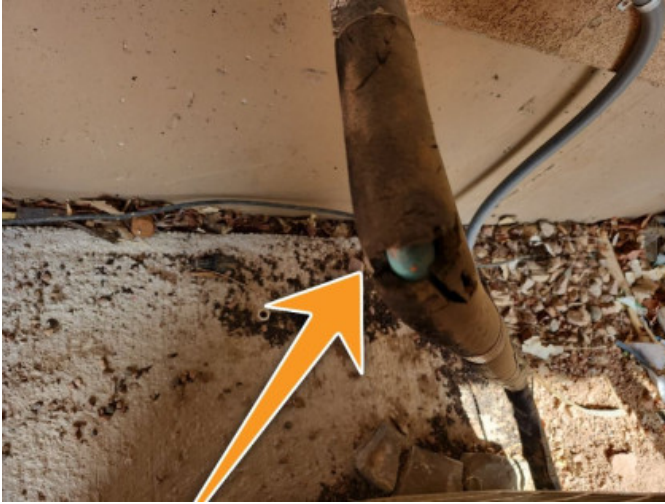
Always seal around the refrigerant line to prevent moisture intrusion and rodents, insects from entering the home. Repair.

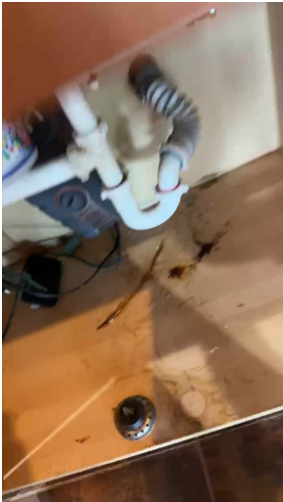
DEFICIENCY 9.1

Active Leak - Drain Pipes

During the inspection I came across a drain, waste and/or vent pipe that was actively leaking. I recommend having a qualified plumber evaluate and repair.

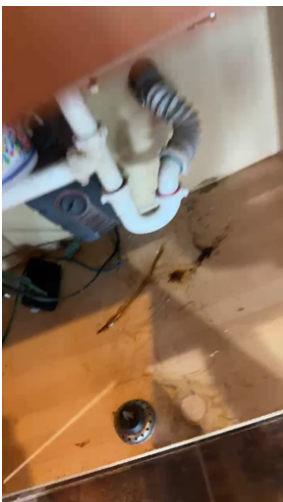
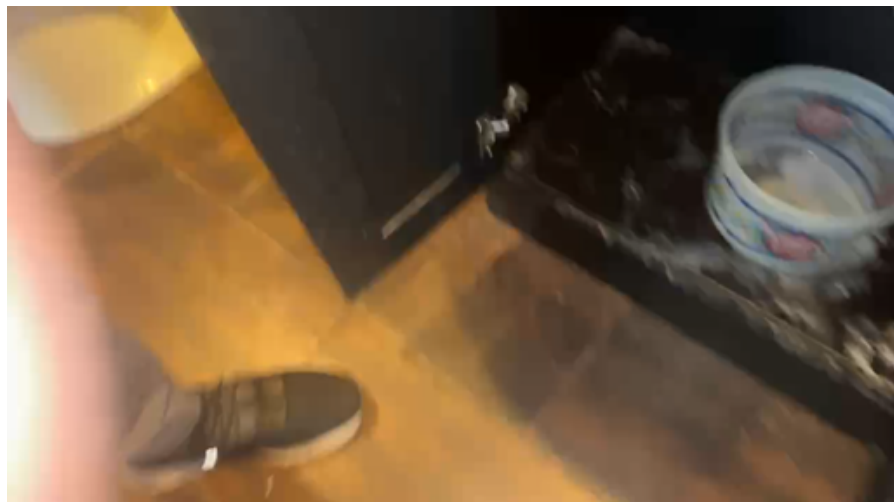
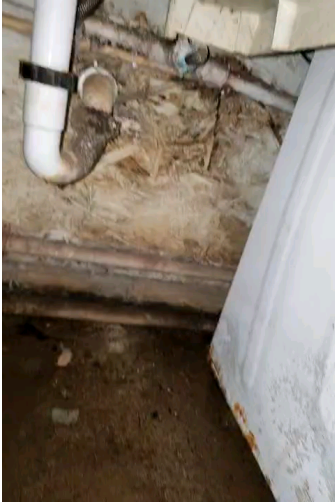
DEFICIENCY 9.2

Active Leak - Supply Pipes

During the inspection, an active leak was observed on a supply line. Recommend a qualified plumber evaluate and repair.

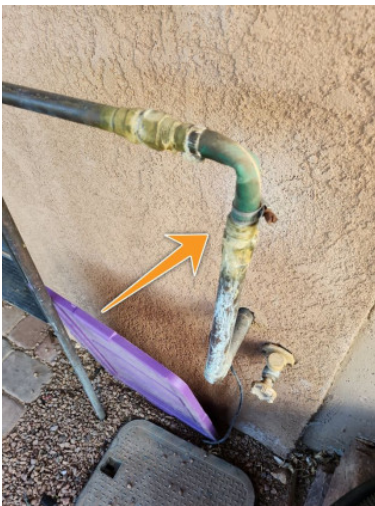
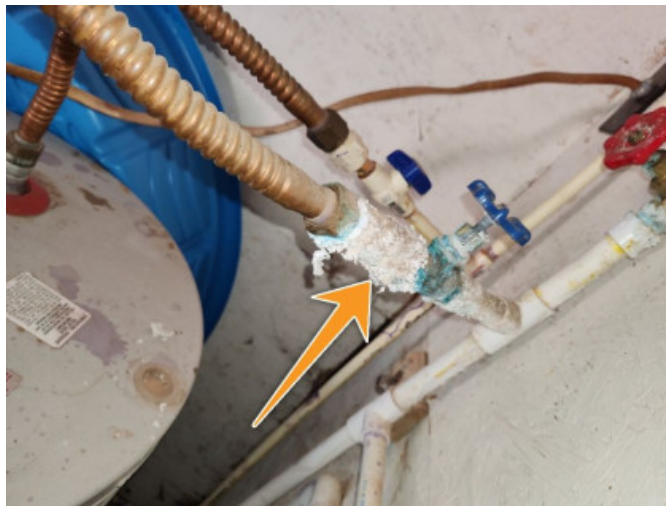
Pipe and/or fittings were observed to have corrosion. This can lead to a shortened lifespan. Recommend a qualified plumber repair.

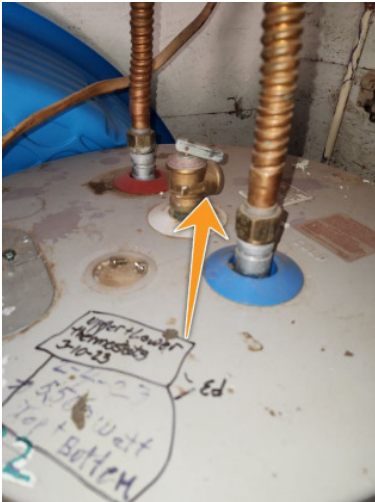
Recommend installation of a TPR valve by a qualified plumber

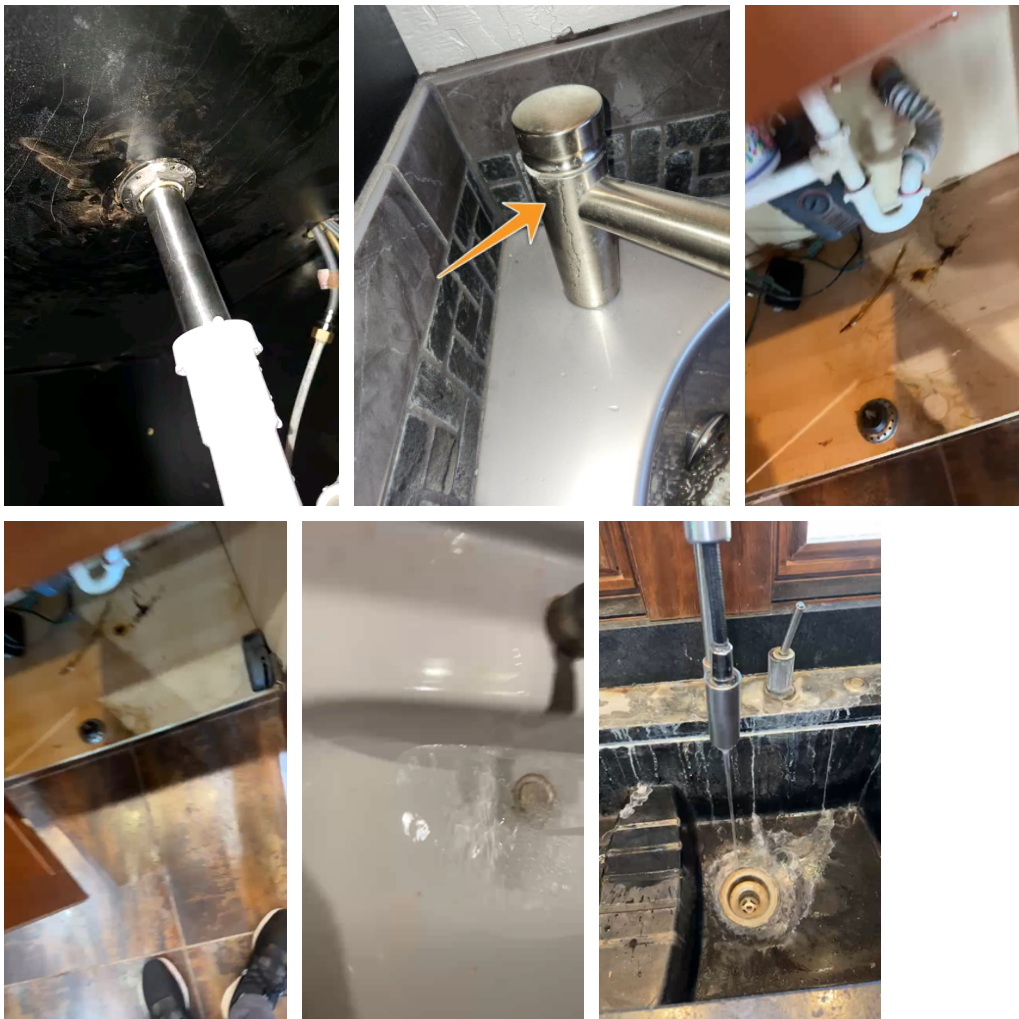
The fixture has an active leak. I recommend repairing the fixture by fixing the seal or replacement of hardware if necessary.

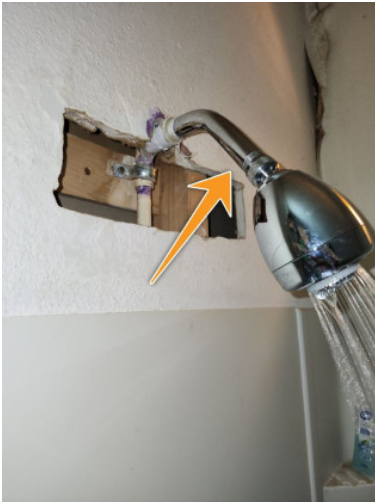
One or more of the plumbing fixtures in the home were loose during the inspection. I recommend having the fixture secured and sealed around in order to prevent any leaks.

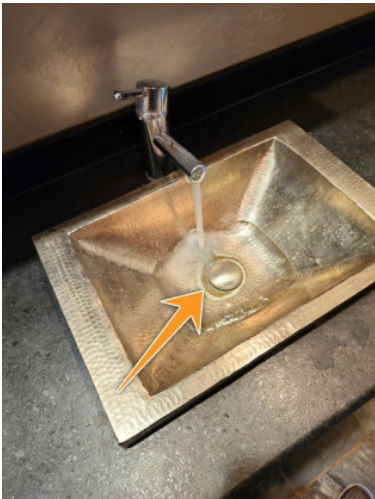
DEFICIENCY 9.8

Not Functioning - Drain Assembly

The drain stopper at the fixture was missing or not functioning. Repair or replace.

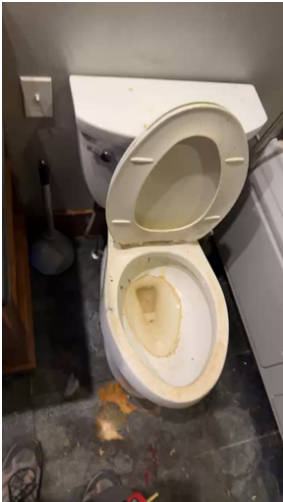
DEFICIENCY 9.9

Broken/Not Functioning - Toilet

The toilet is not functioning and is missing parts, recommend replacement.

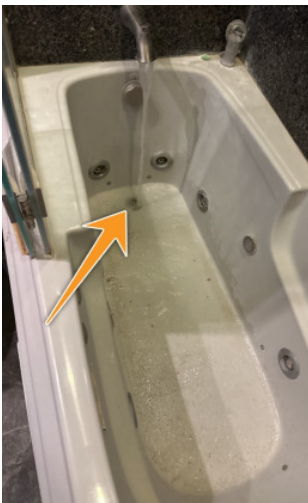
DEFICIENCY 9.10

Inoperable/missing - Tub stopper

The tub stopper does not function properly. Recommend repair or adjusting as needed.

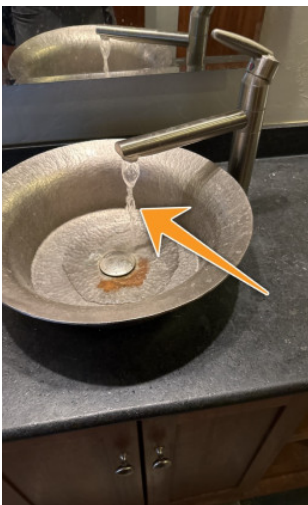
DEFICIENCY 9.12

Poor Flow - Plumbing Fixture

One or more plumbing fixtures had low flow at the time of the inspection. Recommend repair or replacement.

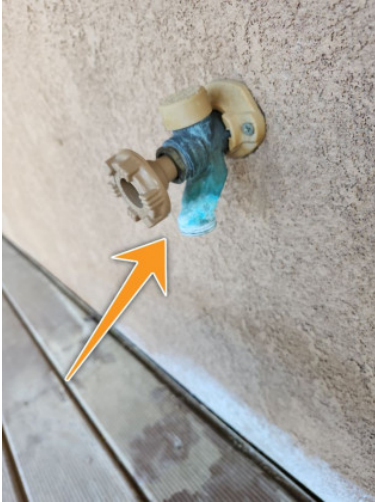
Though they were not leaking at the time of the inspection the fixture was corroded. Recommended monitoring and replacement as it begins to leak.

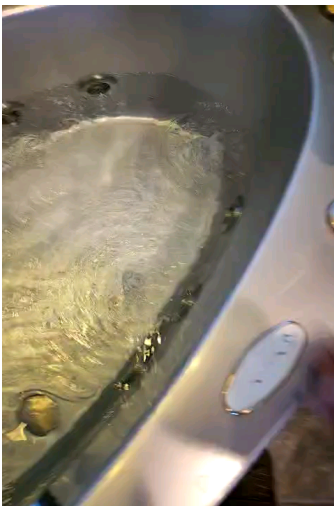
DEFICIENCY 9.14

Jetted Tub - Inoperable

The jetted tub did not operate at the time of inspection. I recommend evaluation and repair by a licensed plumber.

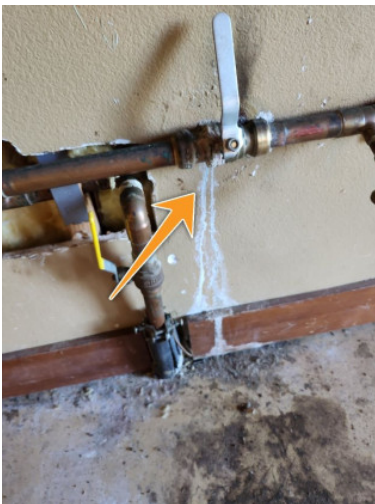
One or more plumbing fixtures or drain lines showed evidence of past leaks. Although no active leaks were observed at the time of inspection, I recommend monitoring moving forward.

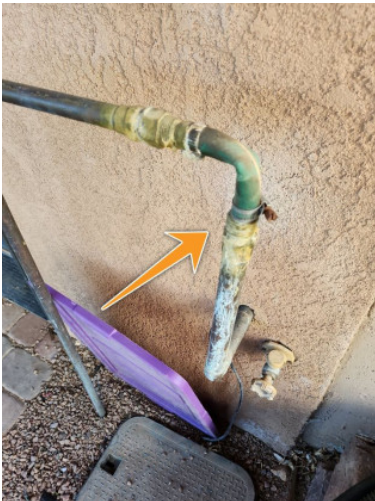
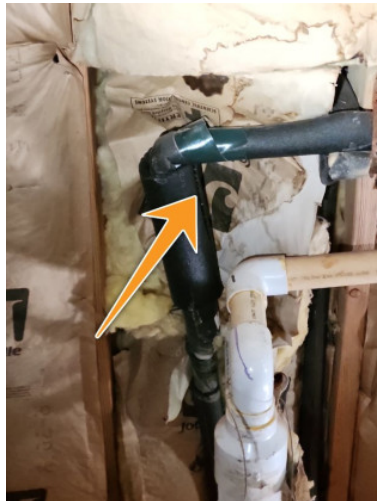
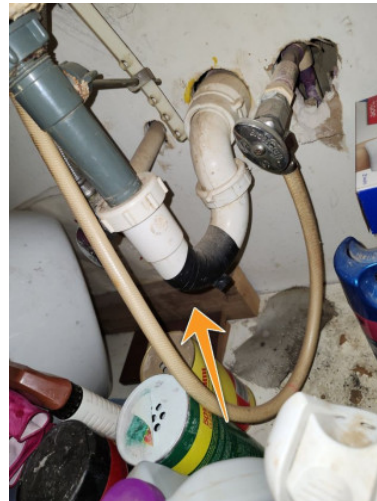
At the time of inspection there appeared to be some DIY plumbing in one or more locations of the home. Recommend evaluation and repair by a licensed plumbing contractor.

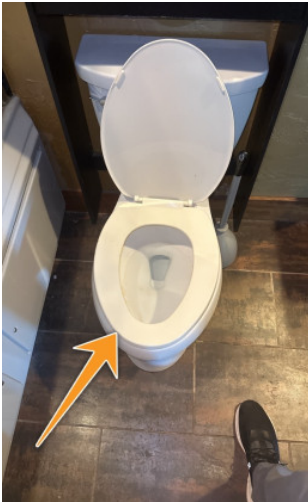
DEFICIENCY 9.19

Unable To Test Toilet - Water Off

At the time of inspection the toilet water line was turned off and I was unable to get it back on. It appeared to be stuck. Recommend repair and testing prior to closing.

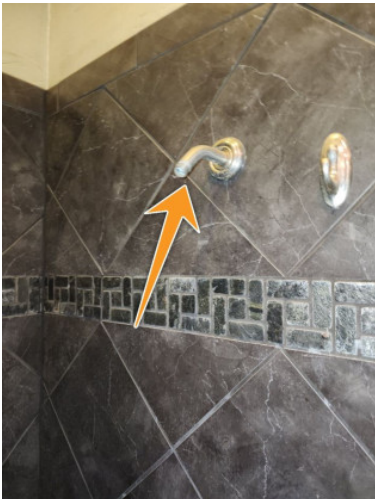
DEFICIENCY 9.20

Missing Showerhead

Recommend replacement.

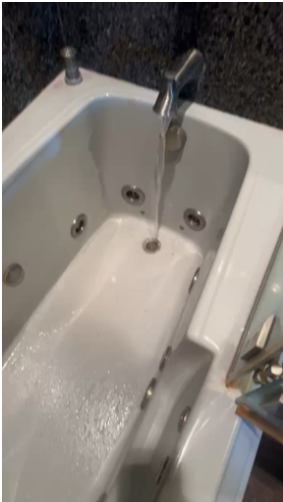
DEFICIENCY 9.21

Missing Drain Plug

Recommend installing as needed.

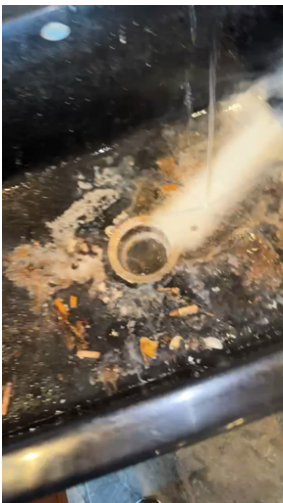
DEFICIENCY 9.22

Clogged - Sink

A clogged sink was observed at the time of the inspection. Recommend evaluation and repair as necessary.
