Top Choice Inspectors

Residential Inspection Report

14525 Aiken Ride View , Colorado Springs, Colorado 80926

June 28, 2024 09:00 am

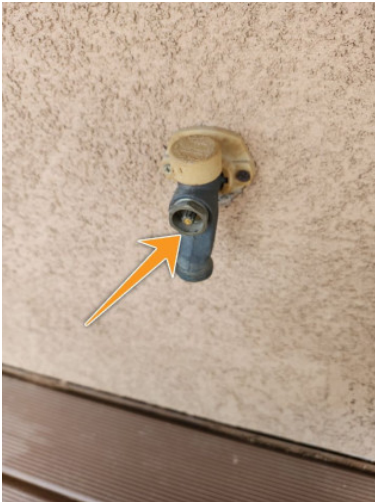
Recommend a licensed plumber evaluate inoperable host spigot and repair.

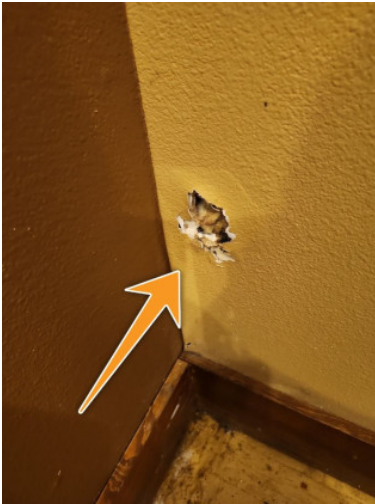
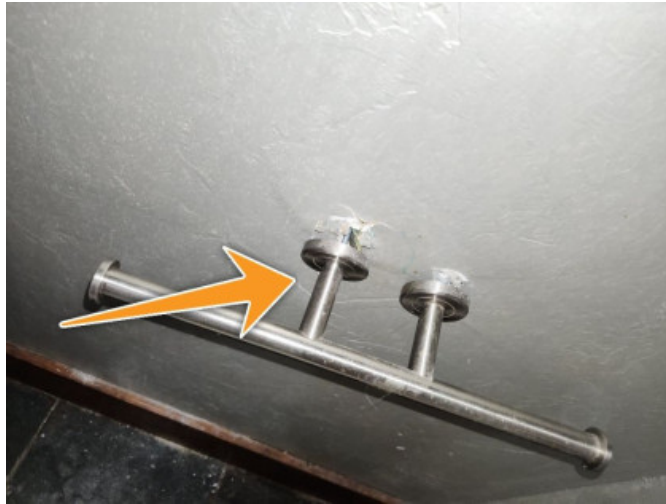
Minor dents, dings, and holes were observed in drywall around the home.

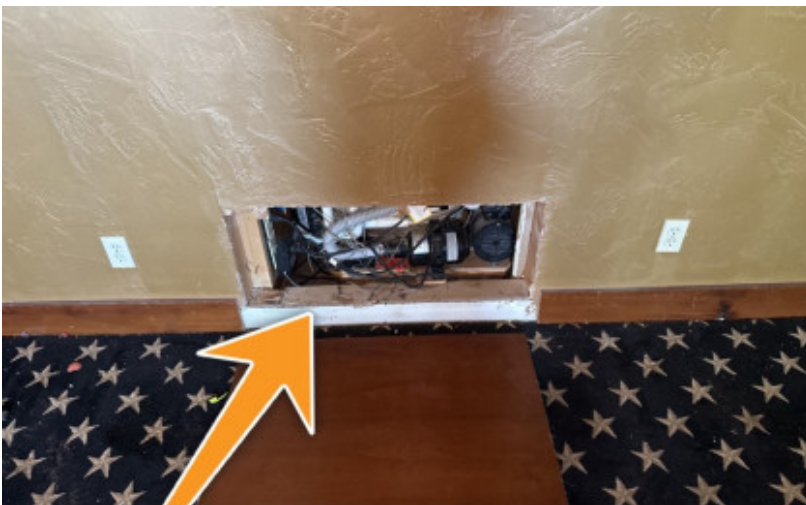
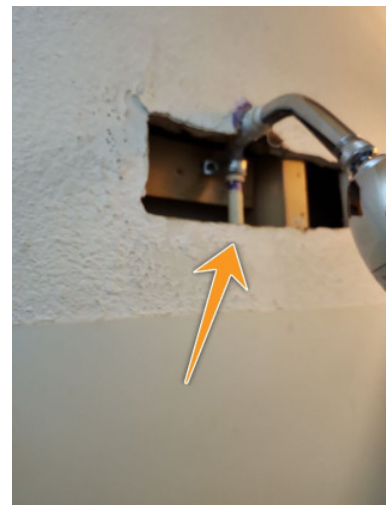
minor drywall damage was present at time of inspection

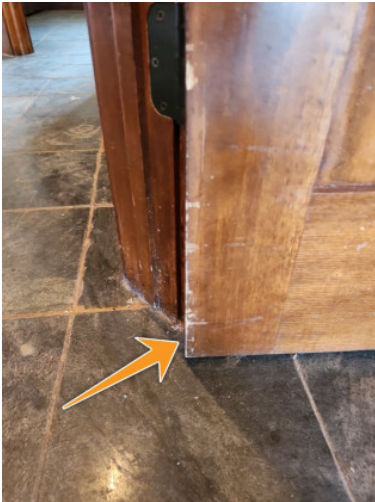
I inspected all of the doors in the home and I found one or more that had damage. I recommend having the doors repaired, or replaced if necessary.

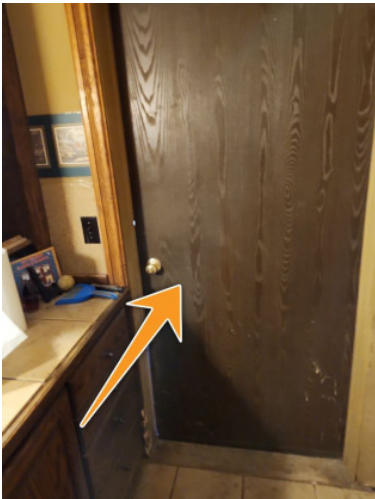
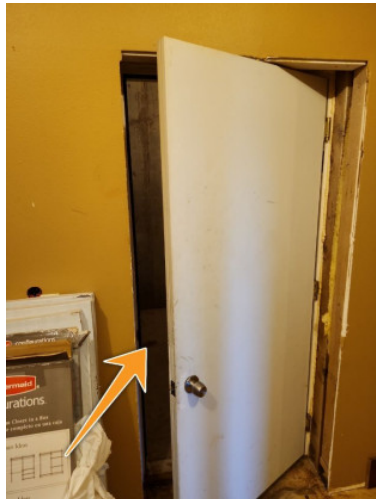
DEFICIENCY 10.4

Doesn't Latch / Lock - Interior Door

There were one of more doors that didn't latch and/or lock properly. In order to gain the full the function and safety of the doors, I recommend having the doors repaired or replaced if necessary.

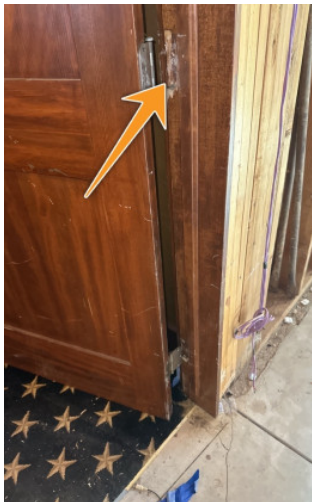
DEFICIENCY 10.5

Hardware Loose - Interior Door

I found that hardware at one or more doors was loose at the time of the inspection. Recommend repair or replacement.

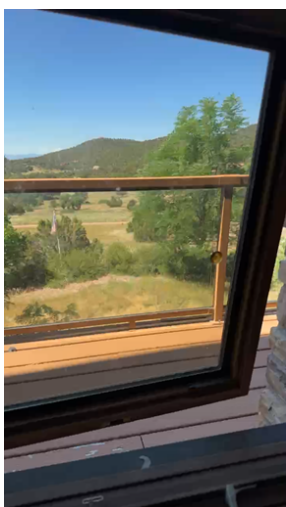
DEFICIENCY 10.6

Inoperable - Window

Some of the windows are not functioning properly. Recommend repair or replace.

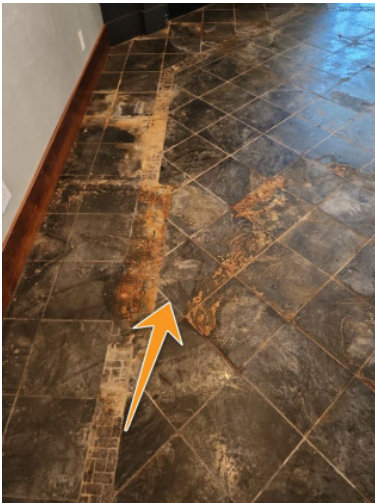
When inspecting the home's flooring, one or more areas had visible moisture damage. I recommend a qualified flooring contractor evaluate & repair areas of moisture.

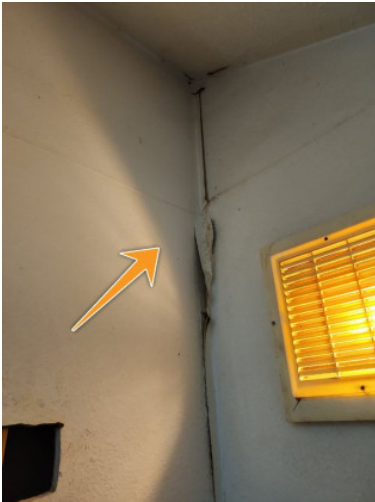
One or more locations on the walls and ceiling had damaged texture on the drywall. Recommend touching up as needed.

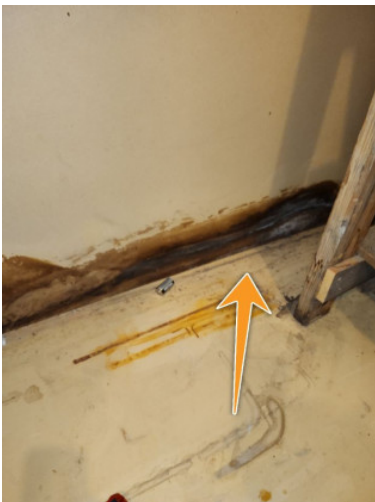
At the time of inspection, there was evidence of water damage on an interior wall. Recommend further evaluation by a licensed contractor.

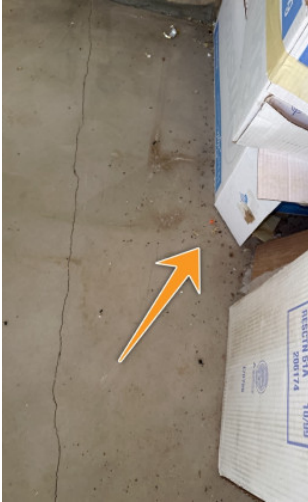
DEFICIENCY
10.12

Evidence Of Possible Termites/Pests

Recommend having a licensed professional evaluate further.

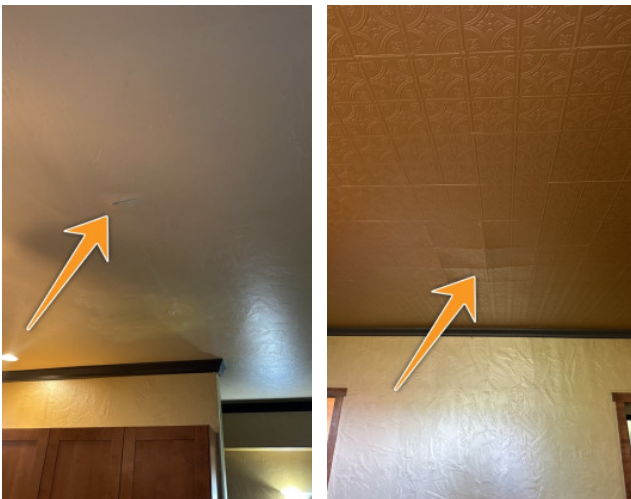
DEFICIENCY
10.13

Hole/Damage - Ceiling

Recommend repair by a licensed contractor.

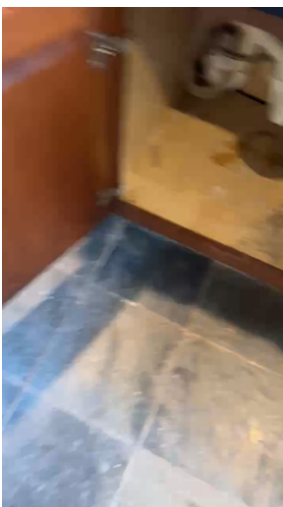
Damaged - Cabinet

One or more of the cabinets had visible damage at time of inspection. I recommend having the cabinets repaired or replaced as necessary.

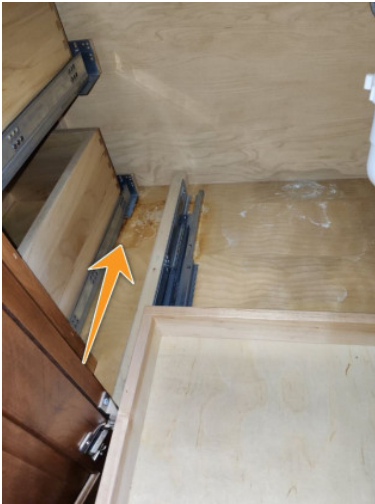
While inspecting the cabinets, I noticed water damage. I recommend having the source of the damage evaluated and the cabinet should be monitored.

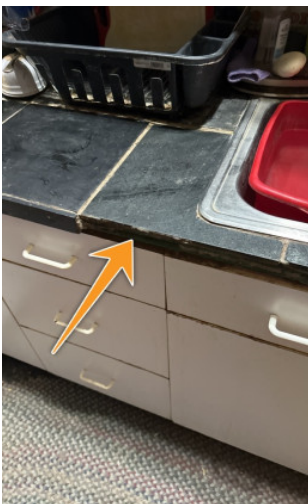
Counter Top Damaged

Recommend sealing and/or replacing.

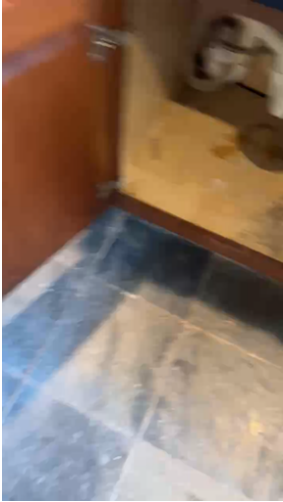
Adjustment Needed - Cabinet

At the time of inspection there were one or more cabinets that were not operating smoothly, or need a slight adjustment.

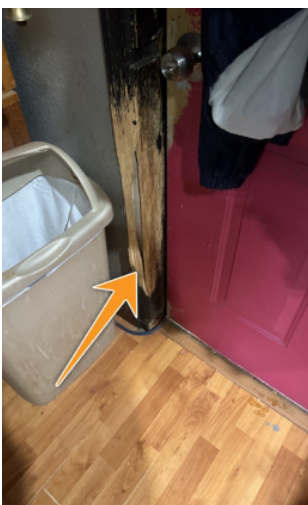
DEFICIENCY 10.18

Dog Damage - Interior Trim

There was damage to the trim caused by a dog at the time of the inspection.

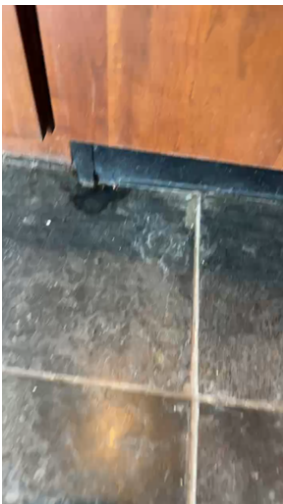
DEFICIENCY 11.1

Leaking - Dishwasher

Dishwasher leaks when cycle was ran. Recommend qualified professional to evaluate.

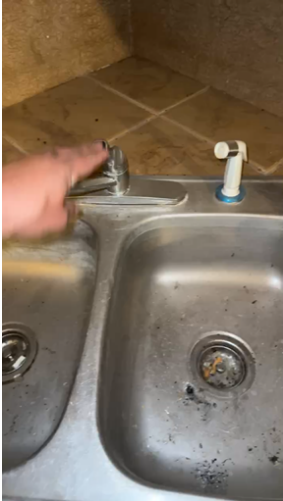
DEFICIENCY 17.1

Inoperable - fixture

The fixture was inoperable at the time of inspection. I recommend repair. It is possible that a valve connected to the fixture is shut off somewhere in the home.

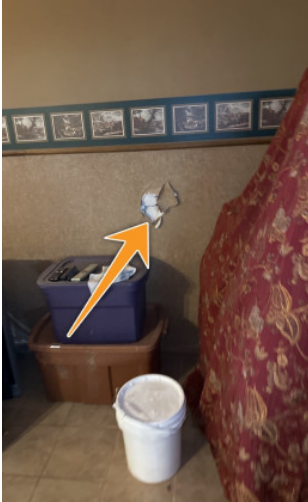
DEFICIENCY 18.1

Damage drywall

Minor/Maintenance

minor drywall damage was present at time of inspection

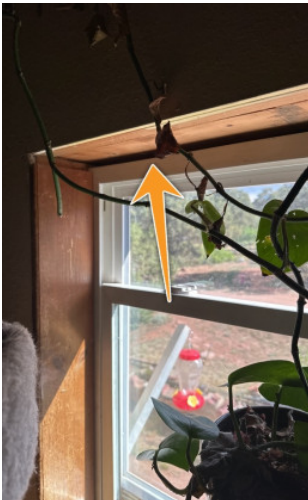
DEFICIENCY 18.2

Improper installation - Window

Estimated Severity : ■ □□ Repair

There appears to be a single hung window that was used as a slider recommend replacement.

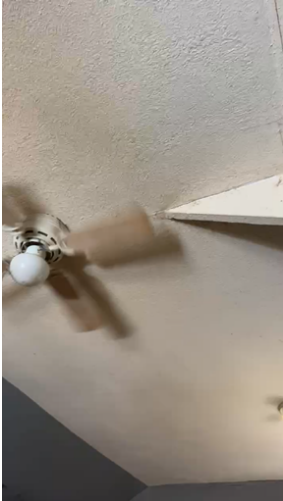
DEFICIENCY 18.3

Settling Cracks - Walls

Estimated Severity : ■ □□ Repair

All homes from time to time have settling cracks. This is simply cracking from the home settling as dirt underneath settles. These cracks are not to be concerned about. But if you are concerned about the structural integrity of your home, I recommend further evaluation by a structural engineer.

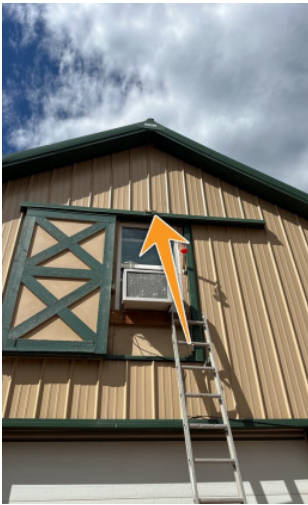
DEFICIENCY 19.1

Loose and/or Exposed Wiring

Estimated Severity : ■ □□ Repair

There is unsafe and exposed wiring visible and present during the home inspection. I recommend a licensed electrician repair and secure properly.
