## General Summary

**Clear Pathways, Inc.**

**Customer**  
Chip Jones

**Address**  
21182 Mt Rd  
Rappahannock Academy VA 22538

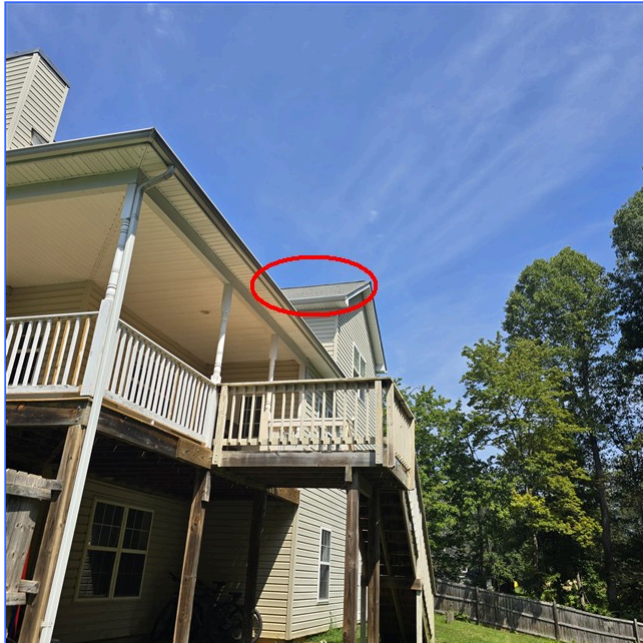
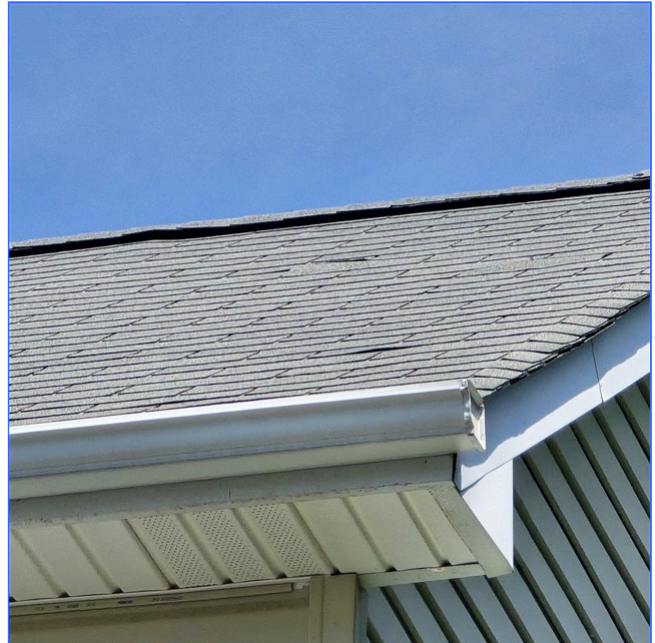
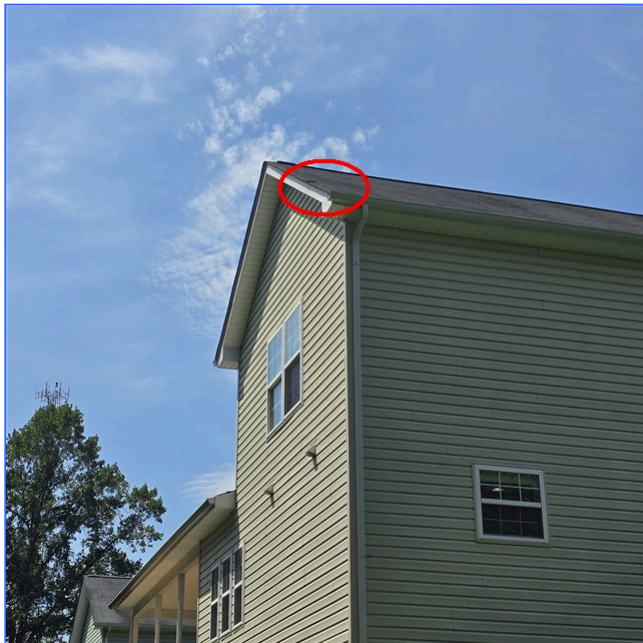
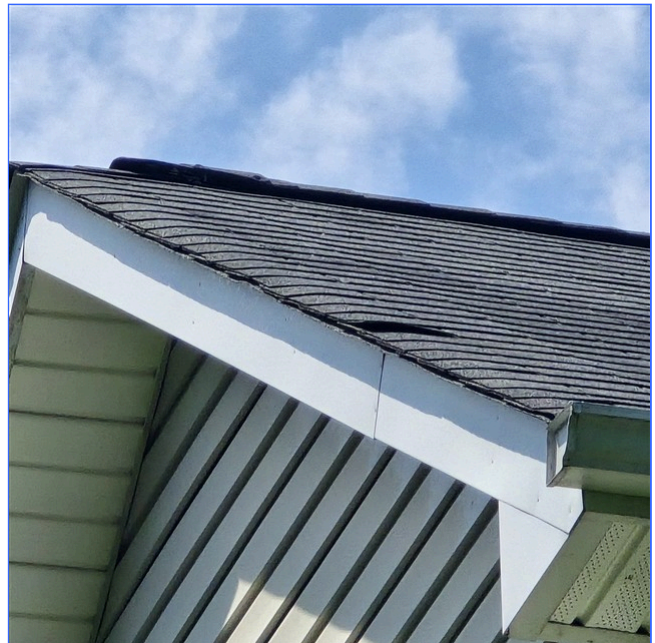
Some of the three tab asphalt fiberglass shingles are raised in various areas. Raised shingles are more vulnerable to wind damage and water intrusion. A qualified roofing contractor is recommended to further evaluate the affected areas and repair or secure the shingles as needed. Example areas pictured. Please note, the shingles appear to be original to the 2008 construction and are older in age. Continued maintenance and repairs should be anticipated, and budgeting for future roof replacement is recommended.

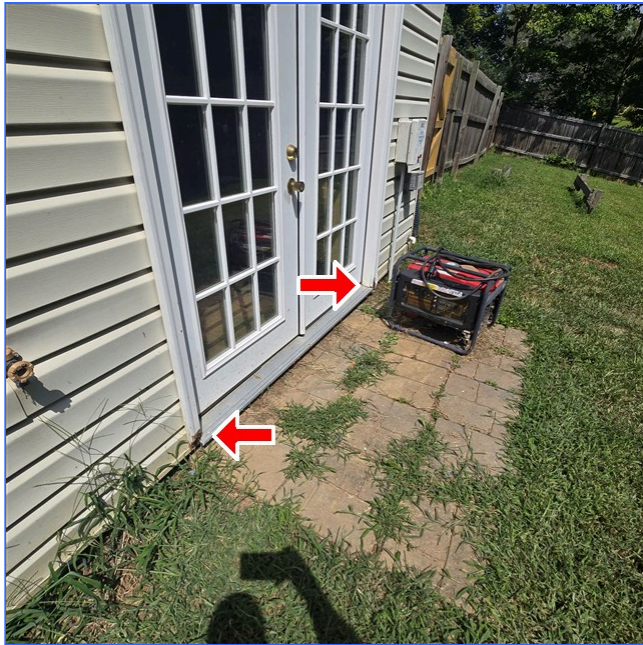
2.0 Item 1(Picture)

(1) Various areas around the house show signs of moisture damage to the trim. Much of the trim will need to be scraped, caulked, and painted to help prevent further moisture damage. It is recommended to have a qualified, licensed contractor evaluate the affected areas and make any necessary repairs to ensure the trim is properly sealed and protected. Example areas pictured.

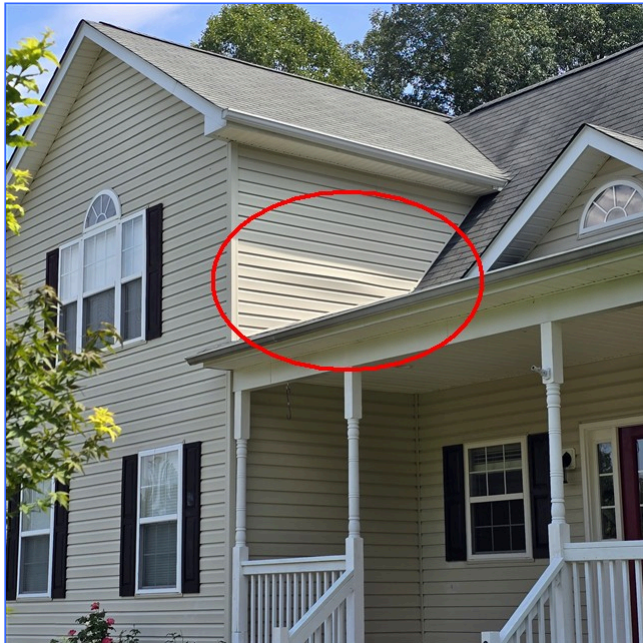
2.0 Item 2(Picture)

(2) Sections of vinyl siding are loose in a few areas around the exterior of the home. Loose vinyl siding can allow moisture or pests to enter behind the cladding and may lead to damage over time. It is recommended that a qualified contractor secure the loose sections and make any necessary repairs to maintain proper protection and appearance. Example area pictured.

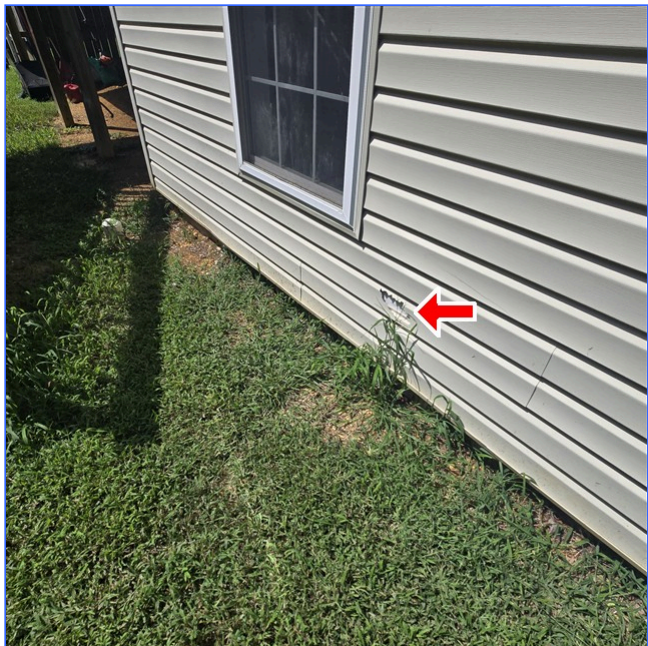
2.0 Item 3(Picture)

(3) Chipped and damaged vinyl siding was noted in a few areas around the house. This appears to be mostly cosmetic, but repairs are recommended to improve the exterior appearance and help protect the siding. A qualified contractor can fill small damaged areas with a closely matched exterior sealant or replace the affected siding sections for a cleaner repair. Example area pictured.

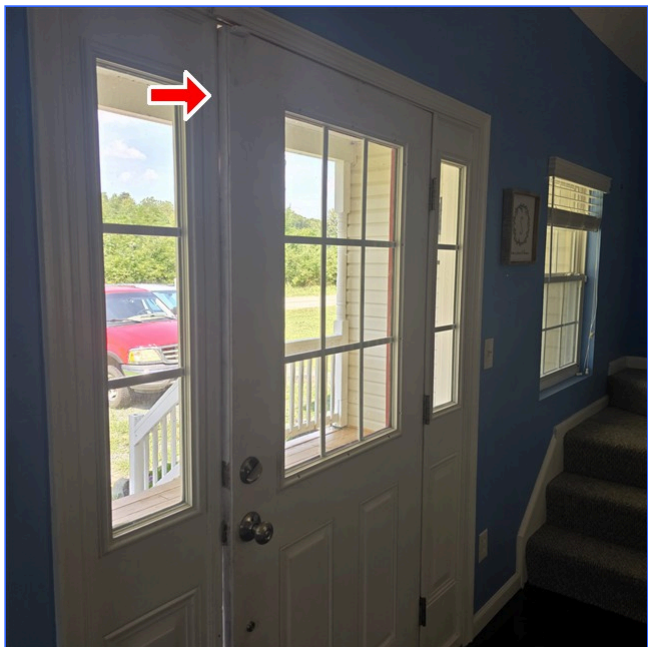
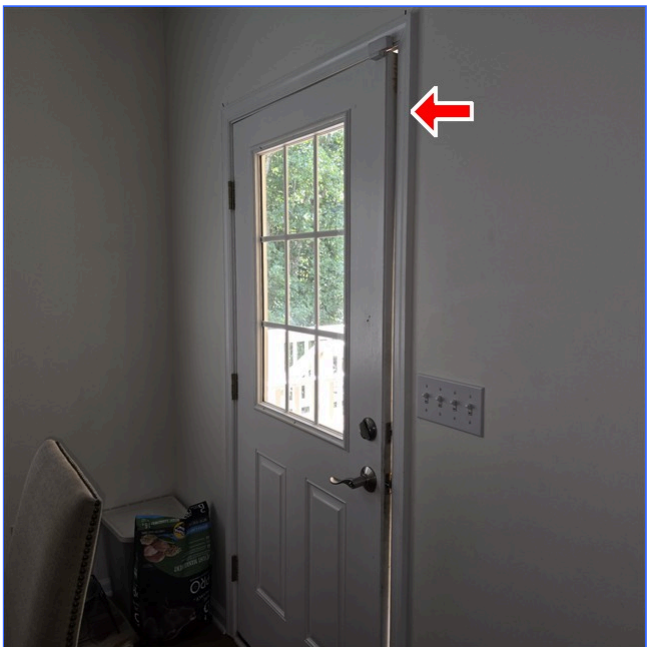
The exterior doors rub against the frames when opening and closing, affecting proper operation. A qualified licensed contractor is recommended to further evaluate the doors and make adjustments or repairs as needed. Also see 2.0 comment.

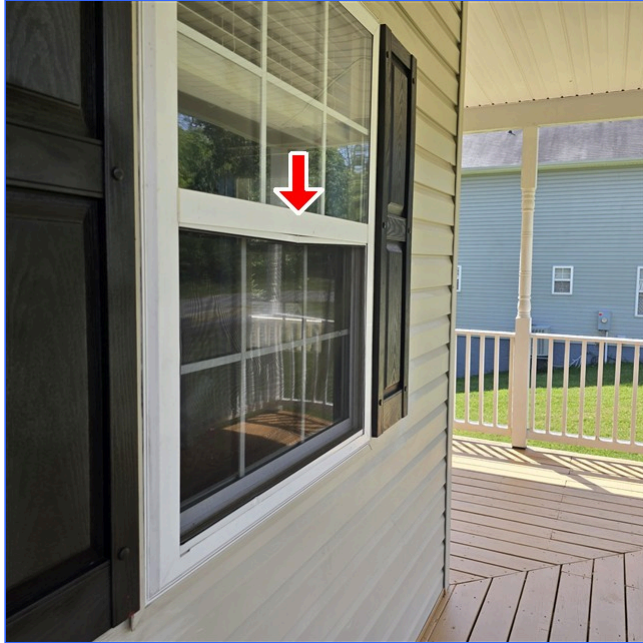
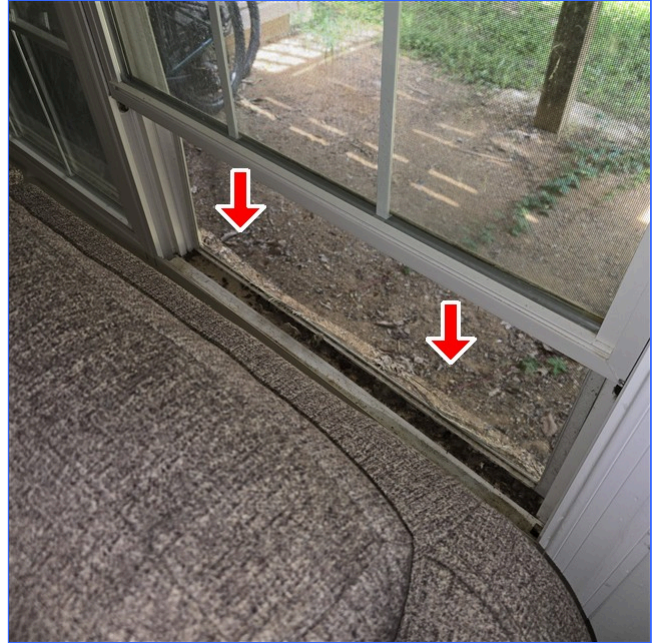
Some of the window screens and frames are damaged, which may affect their fit and ability to keep insects out. It is recommended to have the damaged screens and frames repaired or replaced as needed by a qualified window contractor. Example screens pictured. Also see 2.0 comment.

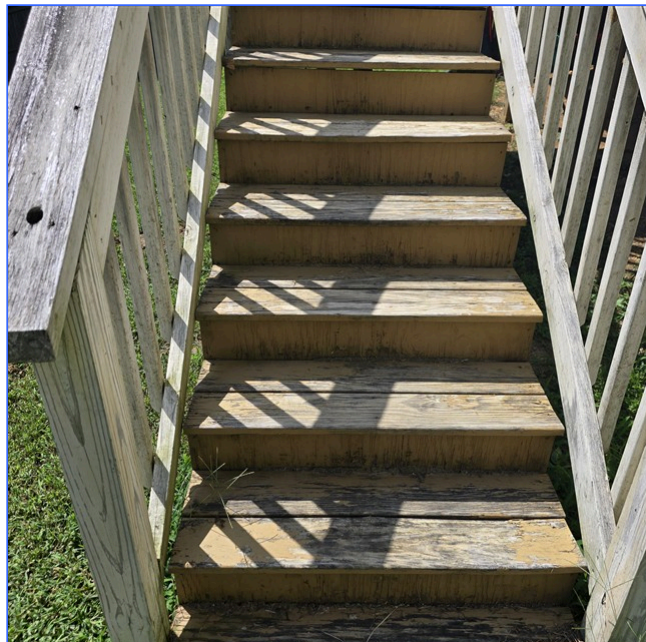
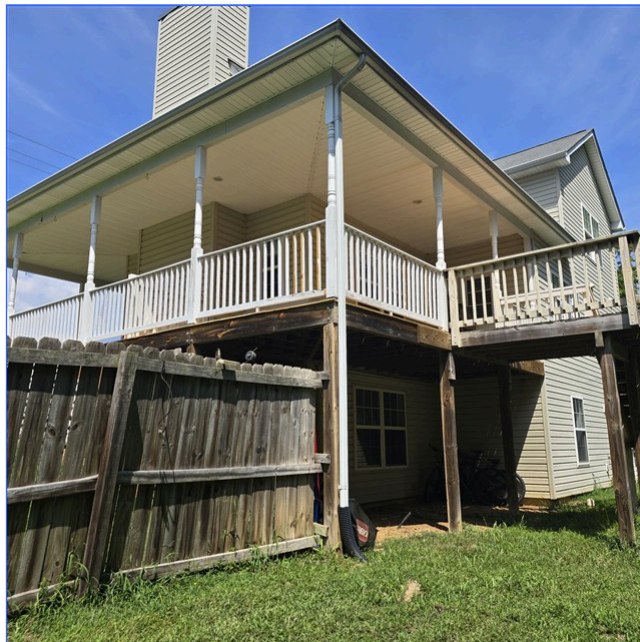
(1) The deck boards are weathered and would benefit from cleaning and application of a water sealing treatment to help protect the wood from further deterioration. Some of the railing and picket surfaces are also not fully painted or protected. A qualified licensed contractor is recommended to clean and apply an appropriate protective finish to the exposed wood surfaces as needed. Example areas pictured.

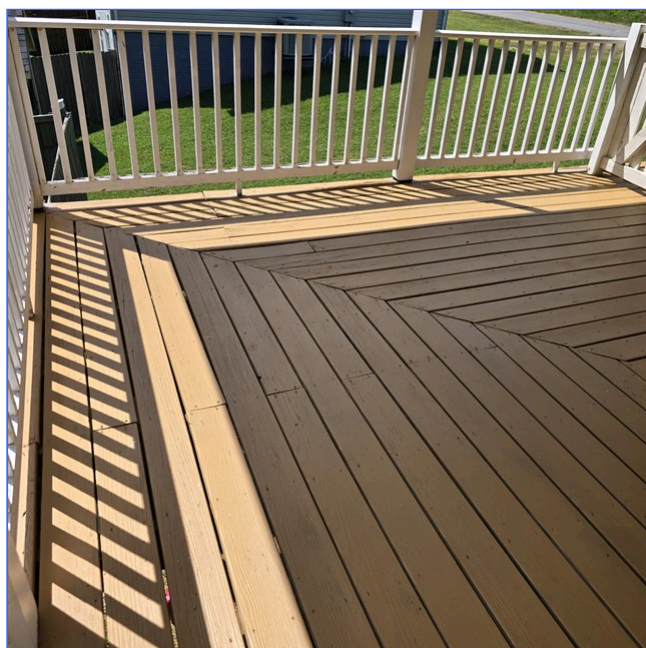
2.3 Item 3(Picture)

(2) There are uneven areas on the rear deck surface. This may be related to the original construction or movement and settlement of the deck structure. A qualified licensed contractor is recommended to further evaluate the deck and make adjustments or repairs as needed. Example area pictured.

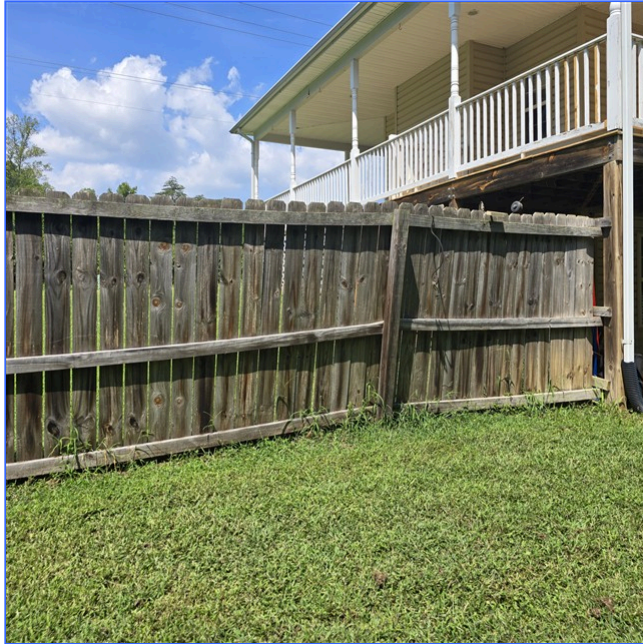
2.3 Item 4(Picture)

(3) Although the fencing is not part of the home inspection, it is noted that some of the fence panels are leaning. A qualified licensed contractor is recommended to further evaluate the fencing and make repairs as needed. Example area pictured.

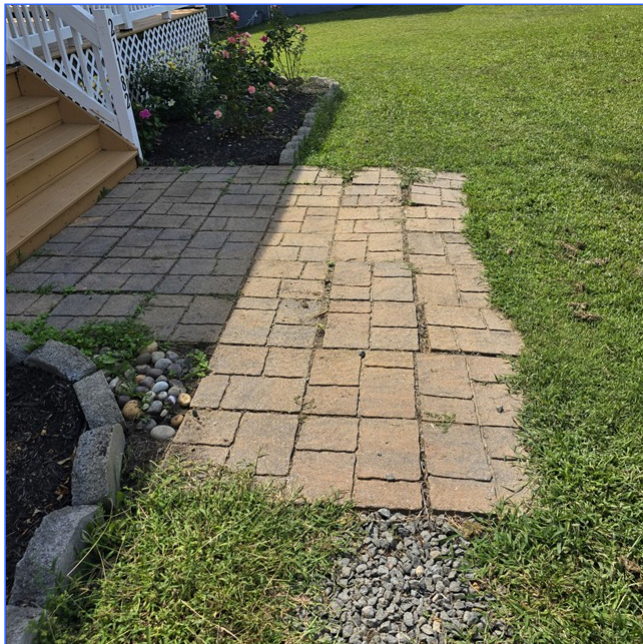
2.4 Item 1(Picture)

The pictured paver walkway is uneven, with some of the pavers loose or displaced, creating potential trip hazards. A qualified licensed contractor is recommended to further evaluate the walkway and reset or repair the pavers as needed.

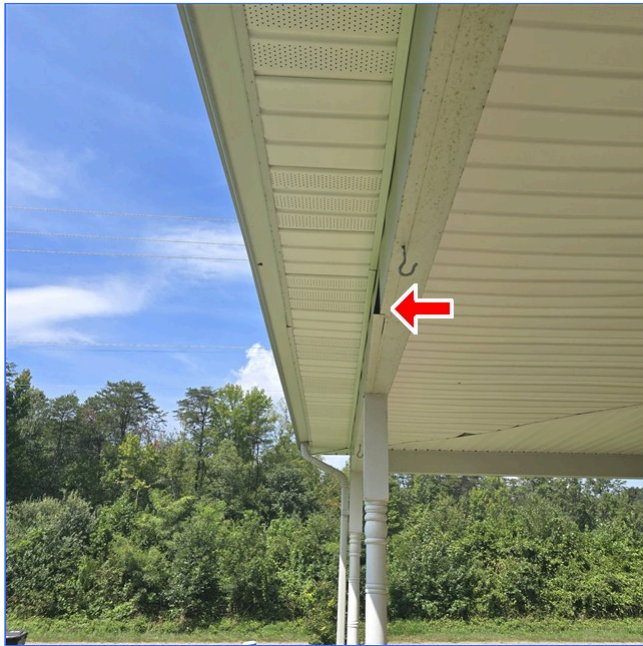
2.5 Item 1(Picture)

(1) The pictured fascia wrap is loose and pulling away from the underlying fascia. A qualified licensed contractor is recommended to further evaluate and properly secure or repair the fascia wrap as needed.

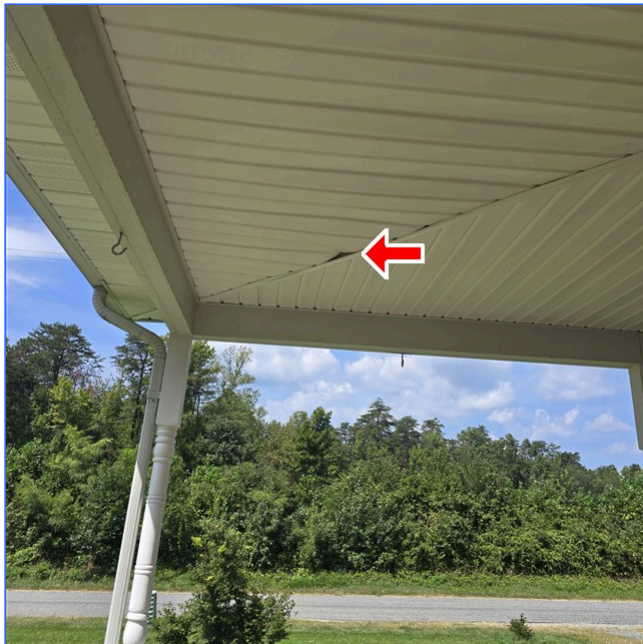
2.5 Item 2(Picture)

(2) There is an opening in the soffit material at the pictured front porch area, which may allow moisture, insects, or pests to enter the concealed space. A qualified licensed contractor is recommended to further evaluate the area and make repairs as needed.

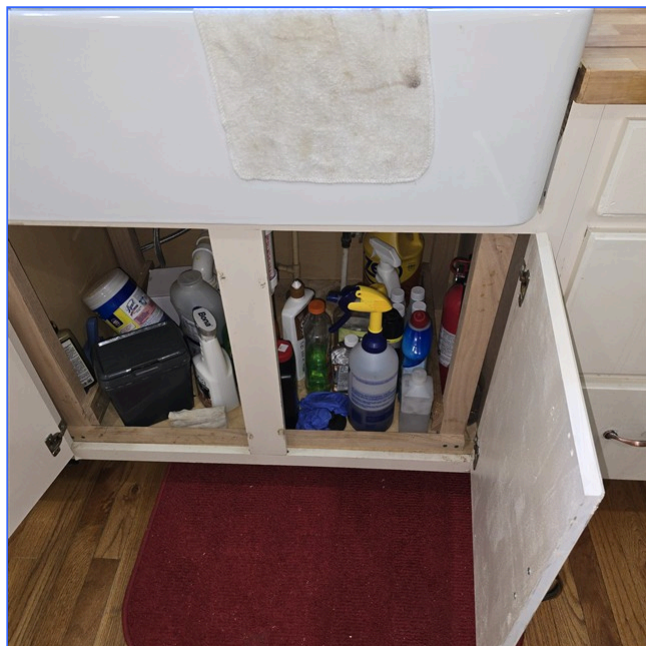
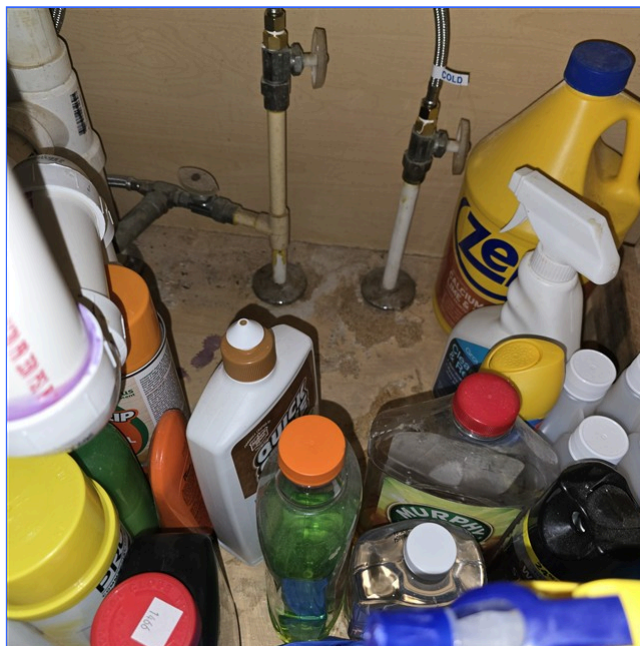
(1) There are stains present on the bottom of the kitchen sink cabinet, which may be from previous leaks or spills. The plumbing was tested by running water for several minutes, and no active leaks were observed at the time of the inspection. It is recommended to monitor the area periodically and address any leaks if they develop. A qualified plumber can further evaluate if there are ongoing concerns.

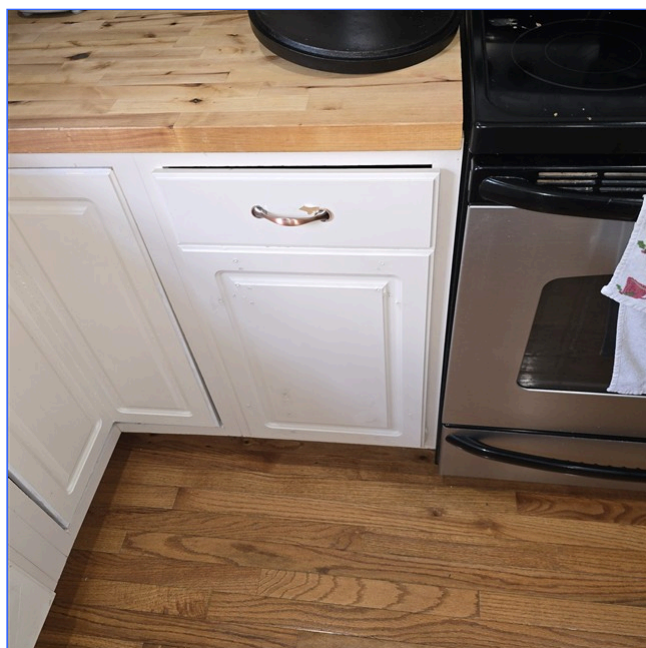
3.4 Item 3(Picture)

(2) Some of the kitchen cabinets show normal wear and aging in various areas. Minor repairs or touch ups can be made as desired by a qualified licensed contractor. Example area pictured.

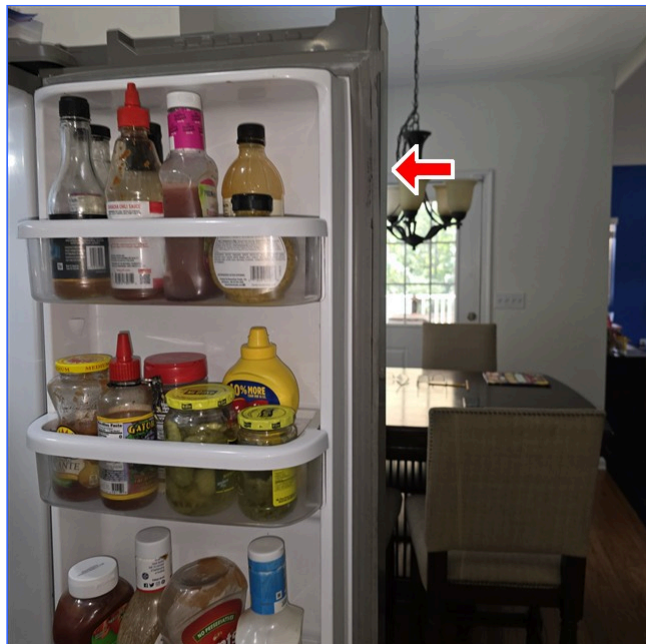
3.12 Item 1(Picture)

The refrigerator door seal is torn in a few areas, which may prevent the door from sealing properly and affect efficiency. A qualified appliance repair technician is recommended to further evaluate and replace the seal as needed. Example area pictured.

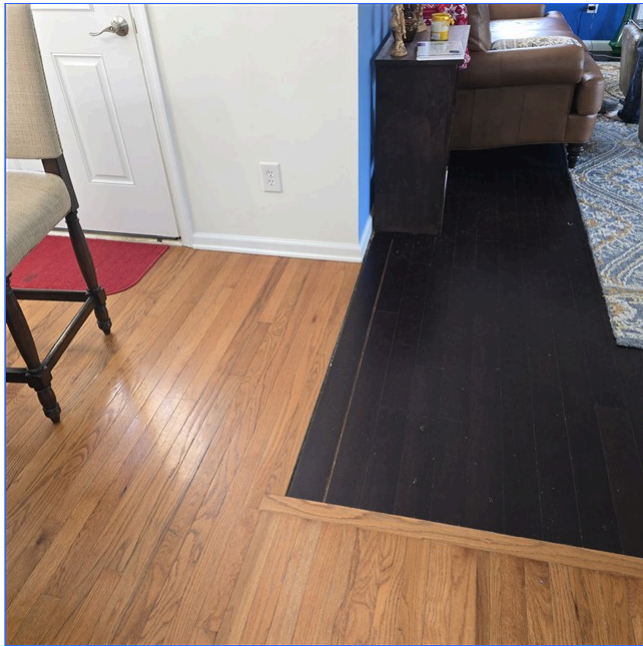
4.2 Item 1(Picture)

Some of the wood flooring has gaps between the boards in various areas. A qualified licensed contractor is recommended to further evaluate the flooring and make repairs or adjustments as needed. Example area pictured. Also see 4.1 comment.

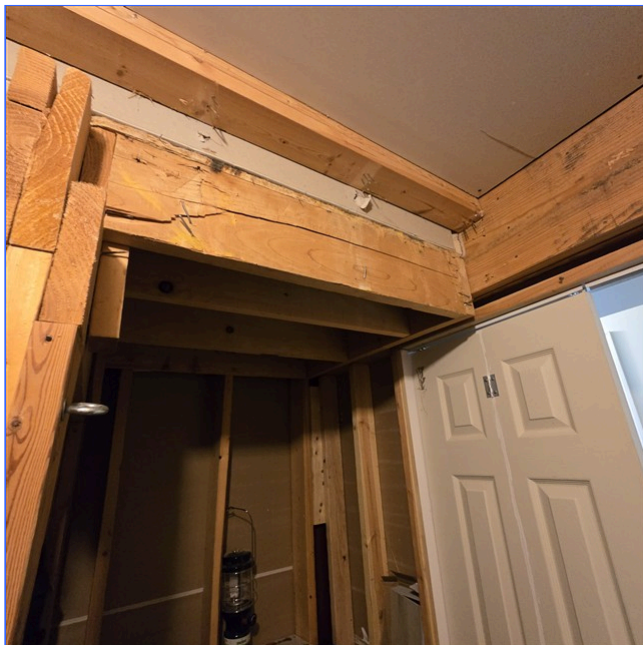
4.3 Item 1(Picture)

The framing for the basement stair landing is split and damaged in areas. Some of the framing that may have provided additional support also appears to have been removed. A qualified licensed contractor is recommended to further evaluate the landing and surrounding framing and make repairs or provide additional support as needed.

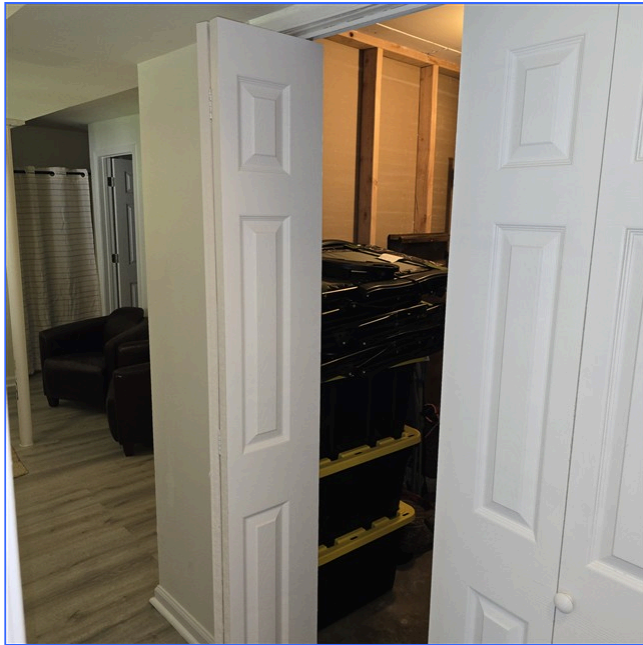
4.4 Item 1(Picture)

A few of the doors are difficult to open and close, and some do not latch properly. This may be due to settling, loose hardware, or misalignment. It is recommended to have a qualified contractor adjust or repair the affected doors to ensure proper function and secure latching. Example doors pictured. Also see 4.1 comment.

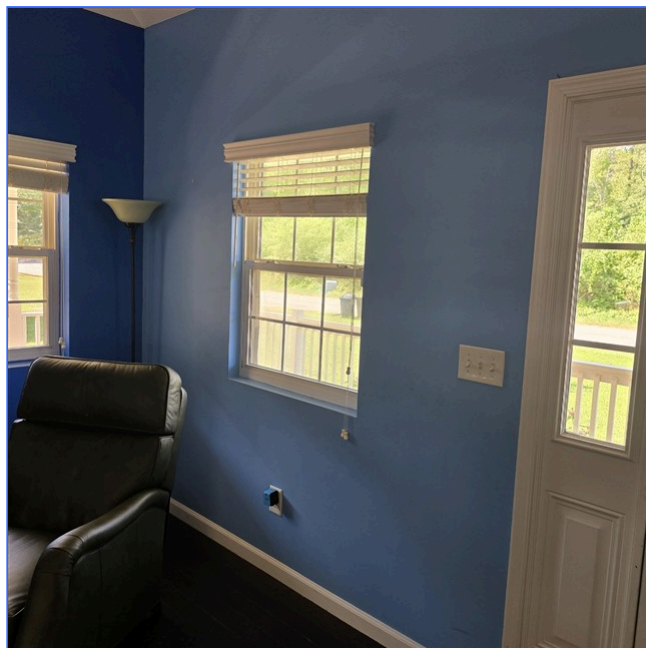
4.5 Item 1(Picture)

(1) Some windows show signs of broken dual pane seals, which can cause condensation or fogging between the panes of glass. It's difficult to determine the exact number of windows affected, as factors like dirty windows or lack of sunlight or proper lighting can affect visibility and make it challenging to assess. While this condition doesn't typically affect the window's functionality, it can impact energy efficiency and appearance. A window professional can evaluate the situation and determine how many windows have faulty seals and recommend the necessary repairs or replacements. Example window pictured. Also see 4.1 comment.

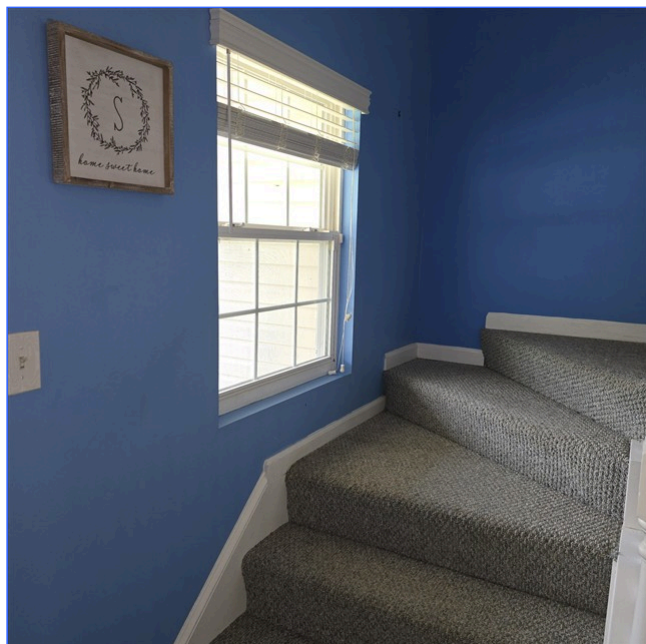
4.5 Item 2(Picture)

(2) The glass in the pictured stairway window does not appear to be safety tempered glass. Due to its location adjacent to the stairs, this presents a potential safety concern if the glass is broken. A qualified licensed contractor is recommended to further evaluate the window and upgrade the glass as needed for improved safety.

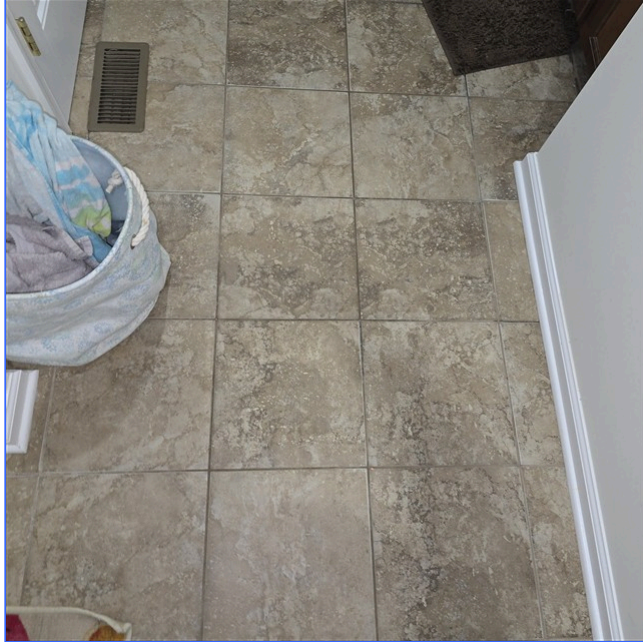
5.2 Item 1(Picture)

Some of the grout between the bathroom floor tiles is missing or deteriorated, which may be related to movement or loose tiles. A qualified licensed contractor is recommended to further evaluate the affected areas and make repairs as needed. Example area pictured.

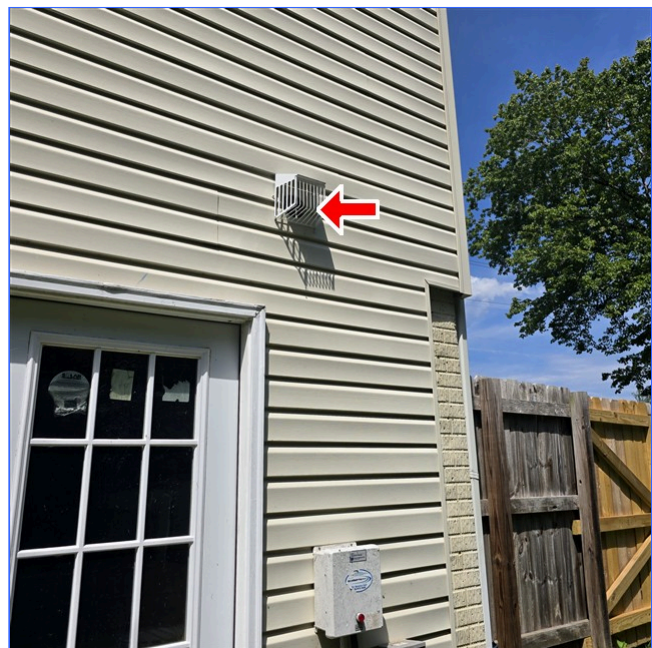
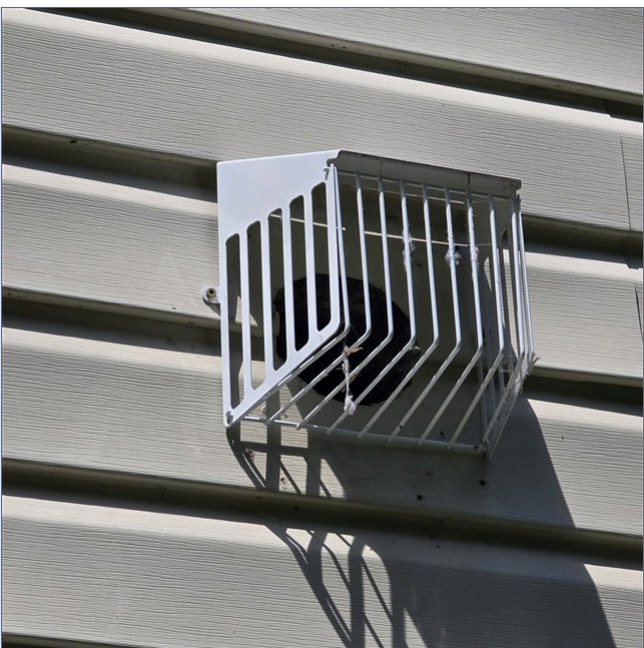
(1) The pictured exterior exhaust vent cover is missing the backdraft damper, leaving the vent opening exposed to outside air, insects, and pests. A qualified licensed contractor is recommended to further evaluate the vent and repair or replace the cover as needed.

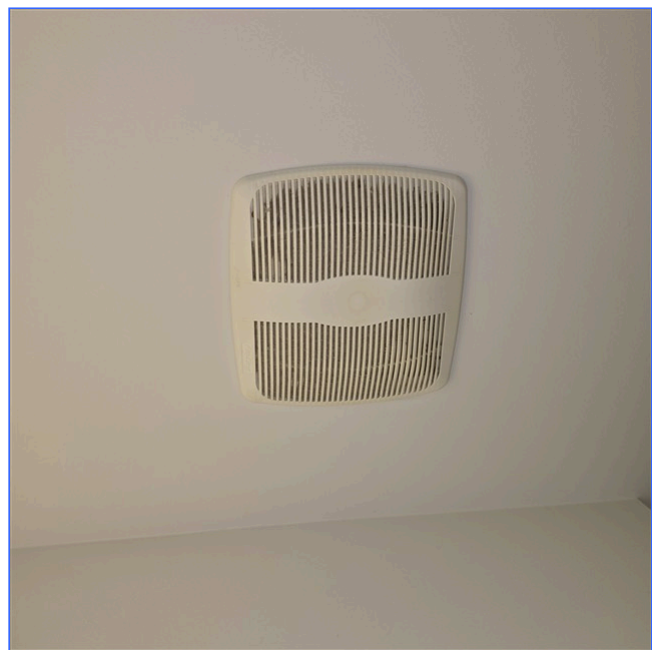
5.8 Item 3(Picture)

(2) The bathroom exhaust fans are dirty with visible dust and debris buildup. This can restrict airflow and reduce the fan's ability to remove moisture from the room. Excessive dust on the fan components can also create a potential fire concern over time. A qualified contractor is recommended to clean the fans thoroughly and maintain them regularly for proper and safe operation. Example fan pictured.

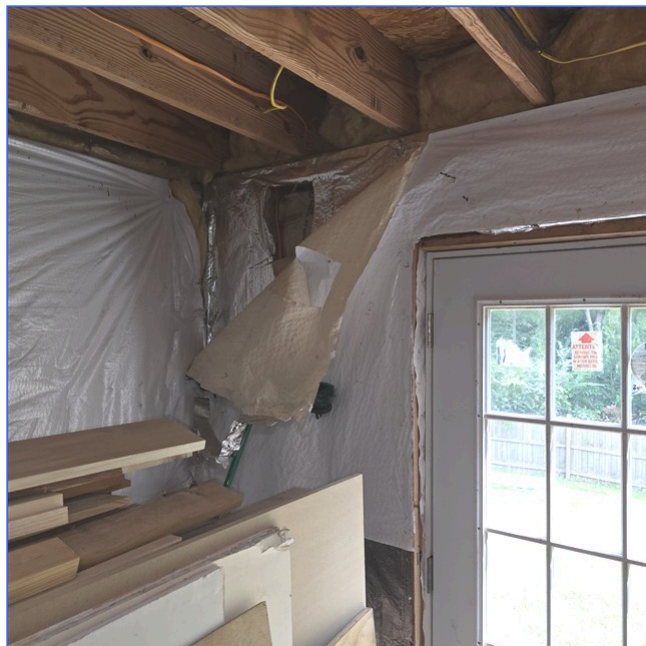
6.0 Item 1(Picture)

(2) Some of the insulation along the basement foundation walls is loose and pulling away in various areas. A qualified licensed contractor is recommended to further evaluate the insulation and properly secure or repair it as needed. Example area pictured.

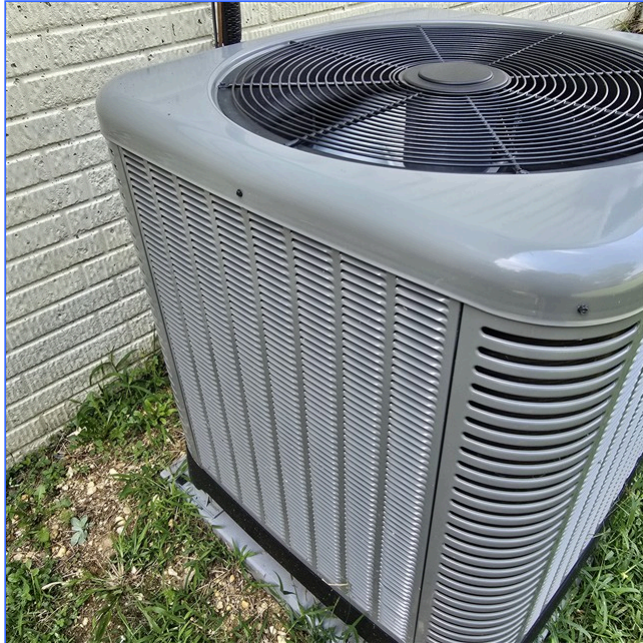
9.0 Item 1(Picture)

The outdoor HVAC unit was making unusual noises and had noticeable vibration during operation, which may indicate a mechanical or component related issue. A complete system evaluation and servicing by a qualified licensed HVAC contractor are recommended to determine the cause and make repairs as needed.

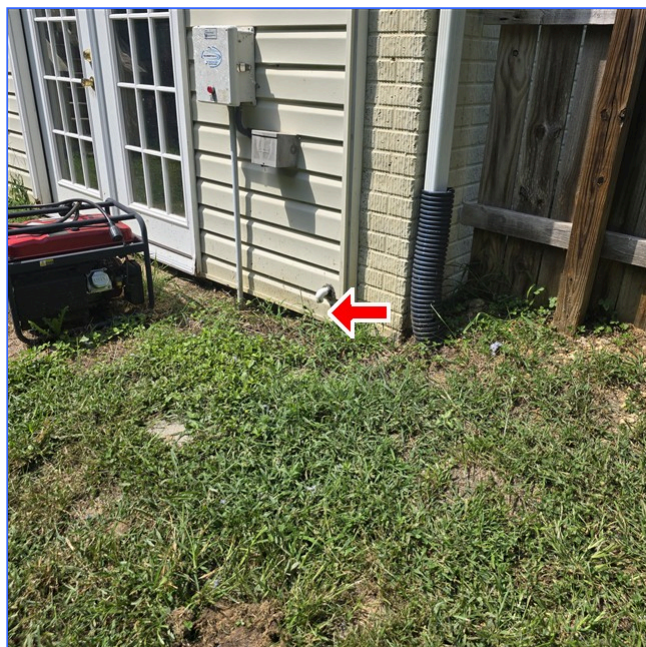
9.6 Item 1(Picture)

The condensation line should be extended further away from the house to prevent water from accumulating near the foundation, which could lead to moisture issues or damage. It is recommended to have a qualified professional extend the line to ensure proper drainage and protect the home's structure. Also see 9.0 comment.

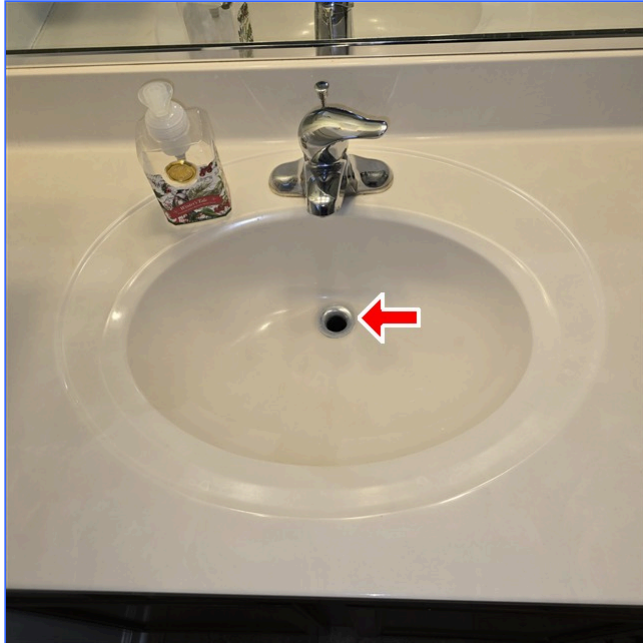
5.5 Item 1(Picture)

Some of the bathroom sink drain stoppers are not operating properly. Non functioning stoppers can prevent the sink from holding water when needed. It is recommended that a qualified plumber or contractor repair or replace the drain stoppers as needed to restore proper function. Example area pictured.

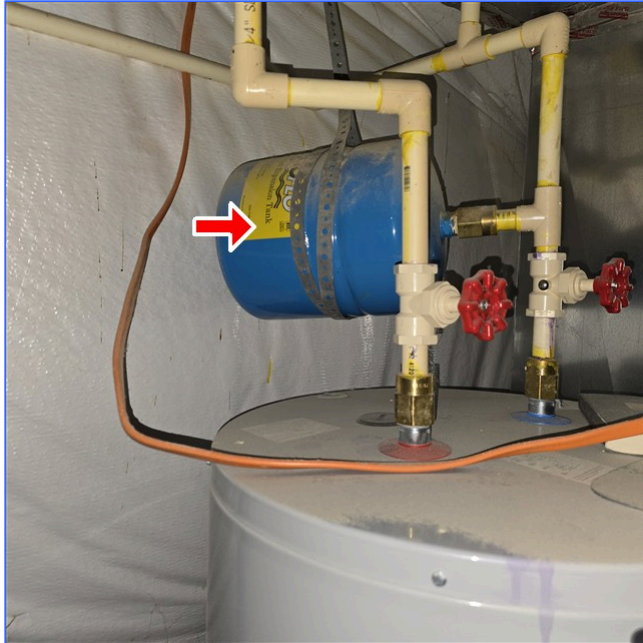
7.2 Item 1(Picture)

The expansion tank for the water heater is full of water, which is not normal. The expansion tank is designed to contain an air cushion that helps absorb pressure changes as the water heats up. Recommend evaluation by a qualified licensed plumber and replacement of the expansion tank as needed.

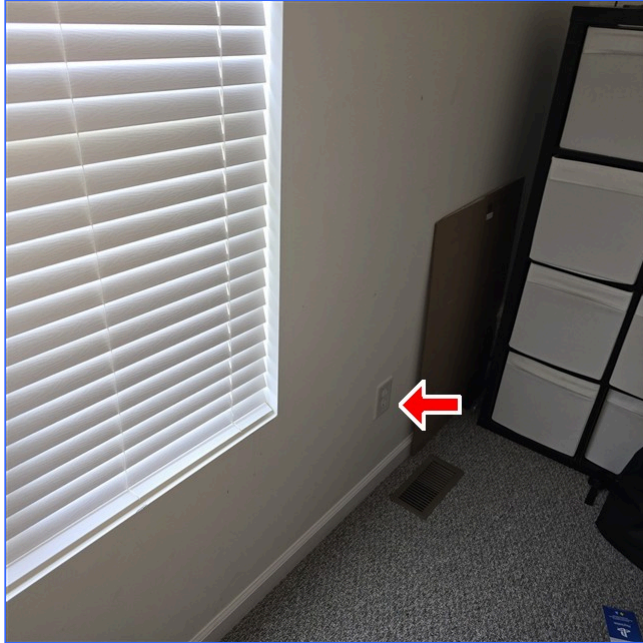
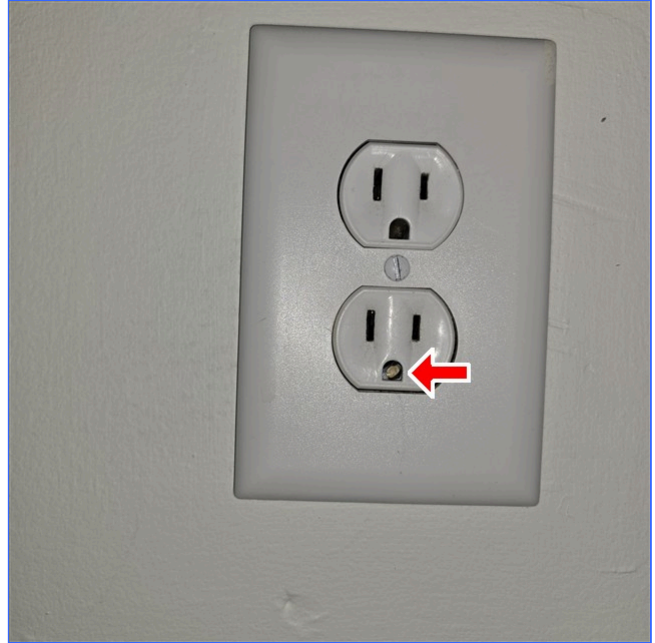
(1) The pictured electrical outlet is damaged, and nothing can be plugged into it due to what appears to be a broken or obstructed grounding slot. It is recommended to have a qualified licensed electrician replace the outlet to ensure safe and proper function. Also see 4.1 comment.

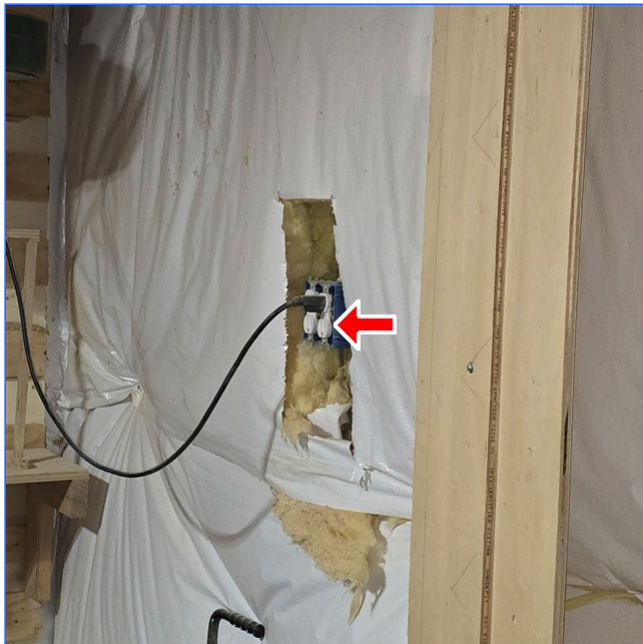
4.6 Item 3(Picture)

(2) Multiple electrical outlets and wall switches throughout the house are missing cover plates, leaving the electrical components exposed and creating a potential safety concern. A qualified licensed electrician is recommended to install proper covers. Example area pictured.

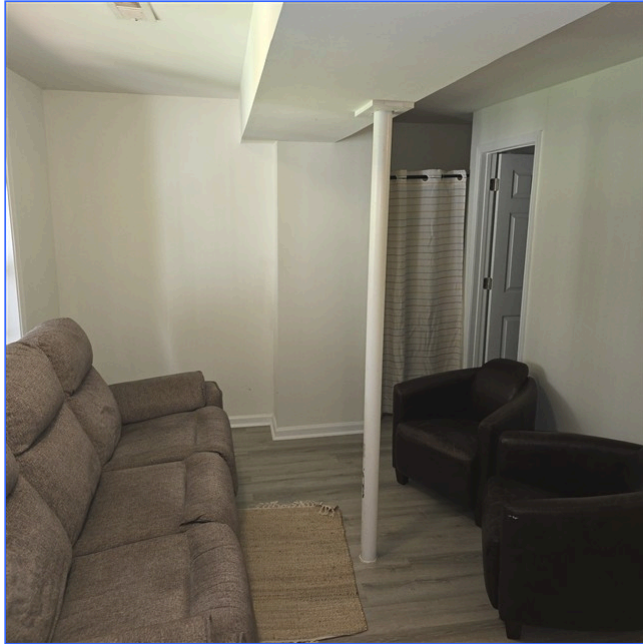
4.6 Item 4(Picture)

(3) Multiple walls in the finished basement area have no electrical outlets installed. Additional outlets may be needed for proper and convenient use of these areas and to reduce reliance on extension cords. A qualified licensed electrician is recommended to further evaluate the electrical system and install additional outlets as needed. Example area pictured. Also see 6.0 comment.

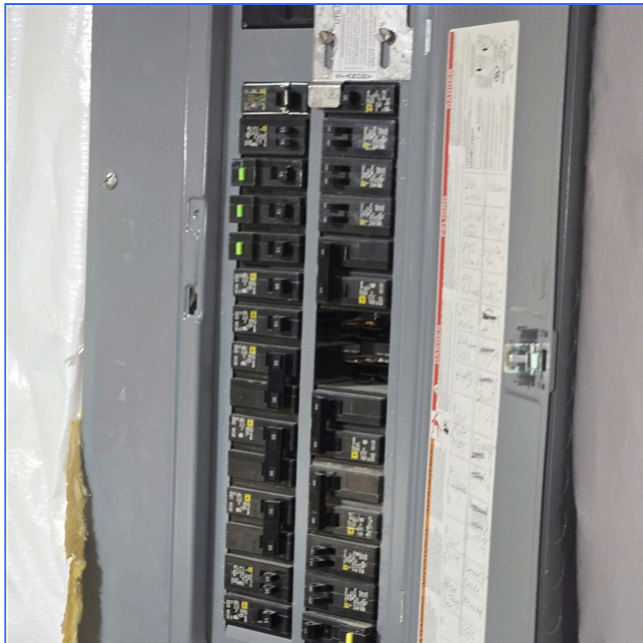
8.1 Item 1(Picture)

The main electrical panel has unprotected openings, which can pose a safety hazard by allowing accidental contact with live components or the entry of debris. It is recommended to have a licensed electrician install proper protective covers or filler plates to ensure the panel is safely enclosed.

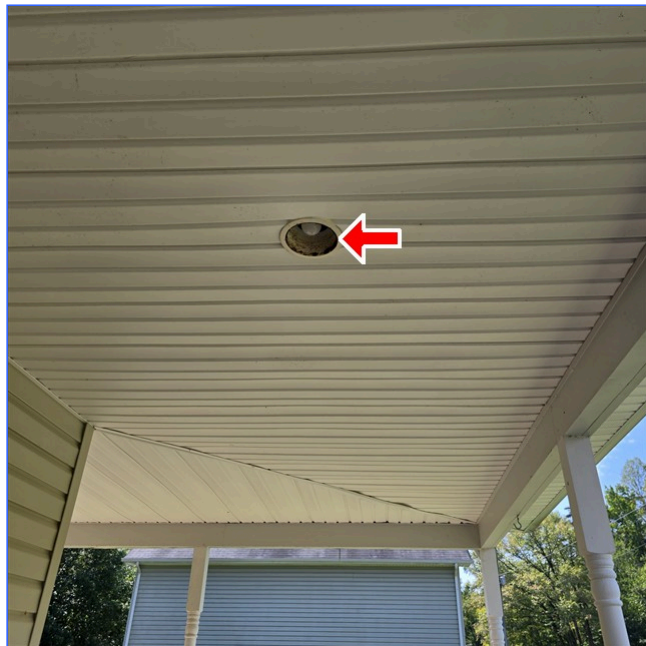
8.3 Item 1(Picture)

(1) Some of the exterior light fixtures are showing surface rust and deterioration from age and exposure to the elements. A qualified licensed electrician is recommended to further evaluate the affected fixtures and repair or replace them as needed. Example area pictured.

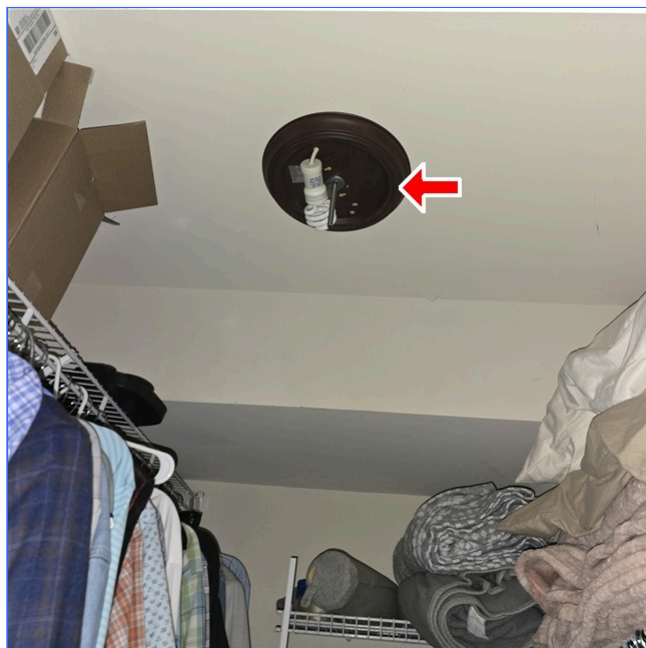
8.3 Item 2(Picture)

(2) The globe is missing from the pictured closet light fixture, leaving the bulb exposed and unprotected. A qualified licensed electrician is recommended to install a proper globe or replace the fixture as needed.
