| DESCRIPTION AND BACKGROUND HISTORY INCLUDING CONSTRUCTION DATE(S), PHYSICAL DIMENSIONS, MATERIALS, MAJOR ALTERATIONS, IMPORTANT BUILDERS, ARCHITECTS, ENGINEERS, ETC. | CURRENT USE | ORIGINAL USE |
| | Remodeled Bungalow. Wood frame set on post and block foundation; rectangle (24' x 30'); 4 bays wide; 1½ stories; narrow clapboard siding; asphalt-shingled saltbox roof with slightly extended eaves, sloping down to porch on south facade; off-center entrance on south facade; corbelled off-center interior chimney on north facade. Exterior features include 6/1, 8/1, 2/2 and 10/1 double-hung sash with plain surrounds; gable-roofed dormer on north facade; plain fascia board; corner boards; 1-story, enclosed shed-roofed porch with center entrance, on north facade; porch on south facade supported by plain posts and railing. Notable landscape features include 8 wood frame, gable-roofed outbuildings; 14 apple, plum trees. | Residence/Rental |

PHOTOGRAPHS AND SKETCH MAP OF LOCATION

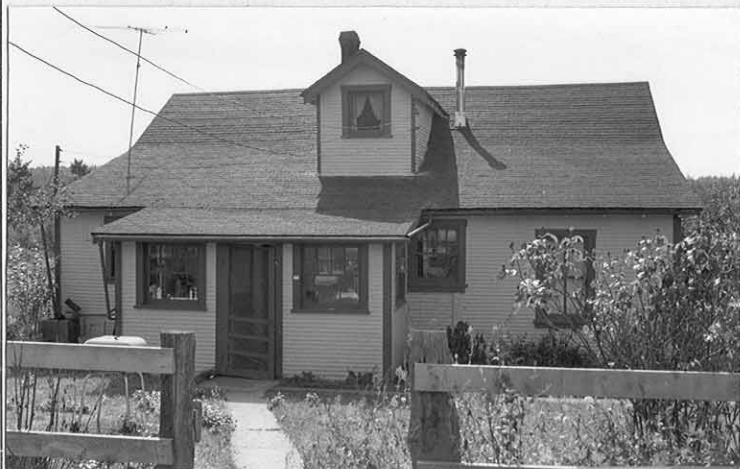
FROM N

This farmhouse was built about 1916 by Elmer Morris, for himself and his family. The size of the farm was approximately 19 acres, and Morris raised dairy cows, chickens, and turkeys. Alterations to the house were done about 1929 by Pop Smith. A new chimney was put in, a porch was built on, the north facade dormer added, and the east end of the house extended. A growing family accounts for the changes. Elmer's son owns the property today, and uses it as a rental.

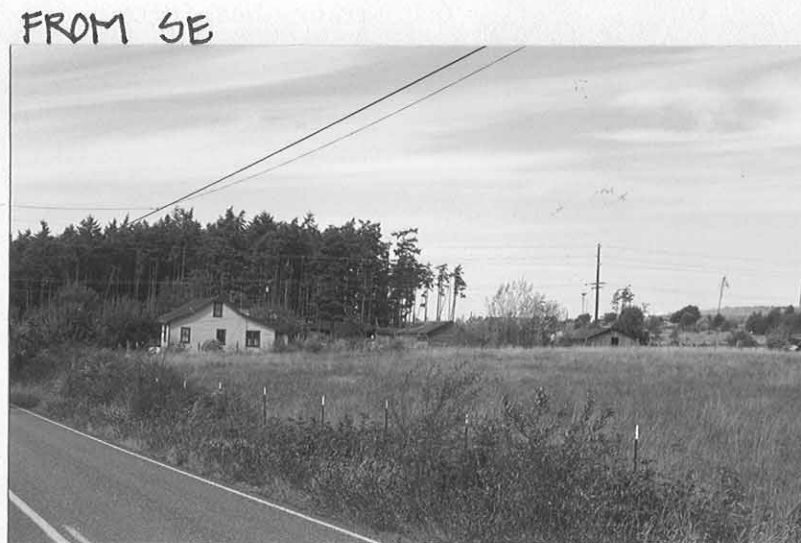
FROM SE

1995: New concrete foundation; shed roof dormer added to front facade; one contributing building and five contributing structures.
