ŠKODA Superb III (from 2015)

ŠKODA Superb Combi III (from 2015)

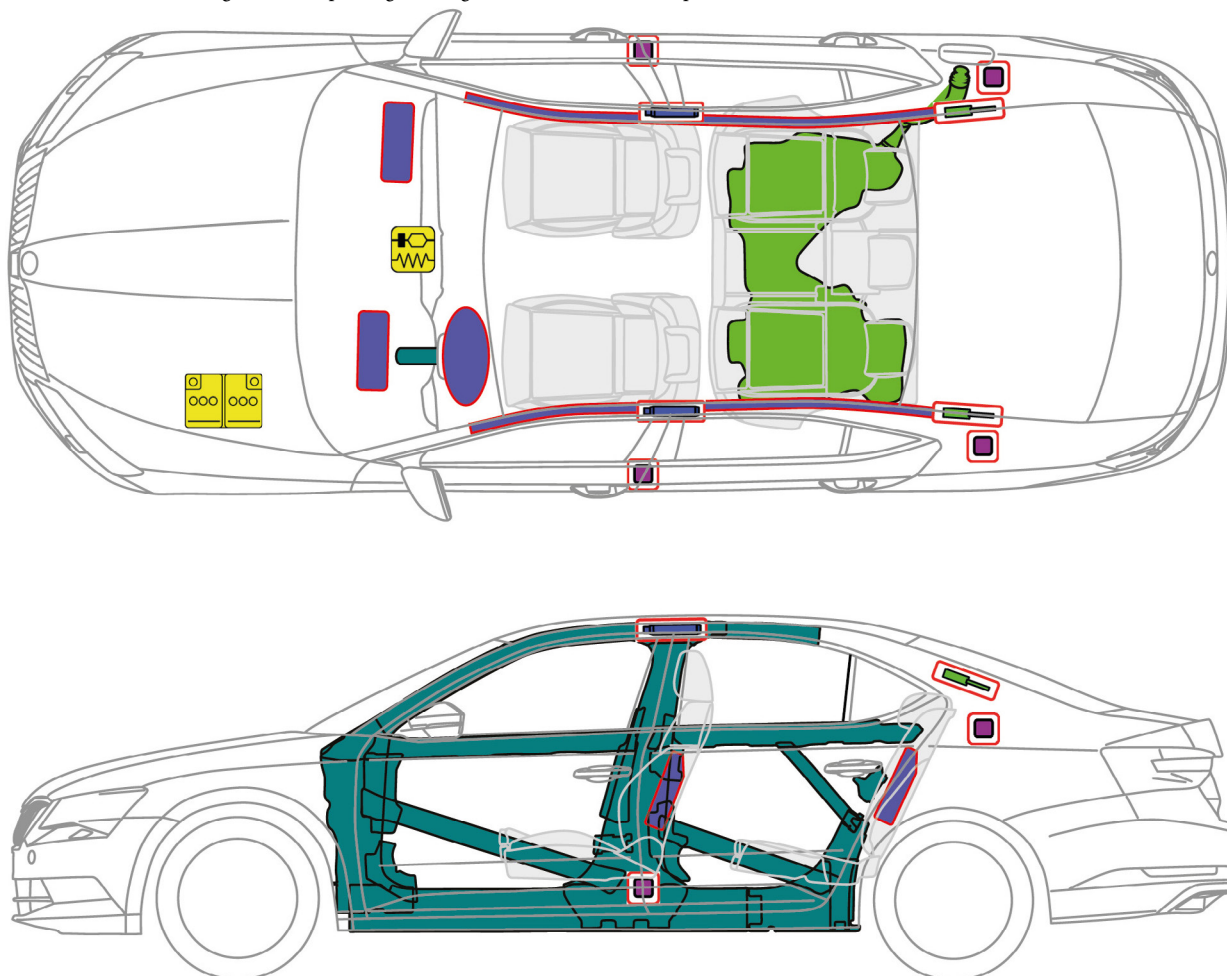
Note: The Rescue Sheet depicts a LHD vehicle (as allowed under the ISO 17840-1). All components (other than steering wheel and passenger airbag) are located in the same position in the Aust/NZ RHD model.

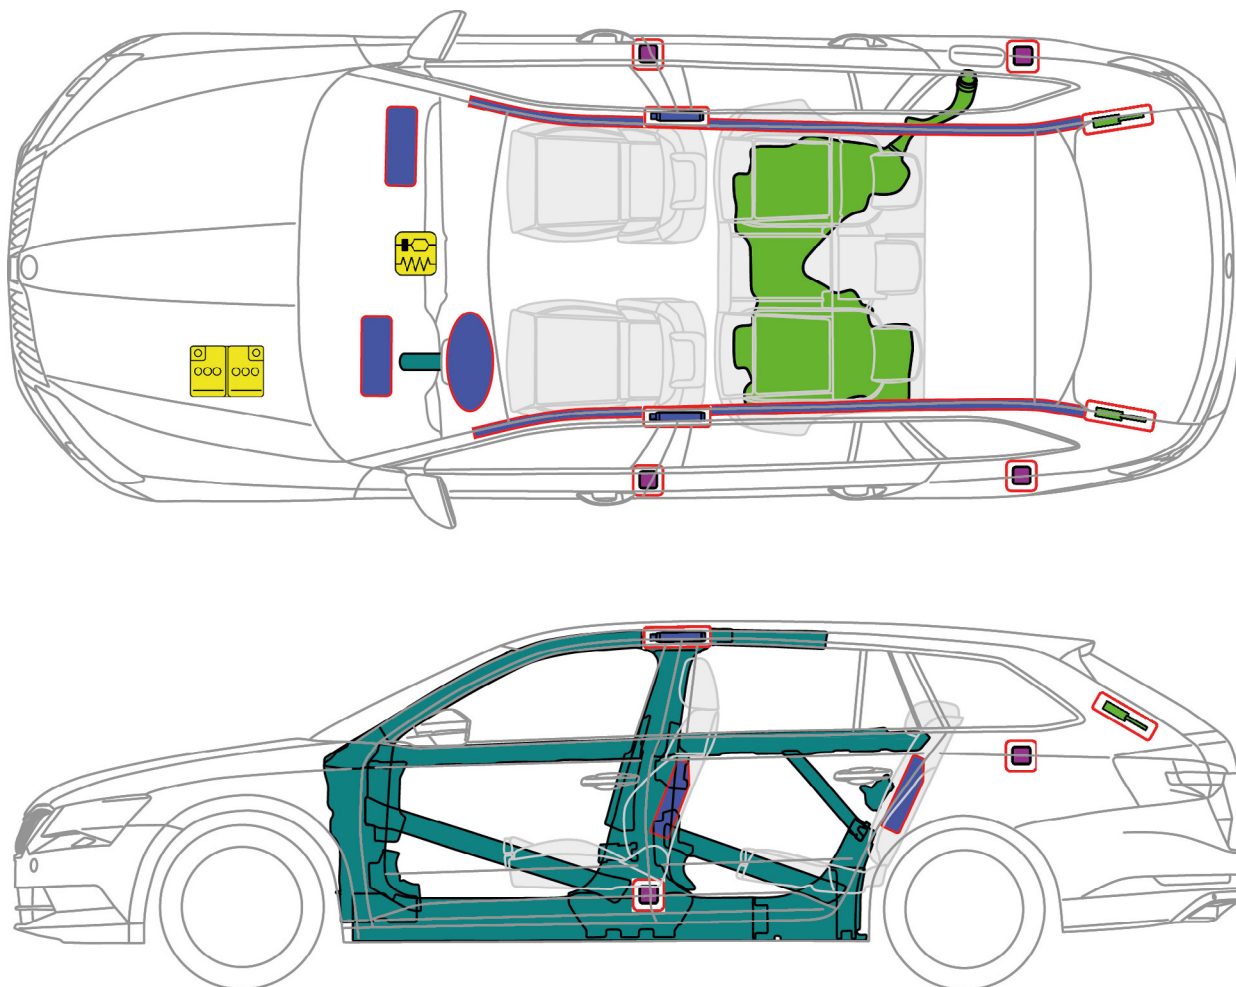
Note: The Rescue Sheet depicts a LHD vehicle (as allowed under the ISO 17840-1). All components (other than steering wheel and passenger airbag) are located in the same position in the Aust/NZ RHD model.
