## St. Patrick Church Solves Slippery Step Problem with Form-A-Tread®

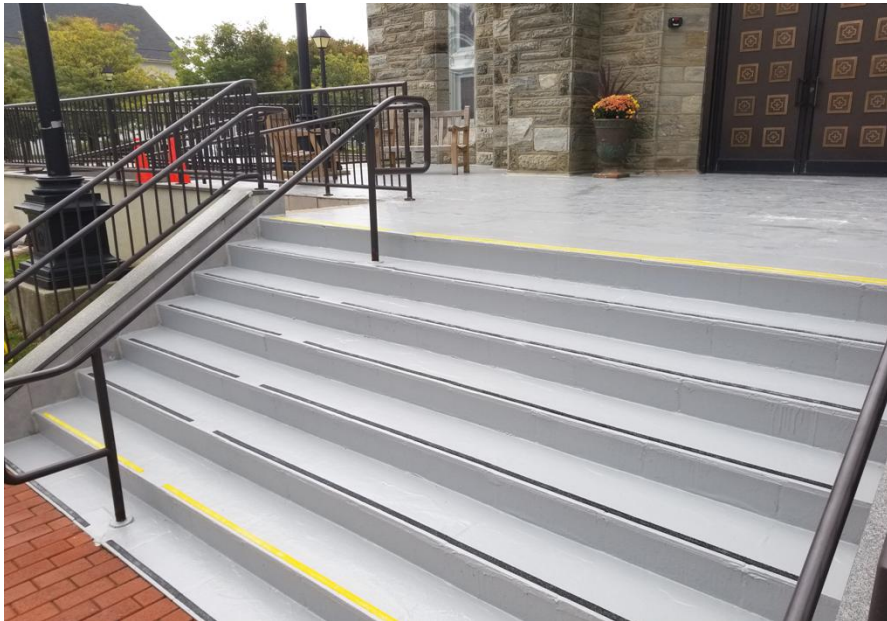
**Problem:** The new tile steps were slippery. To improve traction an epoxy coating with sand broadcasted on top was applied in 2012. The sand wore off in a few years so another epoxy coating was applied. Unfortunately the new coating was very slippery. The steps were so slippery that one parishioner fell and the Church had to close the front steps to pedestrian traffic. This was a major inconvenience and liability concern for this active Church.

Form-A-Tread®, a 100% epoxy based material containing slip resistant properties and UV inhibitors was selected. Adhesion testing to the existing epoxy coating was conducted prior to installation. A 1" wide Black stripe was installed directly onto and ½" from the front edge of the step. To improve visibility especially in low light situations, Form-A-Tread **Safety Yellow** was applied on the bottom step and two 1" stripes on the top step. An additional 1" wide Black stripe was applied on the landing. The stairs are exposed to heavy foot traffic and weather extremes so Tread Grit® HD was sprinkled on after spreading for additional traction and durability.

**Installation Time:** Under 3 hours. Surface preparation consisted of removing dirt and loose coating with a stiff wire brush. Form-A-Tread was installed in the early afternoon and allowed to cure overnight. Steps were ready to receive foot traffic by 6AM the next morning. Temperature of install area = 60 to 75°F.

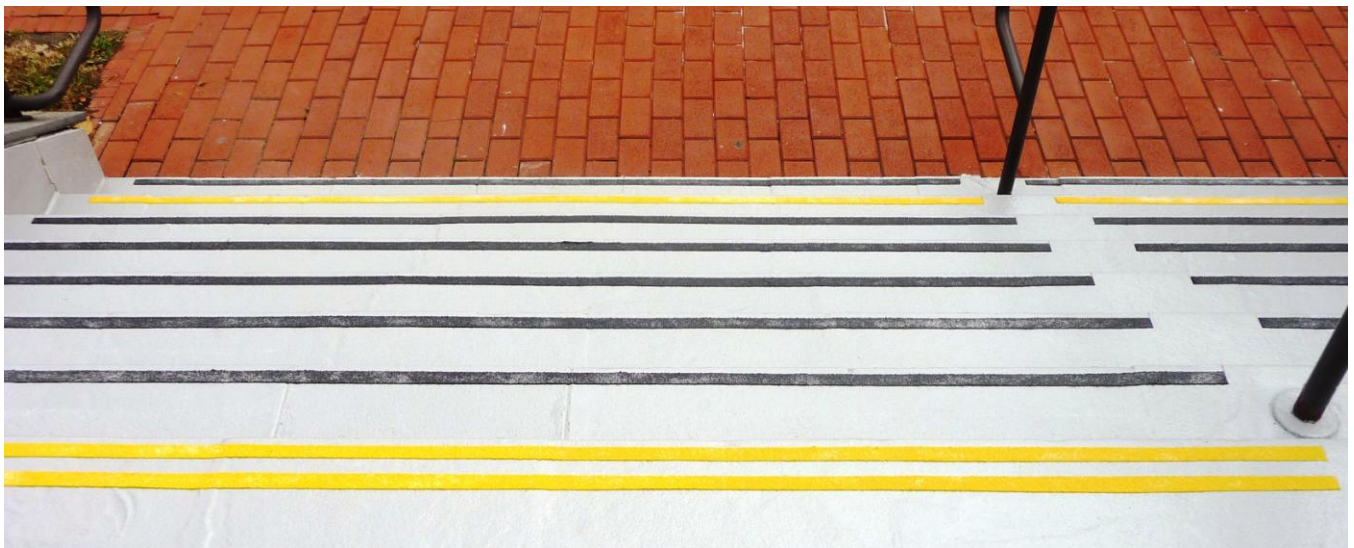
**Summary:** Traction, safety and visibility on St. Patrick Church front steps were greatly improved. The steps are open again and feedback from Church leadership, parishioners and students has been extremely positive.
